HISTORIC STRUCTURES REPORT

NARBONNE HOUSE

Salem Maritime National Historic Site

Salem, Massachusetts

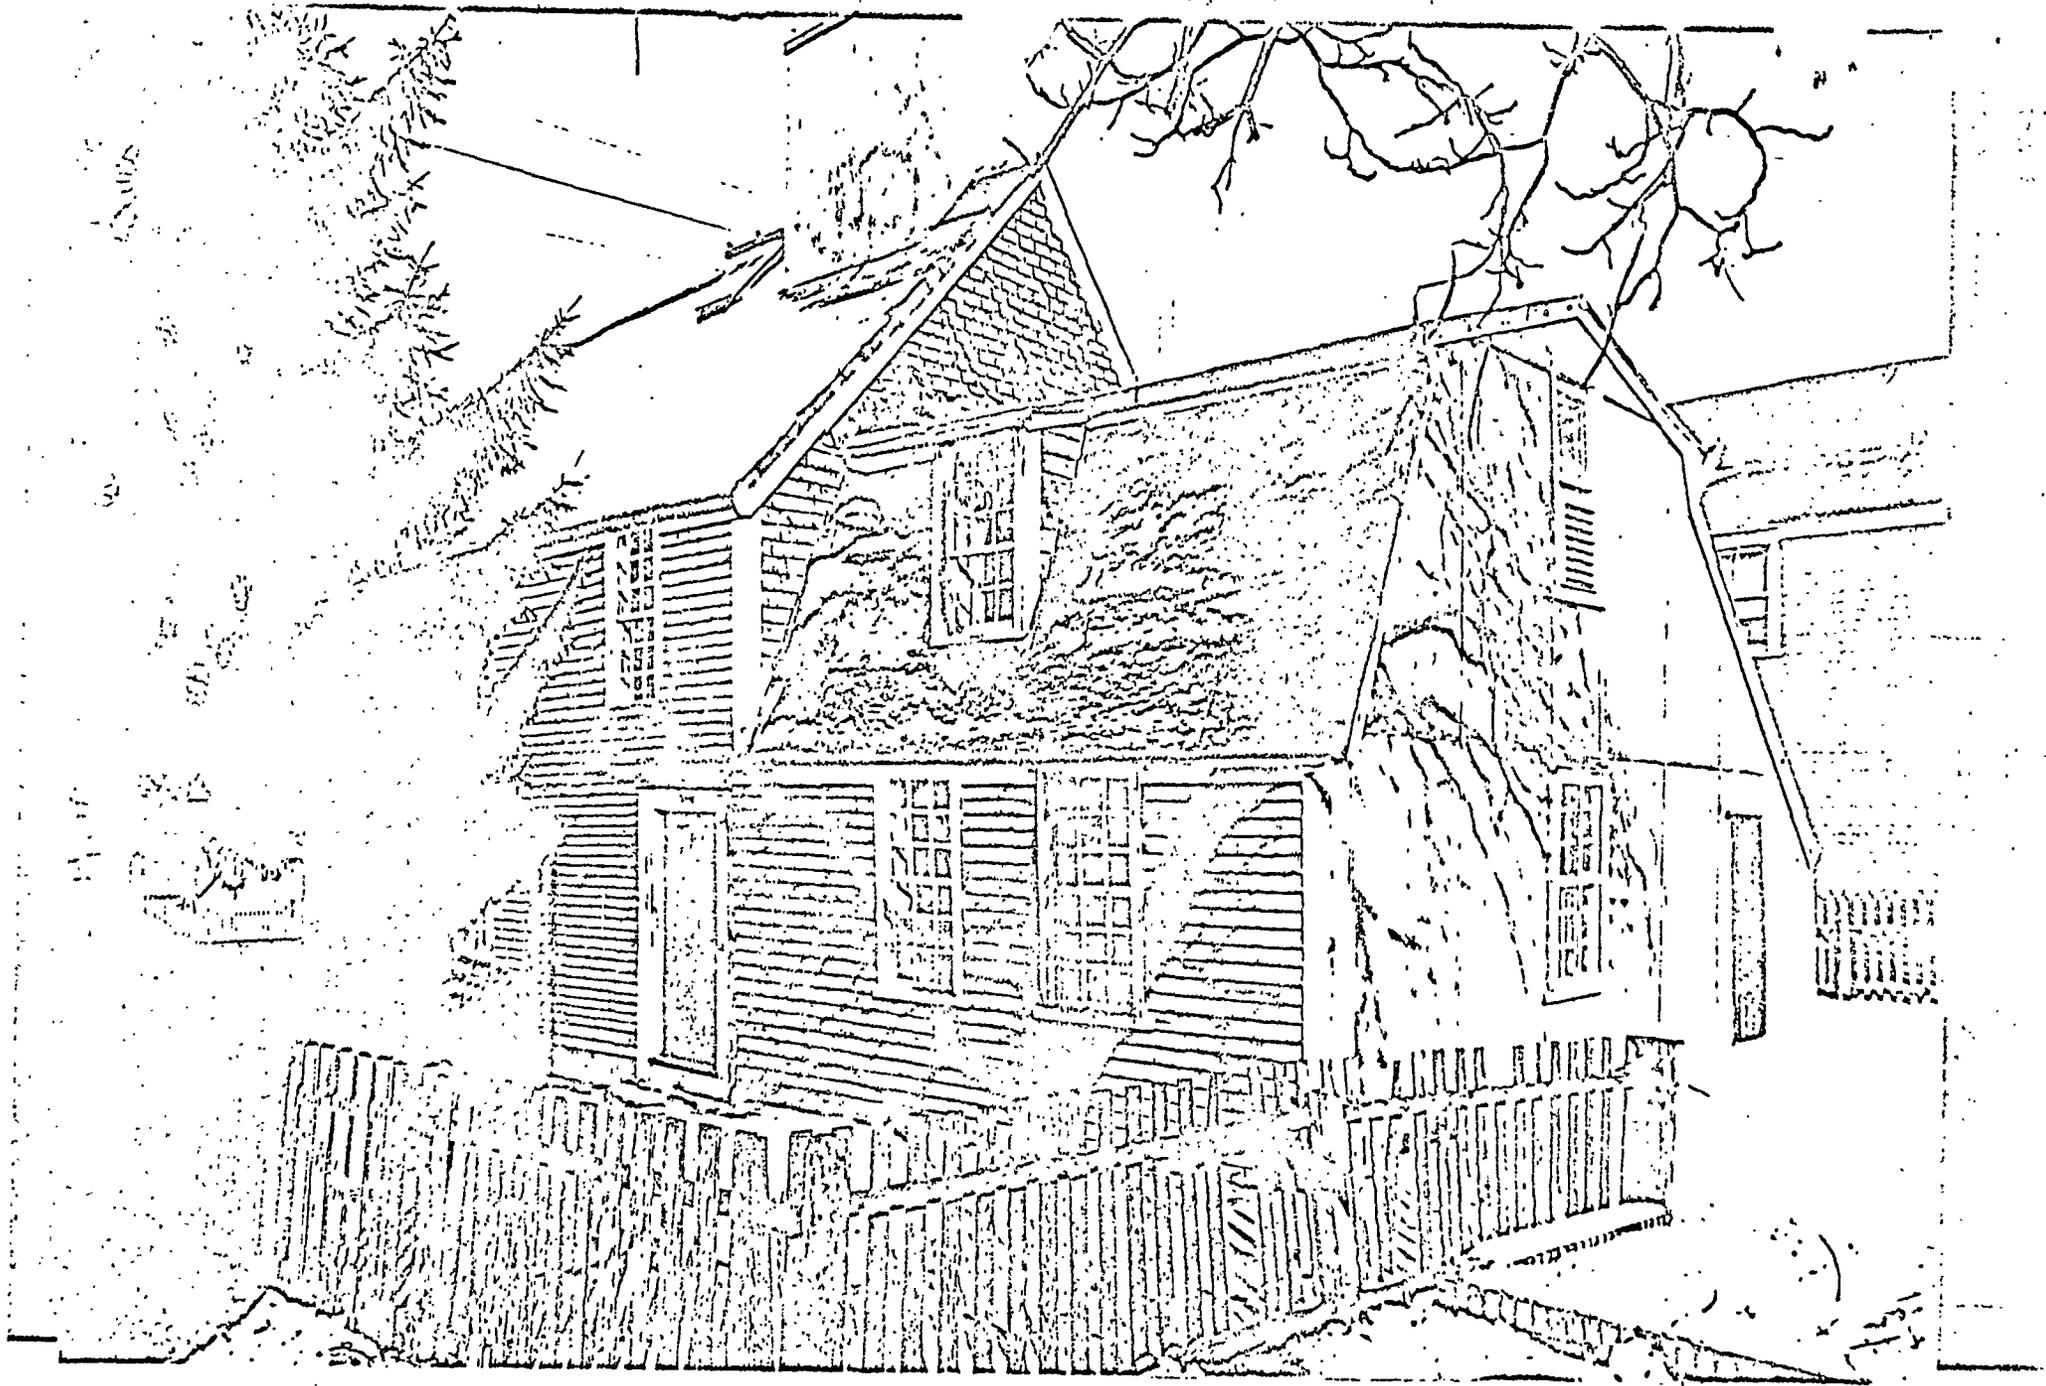
- Likewise no evidence has been found for active settlement of the west wall of the addition to the south, where a curbed or bulged appearance seems to pertain partly to the adaption of this structure to the larger original house, (Photograph 1).

1. Narbonne House, Salem, Mass. Contemporary view of exterior from the southwest.

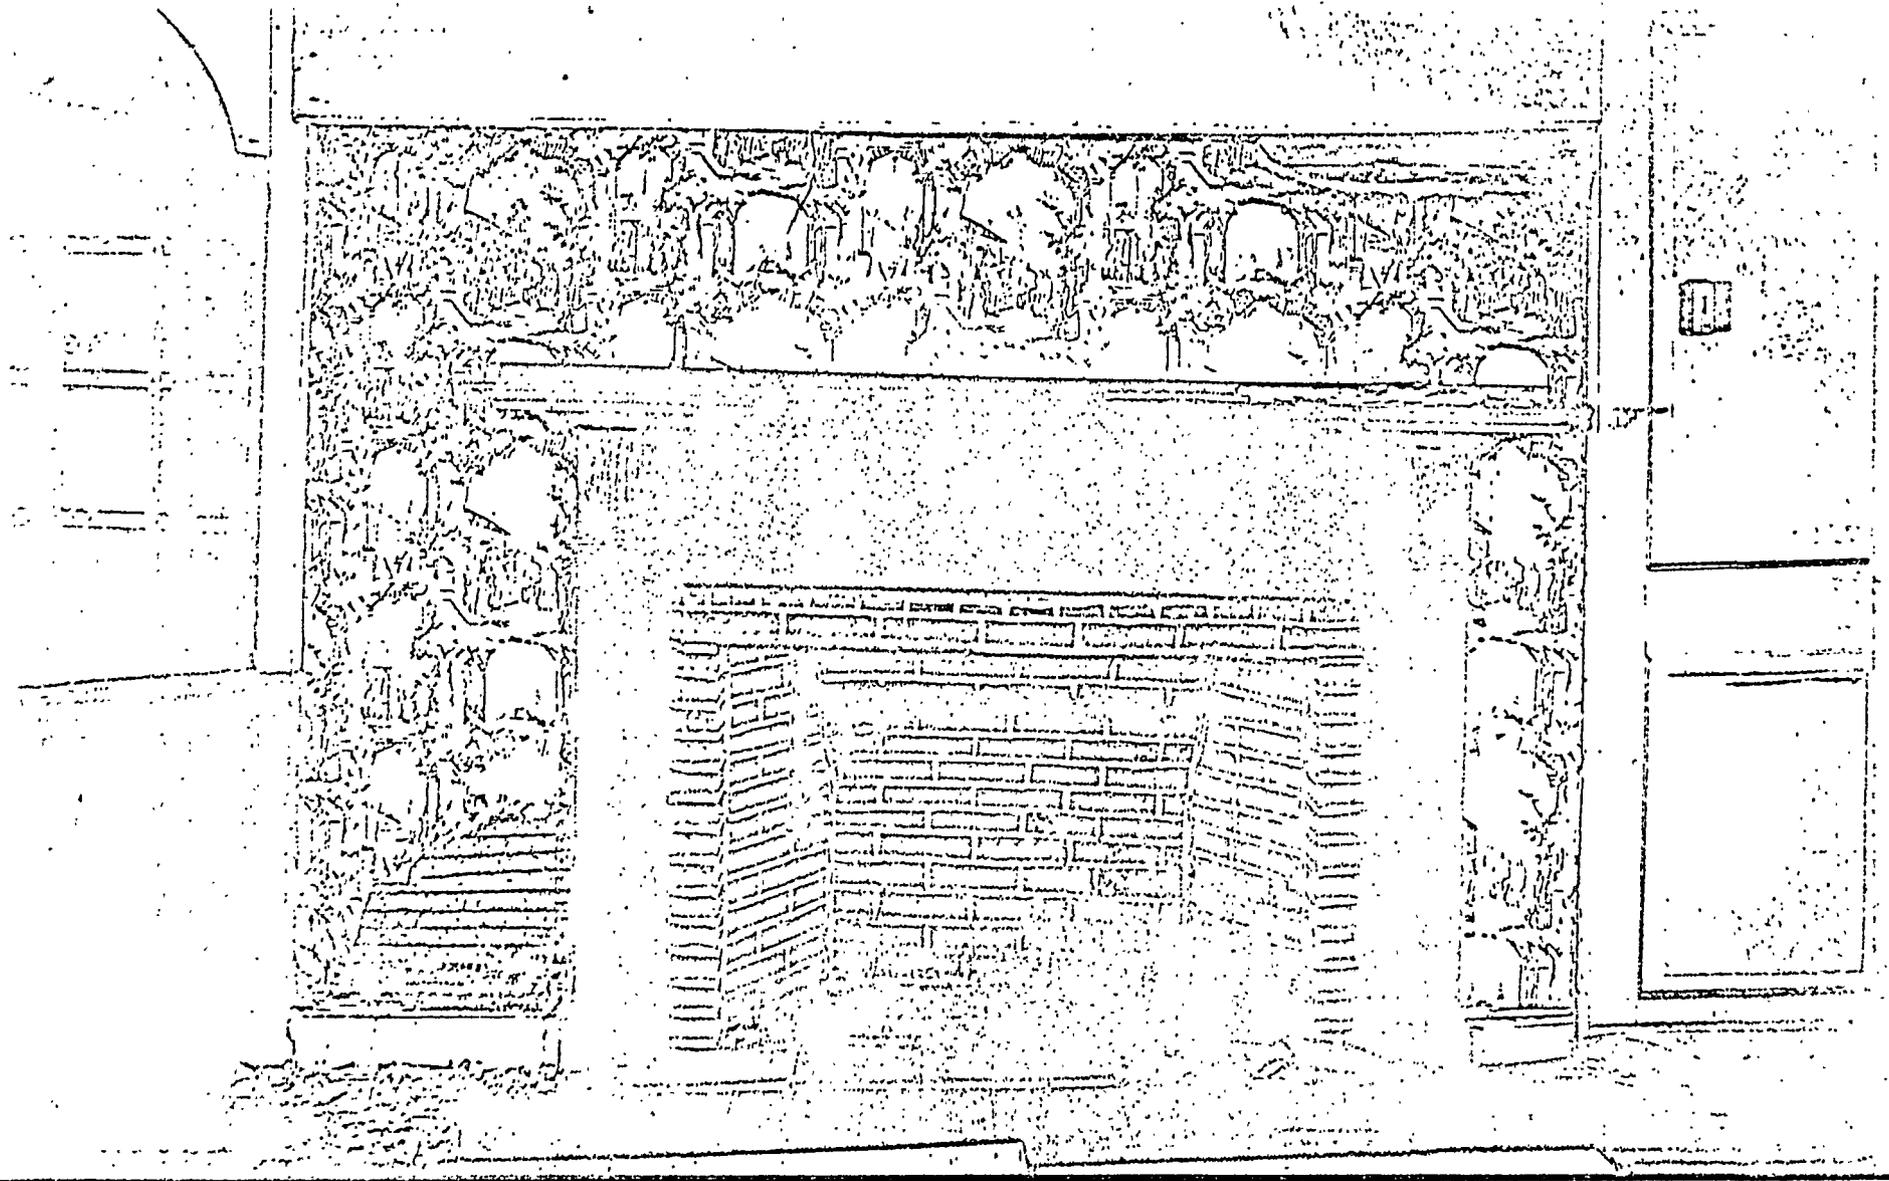
14. Narbonne House, Salem, Mass. Fireplace in north room, first floor before removal of mantel, lath and plaster. Settlement of northwest corner of chimney has caused fireplace to sink several inches (lower right).

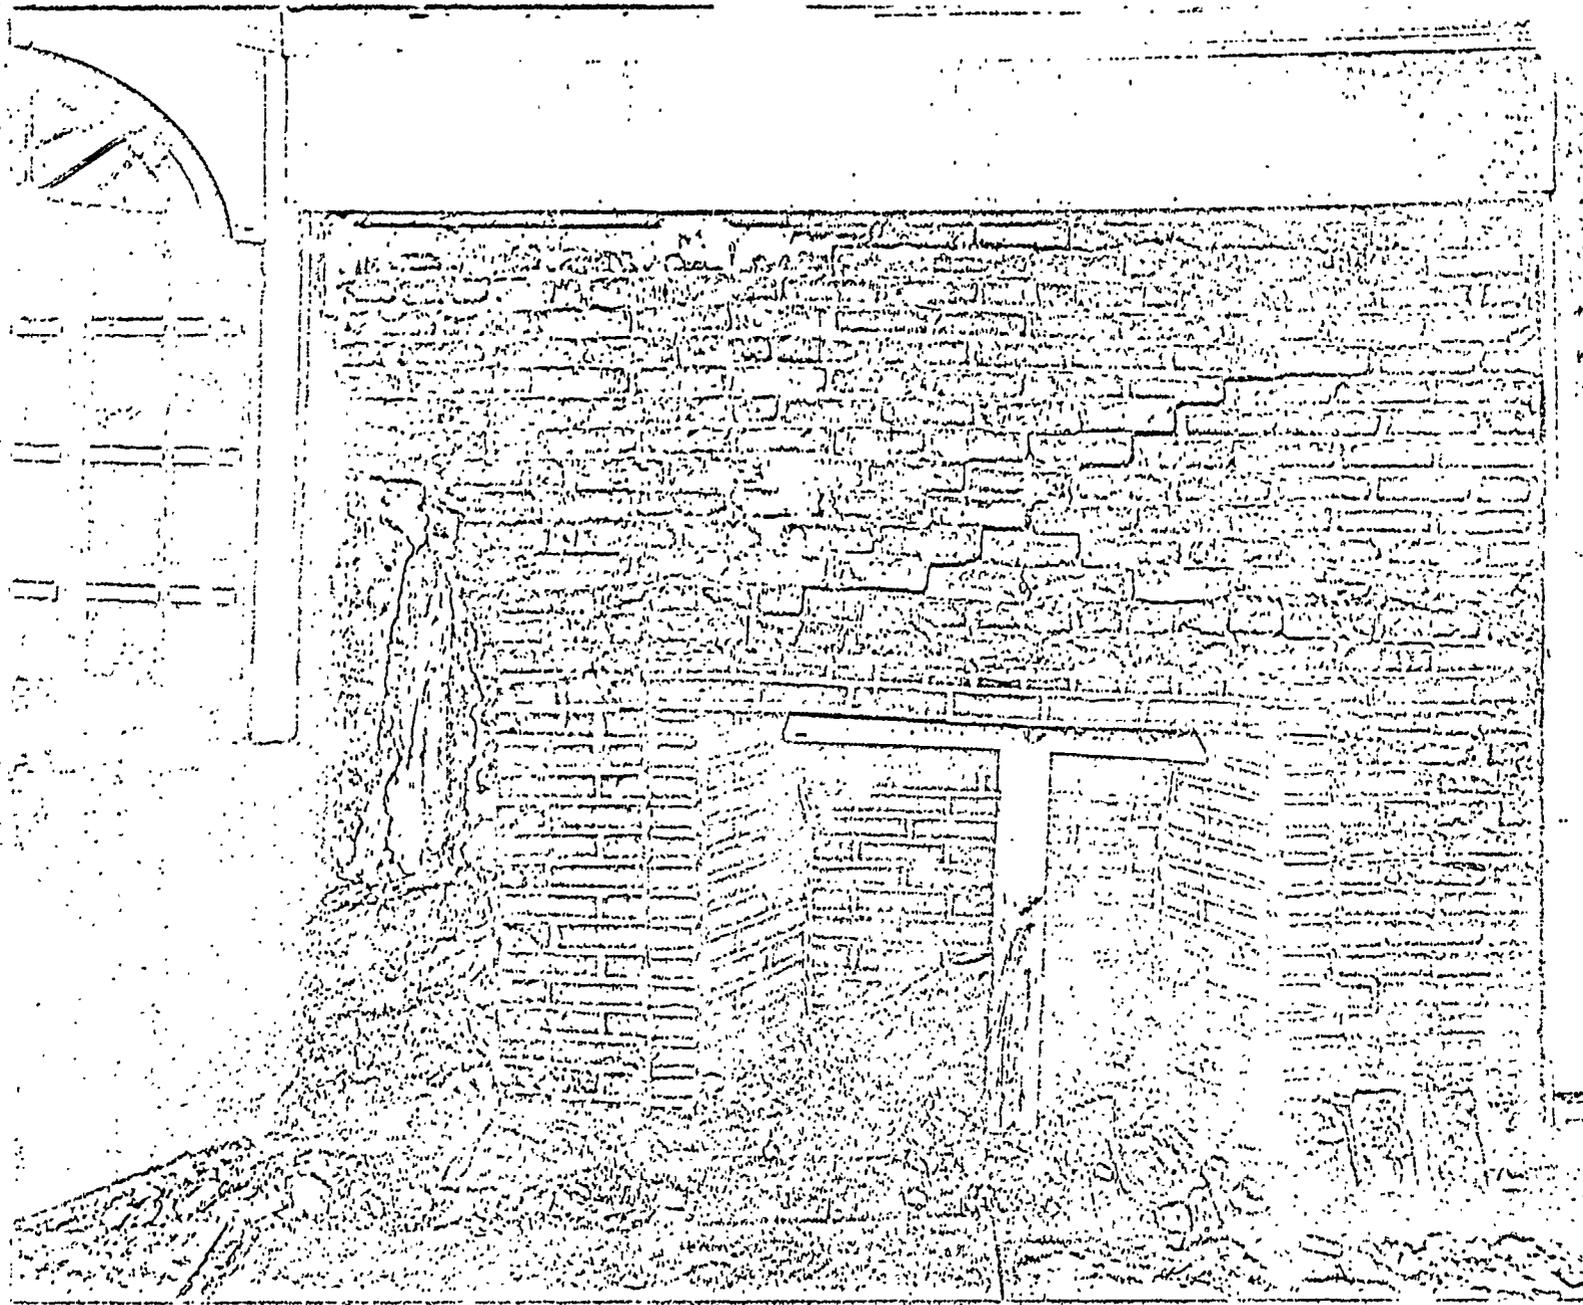
15. Narbonne House, Salem, Mass. Fireplace in north room, first floor after removal of mantel, lath and plaster showing condition of the brickwork. The lath and plaster wall surface was removed in one piece, complete with furring strips, and can be reinstalled intact with

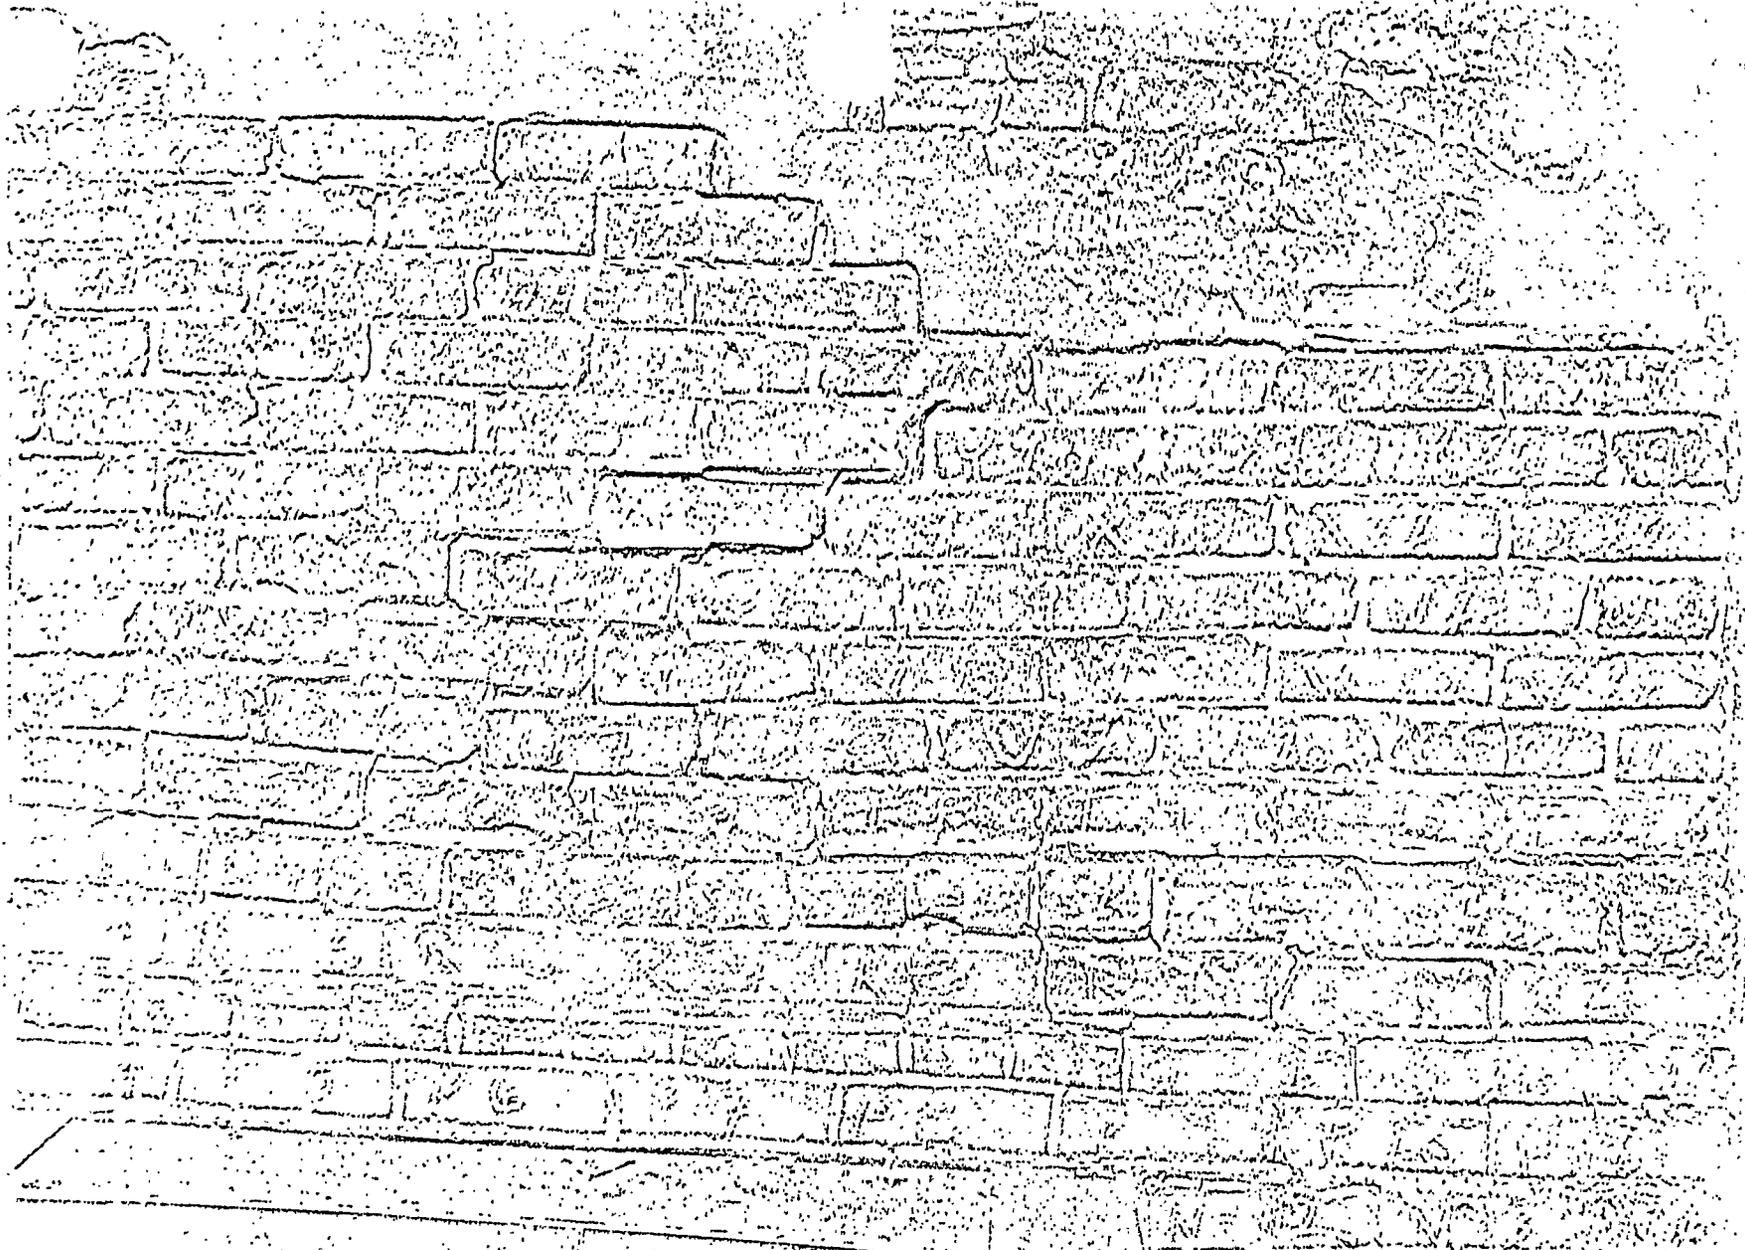
19. Narbonne House, Salem, Mass. Detail of fireplace in north room. Record photograph of numbered bricks above lintel before their removal. Cracks are the result of continuing settlement at the northwest corner of the chimney.

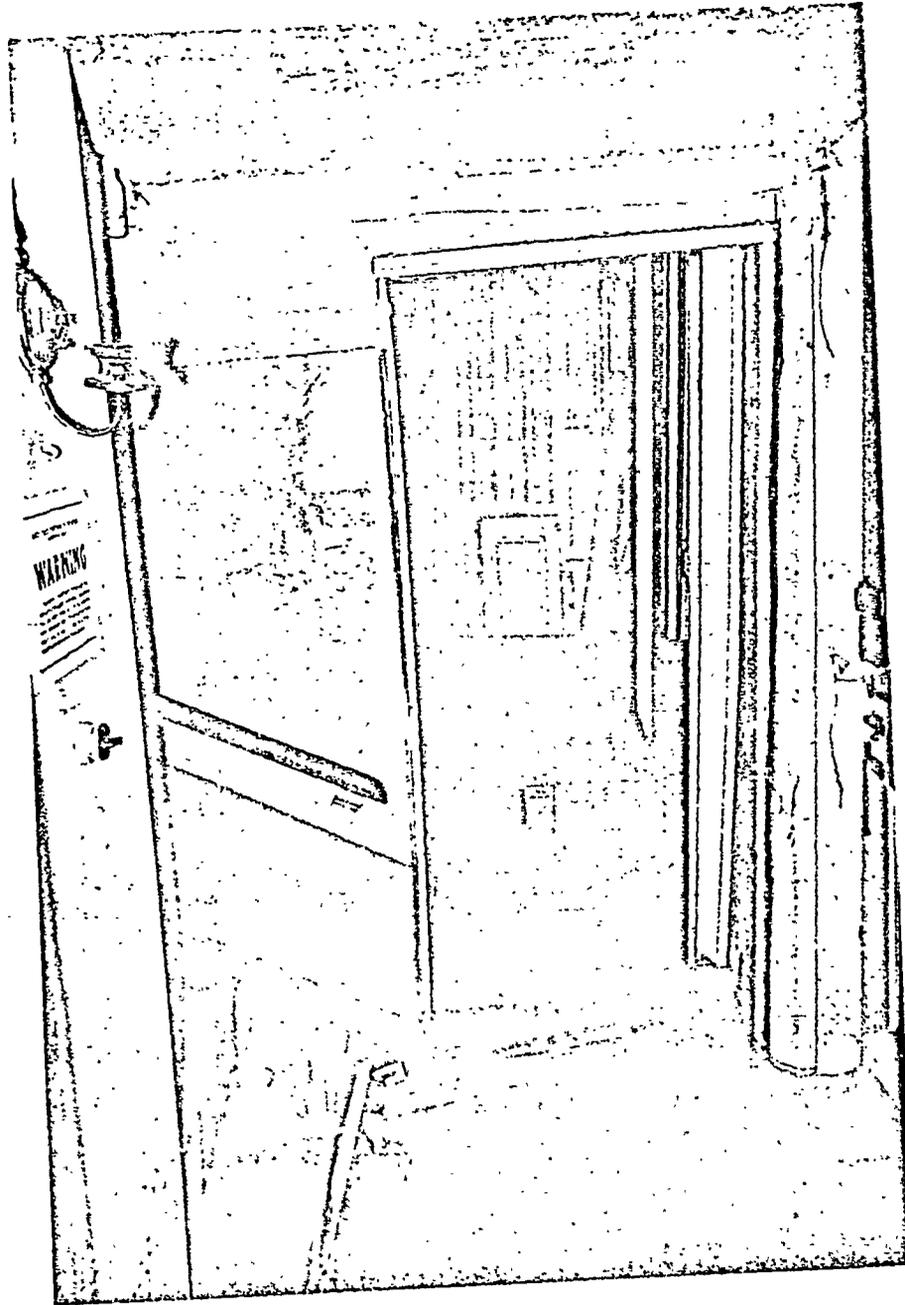
Photograph 32: View toward south in first floor front (west) entrance hall. Chimney girt has been substantially cut to make headroom for door.
