SPECIAL REPORT

SALEM MARITIME NATIONAL HISTORIC SITE

JULY 13 and 14, 1940

BY
Oscar S. Bray
Associate Engineer
and
Ross F. Sweeny
Assistant Engineer

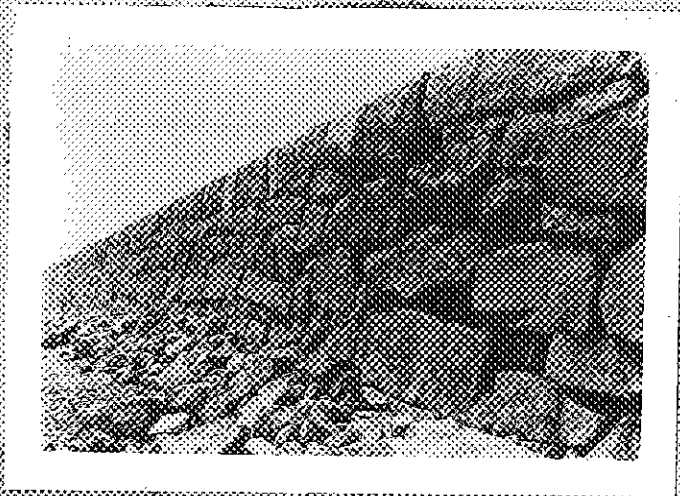
Sta. 15495

West Side
