COMMANDING OFFICER'S QUARTERS (Building 1)

Springfield Armory National Historic Site
Springfield, Massachusetts

Historic Structure Report

James J. Lee III
Architectural Conservator
and
Marilou Ehrler
Historical Architect

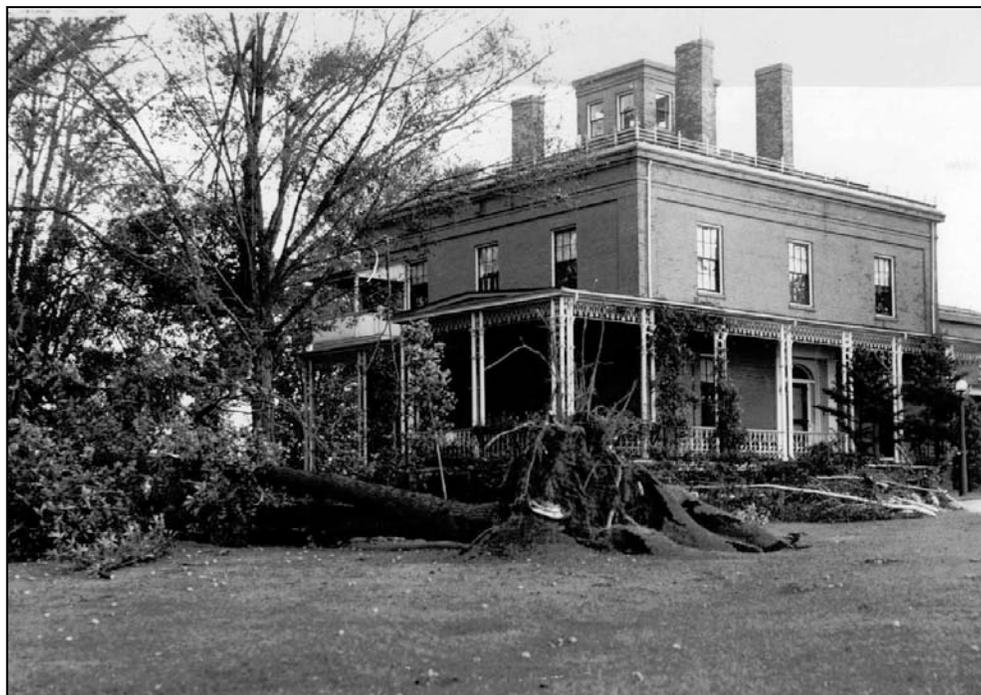
Figure 42. Commanding Officer's Quarters looking northeast, tree damage from hurricane, September 1938. Note the one-over-one sashes in the cupola.

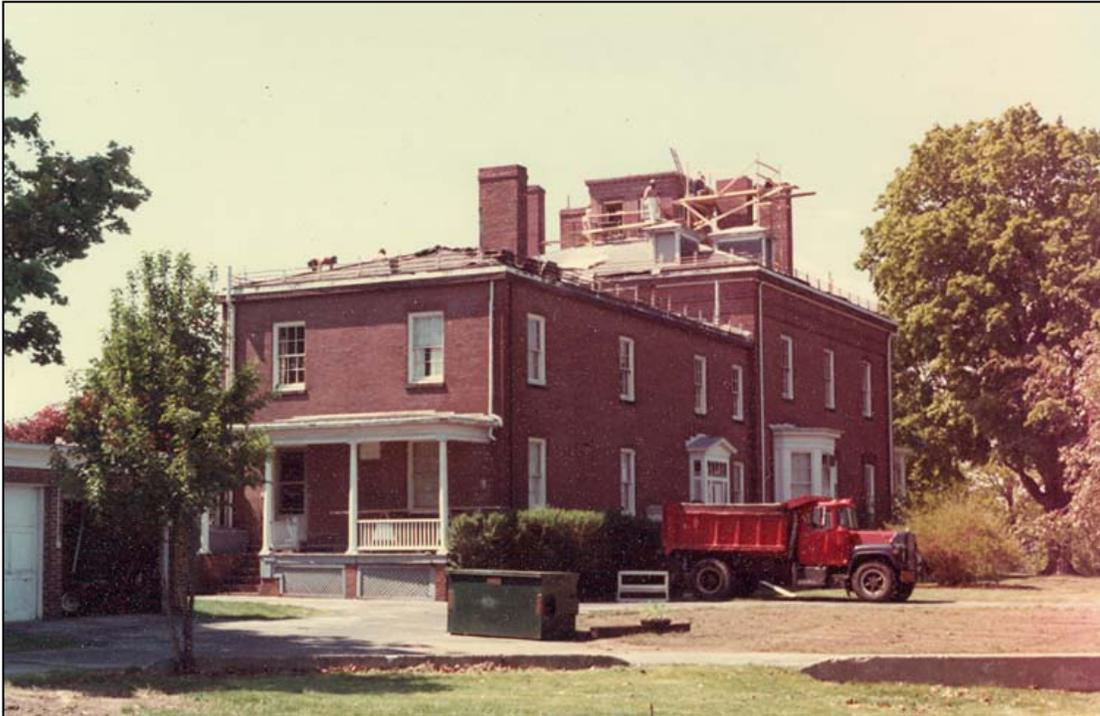
Figure 63. Commanding Officer's Quarters looking southwest, depicting 1980 repairs to roofs and chimneys.

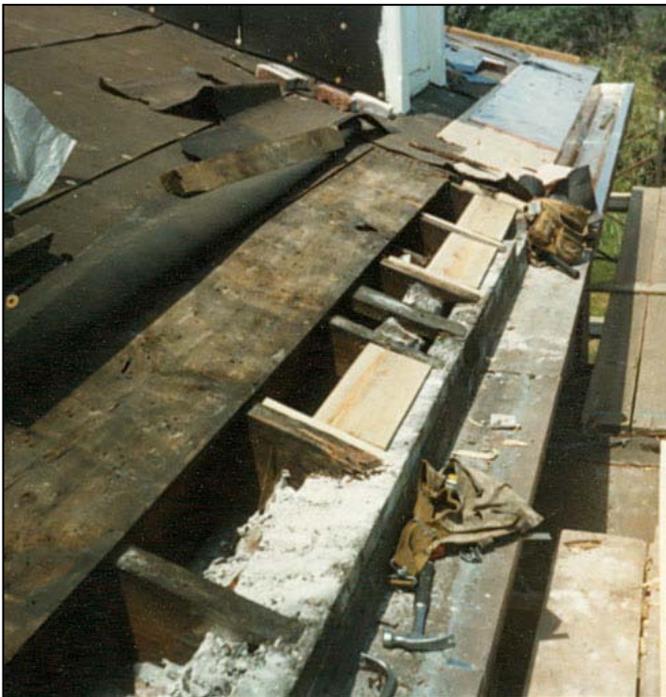
Figure 64. "Bldg 1-East eave, Main roof: Cornice stone, brick gutter backing/firestops, rafters, sheathing. Note new press[ure] treated snowrail stanchion anchor blocking, gutter apron beyond. 7/1/80" (handwritten on back of photograph).

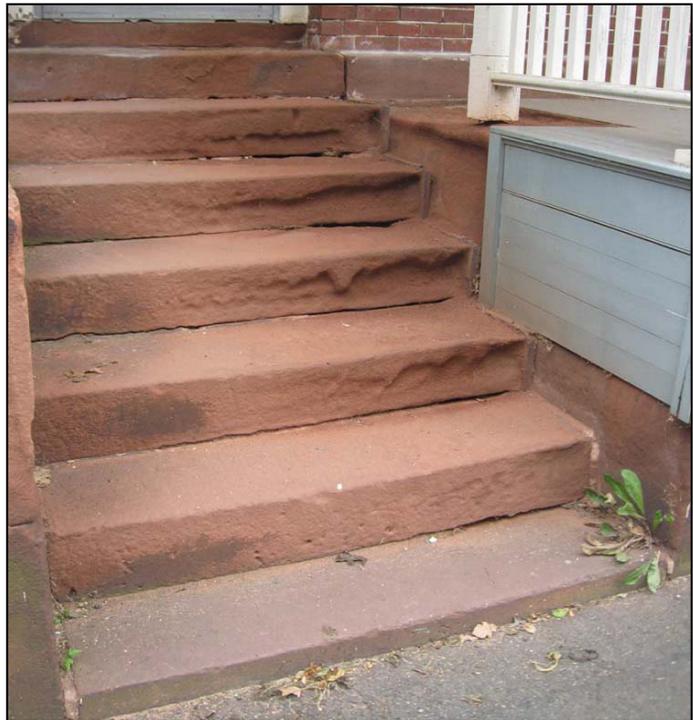
Figure 76. Commanding Officer's Quarters, Ell, east elevation, deteriorated brownstone steps leading to D116, 2008.
