# **BUILDING No. 5 & 6**

## **HISTORIC STRUCTURE REPORT**

**Springfield Armory National Historic Site  
Springfield, Massachusetts**

2012

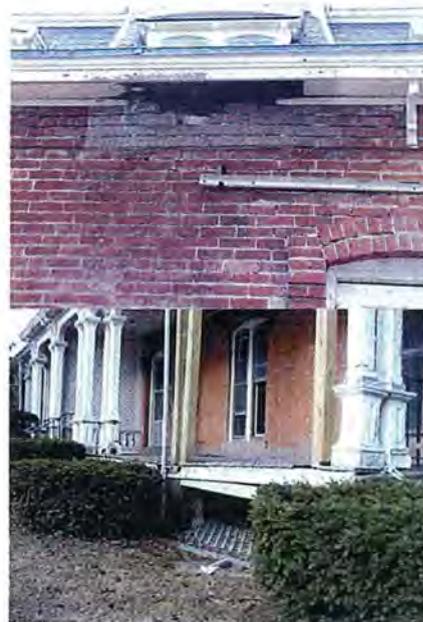
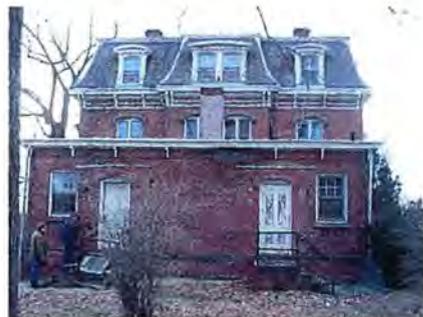
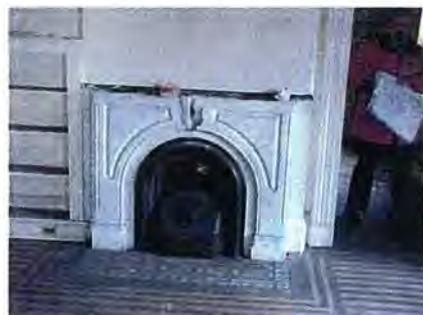
The open entry porch in the front of the building is in very poor condition. Most of the wood is rotted, and some ornamental rails and balusters are missing (they were later found to be stored in the basement). Further exploration may lead to a small amount of this wood being salvaged. The porch superstructure also seems to be experiencing some distress with some of the support columns vertically displaced causing the floor and roof to shift; this may be indicative of more significant foundation issues. Some temporary columns have been installed as a mitigation measure to replace those that have been permanently damaged. The stone front entry steps are also displaced. To the rear, the original wall-hung exterior light fixtures are missing and one of the two masonry service entry stairs has collapsed. It should be noted that a

chimney structure on the rear of the building is covered in plywood and bound with straps: its condition is unknown but assumed tenuous.

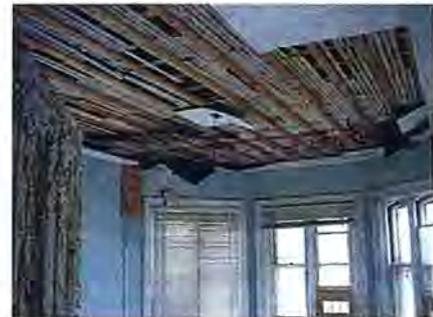
There is evidence of past water infiltration problems scattered intermittently throughout the interior of the building, and in some locations it is severe. This includes, but is not limited to, water staining, complete plaster delamination, discoloration, paint peeling, etc. From visible surface conditions observed, it appears that ceiling joists are still in reasonably good condition: more destructive exploratory work may be performed to assess full extent of water damage during subsequent design phases.

The kitchen is in poor condition with vinyl tile floors, plaster walls and a plaster ceiling. All cabinets, appliances, etc. are severely damaged and offer no architectural or functional salvage potential

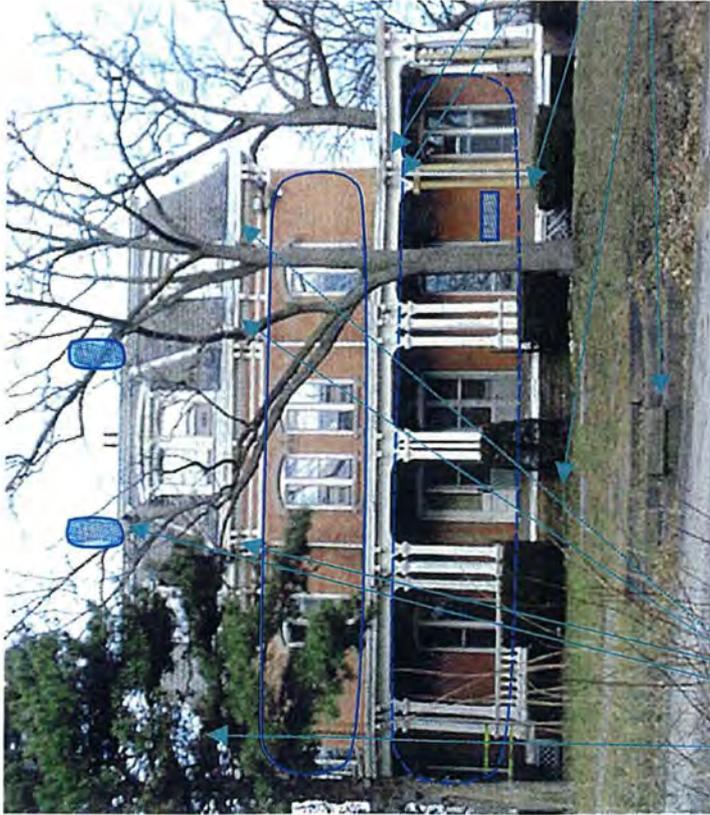
# Building #5/6 West Façade

- Significant weathering; soffit rot severe
- Significant rot at ridge
- Broken wooden ridge scroll
