100% SUBMITTAL
November, 1995

HISTORIC STRUCTURES REPORT

LACKAWANNA HERITAGE VALLEY TROLLEY MUSEUM

Silk Mill Building
Steamtown National Historic Site

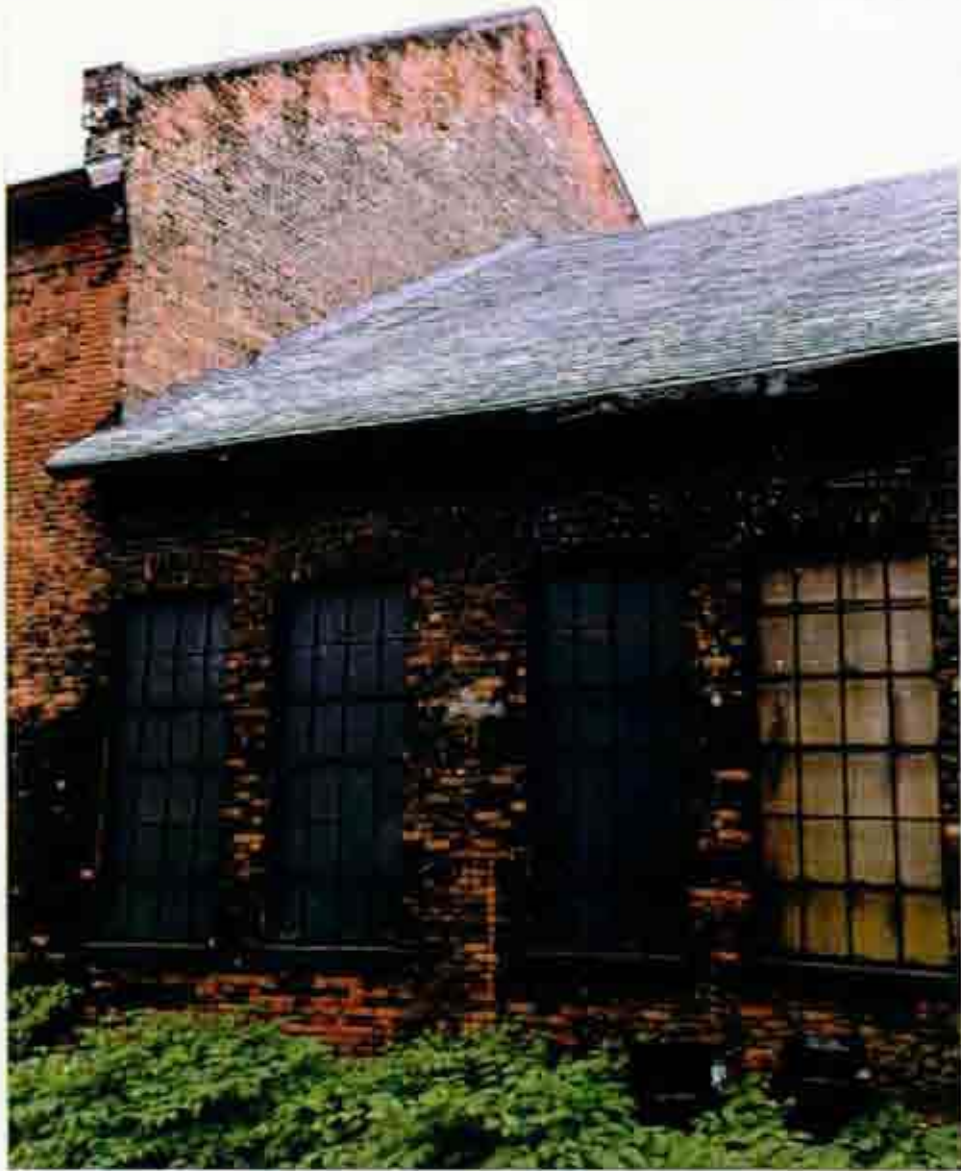
Figure 3.2

The west and east sides of the parapet wall between the eastern two story area of Bay 4 and its western 1-1/2 story area are in poor condition with severe joint deterioration and spalling, broken and missing brick. The top of the parapet wall is a rowlock brick coping showing minor signs of deterioration. See Figures 3.2, 3.8 and 3.14.

Detail of brick parapet on Pattern Shop; note that there are no butt joints or lines of demarcation to suggest anything other than that the building was originally constructed in this configuration.

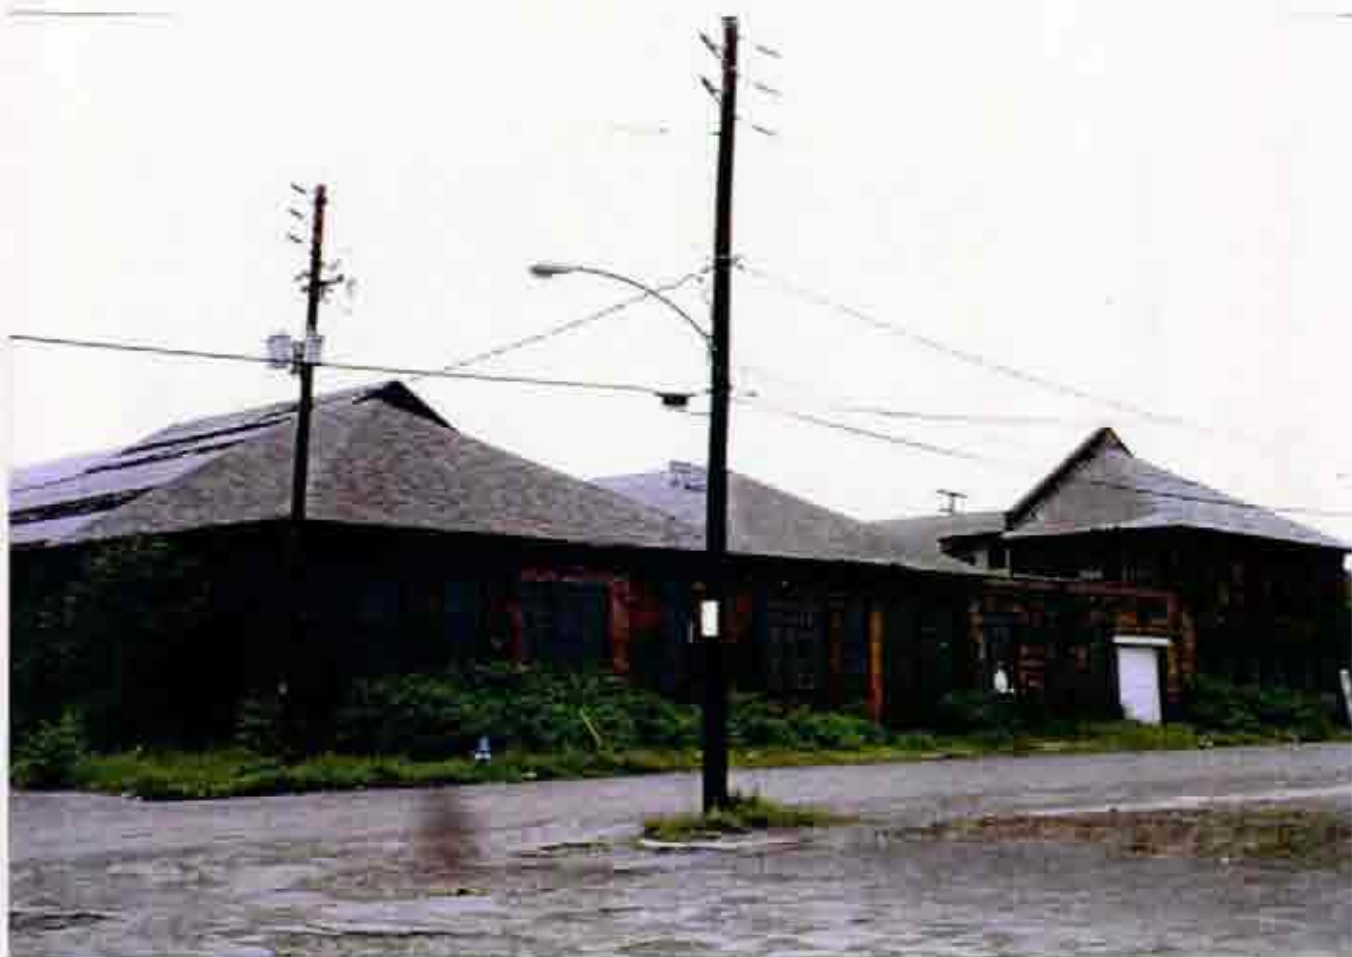
Figure 3.4

The exterior load bearing brick masonry walls exhibit varying degrees of deterioration, depending upon their particular orientation to the prevailing weather patterns. Beginning on the east elevation, the lower portions of all four bays show minor signs of mortar joint deterioration along with spalling, broken and/or missing brick. The infill brick at Bay 3 is conspicuously different in texture and color from the three other bays, the result of later construction. There are also numerous structural stress cracks between the first and second floor windows of Bay 4. Also, all four bays show clear signs of alterations made over time to the masonry openings, as demonstrated by the variety in color and texture of brick used for these changes. See Figure 3.4.

General view of east elevation of the Machine Shop (Bay 1) on the left side, and Pattern Shop (Bay 4) on the right side.

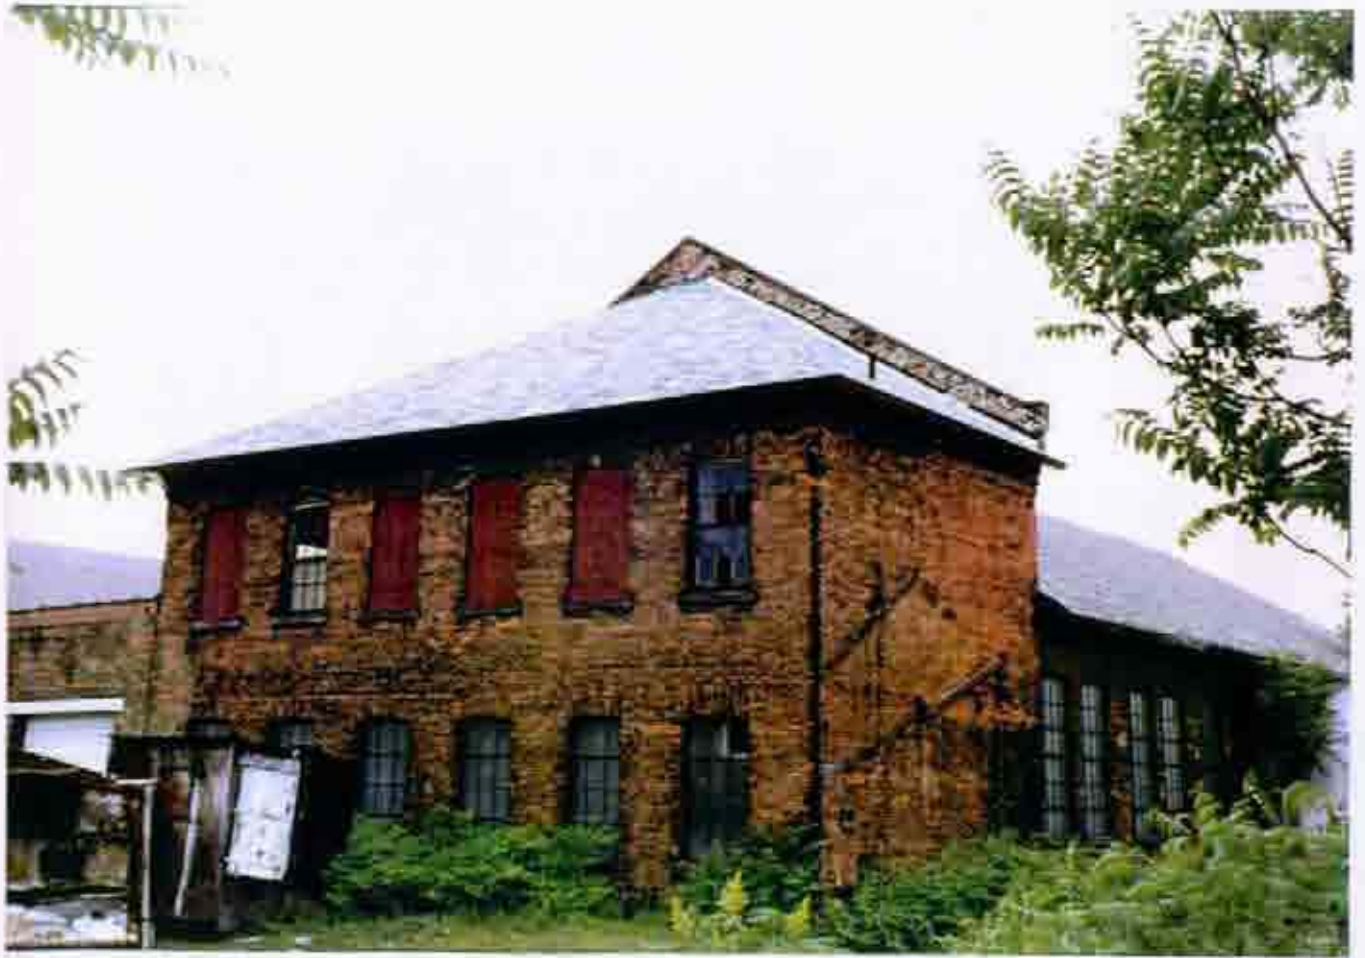
Figure 3.8

Detail of ghost of the former one story, gable roofed addition on the north side of Bay 4.

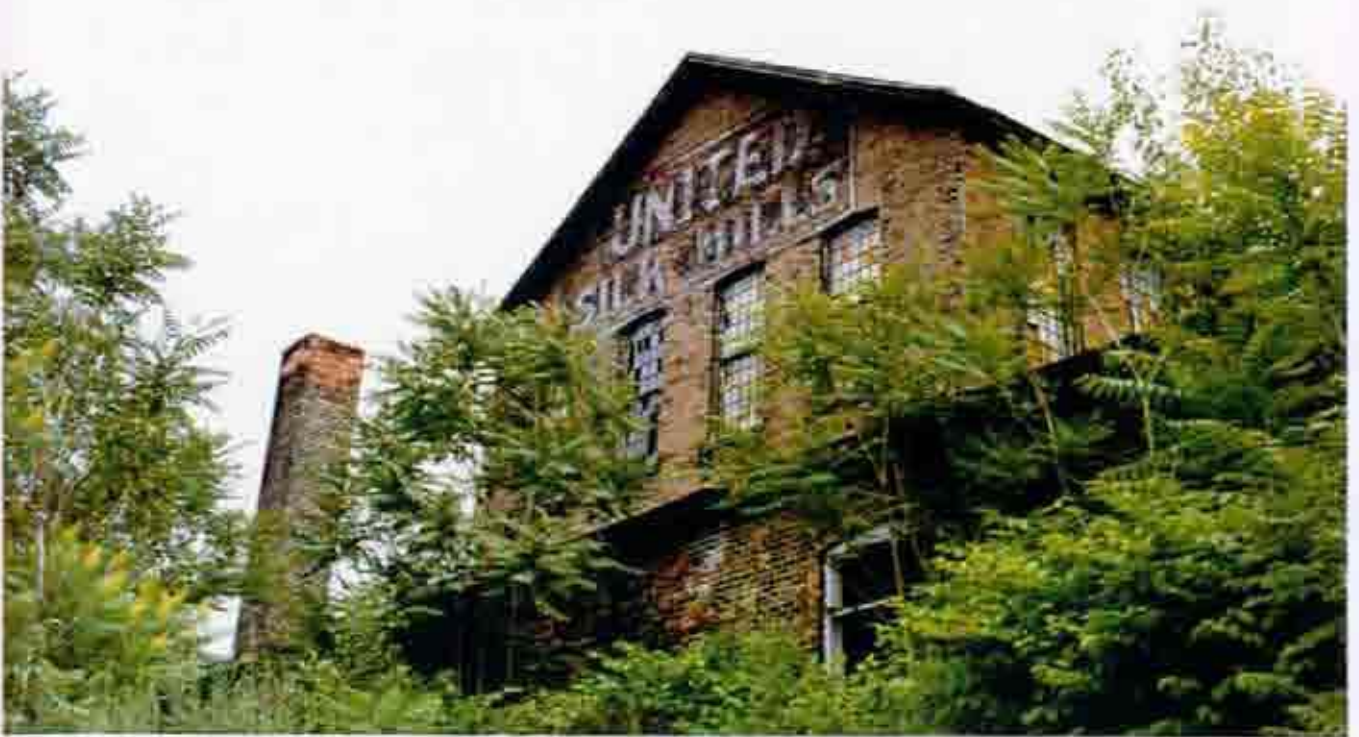
Figure 3.13

The brick walls of the third floor area above the west end of Bay 2 also show signs of joint deterioration; in addition, this portion of the building contains some brick spalling along the bottom coursing at the lower roofs on all of its four elevations. See Figure 3.13.

The upper and lower courses of brick in the draft stack at the western end of Bay 3 show signs of deep joint deterioration while the remaining middle areas of the stack are in good condition. See Figure 3.13.

Detail of painted lettering for United Silk Mills on the west facade of the third floor of Bay 2.

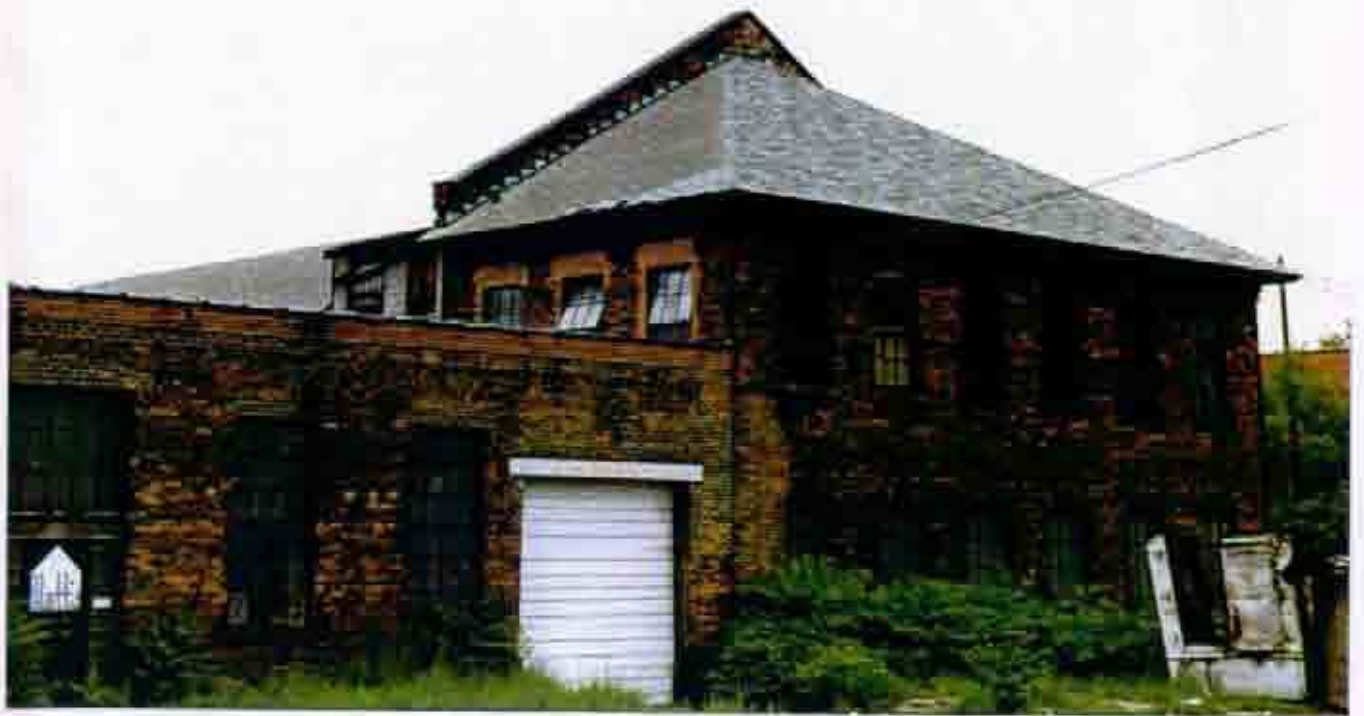
Currently, the wood fascia boards and/or metal edge flashings along the roof eave perimeter of Bays 1, 2 and 4, including the eaves of the third floor story, are severely deteriorated or missing altogether. There has been some spot fascia repair work along the west edge of Bay 1 and three edges of the two story area of Bay 4. The east wall of Bay 3 has a terra cotta tile coping that is in good condition. See Figure 3.14.

Figure 3.14
Detail of the east elevation of Infill Bay 3 (to the left of Bay 4).

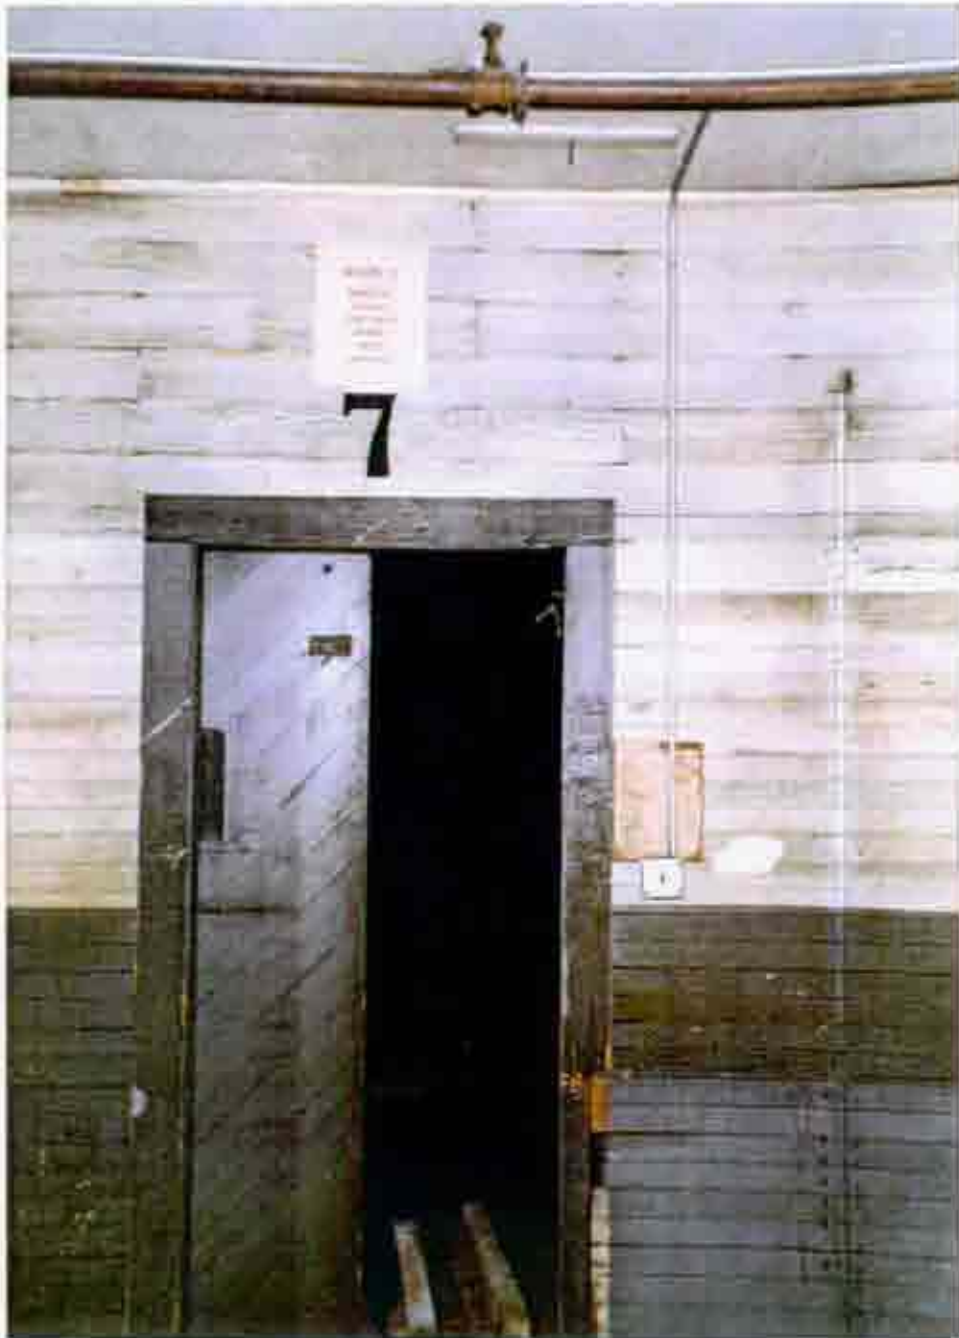
Between the lower concrete slab floor running north-south at the east end of Bays 1, 2 and 3 and the 22" high raised wood plank floor in the remaining west end of these bays, a classically inspired, horizontally beaded, 1" x 6" tongue and groove, wood board partition with sliding loading dock doors and square window openings is positioned at the mezzanine level behind. The partition is in good condition, as are the remaining doors and their hardware. See Figure 3.15.

Figure 3.15
Detail of the wood partition and typical door, installed by the Williams Baking Company.
