National Park Service
Cultural Landscapes Inventory
1998

Revised 2004

Ellis Island
Statue of Liberty NM - Ellis Island National Monument

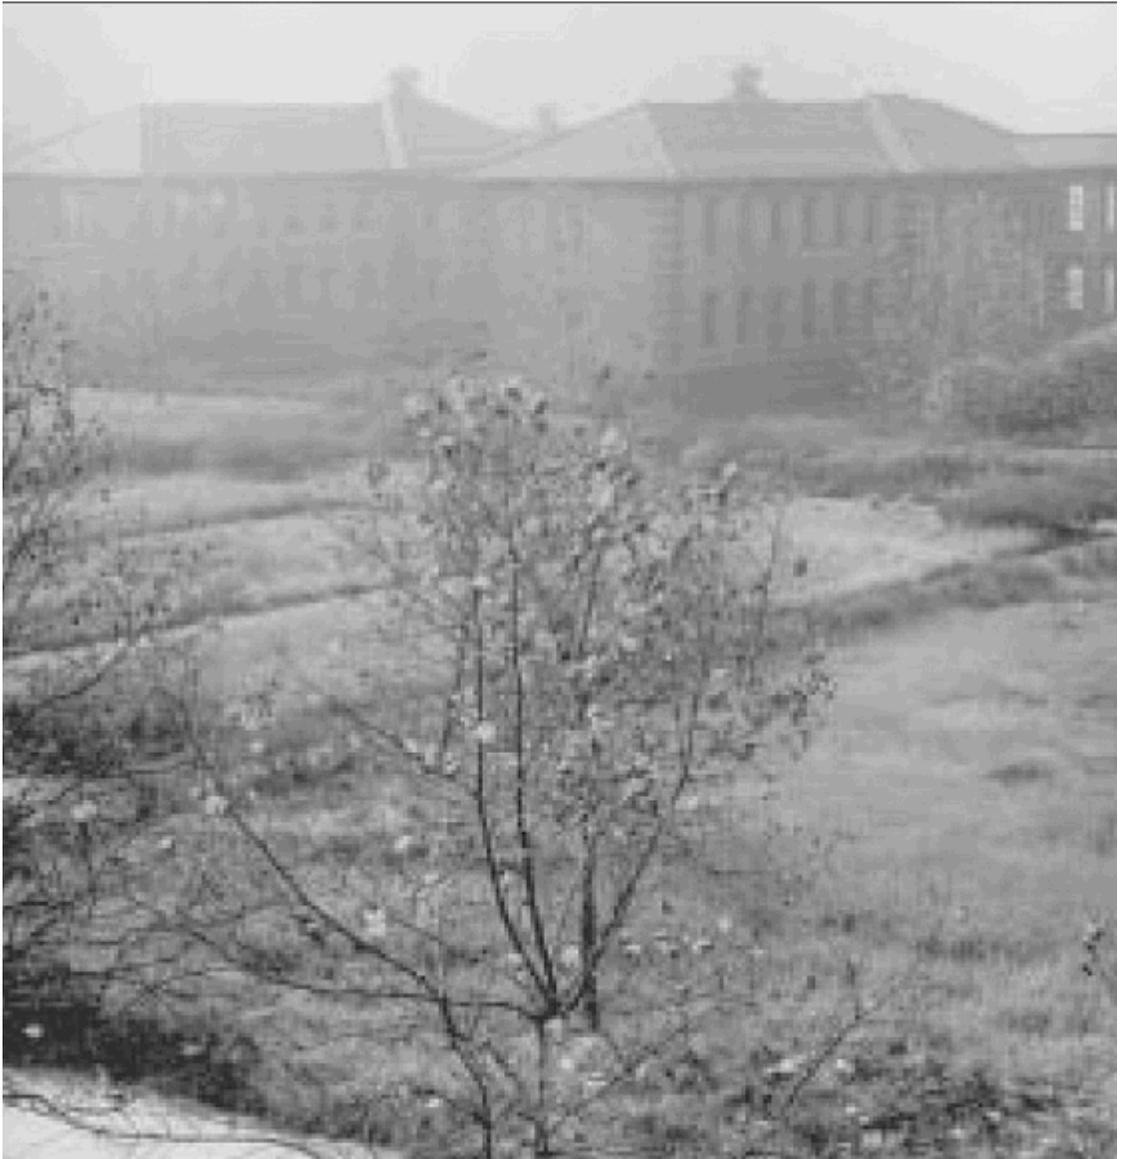
Fig 5.9 - Open lawn between Islands 2 & 3, became filled with mature grasses and shrubby growth due to lack of maintenance after island's closure, c. 1958. (ELIS CLR)

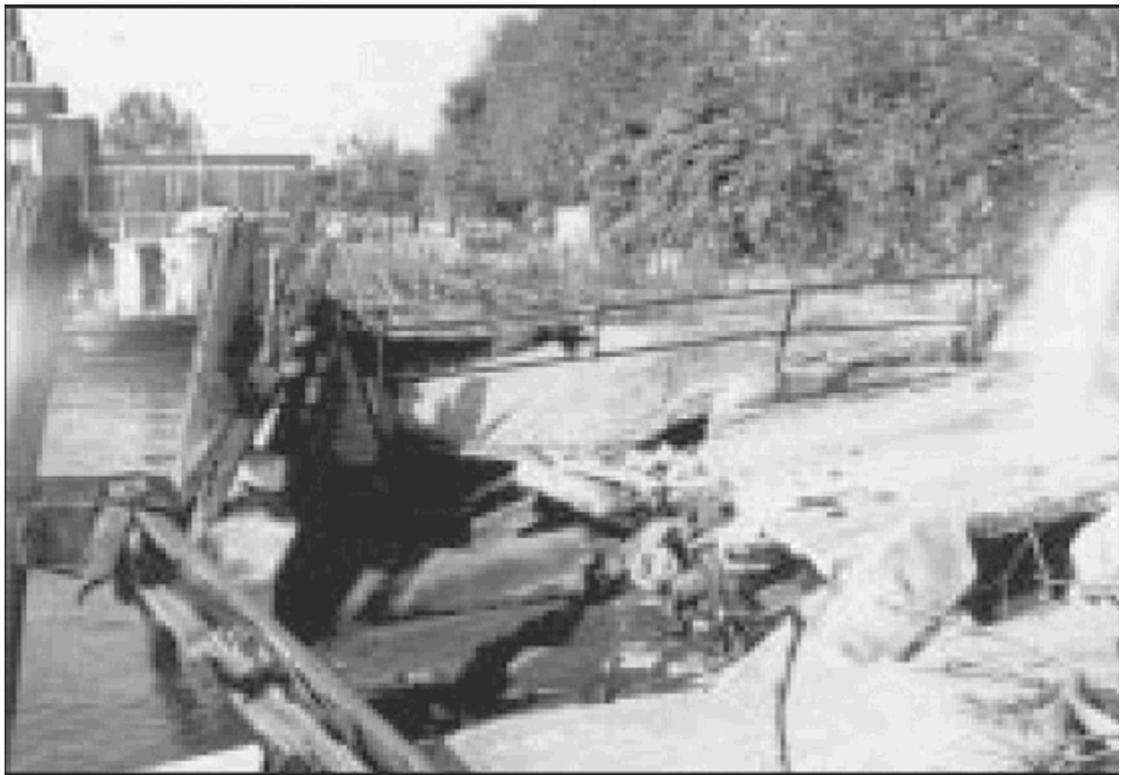
Fig 6.4 - Deteriorated section of seawall and walkway along north side of ferry basin on Island 1, early 1970s. (ELIS CLR)

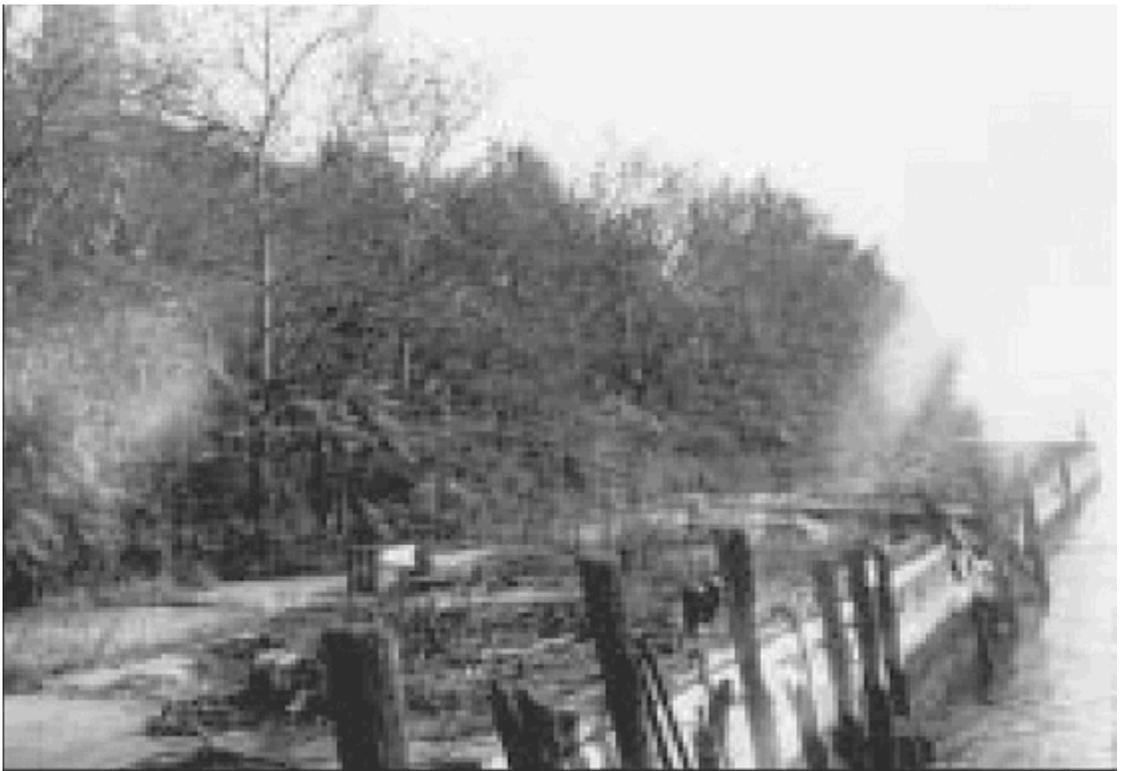
Fig 6.5 - Overgrown vegetation nearly obscures main immigration building on Island 1, mid-1970s. (ELIS CLR)

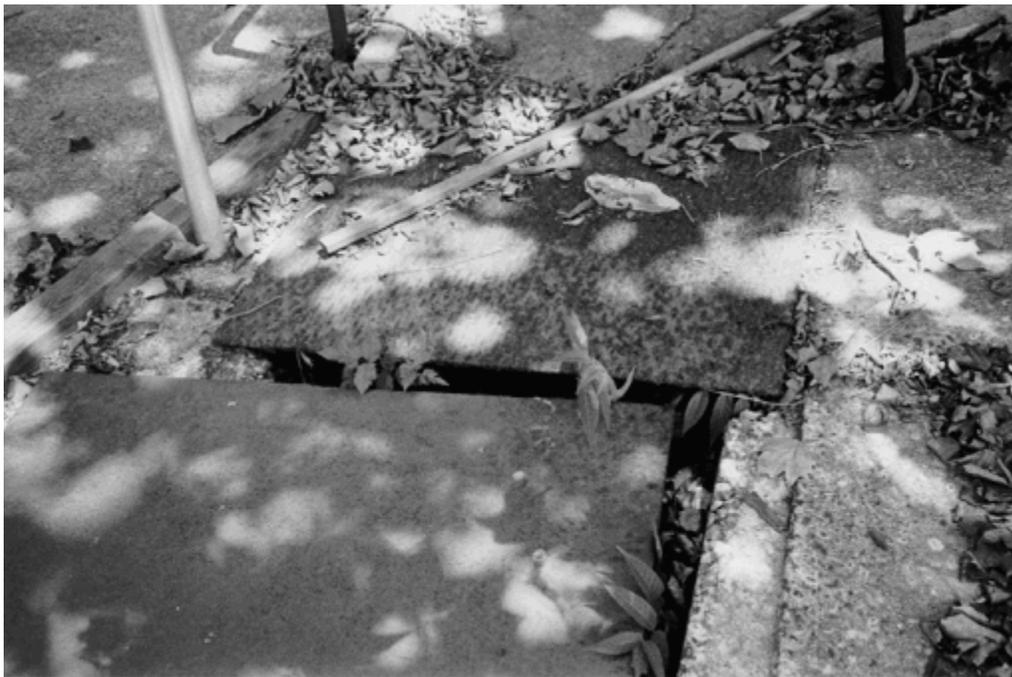
Cesspools in main path on Island Two covered by metal plates (OCLP, 1999).

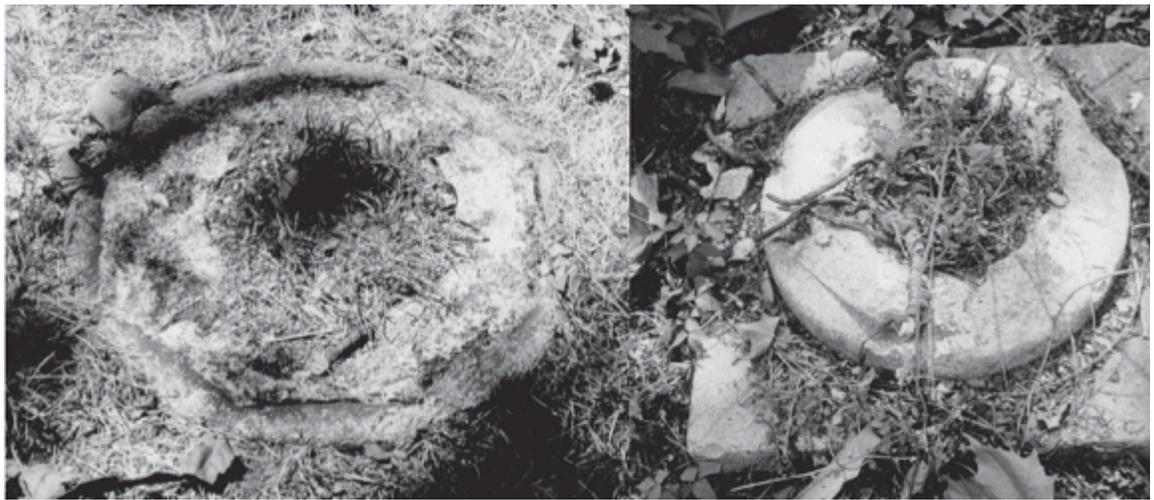
Historic deteriorated lamp bases, Island Two (L) and Island Three (R) (OCLP, 1999).

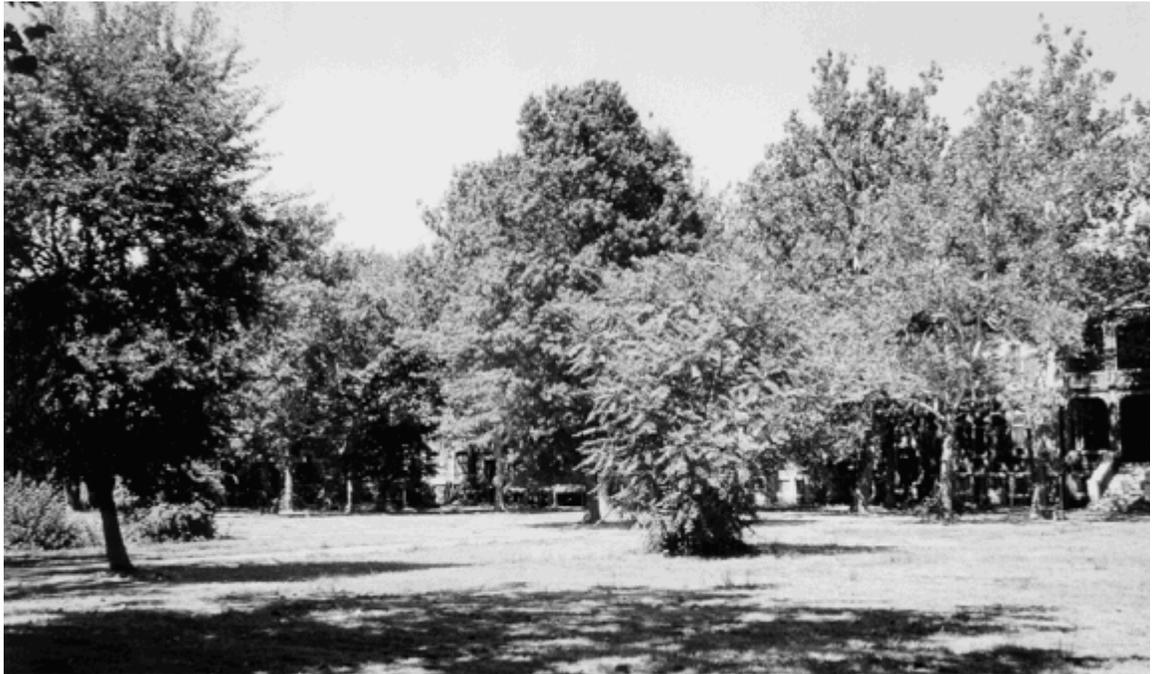
Lawn between Islands Two and Three, minimally maintained (OCLP, 1999).
