Condition Assessment Report

Cultural Resources, Partnerships and Science Division
Southeast Region

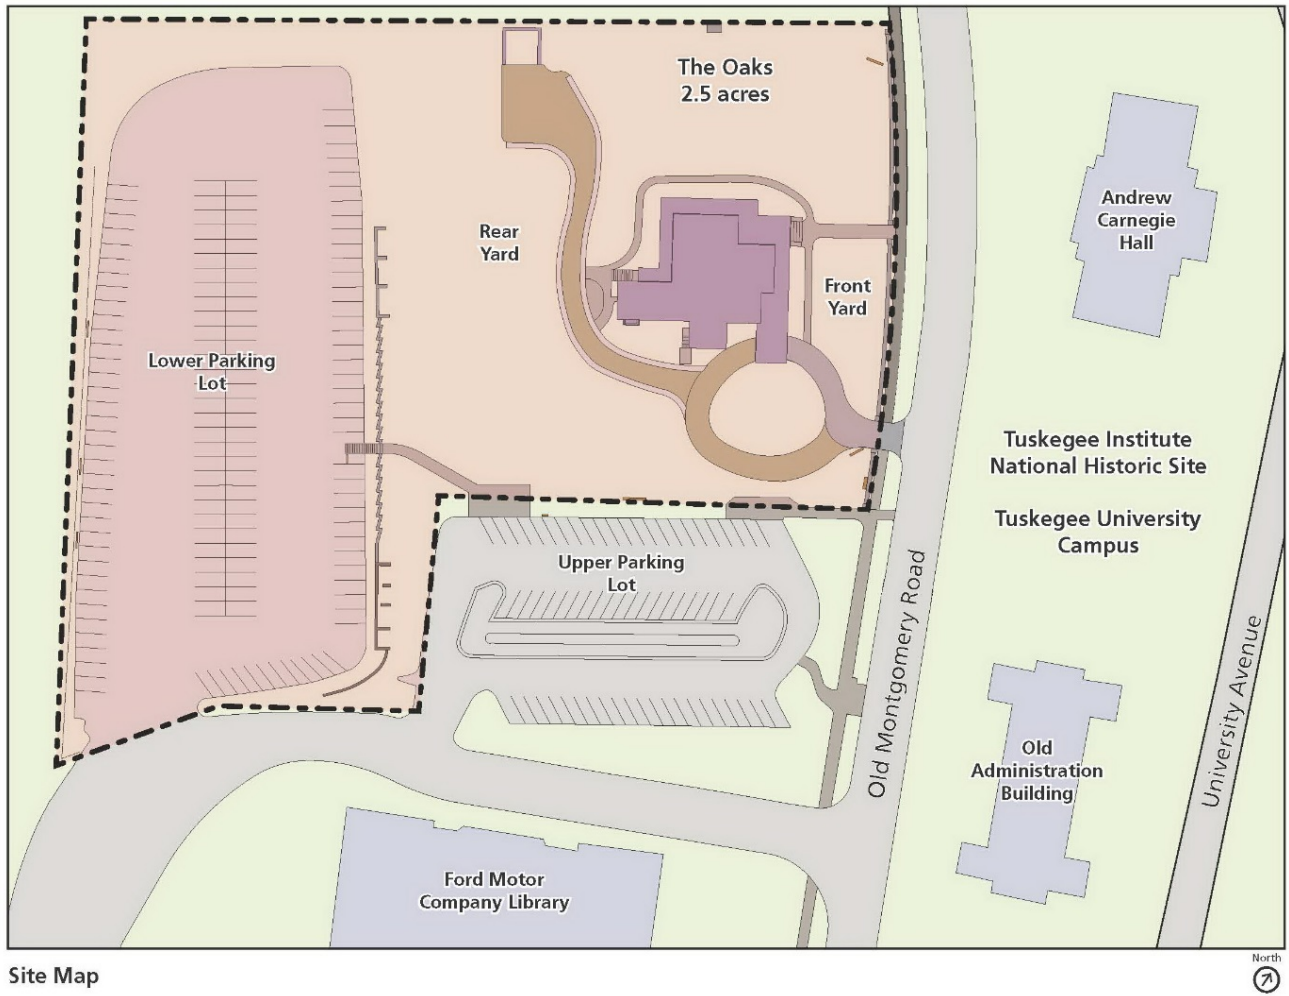
A site plan is provided in Figure 2, and overall views of the house are provided in Figure 3 through Figure 7.

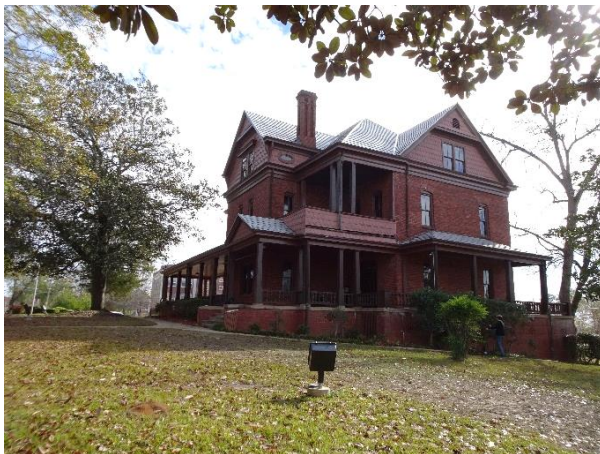
FIGURE 3. The Oaks, looking southeast. (Source: All photographs by authors unless otherwise noted.)

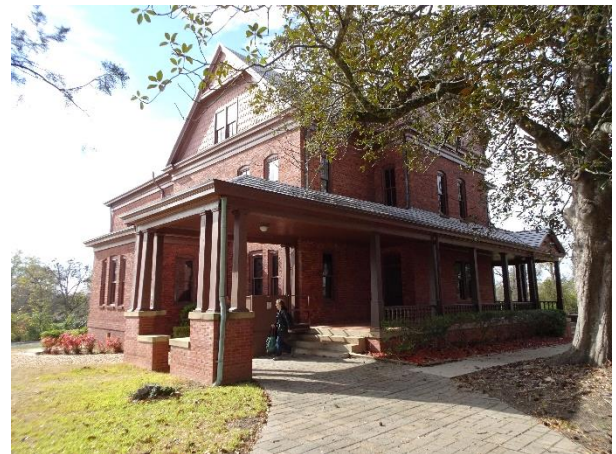
FIGURE 4. The Oaks, looking southwest.

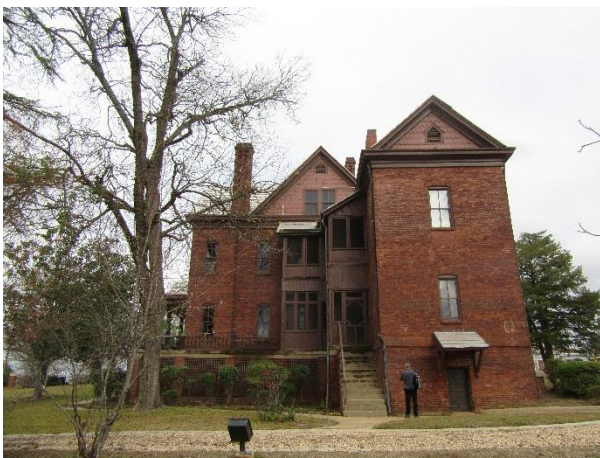
FIGURE 7. The Oaks, south elevation, looking north.

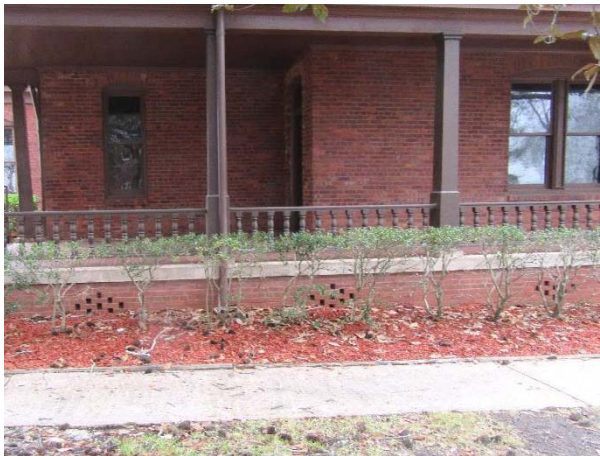
FIGURE 17. Diamond-shaped brick detailing found on the north elevation.

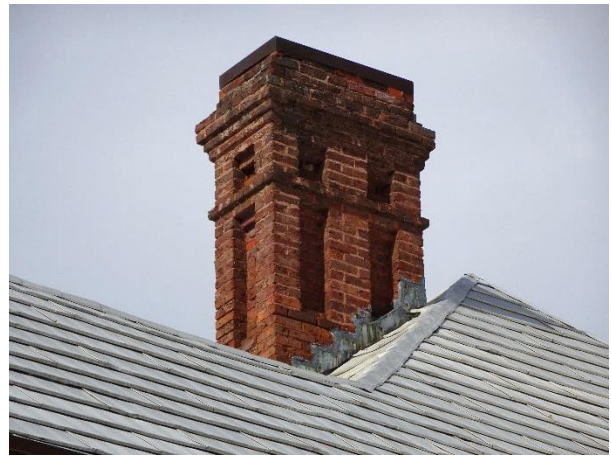
FIGURE 18. Typical brick chimney with corbelled brick details.

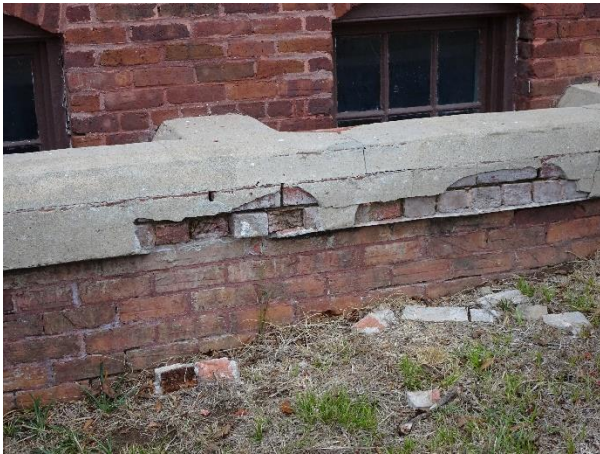
FIGURE 19. Spalling of the brick and cementitious parge coating at the light well walls.

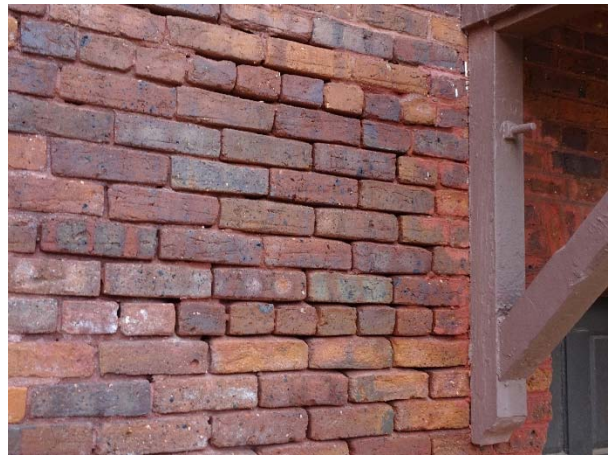
FIGURE 20. Eroded mortar joints at the field of the wall.

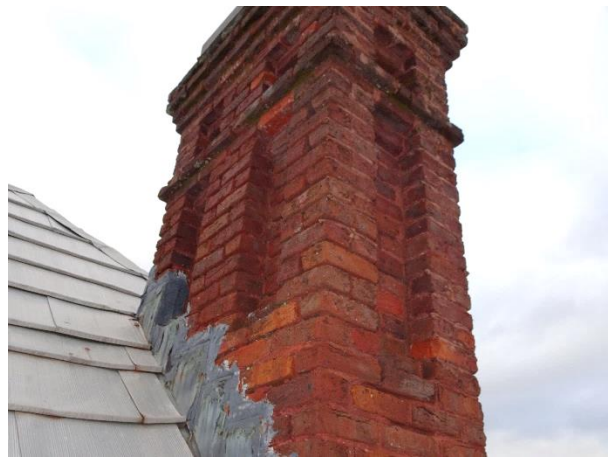
FIGURE 21. Deteriorated mortar joints and evidence of previous repointing efforts visible at the chimney.

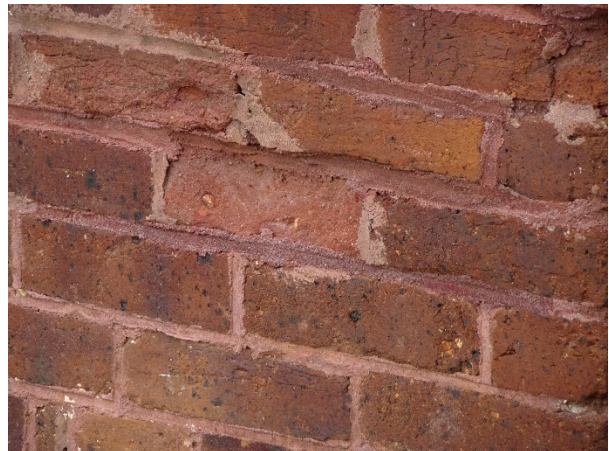
FIGURE 22. Evidence of previous mortar repointing in the field of wall.

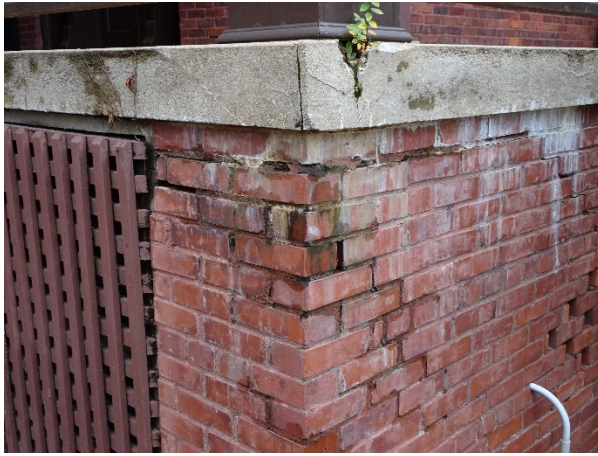
FIGURE 23. Step cracking, open joints, and evidence of water infiltration at the porch walls.

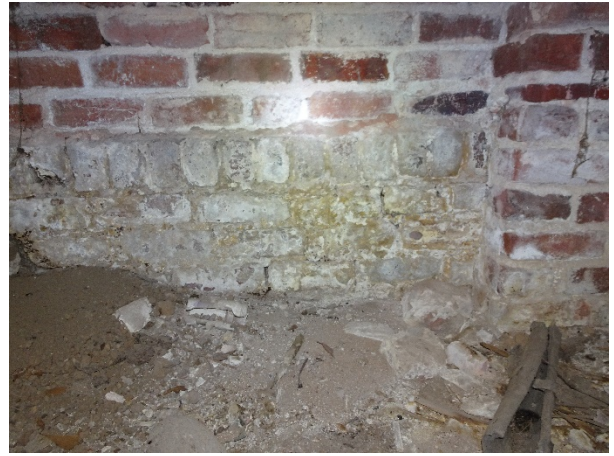
FIGURE 26. Accumulation of efflorescence at base courses of the porch walls.

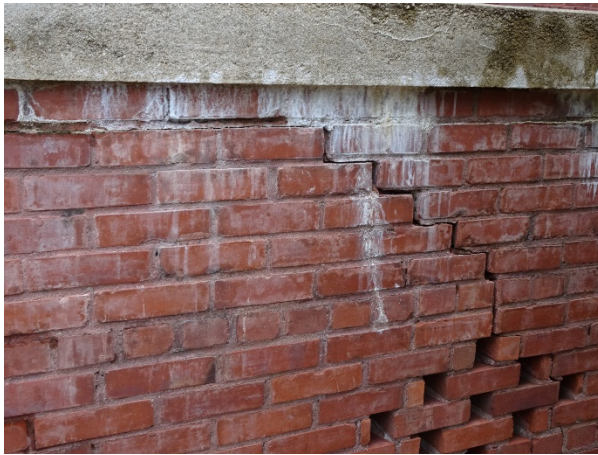
FIGURE 24. Step cracking and efflorescence at the porch walls.

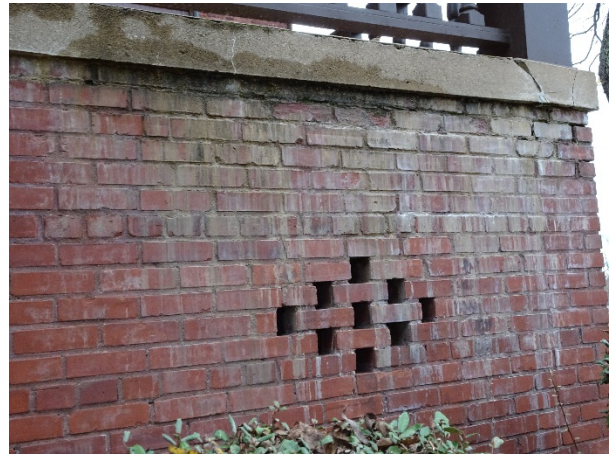
FIGURE 27. Moisture staining at porch walls.

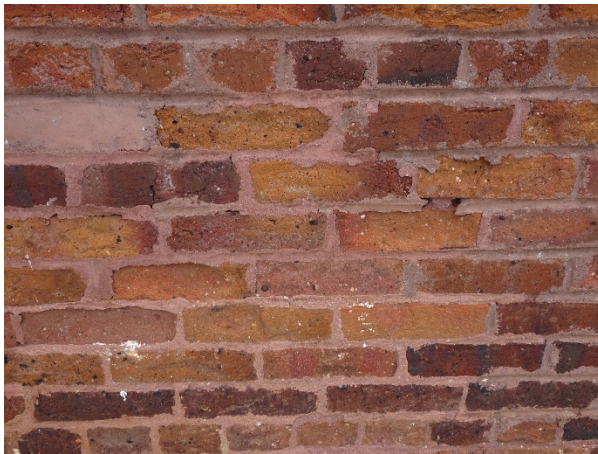
FIGURE 25. Face spalling of brick.

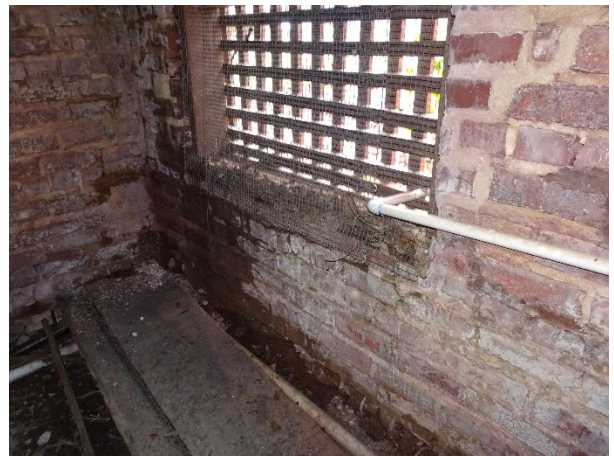
FIGURE 28. Evidence of moisture infiltration at northwest corner of porch.

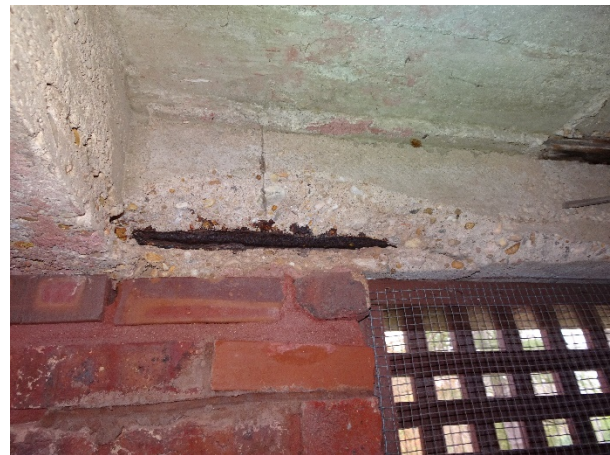
FIGURE 29. Spalled concrete bond beam at porch wall.

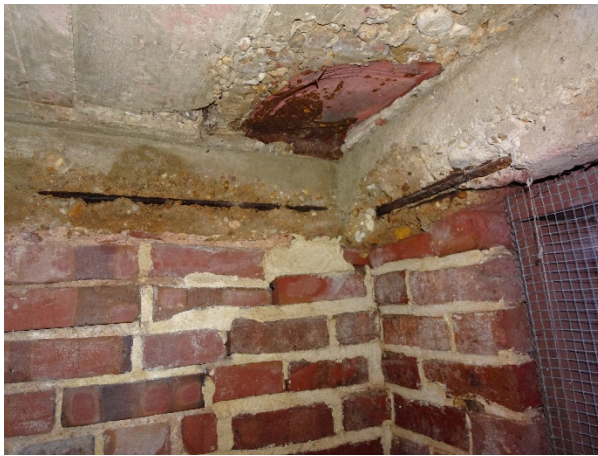
FIGURE 30. Spalled concrete bond beam at porch wall.

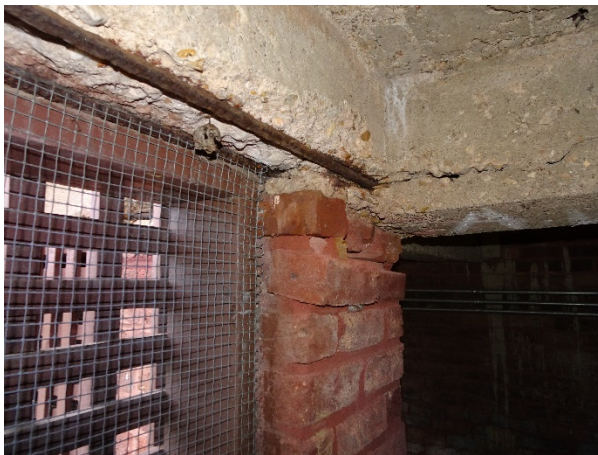
FIGURE 31. Spalled concrete bond beam at porch wall.

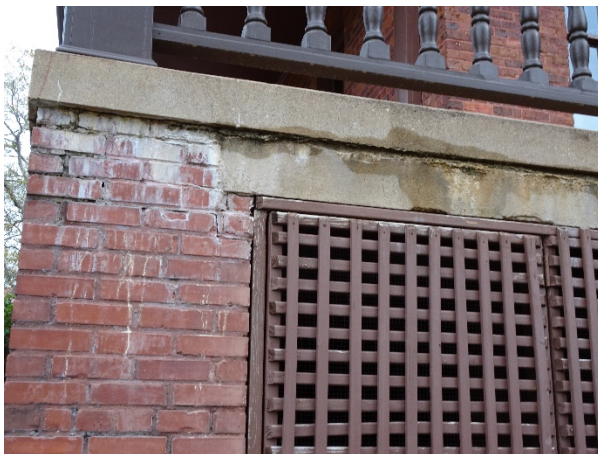
FIGURE 32. Moisture staining and evidence of moisture infiltration at concrete bond beam.

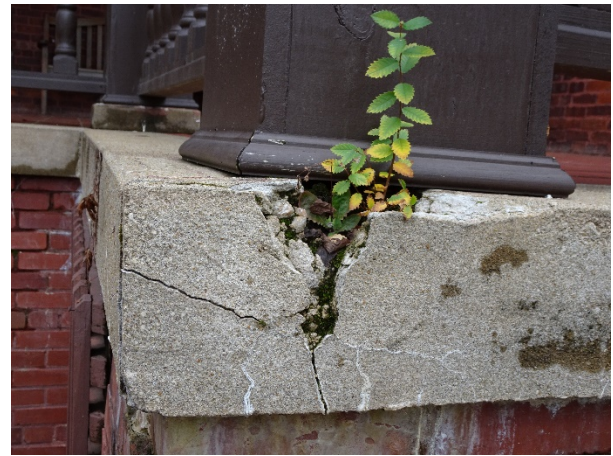
FIGURE 33. Spalling and cracking of concrete at northwest corner of porch.

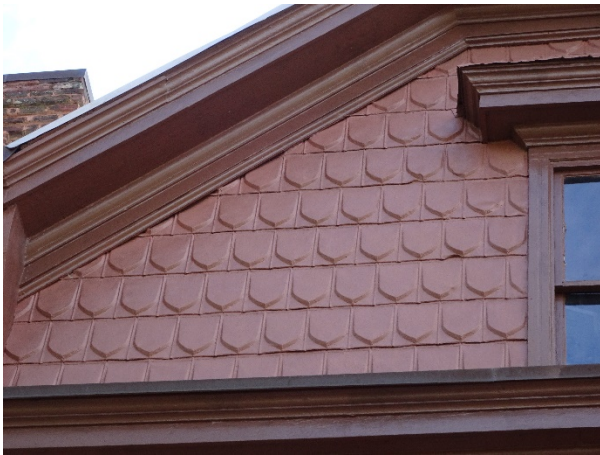
FIGURE 34. Pressed sheet-metal cladding at end gable.

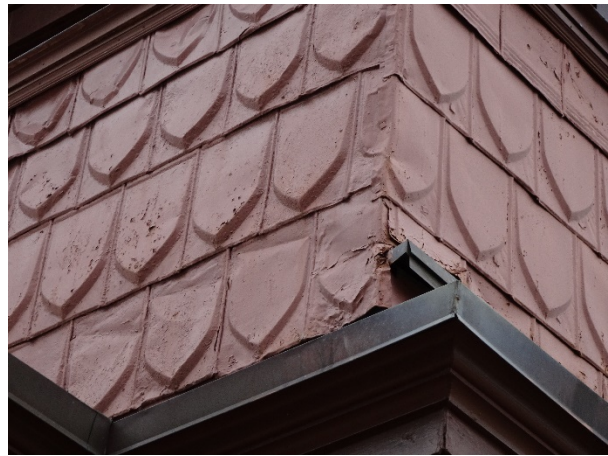
FIGURE 35. Peeling paint at pressed sheet-metal cladding.

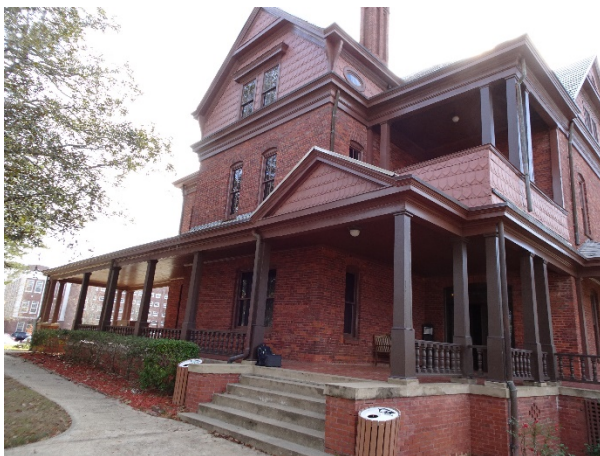
FIGURE 36. The Oaks, north elevation, looking southeast.

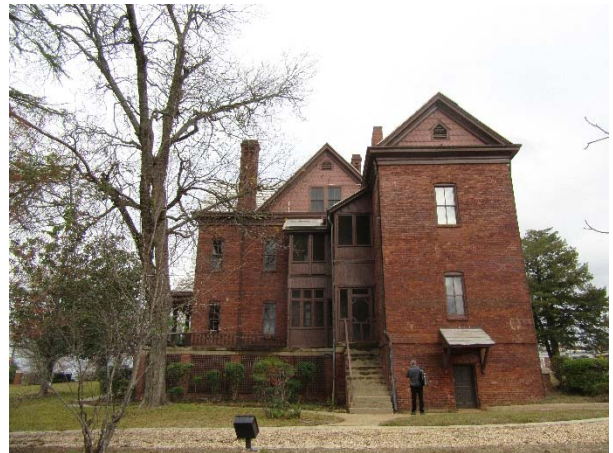
FIGURE 38. The Oaks, south elevation, looking north showing the two-story, screened-in porch.

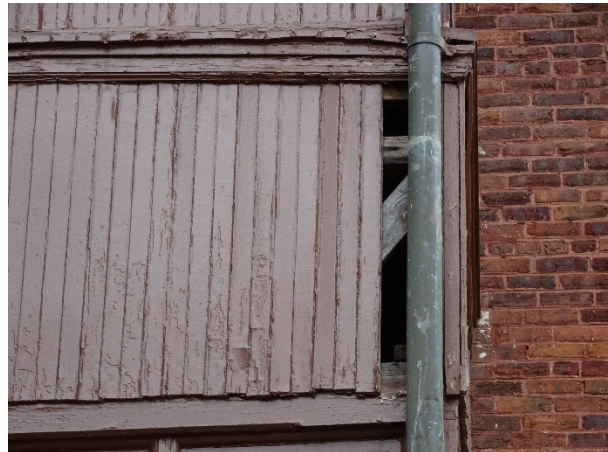
FIGURE 39. Missing wood cladding at south two-story porch.

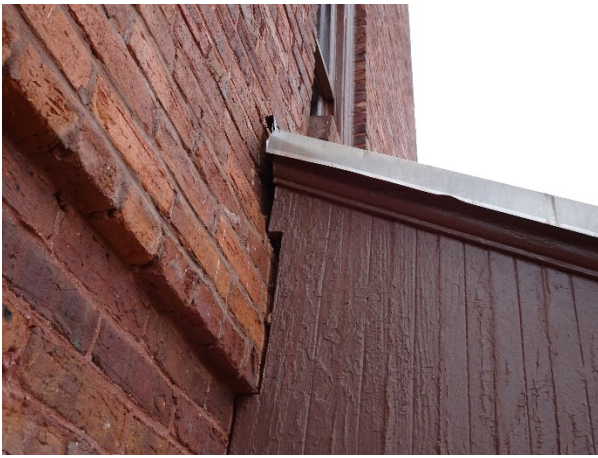
FIGURE 40. Displaced roof framing over south entrance.

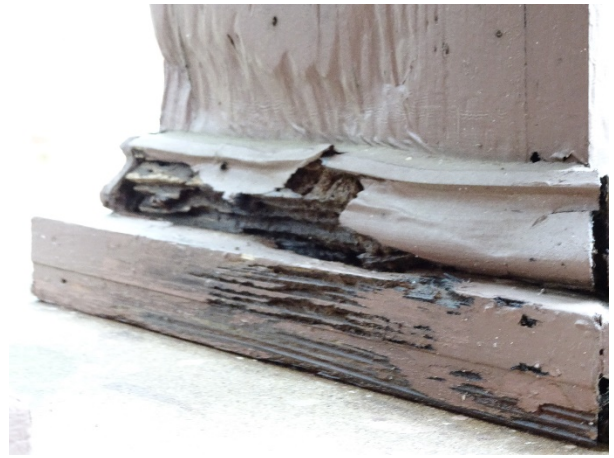
FIGURE 43. Deteriorated wood at base of columns.

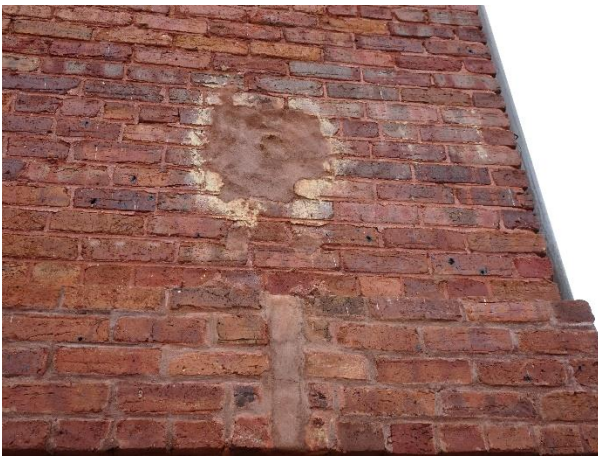
FIGURE 41. Previous cementitious patch repair at abandoned utility openings.

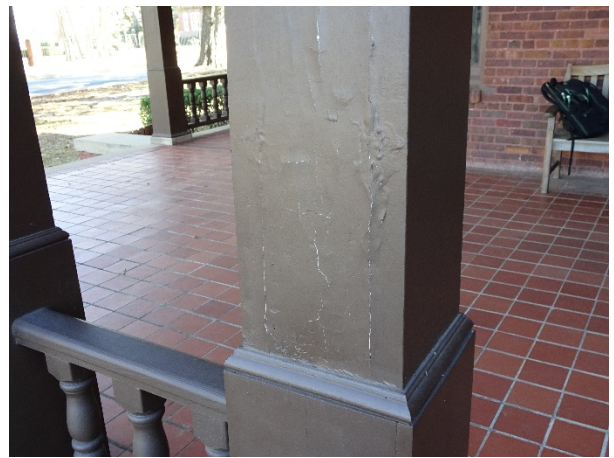
FIGURE 44. Debonded paint and plaster coating at columns.

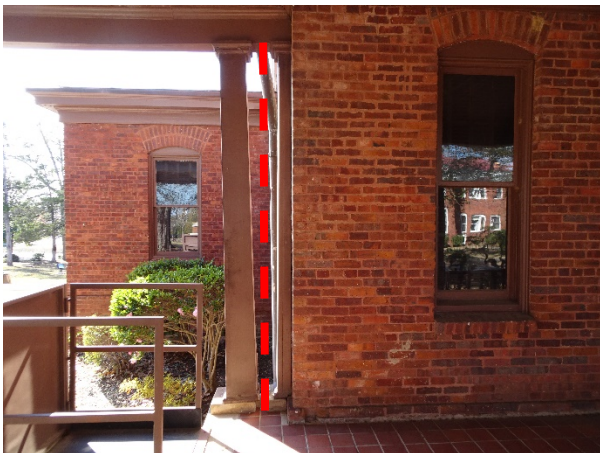
FIGURE 48. Tilted and displaced porch column.

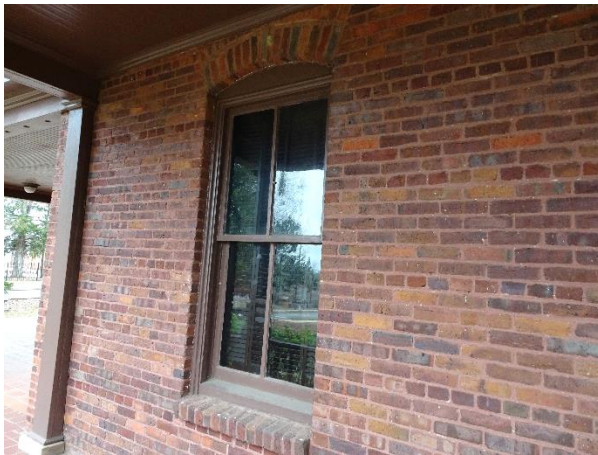
FIGURE 49. Typical masonry window.

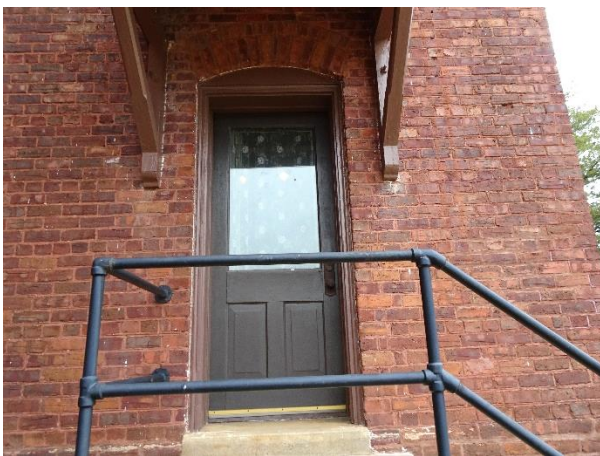
FIGURE 53. Door with awning at east wing addition.

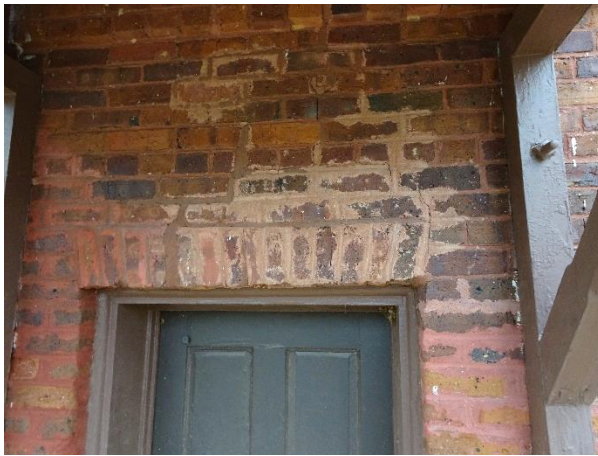
FIGURE 54. Cracking and open mortar joints above flat arch opening.

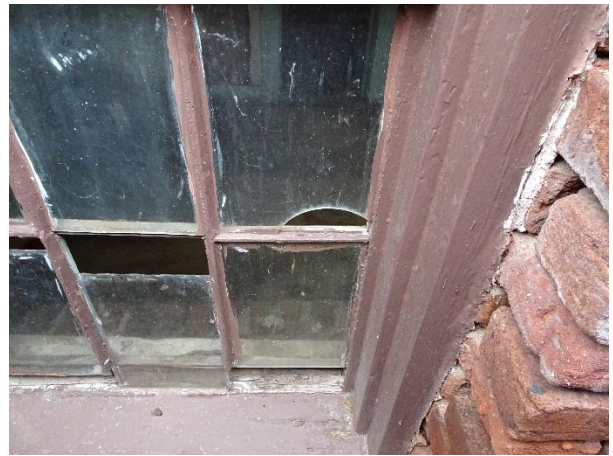
FIGURE 57. Broken and displaced glass at basement windows.

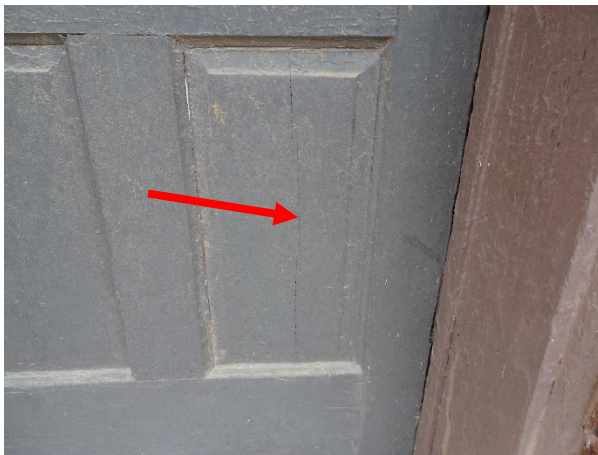
FIGURE 55. Vertical crack in recessed panel.

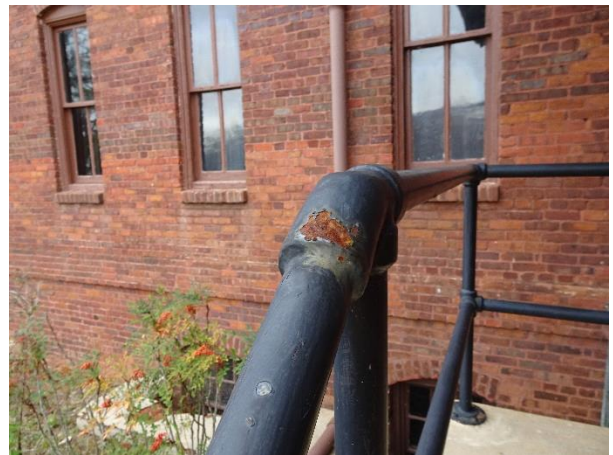
FIGURE 58. Surface corrosion and paint loss at metal handrail.

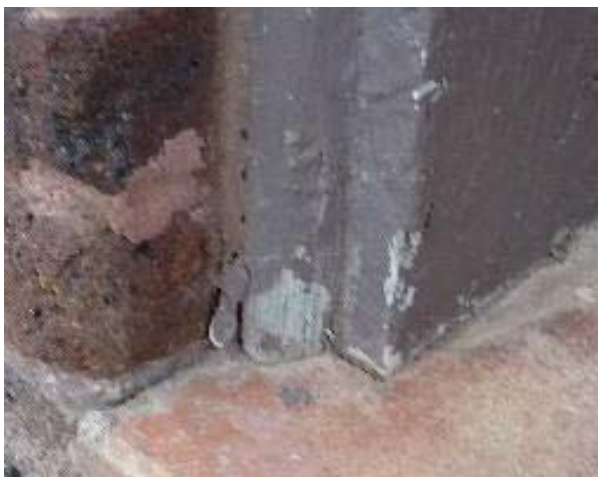
FIGURE 56. Peeling paint at door and window framing members.

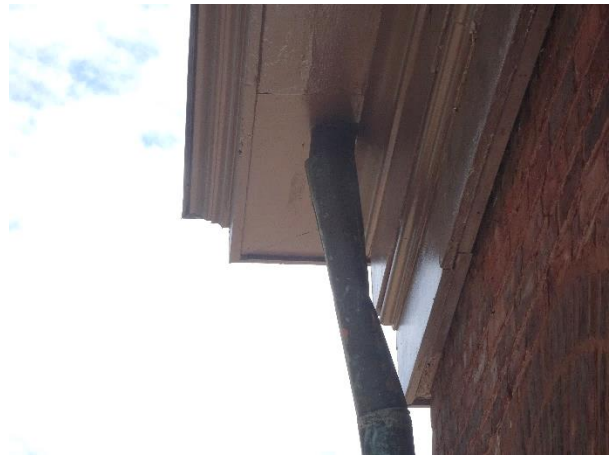
FIGURE 61. Damaged downspout.

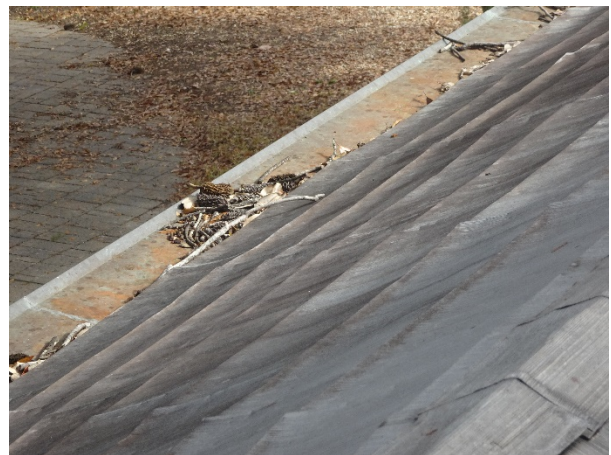
FIGURE 62. Debris and organic matter block a gutter.

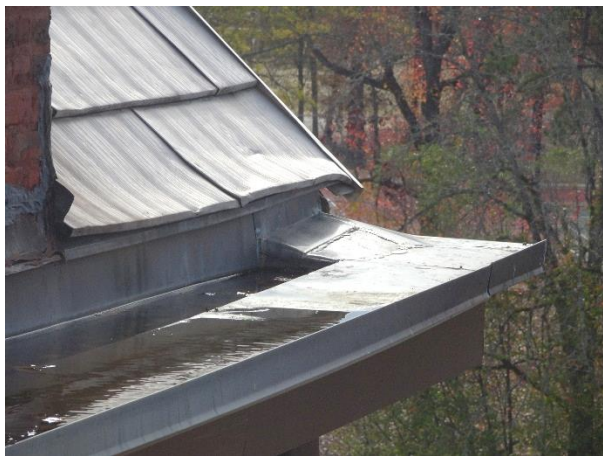
FIGURE 64. Deformed and damaged roofing adjacent to overflowing gutter.

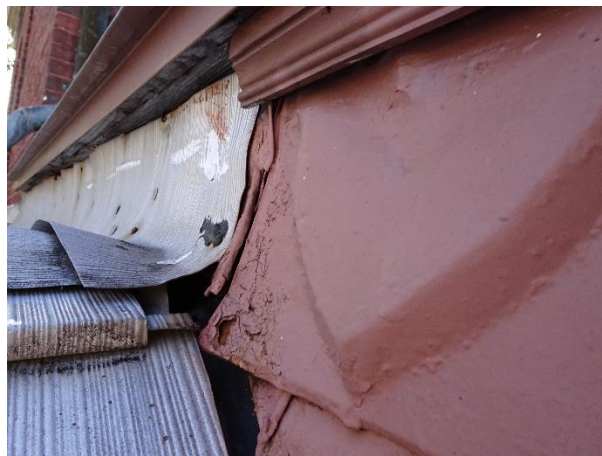
FIGURE 67. Gap at interface between the sheet-metal roof and wall cladding.

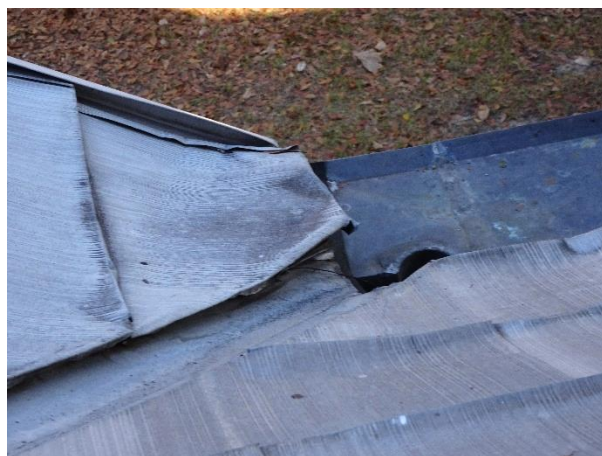
FIGURE 68. Damaged sheet-metal roof cladding near gutter.

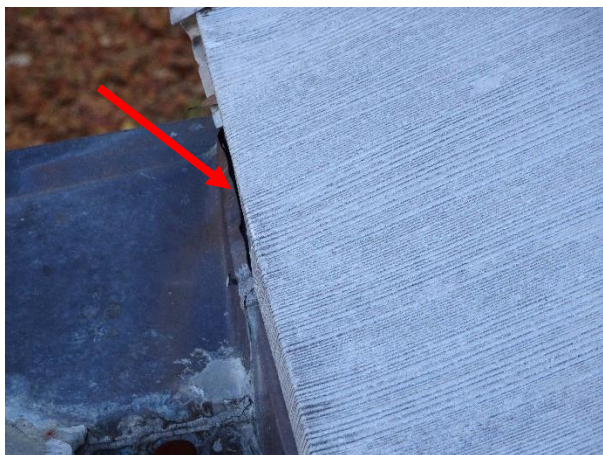
FIGURE 66. Gap between the copper flashing and the roof cladding.

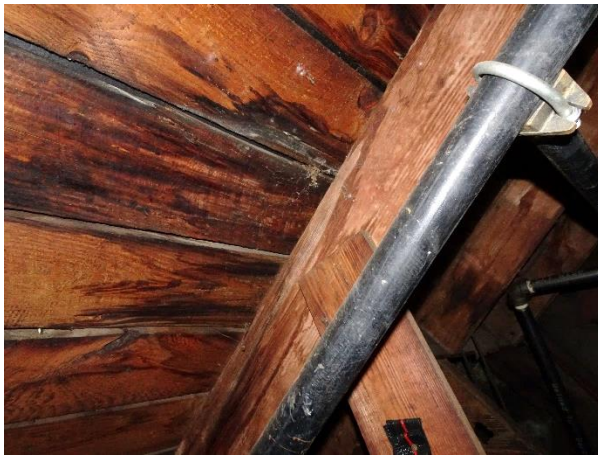
FIGURE 70. Moisture staining at wood sheathing.

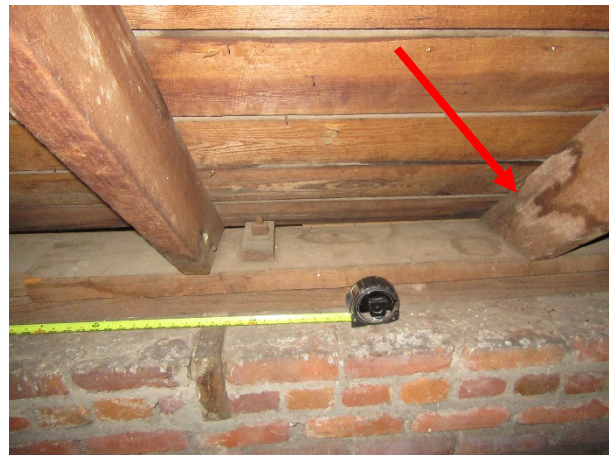
FIGURE 71. Moisture staining at roof rafters.

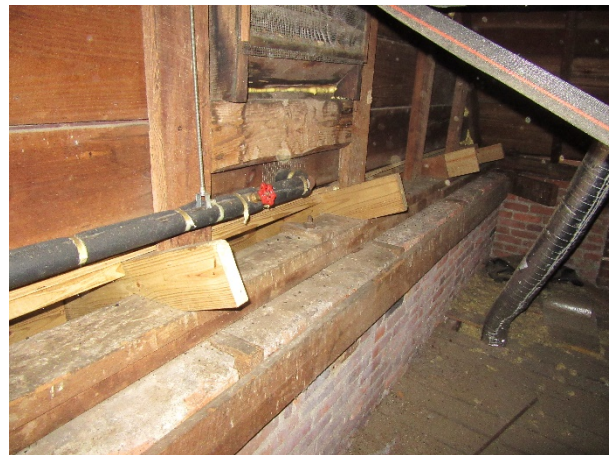
FIGURE 72. Replaced structural kickers at south wing roof.

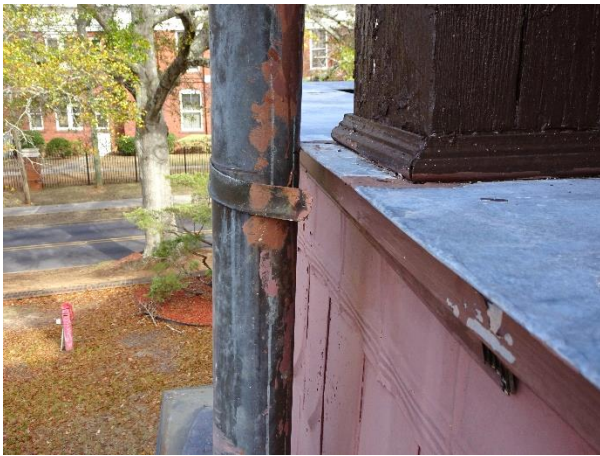
FIGURE 73. Damaged and dislodged downspout strap.

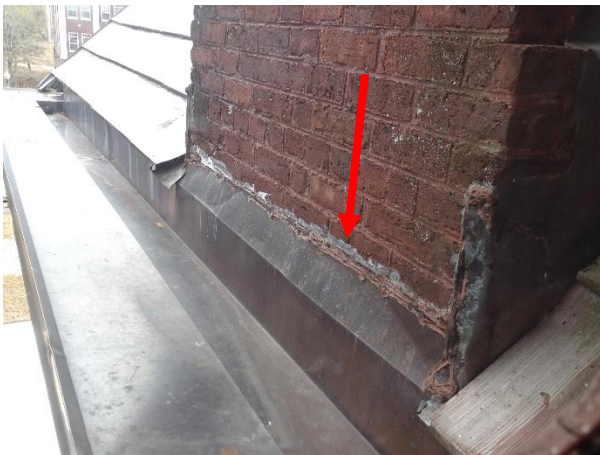
FIGURE 74. Deteriorated sealant at regletted flashing joint.

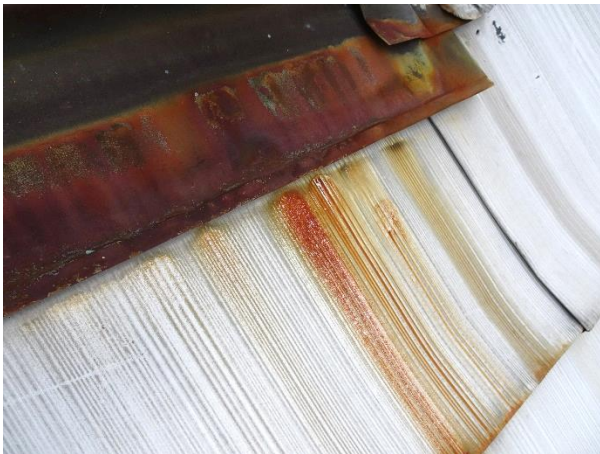
FIGURE 75. Corrosion staining at interface of flashing with roof cladding.

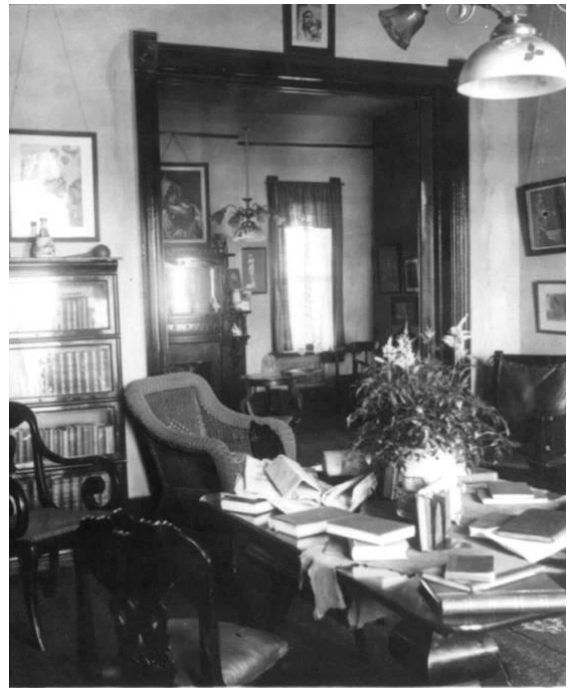
FIGURE 76. Historic photograph of the study, 1906. (Source: Library of Congress, Carol M. Highsmith Archive, Washington, D.C.)

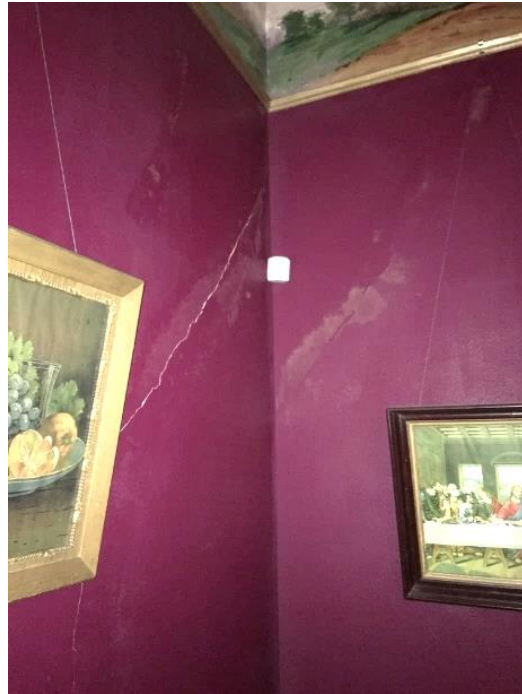
FIGURE 89. Detail of plaster cracking.

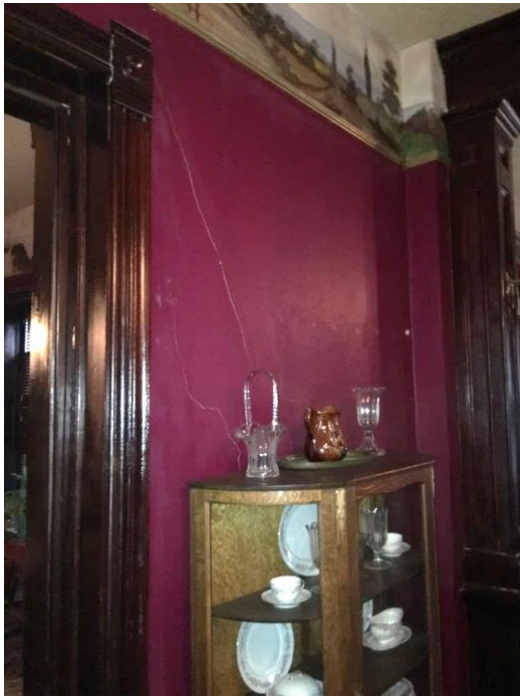
FIGURE 90. Plaster cracking at sliding door pocket (dining room).

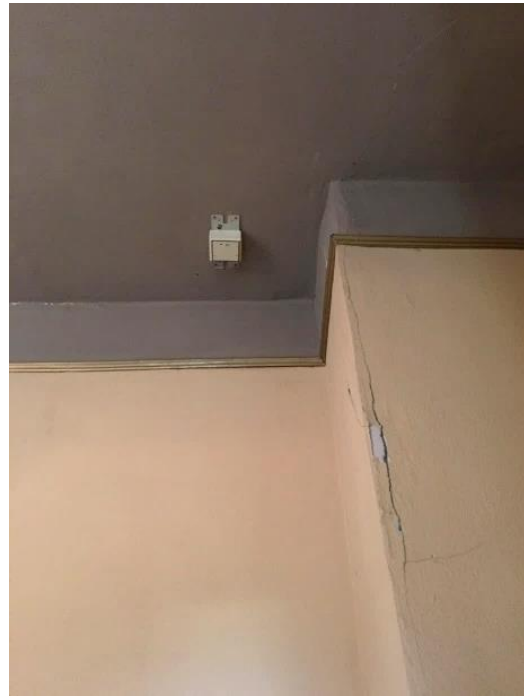
FIGURE 92. Detail of plaster cracking at outside corner of closet projection.

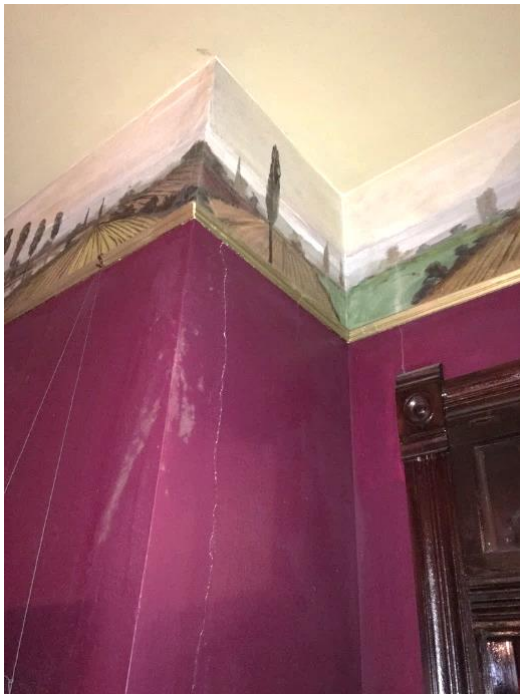
FIGURE 91. Paint damage at dining room.

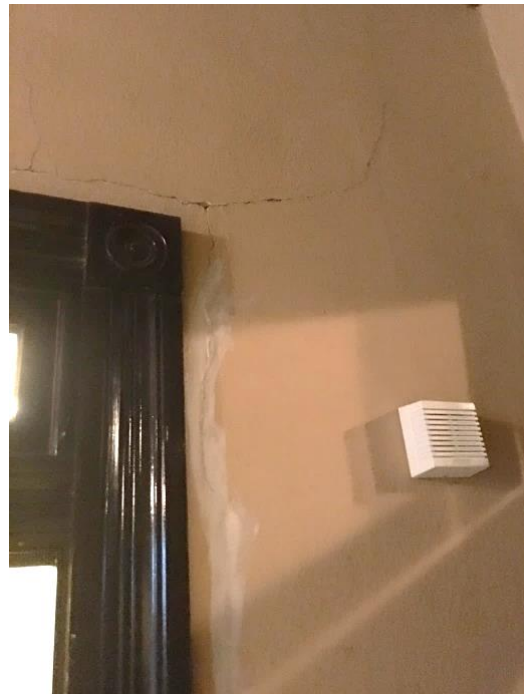
FIGURE 93. Detail of plaster cracking at sides of door frame.

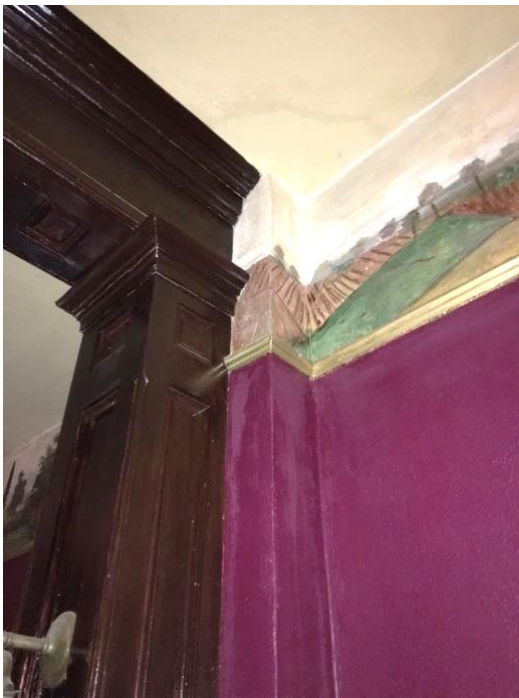
FIGURE 94. Paint damage at dining room addition.

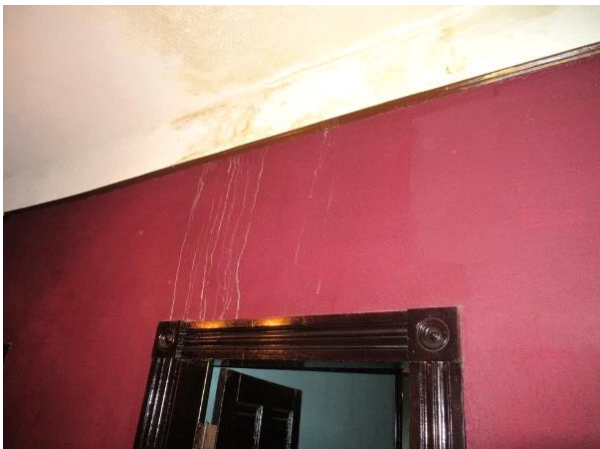
FIGURE 95. Plaster damage from water at second-floor front hall.

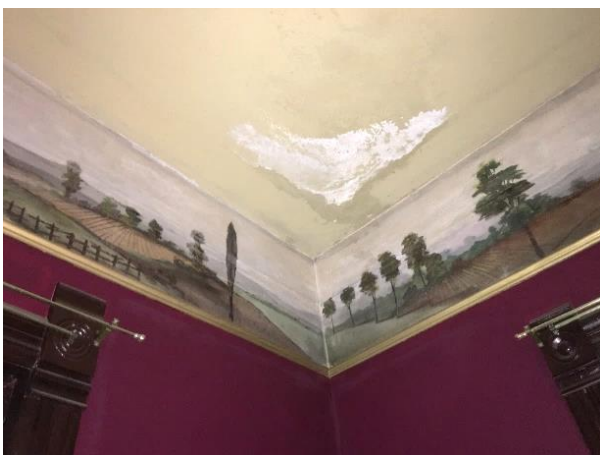
FIGURE 96. Water damage at ceiling.

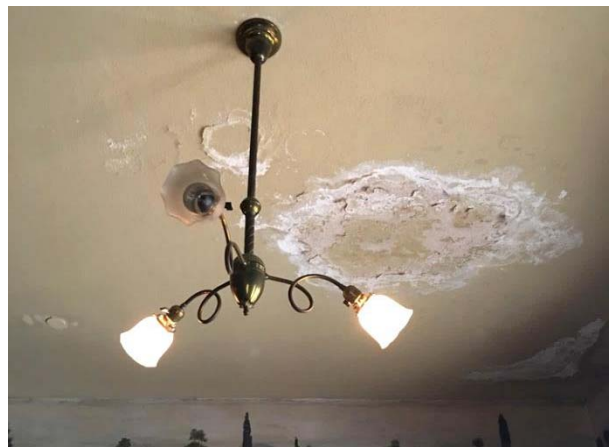
FIGURE 97. Detail of plaster damage at ceiling.

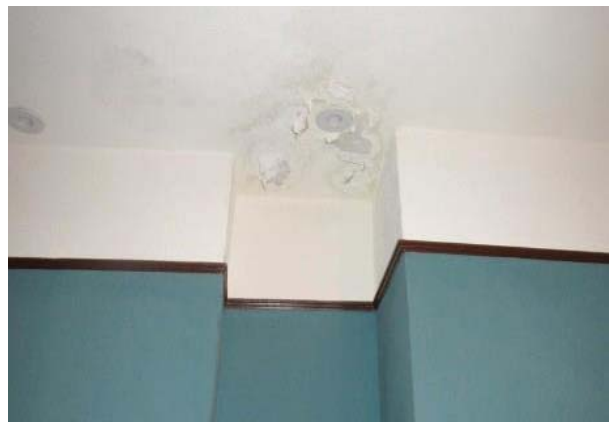
FIGURE 98. Detail of water damage at ceiling, Margaret Washington's bedroom.

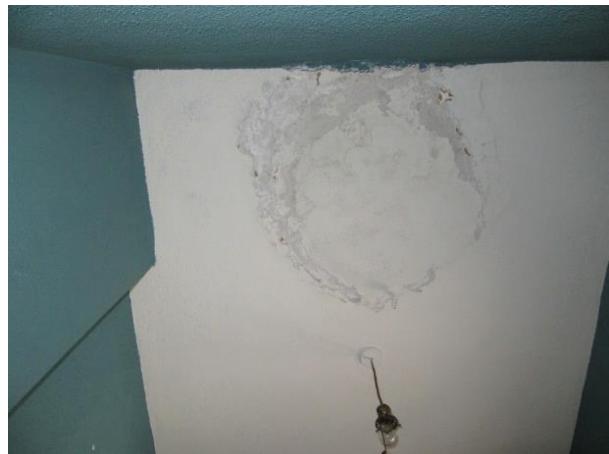
FIGURE 99. Second-floor shower (Room 203) - plaster damage at ceiling.

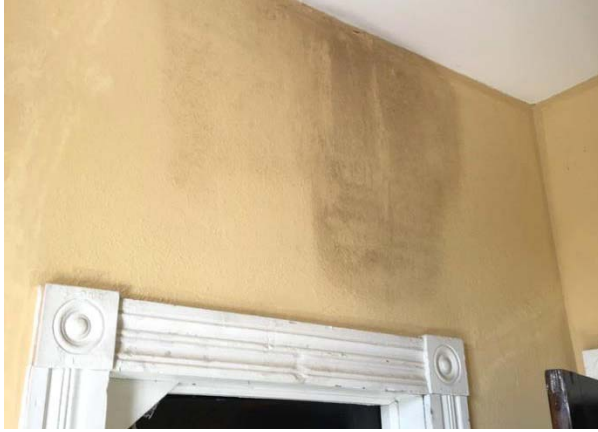
FIGURE 100. Mold / mildew stain at third-floor wall surfaces.

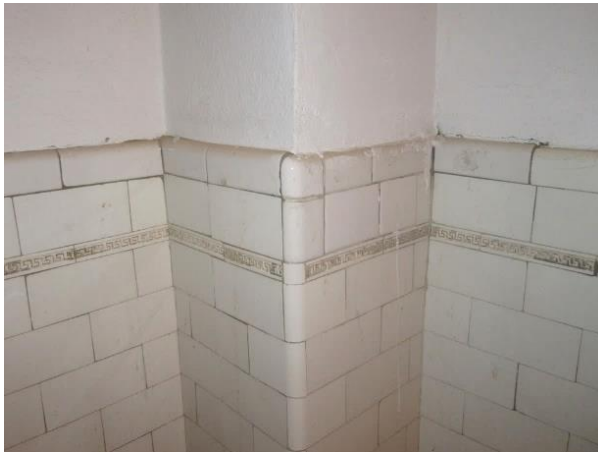
FIGURE 101. Detail of wall tile at bathroom.

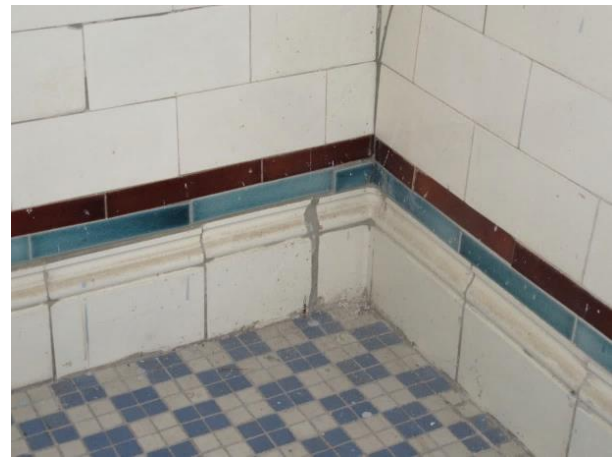
FIGURE 102. Detail at tile wall base.

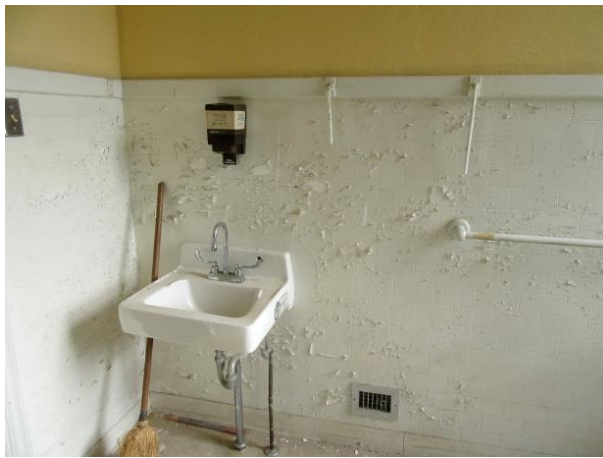
FIGURE 103. Lavatory and painted wainscot in the third-floor bathroom.

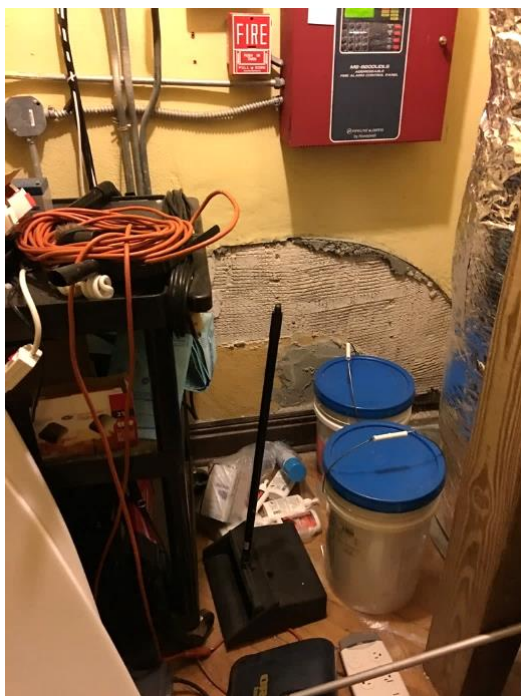
FIGURE 104. Plaster damage in the guest room closet.

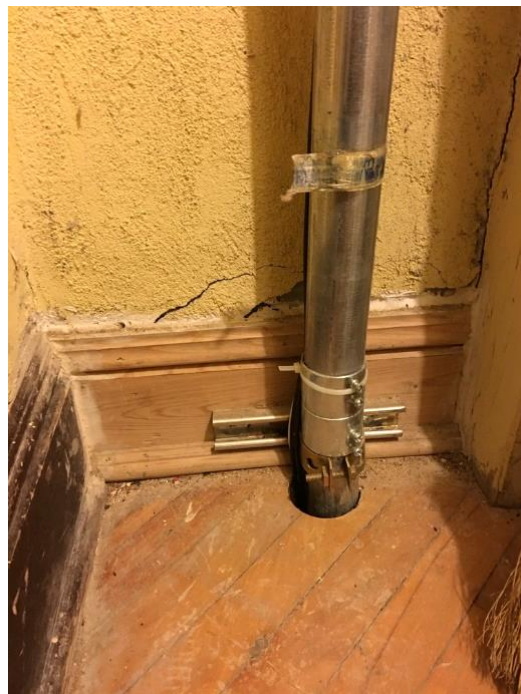
FIGURE 106. Conduit penetration in the guest room closet floor.

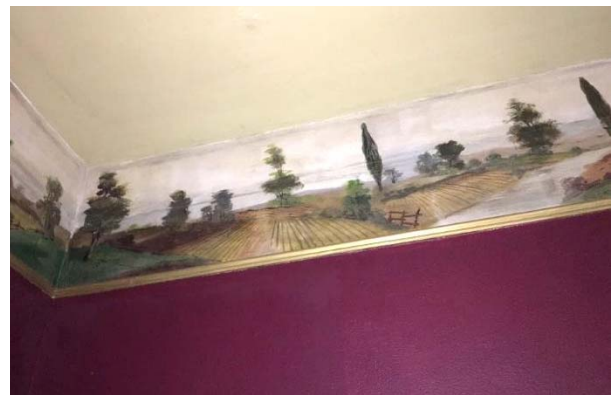
FIGURE 112. Detail of frieze mural at dining room addition.

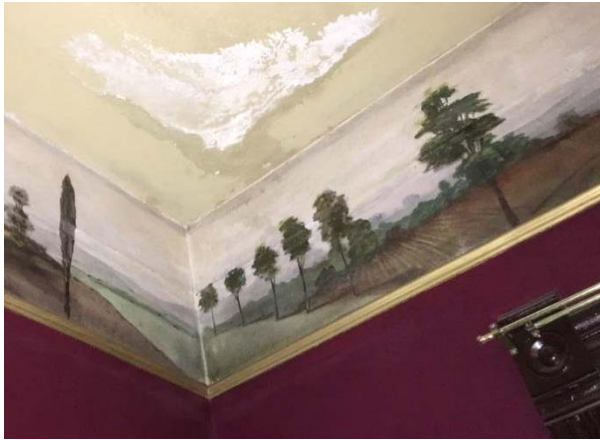
FIGURE 113. Frieze mural at dining room addition, affected by water staining.

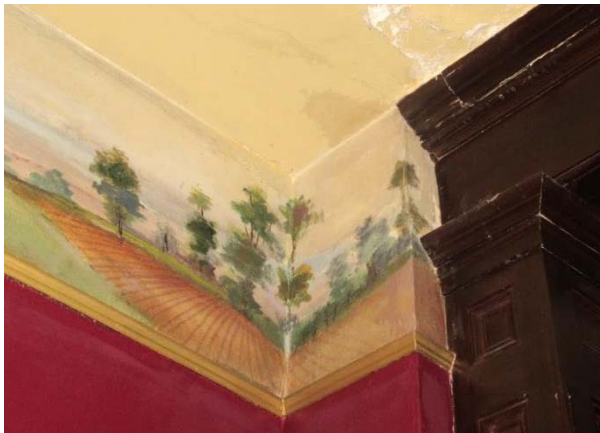
FIGURE 114. Detail of frieze mural at dining room addition.

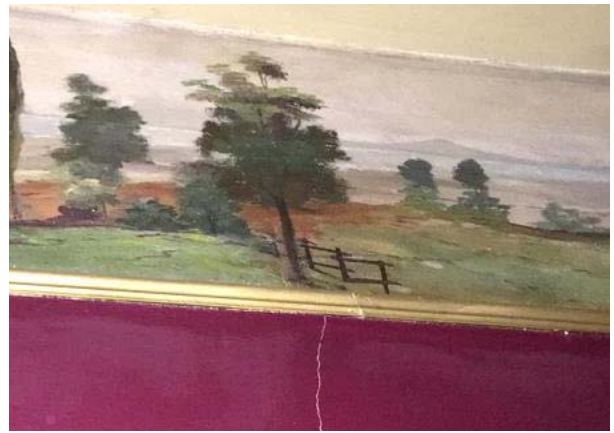
FIGURE 115. Previously repaired crack at mural where retouched paint is not visible.

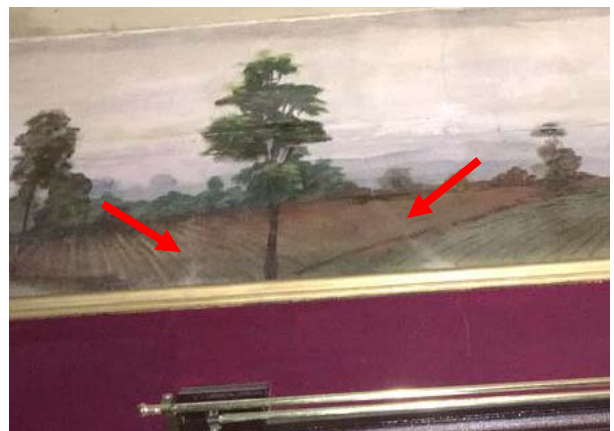
FIGURE 116. Previously repaired crack at mural where retouched paint is visible.
