Condition Assessment Report

Cultural Resources, Partnerships and Science Division
Southeast Region

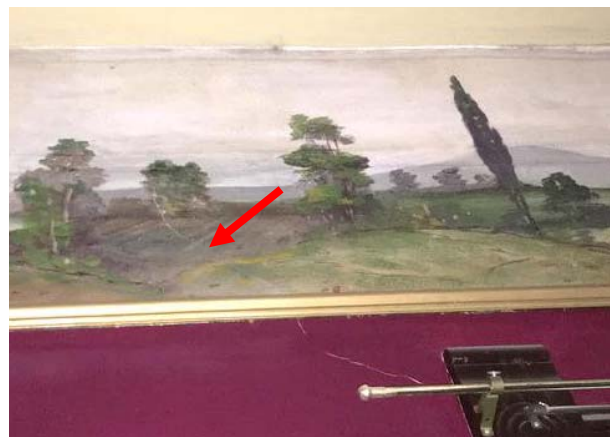
FIGURE 117. Visible plaster crack with no apparent repair or retouching.

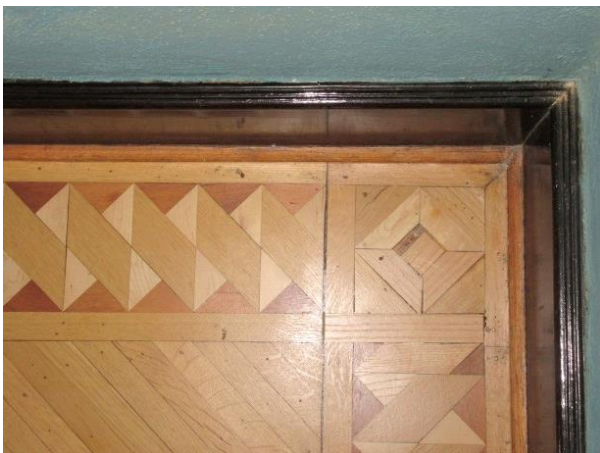
FIGURE 118. Decorative parquet border.

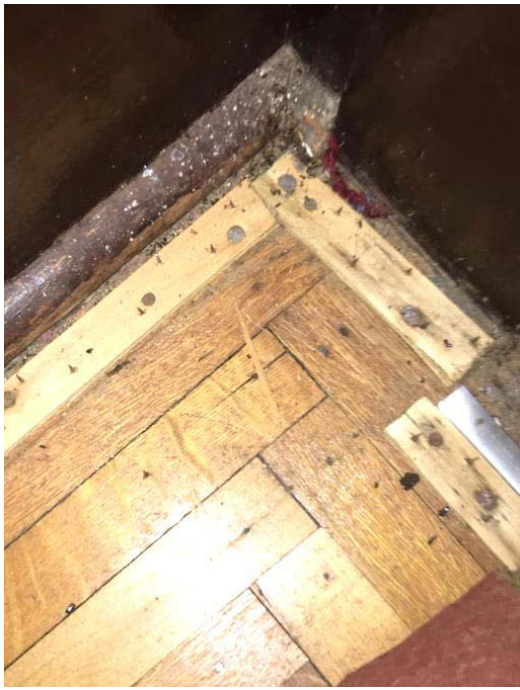
FIGURE 120. Original wood flooring below carpet at vestibule.

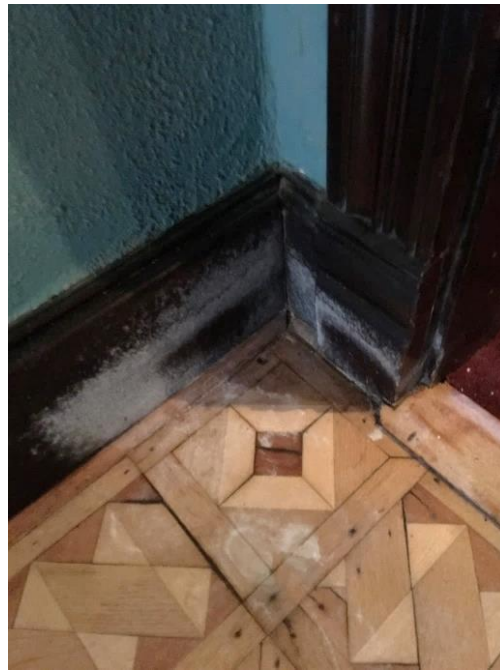
FIGURE 125. Moisture damage at floor and base.

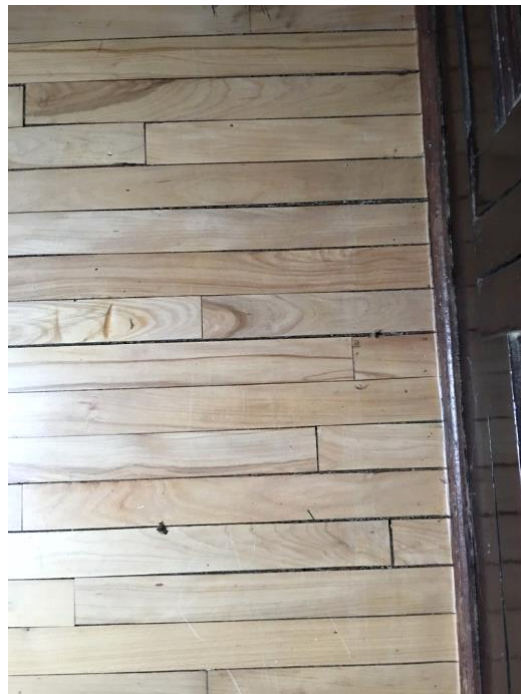
FIGURE 126. Separations at wood floor in pantry.

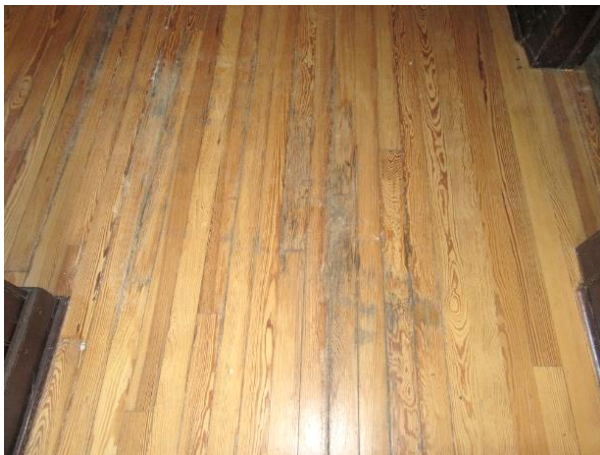
FIGURE 127. Third-floor hall, discoloration from moisture on wood strip flooring.

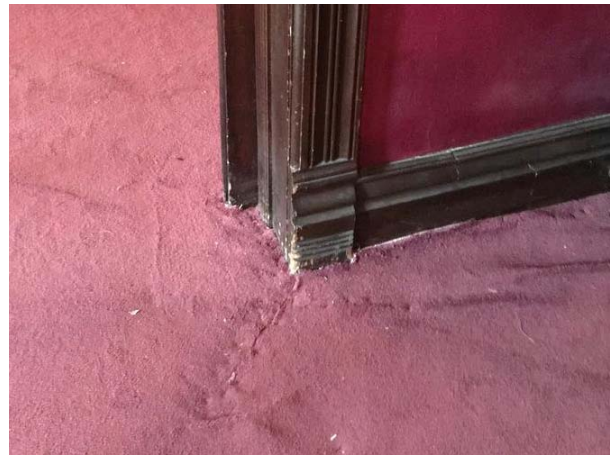
FIGURE 128. Carpet runner in traffic areas.

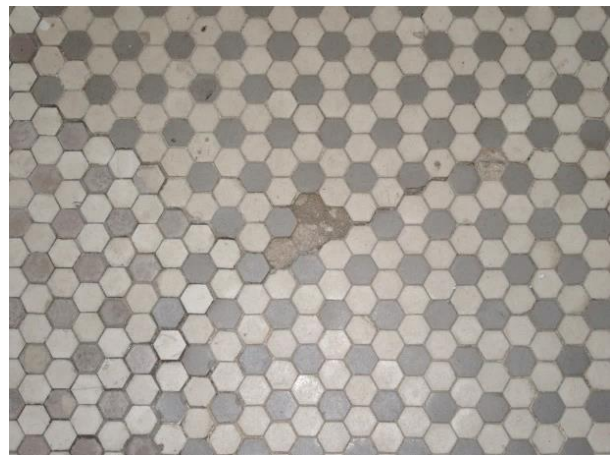
FIGURE 129. Cracks in mosaic floor tile at bathroom.

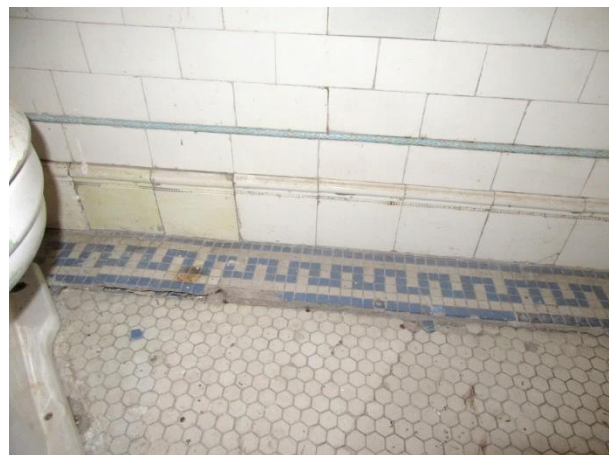
FIGURE 130. Detail of floor tile in the boys' bathroom.

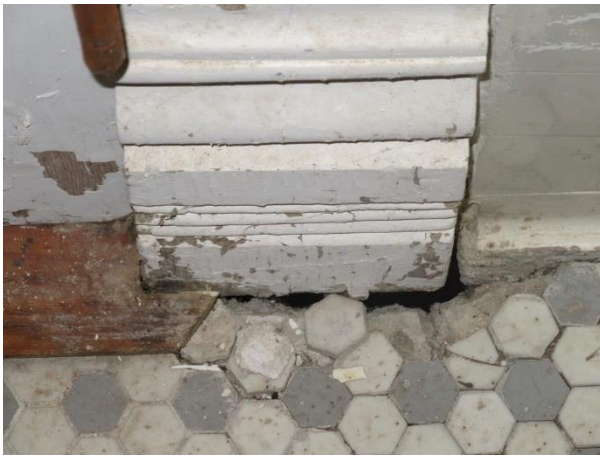
FIGURE 131. Tile damage at door frame.

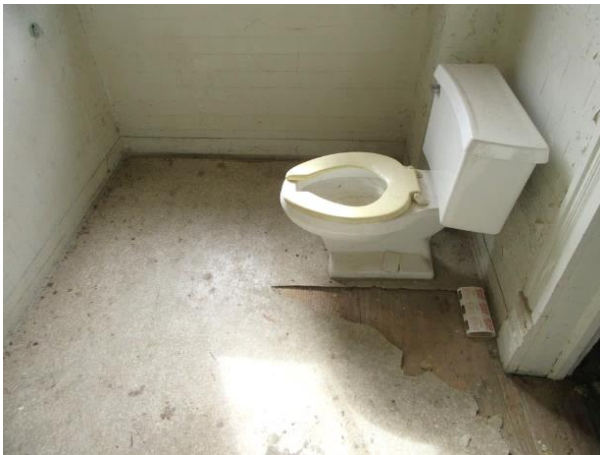
FIGURE 132. Deteriorated linoleum floor in the third-floor bathroom.

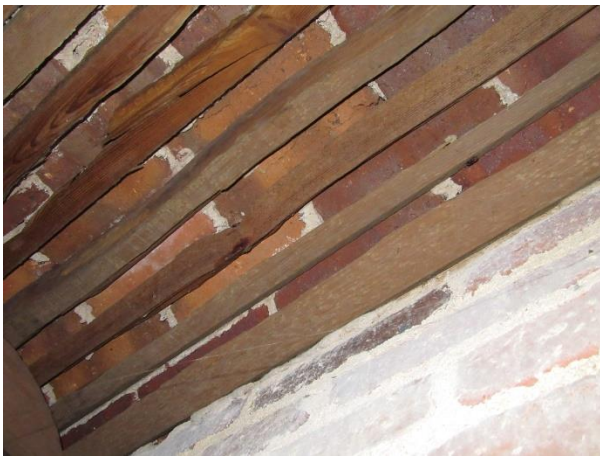
FIGURE 133. Typical masonry infill with wood slats shoring at underside of hearth.

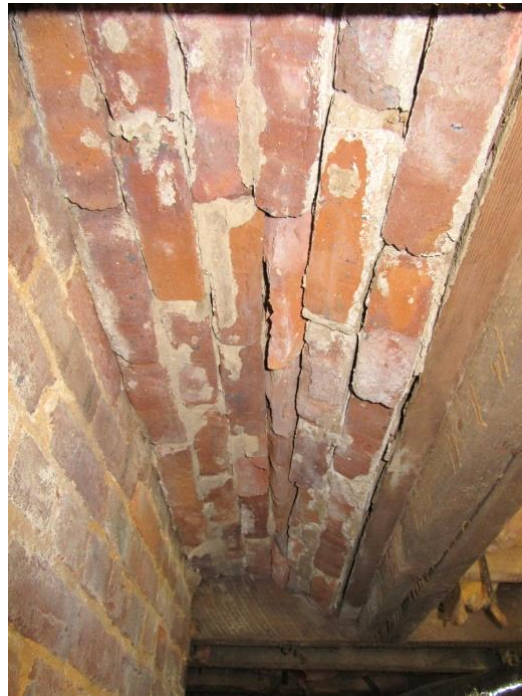
FIGURE 134. Masonry infill at underside of hearth in the guest bedroom.

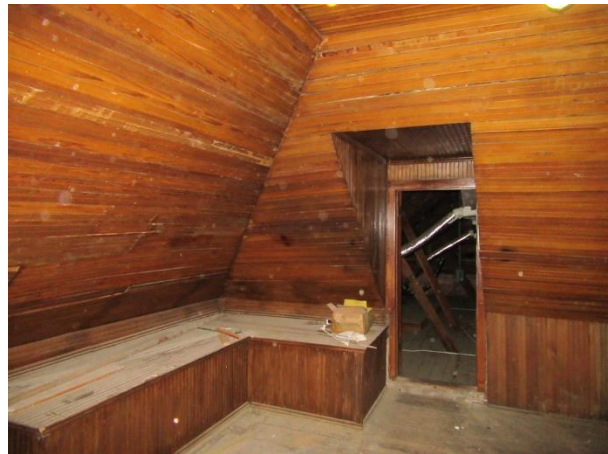
FIGURE 138. Typical stained wood interior at third-floor trunk storage rooms.

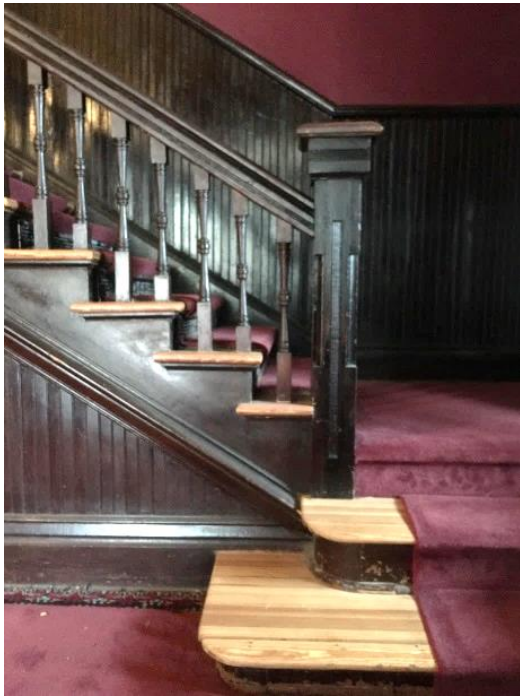
FIGURE 139. Main stair at first floor.

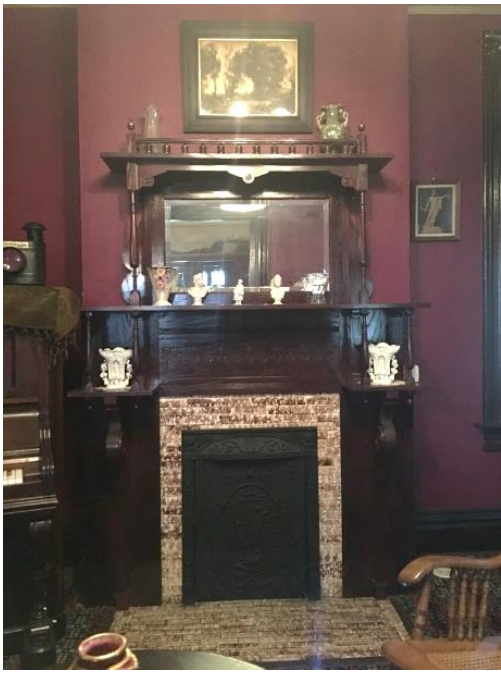
FIGURE 141. Detail at parlor fireplace.

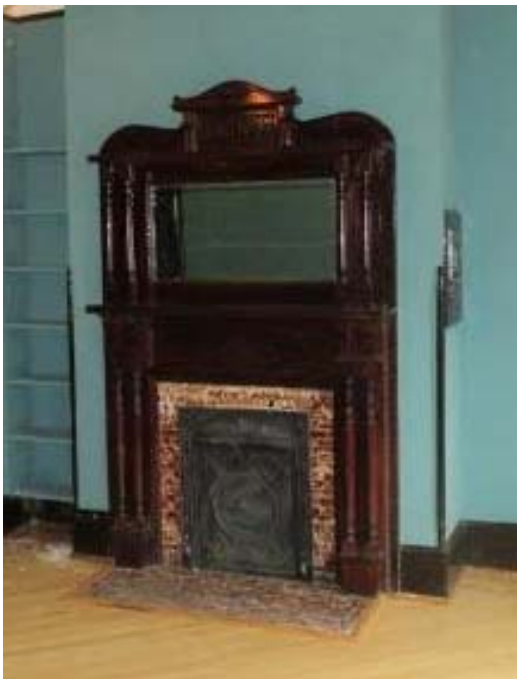
FIGURE 142. Detail of fireplace in Margaret Washington's bedroom.

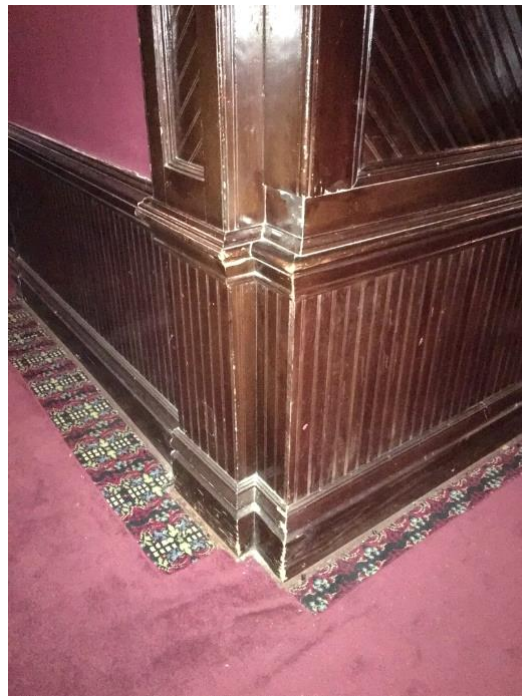
FIGURE 143. Wood wainscot and paneling at foyer.

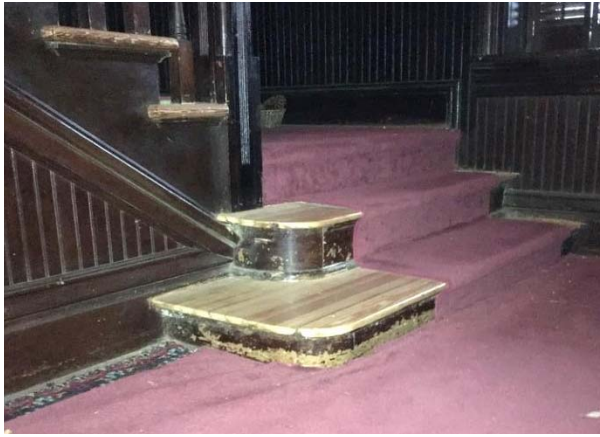
FIGURE 144. Paint deterioration at stair risers.

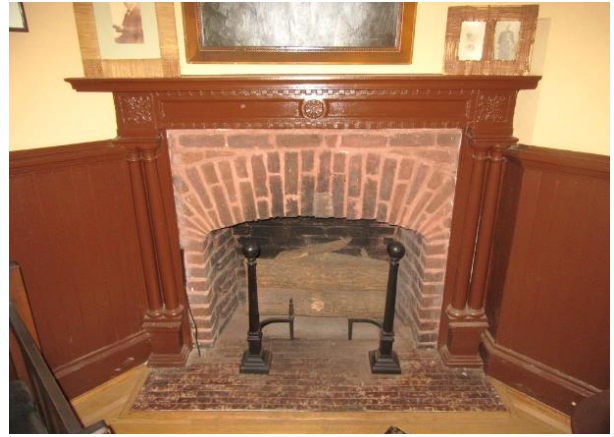
FIGURE 147. Detail of fireplace in the den.

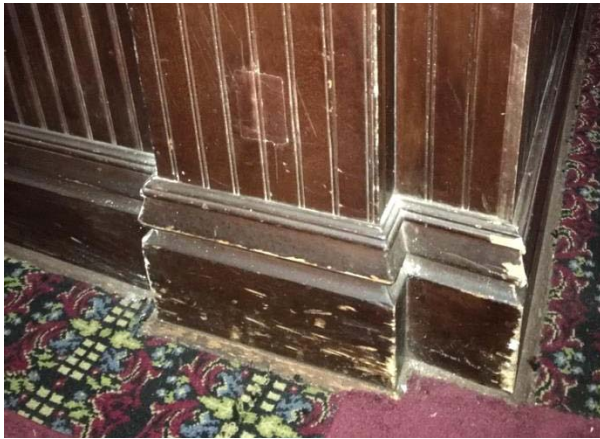
FIGURE 145. General wear and tear at wood base.

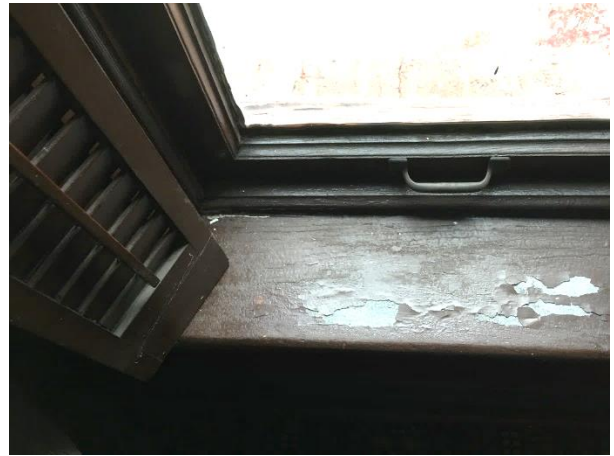
FIGURE 148. Paint delamination at window stool.

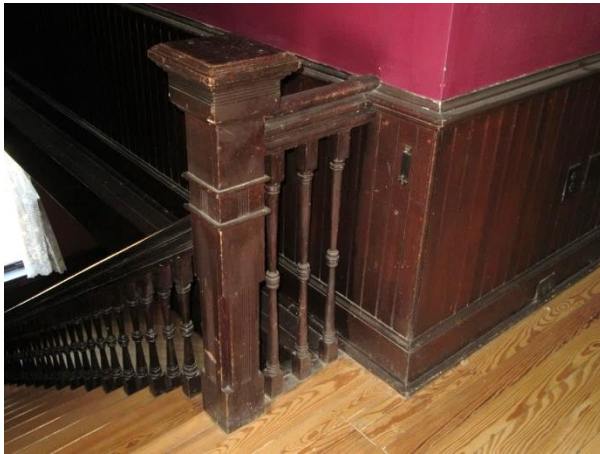
FIGURE 146. Common damage to balustrade rail and newel post on the third floor.

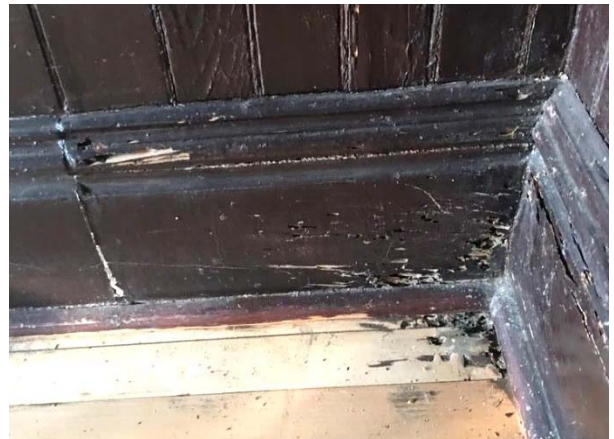
FIGURE 149. Deterioration due to moisture damage in the kitchen.

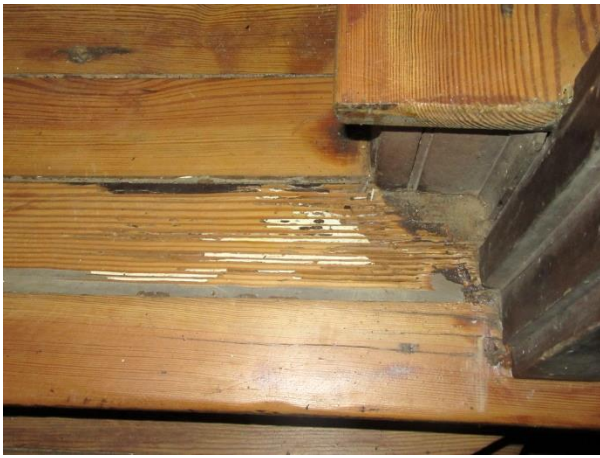
FIGURE 150. Termite damage at basement stair.

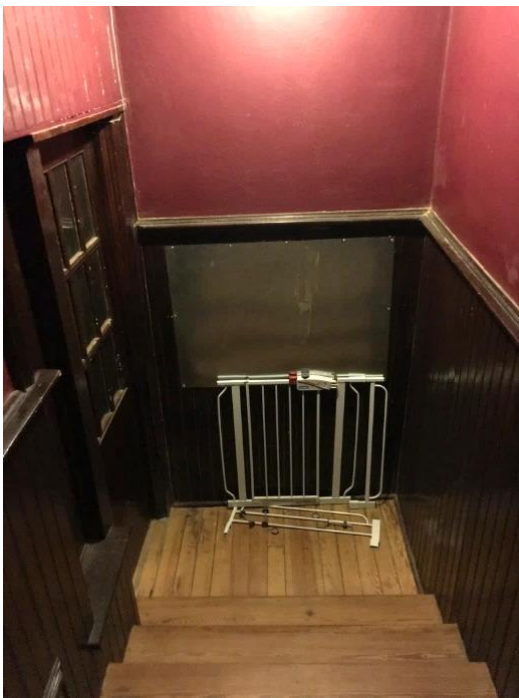
FIGURE 151. Sheet-metal closure at rear hall stair.

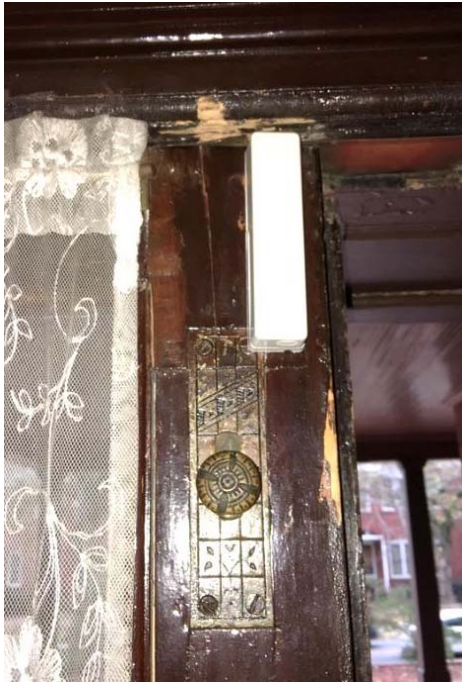
FIGURE 152. Flushbolt at head of inactive leaf at entry. Stile is split from heavy use.

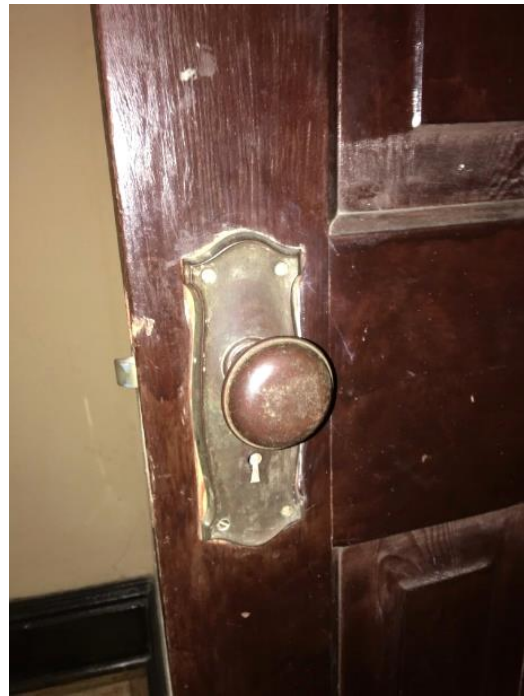
FIGURE 153. Detail at latchset.

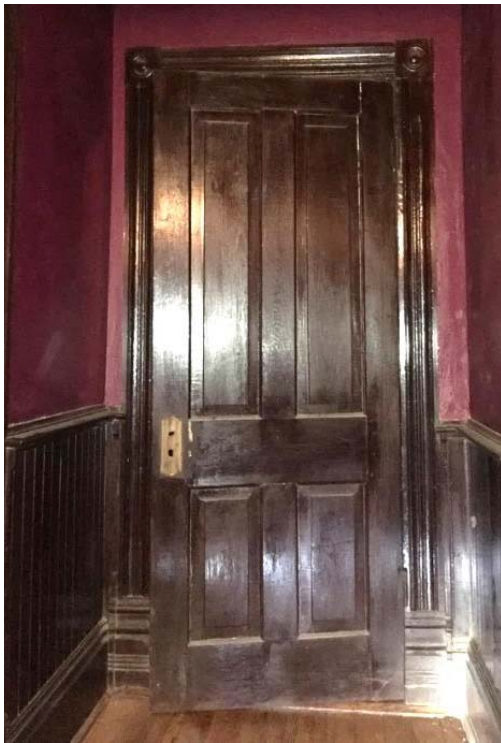
FIGURE 158. Door at rear stair, hardware missing.

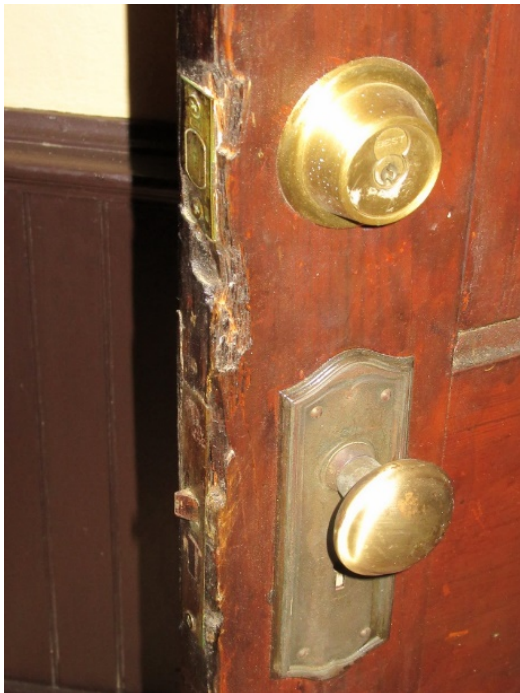
FIGURE 159. Detail of hardware on the third floor.

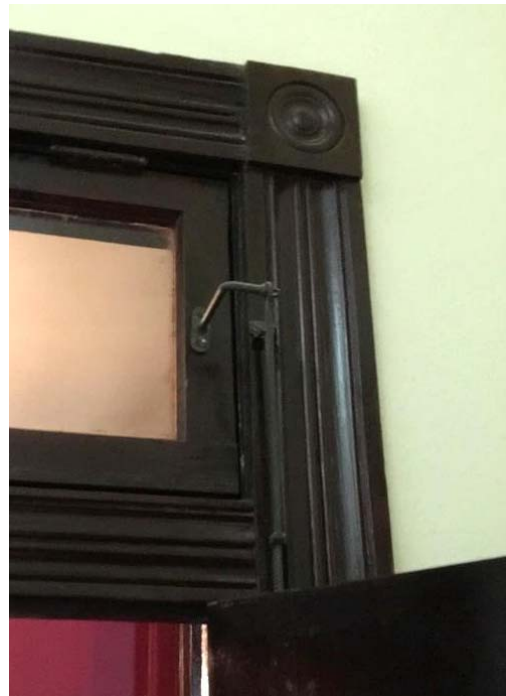
FIGURE 160. Transom with operator hardware.

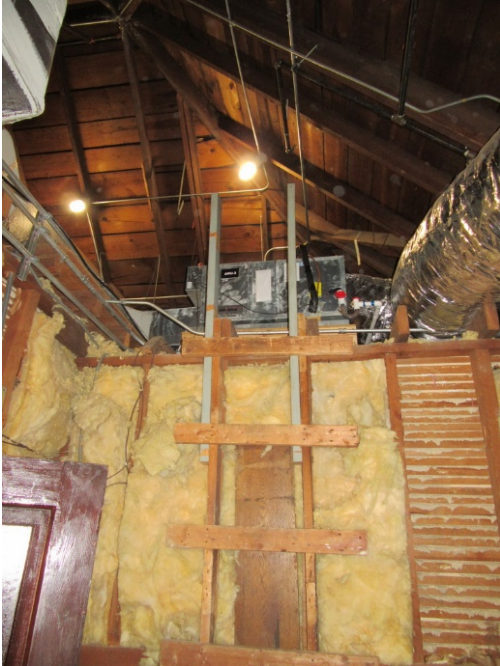
FIGURE 161. Missing insulation at attic side of third-floor wall.

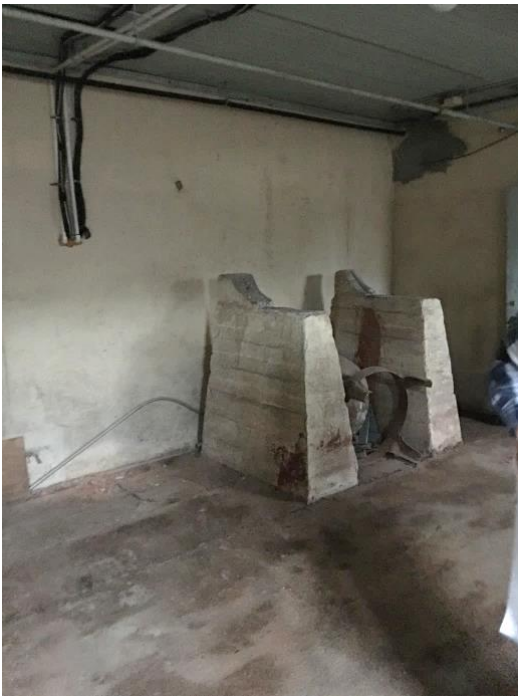
FIGURE 162. Overall view of basement and washtub.

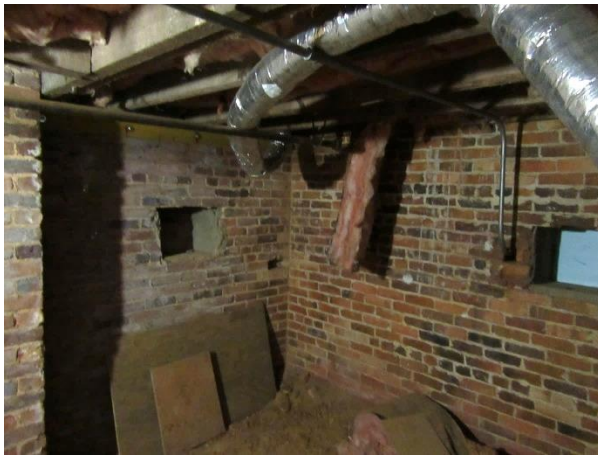
FIGURE 163. Mechanical crawl space / basement, insulation displaced at floor joists.

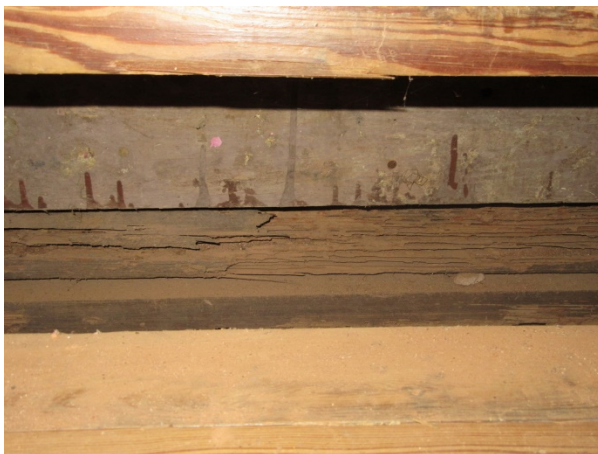
FIGURE 165. Termite damage at basement framing.

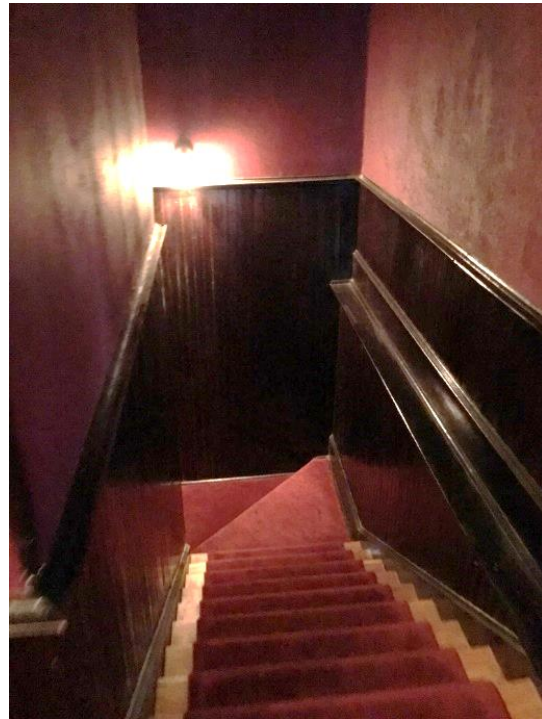
FIGURE 166. Overall view of rear stair from second-floor landing.

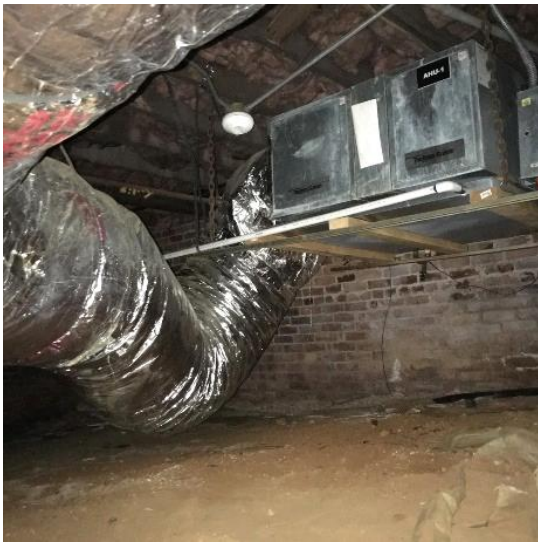
FIGURE 167. Air-handling unit in crawl space.

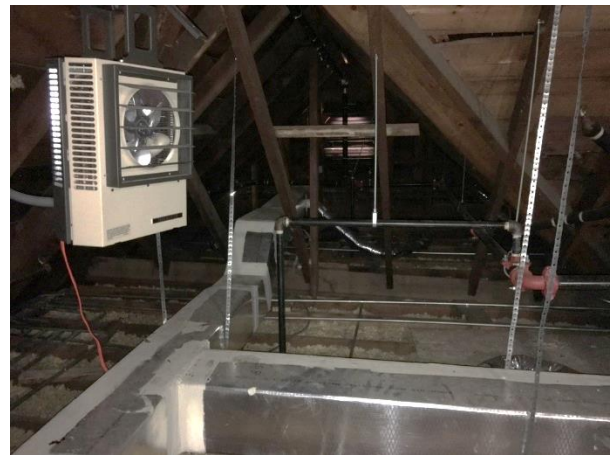
FIGURE 171. Electric heater at attic.

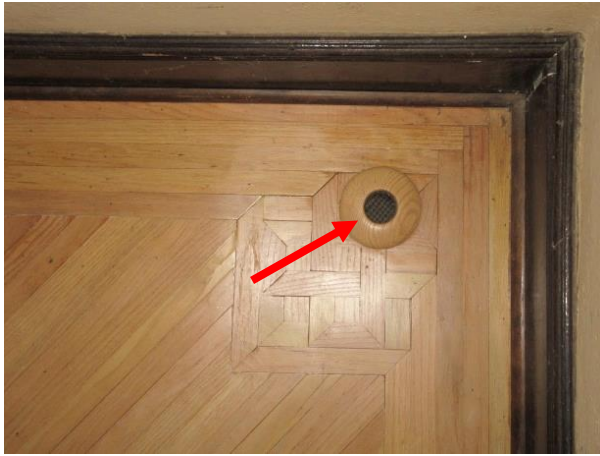
FIGURE 172. Typical Unico distribution nozzle in the parquet floor.

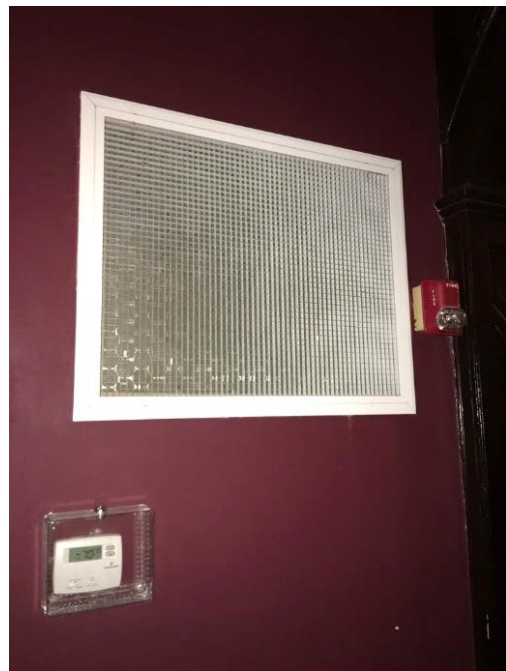
FIGURE 176. Return grille at rear hall.

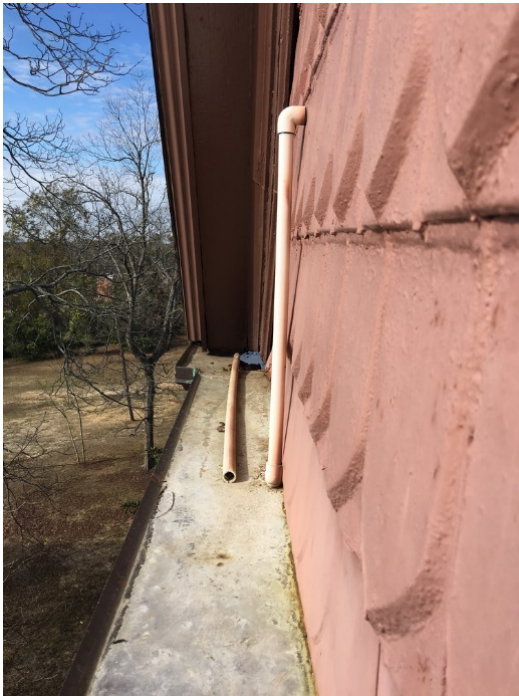
FIGURE 177. Condensate drains from air-handling units and runs on surface of gable infill, spilling into gutter. Pipe disconnected.

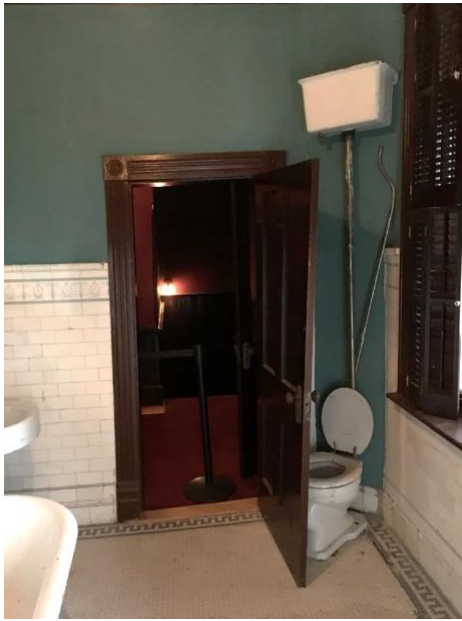
FIGURE 179. Overall view of the second-floor bathroom (Room 210).

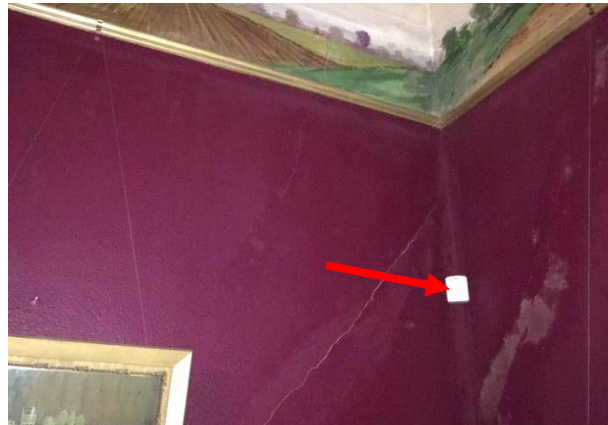
FIGURE 185. Typical security motion sensor.

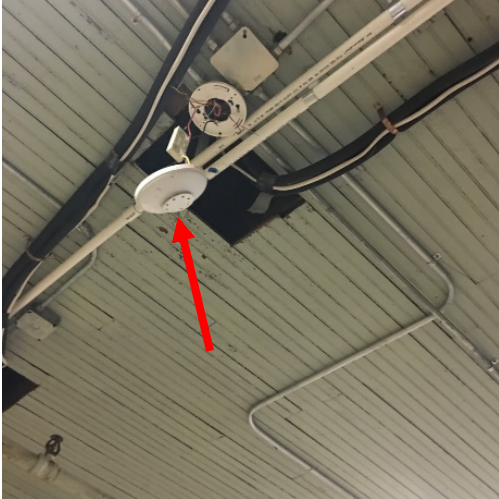
FIGURE 186. Disconnected smoke and fire detectors at basement.

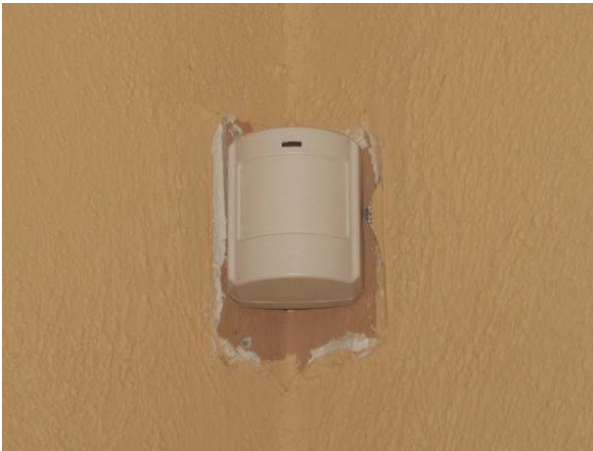
FIGURE 187. Paint incomplete where device has been replaced.

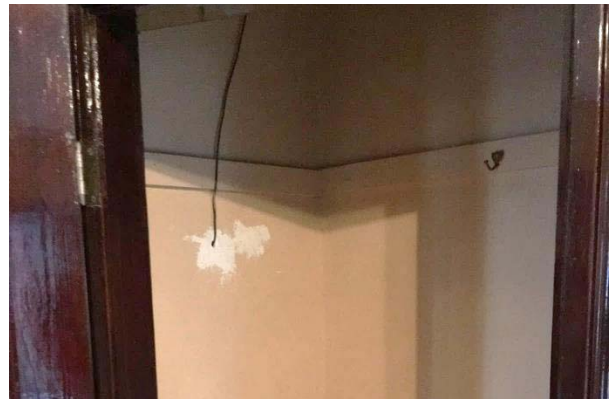
FIGURE 188. Wall penetration at low voltage wiring in closet.

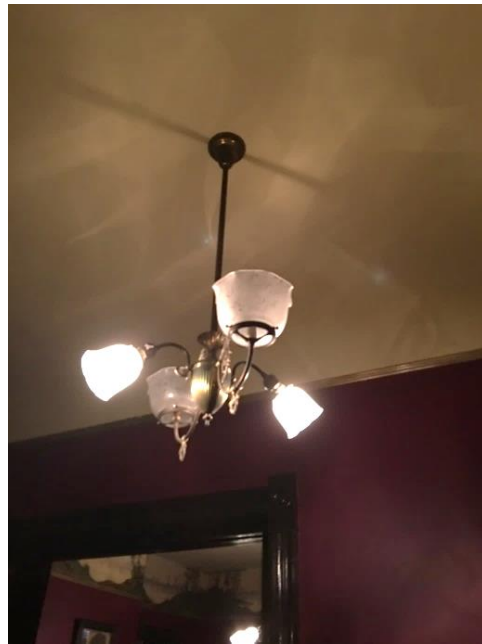
FIGURE 189. Reproduction gas-electric fixture in the foyer.

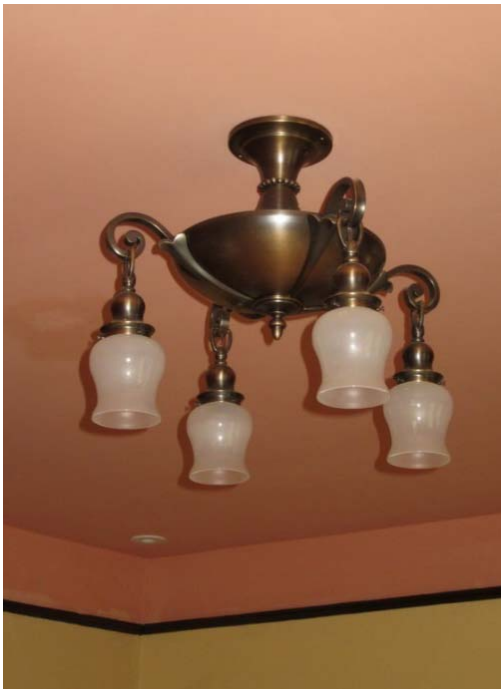
FIGURE 196. Light fixture in the third-floor bedroom.

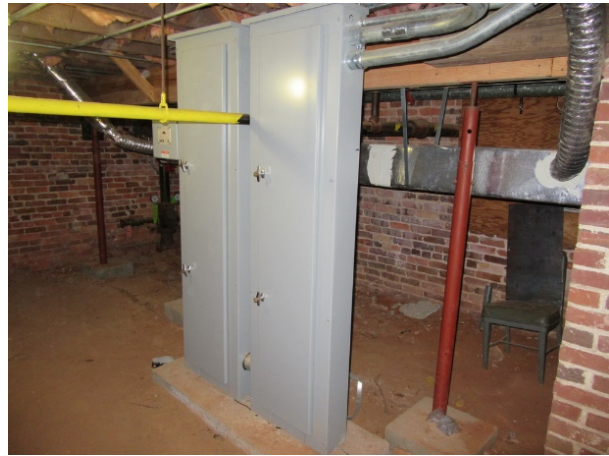
FIGURE 197. Electrical panels at crawl space.

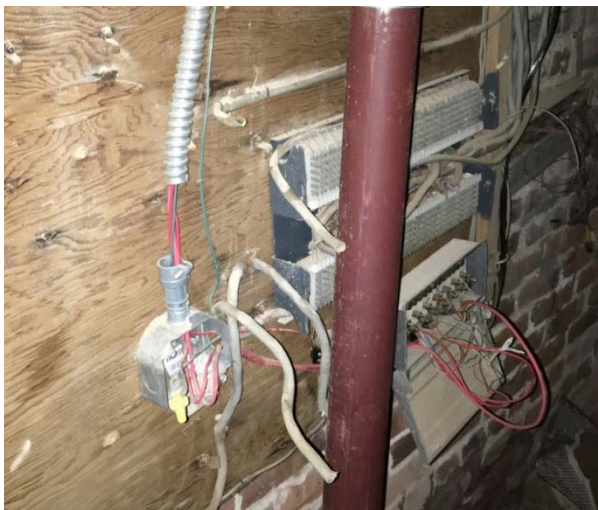
FIGURE 201. Open junction box and panel at telephone backboard, basement.

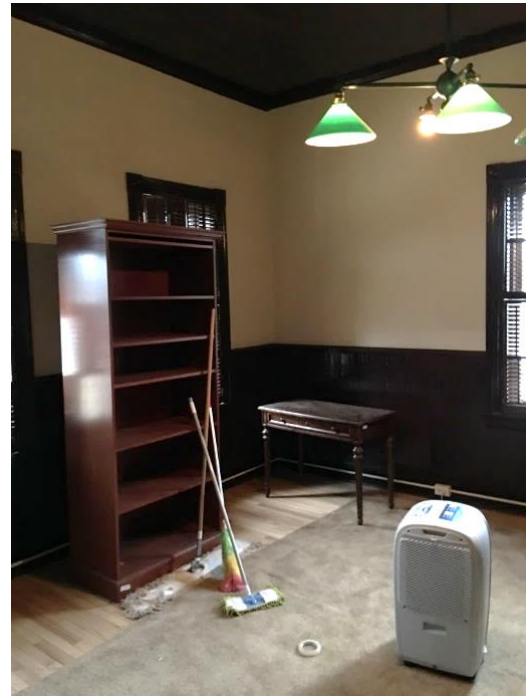
FIGURE 202. Overall view of kitchen with surface-applied conduit at baseboards.

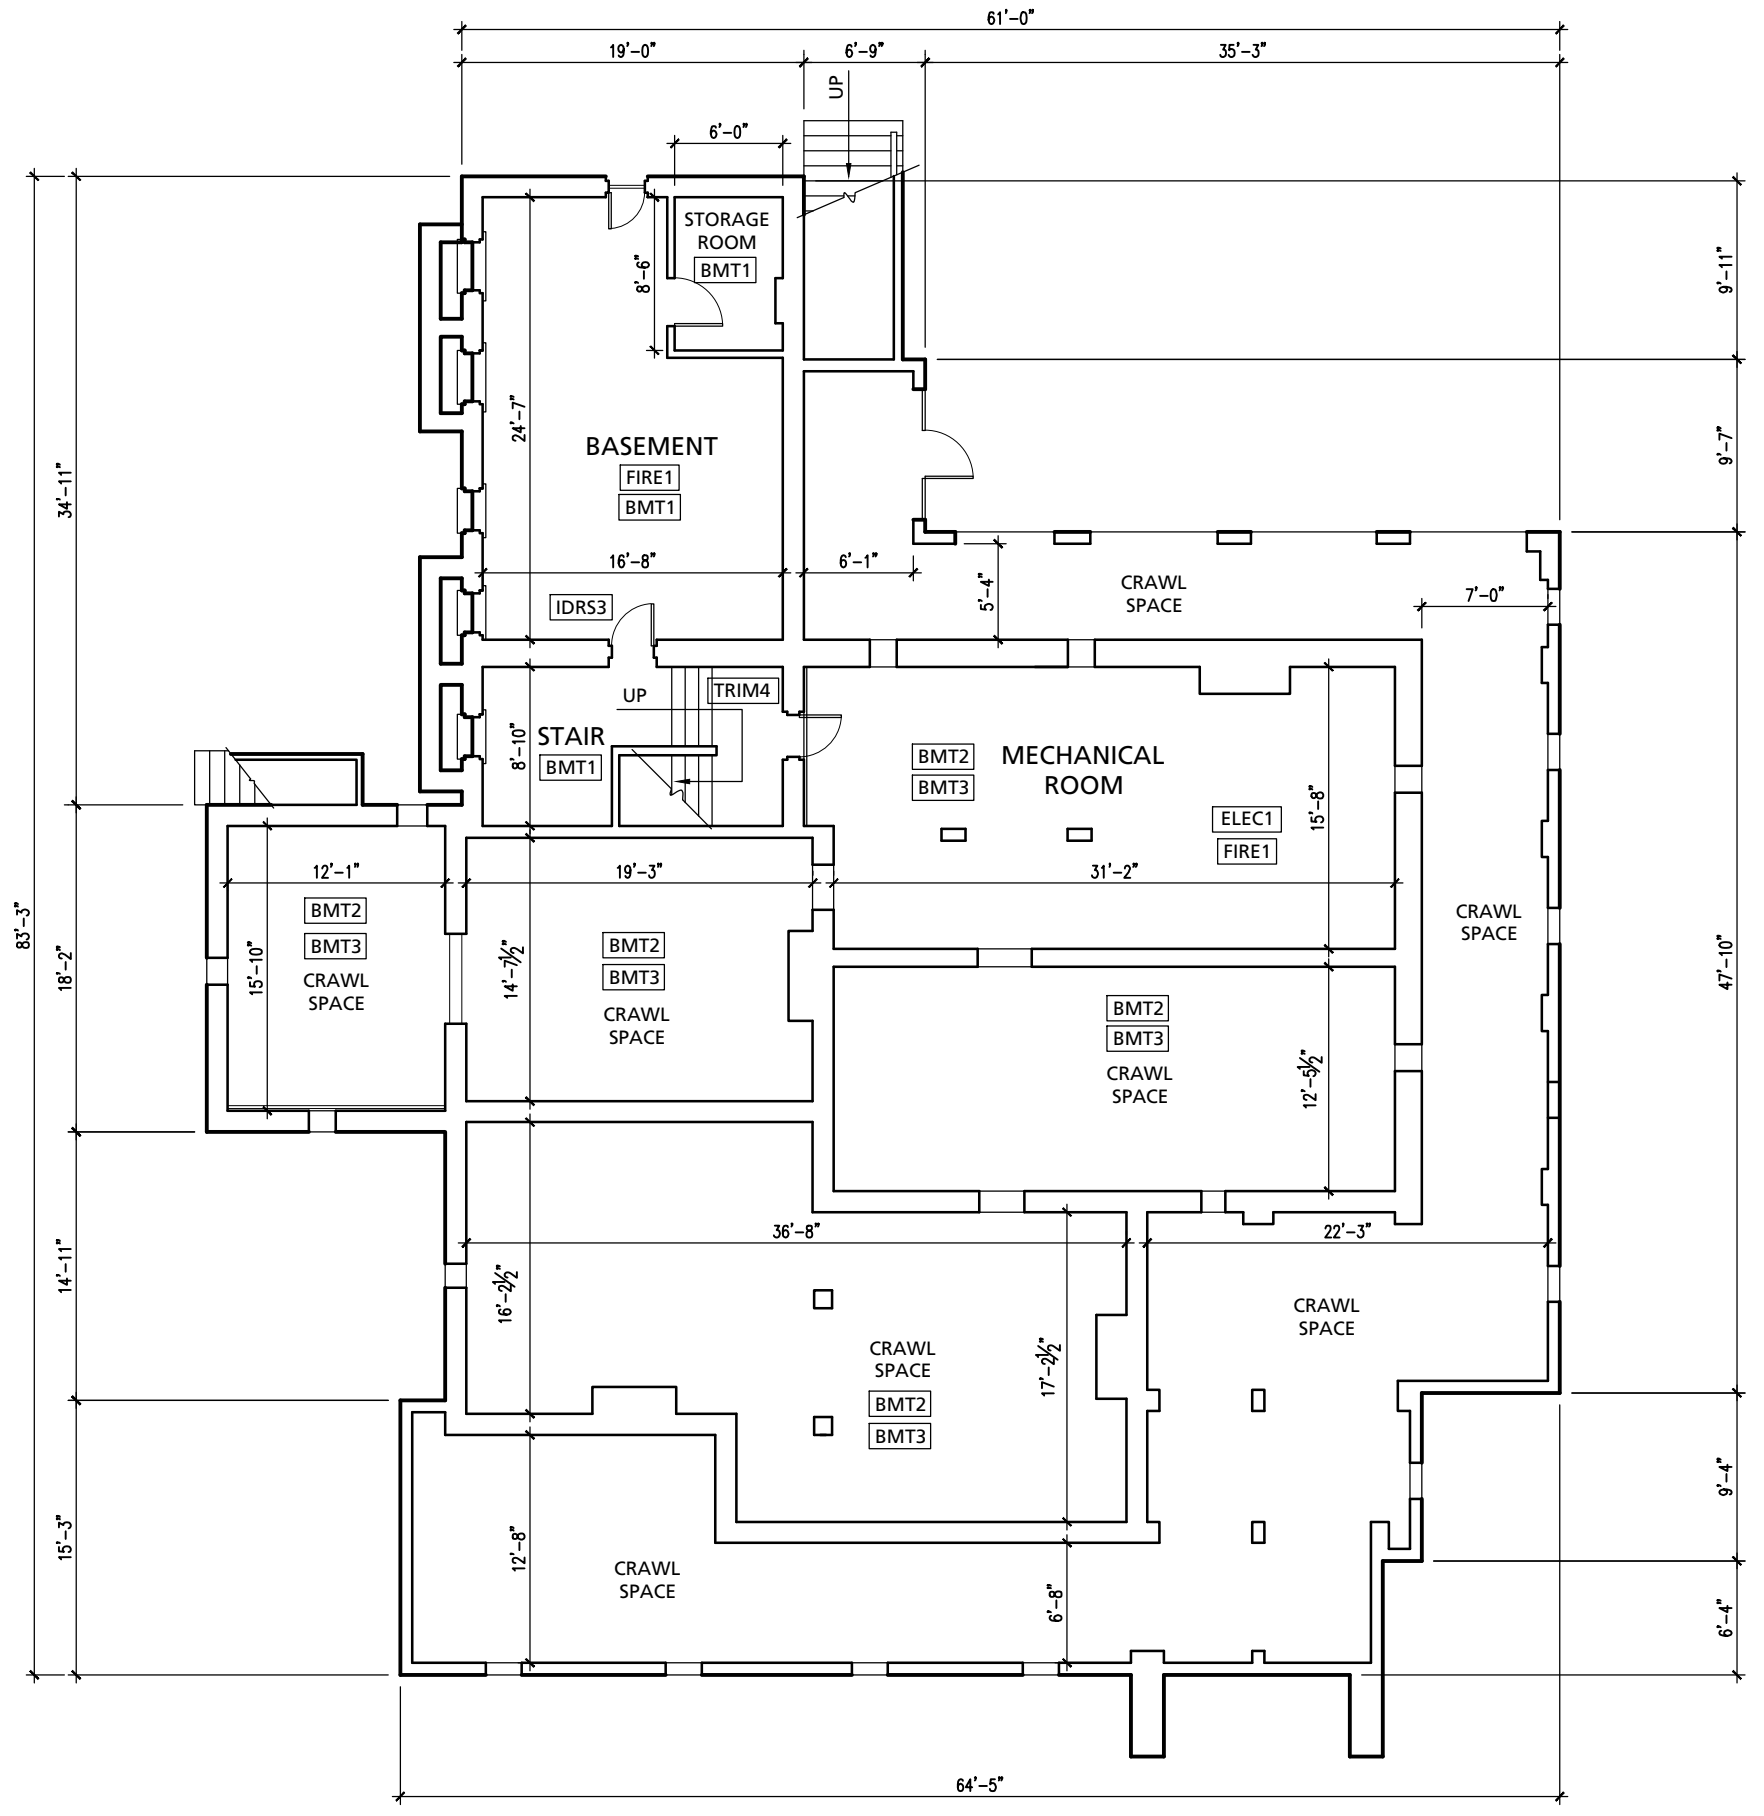
Appendix A: Condition Assessment Drawings
