# George Washington Carver Museum Historic Structure Report

# George Washington Carver Museum Tuskegee Institute National Historic Site

## Historic Structure Report

Prepared by:  
Panamerican Consultants, Inc.  
2390 Clinton Street  
Buffalo, New York 14227

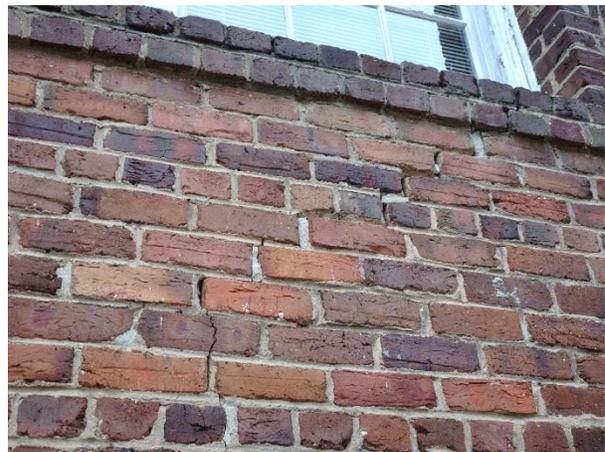
- Step cracking was observed at numerous locations including at the main building and at the north addition (Figure 64 and Figure 65). The step cracking typically extended from the corners of window and door openings. The cracking included open mortar joints, eroded mortar, and vertical cracking through some brick units at locations aligned with head joints. At many window head locations, there was evidence of corrosion at the steel lintels. At some locations, the deteriorated mortar and cracked brick had been repaired with replacement mortar (Figure 66). The replacement mortar was typically cracked and deteriorated as well, indicating that the cracking is still active.

**FIGURE 64.** Typical step cracking at the main building adjacent to window and door openings.

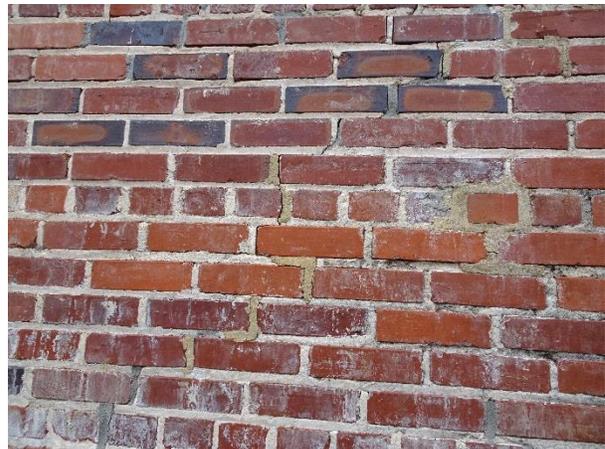
**FIGURE 65.** Step cracking and open joints at north addition.

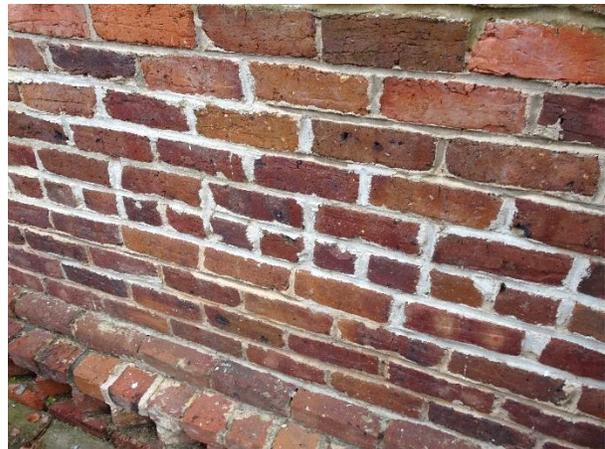
**FIGURE 66.** Area of cracking. Note white-colored replacement mortar.

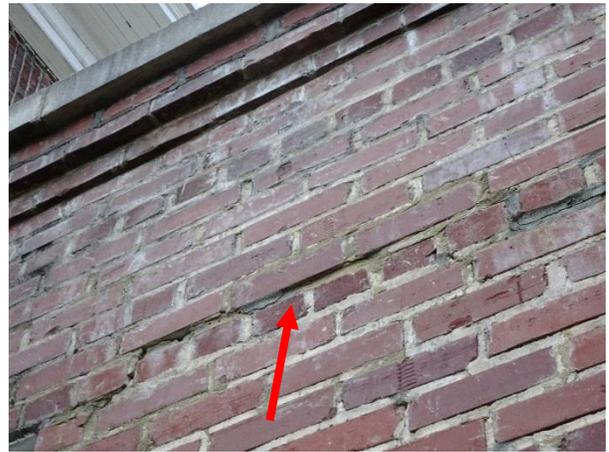
**FIGURE 69.** Bowing at brick units adjacent to a window opening on the north addition.

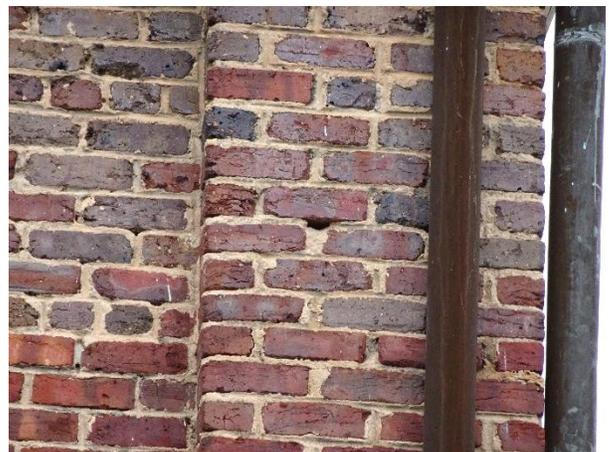
- Open and deteriorated mortar joints were observed in the field of the wall at the main portion of the building and at the north addition. At the main portion of the building, the most significant deterioration was concentrated near downspouts and consisted of eroded mortar at joints and small areas where the mortar had been completely washed away (Figure 70). At the north addition, deteriorated mortar joints were observed throughout the field of wall and consisted of cracked, open, and eroded mortar joints. There was also evidence of numerous previous replacement mortar campaigns (Figure 71). The various localized repointing campaigns were each distinguished by a slightly different color of mortar and quality of work (Figure 72 and Figure 73).

**FIGURE 70.** Open and deteriorated mortar joints at the field of wall.

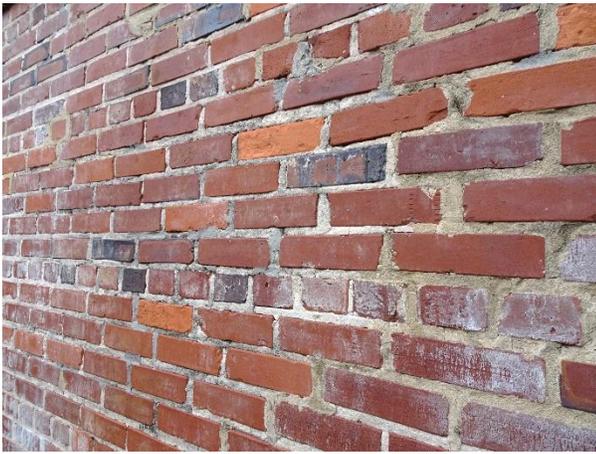
**FIGURE 71.** Different colors of mortar from various mortar repointing campaigns were observed throughout the building.

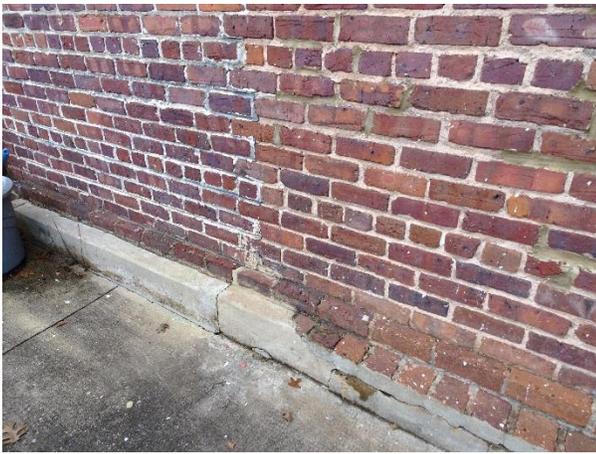
**FIGURE 72.** Different colors of mortar from various mortar repointing campaigns were observed throughout the building.

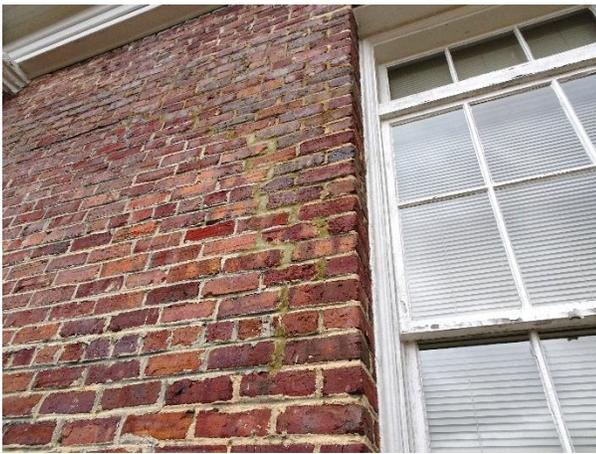
**FIGURE 73.** Different colors of mortar from various mortar repointing campaigns were observed throughout the building.

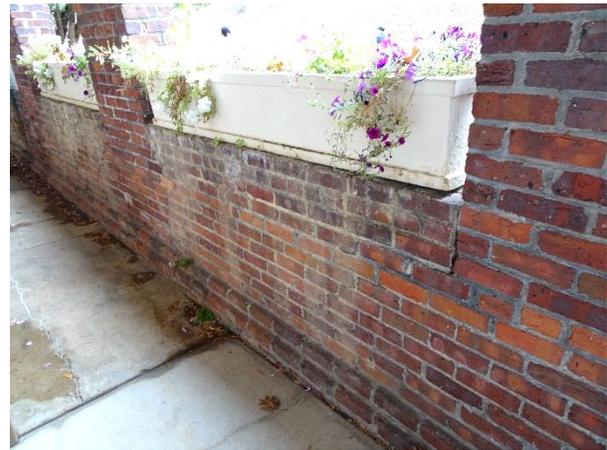
- Efflorescence was observed at the brick masonry walls at the south portico, the stair cheek walls, the underside of brick arch openings, and the north addition. At the south portico, the efflorescence was primarily located at the masonry below planter boxes and appeared to be associated with the moisture expelled from these boxes (Figure 74). Efflorescence at stair cheek walls was most pronounced immediately below the coping of the cheek wall (Figure 75). Efflorescence at arched openings was typically located at the face of the brick on the underside of the arch (Figure 76). At the north addition, efflorescence was extensive throughout the east and north elevations but was most concentrated at the top of the wall, along a horizontal line approximately five courses below the coping (Figure 77). The efflorescence aligns with the bottom of the roof scuppers and is located at the approximate height of the roof.

**FIGURE 74.** Efflorescence under planter units at south portico.

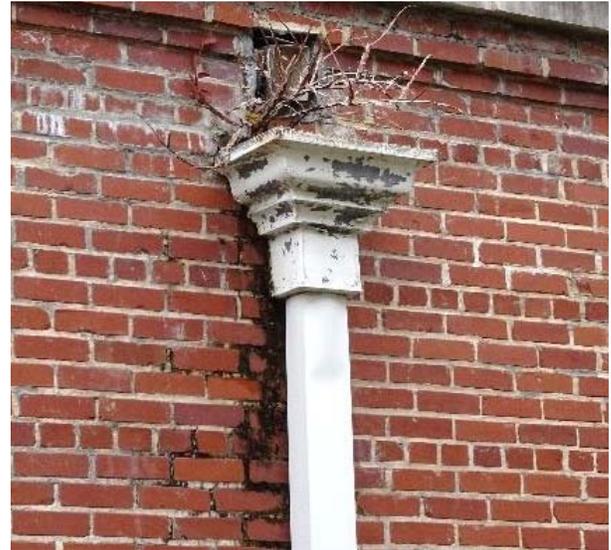
was observed that the scupper box was approximately 8 inches below the bottom of the scupper opening. The scupper sleeve was flush with the opening and did not have a flashing to assist in directing water to the scupper box. Furthermore, the scupper box was observed to have leaves and twigs which diverted the water as it flowed out of the scupper.

**FIGURE 78.** Scupper box at north addition. Note moisture staining and biological growth below scupper.

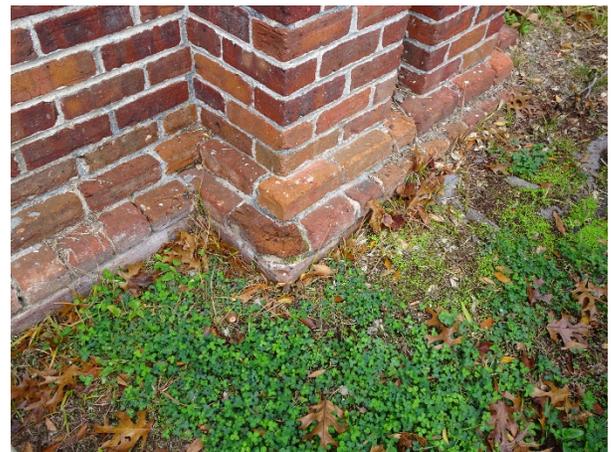
**FIGURE 79.** Spalled brick at main portion of building is typically located at corners and along edges.

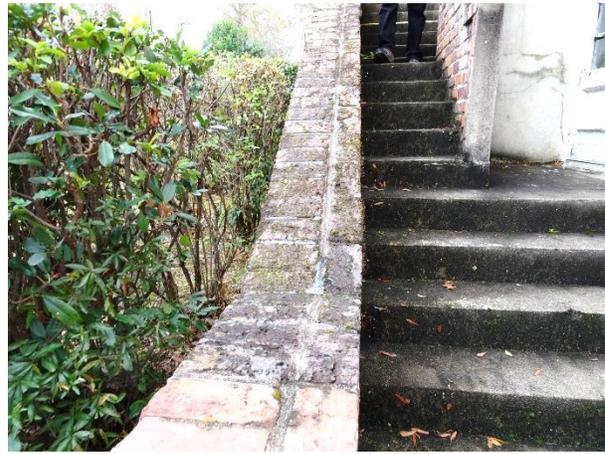
**FIGURE 81.** Biological growth at retaining wall coping.

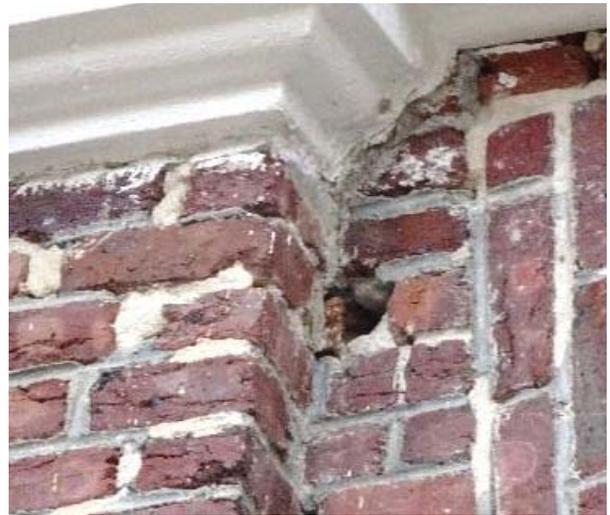
- A large void was observed at one location on the north elevation, adjacent to a pilaster capital (Figure 86). It appears that a header brick was located at the void but has since been removed. A back-up wythe of masonry is visible through the void.

**FIGURE 86.** Missing brick in field of wall.

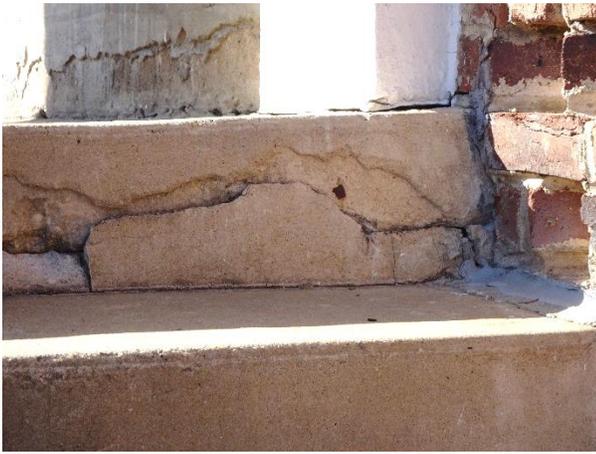
**FIGURE 88.** Cracked and spalled concrete stair tread.

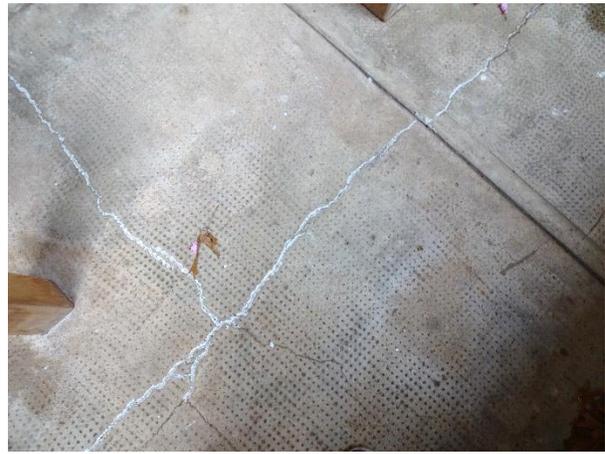
**FIGURE 90.** Cracking and previous repair of concrete slab at south portico entrance.

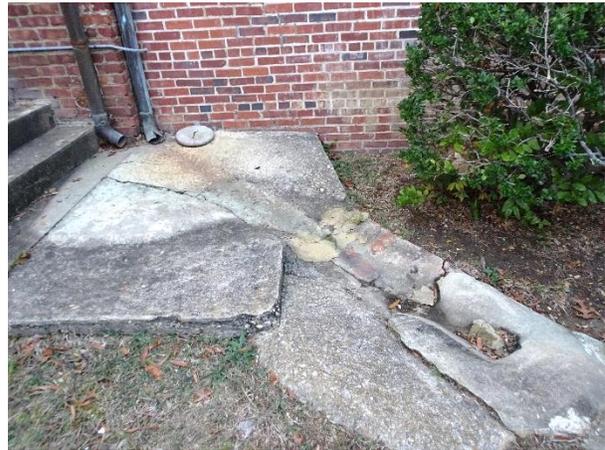
**FIGURE 91.** Cracks and deteriorated concrete at base of east stair landing and drainage gutter.

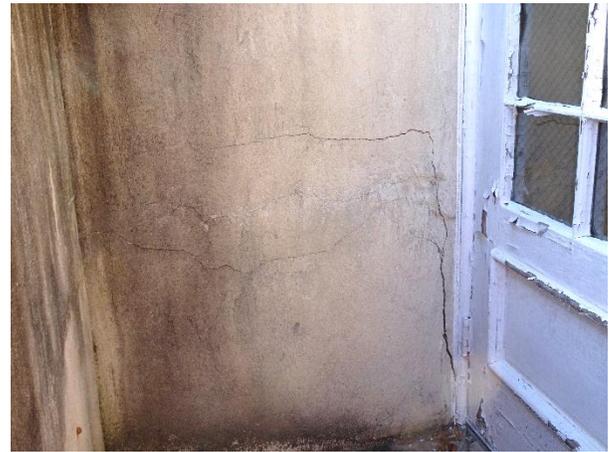
**FIGURE 94.** Cracking at cementitious parge coating at east retaining wall.

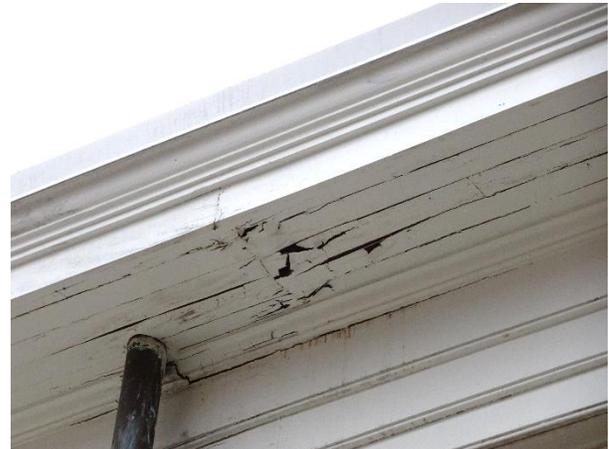
**FIGURE 95.** Deteriorated wood at soffit boards.

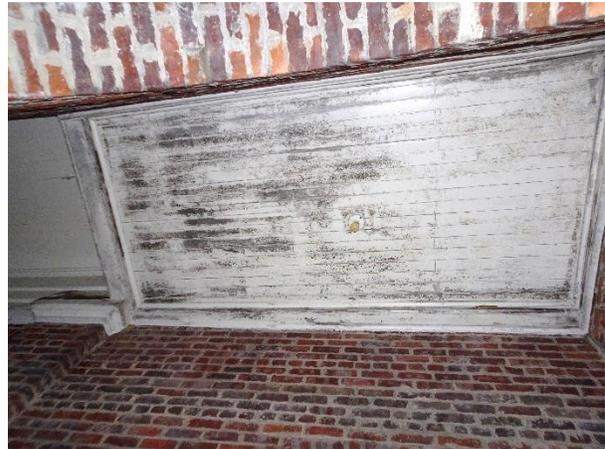
**FIGURE 98.** Biological growth at wood ceiling boards in south entrance portico.

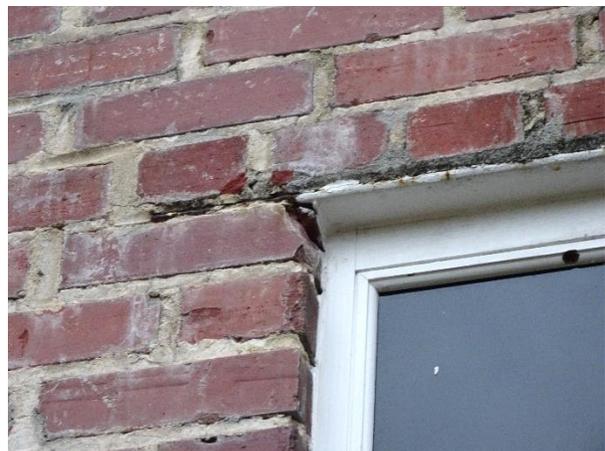
**FIGURE 99.** Corroded steel and open joints at window lintels.

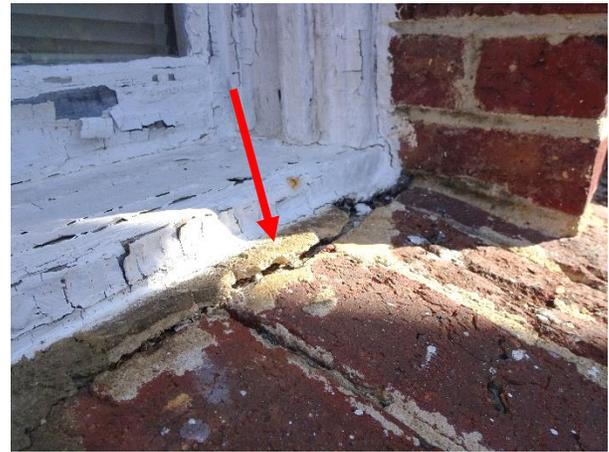
**FIGURE 102.** Spalled and cracked cementitious fill material at window opening.

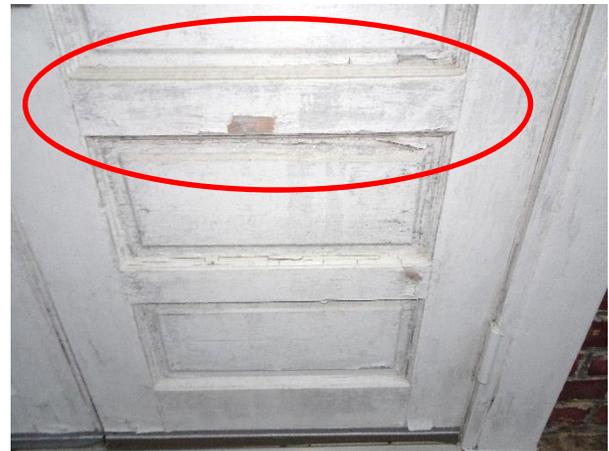
**FIGURE 103.** Peeling paint at exterior door.

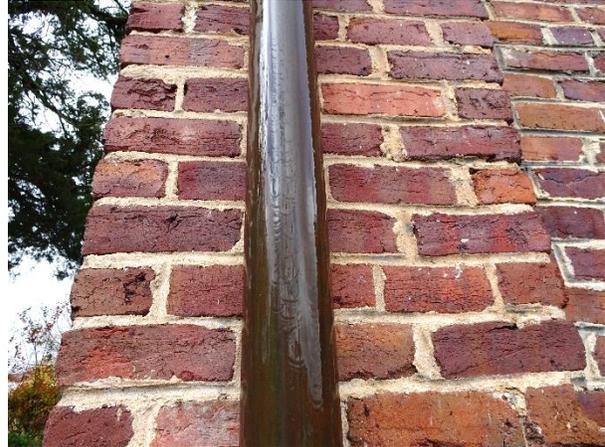
**FIGURE 107.** Overflow of water at clogged downspout.

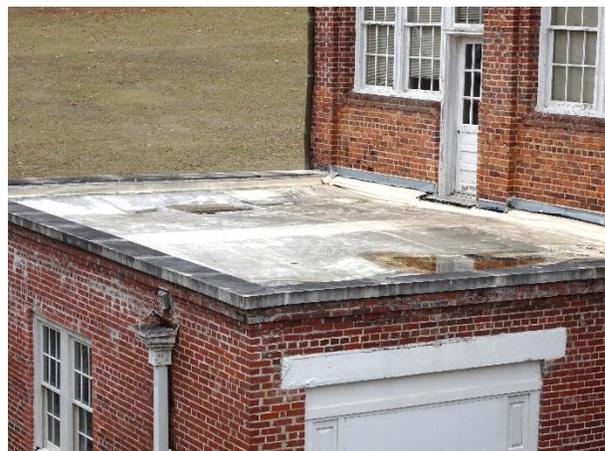
**FIGURE 108.** Ponding water at north addition roof.

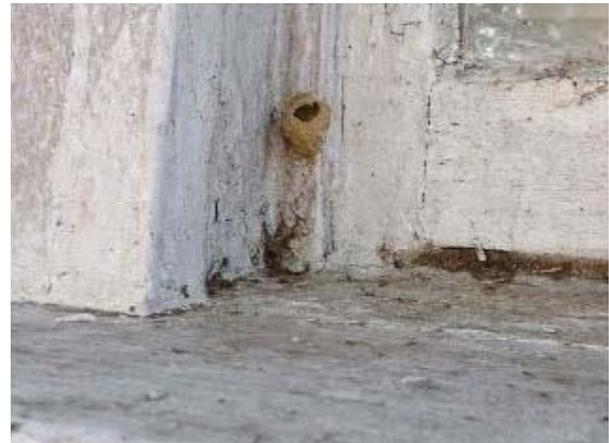
**FIGURE 111.** Mud dauber nest at window opening.

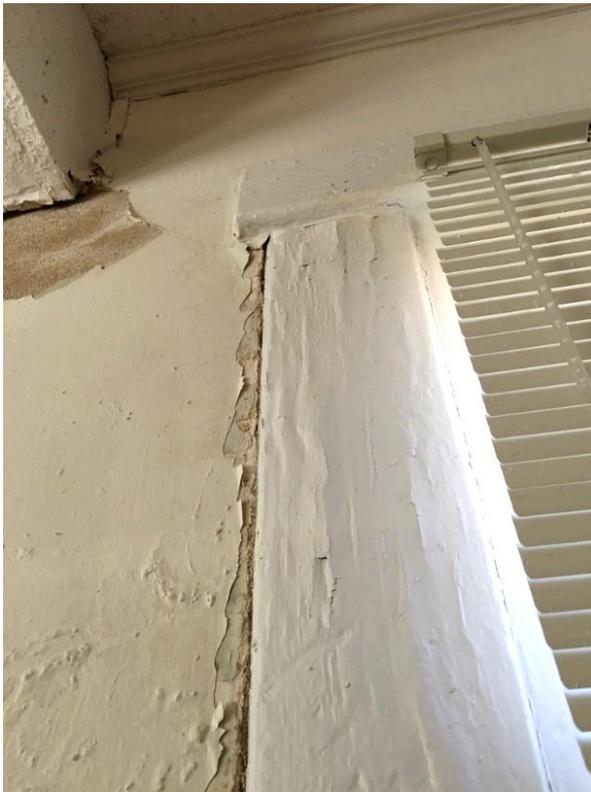
**FIGURE 173.** Opening of joint between plaster and wood trim, blistering of paint, and swelling at trim.

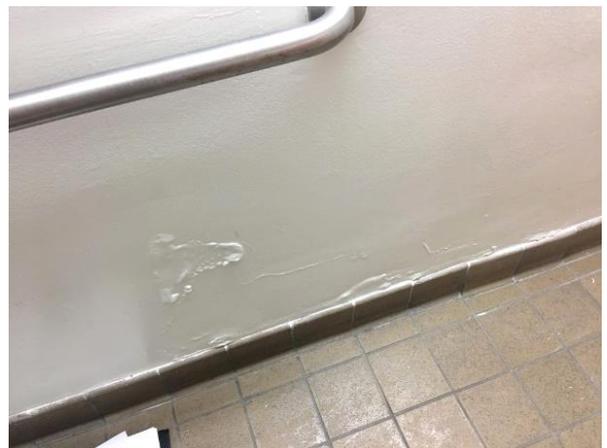
**FIGURE 176.** Blistering of plaster and paint at exterior wall of restroom.

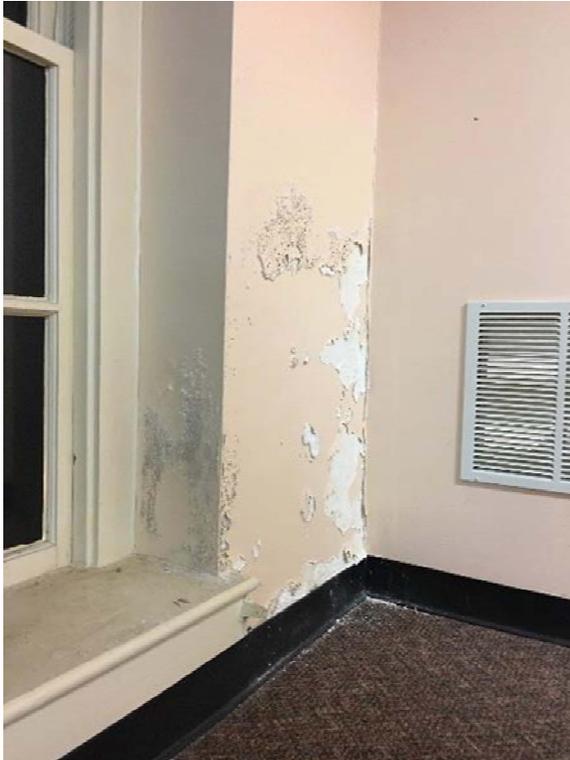
**FIGURE 177.** Blistering paint and plaster at exterior wall and window jamb return.

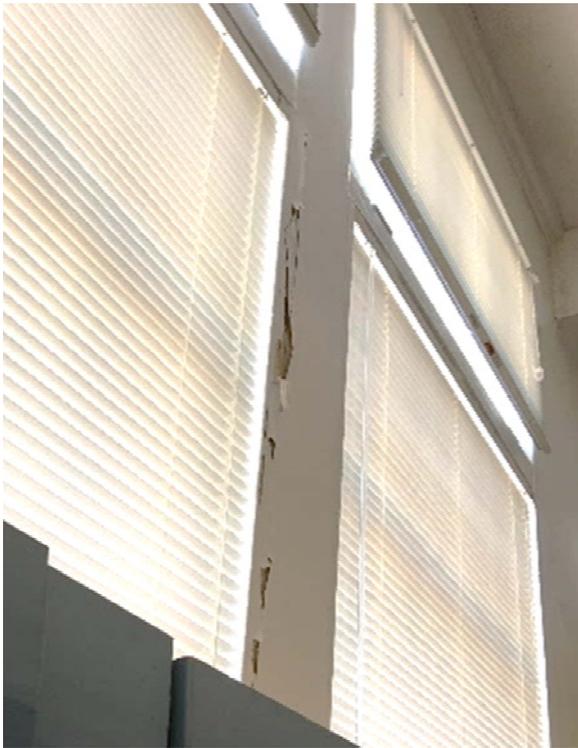
**FIGURE 180.** Delamination of paint at vertical mullion.

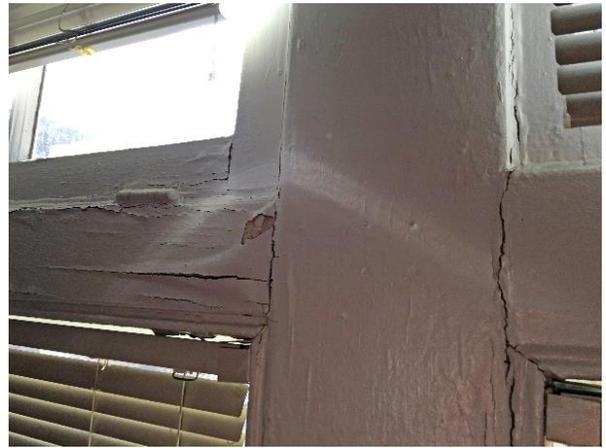
**FIGURE 182.** Moisture damage at horizontal mullion trim.

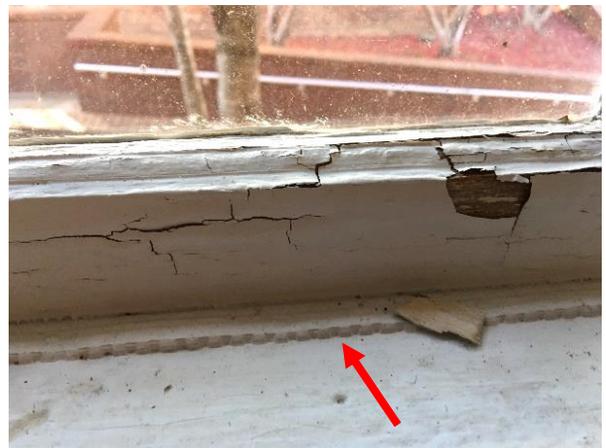
**FIGURE 183.** Delamination of paint at interior of lower sash rail. Typical bulb weatherstrip indicated.

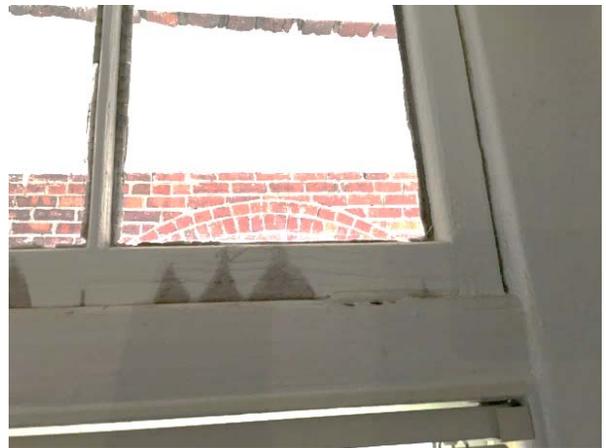
**FIGURE 184.** Delamination of paint at bottom rail of hopper sash at transom.

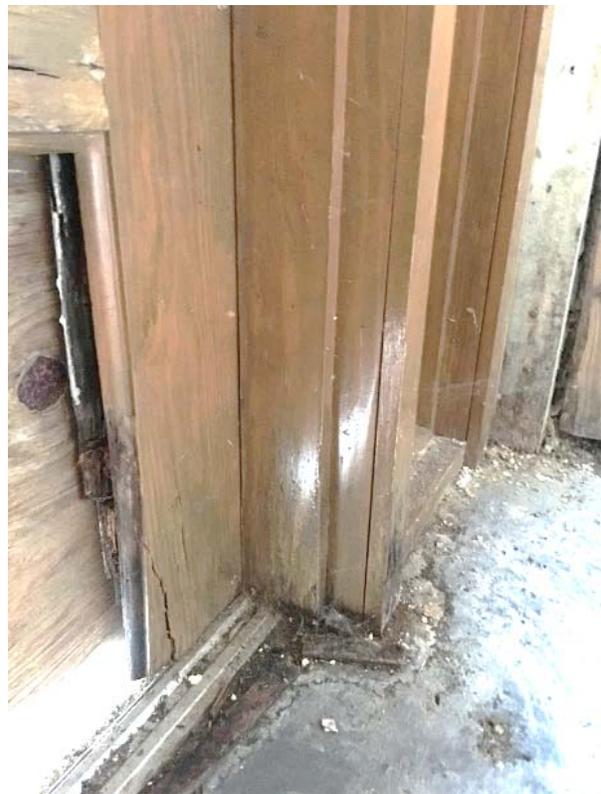
**FIGURE 188.** Moisture damage to sidelight frame at single-story addition.

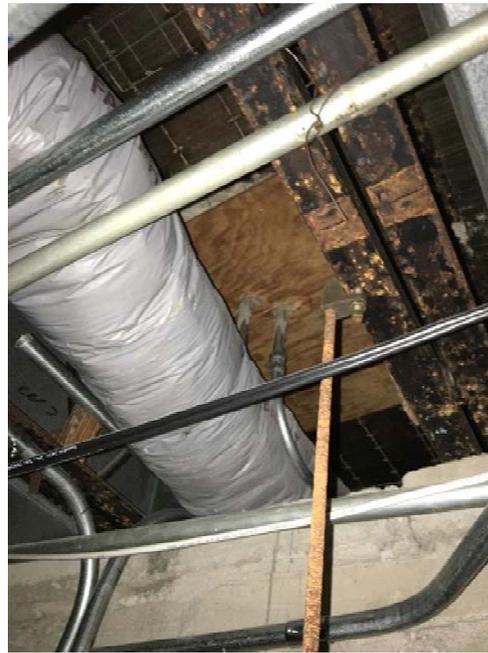
**FIGURE 190.** CMU infill at top of masonry wall terminated at underside of bar joists. Rated ceiling assembly system is not properly terminated at wall or duct penetration.

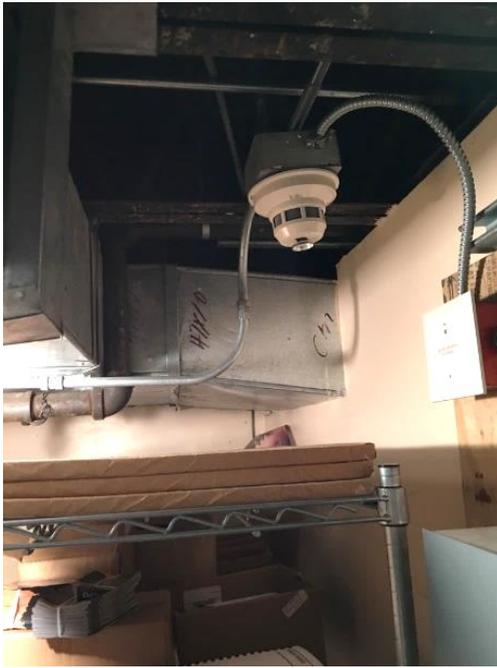
**FIGURE 192.** Termination of gypsum board partition at underside of bar joist in chair storage closet. No gypsum ceiling installed at this room.

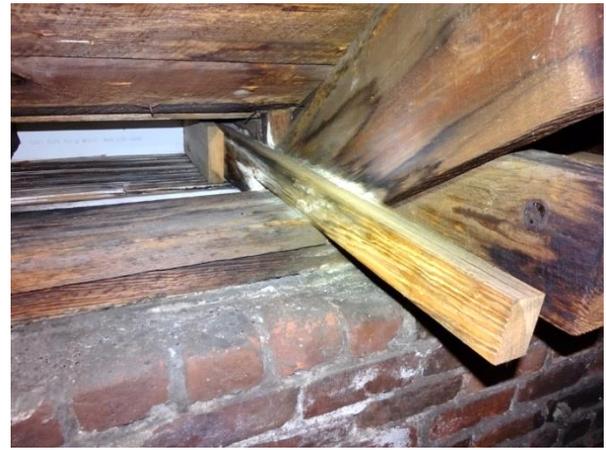
**FIGURE 205.** Example of previous fire damage and water staining observed in the attic.
