STIRLING'S QUARTERS AT VALLEY FORGE NATIONAL HISTORICAL PARK  
HISTORIC STRUCTURE REPORT

PREPARED BY:  
JOHN MILNER ARCHITECTS, INC.  
104 LAKEVIEW DRIVE, CHADDS FORD, PA 19317

JANUARY 2006

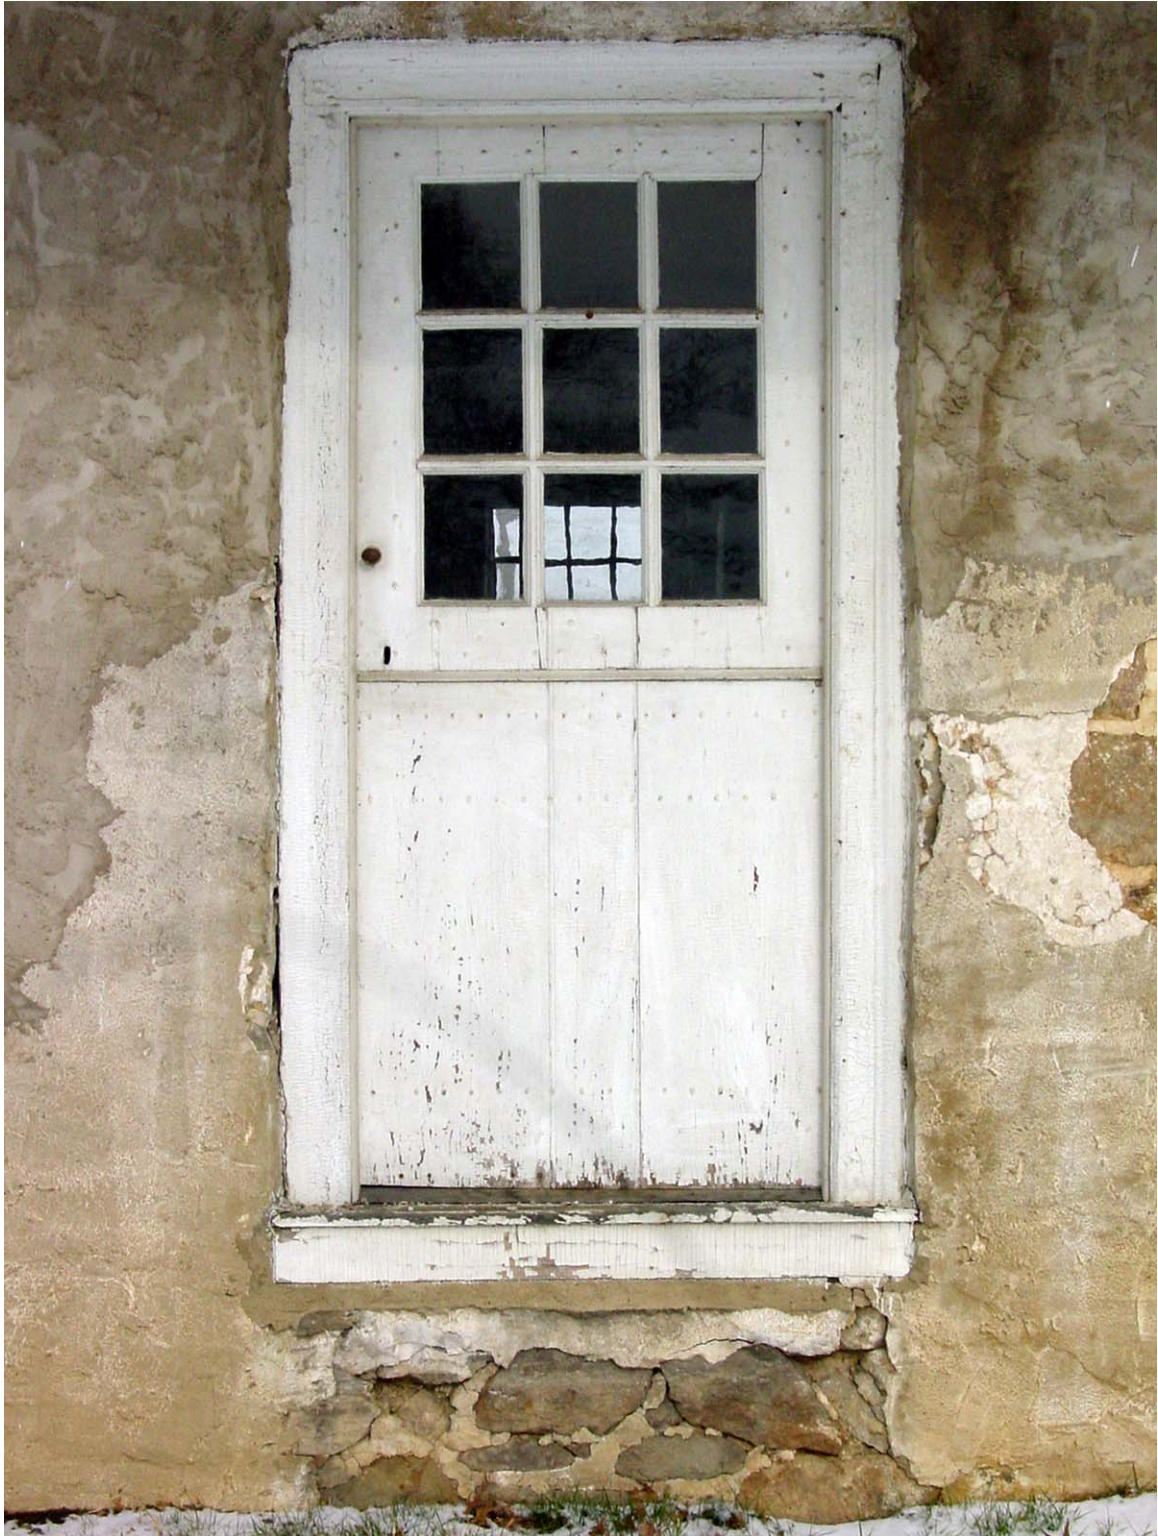
- The wood frame at the entrance to the west block appears to be original; the door is a replacement. (Photo SEc)
- The wood frame and wood door at the entrance to the main block appear to be original.
- The wood frame and wood door at the entrance to the east addition are original to the construction of the east addition, c. 1830. (Photo SEd)

**Photo SEc** - Exterior view of door to west block, looking north. Wood frame appears to be original. Dutch door is a 20<sup>th</sup> century replacement.

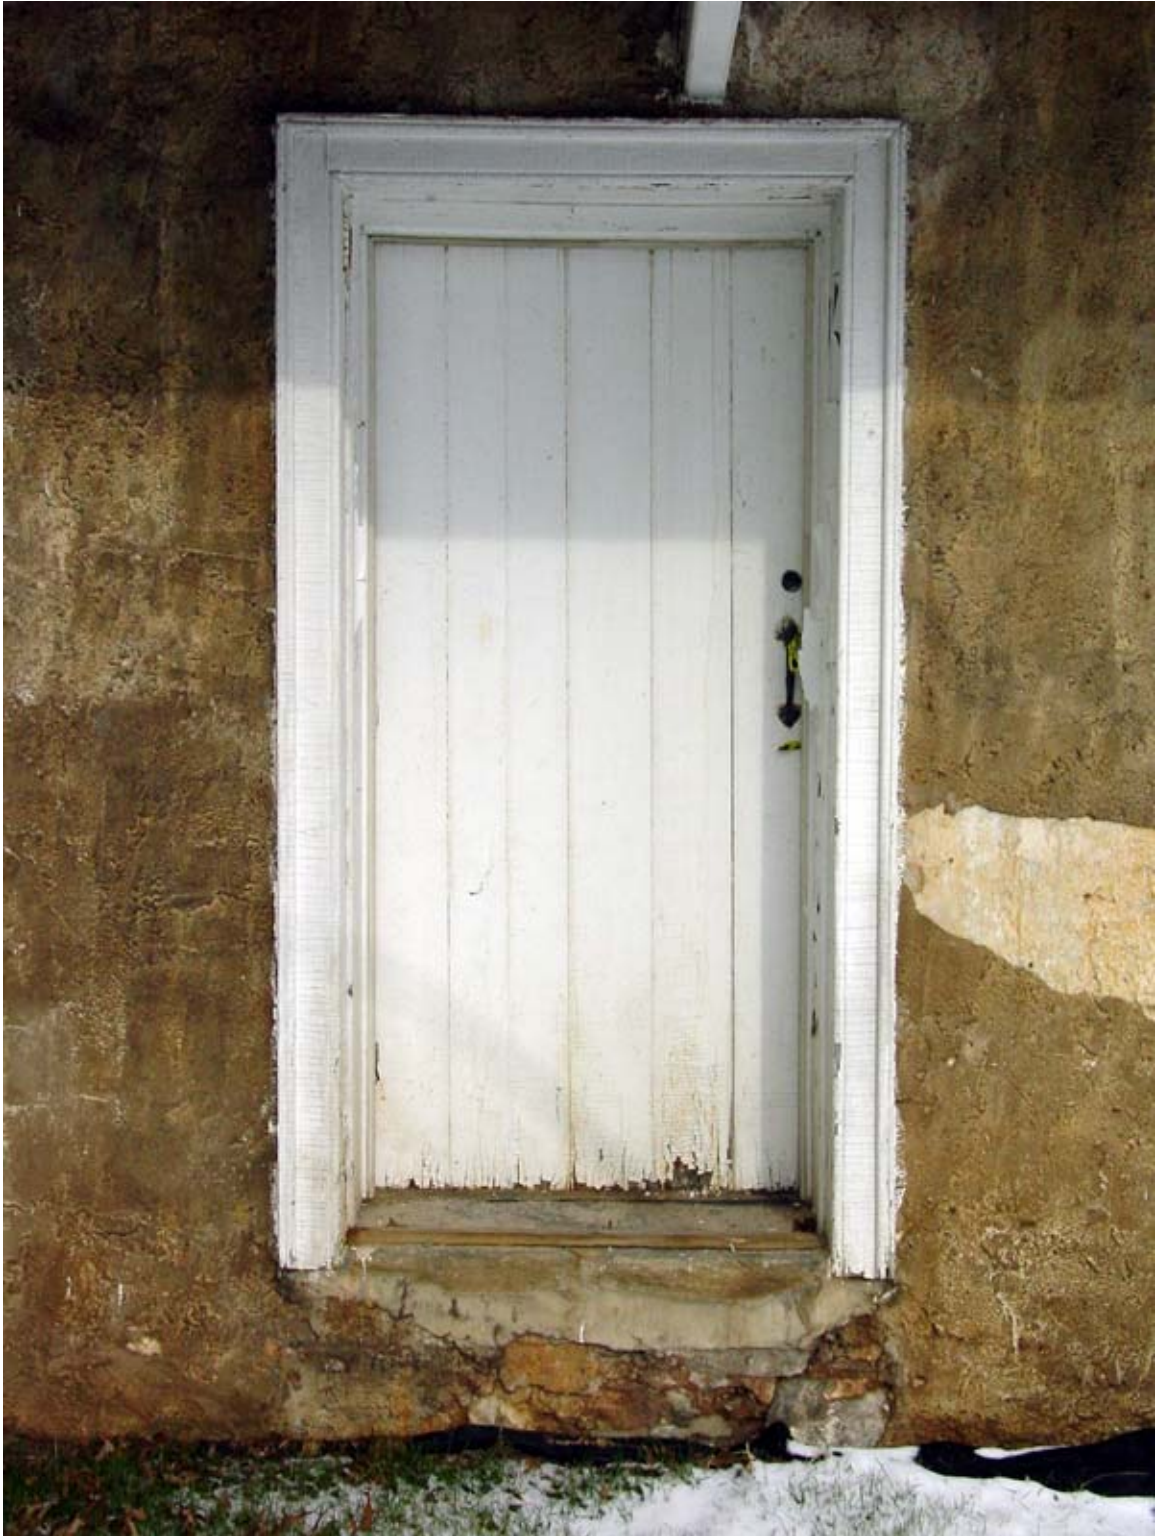
**Photo SEd** – Exterior view of door to east addition, looking north. Wood door and frame appear to be original, c. 1830.

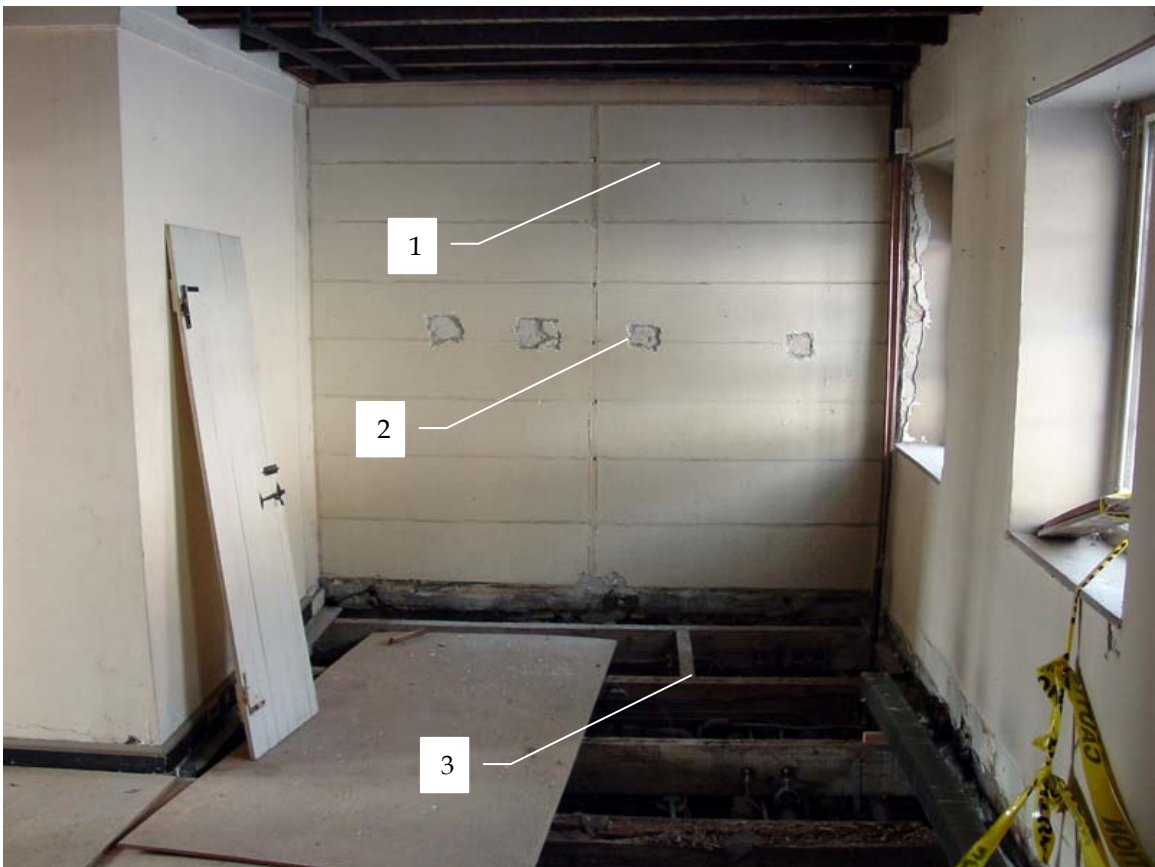
**Photo 102a** – View of west wall, Room 102.

1. Evidence in plaster finish of recent built-in shelving.
2. No evidence of former opening at west wall.
3. Wood flooring removed; wood joists severely rotted.

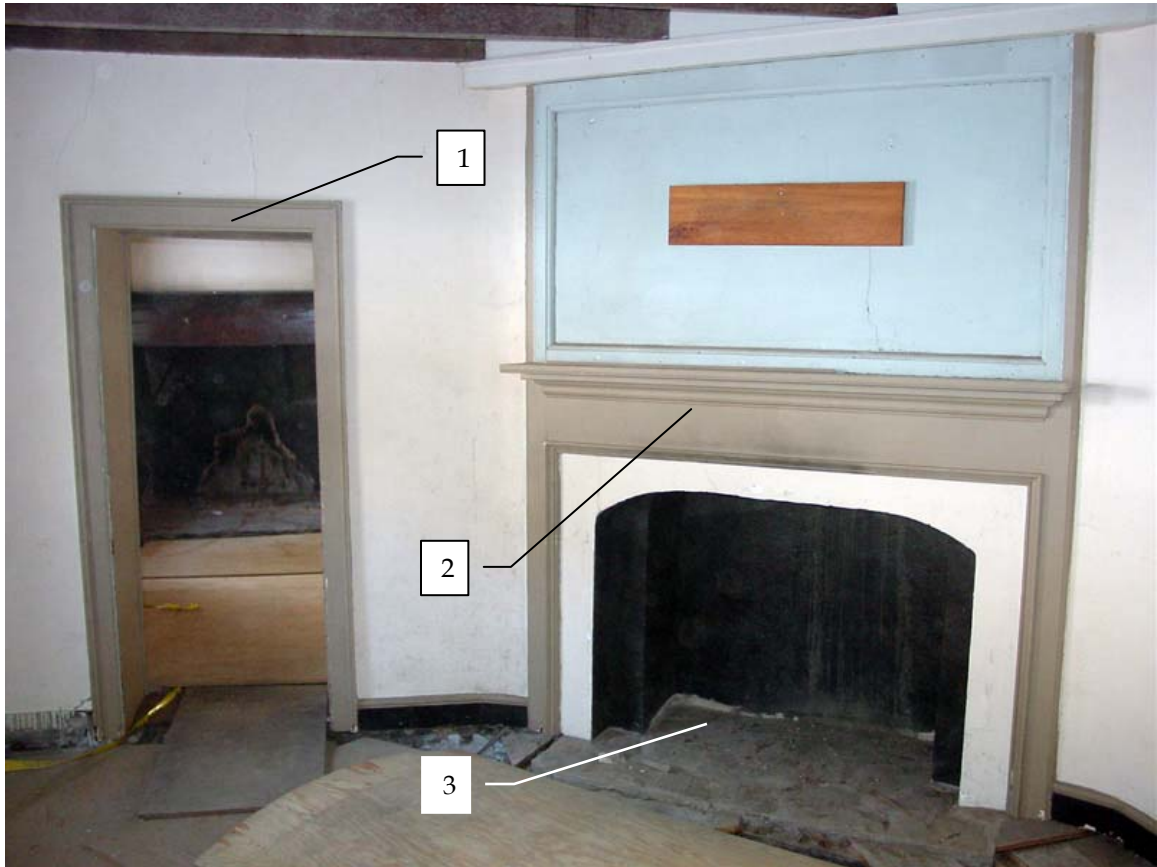
**Photo 102b** – View of east wall, Room 102.

- Corner fireplace is original. Basement foundation and framing confirm that it dates to 1769. (Photo 102b)
- Mantel is not original based on molding profiles and the wire nails used to secure the moldings. The original plaster runs behind the present mantel as well.

1. Doorway to east addition added c. 1830.
2. Replacement mantel.
3. Original c. 1769 fireplace.

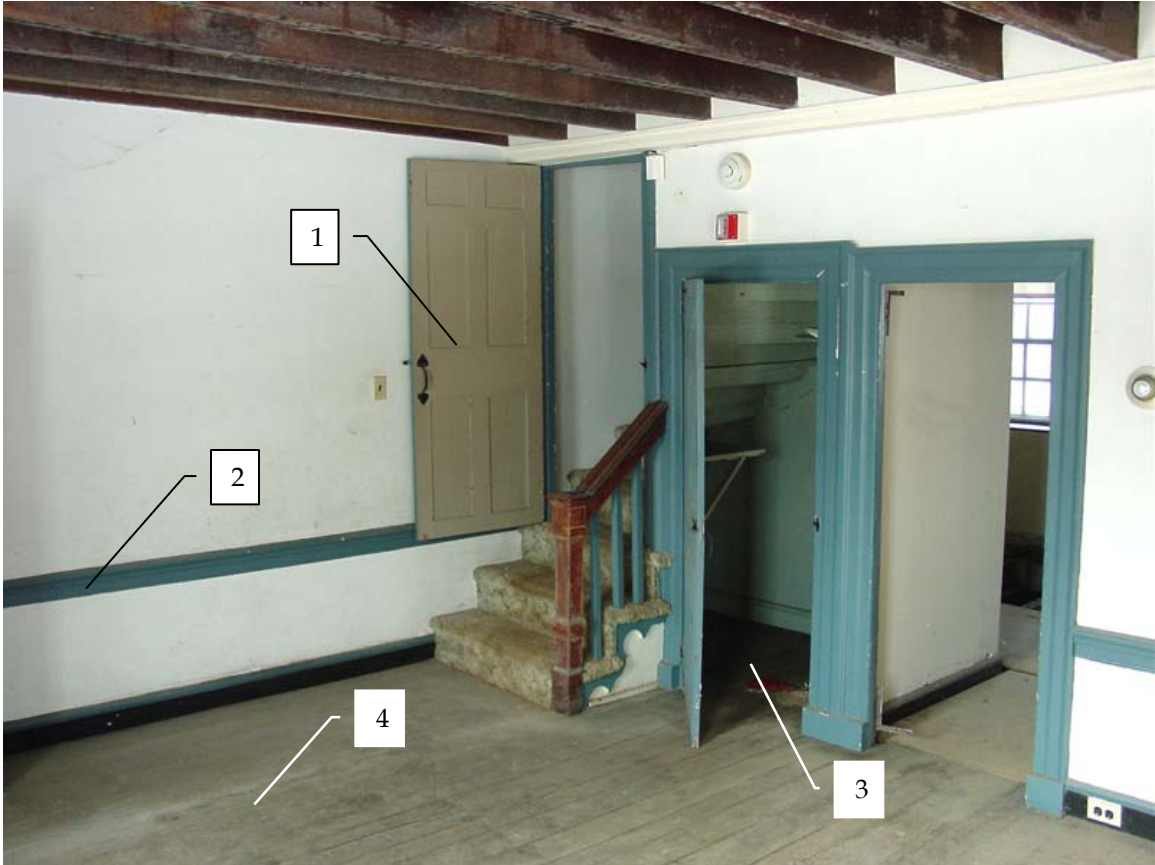
**Photo 103a** – Interior view of Room 103, looking northwest.

1. North wall doors appear to be original to c. 1769 main block.
2. Chair rails appear to be original to c. 1769 main block.
3. Winder stair to basement removed in 1926.
4. Replacement faux-pegged wood flooring.

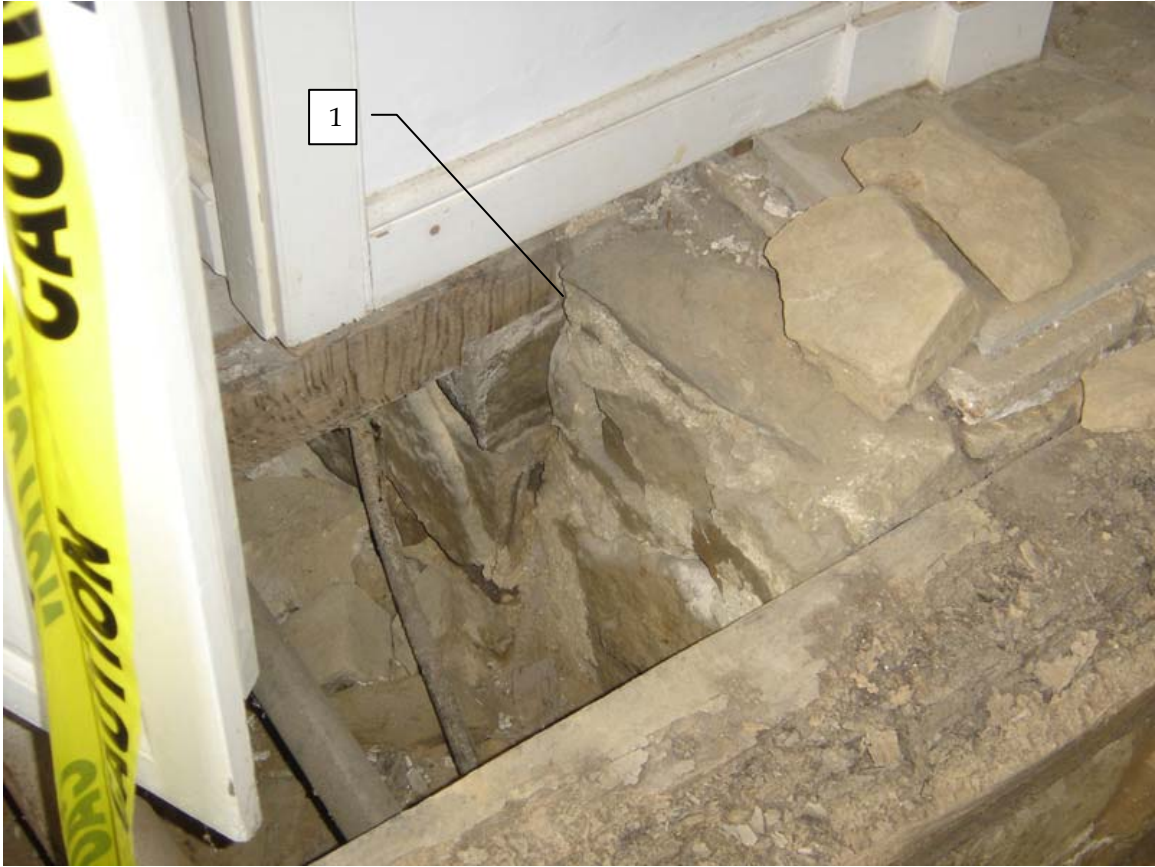
**Photo 104d** – Detail view of south end of hearth foundation, Room 104, looking northwest.

1. Joint between original hearth foundation and subsequent "build-out" to accommodate modifications to original cooking fireplace and the expanded hearth.

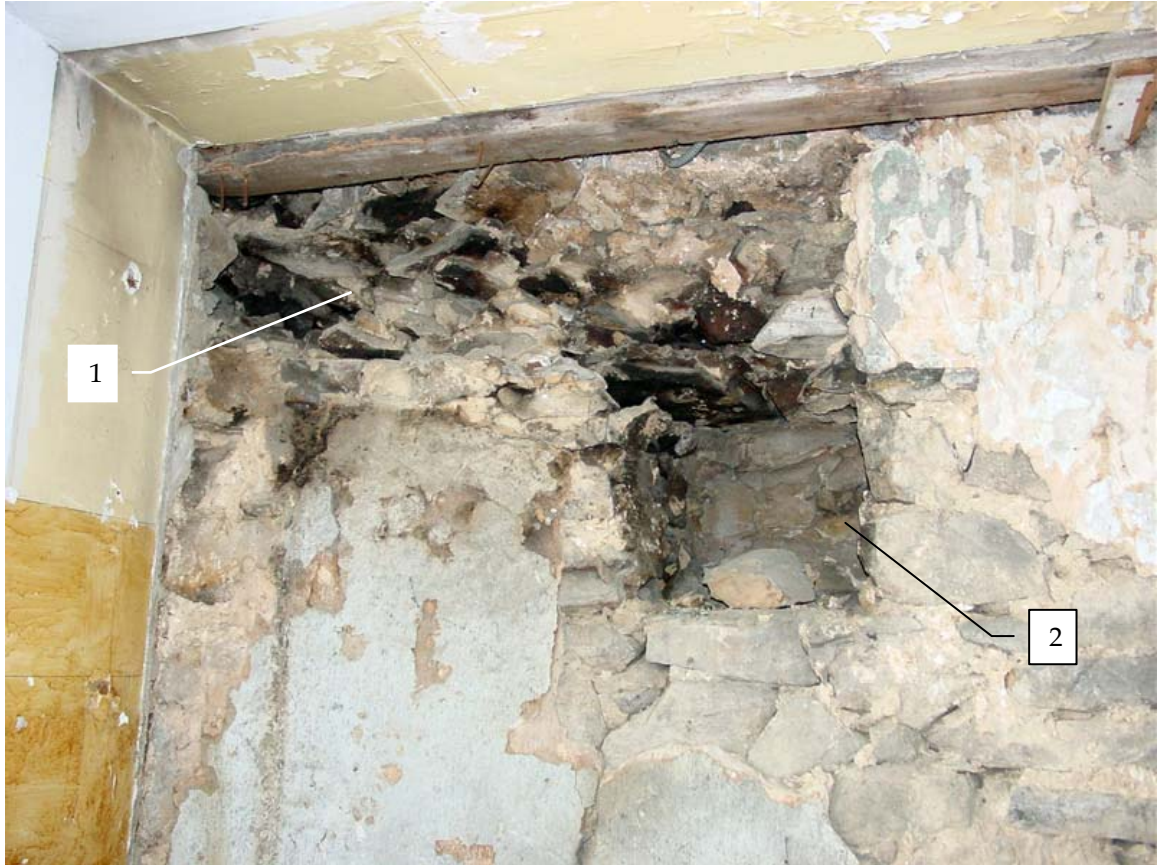
**Photo 106a** - Detail view of northwest corner of Room 106, looking north.

1. Charring at stone masonry thought to be from c. 1810 cooking fireplace.
2. Pocket in stone masonry where end of former fireplace lintel was located.

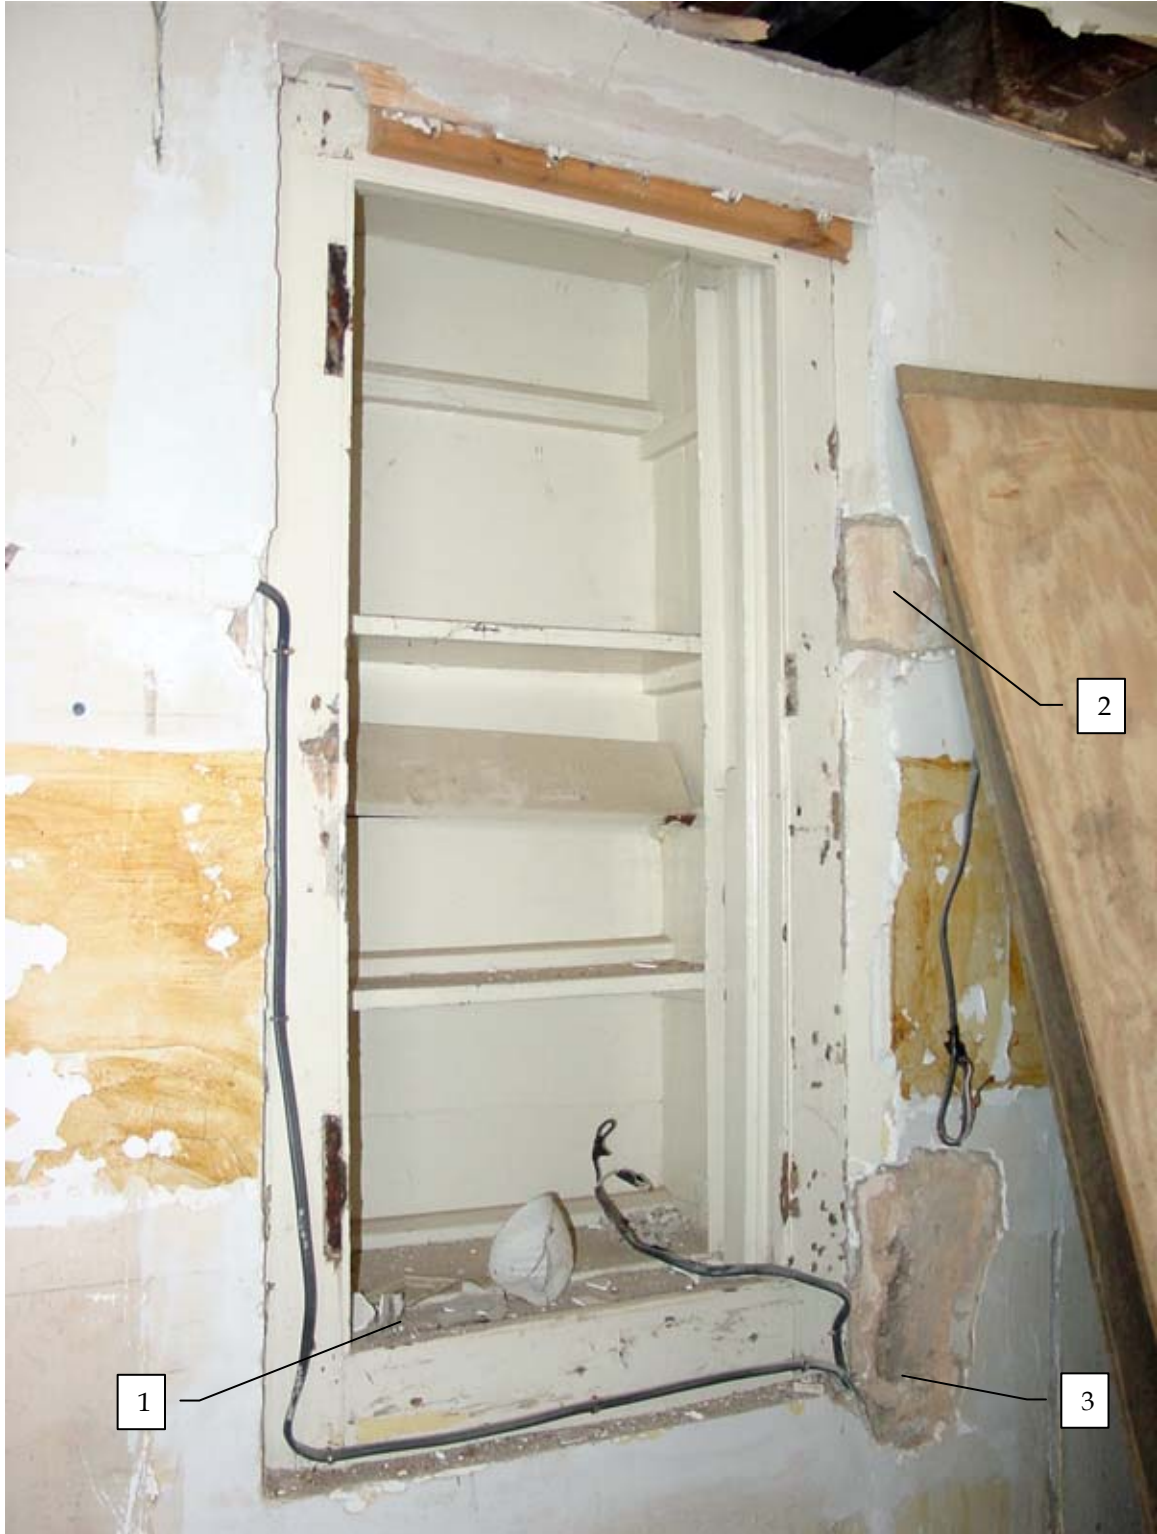
**Photo 106b** - Built-in cabinet set in original window frame at south wall of Room 106, looking southwest.

1. Weathered wood sill was originally exposed to the elements.
2. First-layer of plaster applied to stone masonry butts against wood trim.
3. Pointing mortar at masonry beneath plaster is typical of the type found at other locations on the main block and original c. 1769 kitchen block.

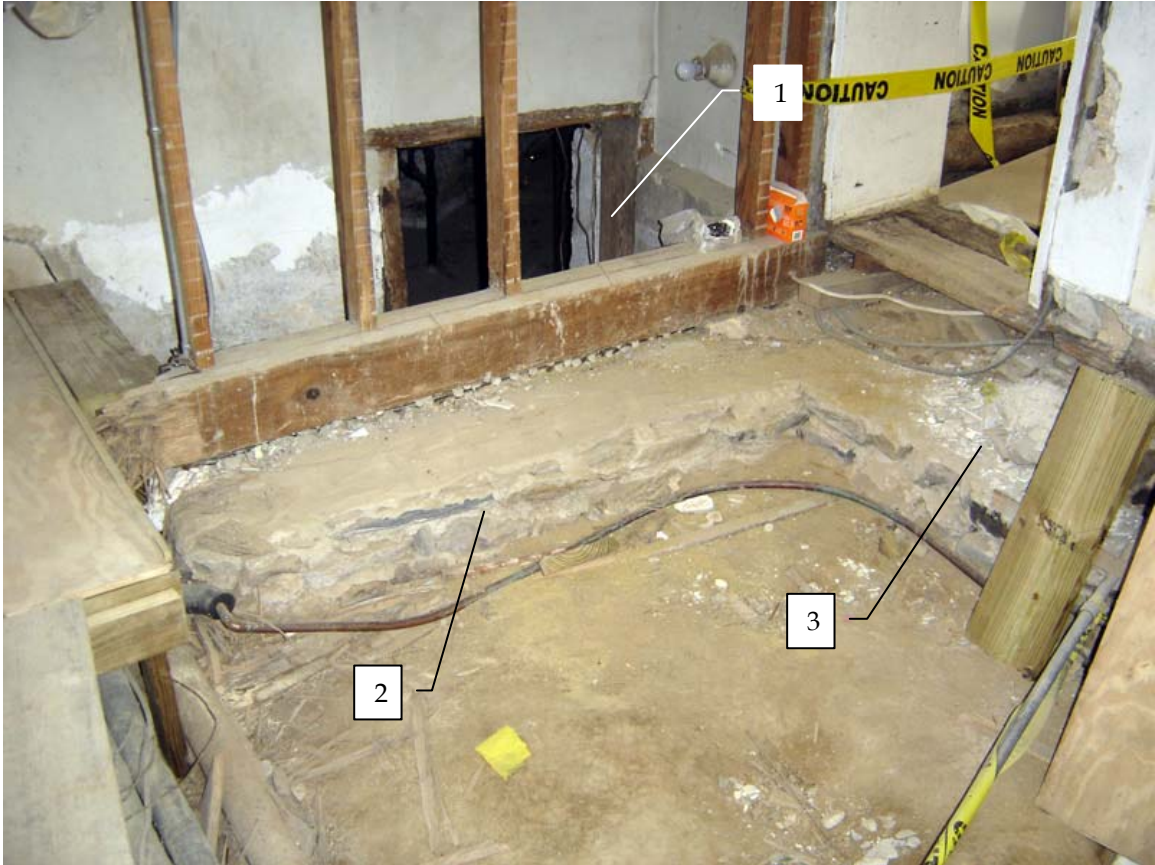
**Photo 106c** - General view of floor in Room 106, looking southeast.

- The east end of the room was heavily modified in 1926 by the addition of an interior basement stair. The wood stair has been removed due to deterioration, but the stone retaining wall forming the stair areaway is intact and in good condition. (Photo 106c, Note 9/106)

1. New stair (missing) to basement introduced c. 1926.
2. Stone retaining wall for areaway.
3. Stone shelf.

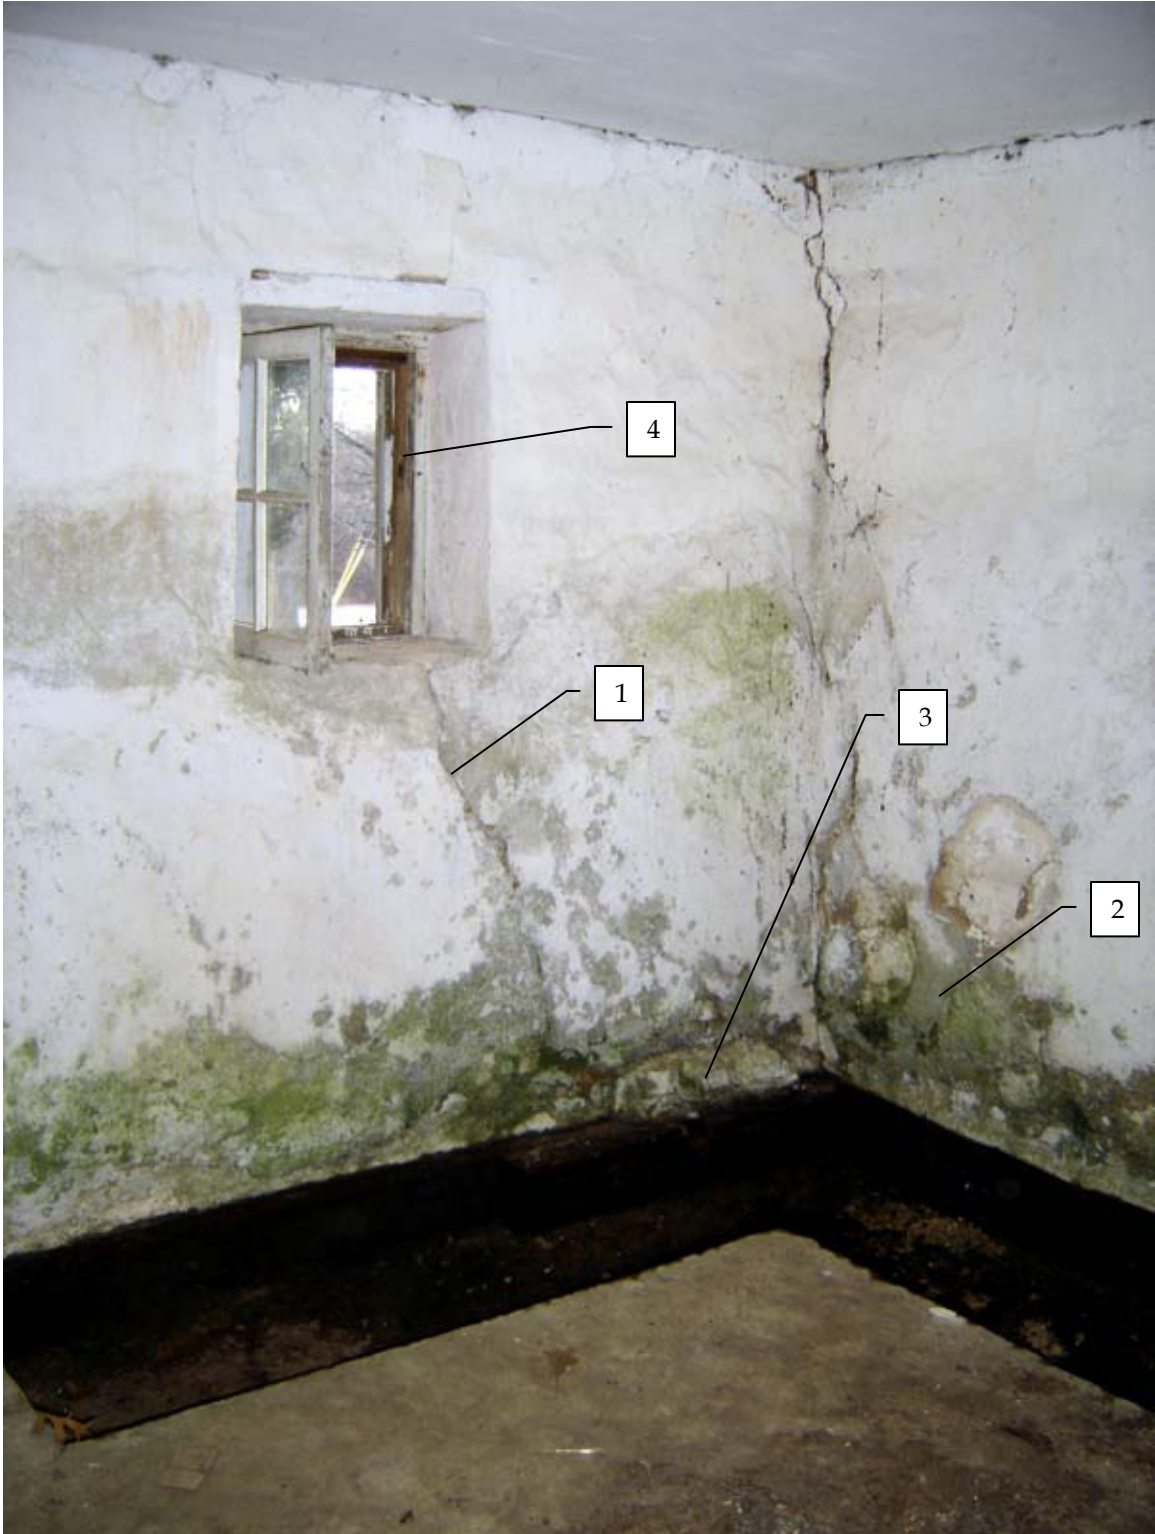
**Photo 109b** – Segment of springhouse interior, Room 109, looking southwest.

1. Masonry cracks.
2. Biological growth on interior wall surfaces.
3. Outlet pipe.
4. South window.

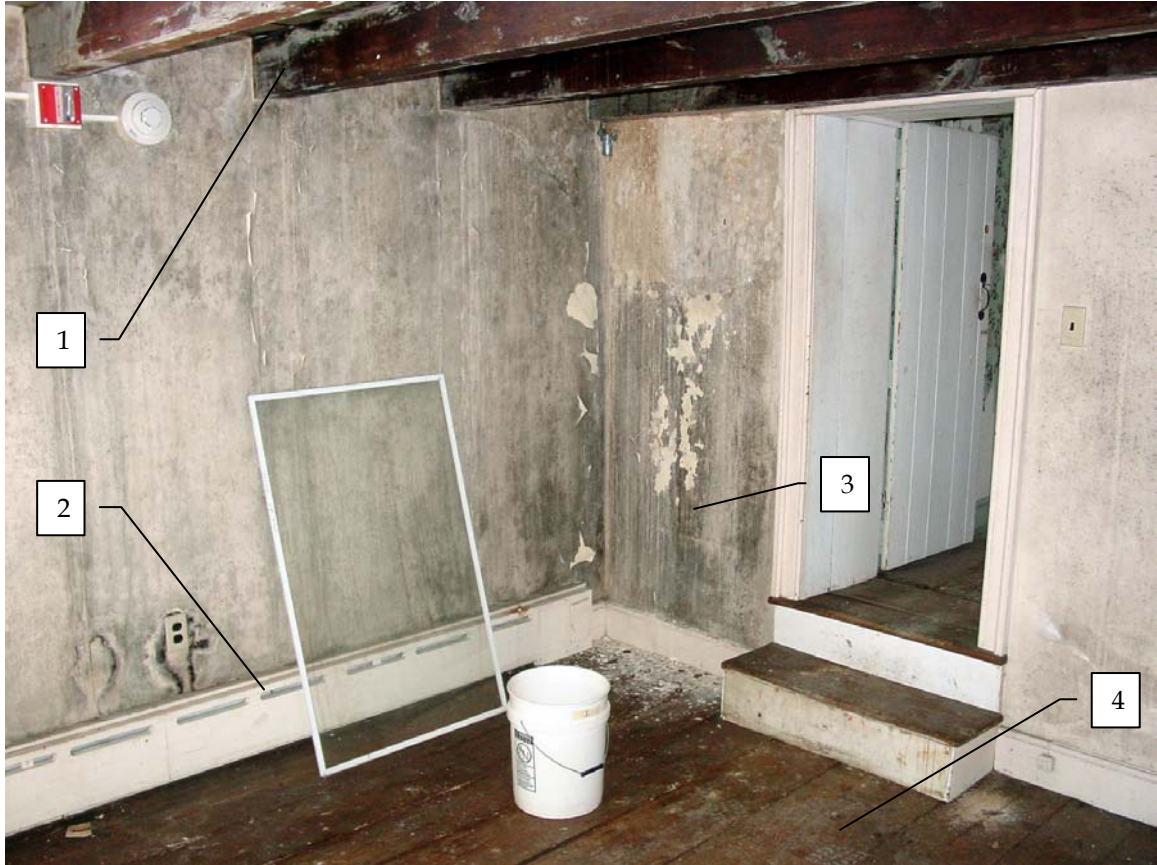
**Photo 201a** – Interior view of Room 201, looking southwest.

1. Wood ceiling joists are exposed, plain sawn with wood tongue-and-groove ceiling above. The varnished surfaces of the wood joists exhibit significant mold growth in scattered locations.
2. Original c. 1830 wood baseboard replaced with radiant baseboard heater at south wall.
3. Plaster walls exhibit significant mold growth and damage from moisture infiltration.
4. Original c. 1830 random width wood floorboards.

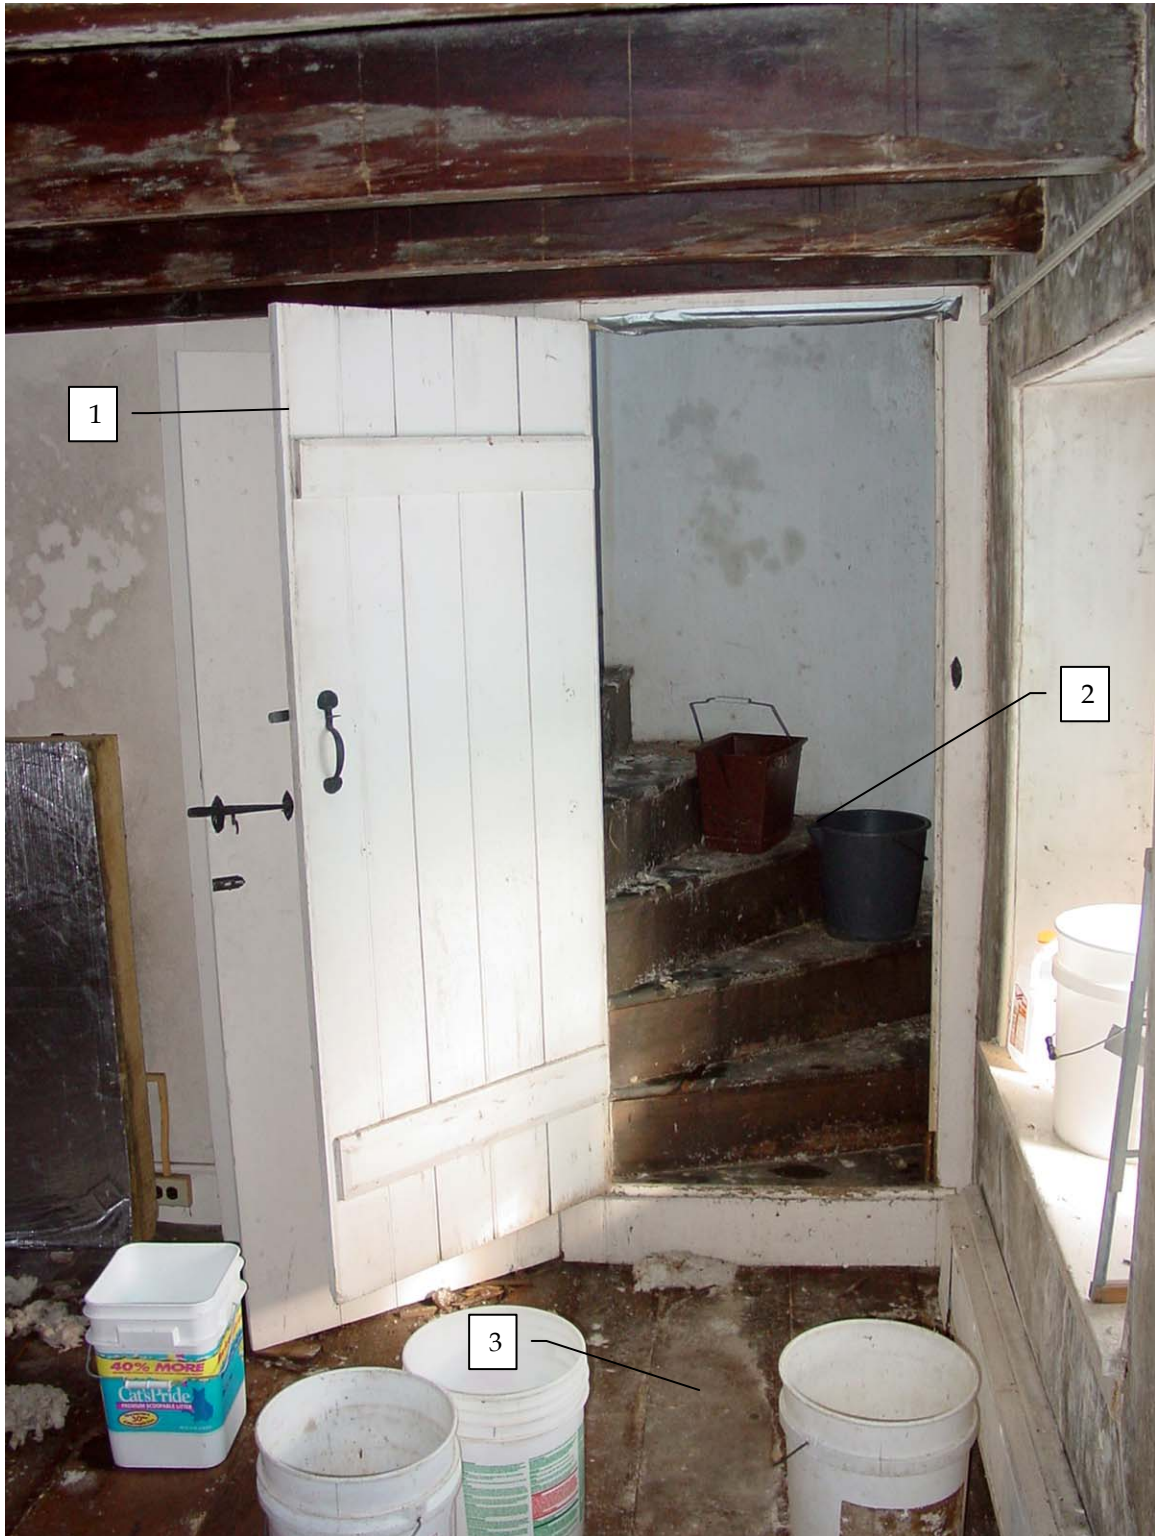
**Photo 201b** – Winder stair (c. 1830) at southeast corner of Room 201, looking east.

1. Beaded wood doors appear to be original.
2. Treads and risers are set into plaster finish.
3. Moisture infiltration is significant as evidenced by damaged plaster, saturated and cupped wood flooring, and extensive mold growth.

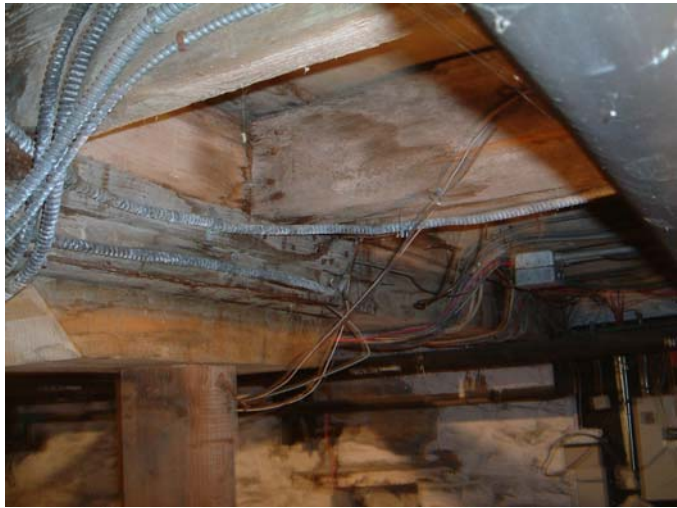
For the longer span, a more recent 8x8 timber beam (east-west) underframes the floor joists; halving the spans and thereby stiffening the floor. The primary central beam is supported by the foundation for the corner fireplaces and chimney mass (east), a central 6x6 post, and the exterior west wall of the block. The first floor farming is in poor condition with approximately half the joists partially consumed by termite infestation. Both of the diagonally running hearth headers are in poor condition. The central summer beam is severely checked exhibiting cracks parallel to the grain. The central post is set into the concrete floor where damp is a concern with regard to serviceability. In addition, the timber lintel at the passage to the east addition is rotten and requires replacement.

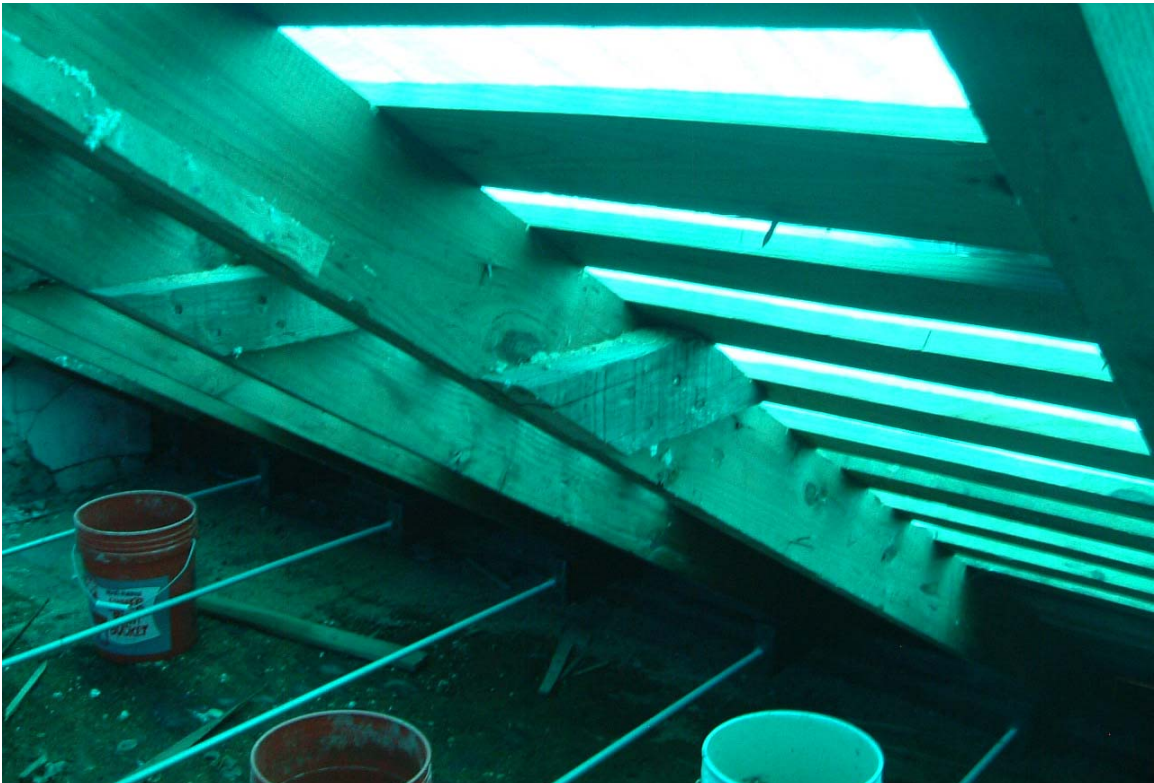
The roof of the west block has been reframed with 2x6 rafters placed at 24" centers, tied at the bottom by a  $\frac{3}{4}$ " diameter threaded rod, and coupled to the base of the rafter with a bolted steel plate connector. The allowable uniformly distributed live (snow) load capacity of the roof structure is 4 PSF. This matches the allowable loading of the original block which is considered inadequate, meeting only  $\frac{1}{3}$  of the minimum recommended by the building code. The threaded rod tie and connector assembly is sufficiently strong enough to address the thrusting at the base of the rafter under code recommended snow loading.

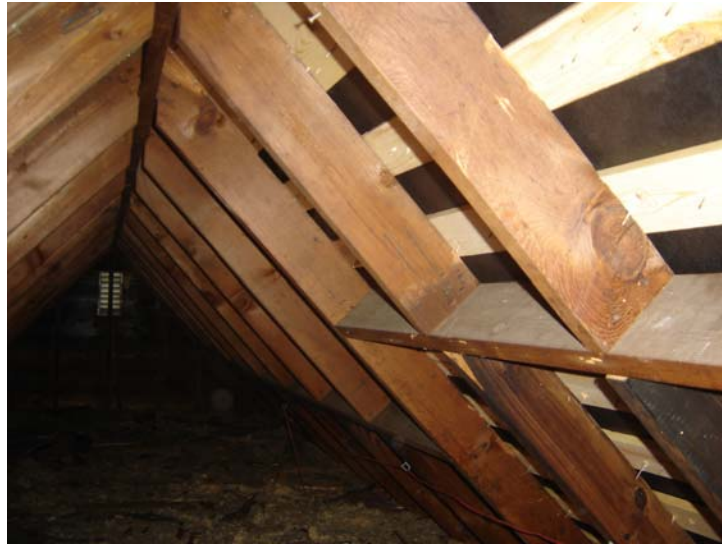
intact, which simplified the repair. Unfortunately, the method of splicing the rafters was poorly conceived. The damaged rafters were square cut and the ridge section of the roof removed. Then a 2x6 wood plate purlin was end nailed to the cut rafters. This provided a means for toenailing the replacement rafters that form the ridge of the roof. The connection has no bending strength and as a result has separated due to the tension at the bottom of the splice, causing noticeable sag in the member.
