VICKSBURG NATIONAL MILITARY PARK

PEMBERTON'S HEADQUARTERS

(WILLIS-COWAN HOUSE)

HISTORIC STRUCTURE REPORT

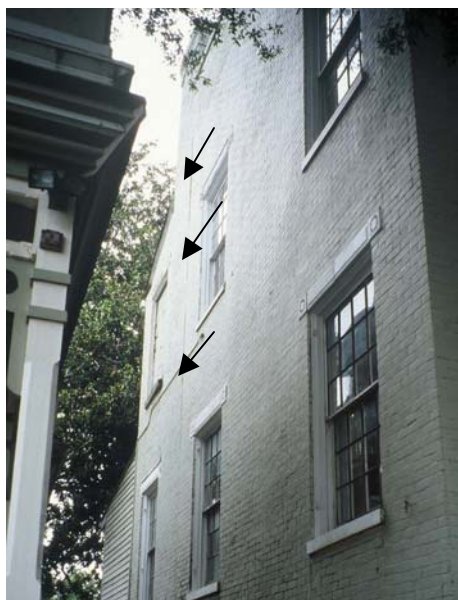
Figure C – 1 Stack joint on east elevation

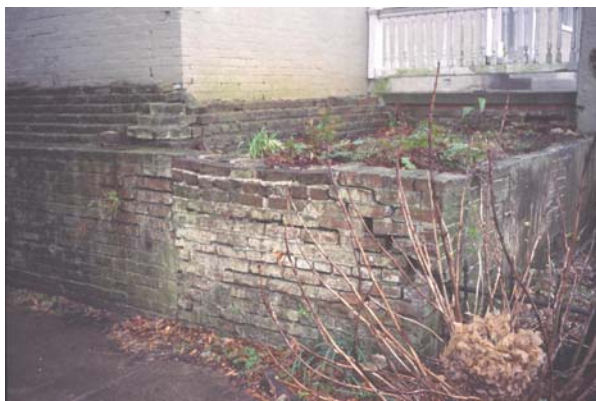
lintels. The cracks appear to be active. The outward thrust of the east wall is the result of the cutting back of the grade along the east elevation. This was done to construct the corner house in the later nineteenth century. A low brick wall that separates these two property lots acts as a retaining wall of the higher grade of the Willis-Cowan House property, but it clearly is inadequate as evidenced by the numerous extensions, repairs and current poor condition.

Figure C - 2 Retaining wall

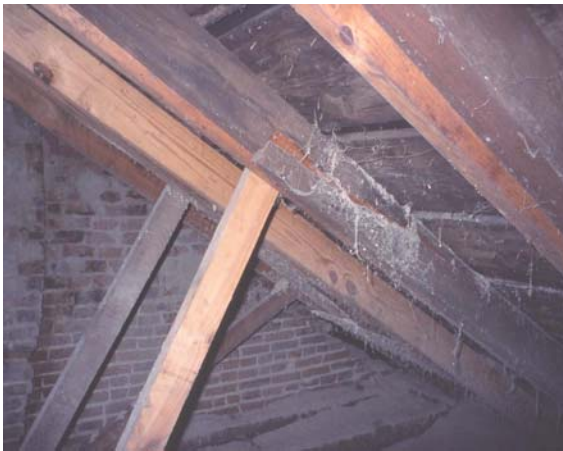
judging from the amount of discoloration and dirt at the split, open wood. It is damage caused by a distributed load applied from above, probably the collapse of the adjoining, southwest chimney. Additional framing dating to the twentieth century now sister and provide post support to the damaged rafters.

Figure C – 3 Split rafters

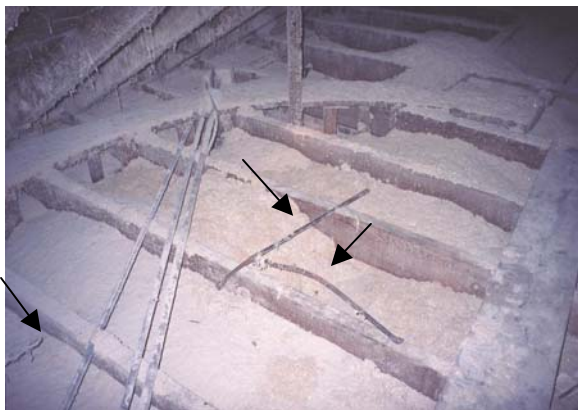
Figure C – 48 Early gas lines in the attic

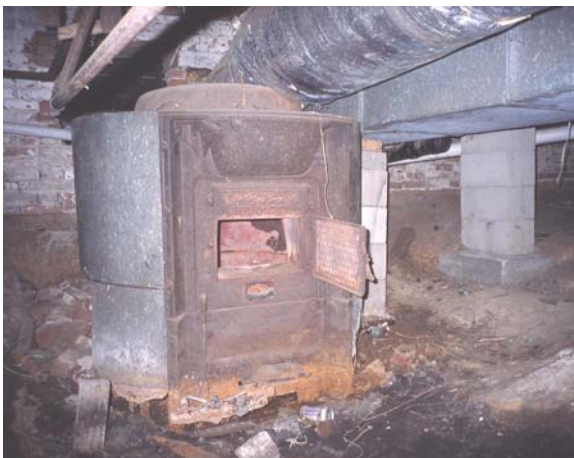
Figure C – 51 Abandoned furnace

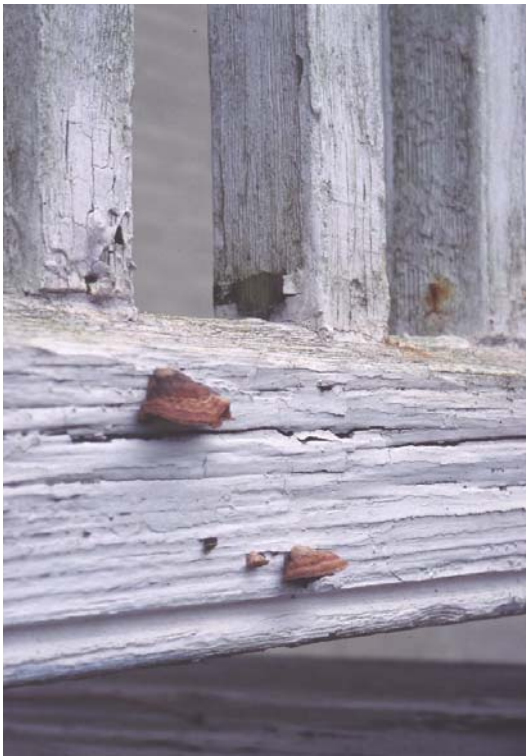
Figure C – 52 Fungus growing on the west porch balustrade

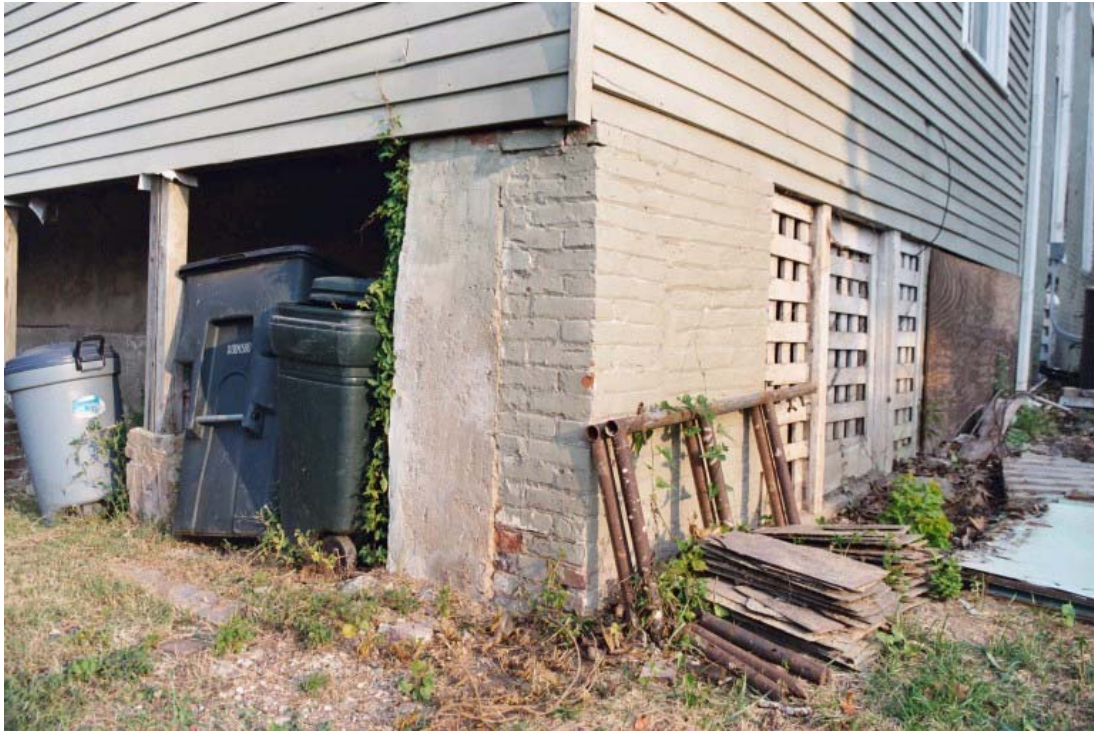
Figure 1 South ell showing added supports for cantilevered floor

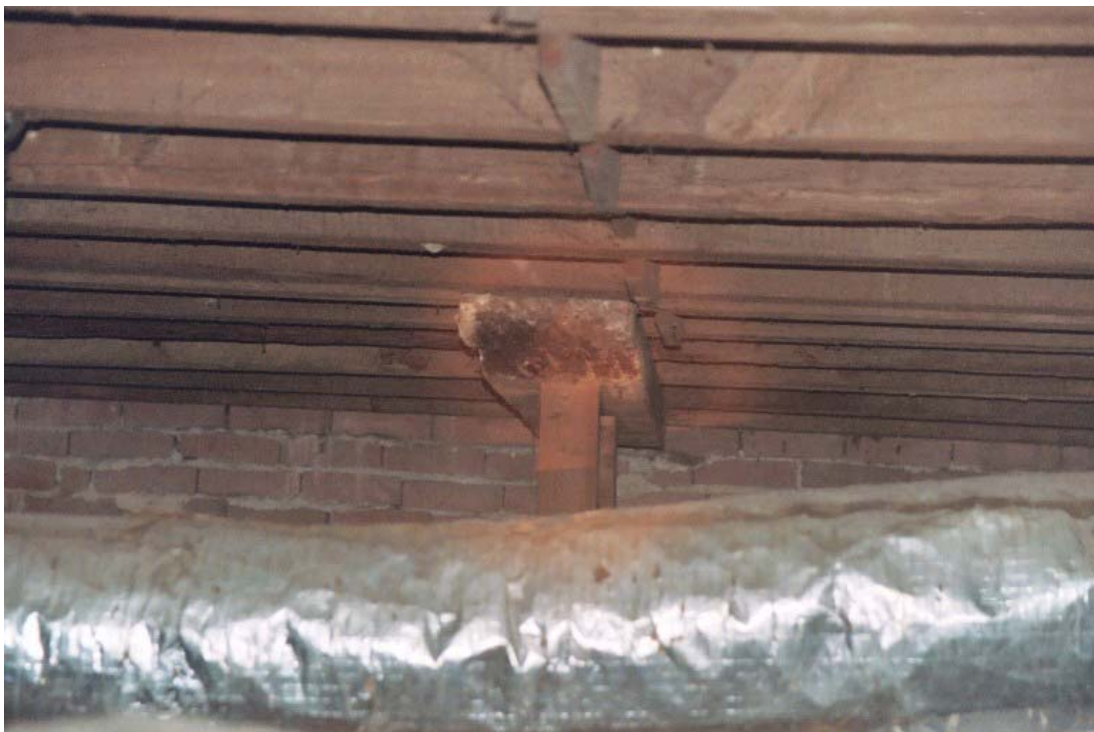
Figure 2 Added supports under northeast room (Room 101)
