PRELIMINARY REPORT ON THE ARCHITECTURE OF  
PAR FORCE GREAT HOUSE, REEF BAY,  
VIRGIN ISLANDS NATIONAL PARK  
AS REVEALED BY ARCHEOLOGICAL TESTING

Roy W. Reaves, III

Southeast Archeological Center  
National Park Service  
Tallahassee, Florida  
1988

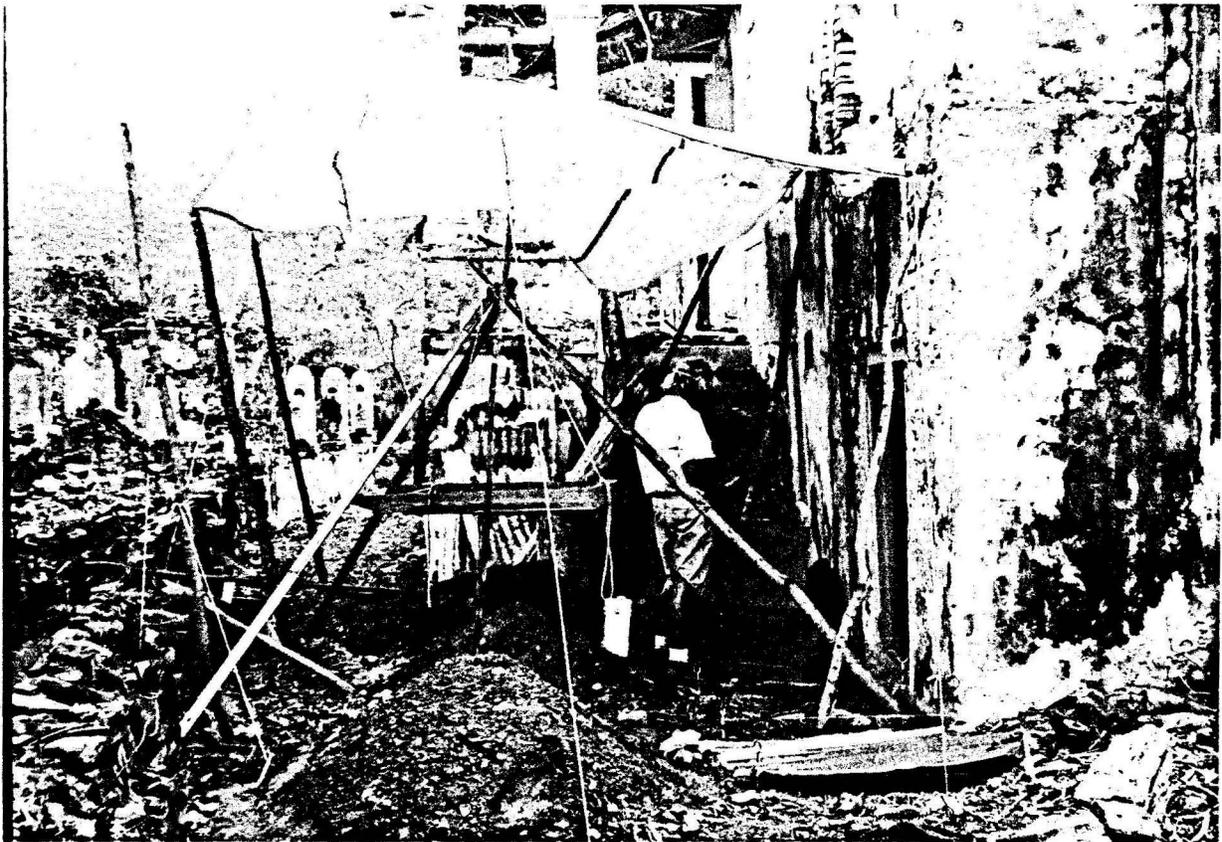
FIGURE 1. Par Force Great House from survey station 1 showing excavation area along west wall.

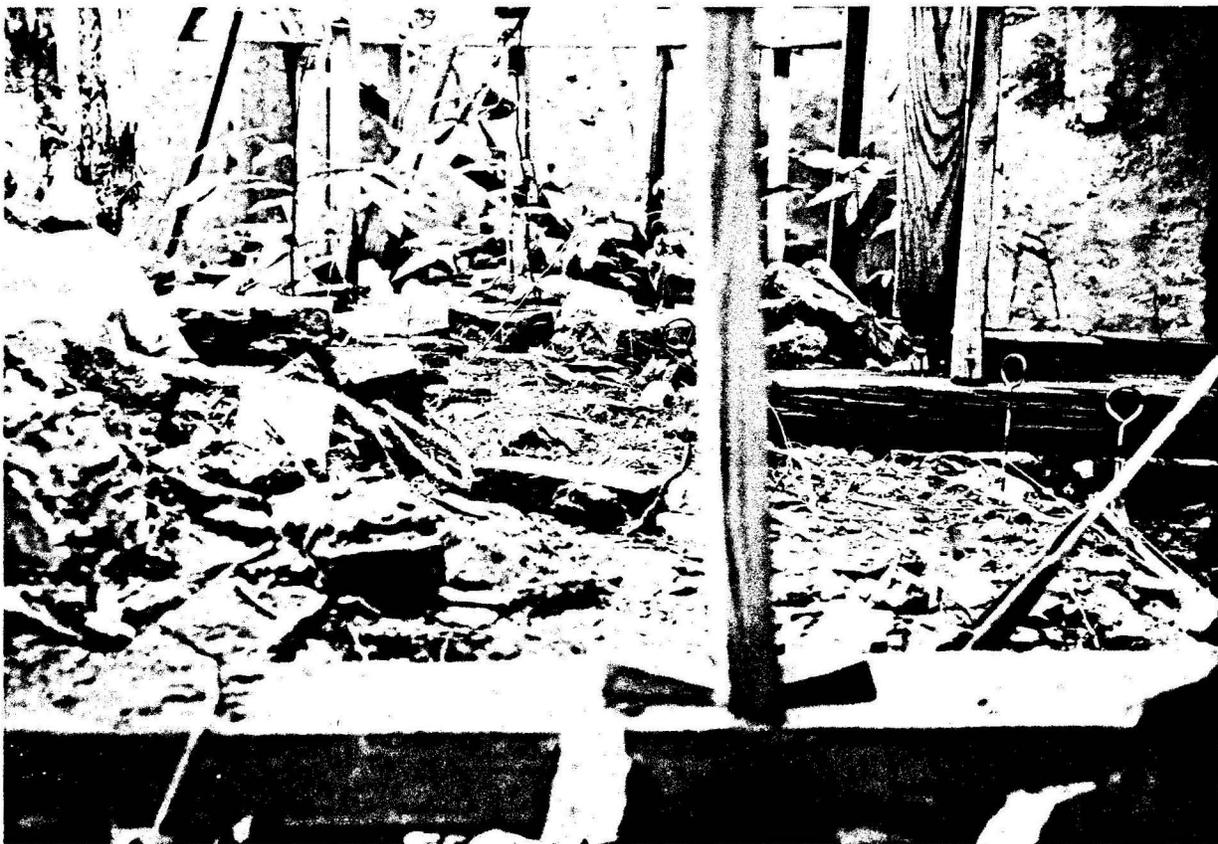
There is a great deal of debris in the basement of the Great House which is made up of roof collapse, floor deposits, other structural elements, hardware, and other materials. All of these constitute archeological deposits of potential value. None should be removed without archeological clearance and appropriate recording and controls.

FIGURE 2. Par Force Great House interior basement room showing collapsed roof material and other debris that make up the archeological deposit.

kitchen may give other activities and points of view. Much of the accumulated debris in the Great House is collapsed roof which was made of a double layer of brick over a wooden support structure. Material that may have been on the roof as a distinct activity area, the methodology and techniques of construction, and the fact that these deposits overlie and seal material that was in the house and basement make this debris an important archeological deposit that should be removed with archeological controls and records in order to preserve as much as possible of the information about these activity areas (Figure 2).

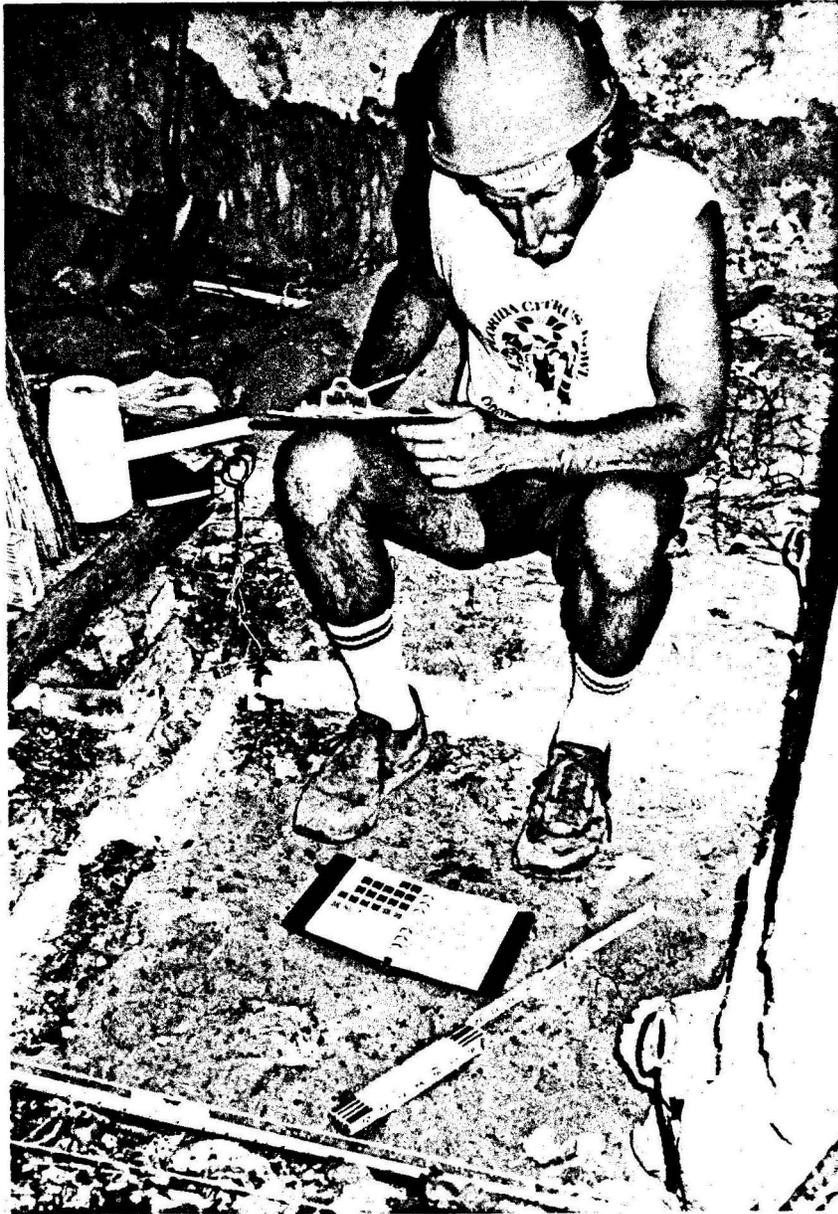
outer wall. It indicated that the bedrock was only a few inches below the present surface. The interior wall is founded on bedrock. Unit 4N4E is along an east-west running wall that intersects with the wall described 2N3E. This unit would be on the east side of that wall if it were the outer or west wall of the eighteenth century building. Support for this hypothesis is the presence of a ca. 6 cm thick floor of very white lime (Figure 4). This floor is overlain with a great deal of charcoal which may be an indication that there was a fire in the building at some point. Since it did not occur in the excavation unit in the room on the other side of the wall, the floor is interpreted as being inside of the eighteenth century building.

FIGURE 4. Par Force Great House interior room east of the wall interpreted as being the west wall of the 18th Century structure. Note the ca. 6 cm thick lime floor.

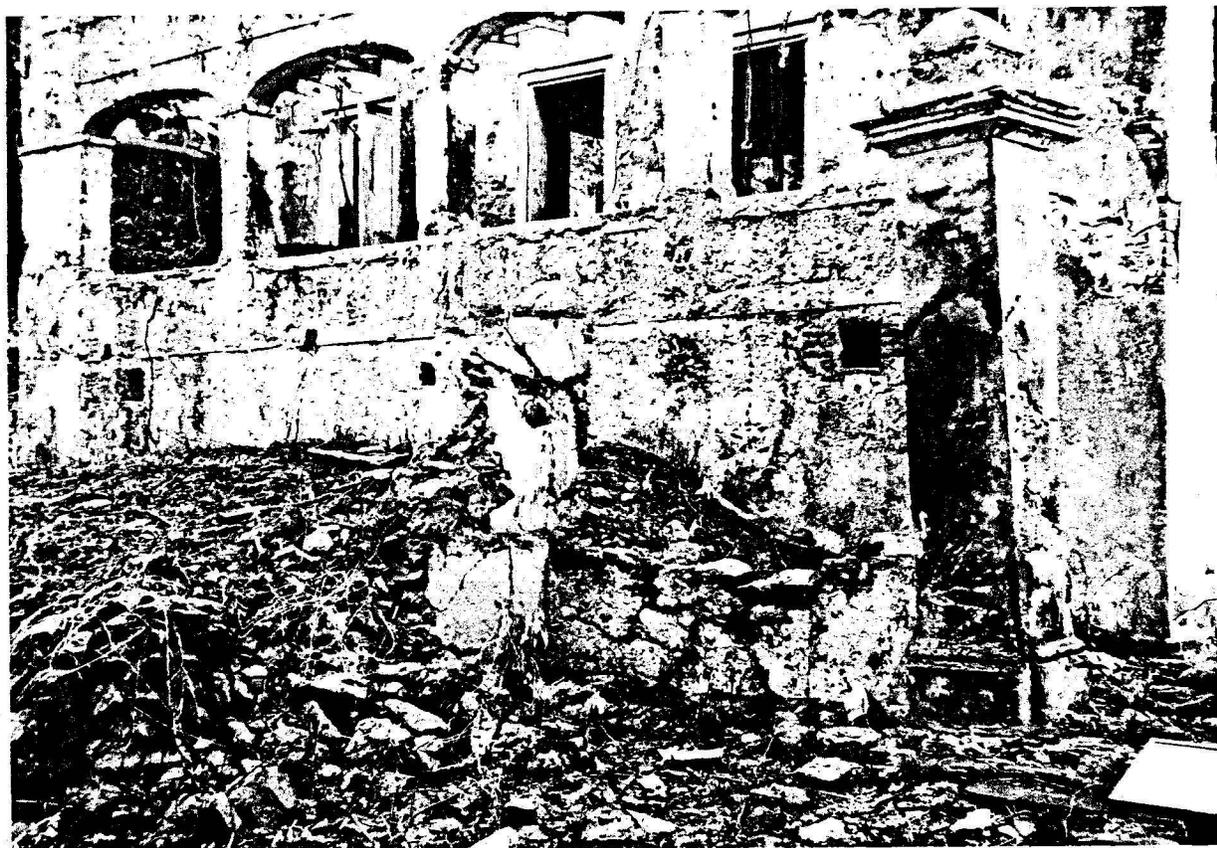
On the north end of the building is an area identified on the site plan for Reef Bay as a cistern enclosed by a dry wall. While no excavations were performed in the area, we believe that this area is misidentified. There is no evidence for a cistern here. The cistern is under the porch to the south of this feature.

There is evidence of a stairway leading up from the west side and there is evidence for a semicircular finished wall as evidenced in the southwest exposure of this feature (Figure 5). It would appear to be some sort of

FIGURE 5. Par Force Great House showing the southwest corner of a feature on the north wall previously identified as a cistern, but believed to be a portico or patio. Note the finished curved wall near the center of the picture.

portico or patio attached to the north end of the building. It should be excavated to determine its function, shape, finish, etc., before attempts are made to reconstruct or stabilize it.
