HISTORIC STRUCTURE REPORT

FINAL REPORT

WASHINGTON MONUMENT AND
ASSOCIATED STRUCTURES

VOLUME III - SURVEY LODGE

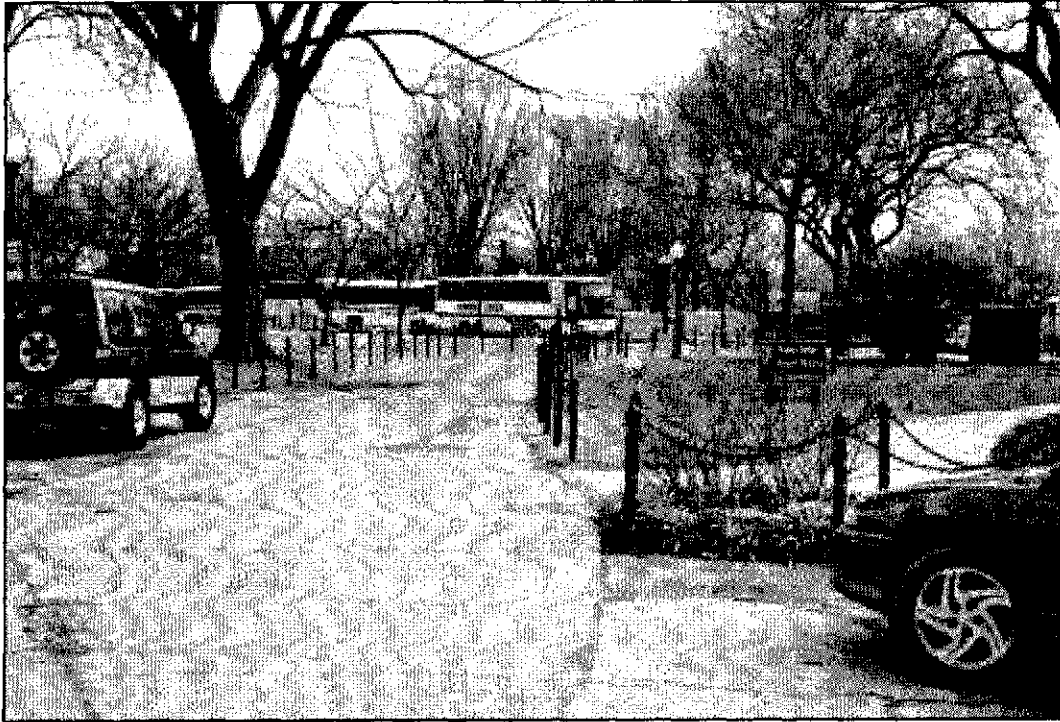
Figure 5.1: Asphalt service drive north of lodge, view to the southeast with serious cracking and previous patches evident.

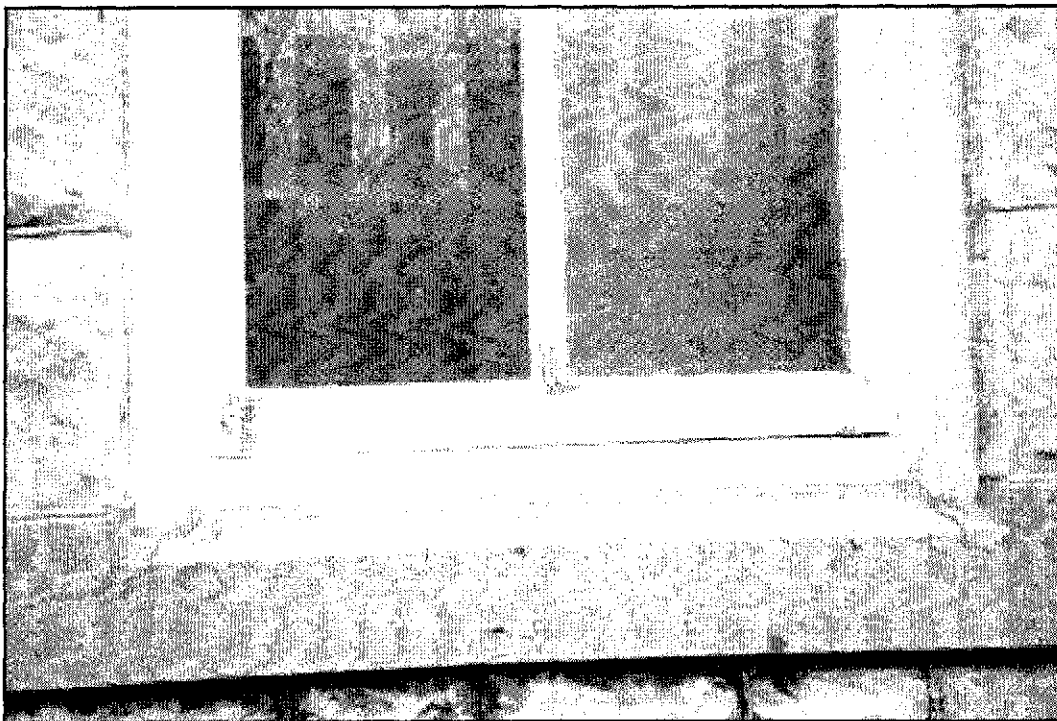
Figure 5.2: Lower sash of double-hung wood window with granite sill, northwest elevation. Note paint deterioration and loose pegs in the window, and drips of paint on the granite sill.

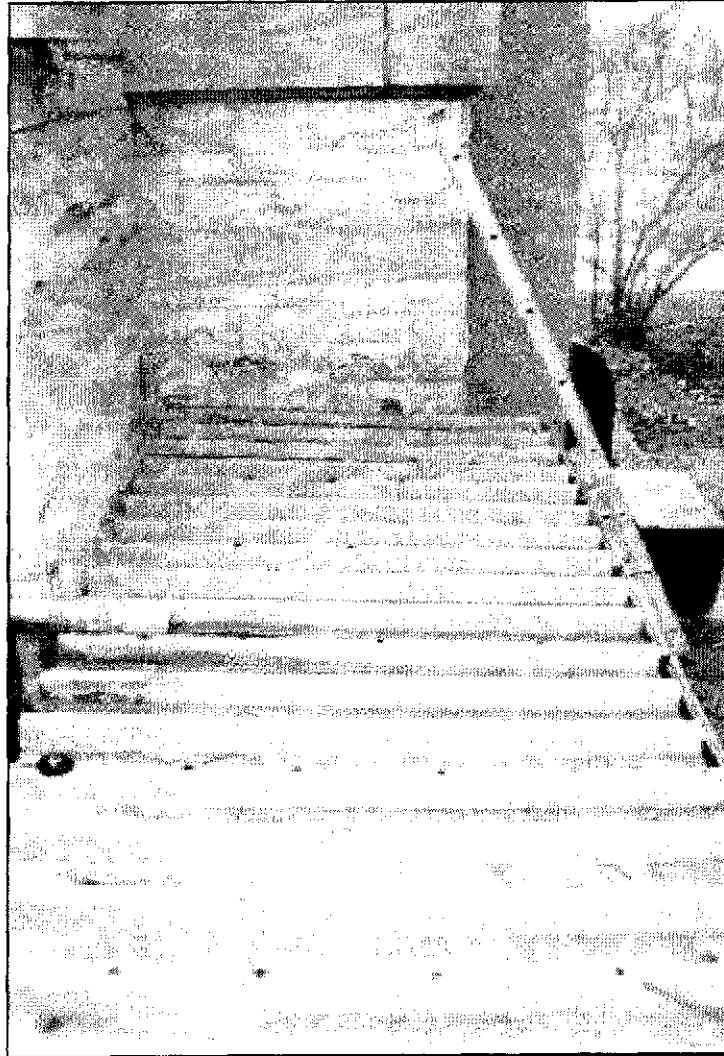
Figure 5.3: Southwest elevation and attached chimney, view to the southeast. Splashing rain is encouraging biological growth above the areaway roof, and ferrous fasteners on the roof deck are beginning to rust.

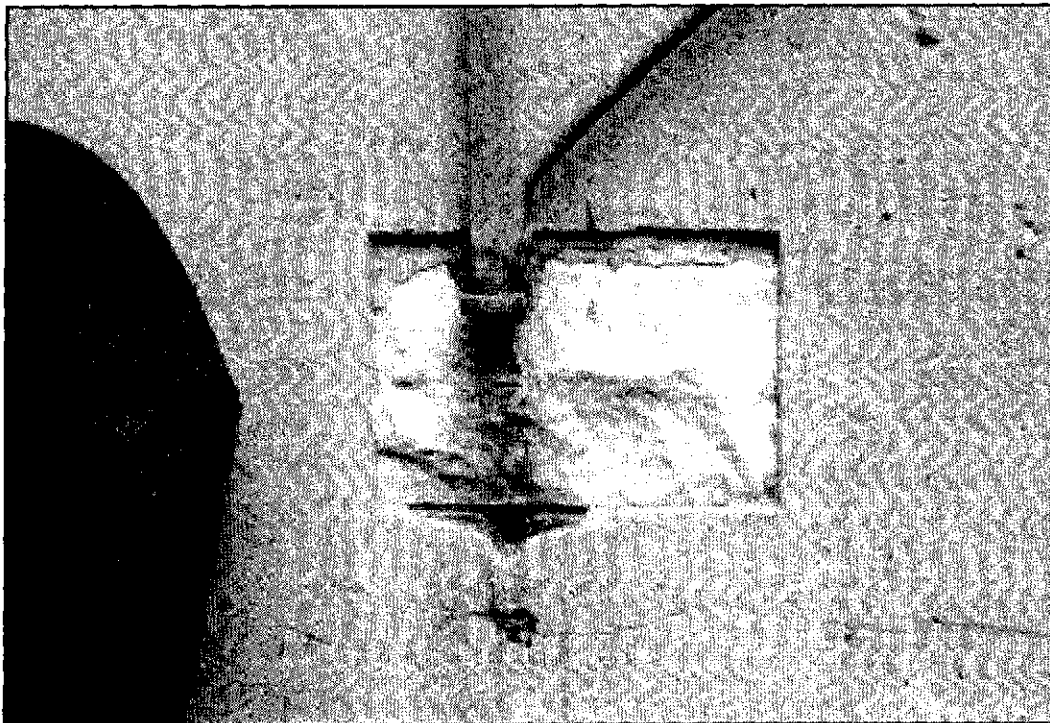
Figure 5.4: Detail of southwest elevation with ferrous staining under attached pivoting metal arm. The stucco has spalled, revealing the red brick back-up of the 1901 addition, and two penetrations are visible.

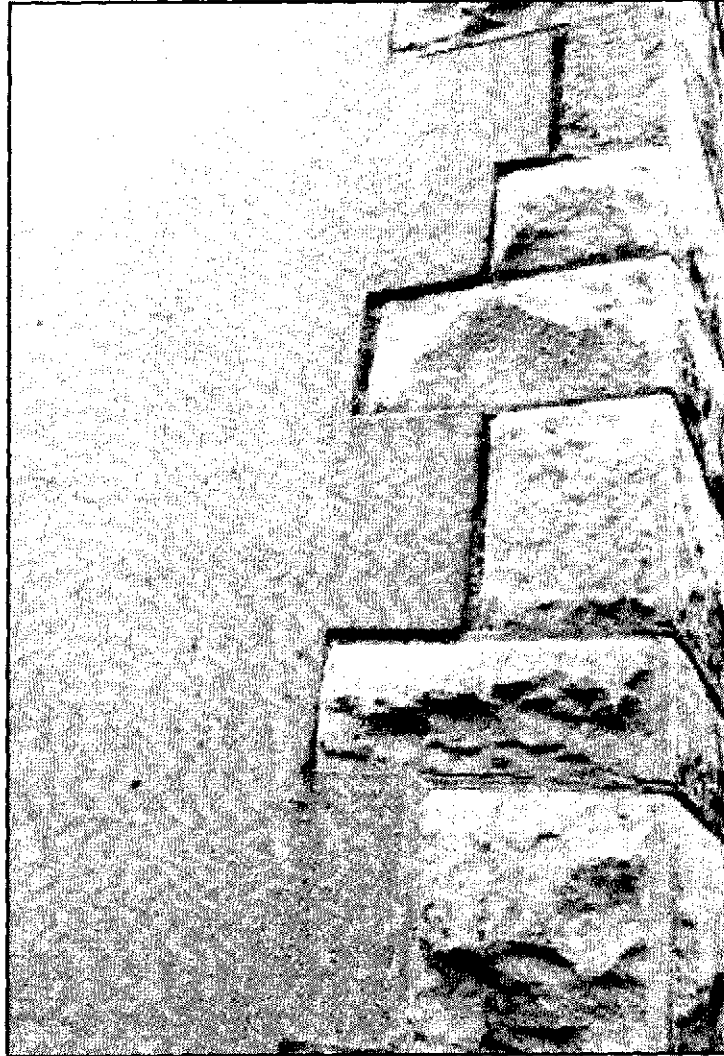
Figure 5.5: Detail of southwest elevation at south corner with open and improperly tooled mortar joints. The red brick back-up of the 1901 addition is visible at the edge of the stucco in some locations.

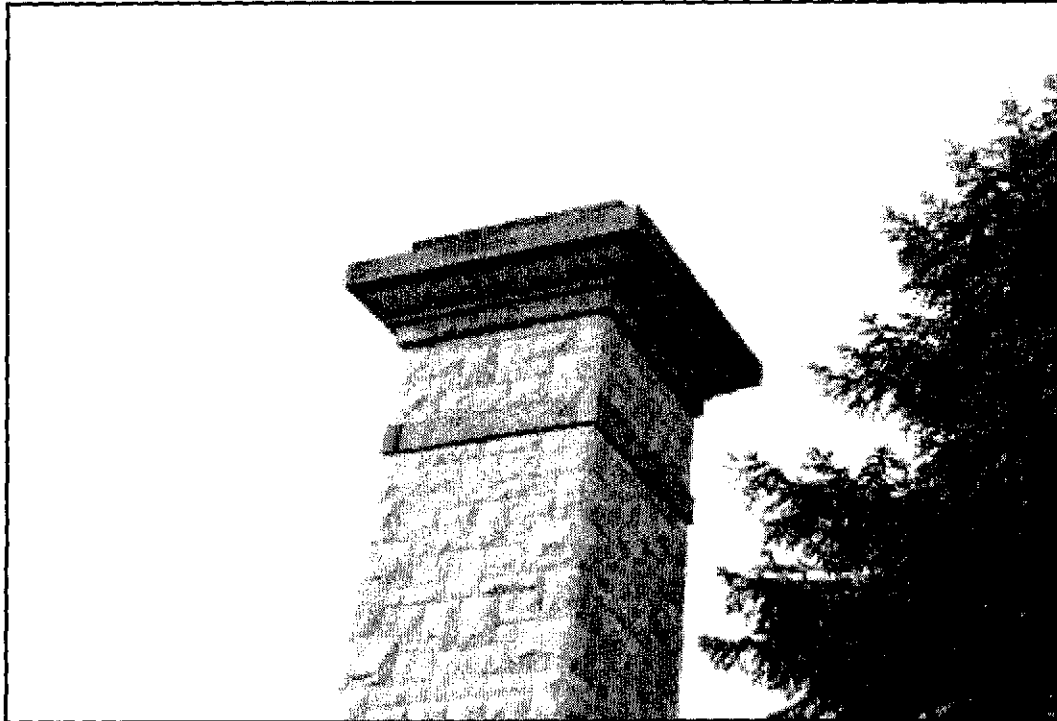
Figure 5.6: Attached chimney, view to the south. The granite belt course has spalled, and the metal chimney cap has stained the granite cornice.

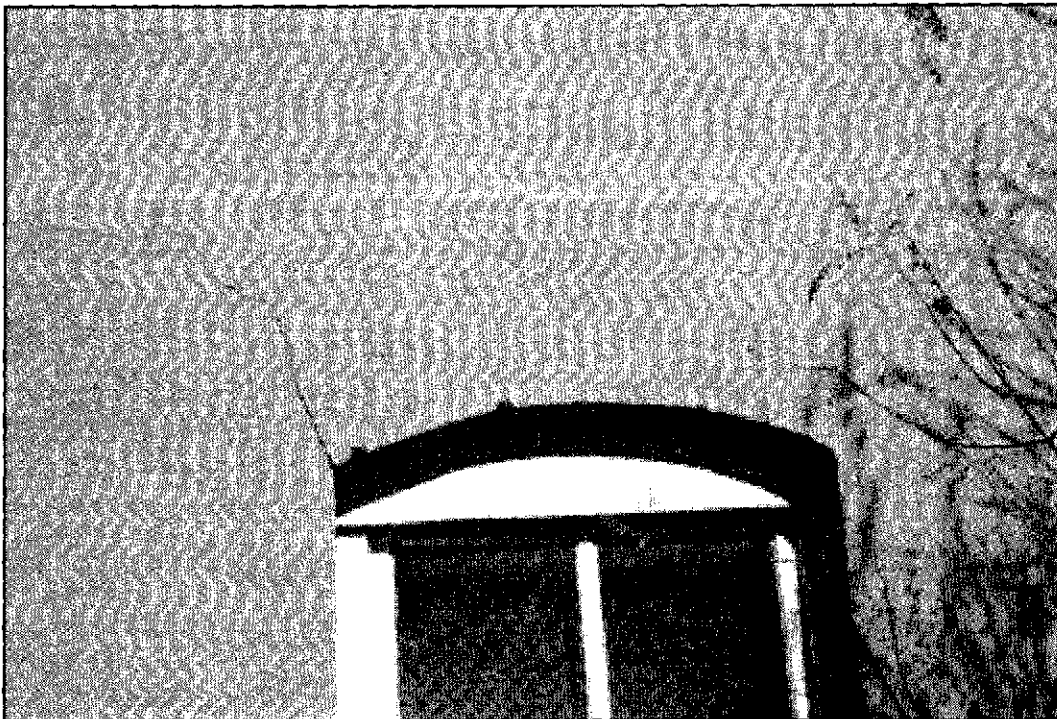
Figure 5.7: Detail of southwest elevation with severe stucco cracking and spots of ferrous staining at window head.

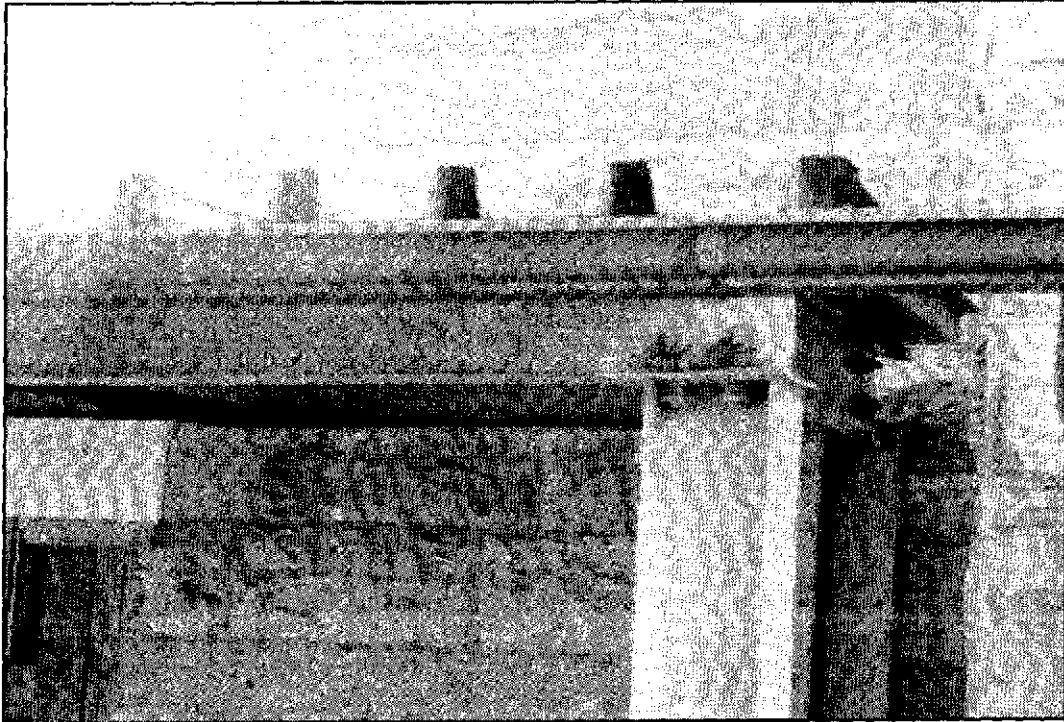
Figure 5.8: Detail of steel structure at northwest areaway roof with failing paint and rust bloom. The K-type hanging gutter and downspout are also experiencing paint failure.

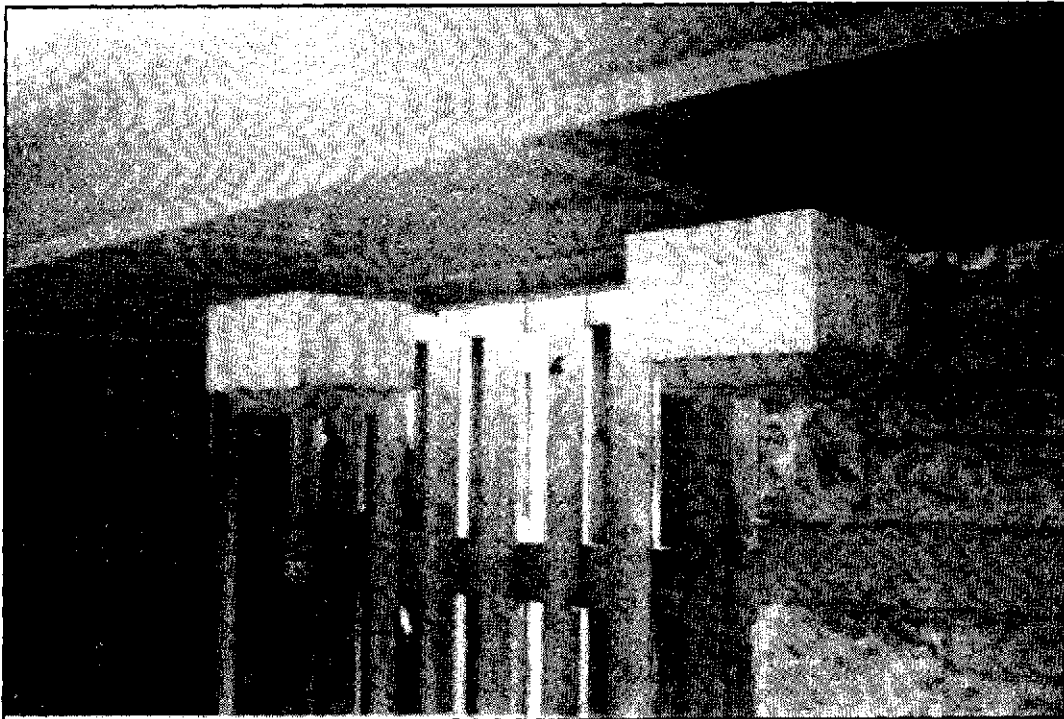
Figure 5.9: Light fixtures under areaway roof supporting bird nests.

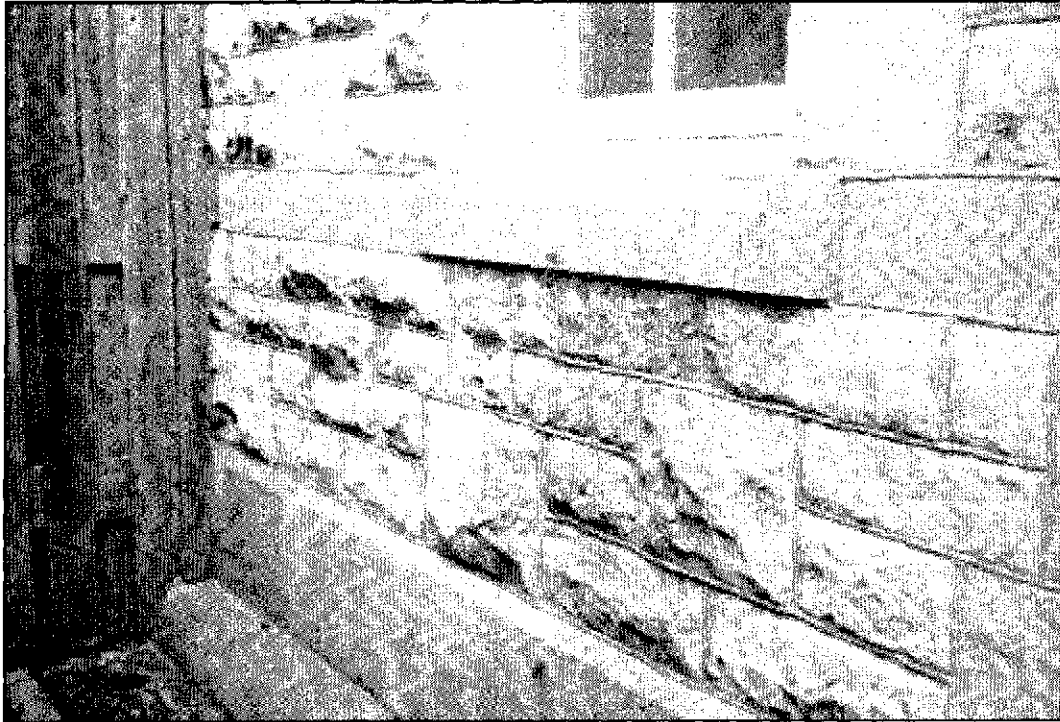
Figure 5.10: Detail of northwest elevation with significant biological growth under previous location of window air-conditioning unit. Ferrous staining and paint spatters are also visible at the granite window sill and water table.

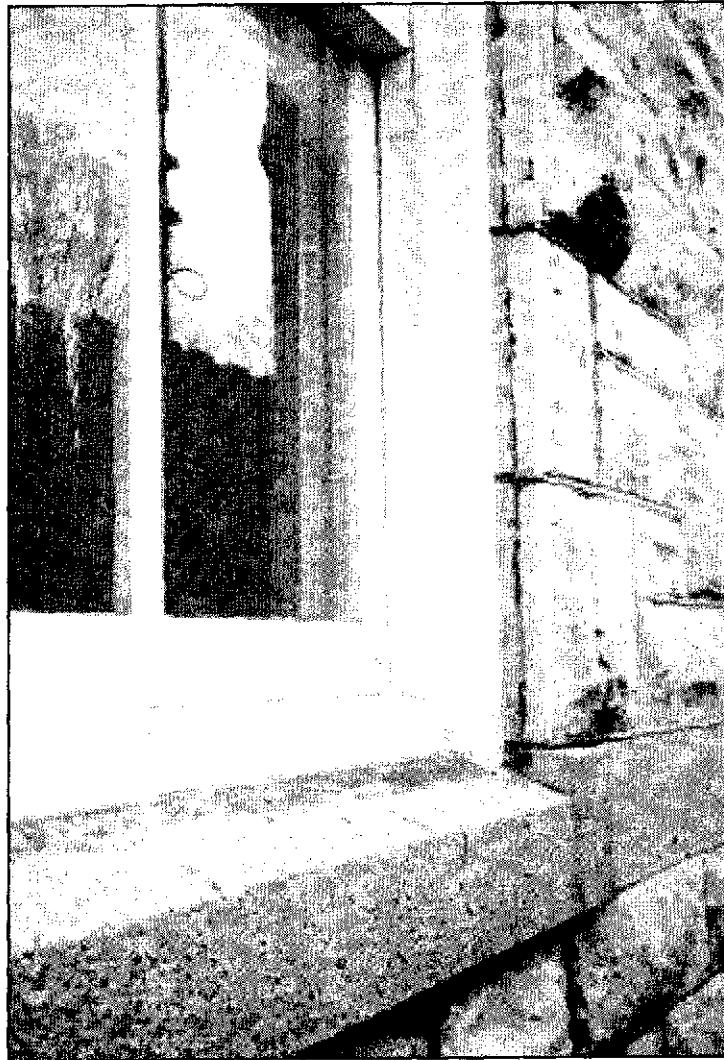
Figure 5.11: Lower sash of double-hung wood window with granite sill, northwest elevation. Note the line of paint at the masonry opening, drips of paint on the granite sill, and the remains of an anchor from a previously removed security screen.

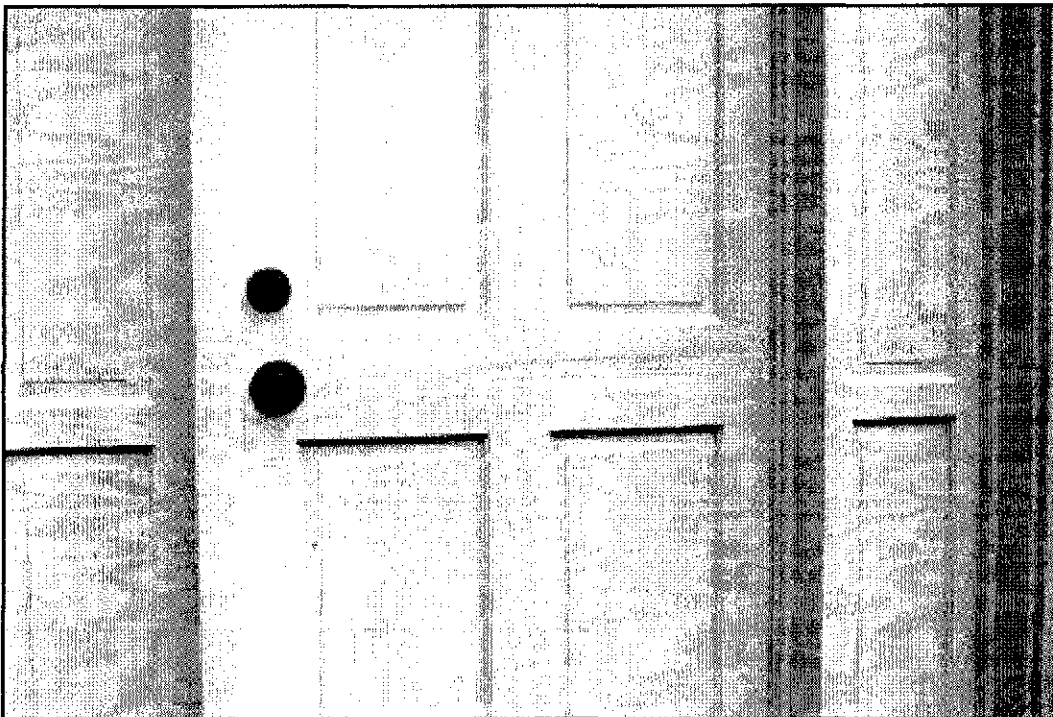
Figure 5.13: Detail of door at northeast elevation with damage to center rail.

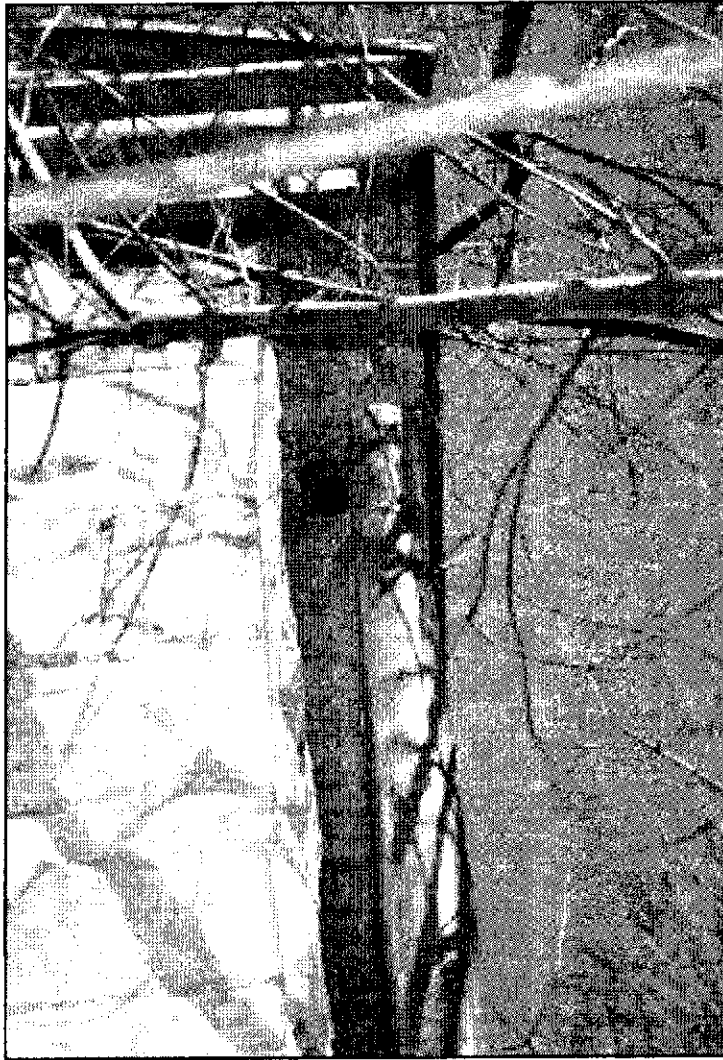
Figure 5.14: Detail of through-cornice downspout disconnected from rain leader at south end of southeast elevation. The downspout is clogged with branches and foliage.

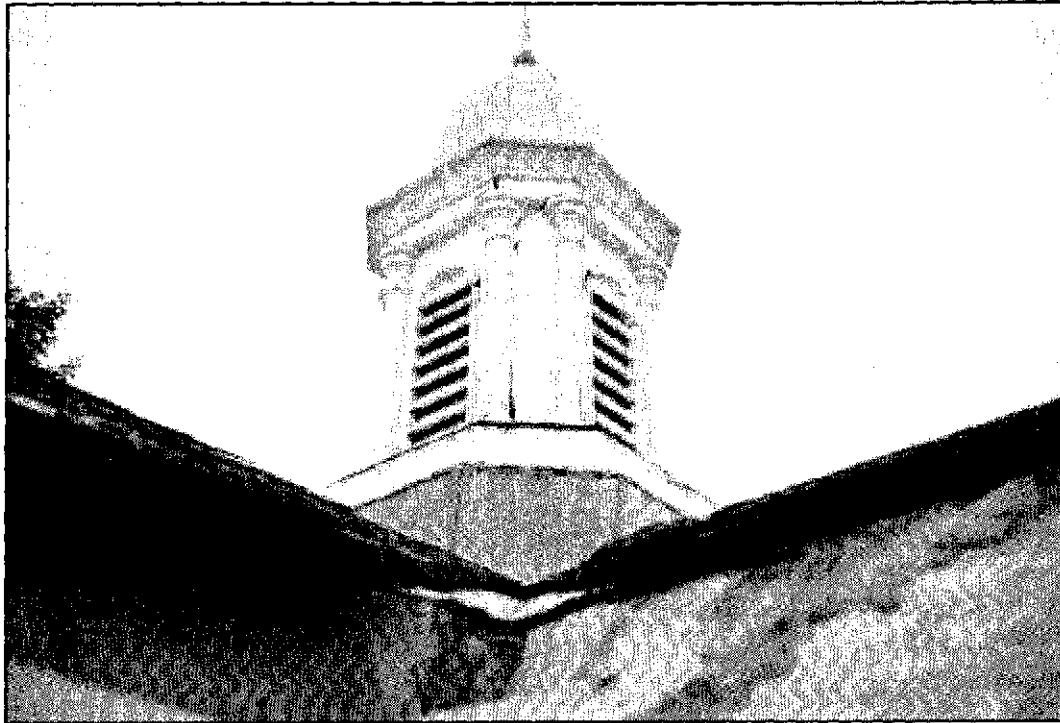
Figure 5.15: Cupola, view to the west with black sealant and failing paint.

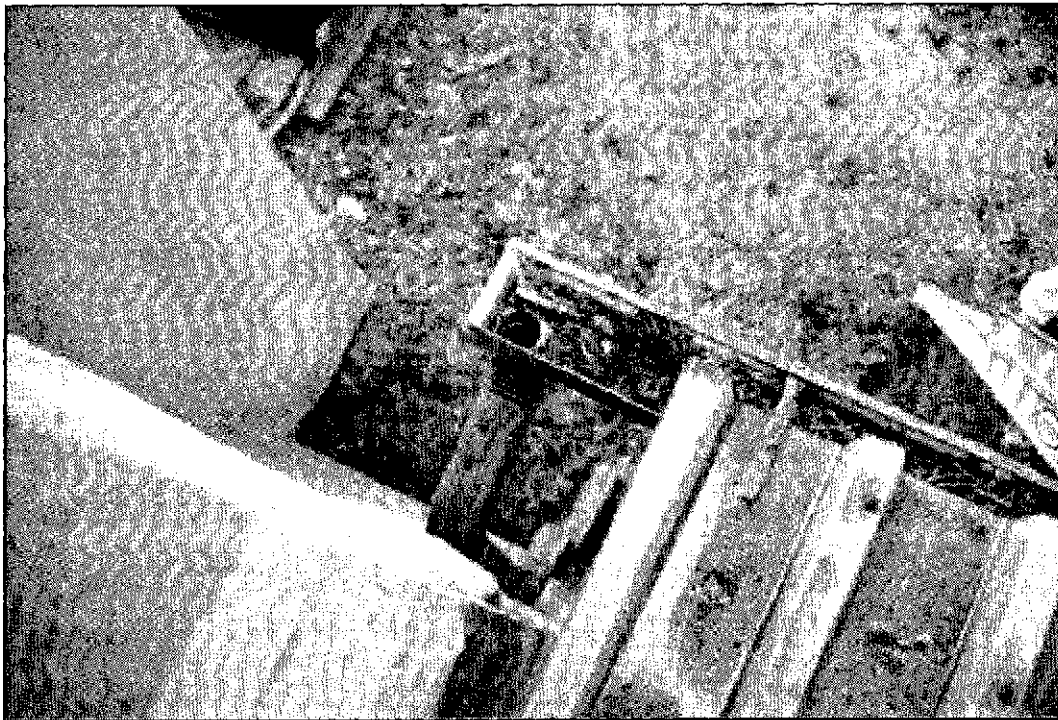
Figure 5.16: Gutter and downspout at southwest corner of areaway roof. Gutter is clogged with branches and foliage and contains standing water. Ferrous fasteners in the roof deck are beginning to rust and stain the galvanized steel. In the background, stucco patches adjacent to the attached chimney are visible.

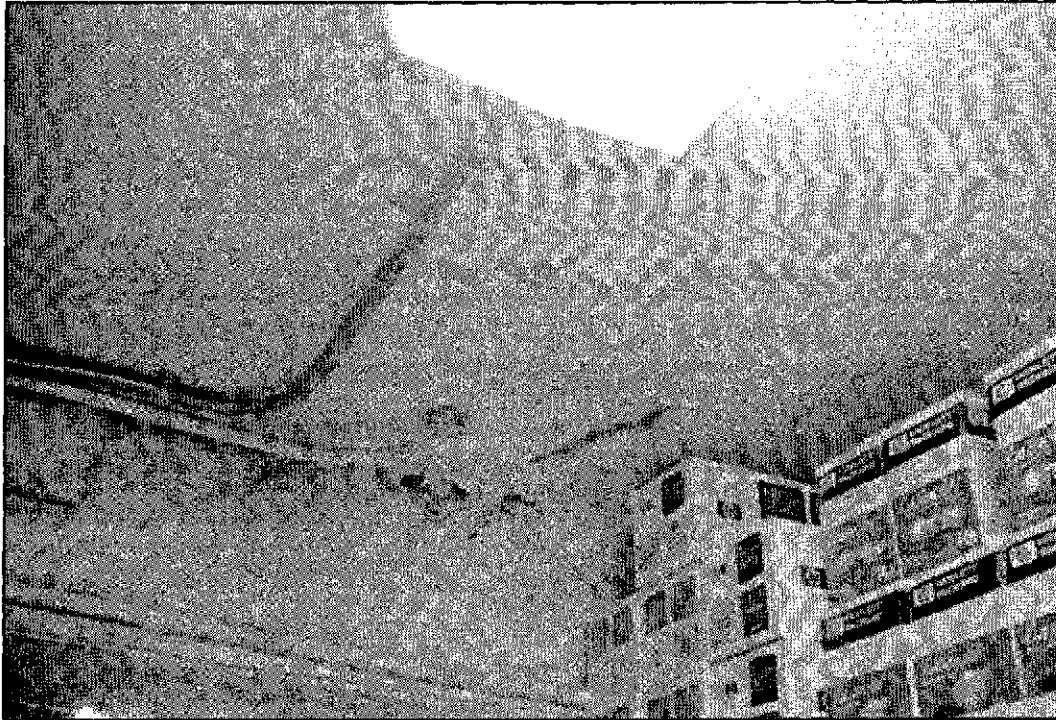
Figure 5.19: Detail of paint failure and water infiltration at concrete ceiling of north storage room. The painted concrete and brick wall at this location has also eroded and is showing signs of rust bloom from embedded ferrous elements.

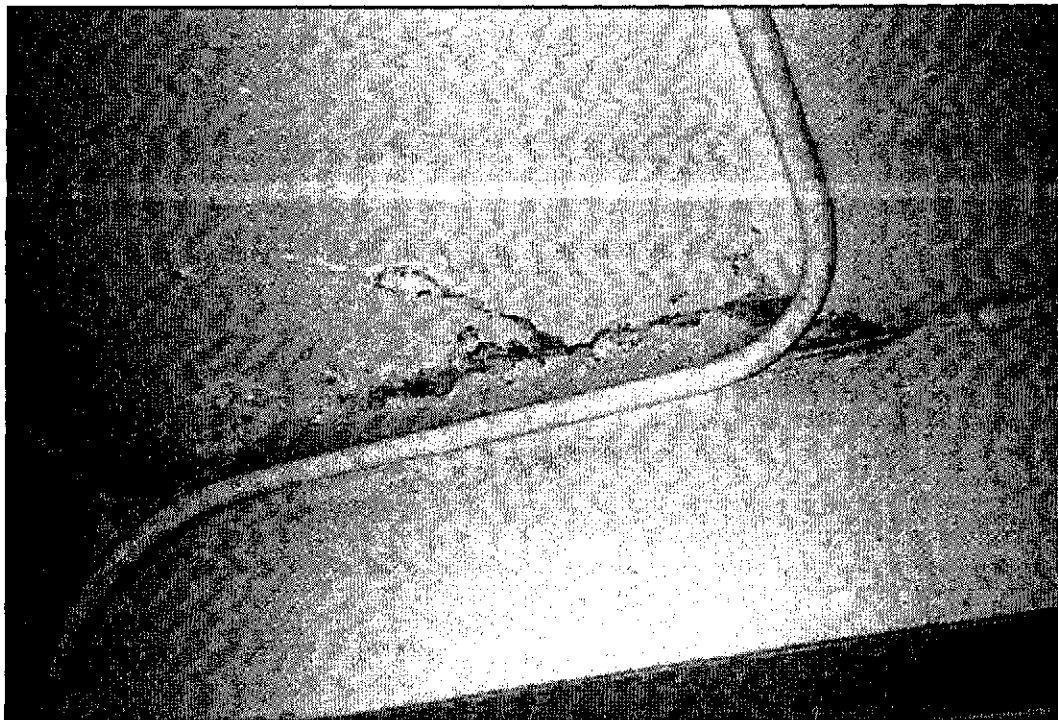
Figure 5.20: Detail of paint failure and water infiltration at concrete ceiling of staff break room.

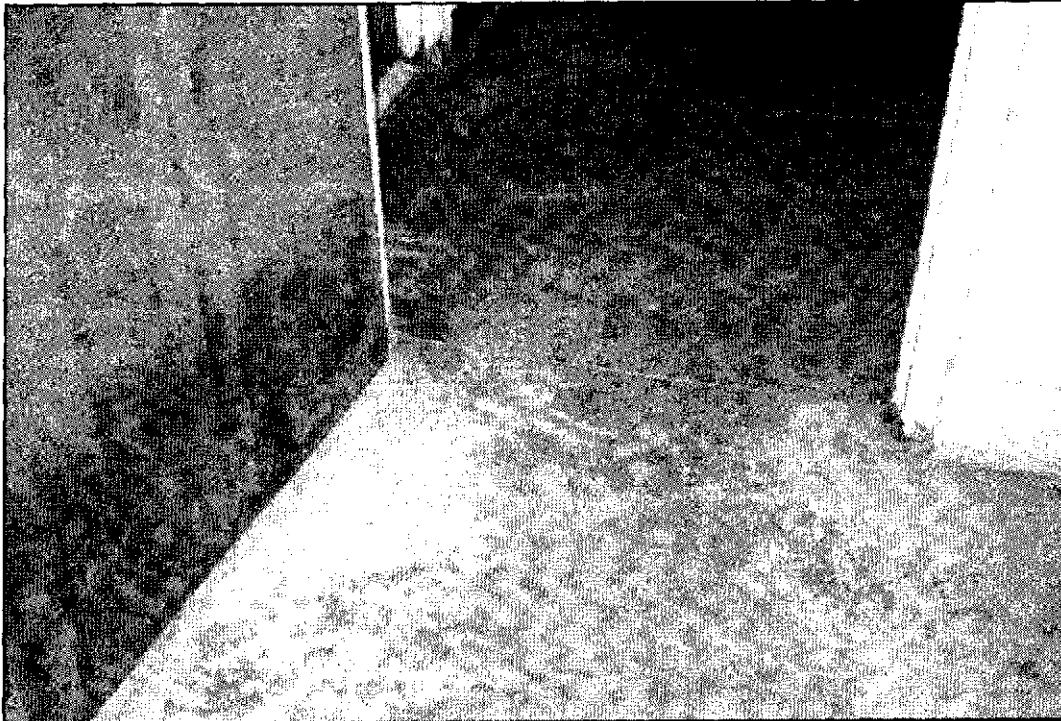
Figure 5.21: Detail of painted concrete floor at door of staff locker room. A large crack beginning at the door frame runs across the opening to an adjacent wall, and the paint has eroded in high-traffic areas.

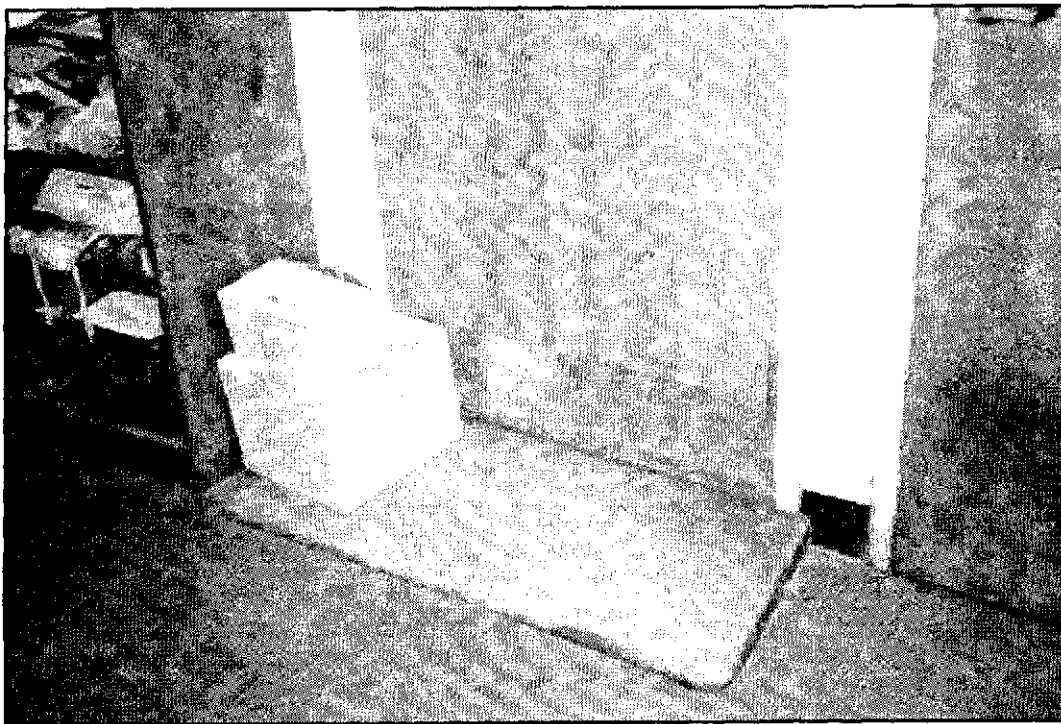
Figure 5.22: Detail of metal ramp at basement entry to handicapped lift with paint failure and rust bloom at perimeter. Also note the soiling and wear at the adjacent wall and door frame.

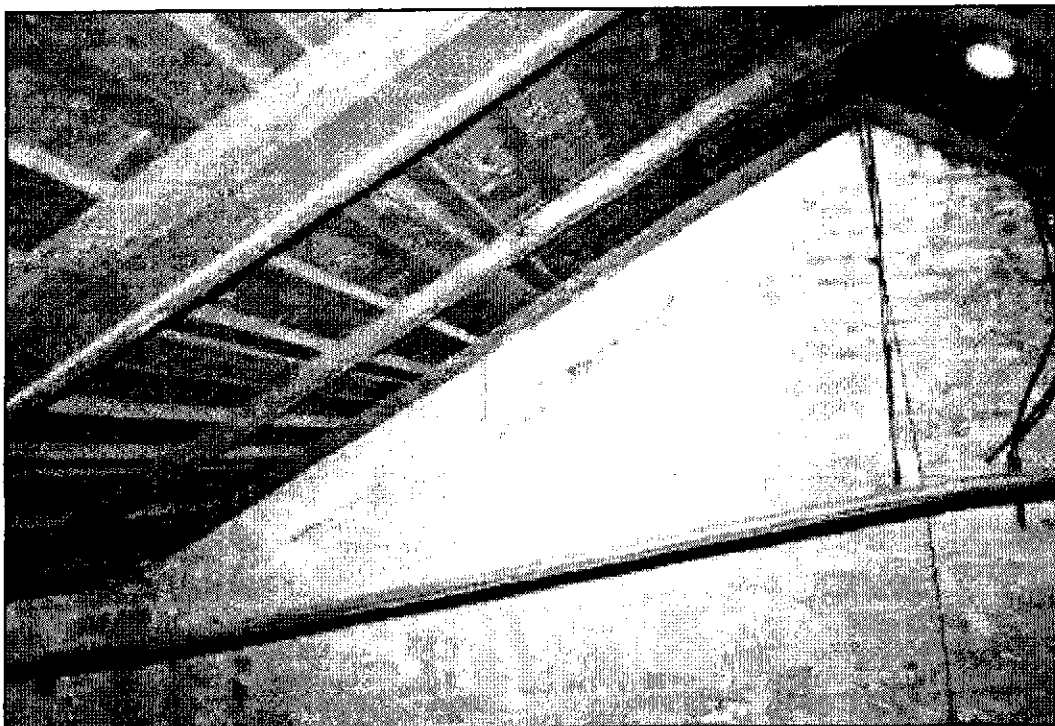
Figure 5.24: Attic, view to the southwest with remains of whitewash and deteriorated mortar under granite cornice.

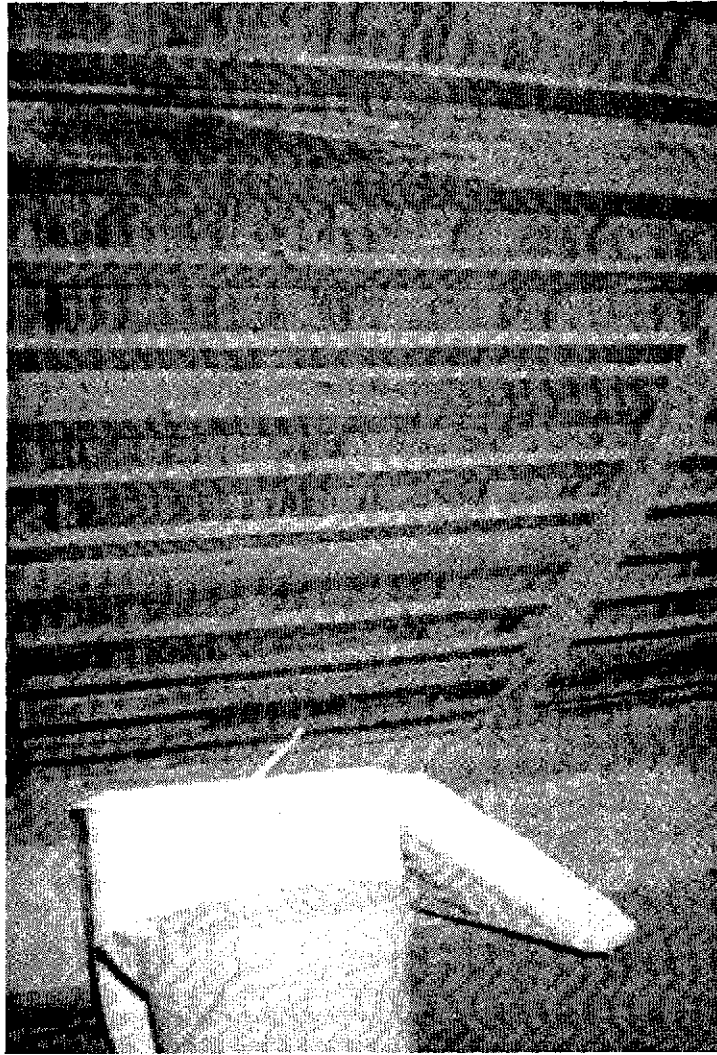
Figure 5.25: Attic, view to the northwest with plastic containers catching water from rain-dampened wood purlins and sheathing.
