National Park Service
U.S. Department of Interior
Northeast Region
Historic Architecture, Conservation, and Engineering Center

**Weir Farm National Historic Site
Weir Studio
Record of Findings: History of the Interior Appearance**

Judith M. Jacob, Senior Conservator
2013

Record of Findings: History of the Interior Appearance

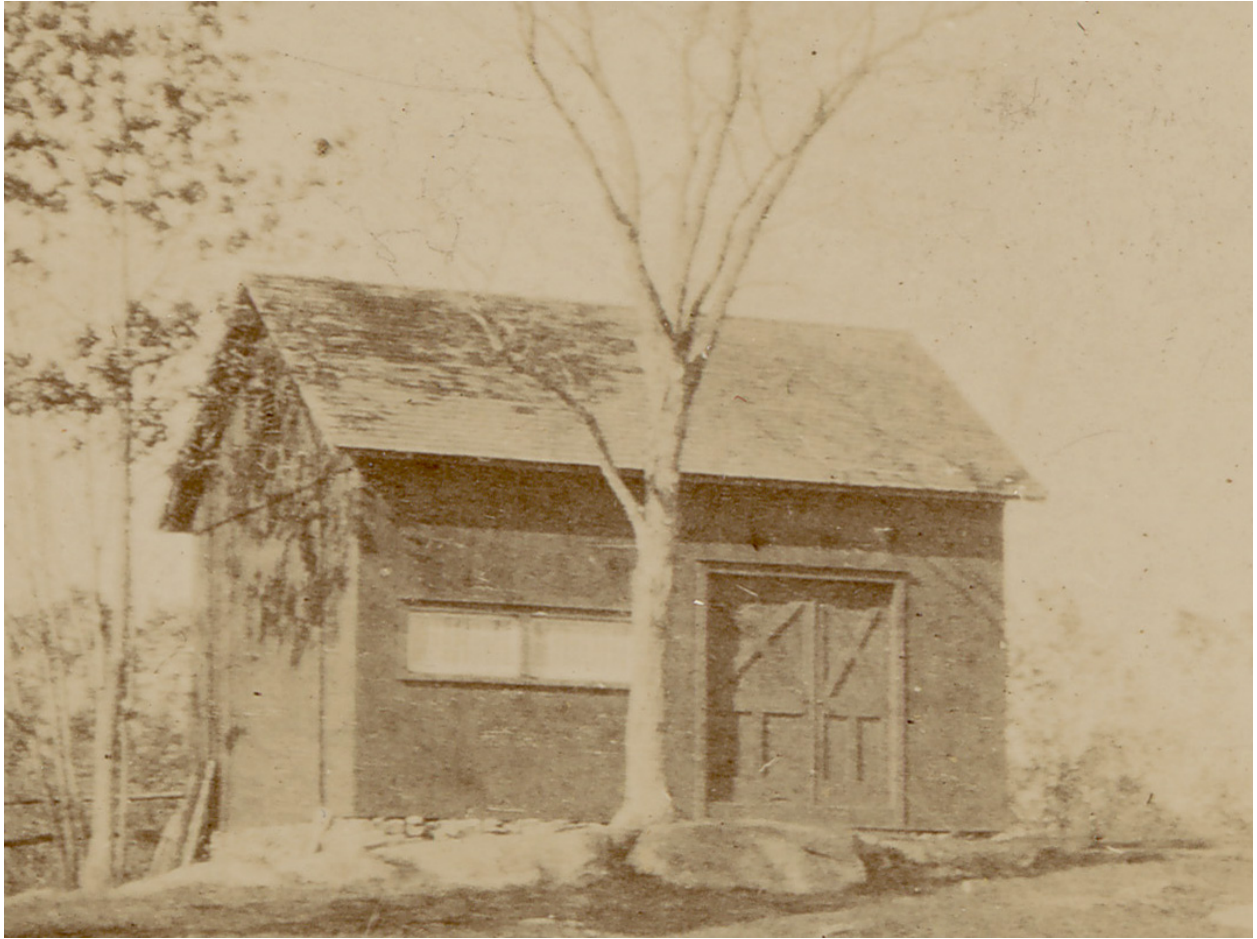
Figure 1: Weir Studio, between 1885-c.1899. Note possible covering on inside of windows. [Detail, Weir Farm NHS, WEFA 9447.]

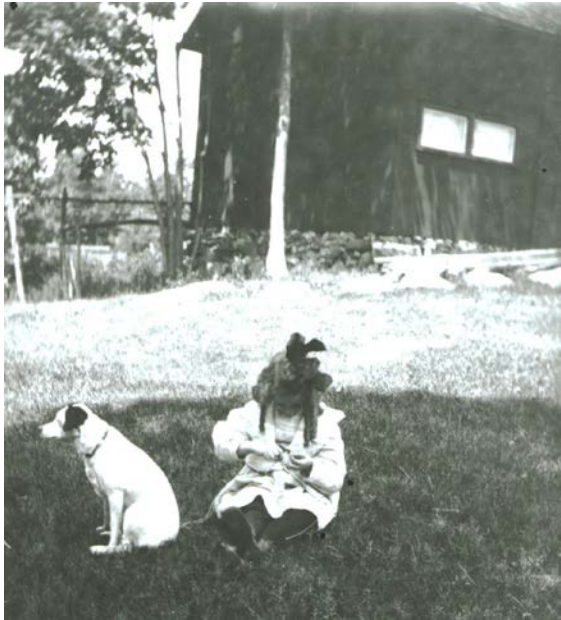
Figure 3: Weir Studio, c.1895. Note possible covering on inside of windows. [Detail, Weir Farm NHS, WEFA HP 896.]

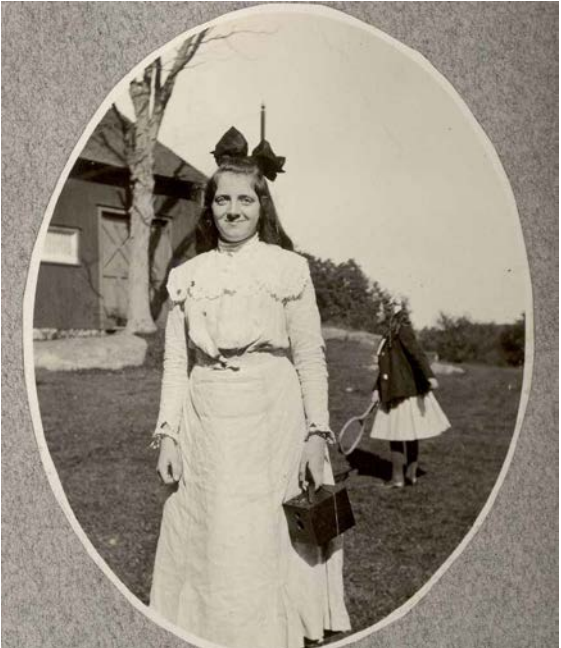
Figure 4: Weir Studio, c.1905. Note possible covering on inside of window. [Weir Farm NHS, WEFA 9451.]

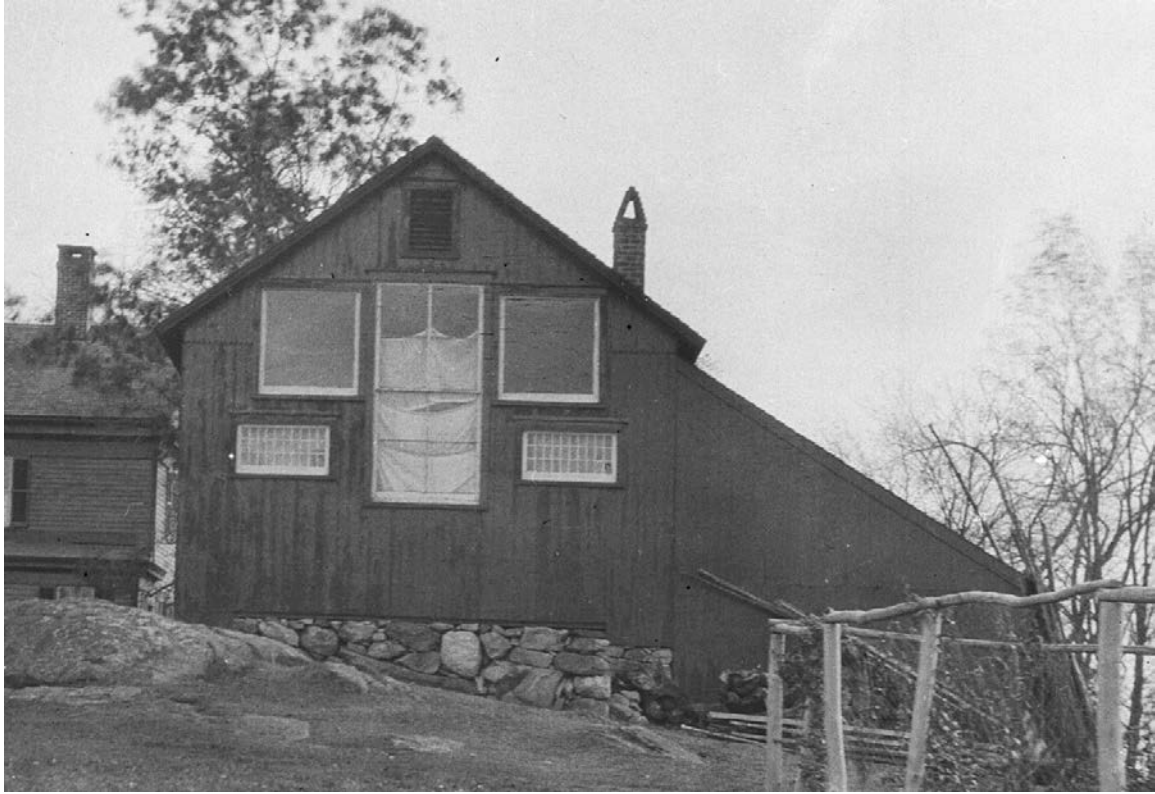
Figure 5: Weir Studio, n.d., after c.1899. Note coverings on inside of windows. [Detail, Weir Farm NHS, WEFA 9451]

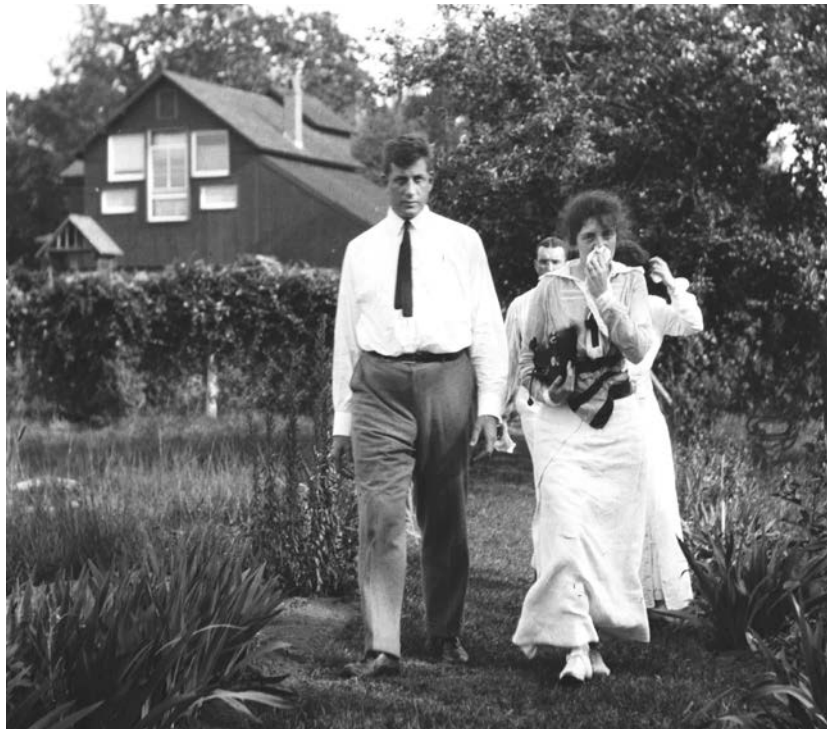
Figure 6: Weir Studio, c.1910. Note coverings on inside of windows and bottom sash of center window is raised. [Detail, Charles Burlingham, Jr. Collection.]

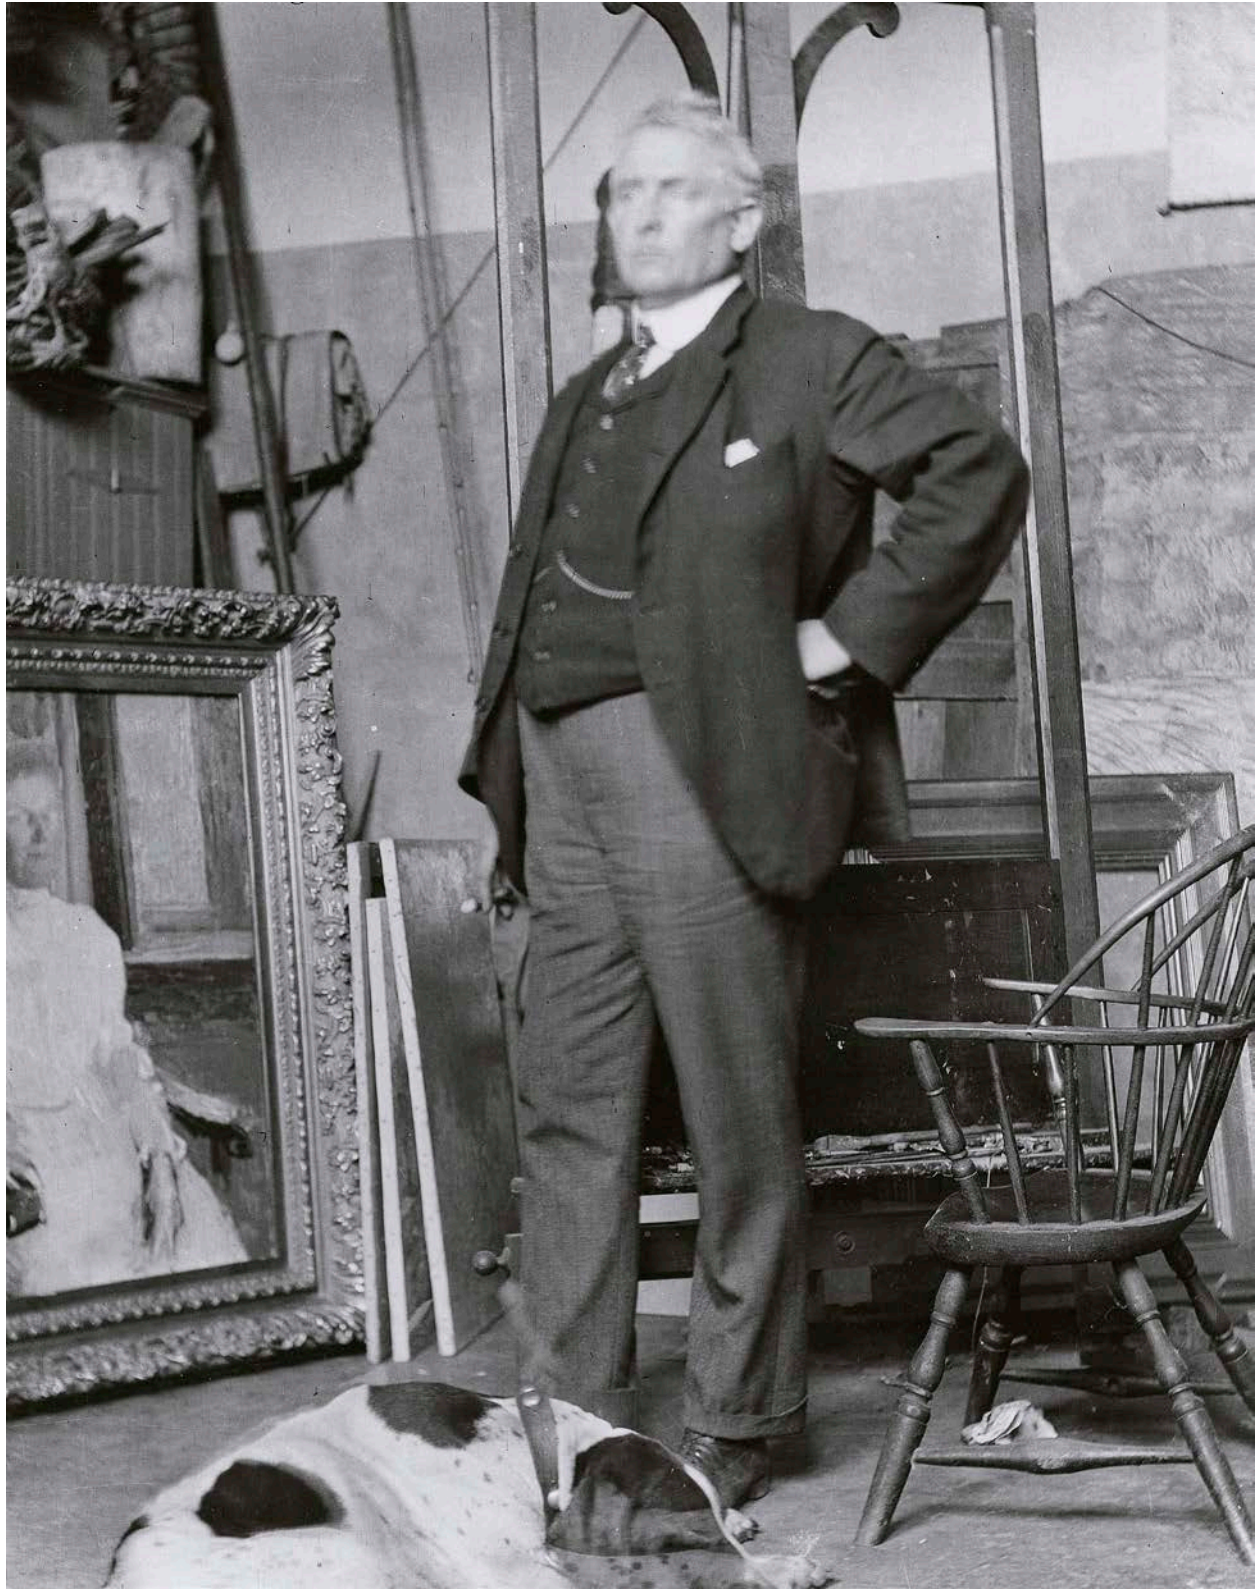
Figure 12: Weir Studio, facing south wall, c.1905. Note different colors on wall. [Brigham Young University, MSS P 78 WeirJA F2 16.]

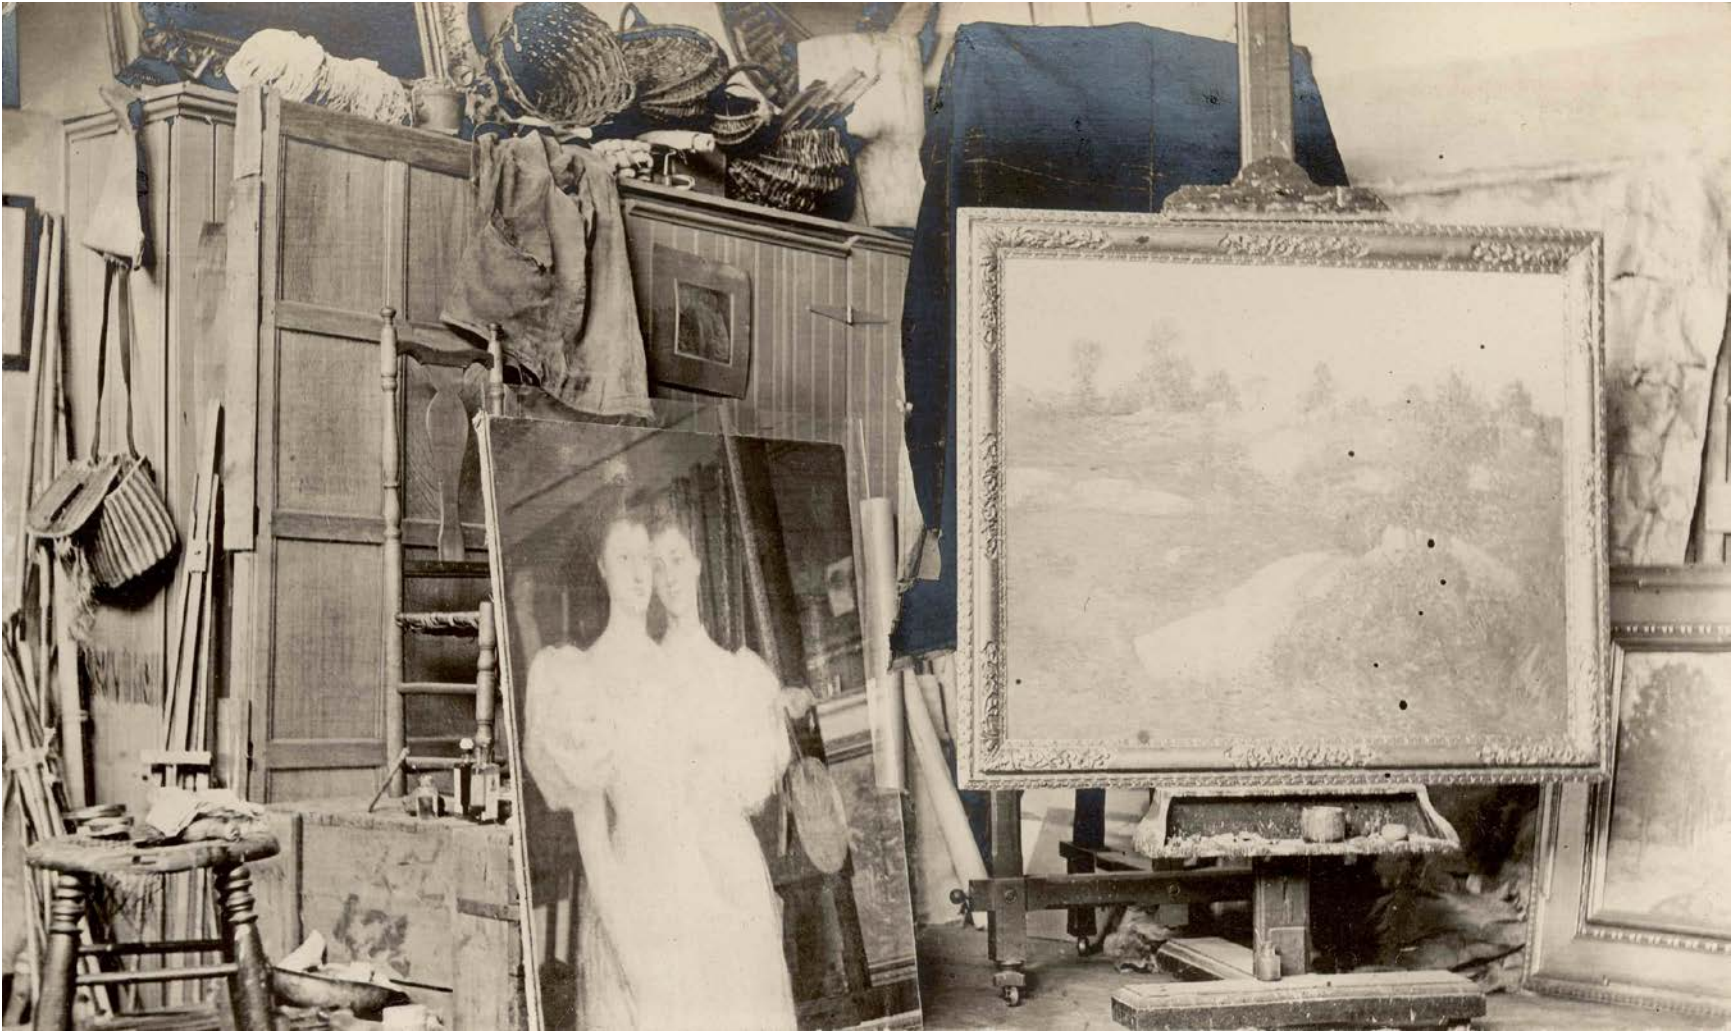
Figure 13: Weir Studio, southeast corner, c.1905. Note cabinet placed against east wall and different colors on wall. [Weir Farm NHS, WEFA 9451.]

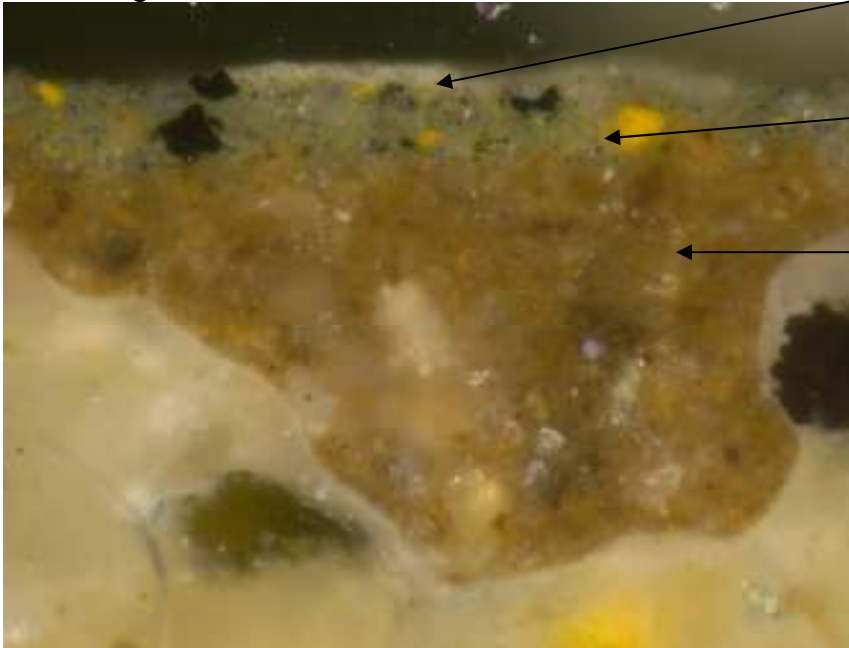
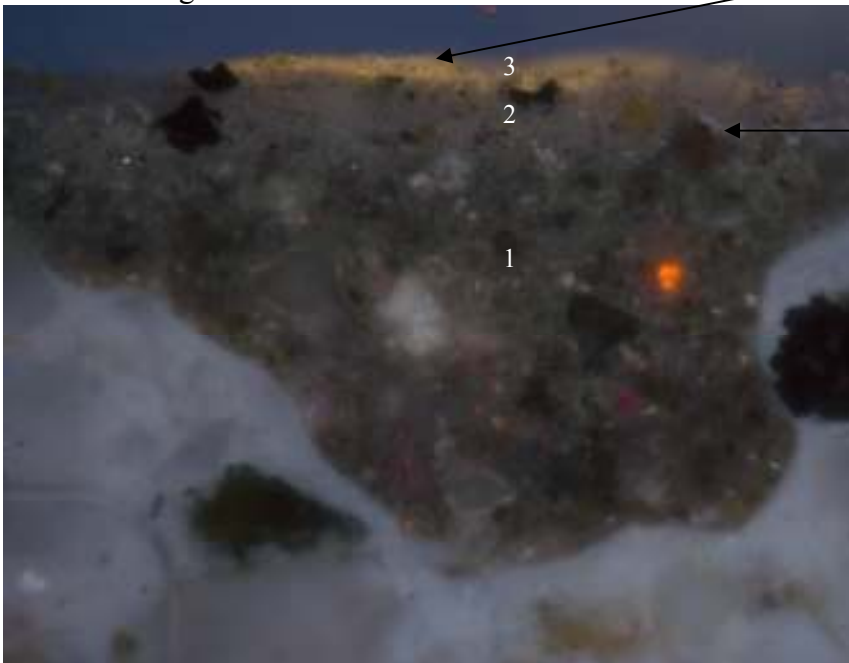
Sample 5. West wall, just to south of W110.
Visible Light 200X

3. Thin blue-gray paint

2. Grayish paint

1. Sandy brownish paint
or plaster on top of
coarse plaster base coat

Remnants of the varnish or
sealant layer on top of brown
layer

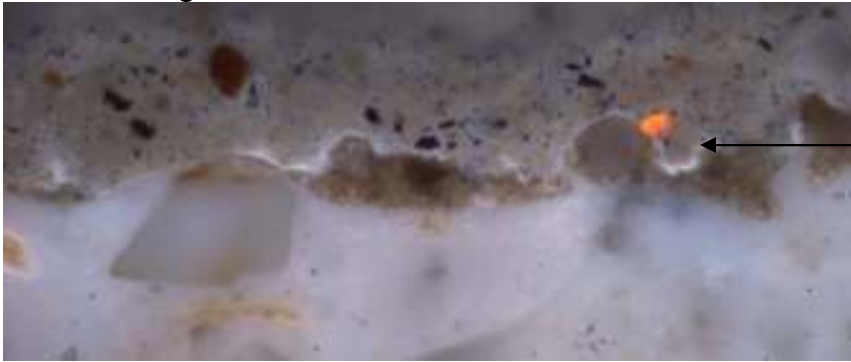
Sample 6. East wall, just below north end of W101.
Ultraviolet Light 200X

Thin plant resin varnish or sealant on top of brown layer, like samples 2 and 5

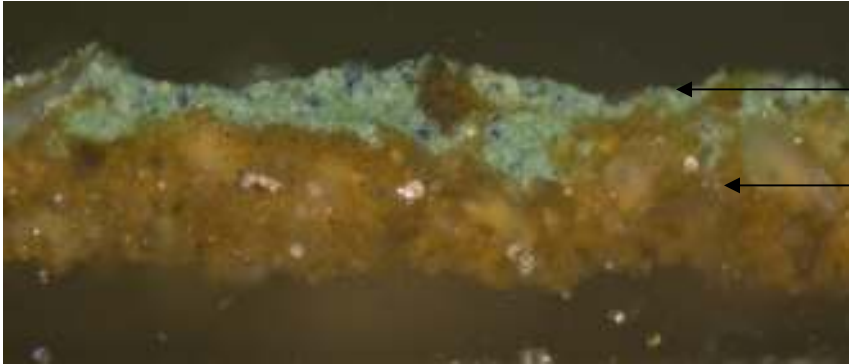
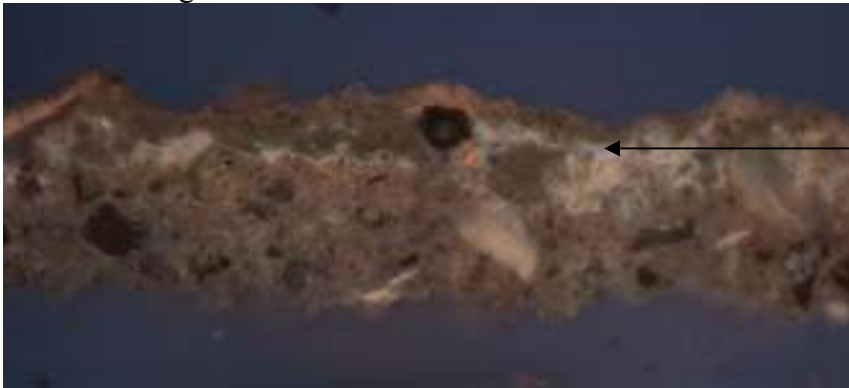
Sample 2. Top of the west plaster eave, edge of ceiling and eave, above E-W beam, with overlap of green ceiling paint.

- 2. Eroded, uneven blue-green ceiling paint
- 1. Coarse brownish layer

Possible plant resin varnish on top of the brown layer (thin bright white autofluorescent layer)

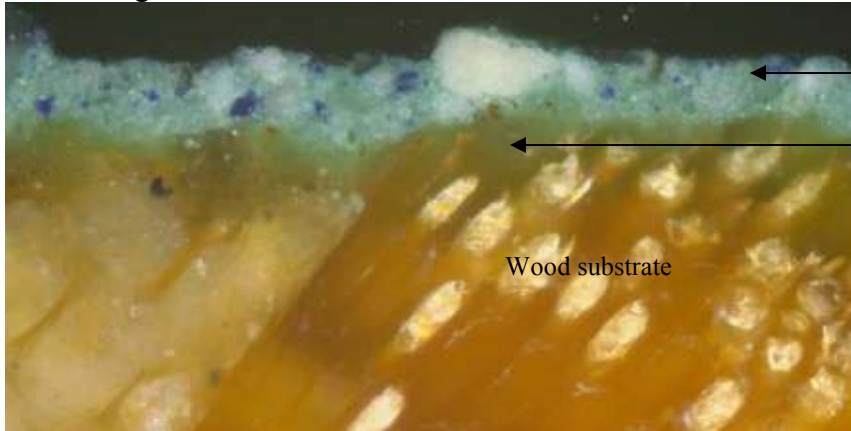
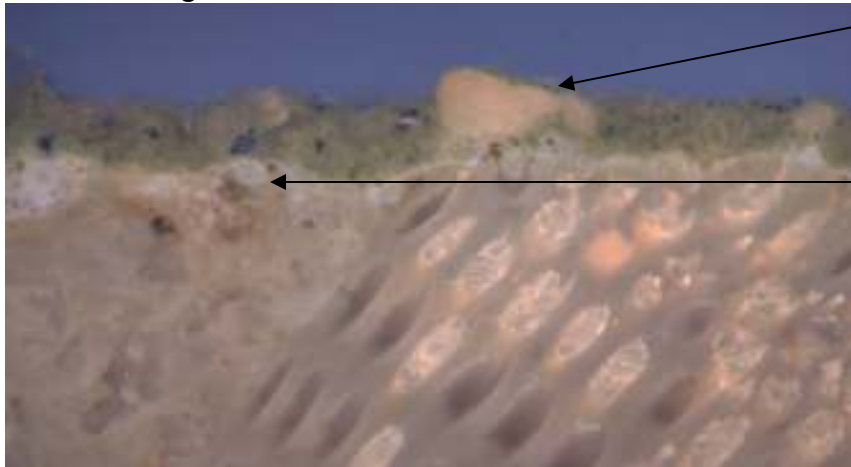
Sample 7. Ceiling sample from brighter area.
Visible Light 400X

← One layer of blue-green paint
← Thin layer of pigmented varnish or sealant

← Clean, bright surface
← Thin layer of pigmented varnish or sealant

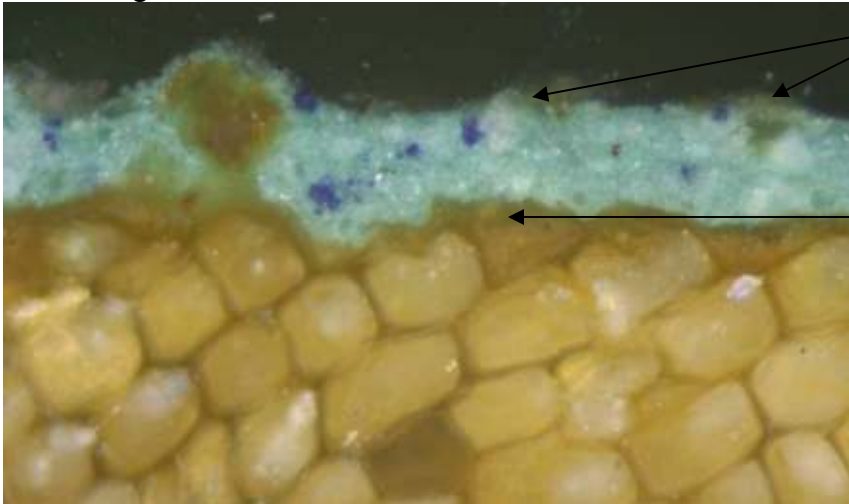
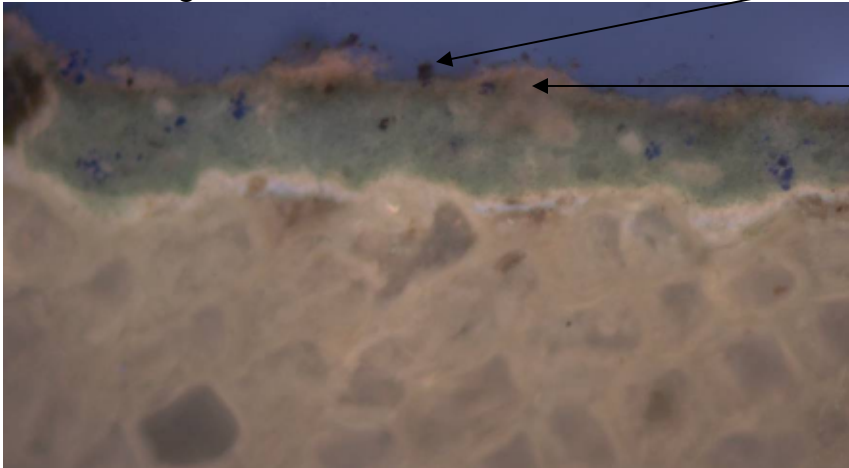
Sample 9. Ceiling sample from darker area.
Visible Light 400X

Subtle tannish accretions on the blue-green paint surface

Thin layer of pigmented varnish or sealant

Sooty particulates on the surface

Discoloration of the surface is most readily discernible in reflected ultraviolet light

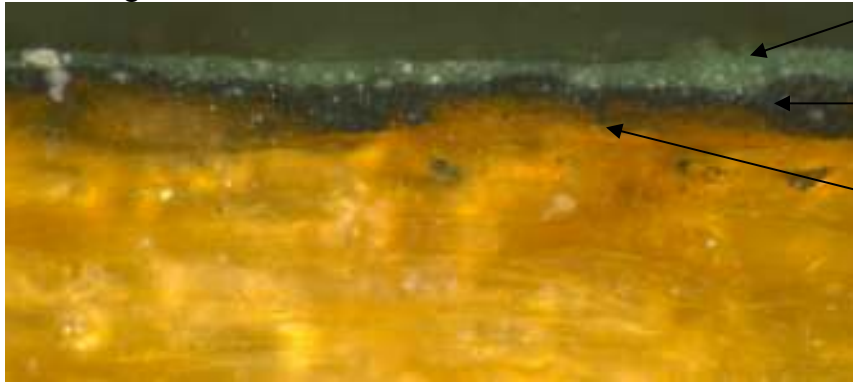
Sample 1. D1, door, north side.
Visible light 200X

Door. One key question about the green paint on the door was whether it is the original color and if so, if it has changed over time. The cross-section shows that the green paint is the third generation on the door. The first generation is a deep red-brown stain (the pigments are trapped in the wood fibers), the second generation is black, and the third generation is a finely ground deep green which does not resemble the green paints found on the ceiling. The surface of this uppermost green door paint does not appear particularly blanched, but it does seem slightly darkened and dirty. It is finely ground and still slightly glossy.

3. Green paint

2. Black paint

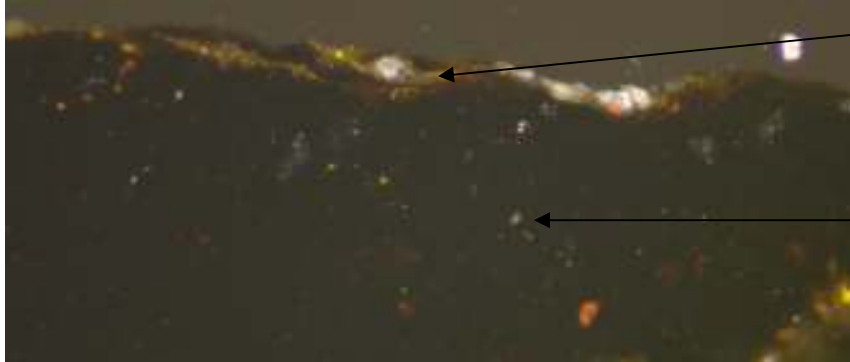
Sample 3. Black paint drips, W108 boards.

Black drips on southernmost west window. This is an interesting material as it appears dark brown and glossy in uncast form, but there are suspended red and yellow pigments discernible in the brownish material when viewed in the cross-section. There are also remnants of a yellowish paint-gray paint on the surface that could be an accidental overlap of gray paint from the wall which are now discolored. This somewhat amorphous brown material is slightly translucent (unlike an oil-bound paint) and it most resembles natural pine tar with some pigments to add opacity, durability, and to contribute to drying. This type of material was a byproduct of turpentine production and was a typical waterproofing material in the 18th and 19th centuries, primarily before the Civil War. The precise nature of this coating would have to be determined with other analytical methods such as FTIR and/or GC-MS, but it does seem to have an oil component, based on the weak positive reaction with the fluorochrome Rhodamine B.

Possible paint remnants from the window

Pigmented amorphous brownish material
