Yosemite National Park
California

Historic Structure Report

Yosemite Museum

Yosemite National Park
Yosemite Valley, California

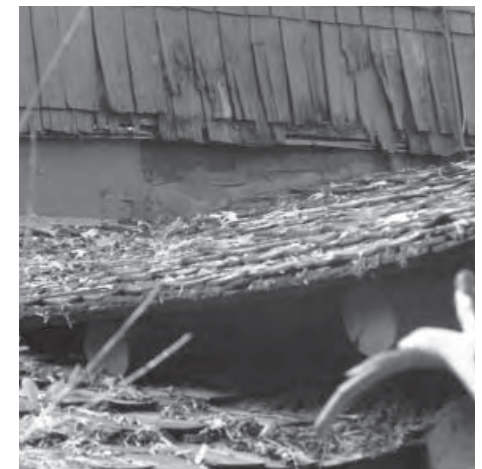
Deterioration above north porch, 2006.

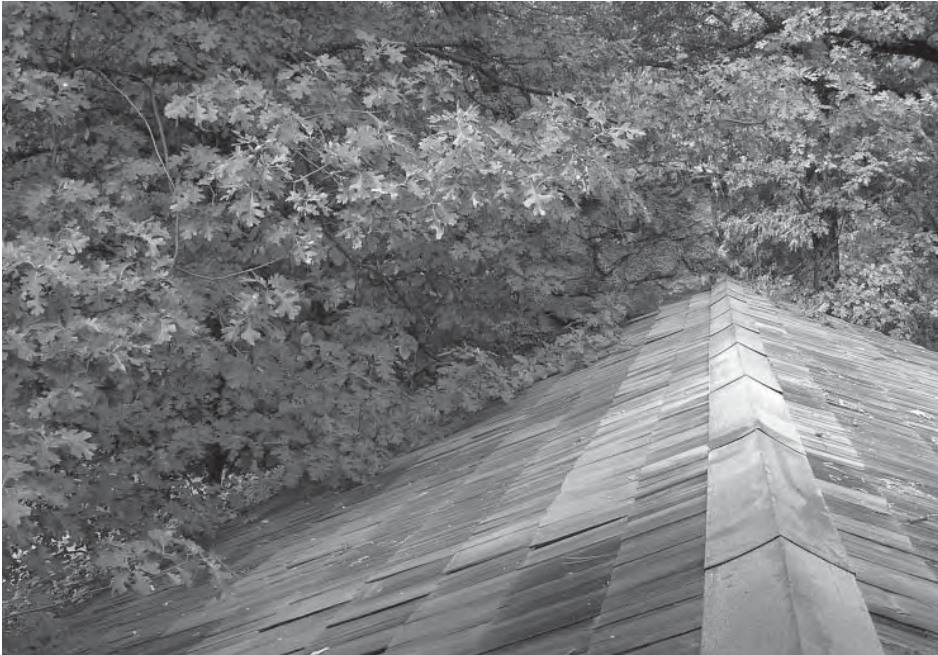
West wing, tree branches in contact with roof, 2006.

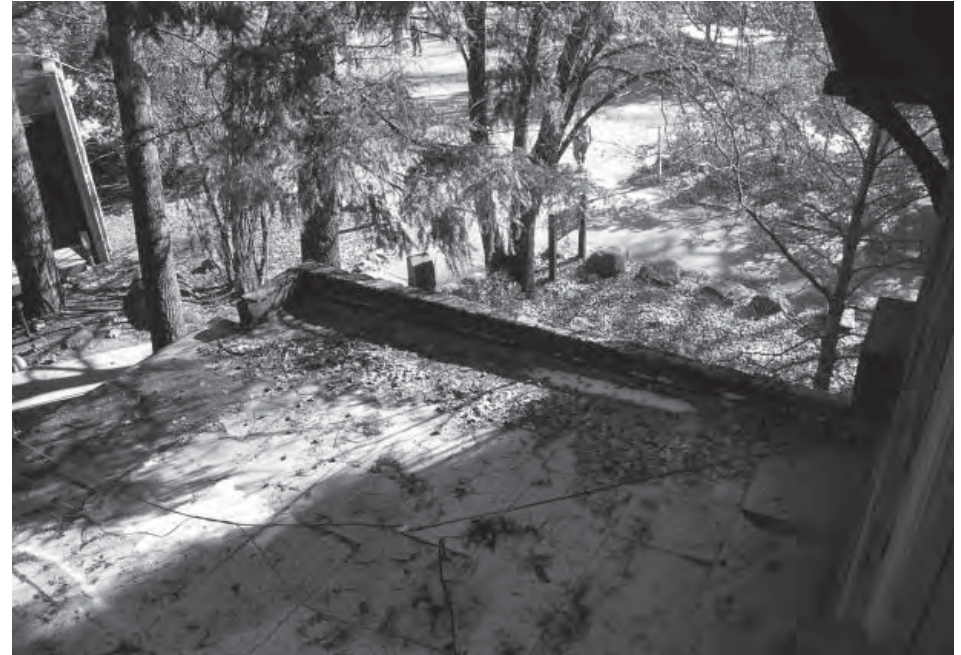
East wing, note accumulation of debris, 2006.

north side preventing the natural shedding of organic debris build up on the roof. There is some minor moss growth evident on the roofing surface.

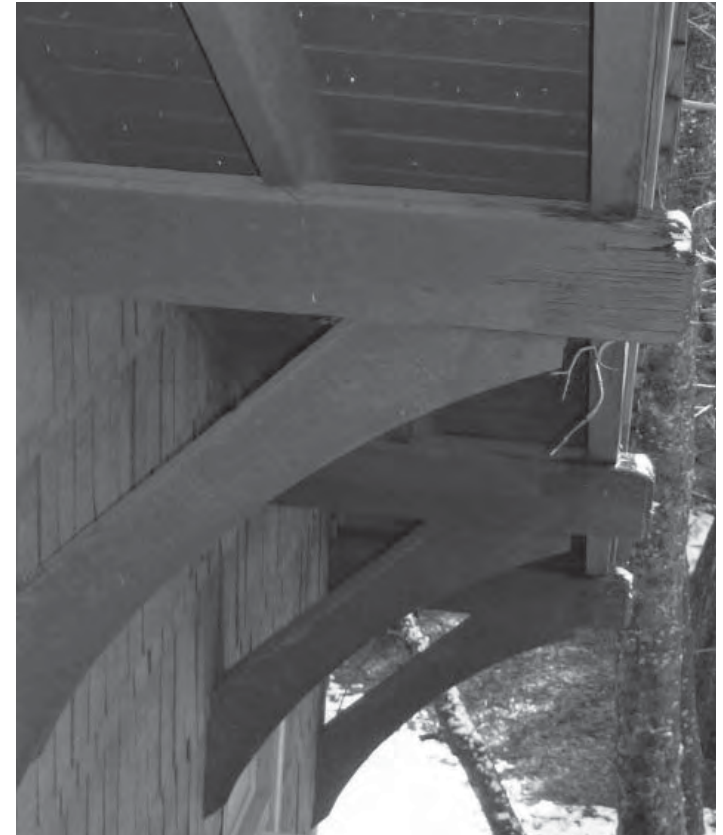
Roof braces, west elevation, 2006.

1. Repair rotted roof braces. Each brace should be individually evaluated to determine the most appropriate repair. Those with minor damage may be repairable with epoxy, however epoxy repairs would need to be monitored closely and maintained with a good coat of paint or sealant to prevent moisture penetration between the epoxy and wood which could accelerate deterioration. A dutchman type repair would be more appropriate on those braces with more extensive rot. In some cases, complete replacement of the top chord may be necessary.
2. Periodically inspect knee braces for evidence of deterioration. Establish a regular schedule for reapplying protective sealant. This needs to be done more frequently than the regular schedule for painting the rest of the exterior due to the vulnerability of exposed horizontal surfaces of the top chord.

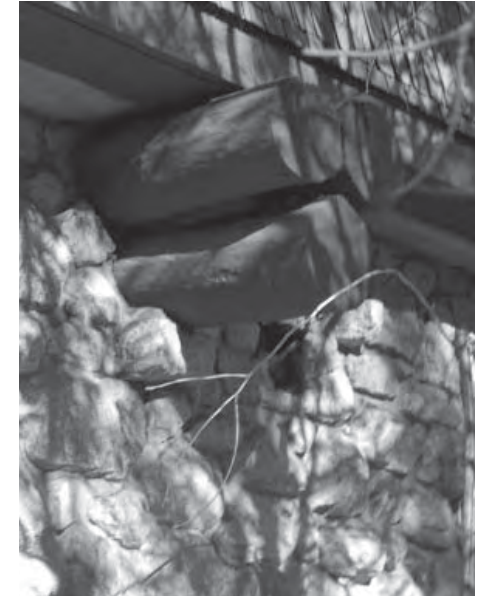
Log detailing on south elevation, 2006.

1. Periodically inspect logs for evidence of deterioration. Establish a regular schedule for reapplying protective sealant. This needs to be done more frequently than the regular schedule for painting the rest of the exterior due to the vulnerability of the exposed horizontal surfaces.

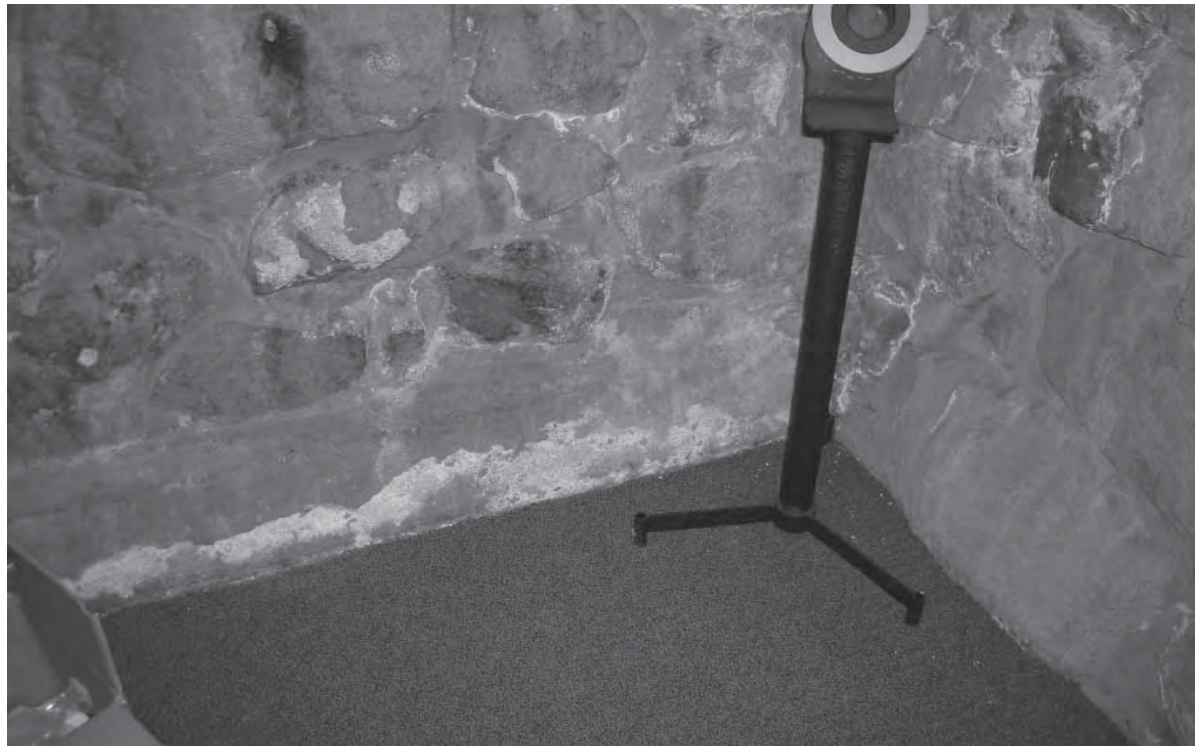
Efflorescence in SE corner of briefing room, 2006.
