Archeological Monitoring,  
Installation of Fire Suppression System,  
Fort Scott National Historic Site,  
Bourbon County, Kansas: 1997-1998

By  
Scott Stadler

Midwest Archeological Center  
Technical Report No. 57

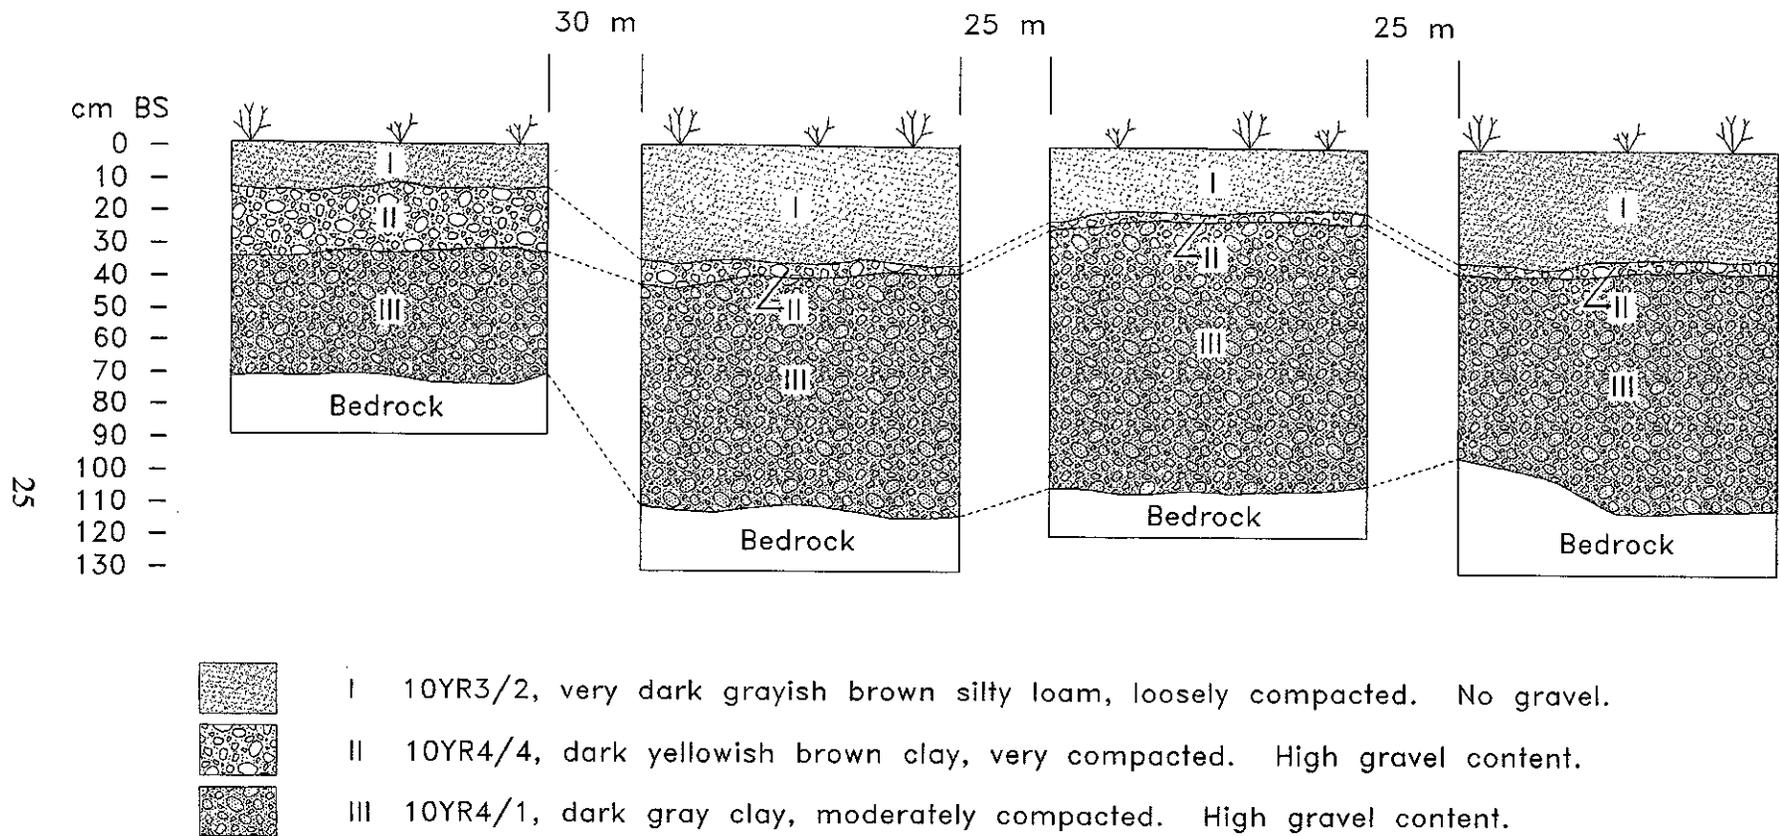
A look at the stratigraphy across the parade ground is of limited value due to the disturbance caused by the construction of Blair and Lincoln Avenues. All of the trenching on the parade ground was within these former streets. There was no evidence of historic grade across the north side of the parade ground, but it may be seen about 30 cm (12 in) below the surface across the east side of the parade ground.

Figure 3. Stratigraphy across north side of parade ground, north wall.

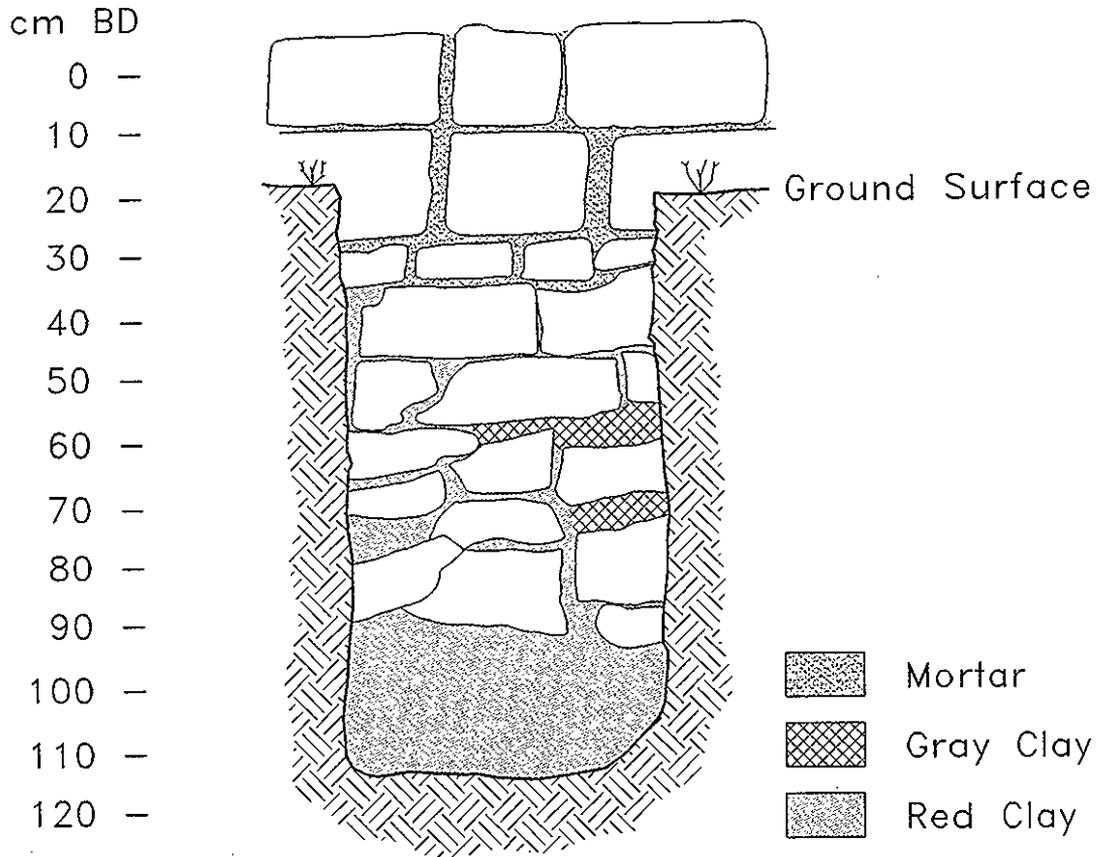
This is a segment of the old Marmaton Avenue. There were no features in this segment. However, trenching did expose the foundation of HS-1. It is constructed of unmortared limestone blocks to a depth

of 95 cm (37 in) (Figure 4). This is the original 1840s foundation. Four metal or ceramic pipes were within 60 cm (2 ft) of the foundation and parallel to it.

Figure 4. Foundation of HS-1, west wall.

During Phase III the foundations of the structures with concrete foundations were breached using a coring device that bored a 25-cm (10-in) hole for the entry of the water line. The foundations of HS-1, HS-2, and HS-4 should not be disturbed, since the water line will be brought into the building by passing under the footings.

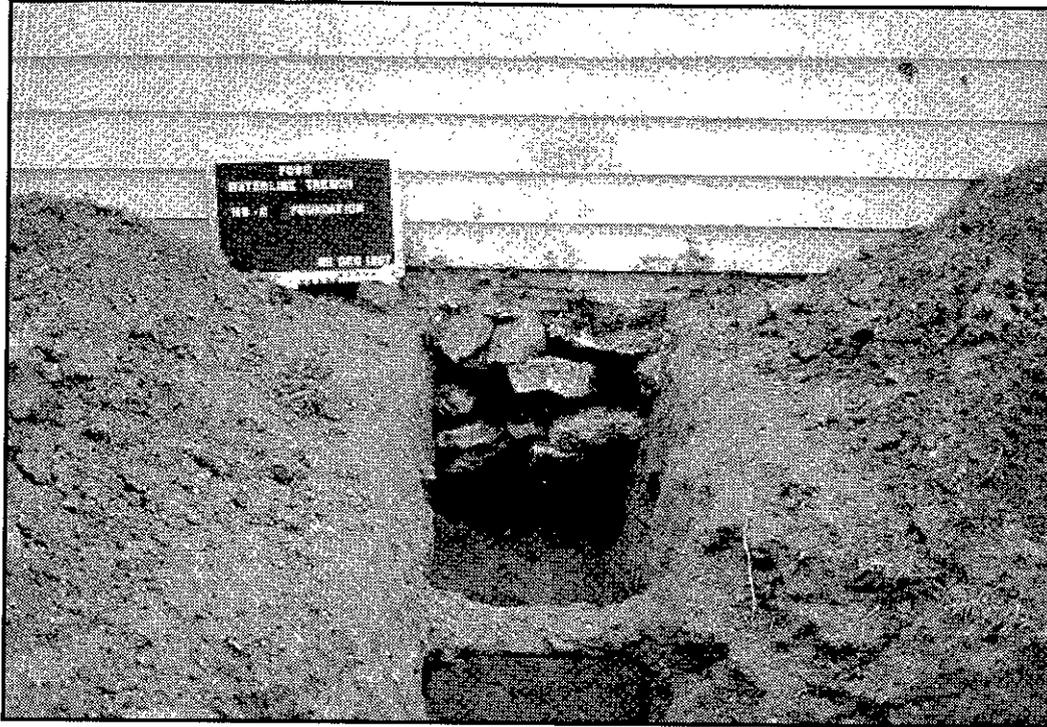
There were no features located in this segment. One piece of tabular limestone (flagstone?) turned up in the north end of the trench. During Phase III no other artifacts were recovered. The foundation of HS-2 is made of small limestone blocks with no mortar. The bottom of the footing is 46 cm (18 in) below surface (Figure 5). One red ceramic drain pipe 10 cm (4 in) in diameter and two ferrous pipes, either water or gas, were found running parallel to the building within 61 cm (2 ft) of the foundation. All pipes appeared to be abandoned.

Figure 5. Exterior of HS-2 foundation.

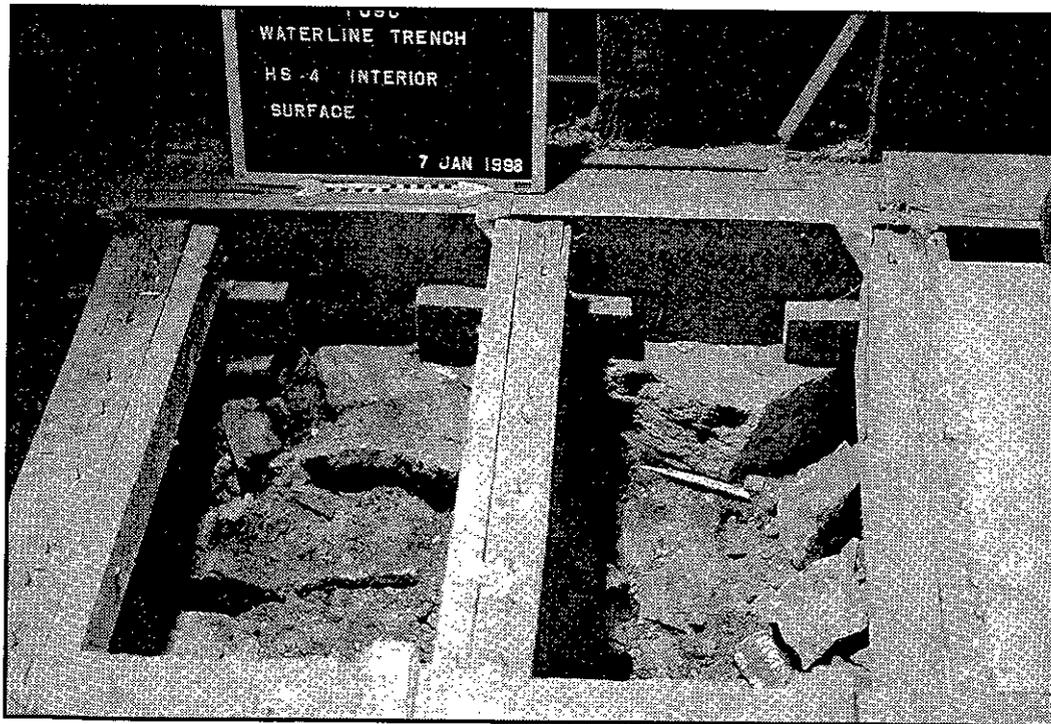
No features were located in this segment. Plain whiteware and curved glass were the only artifacts noted in trenching outside of HS-4. The foundation of HS-4 is composed of small limestone blocks with no mortar. The bottom of the footing is 74 cm (29 in) below surface.

Figure 6. Interior of HS-4 foundation.

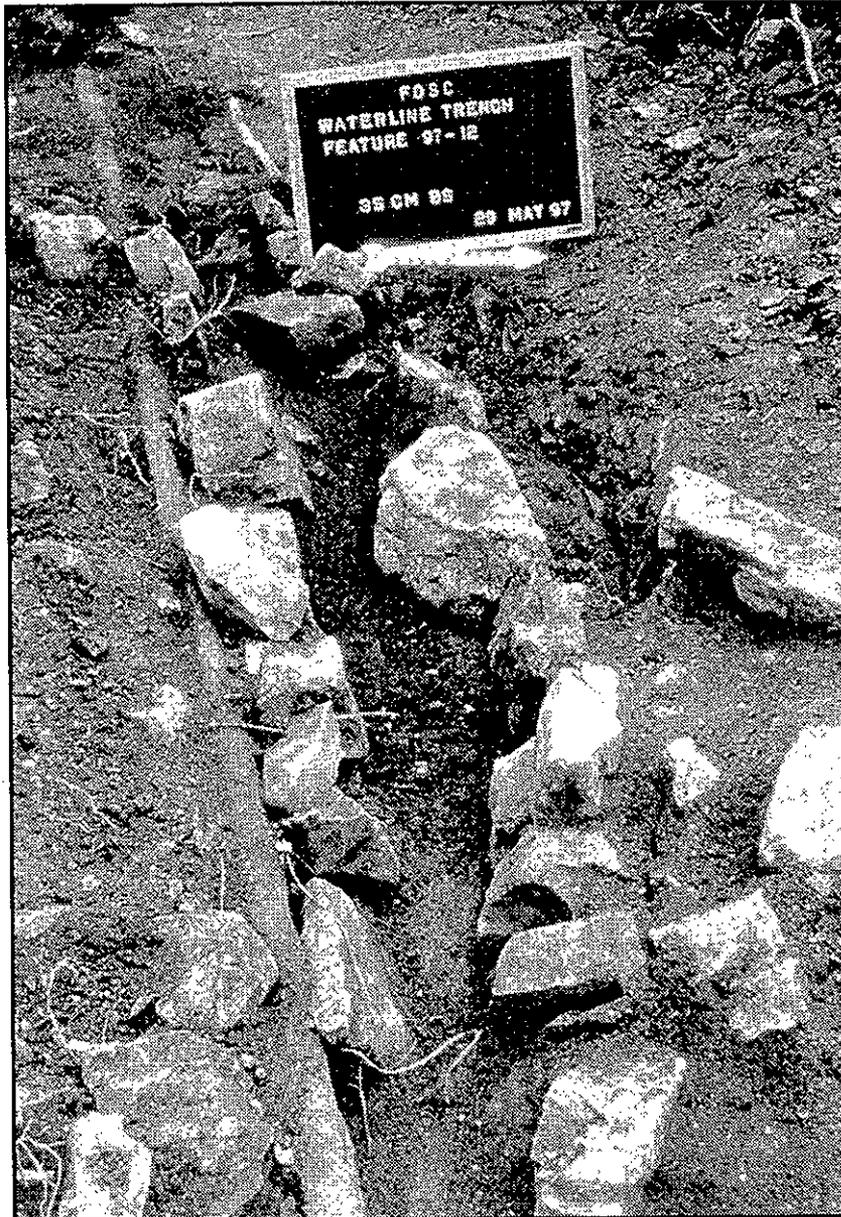
Figure 7. Feature 97-12, stone drain.

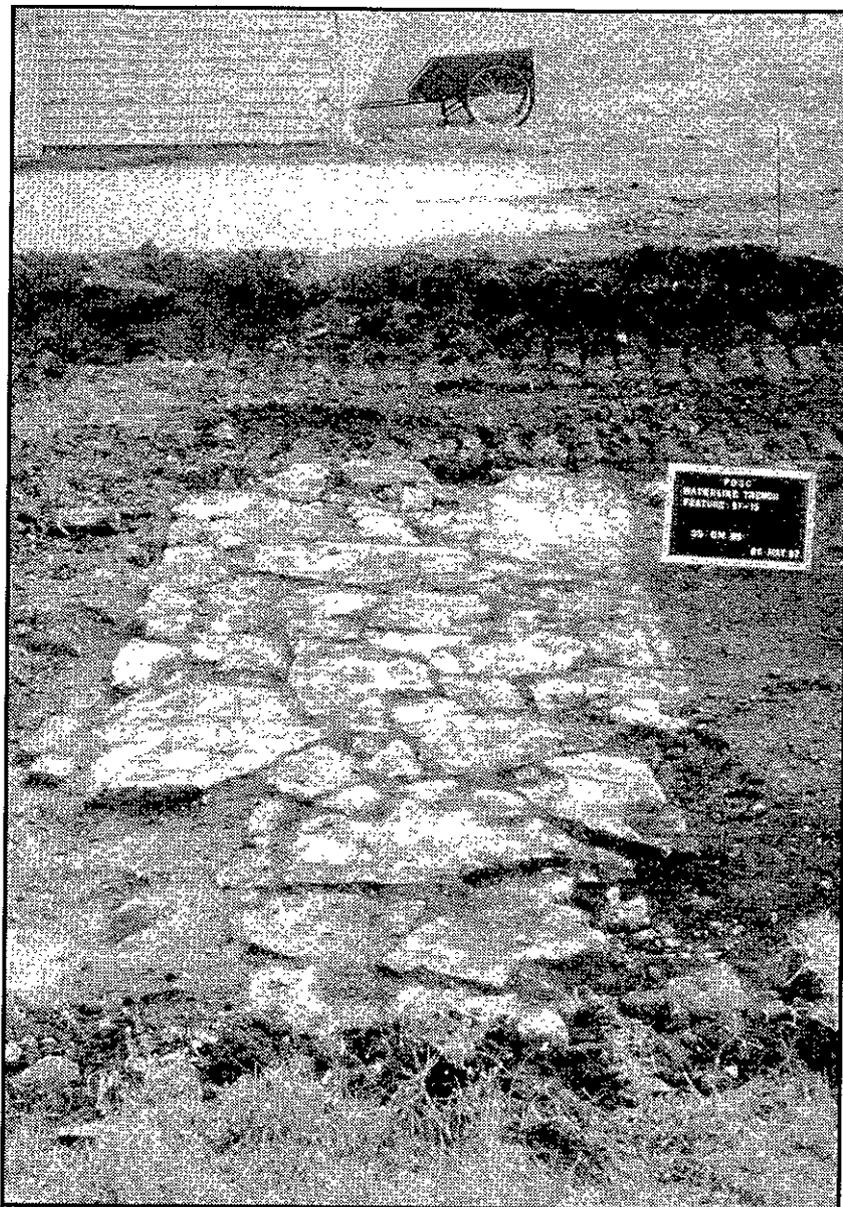
Figure 8. Feature 97-11, stone walk. The feature number that appears on the menu board is incorrect.

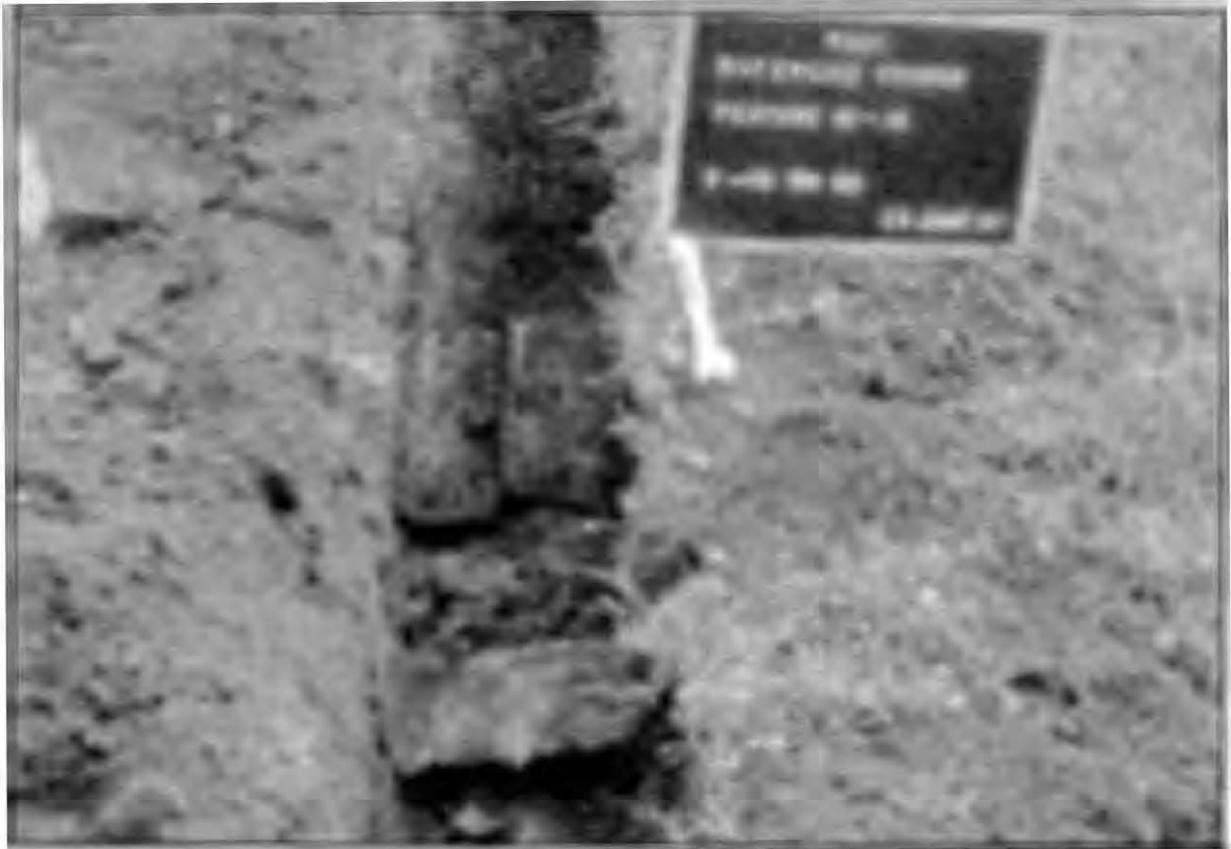
Figure 10. Feature 97-15, stone drain.

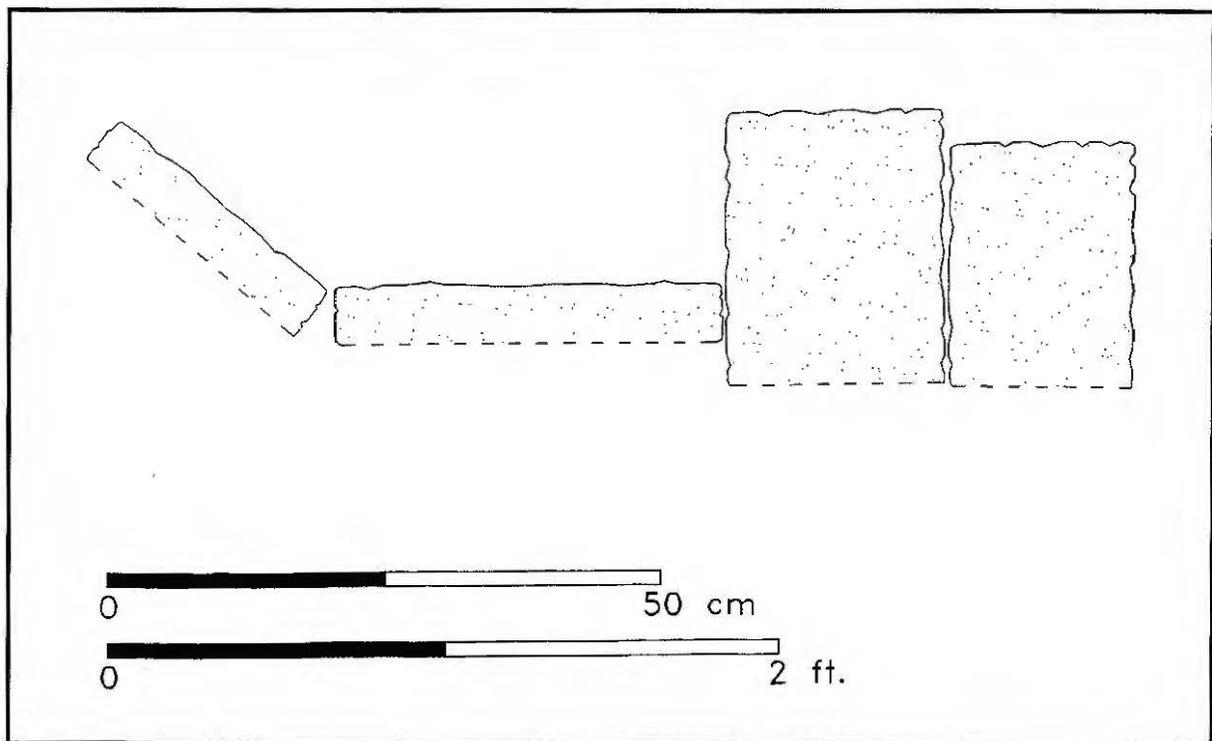
Figure 11. Profile of Feature 97-15, stone drain.

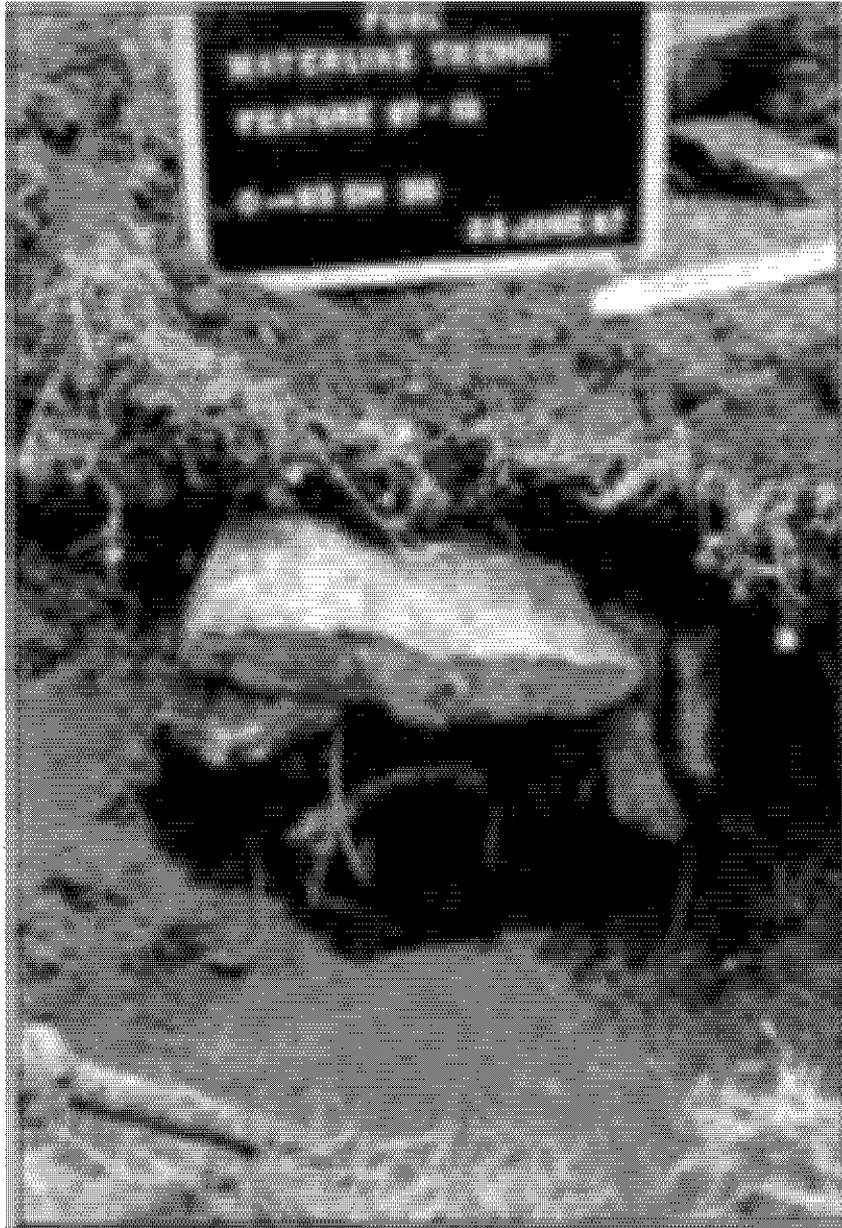
*Feature 97-16.* Foundation of the perimeter wall that surrounded the Officers' Row area and the north portion of the fort in the 1840s (Figure 12). It is 8.5 m (2.9 ft) south of the southeast corner of HS-32. It is constructed of limestone with no mortar and is 40 cm (16 in) wide. The wall on the west side of the trench has been disturbed by the placement of a 1-inch-diameter steel pipe, now abandoned.

Figure 12. Feature 97-16, perimeter wall.

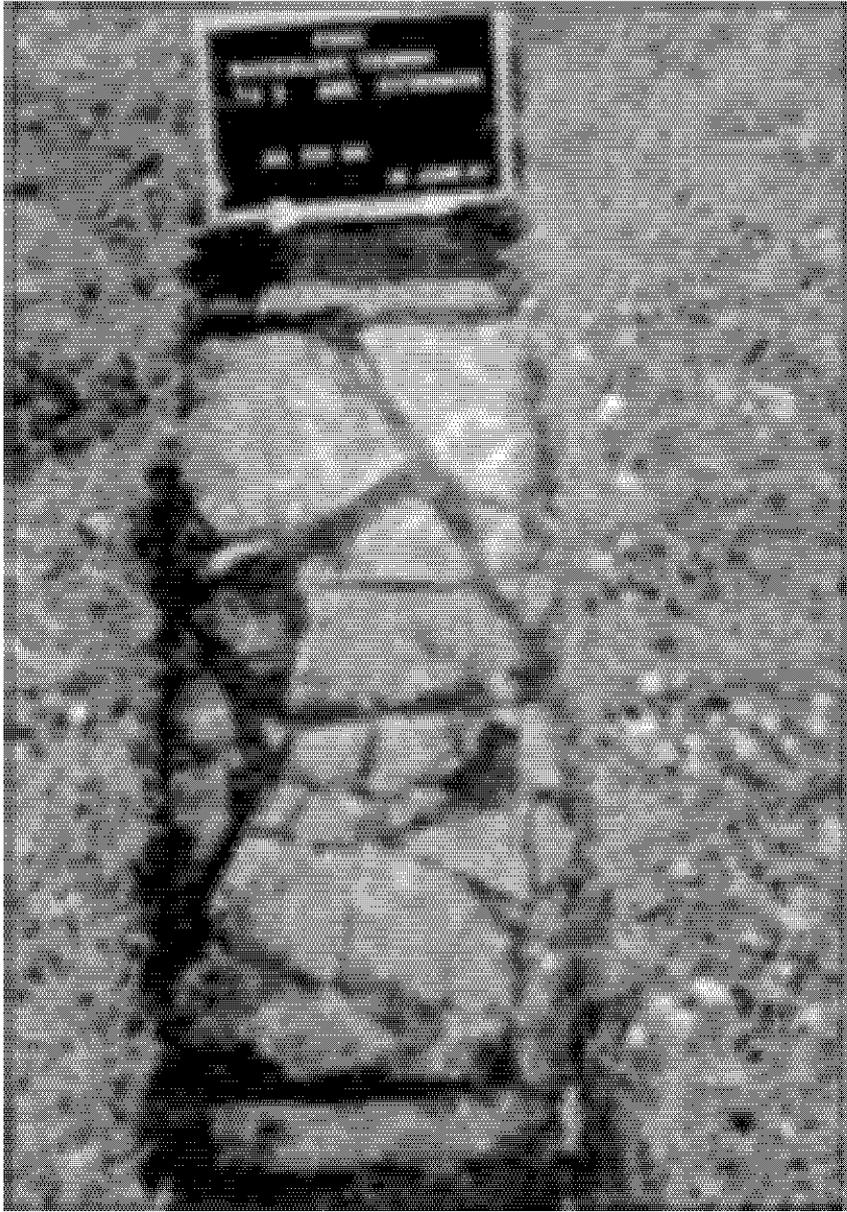
*Feature 97-19.* At 22 cm (8.6 in) below surface, a walkway was encountered (Figure 13). It is constructed of a single layer of tabular limestone, is 140 cm (56 in) wide, and is intact and in good condition. The edges of the walk are bounded by narrow pieces of limestone curb. This feature is extremely similar to the walkway uncovered by Clark in 1993 (Clark n.d.:10-11). That walkway went from HS-2 to an outbuilding (HS-35).

Figure 13. Feature 97-19, stone walk.
