Acadia National Park

Accessibility Assessment

FINAL REPORT

Findings and Recommendations

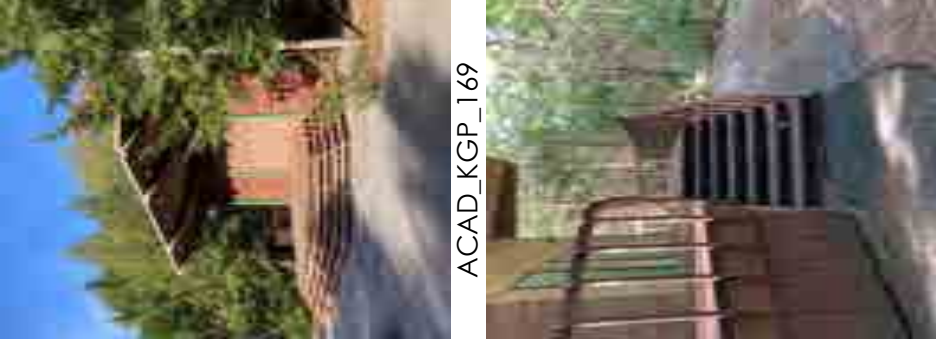
<p>ACAD_KGP_169</p> <p>ACAD_KGP_170</p>
<p>Reference Standards and Guidelines: ABA 405, 504</p>

<p>Location: Amphitheater</p> <p>Corrective Action: Close step risers, install bilateral hand railings, and install a temporary ramp</p>			
<p><u>Deficiency</u> The amphitheater stage does not have a ramp and its stairs have open risers and no hand railings.</p>	<p><u>Solution</u> To make the stage floor more accessible, close the risers on the steps and install bilateral hand railings on the stairs leading up to the amphitheater stage. If possible, consider adding a removable ramp to facilitate access.</p>	<p><u>Criticality</u> Serious</p> <p><u>Timeframe</u> Short-term</p>

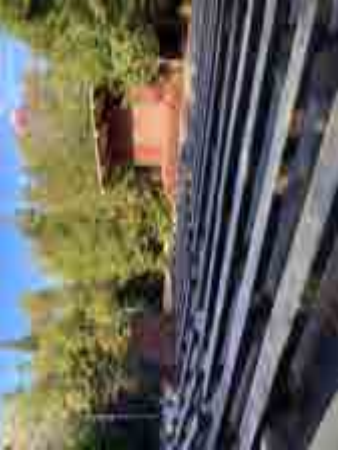
<p>Location: Amphitheater Corrective Action: Identify and mark accessible seating locations and train staff</p>			
<p><u>Deficiency</u> There is no accessible seating at the amphitheater.</p>	<p><u>Solution</u> Identify and mark accessible seating locations in the amphitheater. These accessible areas must be located on ground with a slope <1:48. Recommend identifying areas at stage right front and back and the front corners of the projection hut. Ensure park staff know where these locations are.</p>	<p><u>Criticality</u> Serious</p> <p><u>Timeframe</u> Immediate</p>

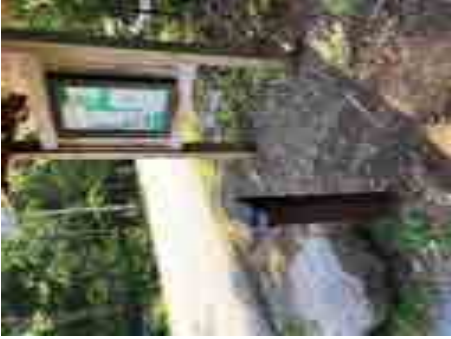
<p>ACAD_KGP_159</p>

<p>ACAD_KGP_164</p>
<p>Reference Standards and Guidelines: ABA 802.1</p>			
<p>Location: Amphitheater Corrective Action: Improve route to information kiosk and that there is clear ground space</p>			
<p><u>Deficiency</u> The route to the information kiosk located at the path from the parking lot to the amphitheater is too uneven.</p>	<p><u>Solution</u> Pave or improve the route to the information kiosk to be stable, firm, and slip resistant with a running slope <1:20, a cross slope <1/4 inch, openings <1/2 inch, changes in level <1/4 inch, and a width of >36 inches as well as with 30x48 inches of clear ground space.</p>	<p><u>Criticality</u> Serious</p> <p><u>Timeframe</u> Short-term</p>

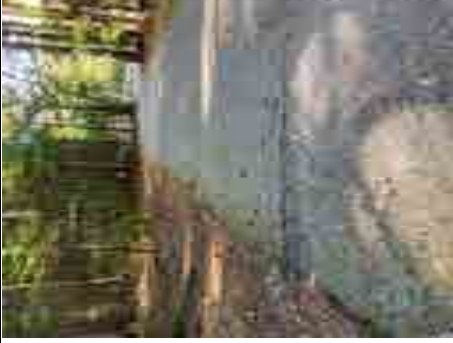
<p>Location: Amphitheater Path Corrective Action: Repave path</p>			
<p><u>Deficiency</u> The paved path to the amphitheater has a too-steep cross slope (2.4%) and its surface is too uneven.</p>	<p><u>Solution</u> Repave the path to meet standards of an accessible route including a stable, firm, and slip resistant surface and with running slope <1:20, a cross slope <1:48, openings <½ inch, changes in level <¼ inch, and a width of >36 inches.</p>	<p><u>Criticality</u> Serious</p> <p><u>Timeframe</u> Short-term</p>

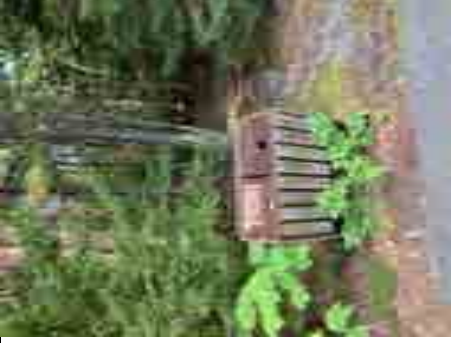
<p>ACAD_KGP_171</p>

<p>ACAD_KGP_160</p>
<p>Reference Standards and Guidelines: ABA 402, 403</p>			
<p>Location: Amphitheater Path Corrective Action: Bring the trash receptacle closer to the path</p>			
<p><u>Deficiency</u> The trash receptacle is outside of reach range of the accessible route.</p>	<p><u>Solution</u> Move the trash receptacle closer to the paved path to be within reach range for someone who has to stay on the paved path due to mobility impairments.</p>	<p><u>Criticality</u> Serious</p> <p><u>Timeframe</u> Immediate</p>

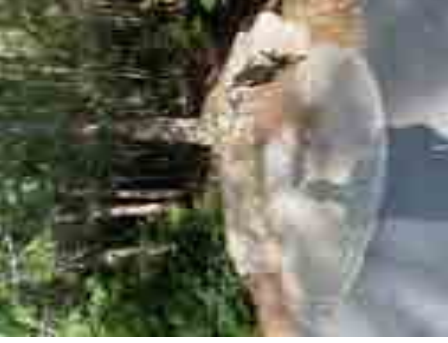
<p>Location: Amphitheater Path Corrective Action: Ensure clear space around all operable sides of the firepit</p>			
<p><u>Deficiency</u> The firepit to stage right in the amphitheater does not have enough clear space around it.</p>	<p><u>Solution</u> Ensure that there is 30x48 inches of clear space around all usable sides of the firepit to ensure someone who has mobility impairments can fully use the firepit.</p>	<p><u>Criticality</u> Serious</p> <p><u>Timeframe</u> Short-term</p>

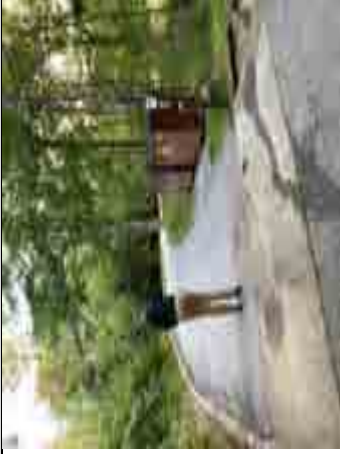
<p>ACAD_KGP_205</p>

<p>ACAD_KGP_172</p>
<p>Reference Standards and Guidelines: ABA 305</p>			
<p>Location: Dump Station Corrective Action: Widen road through the dump station</p>			
<p><u>Deficiency</u> The road at the dump site is too narrow (15.5 ft wide).</p>	<p><u>Solution</u> Widen the road to at least 20 ft to accommodate a vehicle and the necessary clear space required to move around the vehicle.</p>	<p><u>Criticality</u> Serious</p> <p><u>Timeframe</u> Short-term</p>

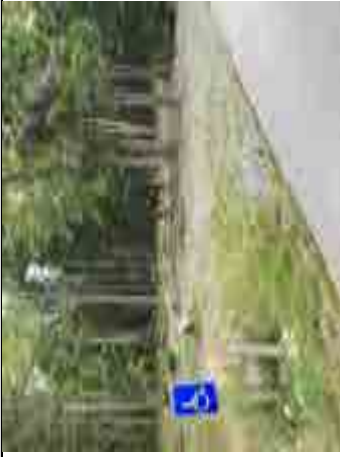
<p>Location: #G3 – Accessible Group Campsite Corrective Action: Replace at least one picnic table with an accessible picnic table</p>			
<p><u>Deficiency</u> There is only one accessible picnic table out of four picnic tables at the group side.</p>	<p><u>Solution</u> Replace at least one of the picnic tables with an accessible picnic table.</p>	<p><u>Criticality</u> Serious</p> <p><u>Timeframe</u> Immediate</p>

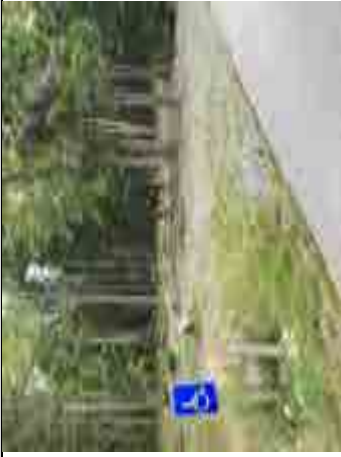
<p>ACAD_KGP_231</p>
<p>Reference Standards and Guidelines: ABA F244.2.3.1, F244.3, F245.2.5.1, and F244.5.3</p>			
<p>Location: Accessible Campsites Corrective Action: Smooth out the transition between the road and the campsite</p>			
<p><u>Deficiency</u> The transition between the accessible camp sites and the road is too large.</p>	<p><u>Solution</u> Decrease the transition between the two surfaces when adding the recommended ground surface material that is firm and stable.</p>	<p><u>Criticality</u> Critical</p> <p><u>Timeframe</u> Short-term</p>

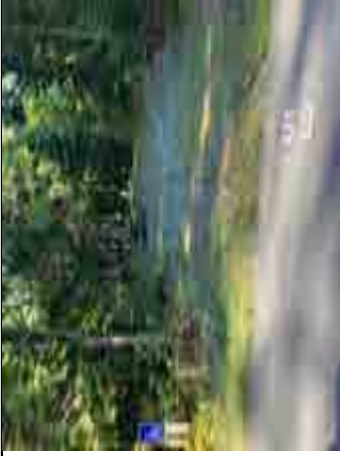
<p>Location: Accessible Campsites Corrective Action: Add firm, stable ground material</p>		
<p><u>Deficiency</u> The ground of the accessible campsites is not firm or stable.</p>	<p><u>Solution</u> Resurface ground of accessible campsites with material that is firm and stable. Recommend using ground material like that used on the carriage roads.</p>	<p><u>Criticality</u> Critical</p> <p><u>Timeframe</u> Short-term</p>

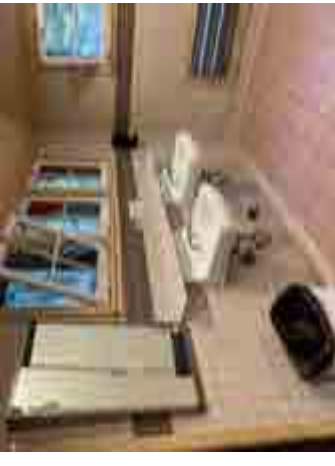
<p>ACAD_KGP_185</p>

<p>ACAD_KGP_181</p>
<p>Reference Standards and Guidelines: ABA 404.2.5, 404.2.9</p>			
<p>Location: Restrooms</p> <p>Corrective Action: Replace angled mirrors</p>			
<p><u>Deficiency</u> Current angled mirrors cause distorted views at some heights.</p>	<p><u>Solution</u> Avoid placing angled mirrors in the rest rooms to avoid distorted views. Ensure mirrors over countertops/lavatories are installed with the bottom edge of the reflecting surface no higher than 40 inches above the finish floor or ground. Ensure that mirrors not located above lavatories or countertops are installed with the bottom edge of the reflecting surface 35" maximum above the finish floor or ground.</p>	<p><u>Criticality</u> Minor</p> <p><u>Timeframe</u> Short-term</p>

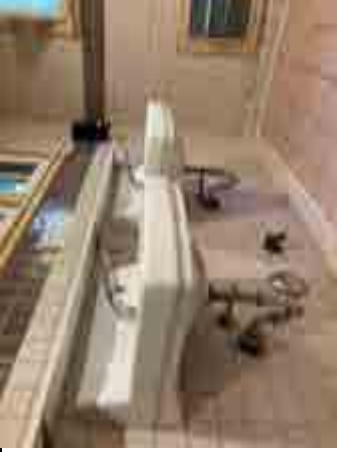
<p>ACAD_KGP_188</p>

<p>ACAD_KGP_183</p>
<p>Reference Standards and Guidelines: ABA 308</p>			
<p>Location: Restrooms Corrective Action: Wrap all exposed pipes under the sinks.</p>			
<p><u>Deficiency</u> The pipes are exposed under the sinks causing a safety risk.</p>	<p><u>Solution</u> Ensure all the pipes underneath the sinks are wrapped/insulated to avoid injury from sharp edges or hot/cold temperatures.</p>	<p><u>Criticality</u> Critical</p> <p><u>Timeframe</u> Immediate</p>

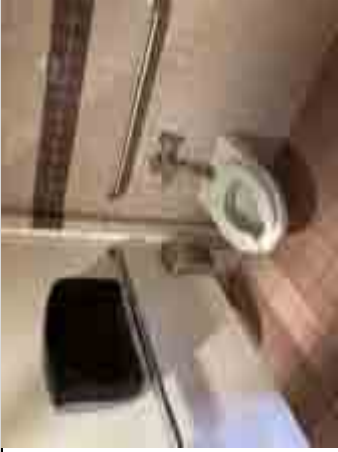
<p>Reference Standards and Guidelines: ABA</p>			
<p>Location: Restrooms</p> <p>Corrective Action: Ensure flush controls are located on the open side of the toilet</p>			
<p><u>Deficiency</u></p> <p>The flush controls are inconsistently positioned correctly throughout the park.</p>	<p><u>Solution</u></p> <p>Ensure the flush controls are located on the open side of the toilet in the accessible water closets to be within reach range for individuals with disabilities.</p>	<p><u>Criticality</u></p> <p>Critical</p> <p><u>Timeframe</u></p> <p>Short-term</p>

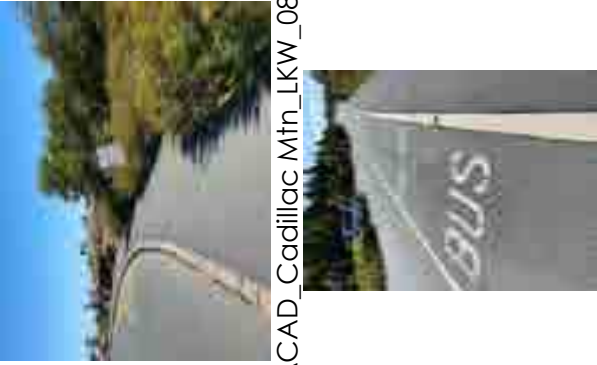
<p>ACAD_Cadillac Mtn_LKW_081</p> <p>ACAD_Cadillac Mtn_LKW_126</p>

<p>Recommended in the interim: identify and mark clear space for a passenger loading zone that connects to an access aisle with a curb cut. Instruct vendors on using this space.</p>	<p><u>Criticality</u> Serious</p> <p><u>Timeframe</u> Immediate</p>

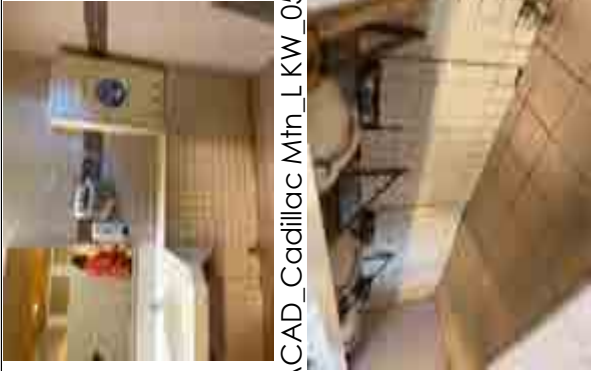
<p>ACAD_Cadillac Mtn_LKW_051</p> <p>ACAD_Cadillac Mtn_LKW_046</p>

<p>ACAD_Cadillac Mtn_LKW_044</p>
<p>Reference Standards and Guidelines: ABAAS 703.4.1 Sign Installation Height</p>			
<p>Location: Restrooms</p> <p>Corrective Action: Lower mounted fixtures and cover exposed pipes</p>			
<p><u>Deficiency</u> Both restrooms have exposed pipes under the sinks and mounted fixtures that are too high to be used by individuals seated in a wheelchair. These include hooks on the walls and changing tables (handle at >57").</p>	<p><u>Solution</u> Move and reinstall fixtures to ABA standards (48 inches or lower) and cover exposed pipes and other sharp edges beneath sinks.</p>	<p><u>Criticality</u> Serious</p> <p><u>Timeframe</u> Short-term</p>

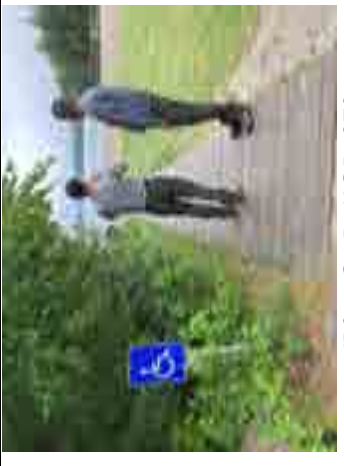
<p>NPS_ACAD_KGP_073</p>

Location: Echo Lake Beach - Boardwalk			
Corrective Action: Reconstruct curve in the boardwalk			
<p><u>Deficiency</u> The gaps between the boards at the curve of the boardwalk are too large (5/8-inch to 1.5-inches).</p>	<p><u>Solution</u> Reconstruct the curve of the boardwalk to decrease the gap between the boards to less than ½ inch.</p>	<p><u>Criticality</u> Critical <u>Timeframe</u> Immediate</p>	  <p>NPS_ACAD_KGP_070</p>
Reference Standards and Guidelines: ABA 302.3, 403			
Location: Echo Lake Beach - Parking Lot			
Corrective Action: Add two signs marking the accessible route down to the beach			
<p><u>Deficiency</u> There is no sign indicating the accessible route from the parking lot to the beach. The sign indicating the accessible route is at the bottom of the paved path at the start of the boardwalk.</p>	<p><u>Solution</u> Add a sign at the parking lot in front of the stairway directing the public to the accessible route. Add a sign in front of the paved route down to the beach indicating the accessible route.</p>	<p><u>Criticality</u> Serious <u>Timeframe</u> Immediate</p>

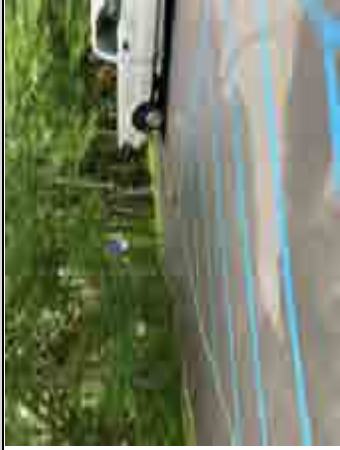
<p>Location: Echo Lake Beach - Parking Lot Corrective Action: Raise sign identifying the van accessible parking space</p>			
<p><u>Deficiency</u> The sign marking the van accessible parking space is too low (56.5 inches).</p>	<p><u>Solution</u> Recommend raising the sign marking the van accessible parking space to >60 inches.</p>	<p><u>Criticality</u> Minor</p> <p><u>Timeframe</u> Immediate</p>

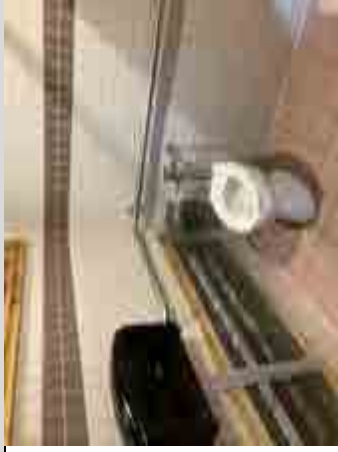
NPS_ACAD_KGP_092

NPS_ACAD_KGP_093
Reference Standards and Guidelines: ABA 606.5			
Location: Echo Lake Beach – Men’s and Women’s Restrooms			
Corrective Action: Increase the accessibility of features within the accessible rest room stalls			
<u>Deficiency</u> The flush control is on the closed side of the toilet, out of reach range. The sanitary basket is behind the toilet, out of reach range. The grab bars are not oriented correctly.	<u>Solution</u> Replace the toilet with one that has the flush control on the open side of the toilet to be within reach range of individuals so they are able to flush. Move the sanitary basket to the open side of the toilet so that individuals do not have to reach across the toilet bowl to access the sanitary basket. Flip grab bar around to orient the long end along the side wall and the shorter end around the long wall. (The side wall grab bar shall be 42 inches long minimum, located 12 inches maximum from the rear wall and extending 54 inches minimum from the rear wall. The rear wall grab bar shall be 36 inches	<u>Criticality</u> Serious <u>Timeframe</u> Short-term

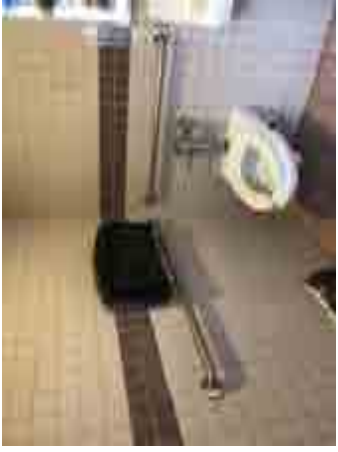
<p style="text-align: center;">ACAD_Fabbri_LMK_079</p>

<p style="text-align: center;">ACAD_Fabbri_LMK_081</p>
Reference Standards and Guidelines: ABBAS 308.2.1			
Location: Family Restroom			
Corrective Action: Replace toilet			
<p><u>Deficiency</u> The flusher is on the wrong side of the toilet.</p> <p>Toilet seat is too high.</p>	<p><u>Solution</u> Replace the toilet with one that has the flush control on the open side of the toilet to be within reach range, so individuals may be able to flush.</p> <p>Toilet seat height should be 17-19" to comply with accessibility standards.</p>	<p><u>Criticality</u> Serious</p> <p><u>Timeframe</u> Short-term</p>

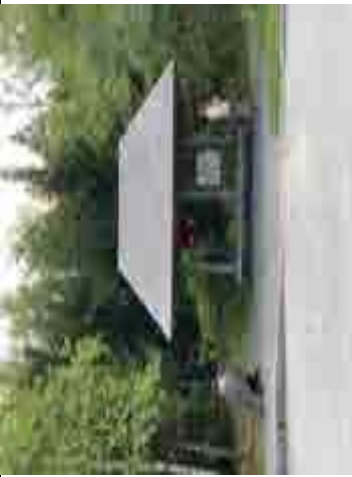
ACAD_KGP_216
Reference Standards and Guidelines: ABA F206, 402, 1016			
Location: Seawall Campground Shuttle Stop			
Corrective Action: Replace ground material with material that is firm and stable			
<u>Deficiency</u> The ground at this shuttle stop is too loose and too steep of a grade.	<u>Solution</u> Resurface with ground material that is firm and stable and level grade to <1:48.	<u>Criticality</u> Serious <u>Timeframe</u> Short-term

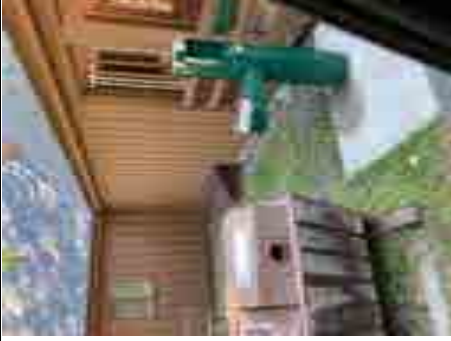
<p>ACAD_KGP_002</p>
Reference Standards and Guidelines: ABA 305			
Location: Ranger's Station			
Corrective Action: Relocate bench			
<p><u>Deficiency</u> The bench is not along an accessible route.</p>	<p><u>Solution</u> Relocate the bench along an accessible route to improve access for all individuals.</p>	<p><u>Criticality</u> Minor</p> <p><u>Timeframe</u> Immediate</p>

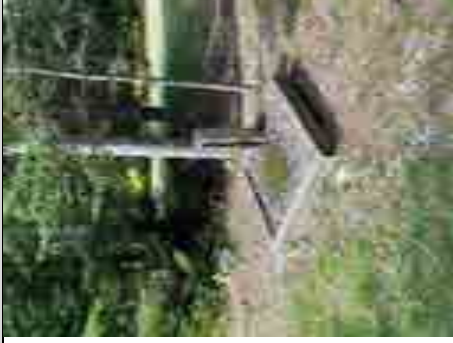
<p>ACAD_KGP_028</p>

<p>ACAD_KGP_026</p>
<p>Reference Standards and Guidelines: ABA 1011.2.1</p>			
<p>Location: Throughout Campground Corrective Action: Replace all water spigots</p>			
<p><u>Deficiency</u> The water spigots throughout the campground are not accessible.</p>	<p><u>Solution</u> Redesign the water spigots to ensure there is a minimum of 30"x60" of clear ground space (with the long side of the space adjoining or overlapping the pull-up space for campers).</p>	<p><u>Criticality</u> Serious</p> <p><u>Timeframe</u> Short-term</p>

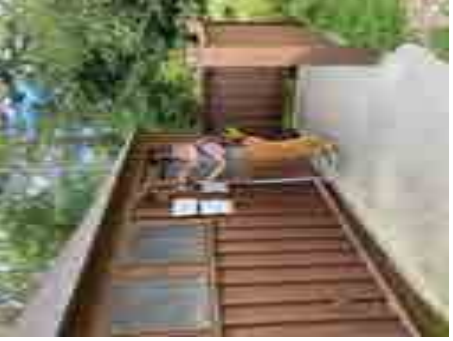
<p>ACAD_KGP_034</p>

<p>ACAD_KGP_035</p>
<p>Reference Standards and Guidelines: ABA 404.2.5</p>			
<p>Location: Restrooms Corrective Action: Perform routine maintenance on the door to reduce door opening pressure. Ensure restroom sign appropriate height.</p>			
<p><u>Deficiency</u> The exterior doors of the restrooms are too difficult to open.</p>	<p><u>Solution</u> Perform routine maintenance on the door to reduce door opening pressure.</p> <p>Ensure the sign marking the restroom is placed on the handle side of the door and that the tactile characters are located between 48" - 60" above the ground.</p>	<p><u>Criticality</u> Serious</p> <p><u>Timeframe</u> Immediate</p>

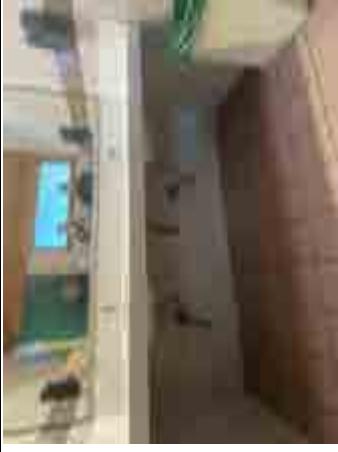
<p>ACAD_Thompson Picnic_LKW_011</p>

<p>ACAD_Thompson Picnic_LKW_001</p>
<p>Reference Standards and Guidelines: ABBAS 606.5</p>			
<p>Location: Men's Restroom</p> <p>Corrective Action: Wrap pipes under sink</p>			
<p><u>Deficiency</u> Pipes under sink are exposed.</p>	<p><u>Solution</u> Wrap the pipes under the sinks in the Restrooms to prevent injury from hot/cold and sharp edges for someone who uses a wheelchair and positions their legs under the sink while washing their hands.</p>	<p><u>Criticality</u> Critical</p> <p><u>Timeframe</u> Immediate</p>

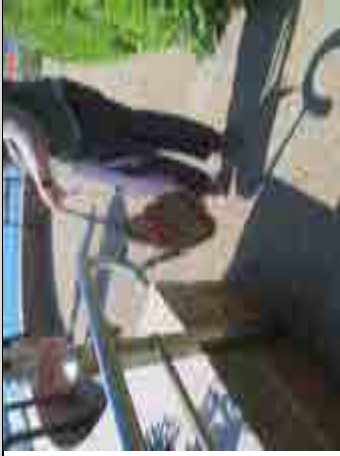
<p>NPS_ACAD_MEC_080</p>

<p>NPS_ACAD_LKW_401</p>
<p>Reference Standards and Guidelines: ABBAS 404.2.3</p>			
<p>Location: Thunder Hole Viewing Area</p> <p>Corrective Action: Replace handrails</p>			
<p><u>Deficiency</u></p> <p>Current handrails are not standard across the area and are not in compliance with ABA standards.</p>	<p><u>Solution</u></p> <p>Replace handrails with grippable rails that fully return on both ends. Handrails should be continuous, on both sides of stairs, and within appropriate height range.</p>	<p><u>Criticality</u></p> <p>Serious</p> <p><u>Timeframe</u></p> <p>Short-term</p>
