COLORADO CULTURAL RESOURCE SURVEY

# Architectural Inventory Form

1. Resource number: 5OT.1728
2. Temporary resource number: N/A
3. County: Otero
4. City: La Junta
5. Historic building name: Bent's Old Fort (Reconstructed)
6. Current building name: Bent's Old Fort (Reconstructed)
7. Building address: 35100 State Highway 194 East, La Junta, CO 81050
8. Owner name and address: National Park Service, Intermountain Region, P.O. Box 25287, Denver, CO 80225

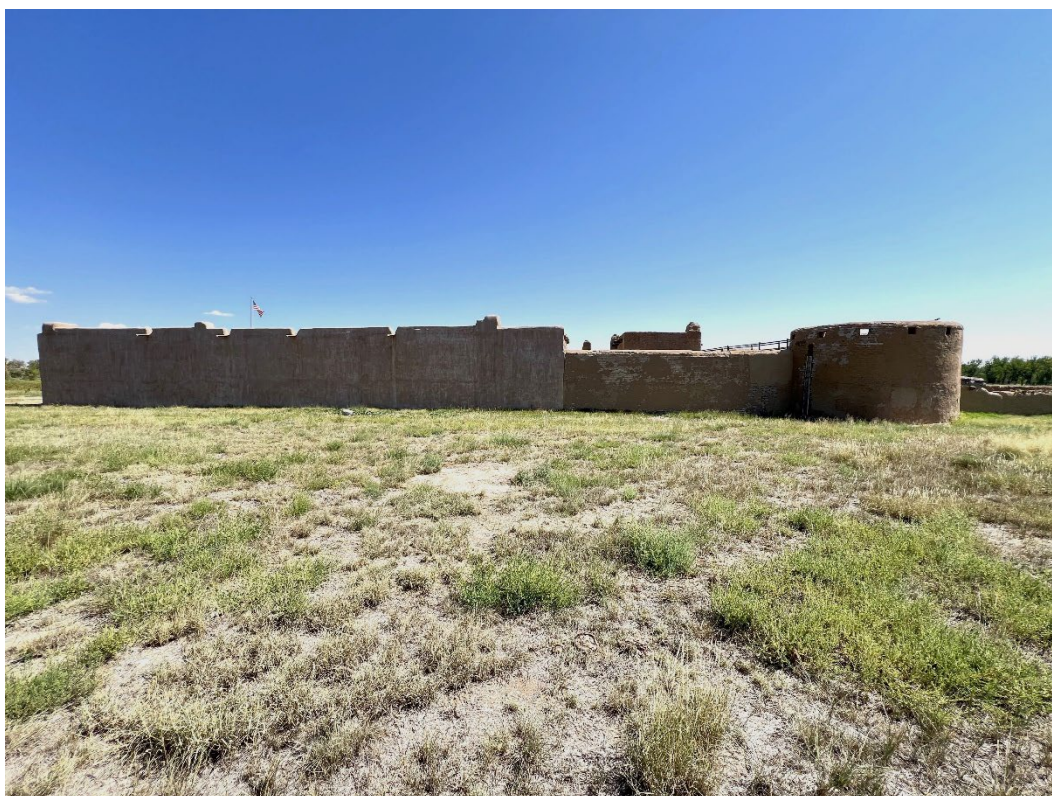
**Photo Number:** 50T.1728\_3

**Description:** Looking at the west elevation of the resource. Note the material transition in the center of the elevation.

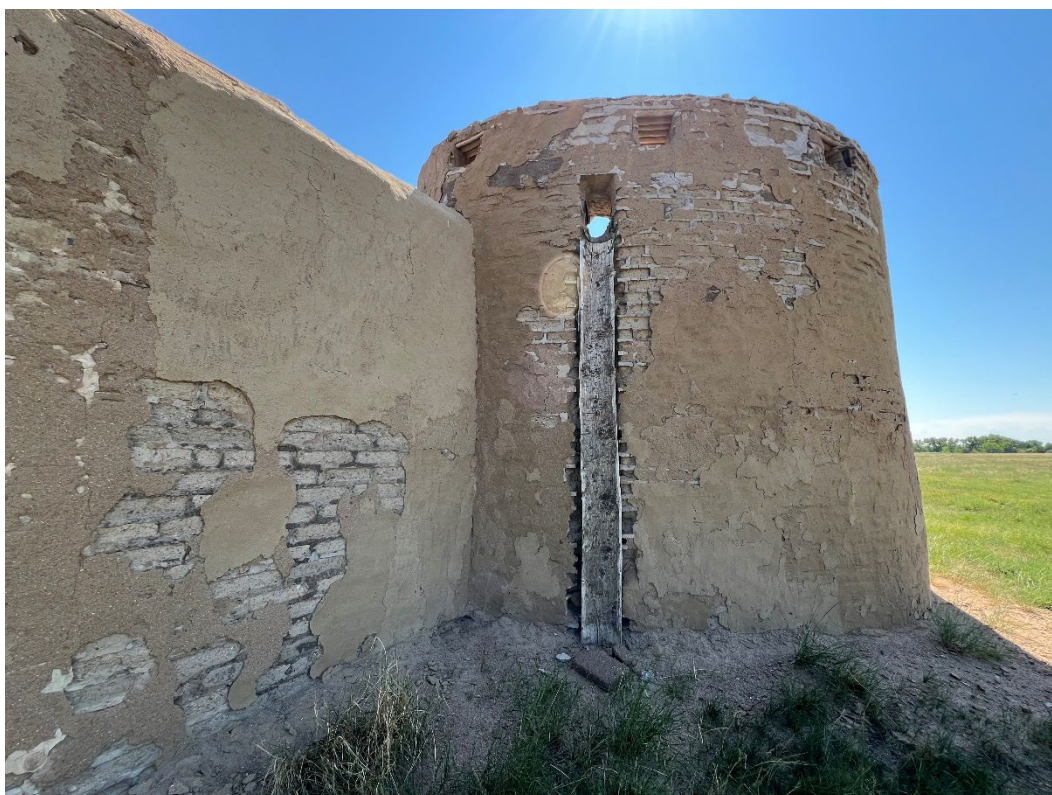
**Photo Number:** 50T.1728\_4

**Description:** Detailed view of the southwest bastion. Note the erosion of the exterior wall, exposing the inner core of the wall.

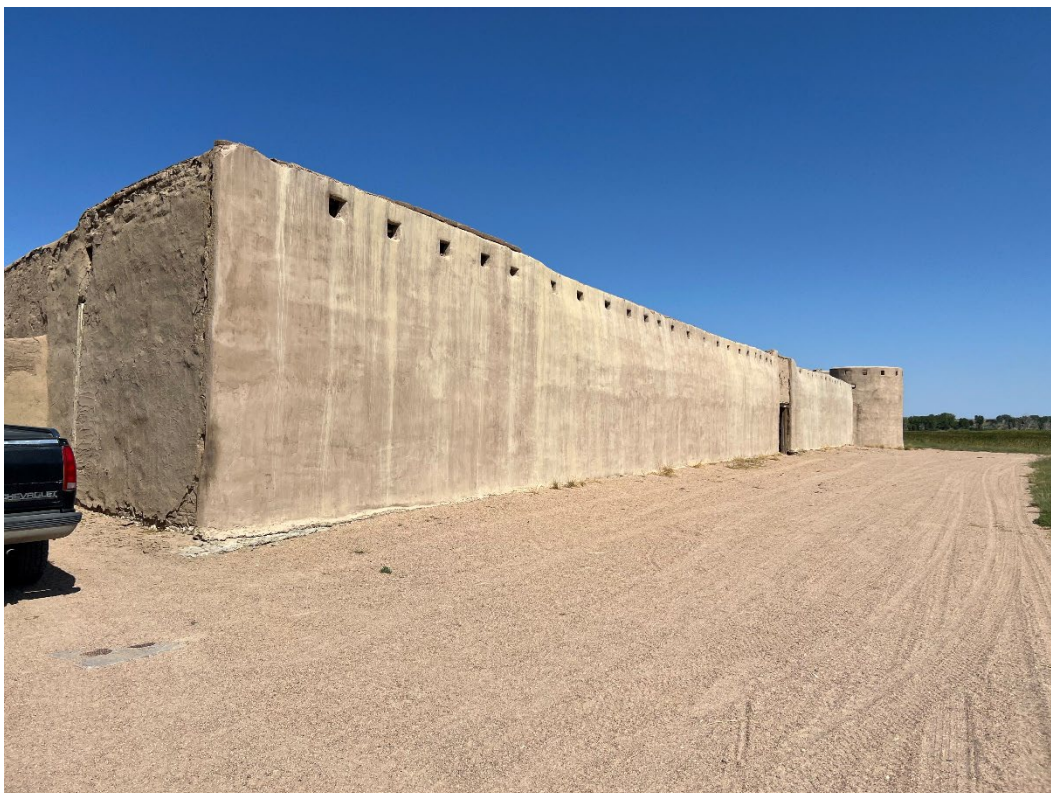
**Photo Number:** 5OT.1728\_8

**Description:** Looking at the east elevation of the resource. Note the concrete exterior wall separating from the inner adobe wall on the far-left side of the photo.

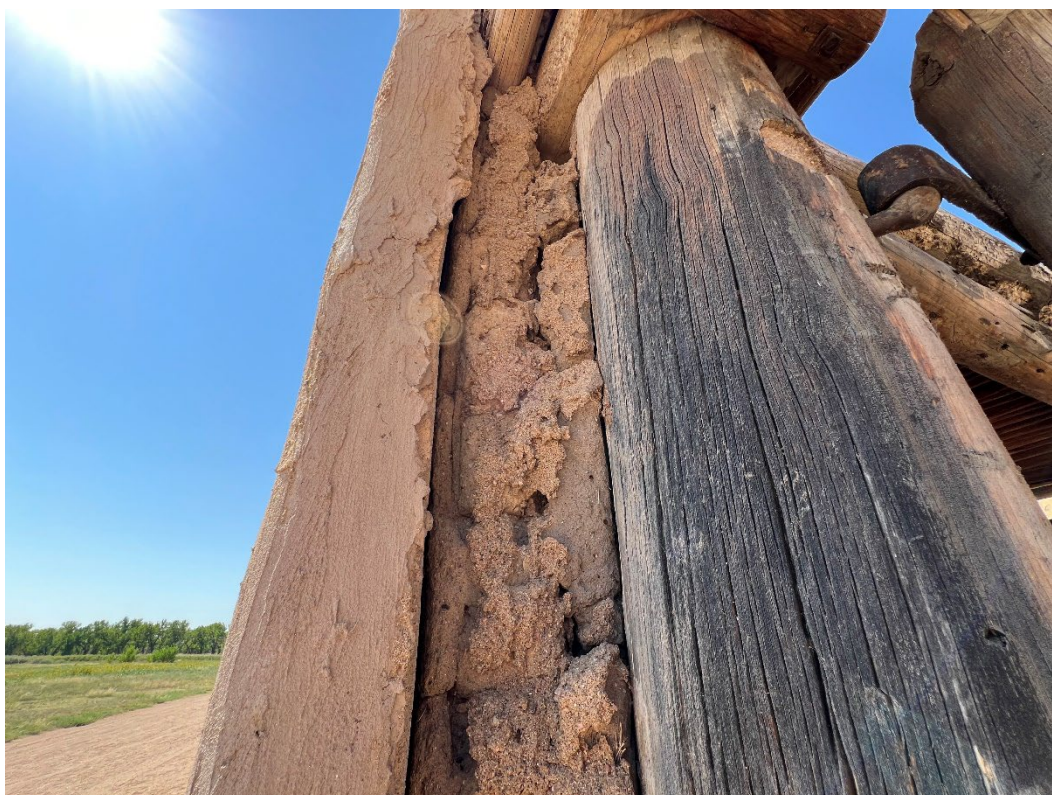
**Photo Number:** 5OT.1728\_10

**Description:** Detail image illustration the various layers of exterior wall over time. Note the degraded state of the interior wall space.

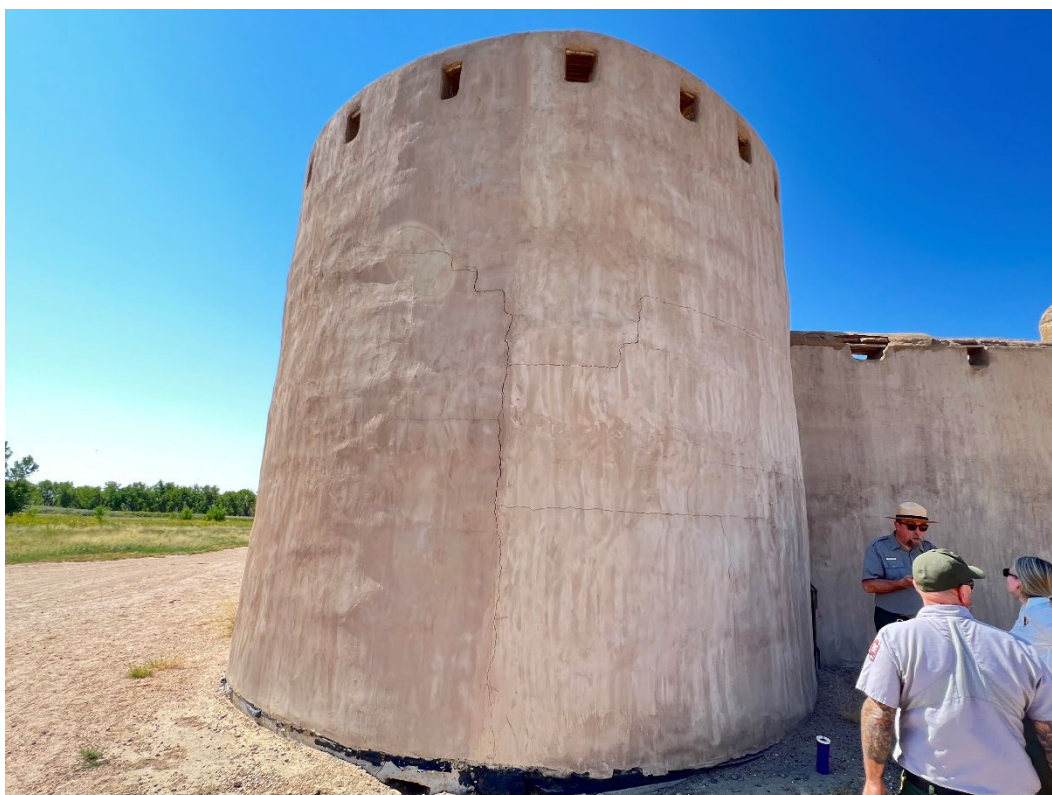
**Photo Number:** 50T.1728\_12

**Description:** Note the considerable cracking of the exterior wall of the northeast bastion.

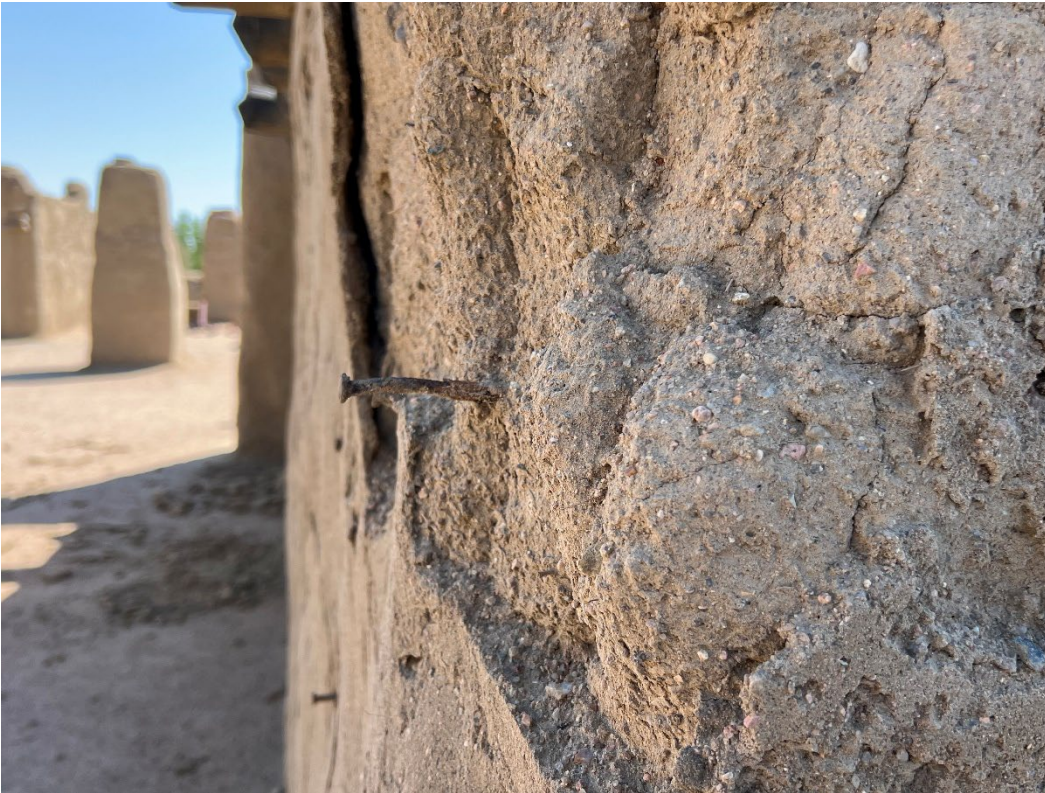
**Photo Number:** 5OT.1728\_17

**Description:** Additional photo illustrating the severe erosion of the exterior wall. Note that the nail was formerly flush with the exterior wall.

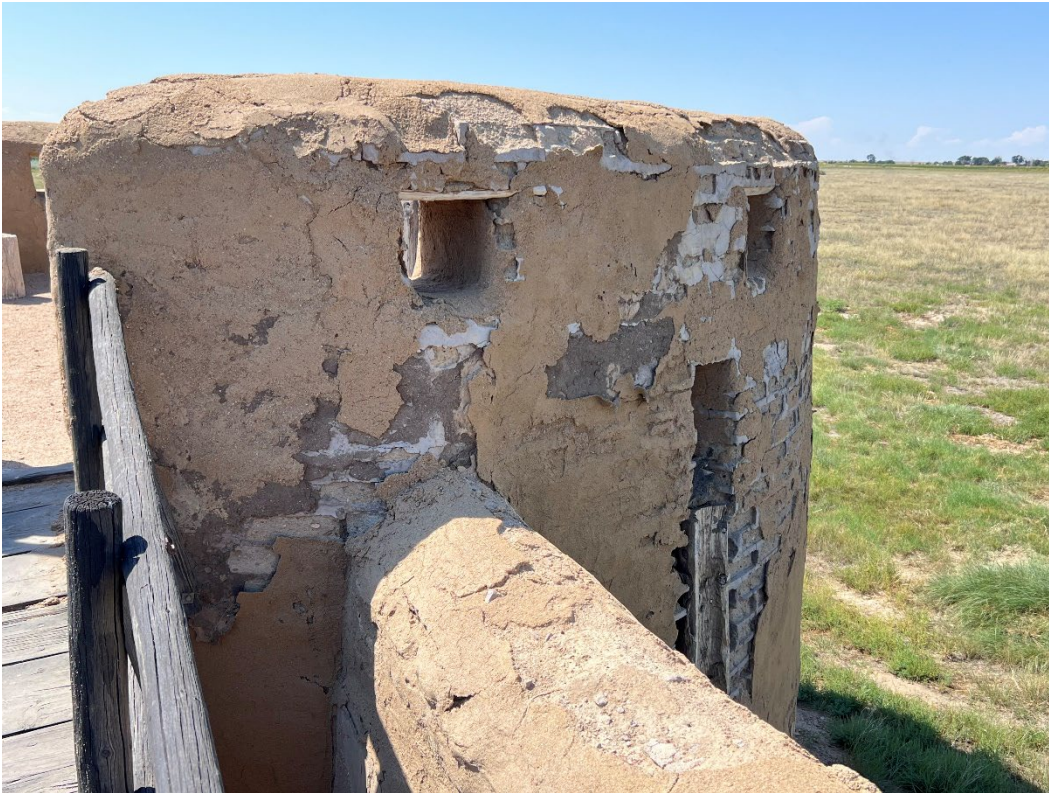
**Photo Number:** 5OT.1728\_19

**Description:** Additional photo showing the erosion along the exterior wall of the southwest bastion.

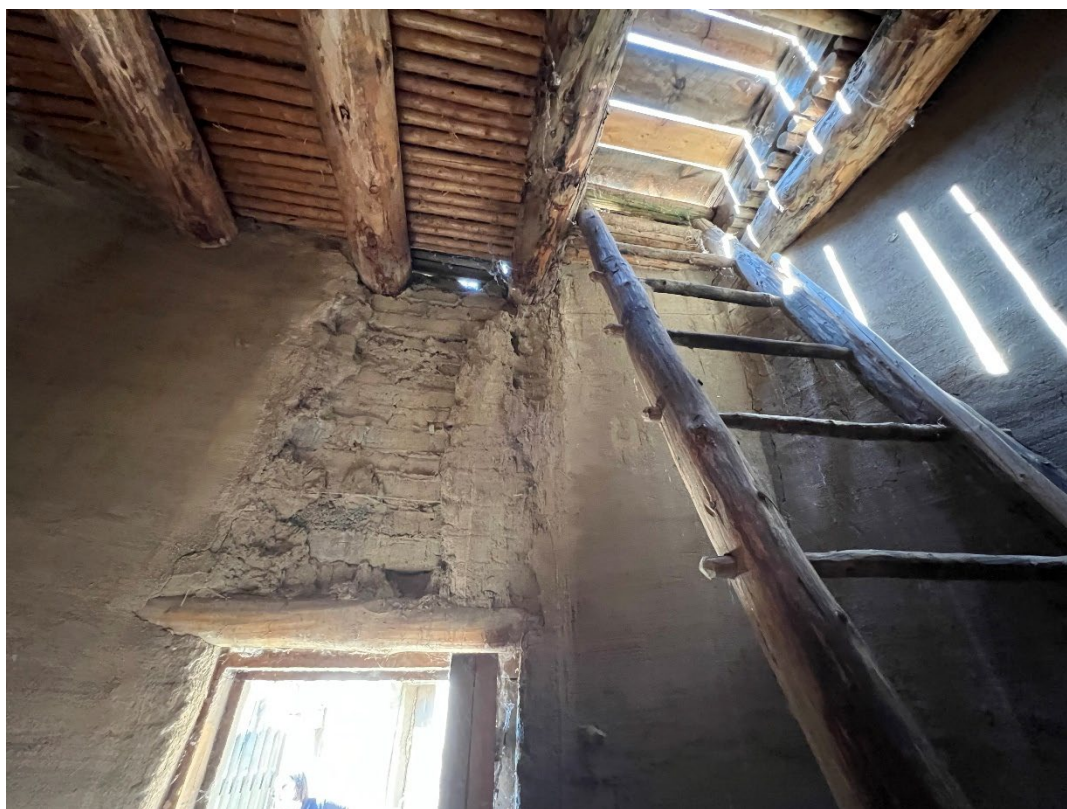
**Photo Number:** 5OT.1728\_21

**Description:** Note the severe erosion of the interior wall.

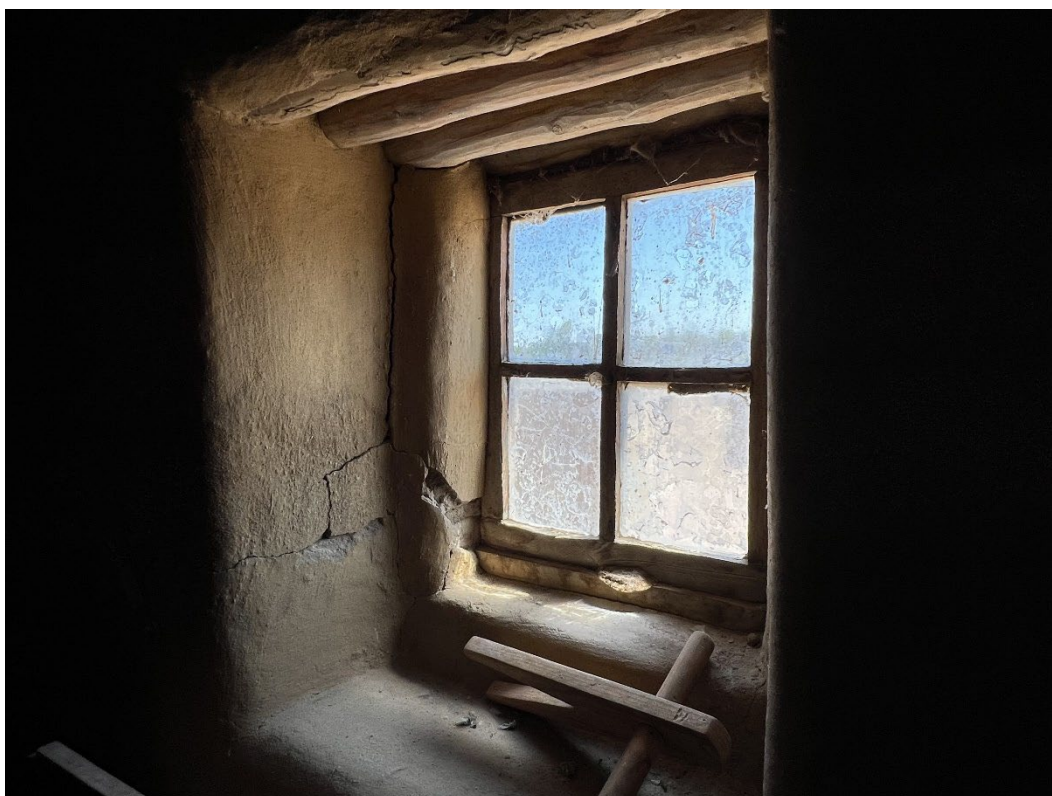
**Photo Number:** 50T.1728\_23  
**Description:** Example of a four-lite window. Note the wall cracking around the frame.  
**View:** Detail

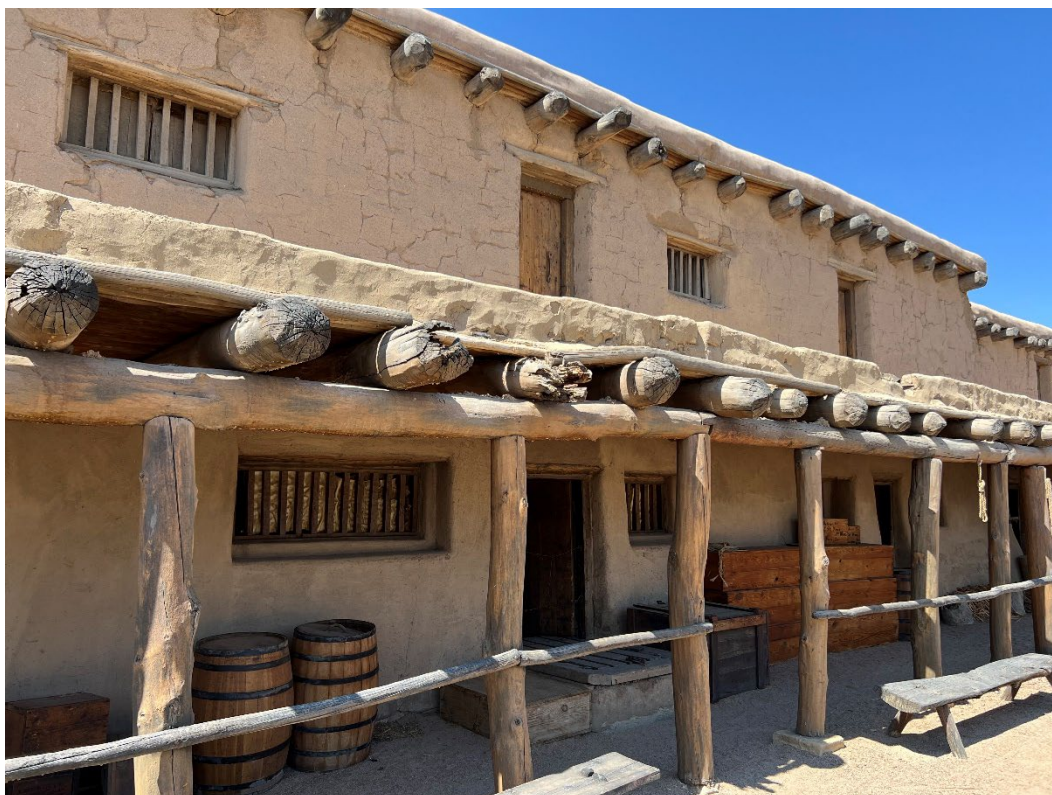
**Photo Number:** 5OT.1728\_29

Post-construction design analysis also highlighted the inherent flaws of the reconstructed fort such as the reinforced concrete bond beams, which didn't account for easy replacement of viga tails as they deteriorated over time. The placement of the viga tails themselves were not period correct, nor were they pressure treated to resist the demanding weather environment of the area. As such, the viga tails exhibited signs of accelerated rotting. Cottonwood beams and support column bases are also composed of incompatible materials. There are several areas where the horizontal joints of cottonwood beams are not properly supported directly underneath vertical columns. Material incapability was also evident. Contact between the adobe mud materials and metal conduit and piping under the flooring resulted in the abandonment of these utilities due to excessive corrosion. Furthermore, sheet metal flashing along the vertical surfaces of the roofing also exhibited a high amount of corrosion. Additionally, the original Bituthane roofing began to fail almost immediately after the fort was reconstructed. Historical records indicate that the material was "fragile and vulnerable to degradation by the sun. Bituthane was a new product on the market in 1976 and relatively untested... there was a problem of incompatibility with the corrosive adobe mud in contact with the sheet metal flashing." Overall, the high cost of maintenance and upkeep of the new fort in the years after its completion led to a push for finding alternative materials that were more resistant to climatic and structural factors. Yet, these changes gradually weakened the "accurate" design of the reconstructed fort.

**Description:** Photograph illustrating the damage to exposed vigas on second level of plaza.

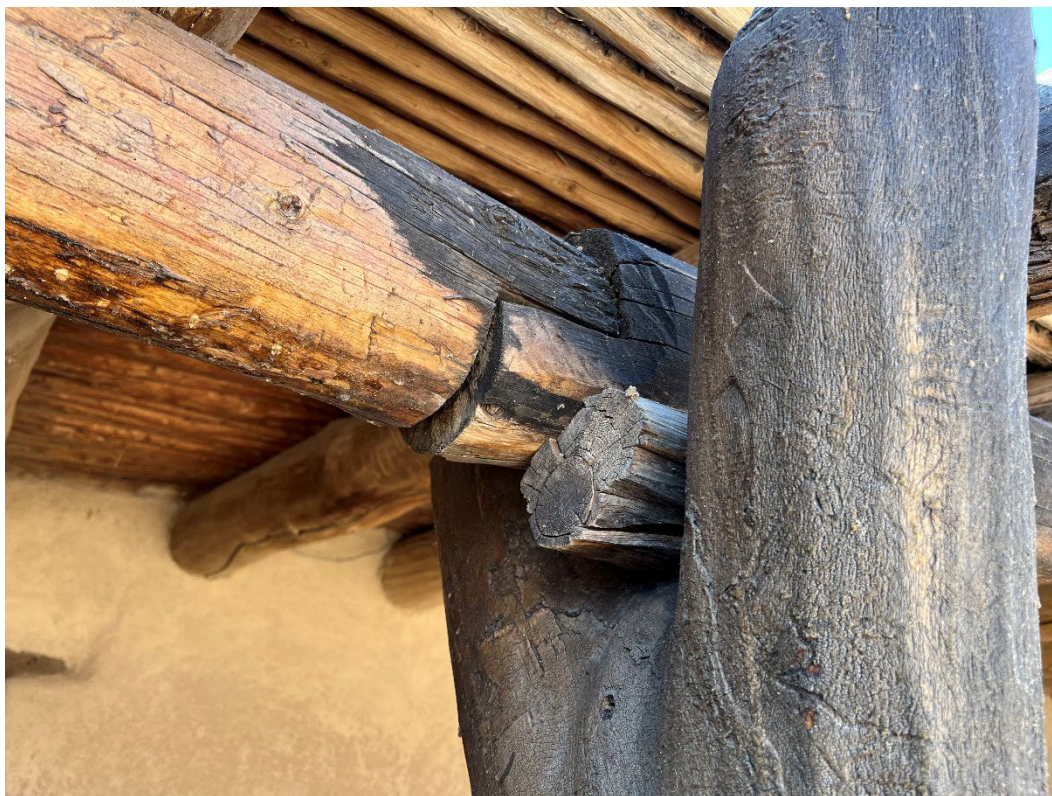
**Photo Number:** 5OT.1728\_30

incompatible materials, and in several areas, horizontal joints of the cottonwood beams lacked proper support directly beneath the vertical columns. Material incompatibilities were also evident, particularly with the metal conduit and piping beneath the floors, which corroded from contact with the adobe mud. Similarly, sheet metal flashing along the vertical roofing surfaces deteriorated due to exposure to the same adobe materials. Furthermore, the original Bituthane roofing began to fail almost immediately after the fort's reconstruction. In the years and decades following the fort's completion, the high cost of maintenance and upkeep prompted efforts to find alternative materials more resistant to the challenging climatic conditions and structural demands. These alternative materials, in turn, undermined the "authentic" design of the reconstructed fort.

**Description:** Photograph illustrating an improperly placed joint.

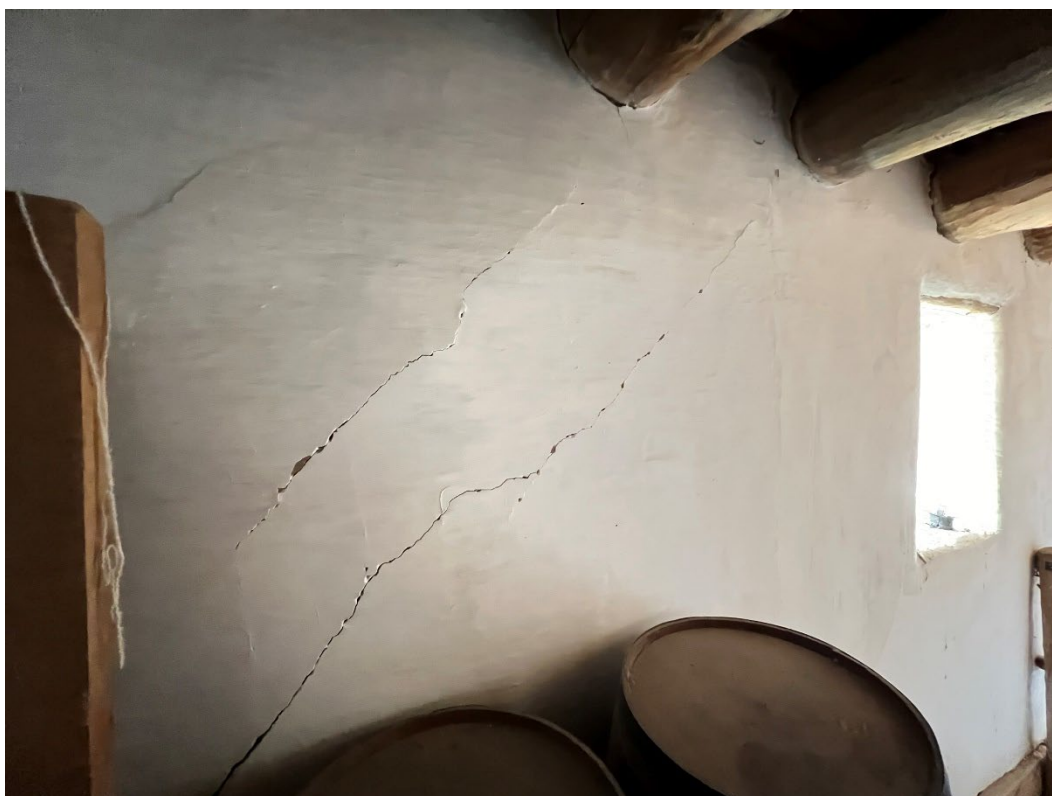
**Photo Number:** 50T.1728\_31

**Description:** Interior photograph showing severe cracking of interior wall.

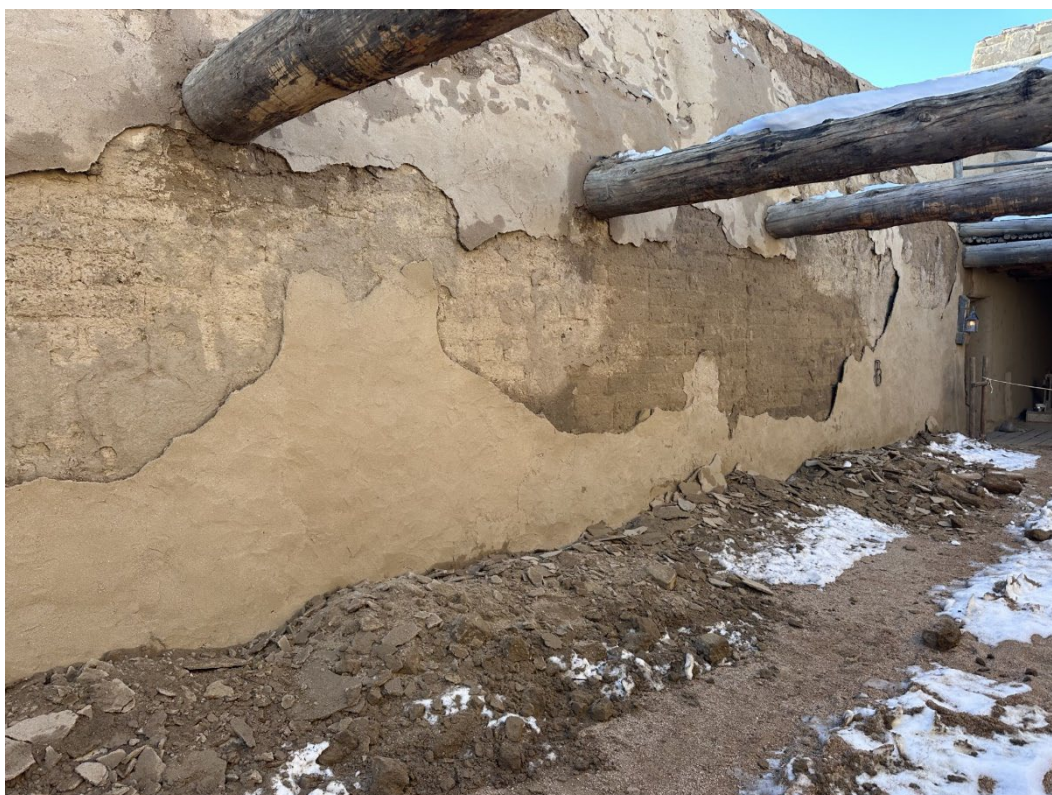
**Photo Number:** 50T.1728\_32

**Description:** Photograph illustrating exterior wall damage due to recent snowfall in November 2024.

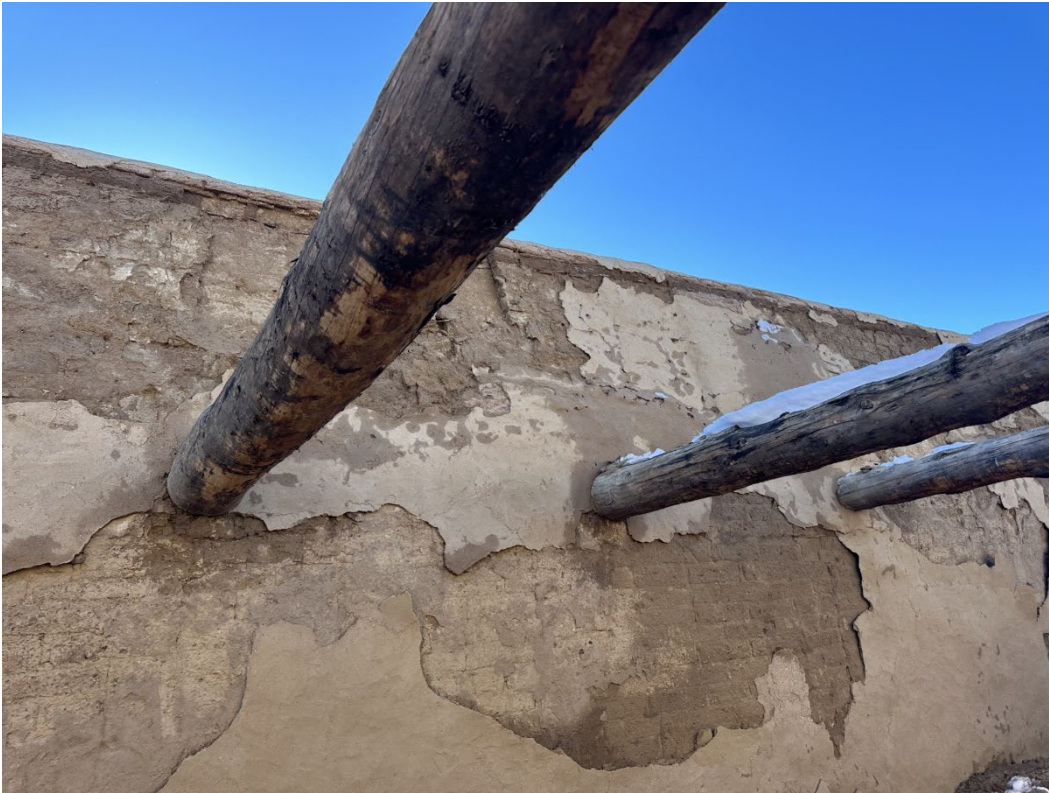
**Photo Number:** 5OT.1728\_33

**Description:** Additional photograph illustrating exterior wall damage from recent snowfall in November 2024.

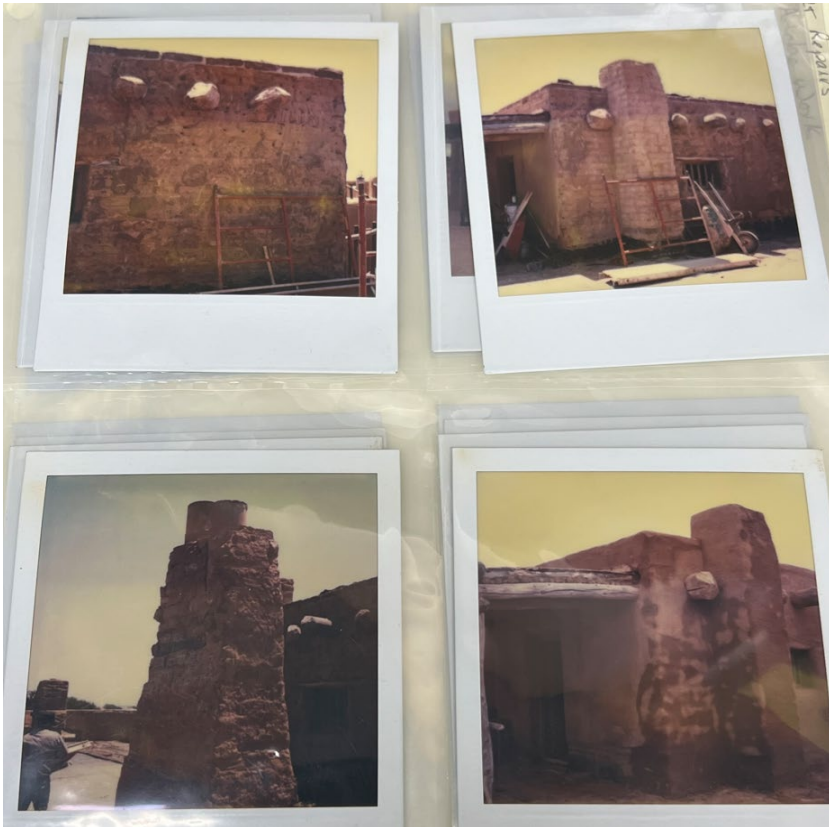
**Description:** Historical photographs showing damage and repair work to chimneys. Photos dated: 1988.

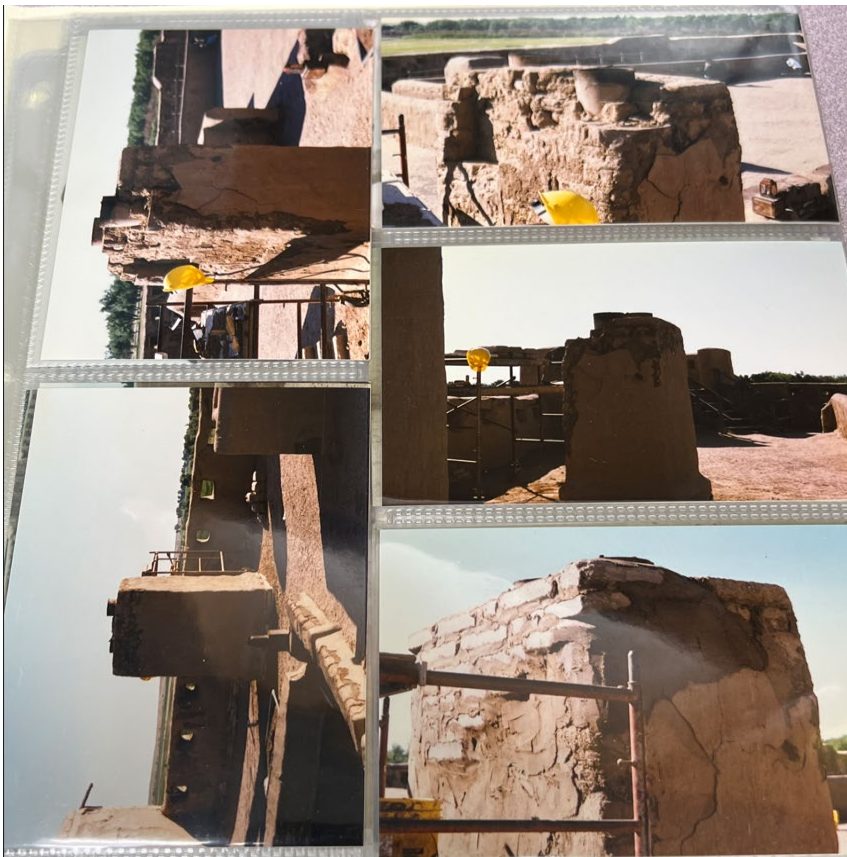
**Reference Photo 7**

**Description:** Photographs illustrating erosion and damage in various areas around the reconstructed fort. Photos Dated: 1996
