**Rehabilitation and Testing  
of 3 Water Supply Wells  
in the Castolon Area,  
Big Bend National Park**

**May 14, 2002**

Larry Martin  
NPS Water Resources Division  
1201 Oakridge Drive, Suite 250  
Fort Collins, CO

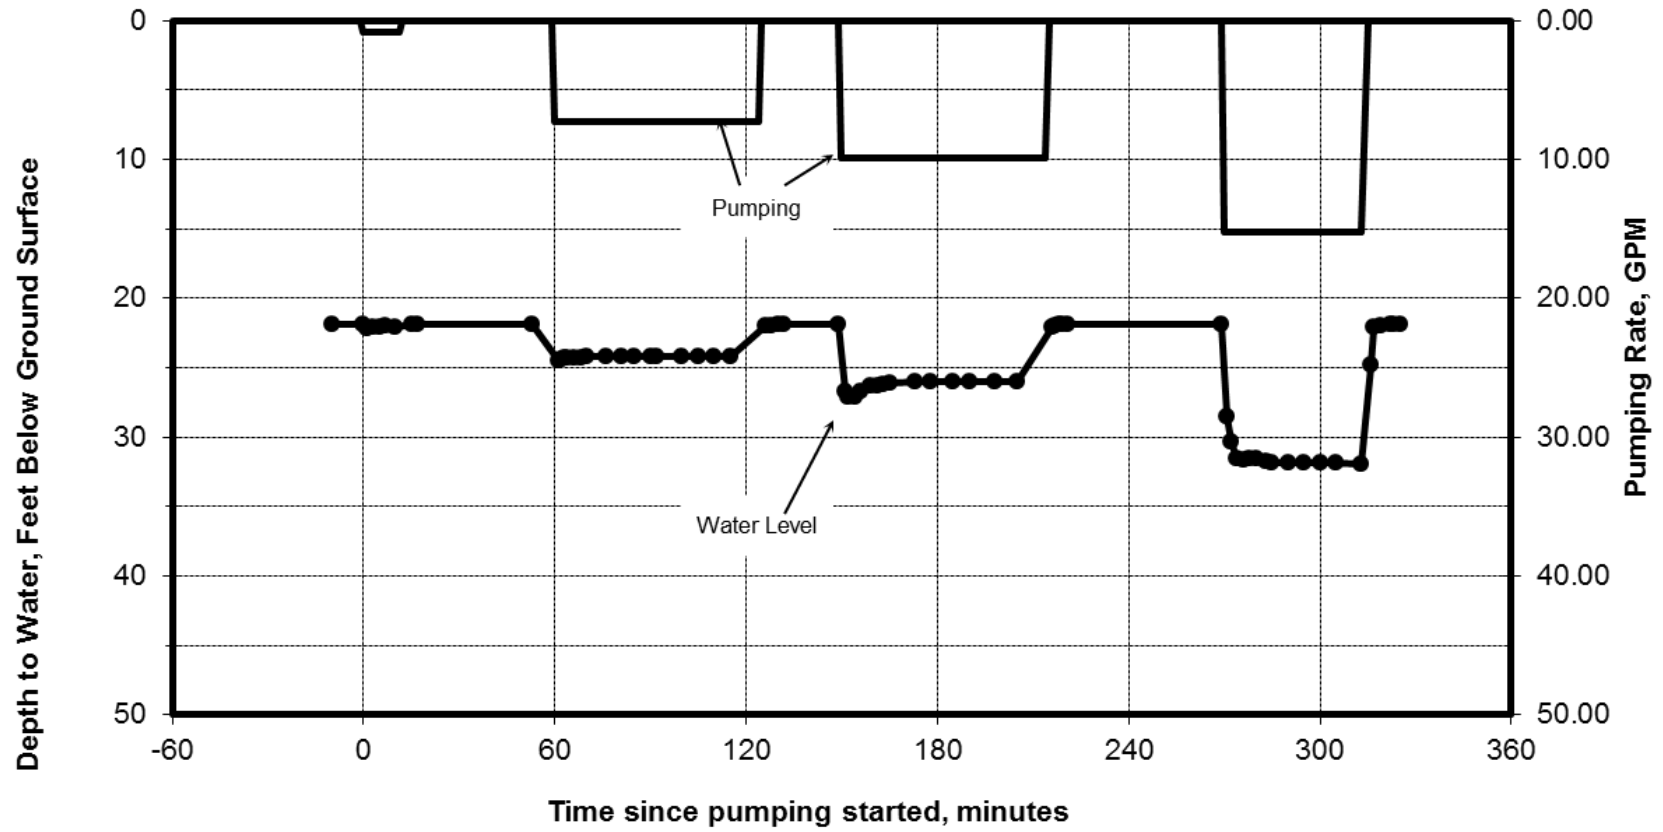
Figure 2. Step drawdown test of Well No. 1 on March 21, 1984

The well was test pumped at several rates in March 1984 (Figure 2). The static water level was 22 feet below ground surface. Pumping at 10 gpm resulted in 4 feet of drawdown. Pumping at 15 gpm resulted in 10 feet of drawdown. Park staff stated that the well was never put into production because the water pumped from it always had a rusty color. Even after pumping continuously for two weeks, the water remained rusty.

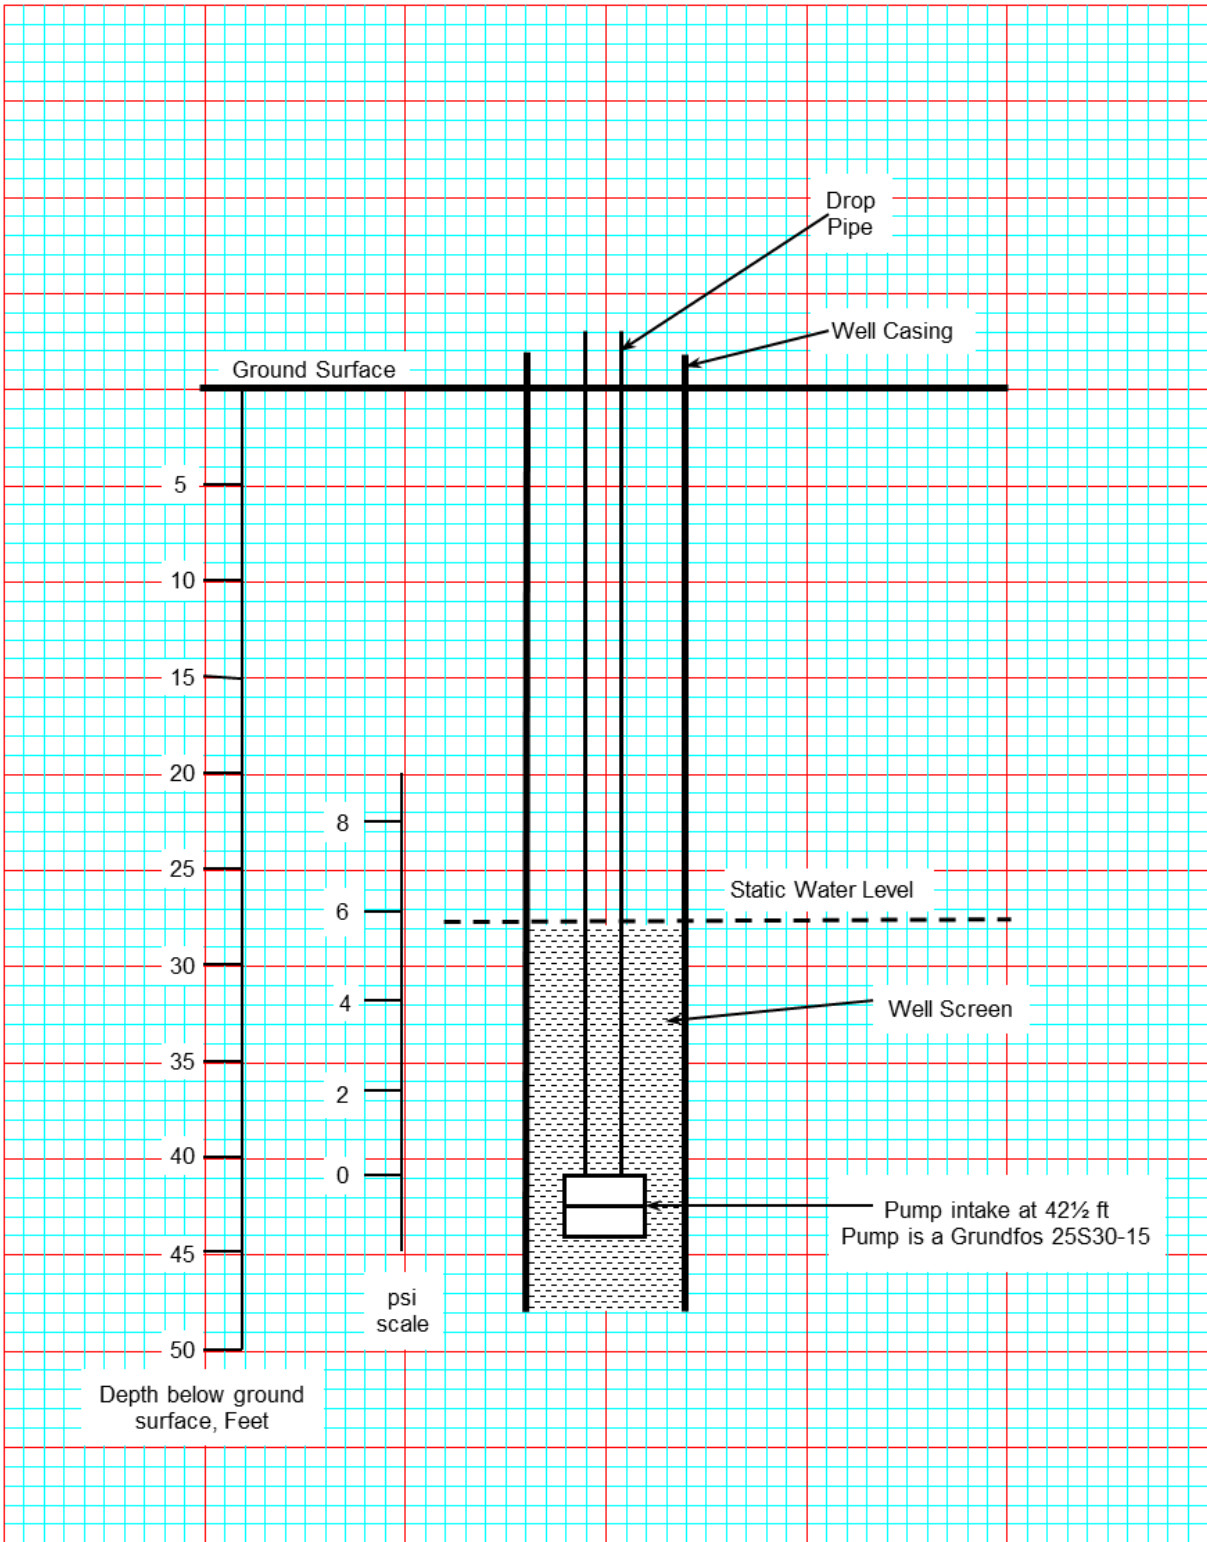
Figure 3. Well No. 1, Castolon Area, Big Bend National Park

The old pump was pulled from the well on April 23, 2002. The measured depth of the well was 42 feet below ground surface. The static water level was 26 feet below ground surface. The bottom part of the pump motor appeared to have been covered by sediments filling the bottom part of the well. There was a hole in the discharge pipe a few inches above the pump. High and low water level electrodes were in the well, but were not connected to the control panel.

The well was redeveloped by jetting, using a high-volume, high-pressure air compressor for several hours. Approximately 5 ft<sup>3</sup> of sand, gravel, and cobbles was removed from the well. The gravel appeared to be native material from the alluvial deposits rather than gravel purchased for use as a gravel pack. Cobbles up to 3-inches in diameter were removed during the jetting process. The well would consistently refill with sediments to a depth of about 48 feet. After 4-5 attempts to clear this material, we

allowed the well to have a final depth of 48 feet. We were concerned that continuing to remove sediments might result in creating a large cavity that would eventually result in surface subsidence. It is also possible that the original drillers report was misinterpreted. The report states that the well was completed with 30 feet of plain casing and 20 feet of screen. Since the measured stickup of casing above ground surface is about 2 feet, the bottom of the well screen might be at 48 feet below ground surface.

Many of the rocks and gravel that were removed from the well had an unidentified black coating. This may be some type of sulfide deposit, as the water has a high sulfate concentration. The zone around 40 feet below ground surface continued to produce fine-grained black sediments for a long time when jetting that area. Eventually, it cleared up after repeatedly jetting that zone.

Yield from the well was estimated to be 25-30 gpm during the jetting operation. Following completion of the jetting operation, the static water level was 25.8 feet below ground surface and the total depth of the well was 47.8 feet below ground surface.

A new pump was installed in the well, including new electrical cable, drop pipe, airline, torque arrestors, etc. The pump is a Grundfos 25S30-15 with a Franklin 3hp motor. This is a "25 gpm" pump. The top of the pump is about 41 feet below ground surface and the pump intake is about 42½ feet below ground surface. The bottom of the airline is at the top of the pump. Figure 3 shows the completed well and a scale for converting the psi reading of the airline to depth below ground surface.

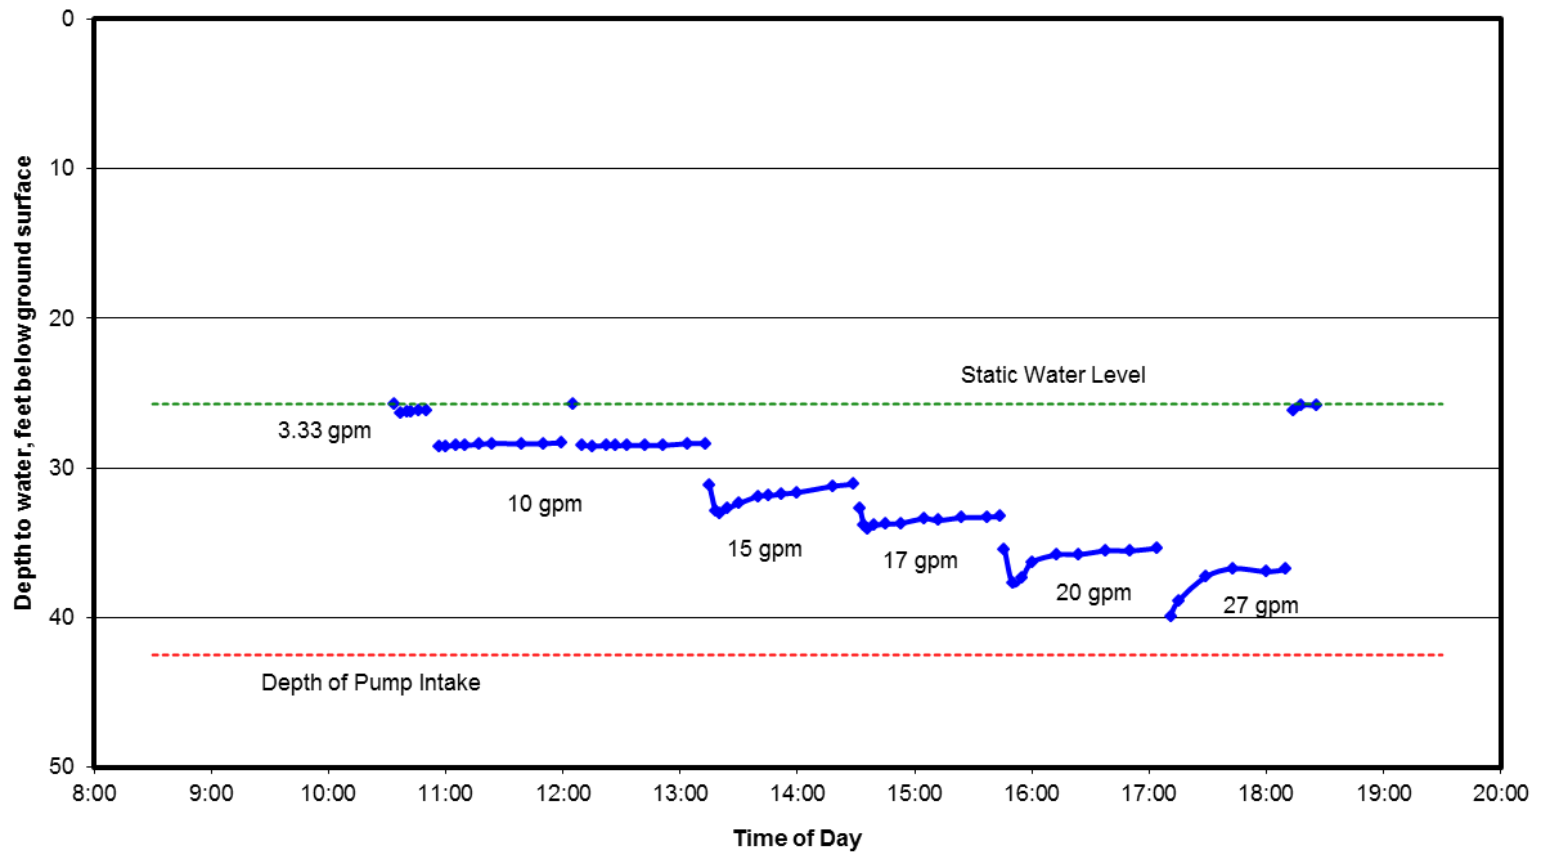
Figure 4. Step drawdown test of Well No. 1 on April 28, 2002

Test pumping the well at full discharge of about 30 gpm would result in drawing the water level down to the pump intake and sucking air after about 5 minutes of pumping. The water level would fully recover within 2 minutes after the pump was turned off. The well was cycled like this 10 times on April 27 and 5 times on April 28 to flush any sediments into the well. This pumping showed that the well would not sustain a pumping rate of 30 gpm.

A step-drawdown test was conducted on the well to determine the optimal and maximum sustainable pumping rates. The well was pumped at 3, 10, 15, 17, 20, and 27 gpm (Figure 4). It was difficult to adjust pumping rates as a very small turn on the valve at the wellhead resulted in a large change in discharge. It is recommended that the control valves at the wellhead be adjusted so the well is pumped at 15-20 gpm. Higher pumping rates cause the water level to be drawn down too far.

The pump installed in this well was originally intended for Well No. 2, but initial testing at Well No. 2 showed that it could not sustain a pumping rate of 30 gpm. Since Well No. 1 had produced 30 gpm during the jetting phase of redevelopment, we moved the larger pump to Well No. 1. Subsequent testing showed that Well No. 1 would not sustain a pumping rate of 30 gpm. The pumping rate can be controlled by partially closing the valve at the wellhead to create more backpressure against the pump. The next time the pump is replaced a 20 gpm pump should be installed.

Use of PVC drop pipe instead of the galvanized steel would eliminate the corrosion problems at the contact between the drop pipe and the pump.

1. The next time the pump in Well No. 1 needs replacement, install a 20-gpm pump.
2. Use PVC drop pipe instead of the galvanized steel to eliminate corrosion problems.
3. The next time the pump in Well No. 2 needs replacement, install a 20-gpm pump.
4. Monitor static and pumping water levels in all 3 wells monthly. Monitor pumping rates from all 3 wells monthly. Routine monitoring will help identify well and pump problems before total failure of the well or pump occurs.

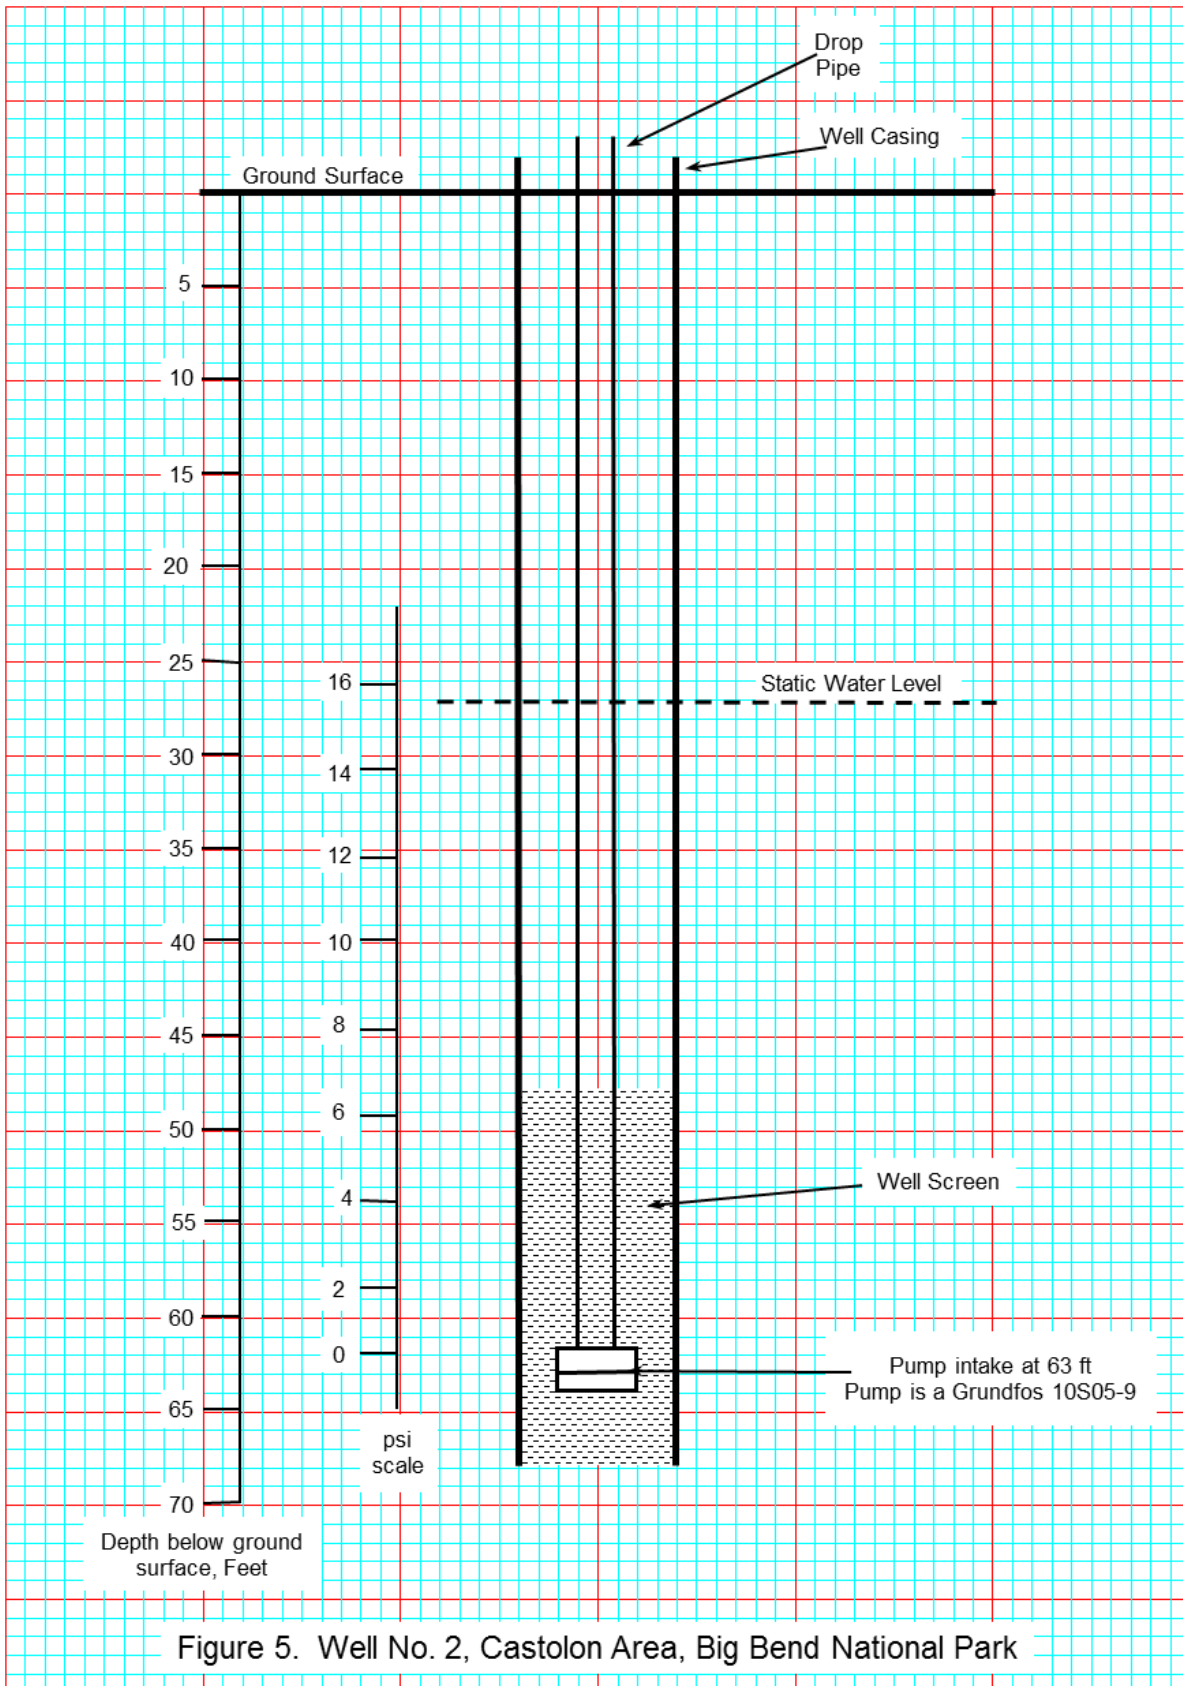
Figure 5. Well No. 2, Castolon Area, Big Bend National Park

The old pump was pulled from the well on April 23, 2002. The measured depth of the well was 62 feet below ground surface. The static water level was 24½ feet below ground surface. The pump and drop pipe appeared to be in good shape. The pump had been replaced in January 1999 and the drop pipe was in good shape at that time. This is the only one of the three wells in the area that had been functional in recent years. It operated at about 16 gpm. The old pump was a Webtrol 102S711B with a Franklin 3 hp motor. This pump can be stored for use as a backup or replacement pump for either Well No. 1 or No. 2 in the future.

The well was redeveloped by jetting, using a high-volume, high-pressure air compressor for several hours. A small amount of rust and corroded casing material was removed from the well. The well appeared to have a very solid bottom, probably a plate welded on the bottom to prevent sediment from entering the well. At the completion of jetting the well measured 68 feet deep from ground surface.

Yield from the well was estimated to be 12-15 gpm during the jetting operation. Following completion of the jetting operation, the static water level was 24.65 feet below ground surface.

Since this well had reportedly produced 30 gpm with no drawdown when it was constructed, and we had hoped to restore the well to near that capacity, we had ordered a 25-gpm pump for the well. During jetting of the well, it appeared that it would not produce 25 gpm. Nevertheless, we installed the 25-gpm pump to provide a good test of the well. The pump would draw the water level down to the pump intake within about 2 minutes. The water level would recover completely within 5 minutes. The well was

cycled through complete drawdown and recovery 10 times with no discernable change in capacity.

The 25 gpm pump was removed from Well No. 2 and later placed in Well No. 1, because we already knew from jetting Well No. 1 that it appeared to be a better producer than Well No. 2. The 10-gpm pump, originally planned for installation in Well No. 1 was installed in Well No. 2. This pump is a Grundfos 10S05-9 with a ½ hp Grundfos motor. It is a “10 gpm” pump. The top of the pump is about 62 feet below ground surface and the pump intake is 63 feet below ground surface. All new equipment was placed in the well including a new pump, electrical cable, drop pipe, airline, torque arrestors, etc. The bottom of the airline is at the top of the pump. Figure 5 shows the completed well and a scale for converting the psi reading of the airline to depth below ground surface.

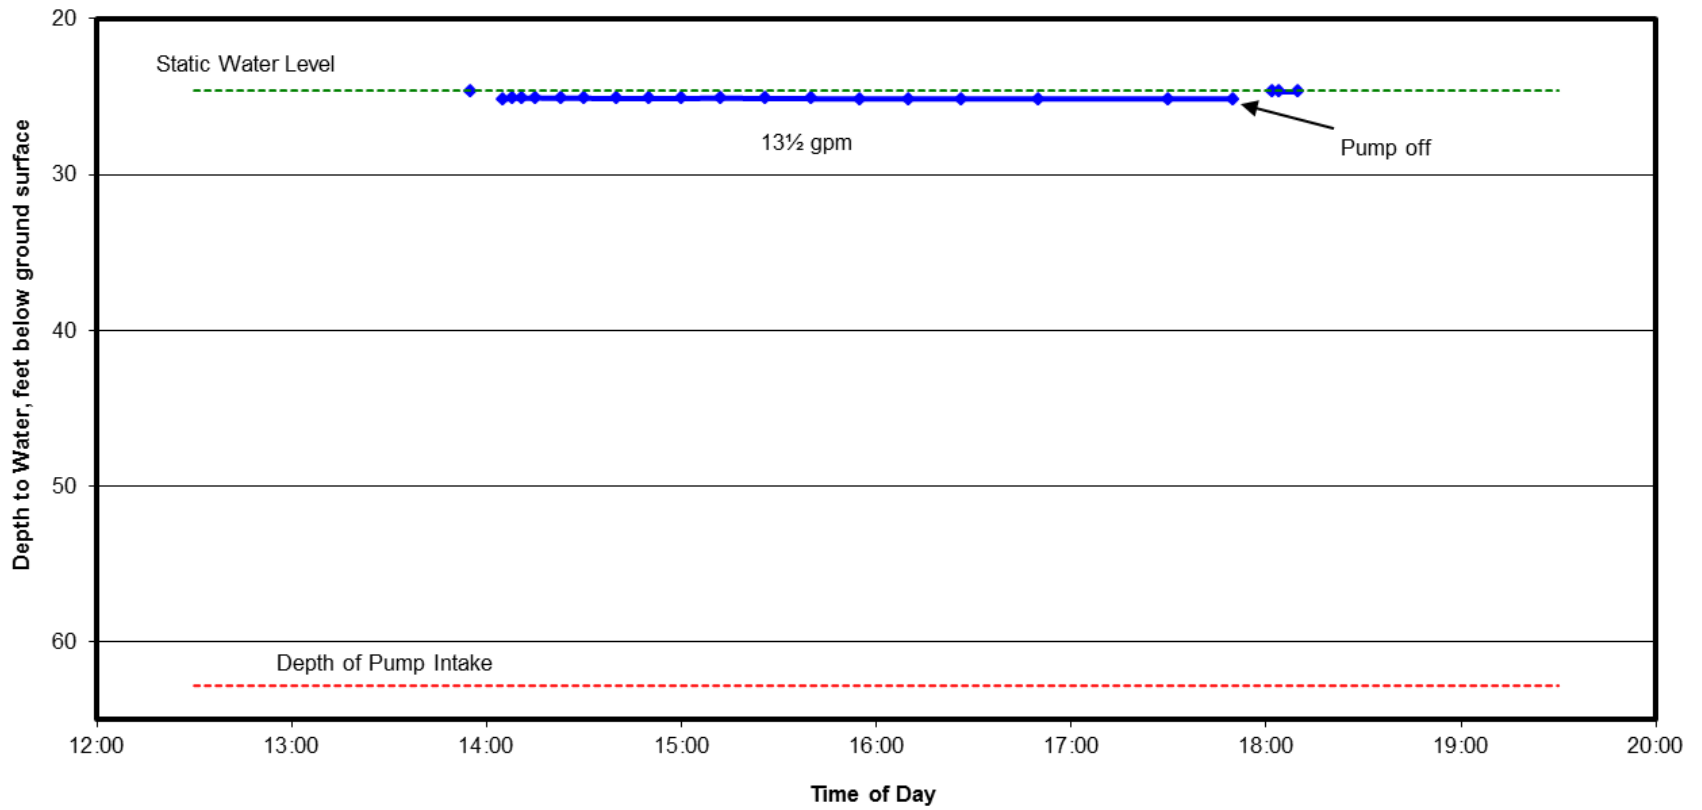
Figure 6. Drawdown test for Well No. 2, April 27,2002

The well was test pumped at the maximum pumping rate for the pump, 14 gpm for 4 hours resulting in about ½ foot of drawdown (Figure 6). This well will produce more water. A 20-gpm pump could safely be installed in Well No. 2.

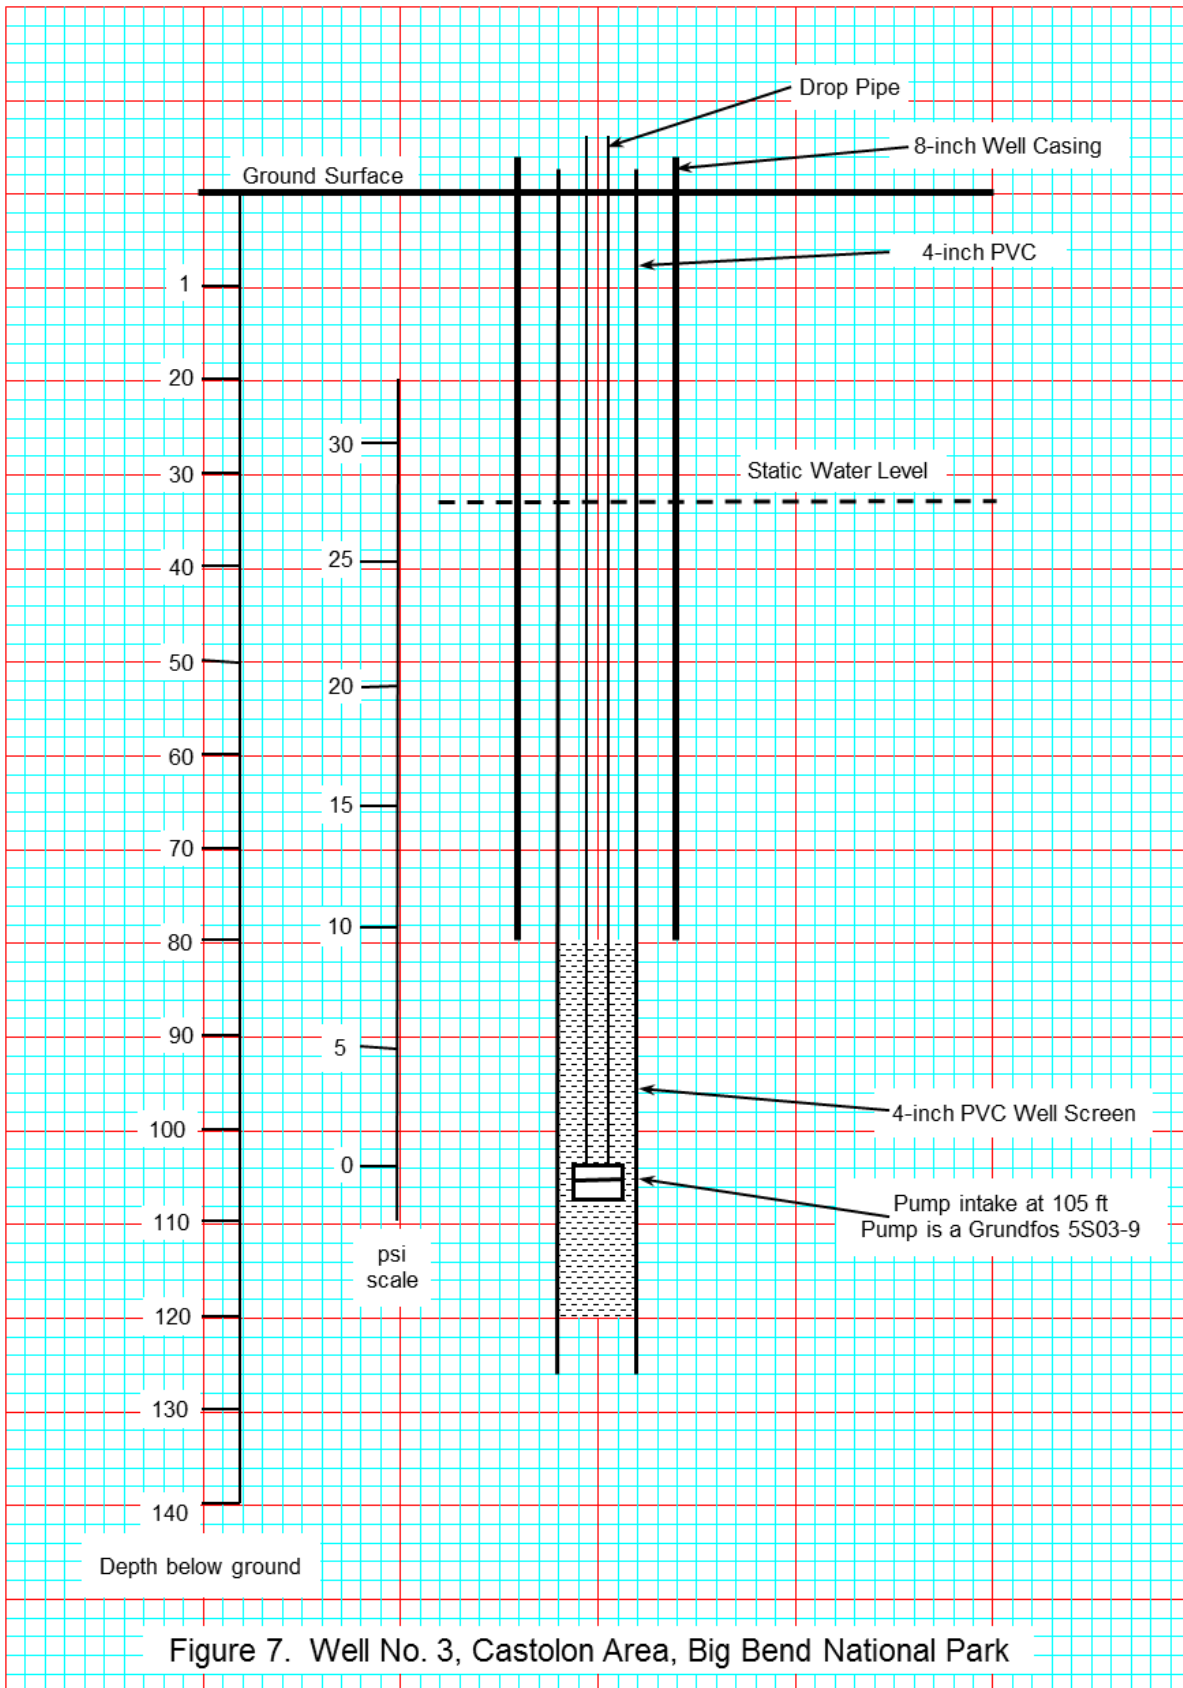
Figure 7. Well No. 3, Castolon Area, Big Bend National Park

The old pump was pulled from the well on April 23, 2002. The measured depth of the well was 130 feet below ground surface. The static water level was 33 feet below ground surface. The check valve in the top of the pump was broken. This allowed water to flow down the pipe and into the well after the pump had shut off, spinning the pump in a backward direction. As water filled the well and reached the upper electrode, the pump would automatically be started. Over some period of time, the excessive torque caused by the pump turning on while spinning backward caused the drive shaft between the pump and motor to break. This is the reason that no water could be pumped from the well, even though the pump could be heard running. The pump that was removed from the well was a Grundfos 10S15-21 with a 1½ hp motor. It was installed in 1996 at a setting of 115 feet below ground surface.

The well was redeveloped by jetting, using a high-volume, high-pressure air compressor for several hours. The maximum depth of jetting was 125 feet below ground surface. We did not want to jet to the bottom of the well because that might have breached the seal at the bottom of the 4-inch PVC liner and allowed the sand filter material from the annular space to flow into the well. Water was blown from the well at a very low rate (less than 5 gpm) during the jetting process. There was not enough water in the well to get the surging action needed to remove fine-grained sediments, which might have allowed increased production from the well. Small amounts of very-fine grained sand were produced during the jetting operation and later during the test pumping. It does not appear possible to eliminate the sand-pumping problem at this well.

A new pump was installed in the well, including new electrical cable, drop line, torque arrestors, etc. The pump is a Grundfos 5S03-9 with a Franklin 1/3 hp motor. This is a "5 gpm" pump. The top of the pump is about 104 feet below ground surface and the pump intake is about 105 feet below ground surface. The bottom of the airline is at the top of the pump, 104 feet below ground surface. Figure 7 shows the completed well and a scale for converting the psi reading from the airline to depth below ground surface.

A low water level electrode was installed at the top of the pump to automatically turn the pump off when the water level was drawn down to that point. This protects the pump from running dry or sucking air. A high water level electrode was installed about 50 feet above the top of the pump. This electrode causes the pump to automatically be turned on when the water level in the well recovers to that level.

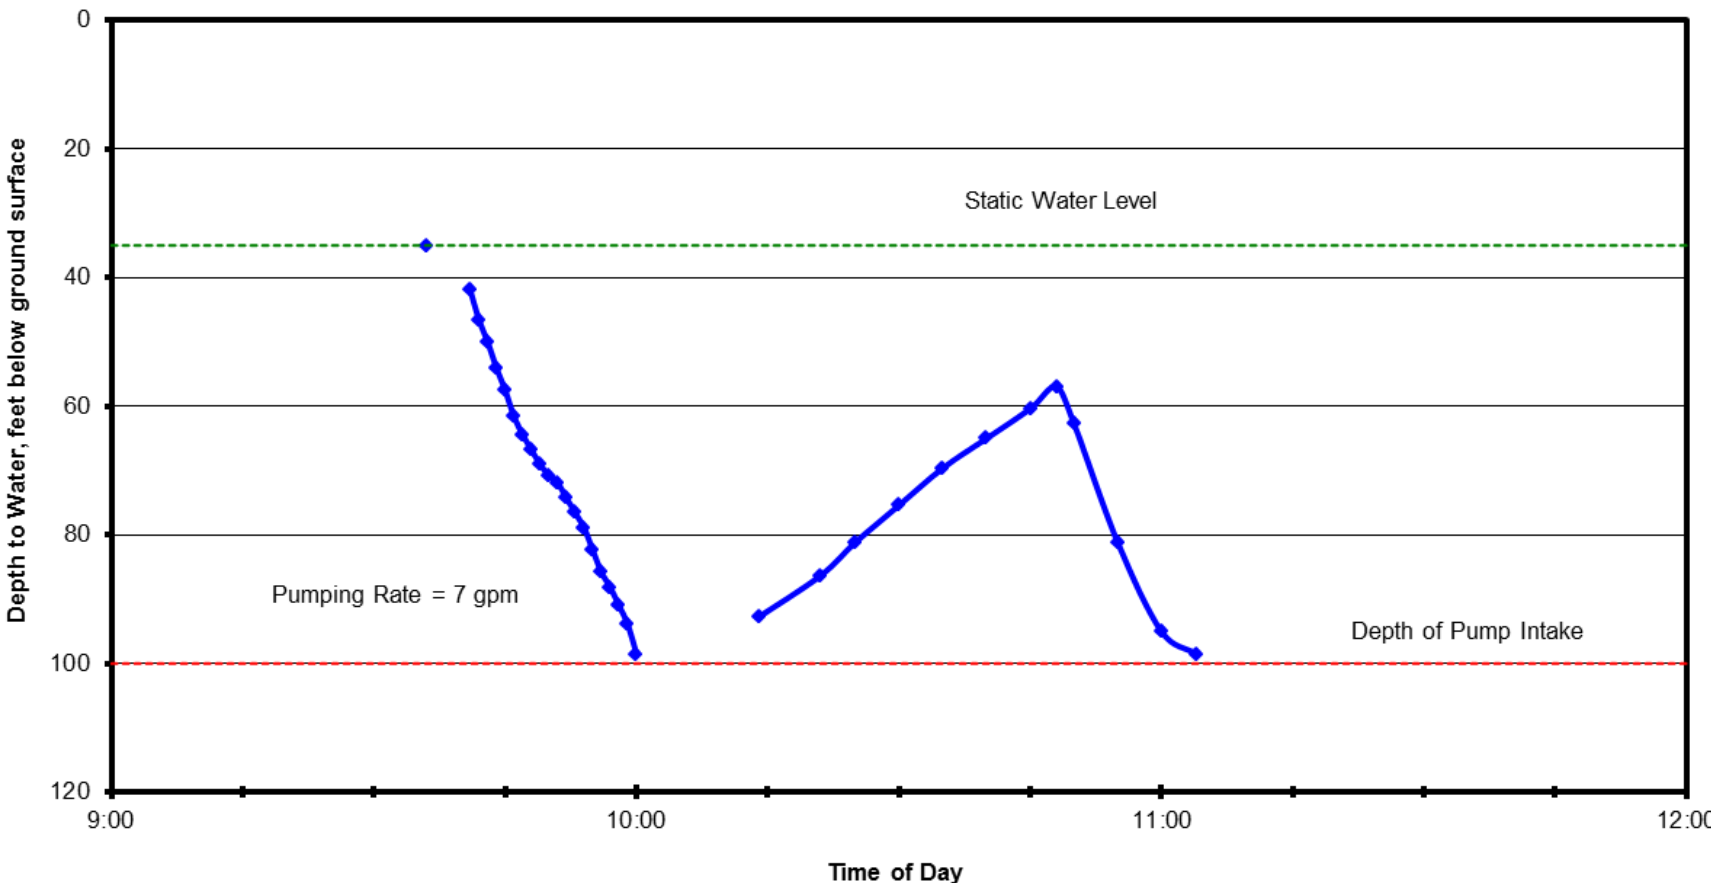
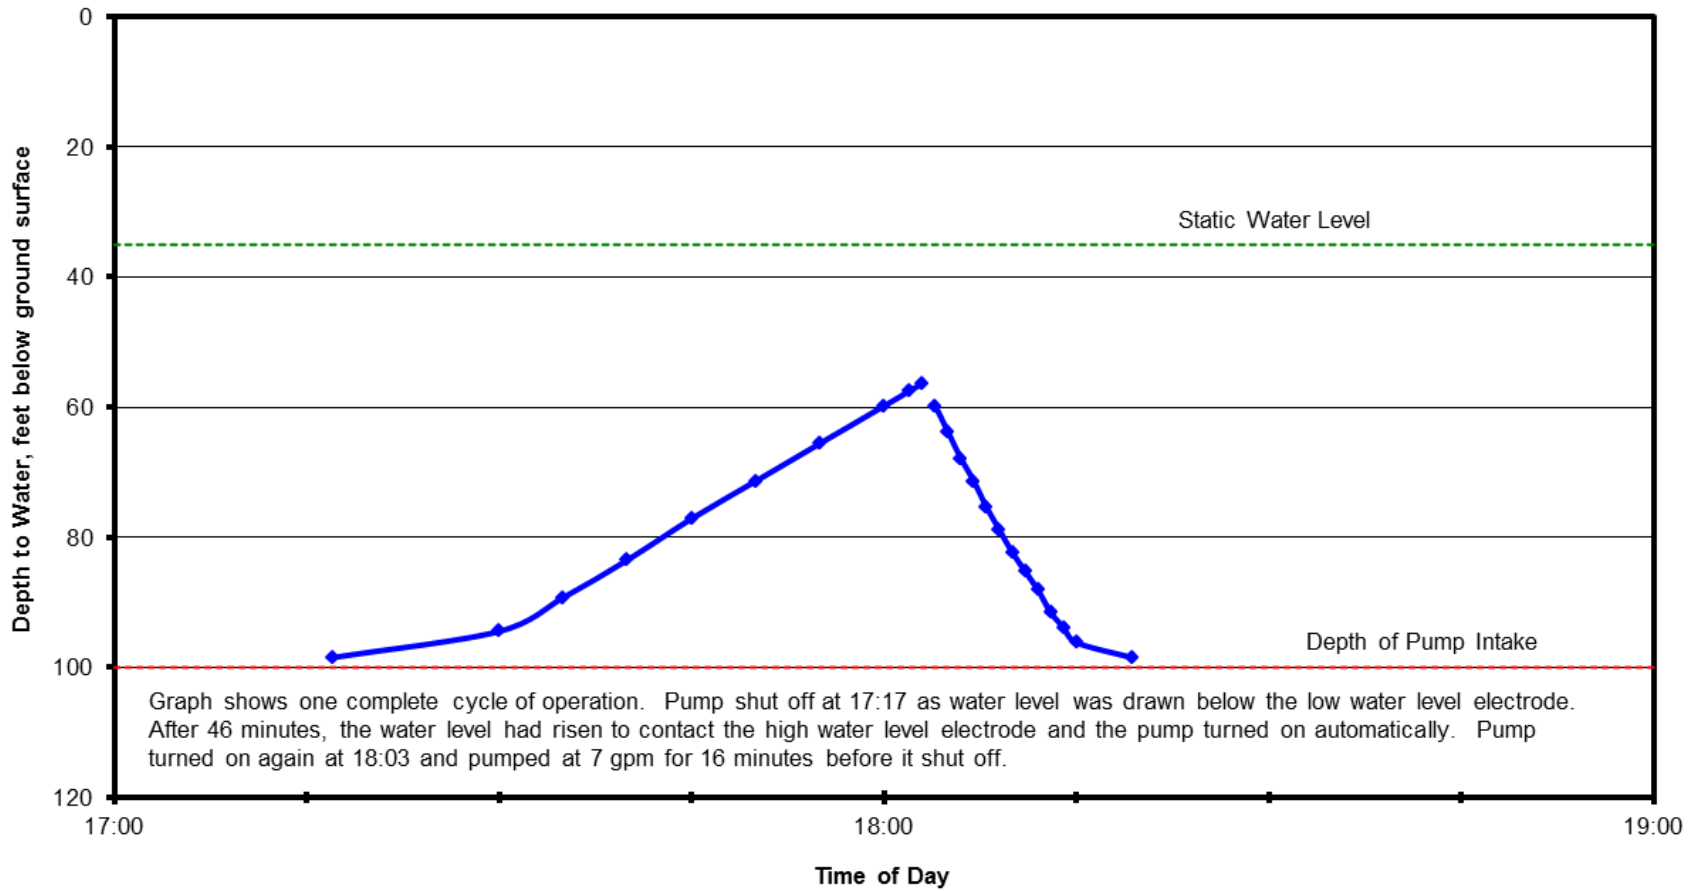
Production from Well No. 3 was tested by pumping water into the old wastewater lagoon behind the water treatment building. The pump would produce 7 gpm, but the water level would be drawn down to the low water electrode in about 15 minutes causing the pump to shut off. It would take about 45-50 minutes for the water level to recover to the high water electrode, causing the pump to turn on again. The pump was allowed to automatically cycle on and off overnight to provide an estimate of the long-term production from the well. It was determined that the well would produce an average of about 100 gallons per hour. Drawdown and recovery of water levels in Well No. 3 during test pumping are shown in Figures 8 and 9.
