CAPE HATTERAS NATIONAL SEASHORE

BODIE ISLAND
LIGHTHOUSE & OIL HOUSE

HISTORIC STRUCTURE REPORT

**Cultural Resources Division
Southeast Regional Office
National Park Service
December 2004**

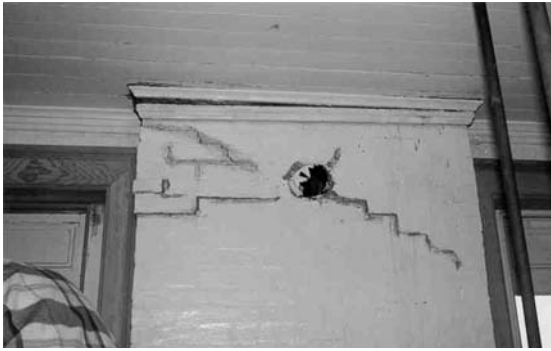
Figure 8 1989 USCOE photo showing cracked masonry in Oil Room interior chimney.

In the Oil House, the ceiling boards and wood molding next to the south chimney wall exhibited signs of water damage, likely caused by deteriorated chimney flashing or bricks. There were cracks and displaced bricks on the inside chimney walls that were probably caused by thermal expansion. The Corps recommended that the wood framing around the chimneys be checked for deterioration and replaced if warranted and that the chimneys be checked for soundness. They suggested that flashing around both chimneys be replaced, and, though the roof did not appear to be leaking, that roof replacement would likely become necessary within the next several years.

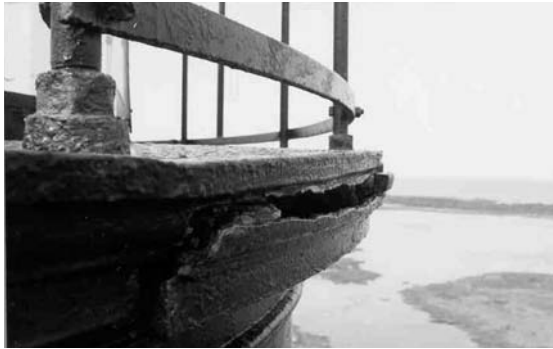
Figure 9 1989 USCOE photo showing deterioration of exterior edge of lantern gallery.

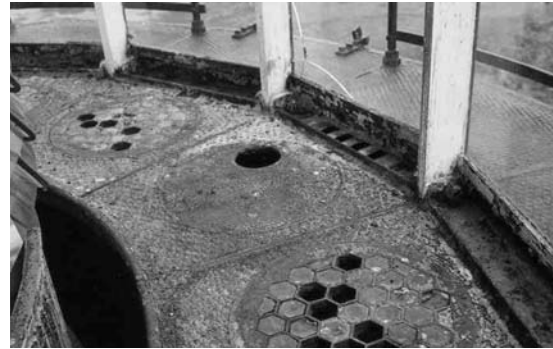
Figure 10 1989 USCOE photo showing missing lantern deck prisms.

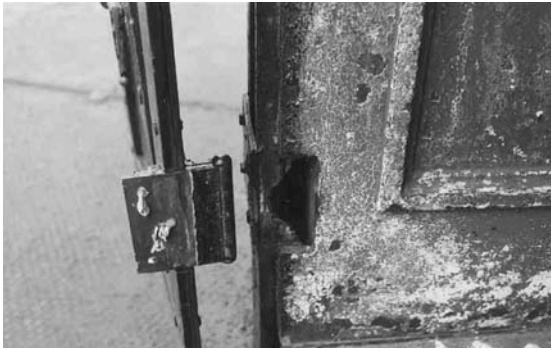
Figure 11 1989 USCOE photo showing detached hinge on door to gallery.

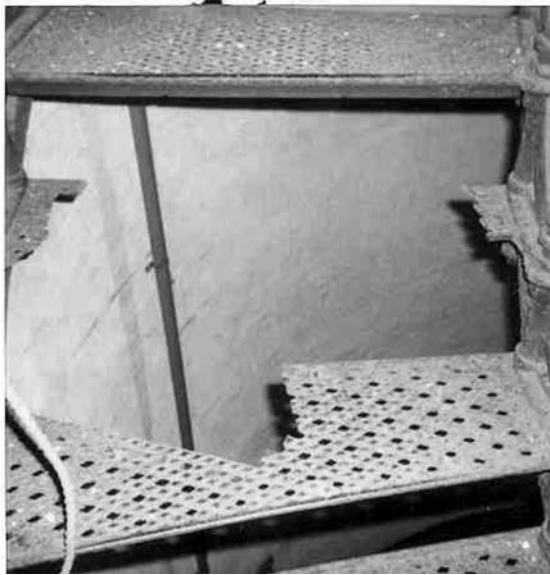
Figure 12 USCG close-up photograph of damage to stair treads, 1992.

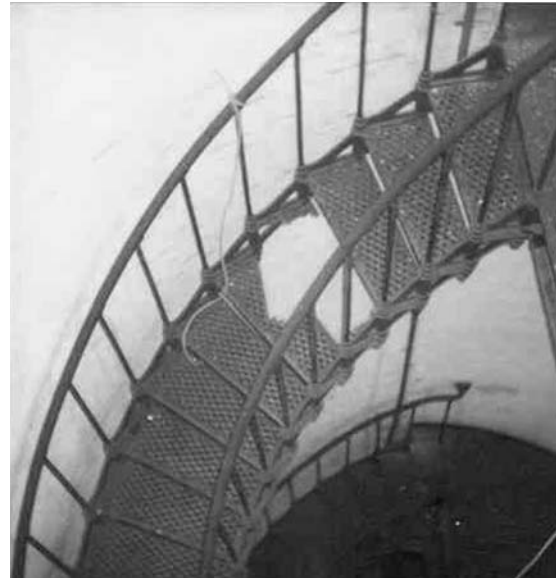
Figure 13 USCG photograph of damage to stair treads, 1992.

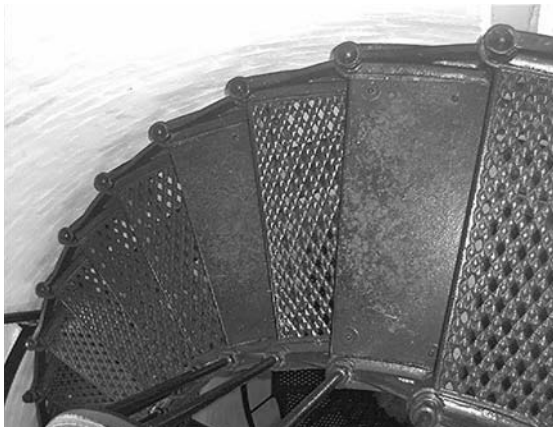
Figure 14 Existing repairs to stair treads.

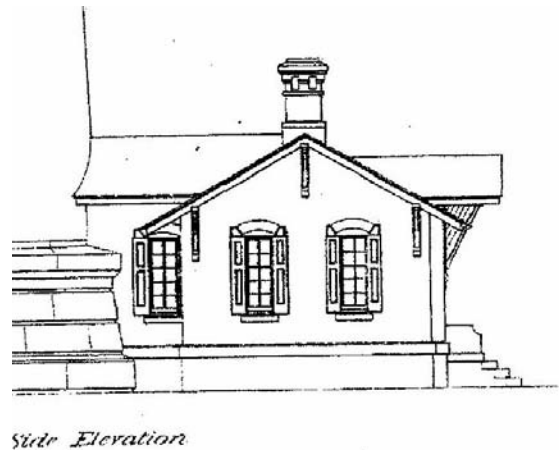
Overall, the north elevation is in sound condition. However, there are signs of past stress in the cracks over the west window in the elevation. This crack has been patched and painted, is sealed, and appears to be inactive.

Figure 18 Drawing detail of north elevation.

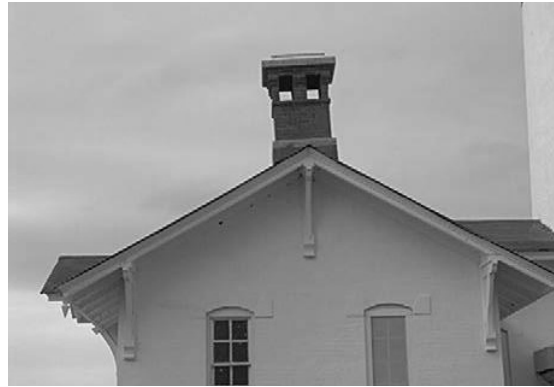
Figure 28 South chimney above the Oil Room.

Preservation efforts in these areas should include removal of damaged materials only and replacement to match existing. There was no

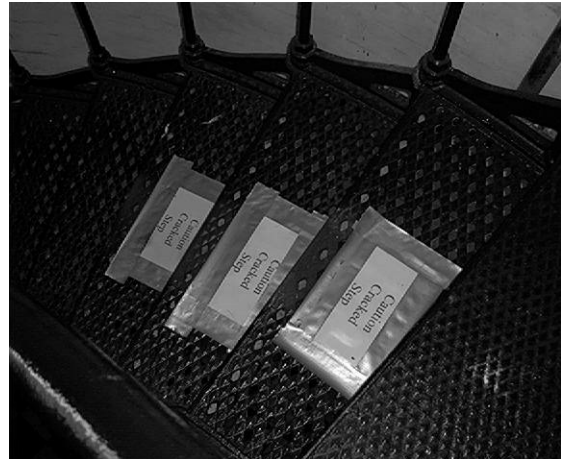
Figure 29 Three treads with notable cracks, below Landing #1.

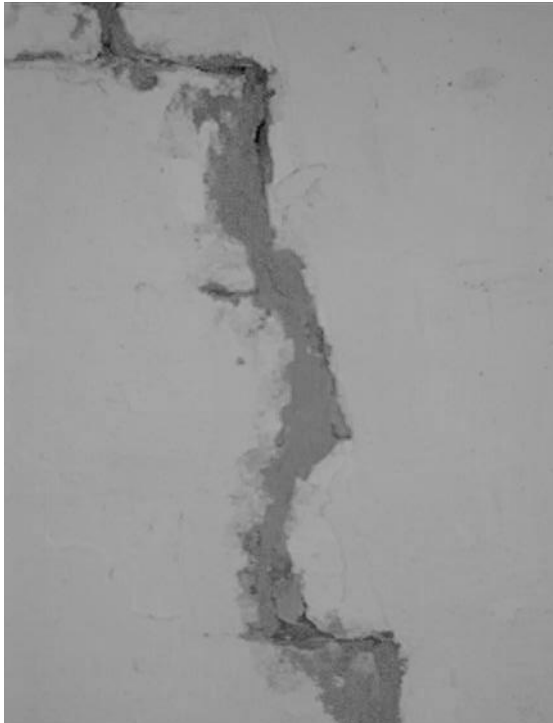
Figure 30 Detail of vertical crack on south side of masonry wall.

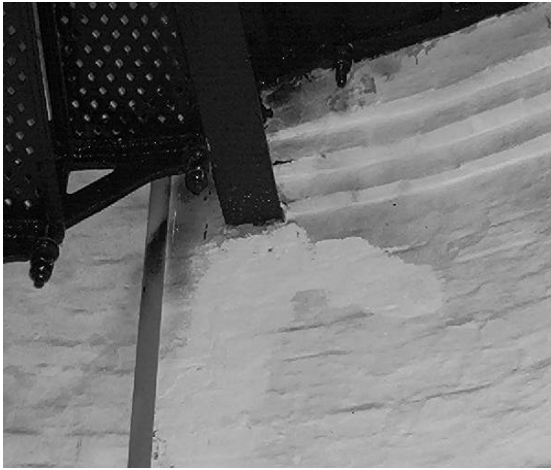
Figure 31 Detail of masonry repair located above landing support beam.

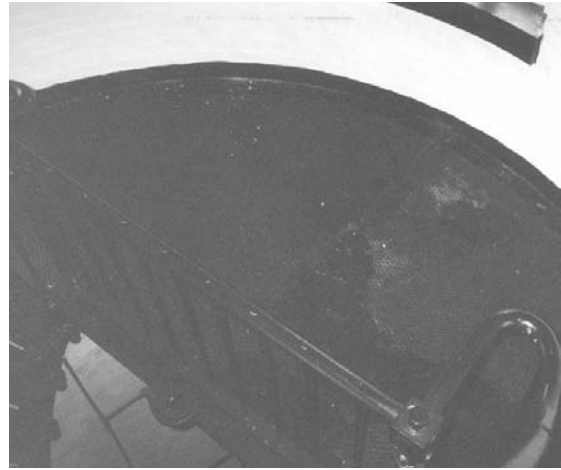
Figure 32 Detail of water collecting on landing that accesses Service Room.

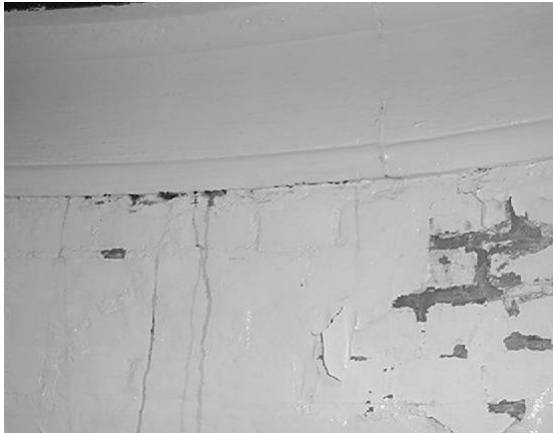
Figure 33 Detail of peeling paint in Watch Room.

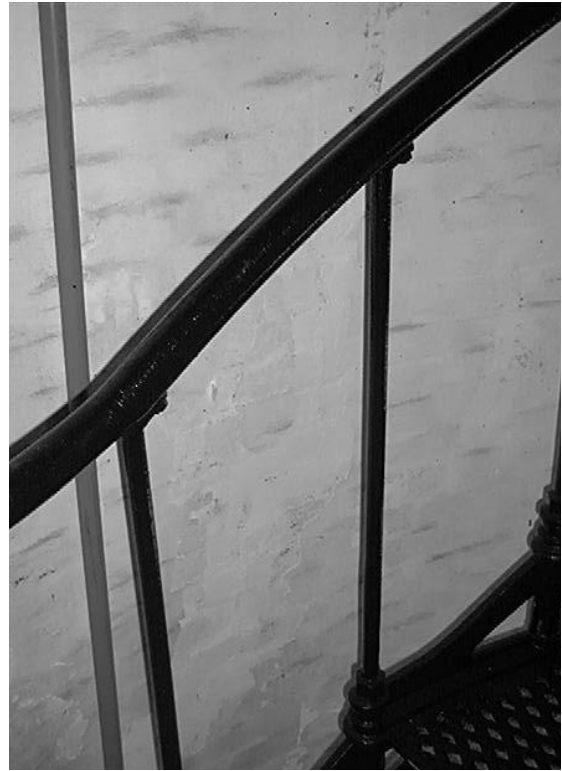
The exterior gallery was not analyzed for public access. Visual observation of the condition of the surface and supports indicates that considerable strengthening of the gallery members would be required before visitors could safely be allowed on the gallery. Such strengthening would include re-fabrication of missing and deteriorated parts, both of the ornamental ironwork and structural components such as

Figure 35 Detail of handrail.

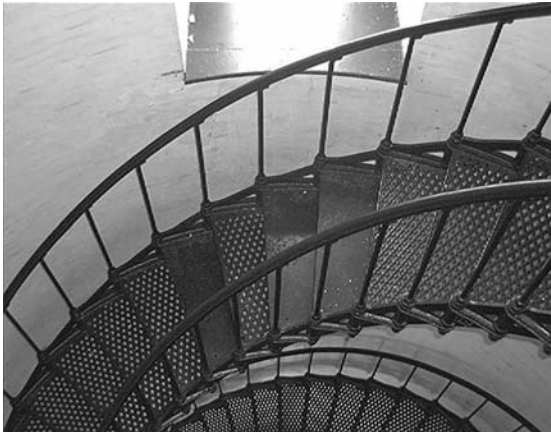
Figure 43 Detail of stair showing tread repair.

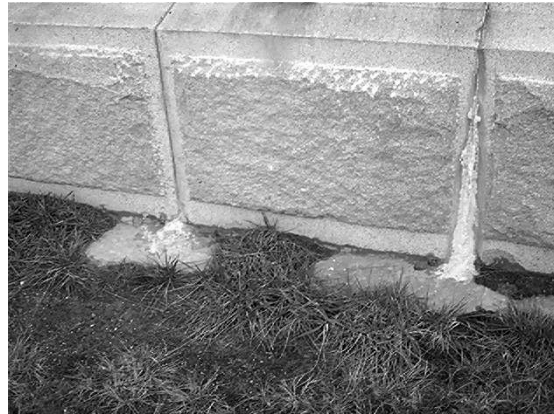
Figure 44 Detail of foundation showing mortar leaching.

- Perform tests on the mortar to determine its composition and repoint the foundations and walls using appropriate methods and mortars.
