**Cape Lookout**  
**Life-Saving Station**  
**HISTORIC STRUCTURE REPORT**

Historical Architecture, Cultural Resources Division

National Park Service

2004

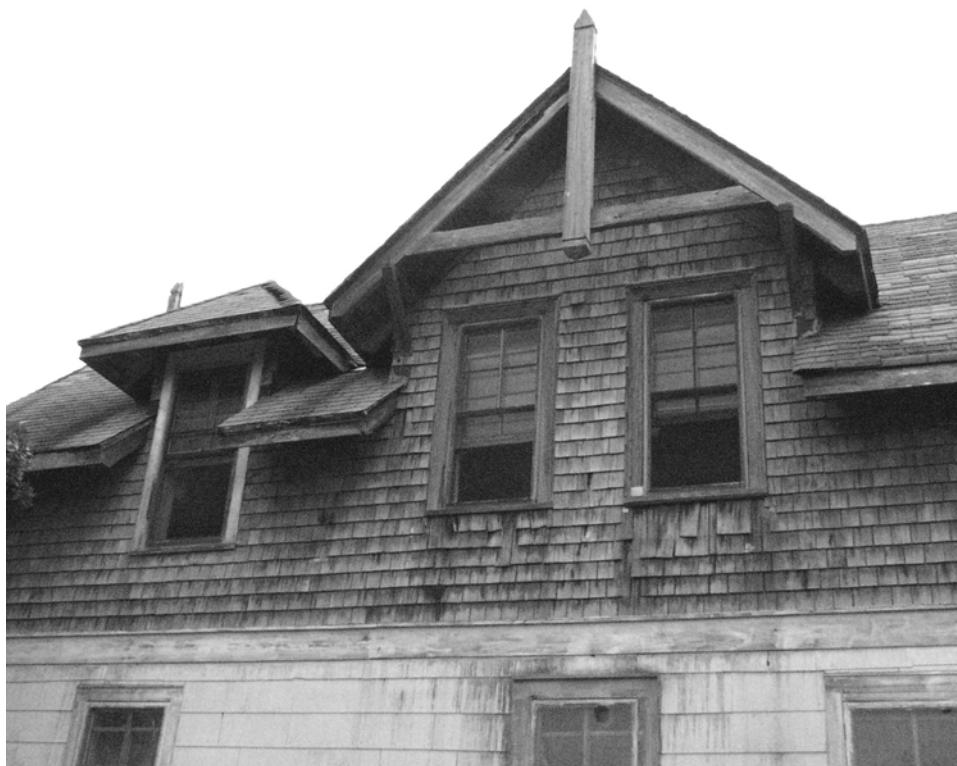
**Figure 54** View of typical exterior sidings, with wood shingles at second floor and asbestos over drop siding at first floor. (NPS-SERO-CRS, 2002)

- Remove and salvage cement- asbestos siding.
- Repair drop siding and wood- shingle siding.
- Repair and re- install missing gable finial.
- Repair all exterior woodwork as needed, matching existing materials.

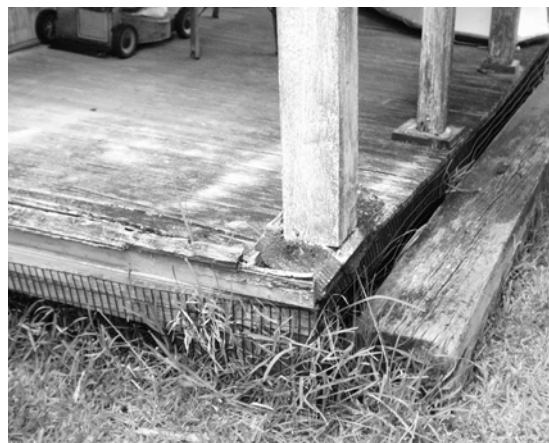
**Figure 60** View of northeast corner of front porch, showing corner post seriously destabilized by deterioration of the sills at that location. (NPS-SERO-CRS, 2002)

- Inspect and repair sills and joists when building is relocated.
- Reconstruct floor system in Room 100.
- Repair porches.
- Reconstruct front porch stairs.
- Rescreen front porch if desired.
- Reconstruct missing balustrades at both porches.

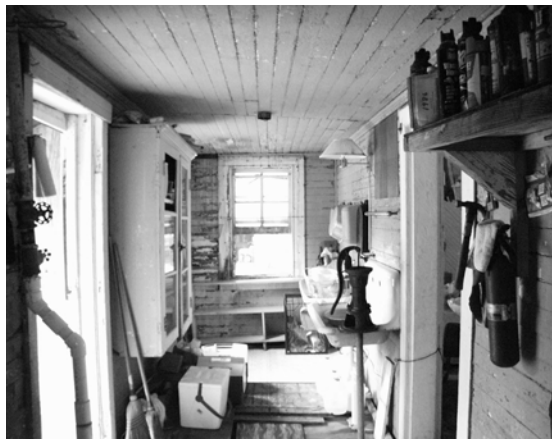
**Figure 64** View south in Room 100, showing location of original entry porch. Door opening at left replaced a window in the original configuration of the space. (NPS-SERO-CRS, 2002)
