CAPE LOOKOUT NATIONAL SEASHORE  
Coast Guard Station Boat House  
**HISTORIC STRUCTURE  
REPORT**

**2004**

2004  
Historic Structure Report  
Coast Guard Station Boat House  
Cape Lookout National Seashore  
Cape Lookout Village  
LCS#: 091830

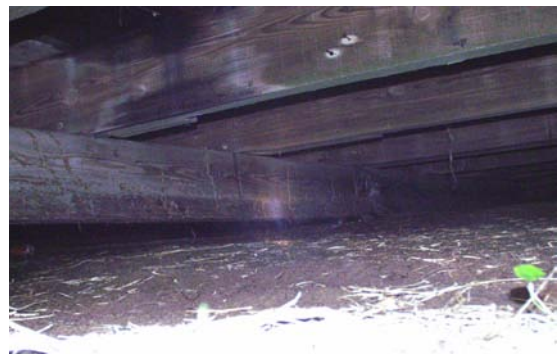
**Figure 25** View of floor framing near rear of house. (NPS-SERO-CR, 2003)

There is evidence that termites have attacked the floor framing, but the damage may not be widespread. Walls are generally plumb, floors are level, and the roof shows no visible signs of structural deficiencies.

- Inspect and repair sills and joists when building is relocated.

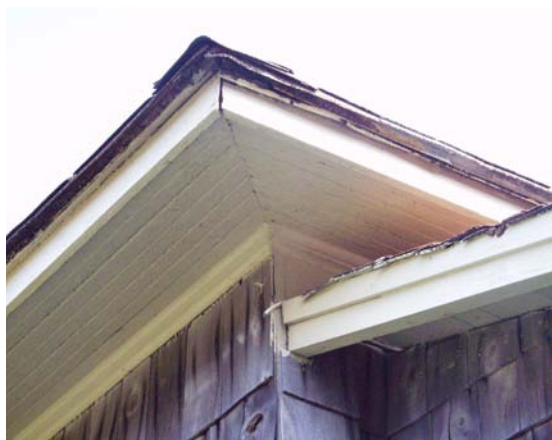
**Figure 26** View of south corner and typical eave detail. (NPS-SERO-CR, 2002)

- Remove cedar shingles; repair original drop siding.
- Repair existing soffit, window and door casing, and window sills.
- Remove wood- shingle roofing and install standing- seam metal roof.

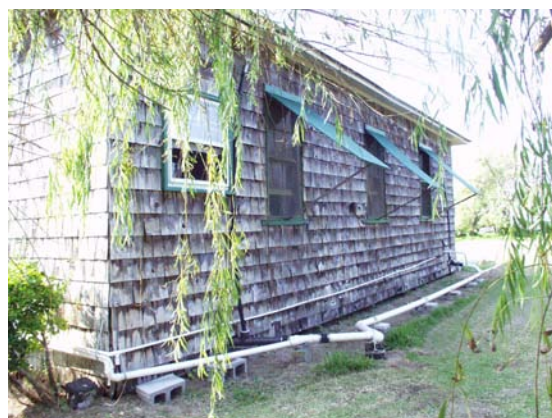
**Figure 27** View of rear (northwest) side of house, showing typical exterior finishes. (NPS-SERO-CR, 2002)

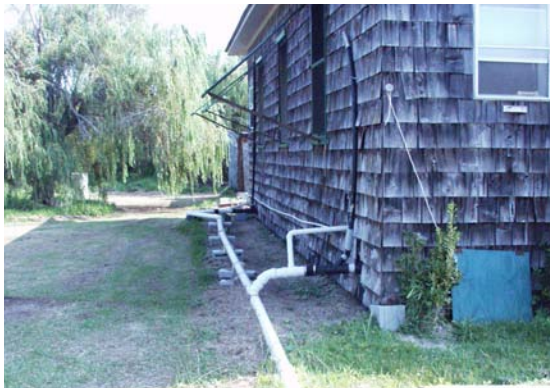
**Figure 39** View of waste lines at rear of house. (NPS-SERO-CR, 2003)

The condition of the wiring could not be examined. Water and sewer lines are relatively new but are run in an *ad hoc* fashion across the rear of the house. There is no central heating.

- Install new water supply and waste lines if new rest rooms are installed.
- Design electrical system with simple lighting to serve exhibits.
- Install smoke/fire detector system.
- If necessary, install electrical base-board heaters.
