# Cape Lookout Village Coca-Cola House Historic Structure Report

**Coca-Cola House**

# **HISTORIC STRUCTURE REPORT**

**2004**

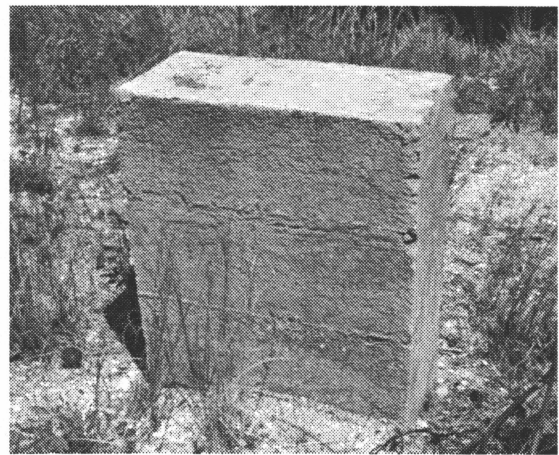
**Figure 20** View of typical concrete pier. (NPS-SERO-CR, 2002)

Except for some of the buildings at the old Coast Guard and Lighthouse stations, which were built on brick piers, most of the residences at Cape Lookout were built on wood pilings. The wood frame of the Coca-Cola House, however, was built on poured concrete piers, spaced about six feet apart, and probably set on some sort of spread footing. Piers are about 8" by 15" in plan and 15" high. All of the piers remain in relatively good condition, except where the original porch was removed along the south sides of the house, allowing some of the piers to be overturned or destabilized.

- Eliminate wood- to- ground contact at all locations, repairing damaged beams as necessary.
- Install metal termite shields at all piers.

- Reset concrete piers for missing porches as necessary.

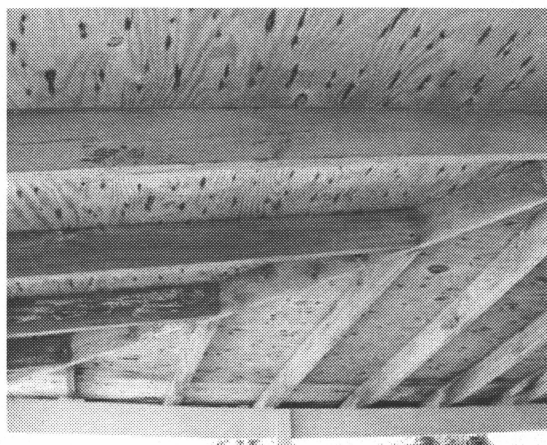
According to tradition, the house was painted red through much of its existence. Traces of this red paint are still visible in the framing of the porch roof around the north corner of the building, and red is also visible on window casing along with white window sash in one of the 1976 photographs. Except for white window sash and an unpainted porch floor, it is

**Figure 22** View of original porch roof framing at north corner of house. (NPS-SERO-CR, 2003)

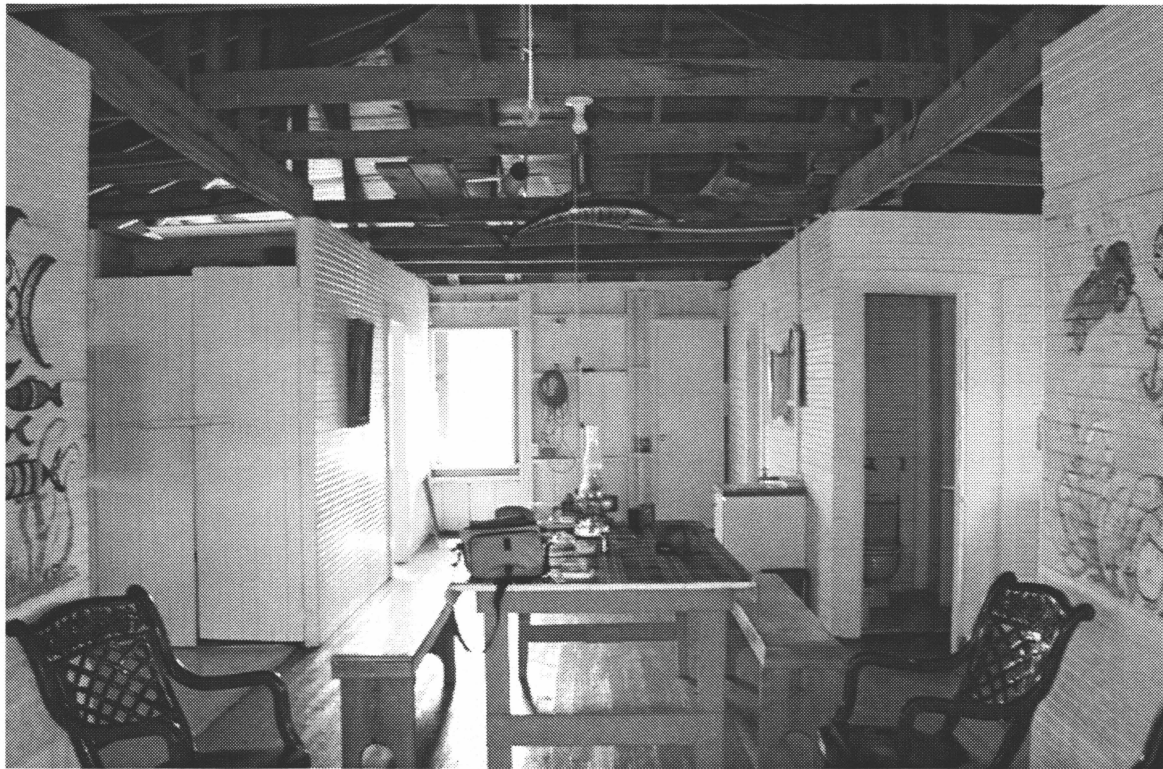
**Figure 24** View to southeast showing back door now opening to the garage. (NPS-SERO-CR, 2003)

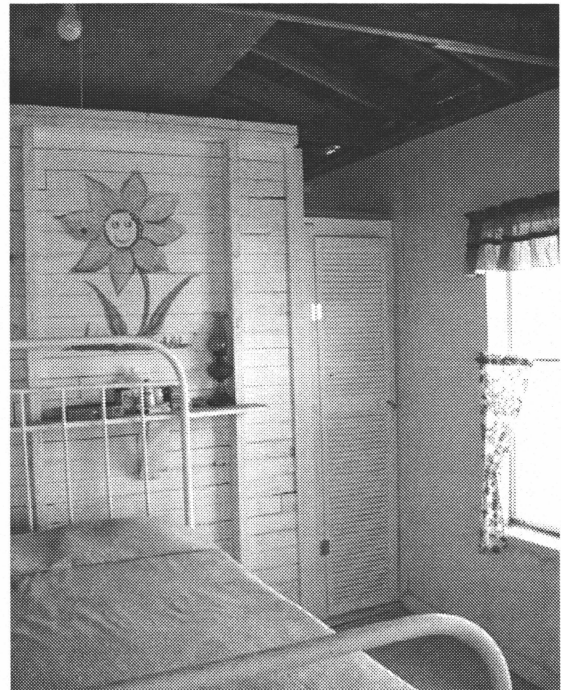
**Figure 31** View south in Room 102, showing altered wall and added closet door. (NPS-SERO-CR, 2003)
