CAPE LOOKOUT NATIONAL SEASHORE  
PORTSMOUTH  
ED STYRON HOUSE  
**HISTORIC STRUCTURE  
REPORT**

**Cultural Resources, Southeast Region  
National Park Service**

2004  
Historic Structure Report  
Ed Styron House  
Cape Lookout National Seashore (CALO)  
Portsmouth Village  
LCS#: 12516

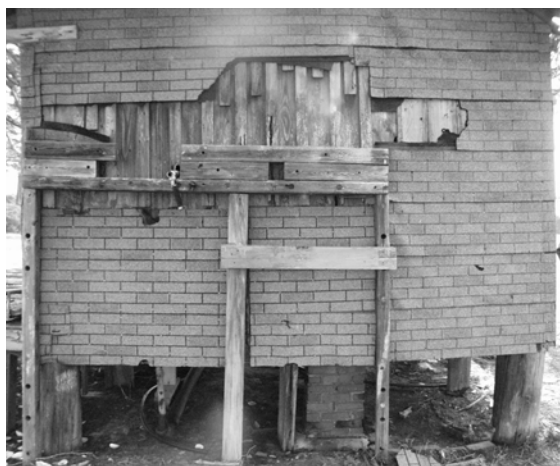
**Figure 3** View of remains of wooden frame for cistern at northeast end of house. Parts of a brick foundation remain in the ground below. (NPS-SERO-CRS)

through a gutter from the southeast (rear) shed of the roof. The gutter and tank are now missing, but part of the wooden frame that supported the tank remains attached to the northeast end of the house.

- Preserve brick pad associated with the cistern at northeast end of house.
- preserve wooden piers associated with missing addition at southwest end of house

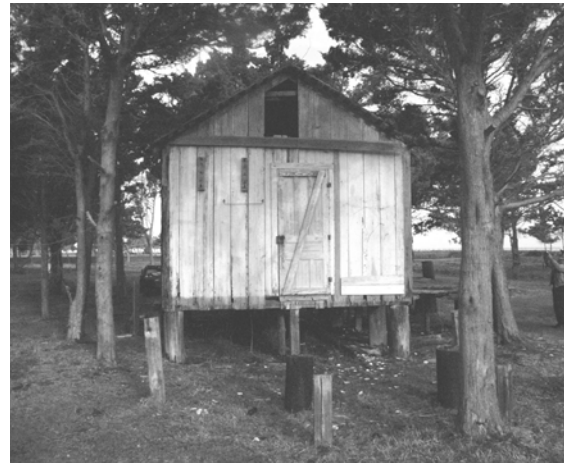
**Figure 5** View of southwest end of house; note piers in foreground which supported the modern addition that was removed after 1984. (NPS-SERO-CRS, 2001)

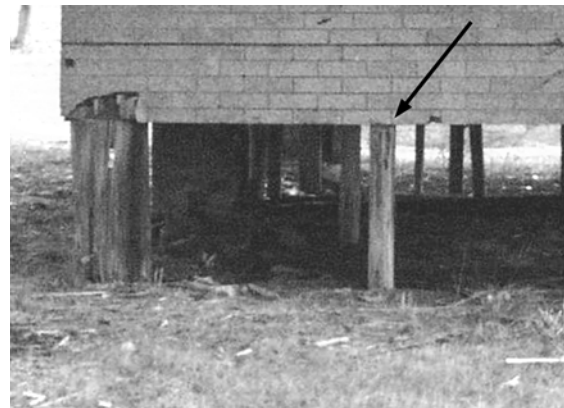
depth into the ground. The original piers appear to be the three 4" by 8" piers on the front of the house, a similar pier at the northwest end, and two 3" by 12" piers under the rear sill of the house. The remainder of the piers appear to have been added or replaced. The most recent piers include the sections of creosoted telephone poles that underpin the four corners of the house.

**Figure 6** View of north end of front of house; arrow marks one of several original wooden piers. (NPS-SERO-CRS, 2001)

- Replace modern wooden piers with wooden piers that more closely match the original.

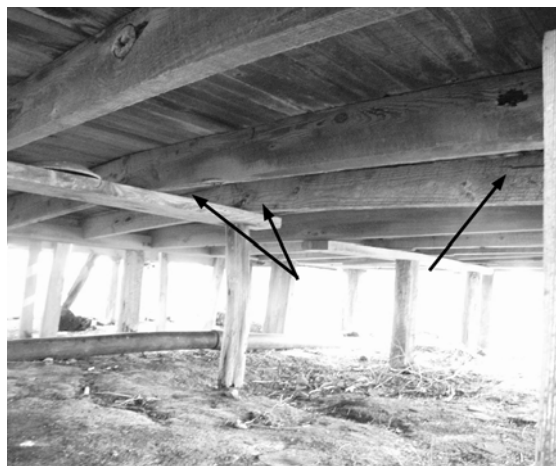
framing to settle several inches. In addition to allowing the entire house to sink, the sagging joists have pulled away from the flooring above in several areas. Wall framing could not be examined but appears to be composed of standard 2 by 4s on about 24" centers. Ceiling joists

**Figure 7** View of floor framing; arrow at right indicates where joist has split; arrows at center show location of two joists that have broken where they cross the added support beam. (NPS-SERO-CRS, 2001)

- Repair roof structure, preserving existing rafters and reconstructing exposed rafter ends wherever possible.
- Repair or replace rear sill; raise and level building structure.
- "Sister" new floor joists to broken joists.

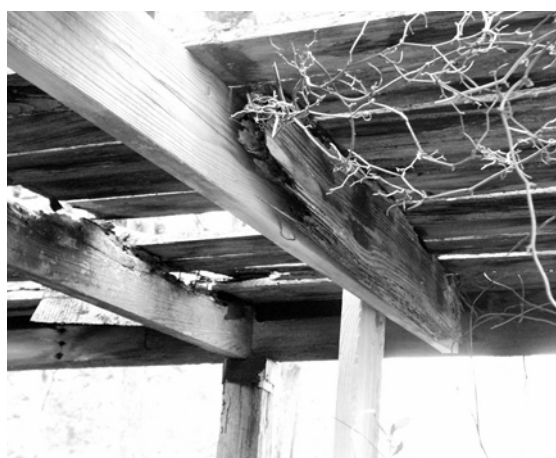
**Figure 8** View under north end of rear deck, showing remains of original floor framing. (NPS-SERO-CRS, 2001)

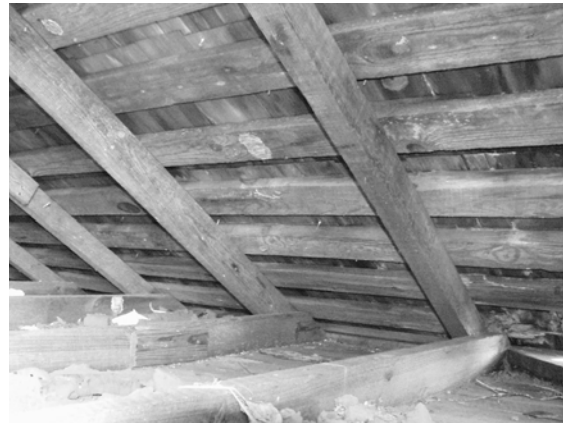
**Figure 9** View of southeast shed of roof; note wood shingles still in place. (NPS-SERO-CRS, 2001)

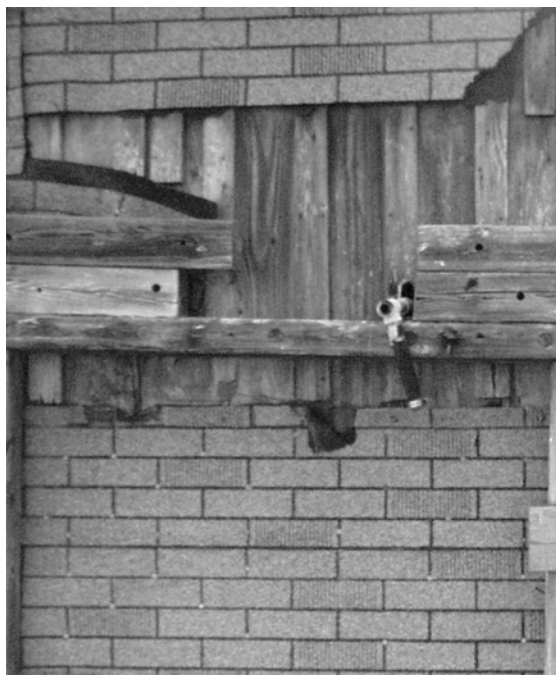
The exterior finishes were considerably altered for installation of the brown, asphalt- composition "brick" panels that now cover most of the exterior. The panels may have been installed around the same time as the asphalt- shingle roof. In order to provide a flat surface for this "brick," battens were removed from the entire house except for a few which remain on the northeast end (see Figure 2, above). In addition, the vertical board siding on the rear (or southeast) side of the house appears to have been relaid horizontally. The lower 12"- 24" of all (or nearly all) of the surviving vertically-placed boards have suffered severe deterioration and rot. It is possible that the boards on the rear were especially deteriorated due to their proximity to the porch deck. To repair the damage, the boards may have been removed, the damaged portion sawn off, and the remainder of the board re- laid horizontally.

**Figure 11** View of “brick” asphalt-composition siding over original board-and-batten siding at northeast end of house. (NPS-SERO-CRS, 2001)

- Remove existing "brick" siding, archiving as much material as practical for possible later re-use.
- Repair board and batten siding, replacing damaged and missing elements as necessary.
- Paint siding red, trim white.

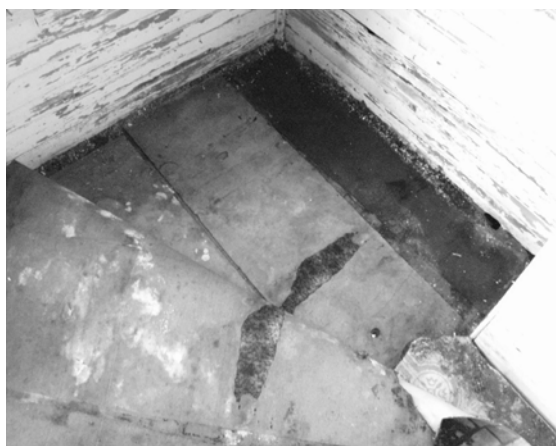
**Figure 15** View of floor in northwest corner of main room, showing early felt-based, imitation linoleum under two later floor coverings. (NPS-SERO-CRS, 2001)

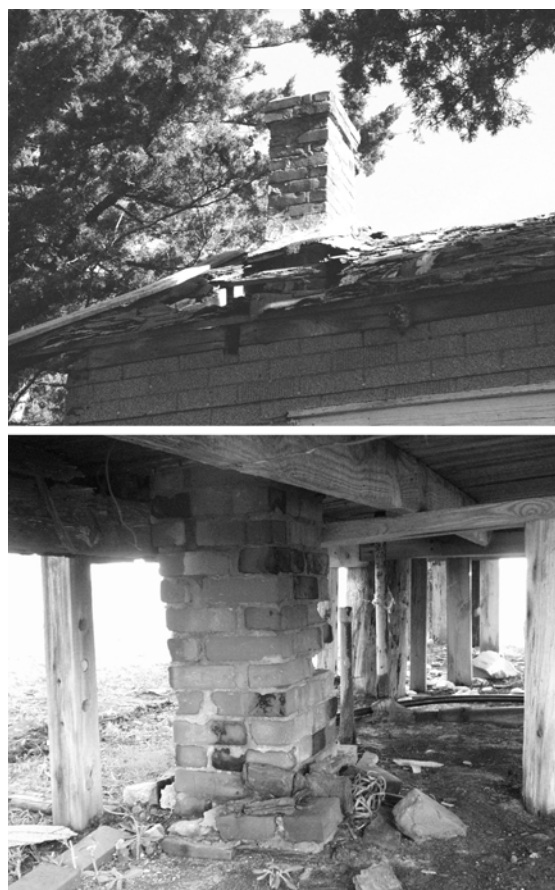
chimney with its 7-1/2", terra-cotta, stove flue. The foundation of the chimney has deteriorated, mostly due to rising damp. The chimney stack above the roof also has some spalling brick; where it rises through the roof, the brick has been disfigured by repeated applications of tar and other sealants.

**Figure 16** Top, view of chimney stack; below, view of chimney foundation. (NPS-SERO-CRS, 2001)

- Repair and repoint chimney as necessary.

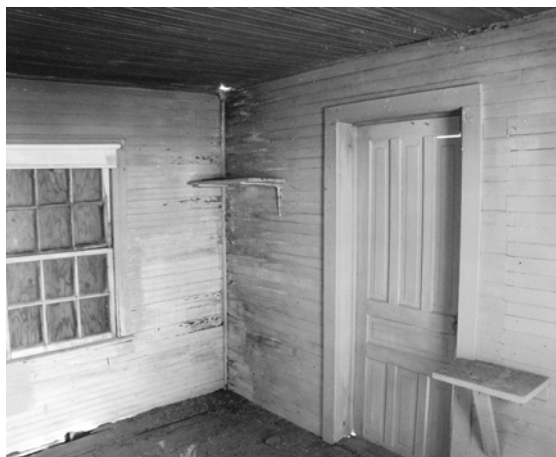
**Figure 17** View south in Room 101. Door to right was originally a window opening, converted into a door to the addition in the 1950s. (NPS-SERO-CRS, 2001).

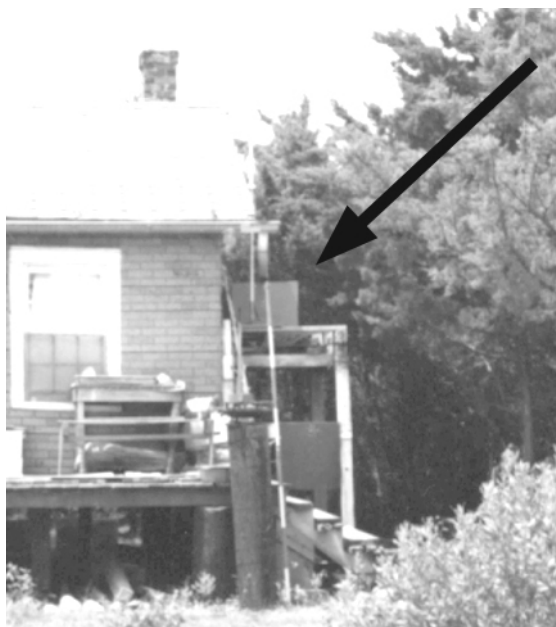
The only water supply was from the cistern at the northeast end of the house. It was supplied by a downspout from the gutter across the rear (southeast) side of the house. Except for part of the support frame and a galvanized iron supply pipe that runs through the wall, all components of this cistern are now missing.

**Figure 18** Detail from 1984 photograph, with arrow indicating now-missing cistern. (NPS-CALO, 1984)
