CAPE LOOKOUT NATIONAL SEASHORE  
Cape Lookout Village  
FISHING COTTAGE #2  
**HISTORIC STRUCTURE  
REPORT**

**Historical Architecture, Cultural Resources Division  
Southeastern Regional Office  
National Park Service**

**2004**

2004  
Historic Structure Report  
Fishing Cottage #2  
Cape Lookout National Seashore  
Cape Lookout Village  
LCS#: 091833

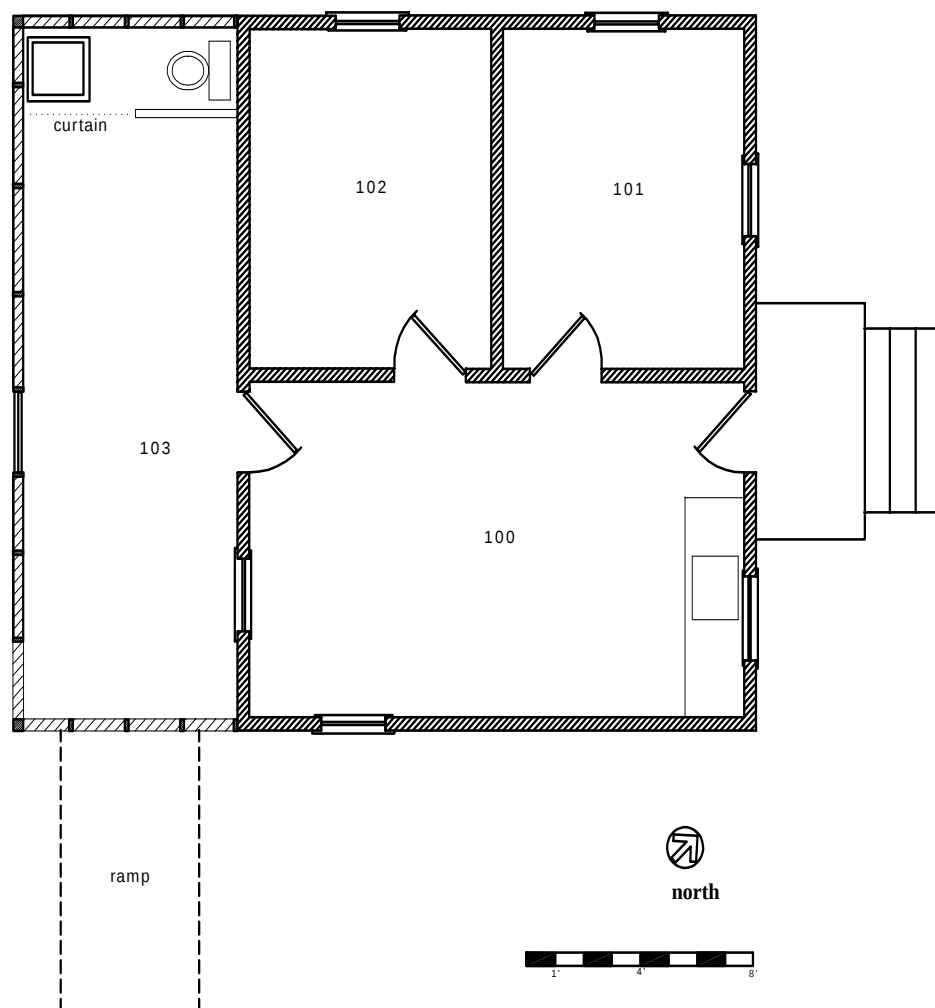
The northwest end of the porch has been partially enclosed in recent years to allow installation of a shower and toilet. At the southeast end, the knee wall has been cut and hinged to swing open and part of the wall above the screening has been removed to increase vertical clearance. These alterations are associated with the ramp that allows small vehicles to be stored on the porch.

**Figure 20** Plan of existing house. (NPS-SERO-CRS, 2002)

- Reconstruct missing portions of southeast porch wall
- Remove plywood shutter at southeast end and replicate board- and- batten shutters to match original shutters elsewhere on the building

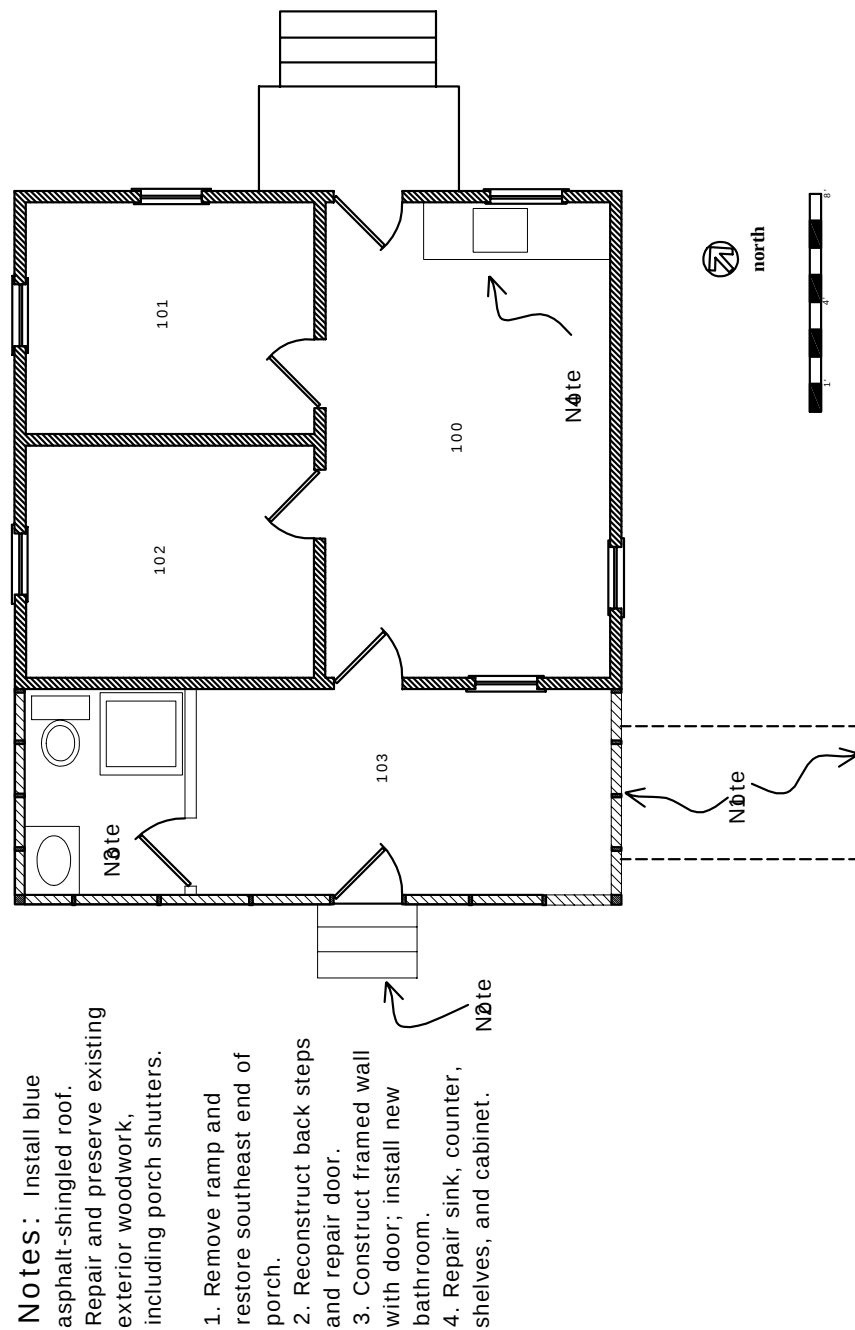
**Figure 21** Proposed plan for treatment and use. (T. Jones, NPS-SERO-CR, 2003)

*Plumbing:* The entire plumbing system should be rehabilitated. The existing bath area, which does not include a lavatory, should be replaced by a conventional bathroom in the same location. A framed wall, with a door opening, should be constructed approximately six feet from the northwest end of the back porch to create the space. The exposed back wall of the house and the outside knee walls and screening that form the other walls of the space can be repaired and preserved. The top-hinged exterior shutters are currently raised for light and air in the bath area, and they can continue to be

- Install new electrical system.
- Install fire and smoke detection system.
- Do not install central heating or air-conditioning; install electric space heaters if necessary.
- Rehabilitate existing bathroom. Rehabilitate existing kitchen.
