Cape Lookout National Seashore  
**GASKILL - GUTHRIE HOUSE**  
**HISTORIC STRUCTURE**  
**REPORT**

2004  
Historic Structure Report  
Gaskill- Guthrie House  
Cape Lookout Village  
CAPE LOOKOUT NATIONAL SEASHORE  
Harker's Island, NC  
LCS#: 272049

## Gaskill-Guthrie House

### Historic Structure Report

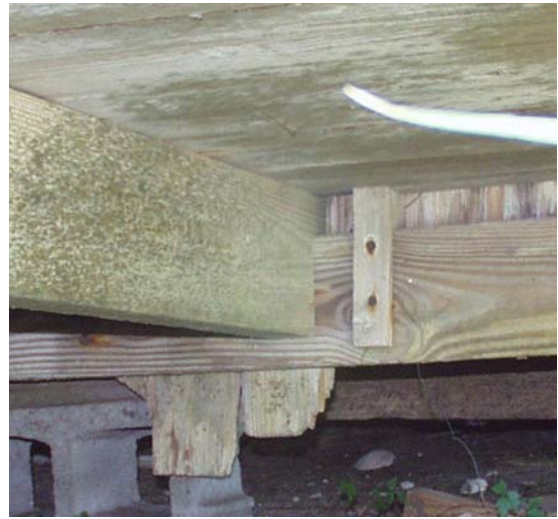
Spacing of joists, studs, and rafters is unusually wide, up to 48" in some cases, and nearly all the framing members are inadequate relative to the demands of modern building codes. An effort was made to storm proof the house, especially in attachment of walls to sills; but overall, the structure is relatively weak and can only have survived 85+ years of coastal storms because of its protected location between the dunes.

**Figure 21** View of front sill of house and typical joist and stud connections. (NPS-SERO-CRS, 2002)

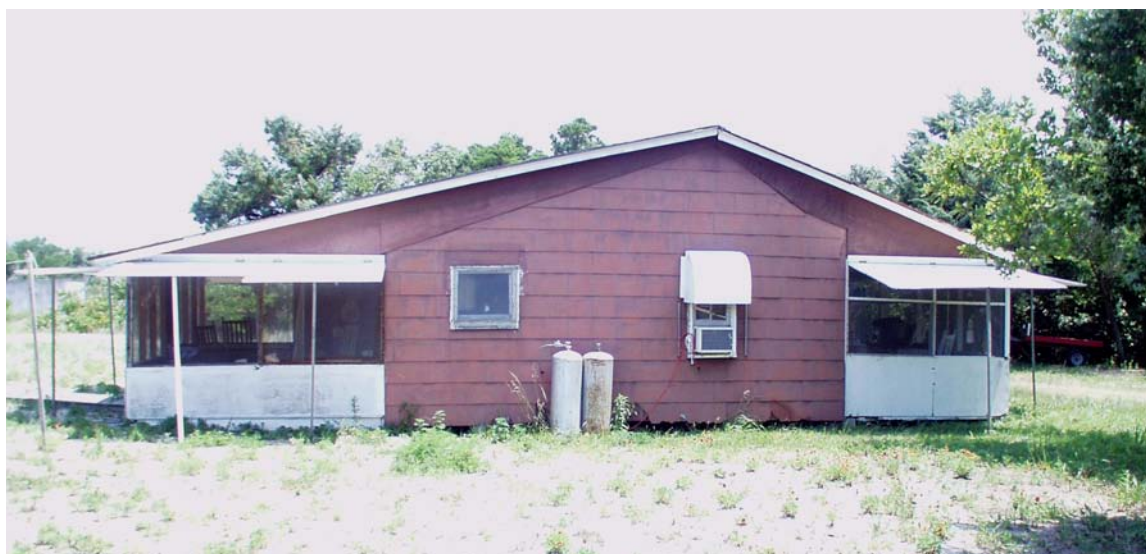
**Figure 23** View of southwest side of house, showing line of original roof prior to installation of present roof after 1976. (NPS-SERO-CRS, 2002)

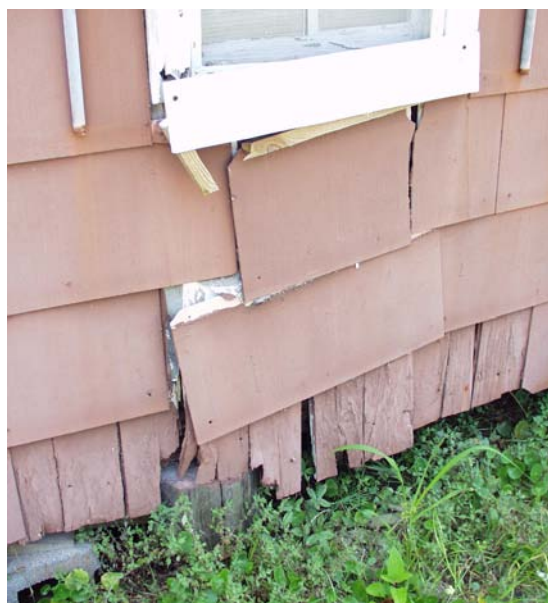
*Floors:* Original floor joists are generally 2" by 6- 1/2" (actual dimension), set on 32" centers. Single 2" by 6- 1/2" boards form the perimeter sills of the original house. As noted above, the mid- span supports for these joists have rotted, which has left the floor system unstable. In addition there has been severe sill damage at several locations, especially on the northeast side of the house.

**Figure 24** View of damaged siding on northeast side of house, the result of major sill damage in this location. Original board siding is exposed across bottom of wall. (NPS-SERO-CRS, 2002)

- Reduce span of joists and rafters by adding intermediate members.
- Repair termite- damaged and/or rotted sills and other framing elements as necessary.
- Reconstruct original porches.
- Restore original roof line.

- Remove asbestos siding, reusing or stockpiling the shingles.
- Repair and preserve underlying tongue- and- groove siding.

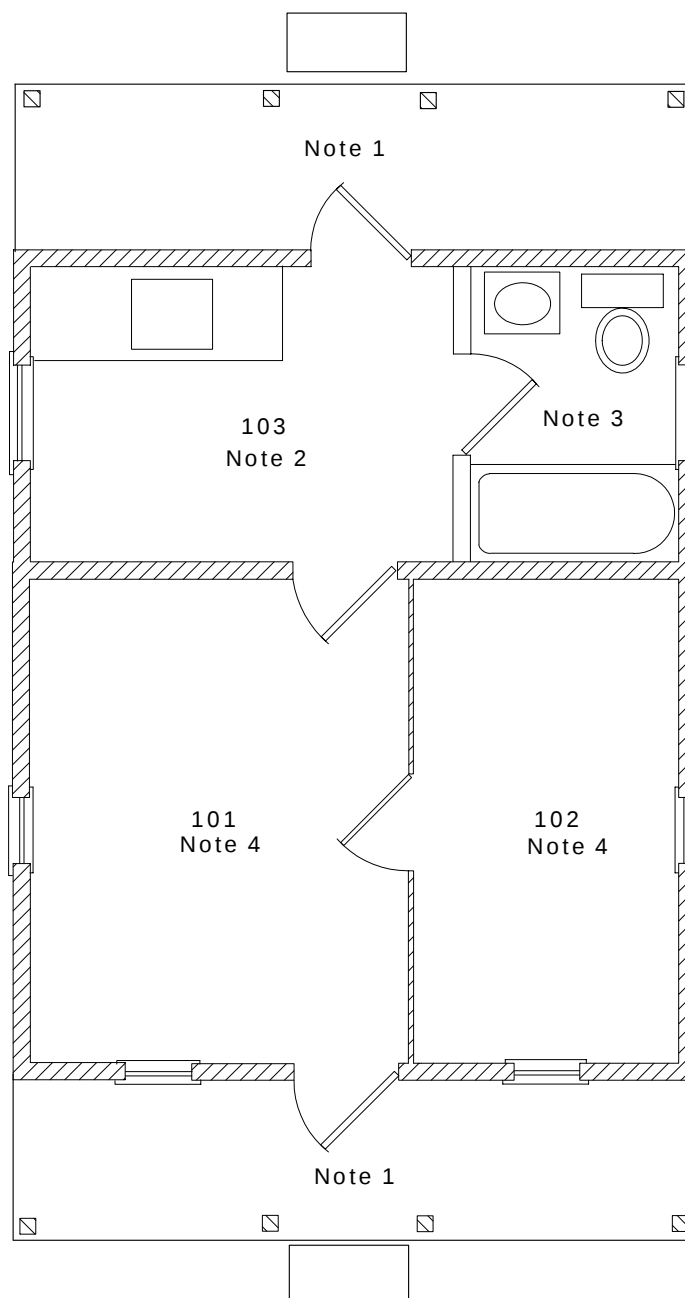
**Figure 31** Proposed plan for treatment and use. (T. Jones, NPS-SERO-CR, 2003)

1. Reconstruct porch using details seen in O'Boyle photographs.
2. Rehabilitate kitchen.
3. Construct partition wall and install new bathroom.
4. Remove hardboard paneling, repair framing, replace hardboard paneling.
