Cape Lookout National Seashore  
Portsmouth  
**GEORGE DIXON HOUSE**  
**HISTORIC STRUCTURE**  
**REPORT**

2004  
Historic Structure Report  
George Dixon House  
Cape Lookout National Seashore (CALO)  
Portsmouth, NC  
LCS#: 12519

## Historic Structure Report

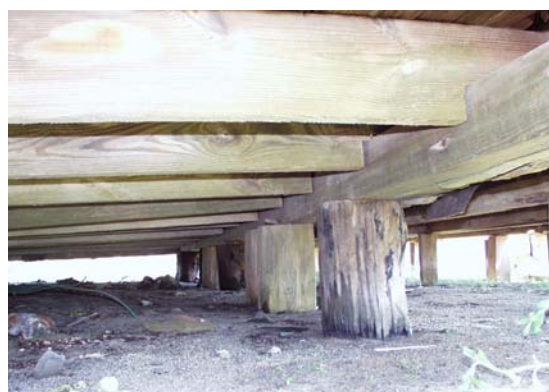
*Sills and Plates:* Perimeter sills have undergone extensive repairs and modifications, especially on the southeast side of the house where the original sill has been replaced by a stacked trio of boards, 2" by 6-1/2". The 6" by 8" sill at the front wall of the house appears to be typical of the original sills. A beam, 6' by 7", runs through the house from end to end and supports the walls above that separate front from rear rooms. Support piers near the middle of this beam (under the central hall) appear to have been undermined and/or otherwise been displaced. As a result, the beam has broken and partially collapsed, causing nearby joists to split and allowing the center of the house to drop several inches.

*Joists:* First floor joists are about 1-7/8" by 7-3/4", set about 24" between centers. Joists run front to rear in the house and are notched and lapped over front and rear sills and over the collapsing center beam. Most are in good

**Figure 11** View northeast of front sill, showing typical joist/sill connections and wooden piers. (NPS-SERO-CRS, 2002)

condition; but at least one joist has split as a result of the collapsing beam.

- Replace sill at southeast end of house and collapsing sill running through center of the house; repair other sills as necessary; raise and level building structure.
- "Sister" new floor joists to broken joists.
- Inspect stud connections to sills and plates and repair as needed.

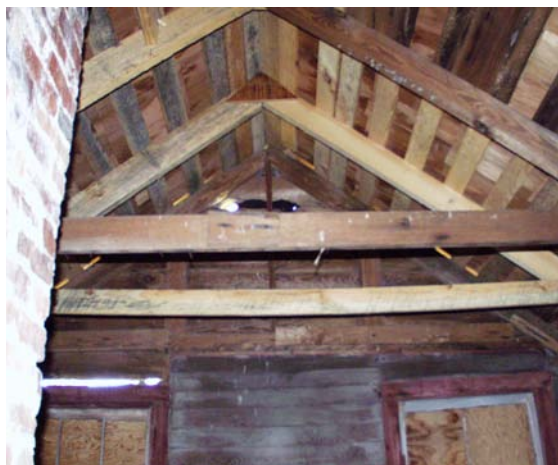
**Figure 12** View to northwest Room 202. Historic ceiling has been removed. (NPS-SERO-CRS, 2002)

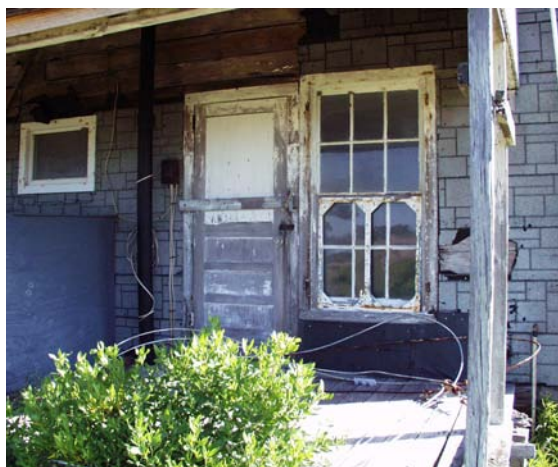
**Figure 13** View of original, 6/6 window with typical wood frame for screening. Original location for back door opening was at window at extreme left in this image. (NPS-SERO-CRS, 2002)

- Repair all existing sash, replacing those that are missing or too badly damaged to repair.
- Restore and reinstall louvered shutters.
- Close window on northeast side of Room 102 if kitchen wing is reinstated.
- Install aluminum- framed half screens.

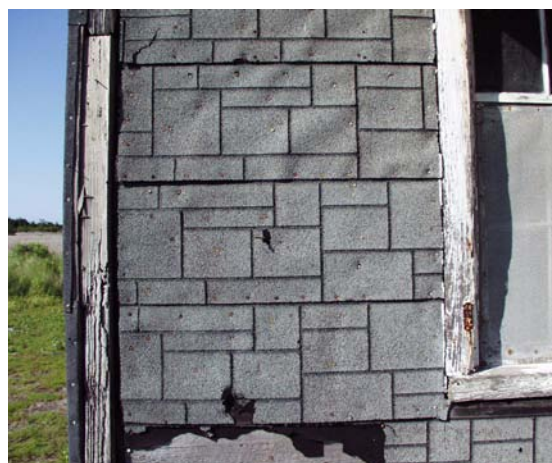
The exterior of the house was also stripped of its original siding. Old siding and material removed from the interior appears to have been used to resheath the house with flush- laid boards that were then covered with the present asphalt composition panels. The old wood- shingled roof covering remained in place but within a few years had been replaced by green, asphalt- composition, “hurricane” shingles.<sup>29</sup>

**Figure 14** View of added asphalt siding. Note part of shutter hinge on adjacent window casing, which is original. (NPS-SERO-CRS, 2002)

- Remove existing asphalt siding, preserving at least one complete panel in the park's permanent collection.
- Identify original 1" by 8" siding material, and re- install all sound material as lapped siding, replacing missing material as necessary.
- Paint siding and trim as dictated by careful analysis of surviving finishes.

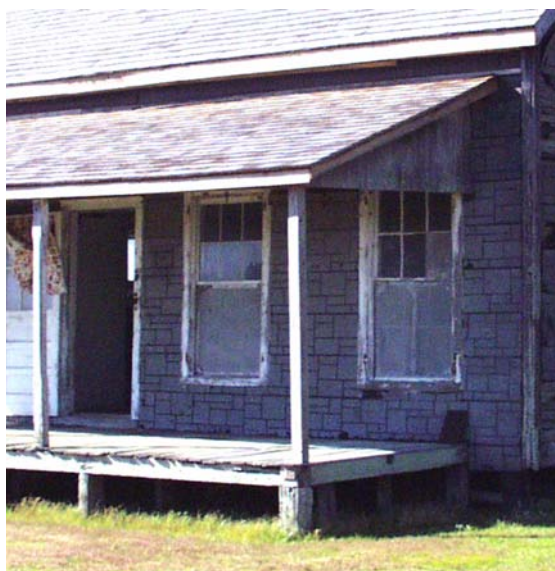
**Figure 15** View of front porch; column at left is original. (NPS-SERO-CRS, 2002)

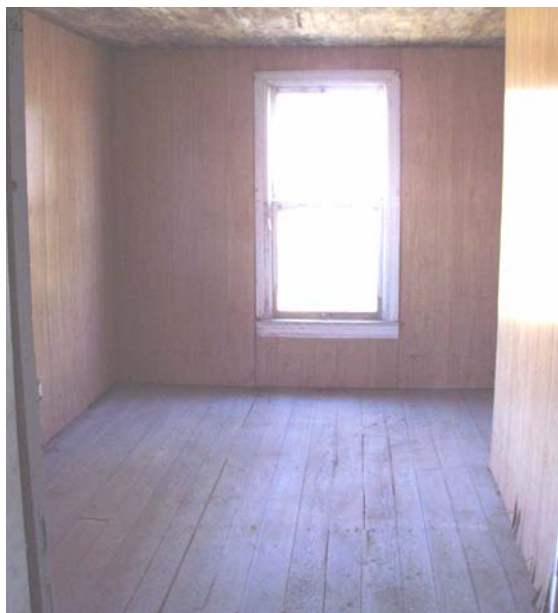
**Figure 20** View north in Room 101, showing window that infills earlier door to now-missing kitchen wing. (NPS-SERO-CRS, 2002)

*Windows:* When the kitchen was repaired after the 1933 hurricane, a door was created out of the original window opening on the north wall in order to connect the relocated kitchen and this room. When the kitchen was moved in 1939, the door was replaced by the present window, which has one-over-one sash.

- Replace front door with four- panel door similar to those that remain on the interior.
- Replace window on northwest side of Room 102 with a four- panel door, similar to the other exterior doors.
- Remove and close existing back door.
- Restore original back door opening, using typical four- panel door.

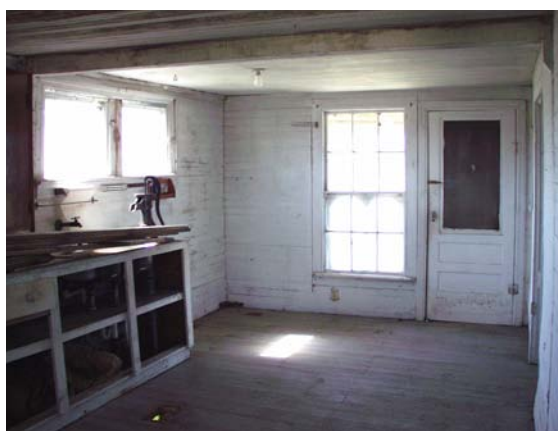
**Figure 21** View west showing what was Room 103, now combined with Room 104. (NPS-SERO-CRS, 2002)

When the original porch door from this room was closed after World War II, the sash that had been part of the window on the south wall of Room 103 appears to have been recycled to fill this opening, since it matches the original sash in Room 101 and elsewhere.

- Remove existing windows in Room 103 and replace with original window now in Room 102.
