CAPE LOOKOUT NATIONAL SEASHORE  
GUTHRIE- OGILVIE HOUSE  
**HISTORIC STRUCTURE  
REPORT**

2004  
Historic Structure Report  
Cape Lookout National Seashore  
Guthrie- Ogilvie House  
LCS#: 09t829

# Guthrie-Ogilvie House

## Historic Structure Report

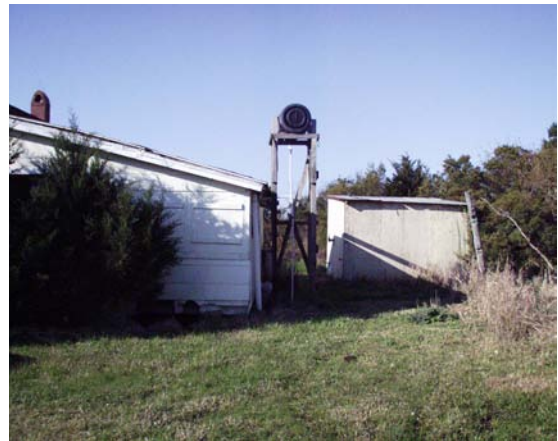
A wood- framed, plywood- covered storage building, constructed since 1977, is located a few feet west of the house, and there is a water tank elevated on a wood frame at the rear of the house. The condition of both structures is only fair.

**Figure 18** View southwest showing modern storage building and water tank. (NPS-SERO-CR, 2003)

- Clear crawl space beneath house of all trash and debris.
- Remove storage building and elevated water tank.
- Follow recommendations of Cultural Landscape Report in determining additional treatment of the surrounding landscape.

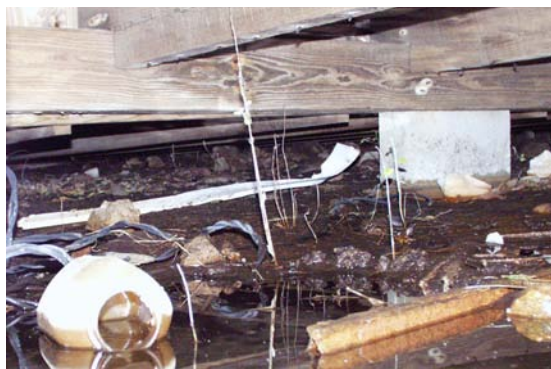
The house is set on wooden piles sunk to an indeterminate depth. The piles are very low, elevating the house less than a foot from the ground. Some have rotted away from the sills, leaving the building's sill and frame unsup-

ported at several locations. All are in poor condition.

Floor framing is generally undersized, and additional piers of concrete- block and brick have

**Figure 19** View south under Room 101, showing front sill of house. (NPS-SERO-CR, 2003)

been installed at random points in an attempt to correct some of these deficiencies.

- Replace foundation piers.
- Raise finish floor level to accommodate changes in grade that are recommended for improved drainage.

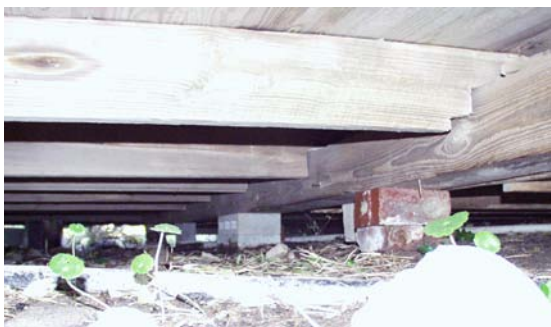
**Figure 20** View west under Room 101. (NPS-SERO-CR, 2003)

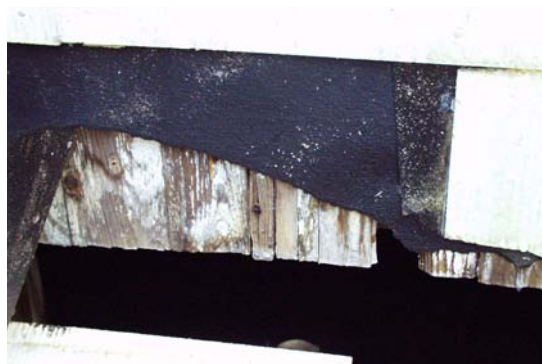
**Figure 24** View of typical wood siding and asbestos-cement siding. (NPS-SERO-CR, 2003)

- Remove asbestos siding and restore tongue- and- groove siding.
- Model window casing after existing front door casing, except for pedimented header.
- Repair and preserve boxed eaves.
- Paint siding and trim white.

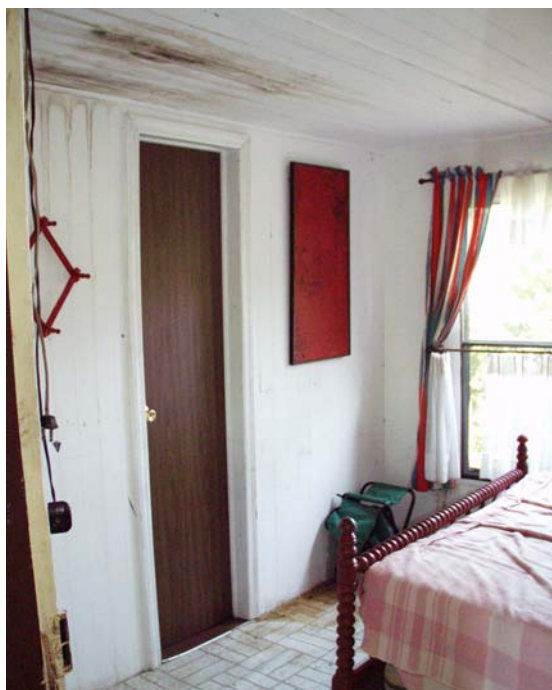
**Figure 34** View north of Room 102, showing door added for bathroom. Note water damage to ceiling. (NPS-SERO-CR, 2003)

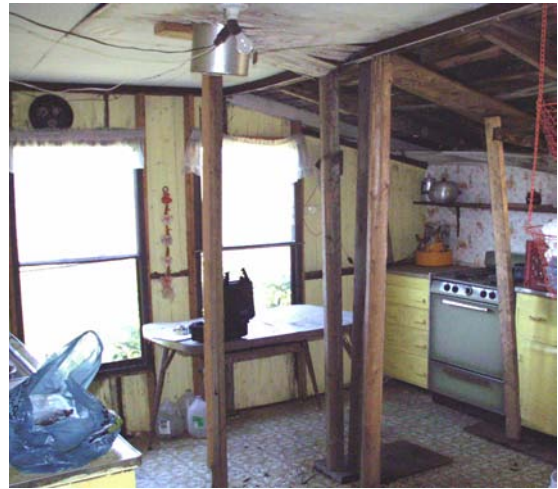
Framing is in generally fair condition in most of the house, but there has been major water damage to roof, floor, and wall framing on the northwest (rear) side of Room 103. In addition, parts of the rear of the house were originally framed for porches, which were later enclosed. With later repairs and alterations, the framing in these areas is very irregular and in generally poor condition.

**Figure 35** View west in Room 103, showing deteriorated shed-roofed addition that was combined with this room after World War II. (NPS-SERO-CR, 2003)

- Reconstruct missing wall and repair framing in Room 103.
- As piers are replaced, inspect and repair sills and floor joists as necessary.
- Where feasible, improve connections of framing members to reduce the possibility of significant damage from high winds.
- Augment floor framing with added support beams as necessary.
- Remove addition to front porch and restore historic porch enclosure.
- Restore original roof line.

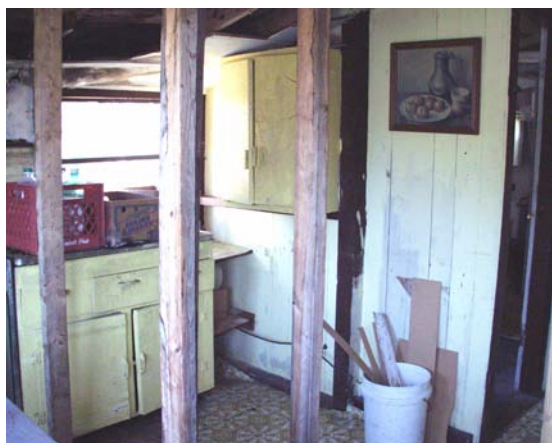
**Figure 38** View to north in Room 103. Posts in foreground have been added to stabilize roof structure where wall was removed. (NPS-SERO-CR, 2003)
