CAPE LOOKOUT NATIONAL SEASHORE  
Cape Lookout Lighthouse  
Keeper's Dwelling (1907)  
**HISTORIC STRUCTURE  
REPORT**

**2004**

2002  
Historic Structure Report  
Cape Lookout Lighthouse Keeper's Dwelling  
(1907)  
Cape Lookout National Seashore  
LCS#: 091838

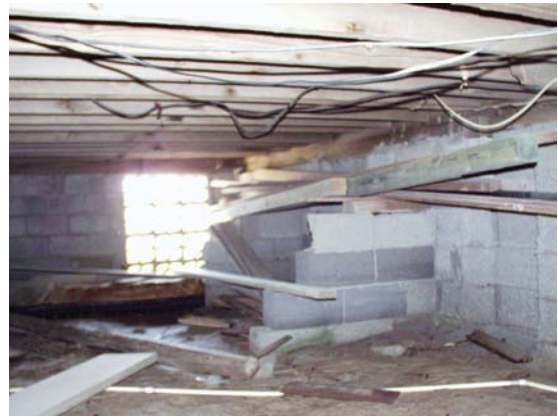
**Figure 3** View north in crawl space, showing lattice block used to allow floodwater to pass through the building. (NPS-SERO-CR, 2002)

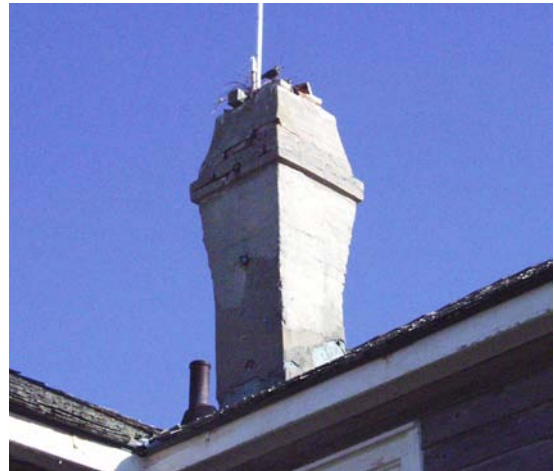
*Chimney:* The house was constructed with a single brick chimney stack that originally served a fireplace in the sitting room (Room 101) and a cook stove in the kitchen. When the house was moved, the foundation of the chimney was lost, but the original fireplace and chimney stack were moved intact and reset on a concrete block foundation. The chimney is

**Figure 4** View of chimney. (NPS-SERO-CR, 2002)

- Match original foundation brick, if located, or, if not, match brick on existing historic chimney.
- Remove stucco from chimney, repair chimney as necessary.

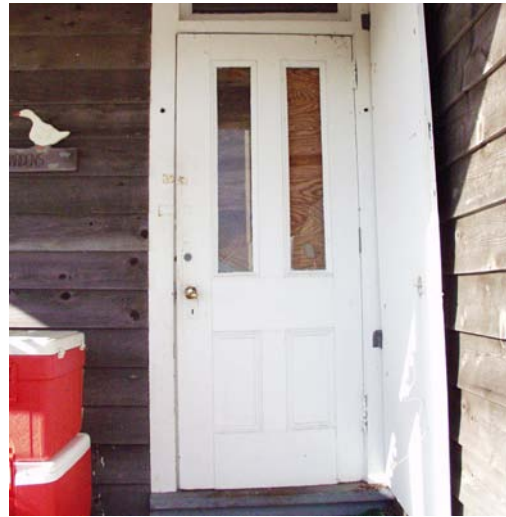
**Figure 8** View of back door. Original front door was of a similar design. (NPS-SERO-CR, 2002)

may simply be the result of old damage and repairs to the door, which closely resembles the door indicated on the original architectural drawings for the house. Vandals recently broke one of the back door's beveled- glass lights.

- Repair and preserve all existing window sash.
- Repair and preserve all wood- framed window screens; where missing, install new wood- framed screens.
- Repair and preserve back door.
- Replace modern front door with replica of original.
- Remove plywood shutters on porches if the added security is unnecessary.

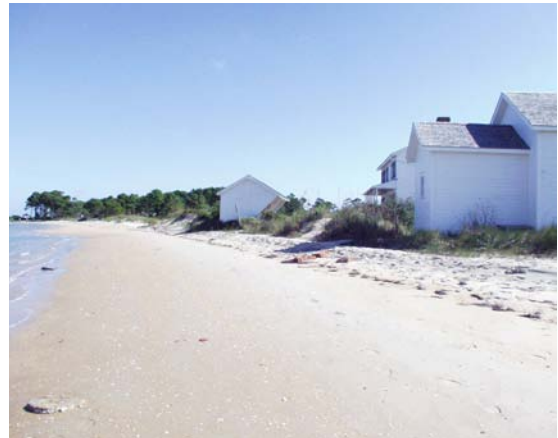
Storms exposed the foundation of the Coal House in 1999, and comparison of the site today with historic photographs makes clear the threat that exists to the entire complex. Over two thousand square feet of the historic light station compound is now below the high water mark, and there are no signs that the erosion is abating. Only periodic beach replenishment by the Army Corps has kept the remainder of the light station complex intact.

**Figure 39** View to northeast showing present shoreline of Cape Lookout Bight at lighthouse station. Summer kitchen is at right and coal and wood shed is at center. (NPS-SERO-CR, 2002)
