# Cape Lookout Village Lewis-Davis House Historic Structure Report

Cape Lookout National Seashore  
**LEWIS - DAVIS HOUSE**

# **HISTORIC STRUCTURE REPORT**

**2004**

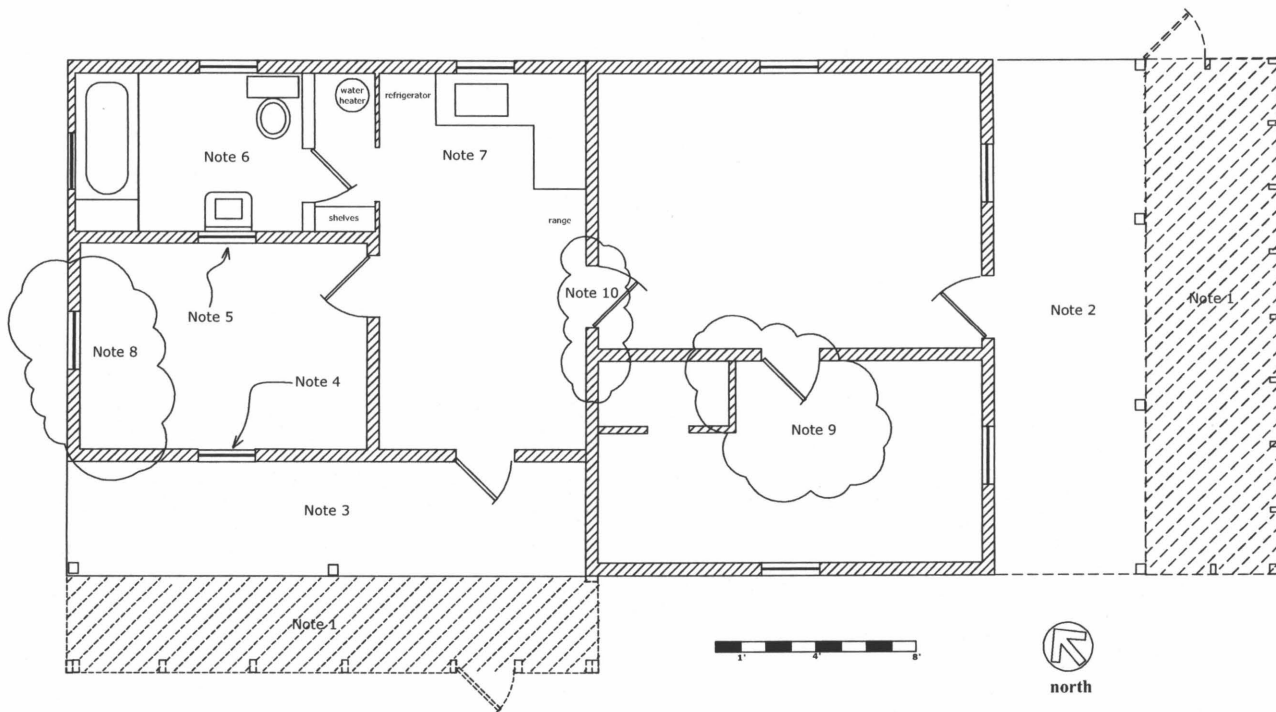
**Figure 1** Proposed plan for treatment and use. (T. Jones, NPS-SERO-CR, 2003)

Remove 1950s roof structure and restore original roofs. Remove cement-asbestos siding, restore underlying board-and-batten siding. Repair and maintain existing historic interior and exterior woodwork.

1. Remove porch additions (hatched areas).
2. Restore front porch, reconstructing partial screened enclosure.
3. Remove existing bathroom installation on side porch, restore screened porch.
4. Install new wood sash, 6/6, to match historic windows.
5. Close opening at this location.
6. Construct new wall to partition this space; remodel for bathroom and utility storage.
7. Install new kitchen sink, counter and cabinets in this area.
8. Repair major water and termite damage to sills, floor and ceiling joists, and rafters in this area.
9. Repair major damage to floor framing in this area.
10. Repair major water damage to structure in this area.

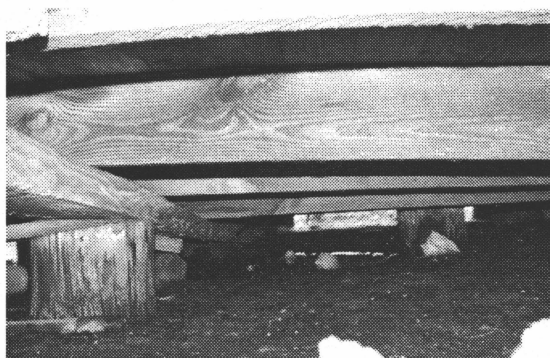
The wood frame of the main body of the house is set on a series of wooden piers, 8" - 12" in diameter, sunk to some indeterminate depth into the ground. Piers are so low that the house's frame is only a few inches above grade. Most are, at best, in fair condition, and concrete block have been inserted at some locations to provide additional support. Water is standing under large areas of the house, contributing to its ongoing deterioration.

**Figure 23** View of crawl space and piers. (NPS-SERO-CR, 2002)

- Raise house and replace all wood piles, replicating the existing size and placement of piles.
- Design and install storm-resistant mechanism to tie the house's wood frame to the foundation piles.

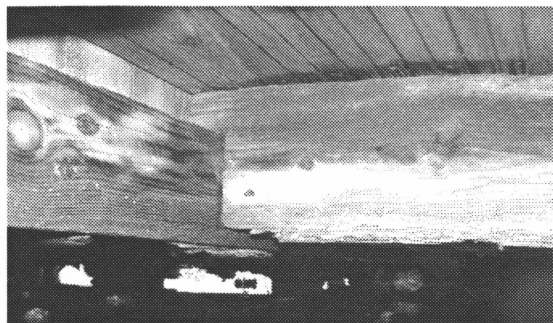
*Floor:* Floor joists appear to be a mix of 2" by 4" and 2" by 6" (actual dimensions could not be ascertained), set on 30" - 36" centers. Deterioration is widespread. Sills appear to be mostly single 2" by 8". Along the northwest side of Room 104, floor joists and sill have collapsed and there is major structural damage in Room

**Figure 24** View of typical joist sill connection. (NPS-SERO-CR, 2002)

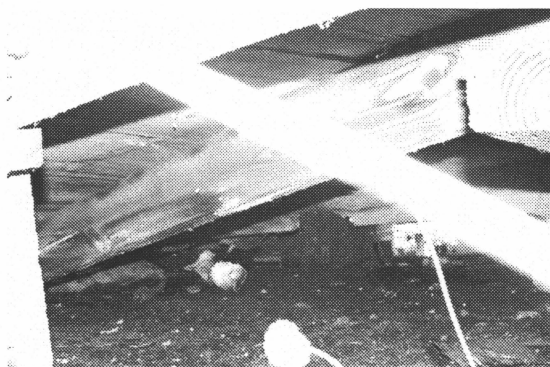
The structure has suffered major damage from termites and a leaking roof. Floors are collapsing in Rooms 101, 104 and 105, and there appears to have been major damage to the sills throughout the house. The roof, too, is in extremely poor condition, with large areas of rotten and termite-ridden rafters and decking. Although most of the historic finishes remain in place, the house as a whole is in very poor condition.

**Figure 25** View of collapsing floor under Room 104. (NPS-SERO-CR, 2002)

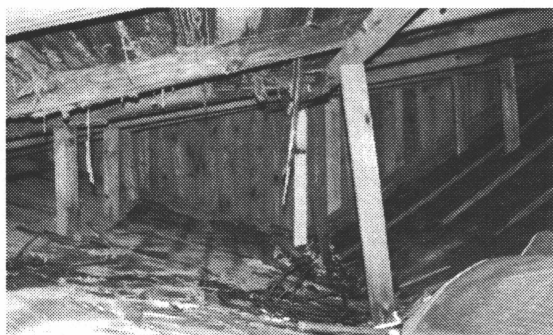
**Figure 26** View of junction of roofs of two original structures; note severe termite damage in rafters and decking at left. (NPS-SERO-CR, 2002)

**Rafters:** There are three main rafter systems in the present structure: one over Rooms 100 and 101, which could not be examined, and another separate system over the rear rooms. When the two halves of the house were joined, a new roof structure was built to cover both of the earlier roofs (see Figure 10). Rafters of this third roof are around 1- 3/4" by 3- 3/4", on 30" centers, and woefully undersized for their span and pitch. Rafters at the rear of the house have been severely damaged by termites.

- Stabilize structure before repairs proceed.
- Remove 1950s roof structure and restore original roofs.
- Repair floor, wall, and ceiling framing as necessary and make improvements in connections of framing members to reduce the possibility of significant damage from high winds.
- Remove porch additions and restore porches to their appearance in the 1940s photographs.
- If entire house cannot be salvaged, repair and preserve original structure encompassing Rooms 100 and 101.

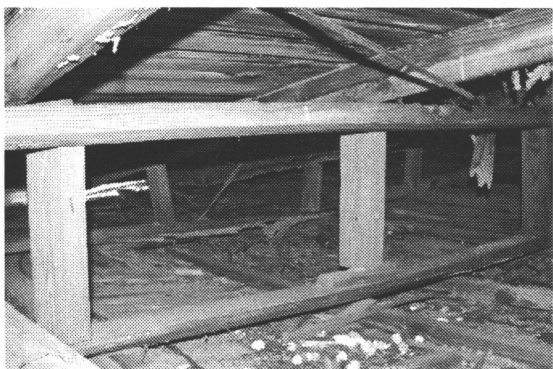
**Figure 28** View of heavily-damaged roof and ceiling structure over Room 104. (NPS-SERO-CR, 2002)

**Ceilings:** Like the walls, the ceilings appear to be very loosely framed, using widely- spaced 2" by 4" joists or, in some cases, 2" by 6" laid flat. The ceiling above Room 104 has been heavily damaged by water penetration and termites.

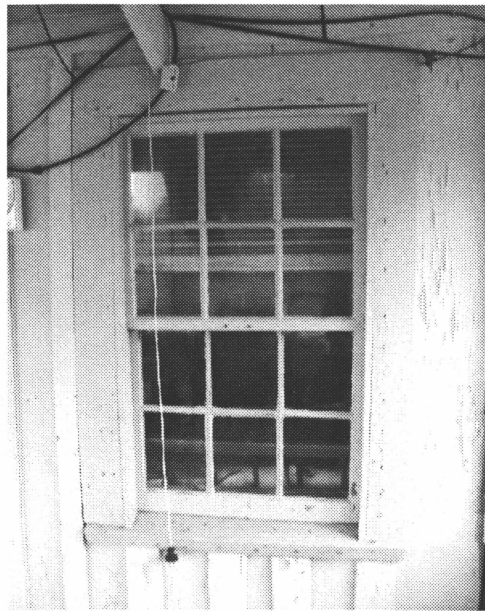
**Figure 29** View of window W-2 on southeast (front) side of house, with exterior siding and trim typical of the original building. (NPS-SERO-CR, 2002)

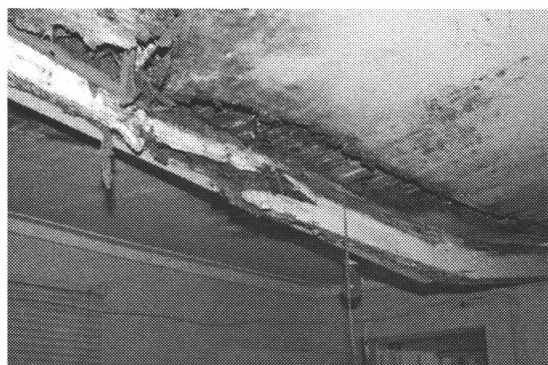
*Ceiling:* The ceiling, like the floor, is on the verge of total collapse due to severe termite and water damage. It was originally finished with double- V- joint, tongue- and- groove boards, 3- 1/2" wide.

**Figure 41** View to east of ceiling in Room 104. (NPS-SERO-CR, 2002)
