Cape Lookout National Seashore  
O'BOYLE - BRYANT HOUSE  
**HISTORIC STRUCTURE  
REPORT**

2004  
Historic Structure Report  
O'Boyle- Bryant House  
CAPE LOOKOUT NATIONAL SEASHORE  
Cape Lookout Village  
LCS#: 271581

## Historic Structure Report

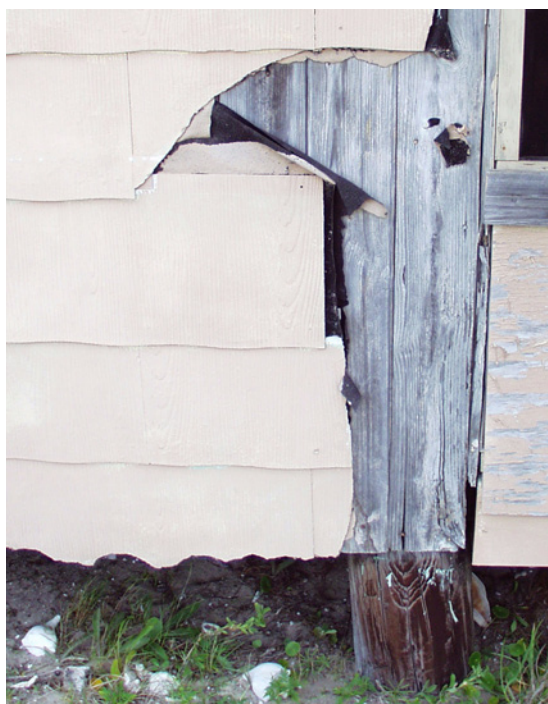
**Figure 28** View of south corner of house showing original siding at center, asbestos siding at left, and modern plywood at right. (NPS-SERO-CRS, 2002)

- repair and preserve asbestos siding;
- repair underlying wood siding as necessary;
- repair window sills, casing, and trim to match those at W- 1 and W- 2, but repair and preserve aprons at W- 8 and W- 9;
- repaint siding, eaves, and other exposed woodwork white, except for window and door sills, casing, sash, and trim and the front porch ceiling, all of which should be painted dark green.

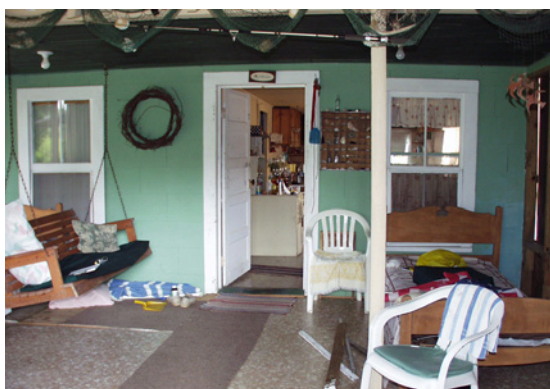
**Figure 32** View of front porch.  
(NPS-SERO-CR, 2002)

- repair sills as necessary;
- improve connections of framing members to reduce the possibility of significant damage from high winds;
- augment floor framing with added support beams;
- preserve historic framing members in situ throughout the structure;
- remove addition to front porch and restore historic porch enclosure.
