HISTORIC STRUCTURE ASSESSMENT REPORT

CARL SANDBURG HOME

CARL SANDBURG HOME
NATIONAL HISTORIC SITE,
FLAT ROCK, NC

NATIONAL PARK SERVICE
HISTORIC PRESERVATION TRAINING CENTER
FREDERICK, MD
JANUARY, 2011

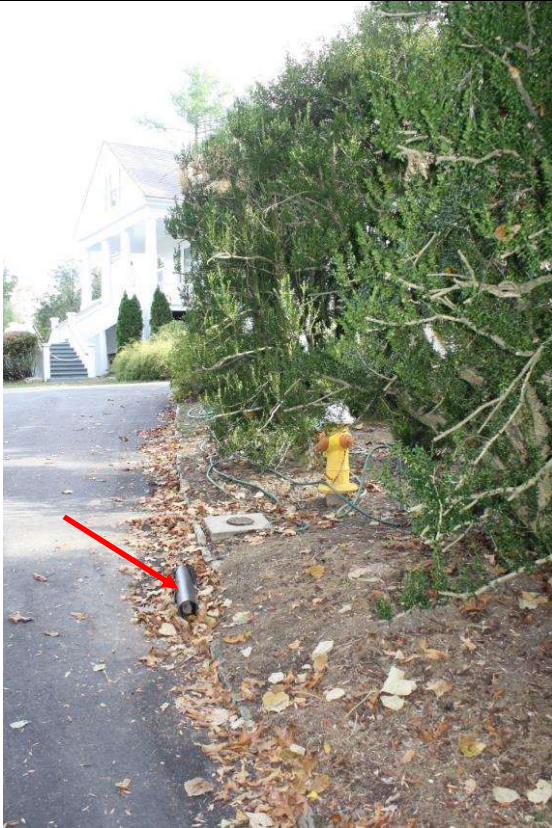
Outlet drains onto asphalt drive.

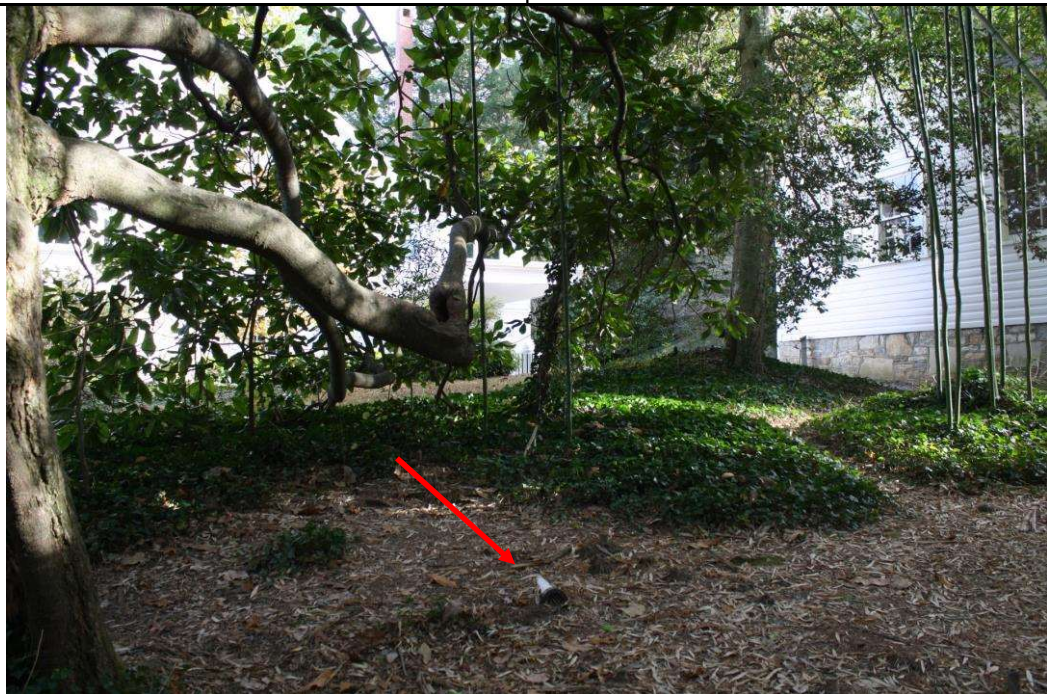
Third drainage outlet sits in the wooded area between the Swedish House and the driveway.

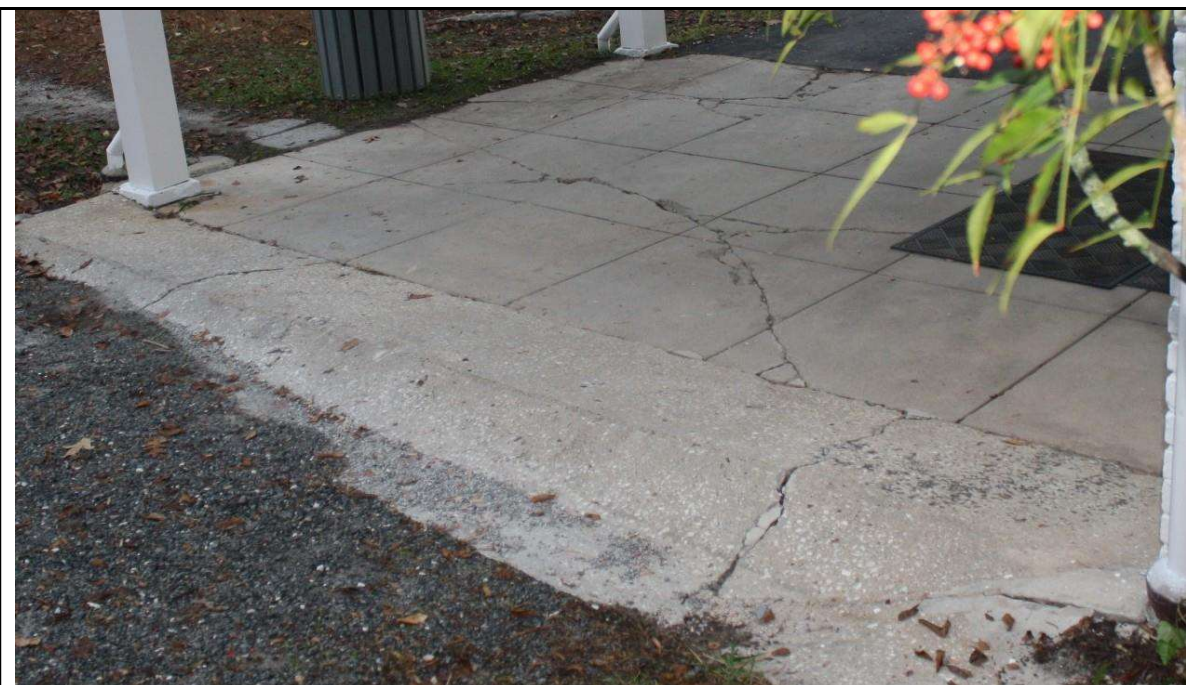
Cracked concrete under porte cochere.

Material & Amount	Unit Cost	Cost
Replace concrete	Per job	\$7,000.00
TOTAL		\$7,000.00

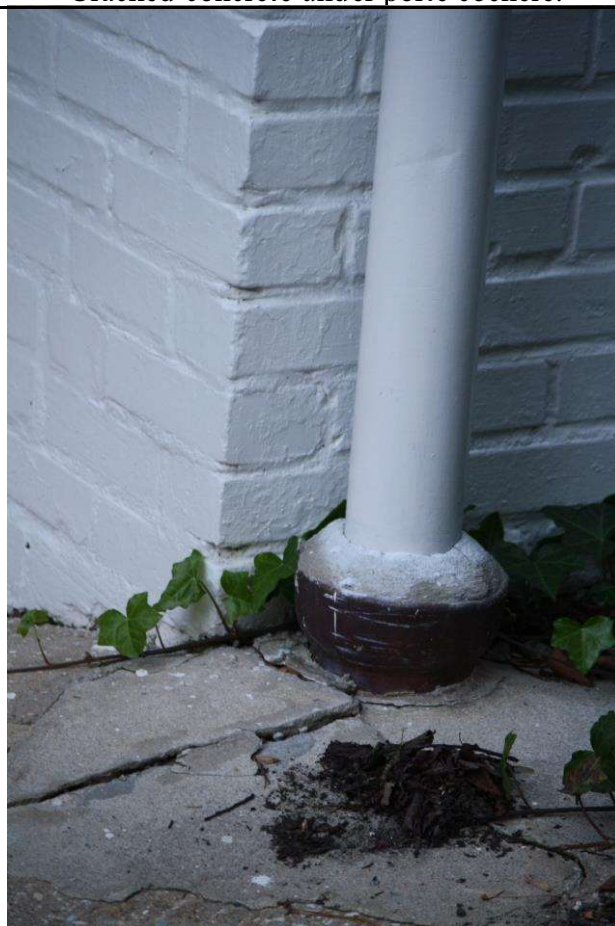
Cracking and heaving at SW corner.

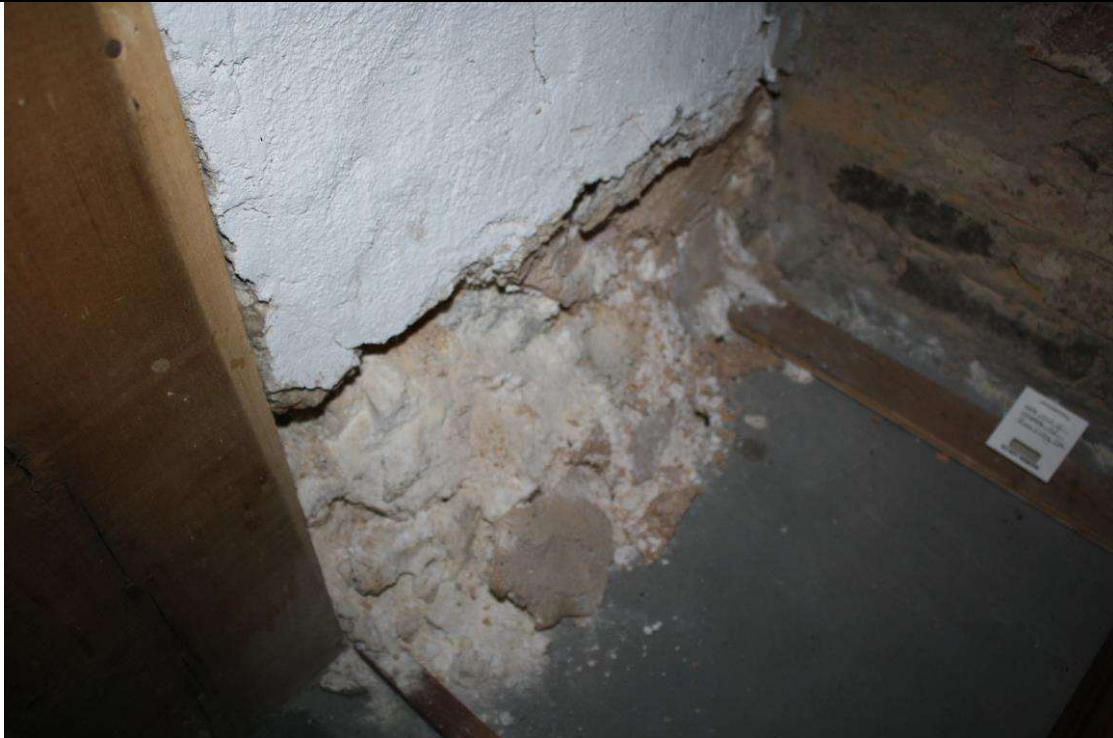
Base of the chimney is deteriorated (wall between Room 001 and 018).

Material & Amount	Unit Cost	Cost
Repair deteriorated areas of brick	Per job	\$4,000
Rake out and repoint joints	\$35/sf	\$6,125
TOTAL		\$10,125

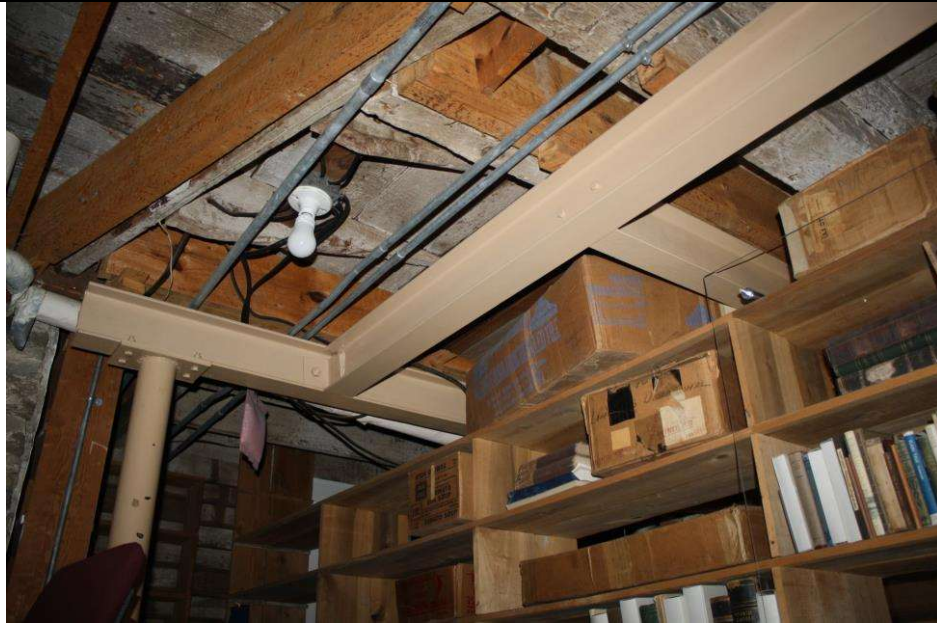
Steel I-beams and lolly columns in Room 018; Some joists replaced.

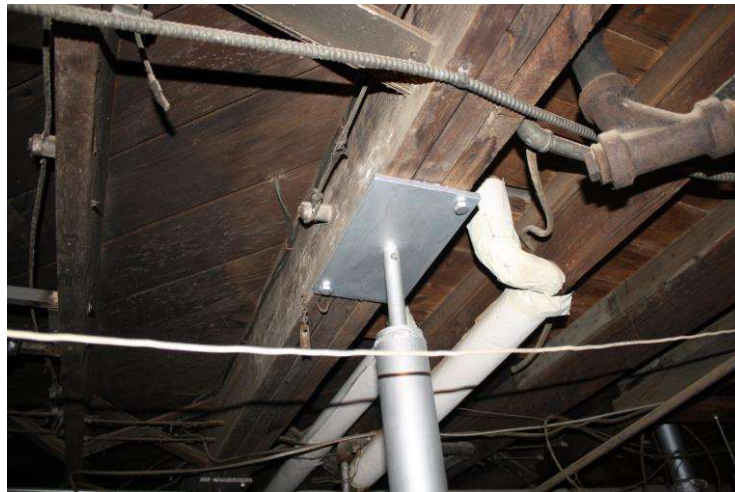
Lolly column under triple joist in Room 011.

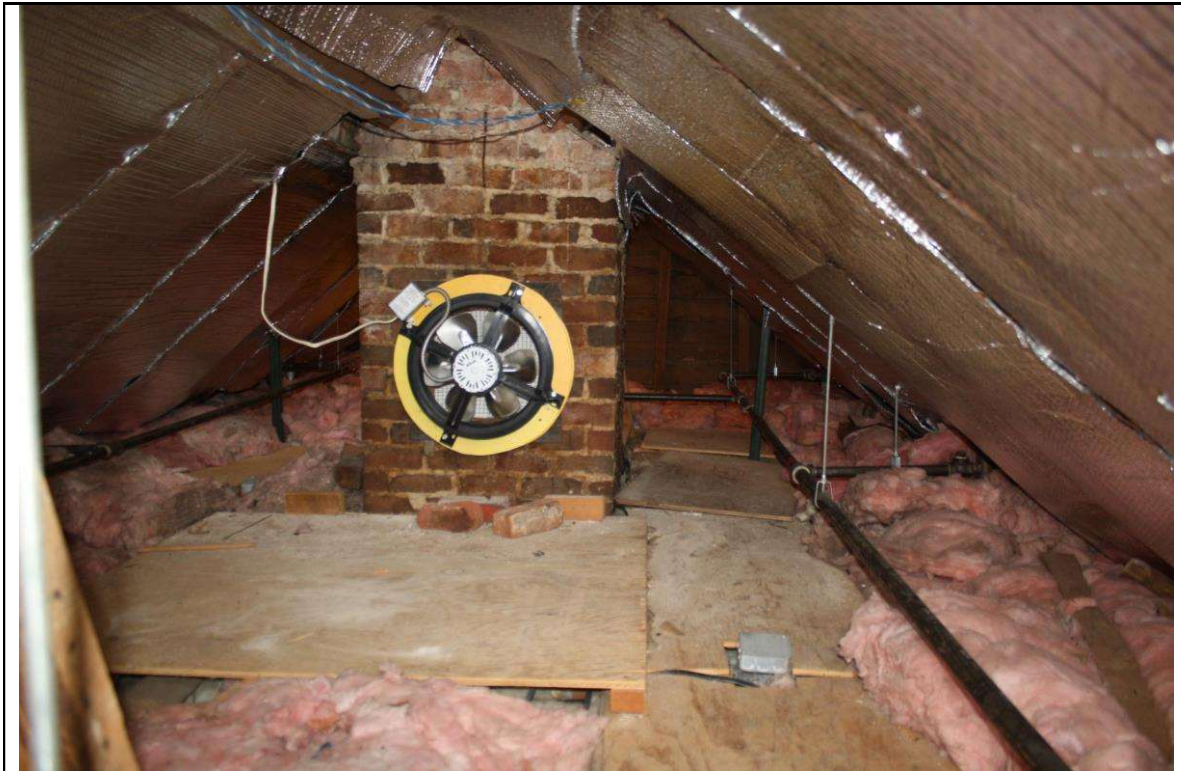
View of roof structure in attic; Foil insulation nailed to rafters.

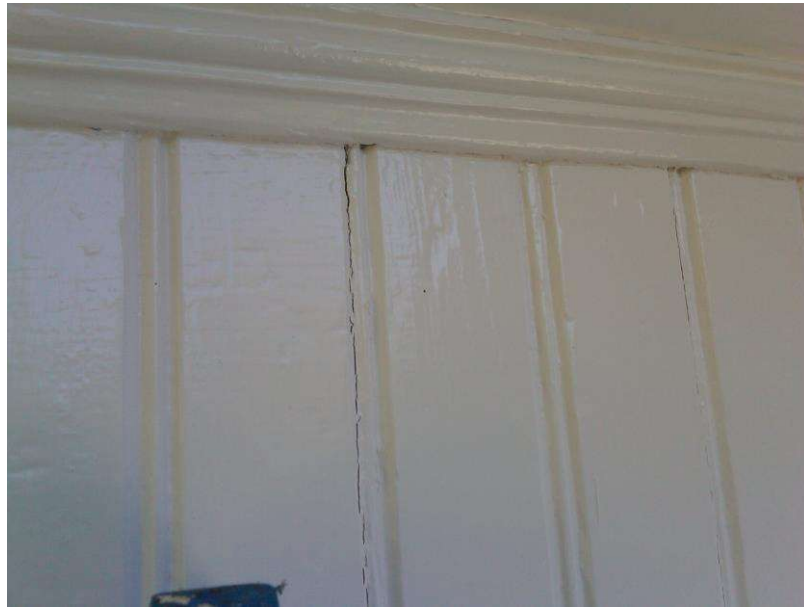
Gaps visible in vertical bead board.

Material & Amount	Unit Cost	Cost
Repair/ Replace deteriorated siding; Repair any large checks/splits; Renail loose boards	Per job	\$3,000.00
TOTAL		\$3,000.00

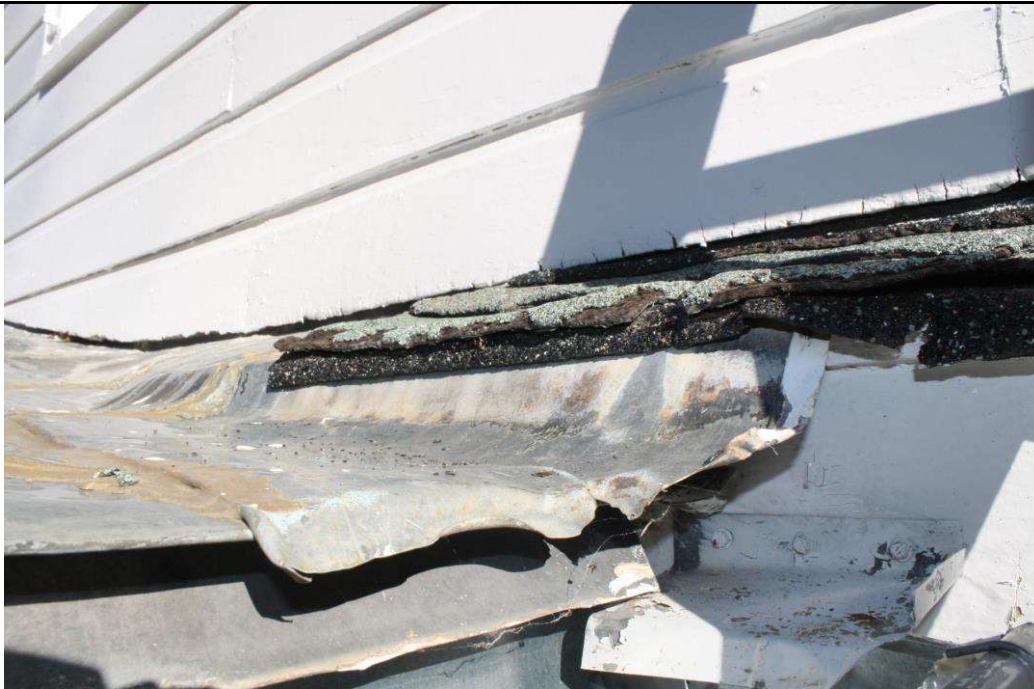
Weathered flashing detail at corner. Also, the deteriorated asphalt shingles on cornice should be replaced with metal flashing.

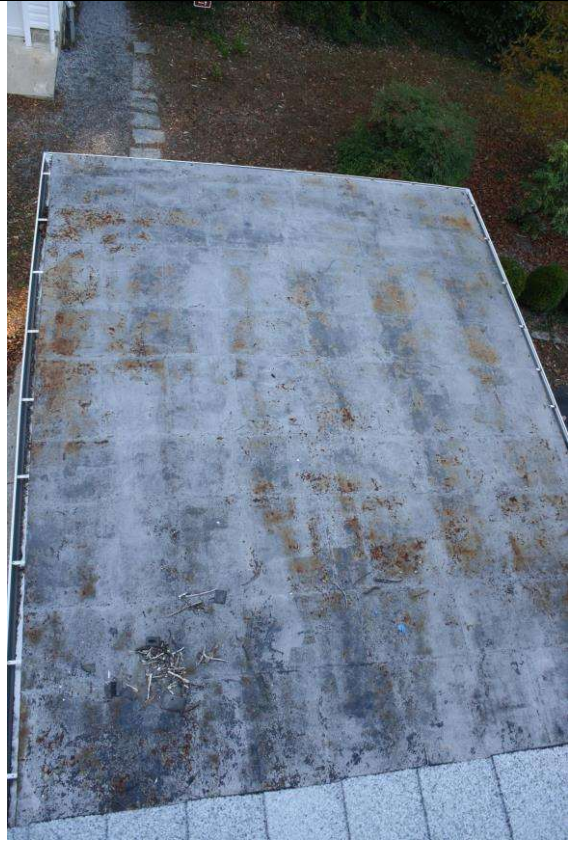
Rusting flat seam pans on porte cochere roof.

Material & Amount	Unit Cost	Cost
Replace porte cochere roof	Per job	\$3,900
Replace West Bay roof	Per job	\$4,000
Replace Addition roof	Per job	\$9,380
Replace Main roof	Per job	\$35,020
TOTAL		\$52,300.00

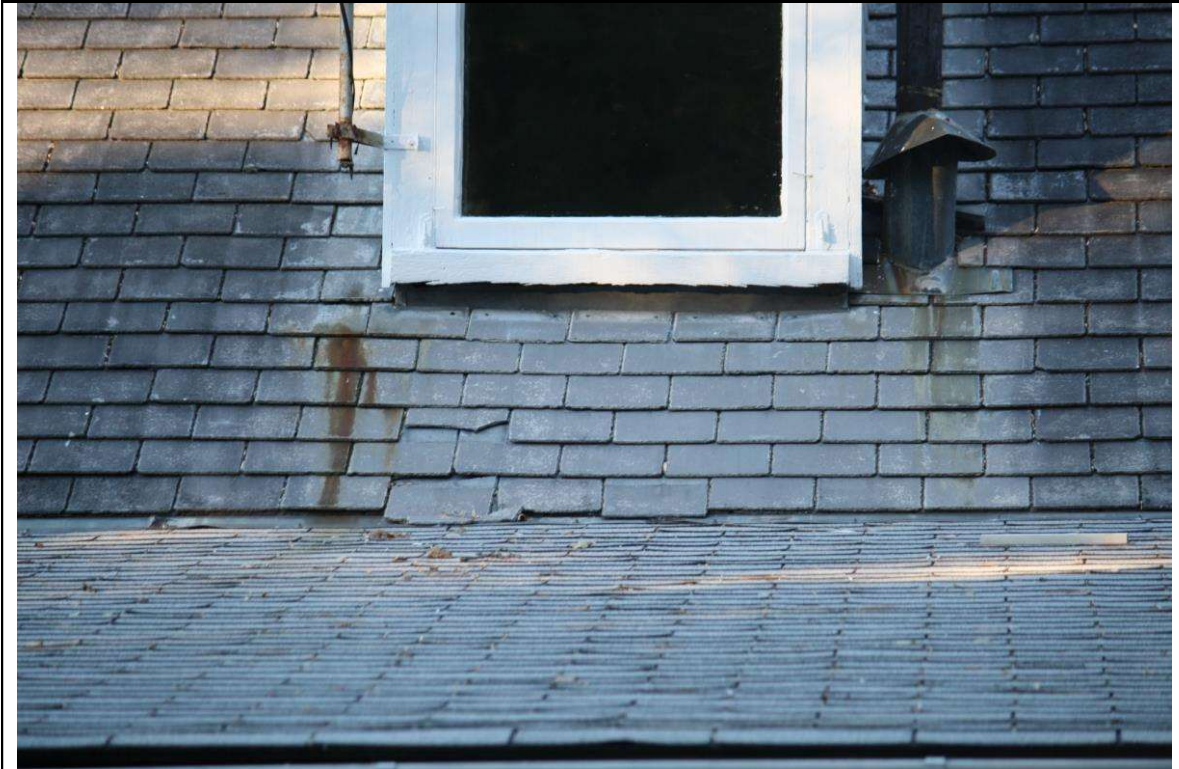
View of chipped, broken and loose shingles; Staining

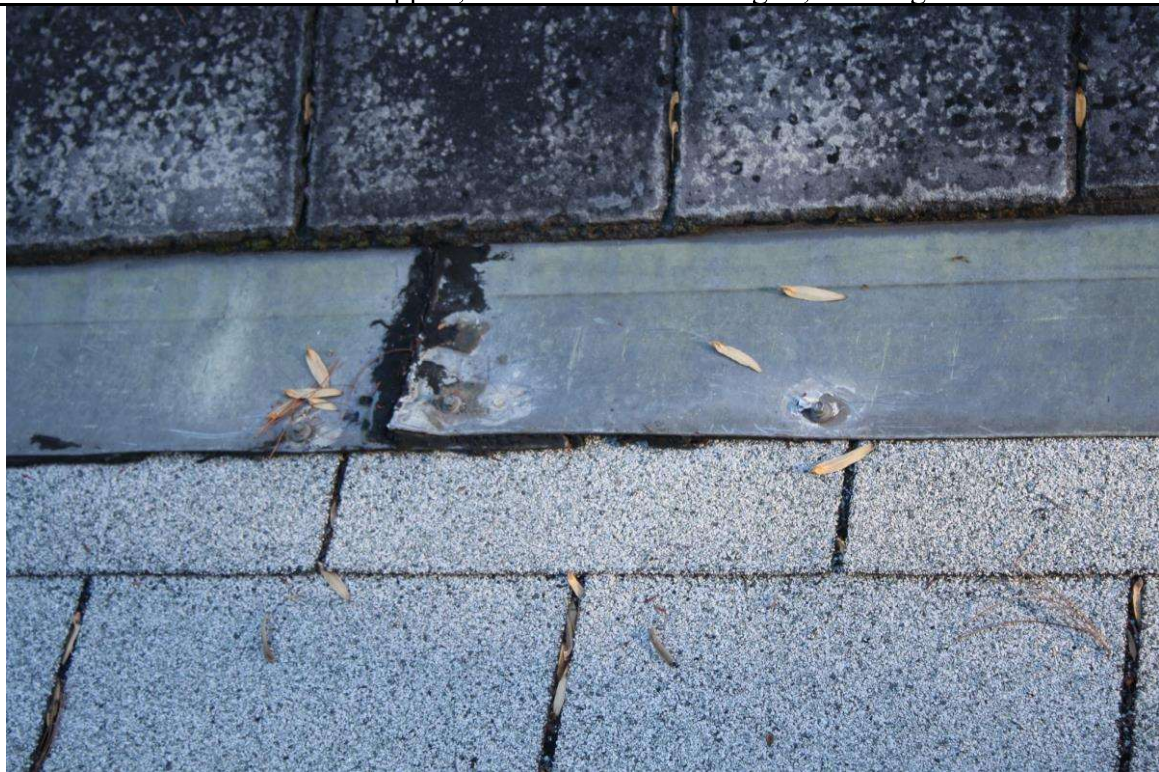
Flashing at roof juncture riveted thru shingles.

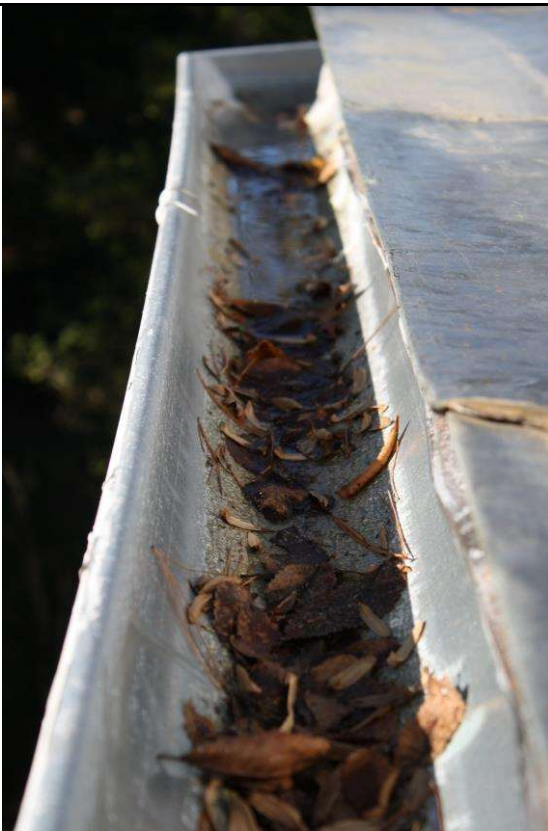
Leaves and standing water in west bay windows gutter

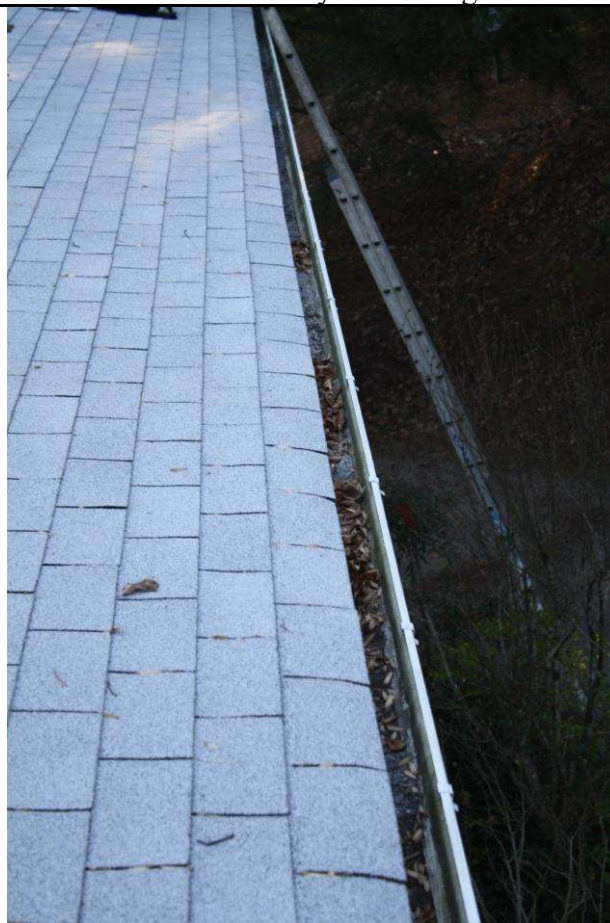
Leaves and debris in Addition roof gutter.

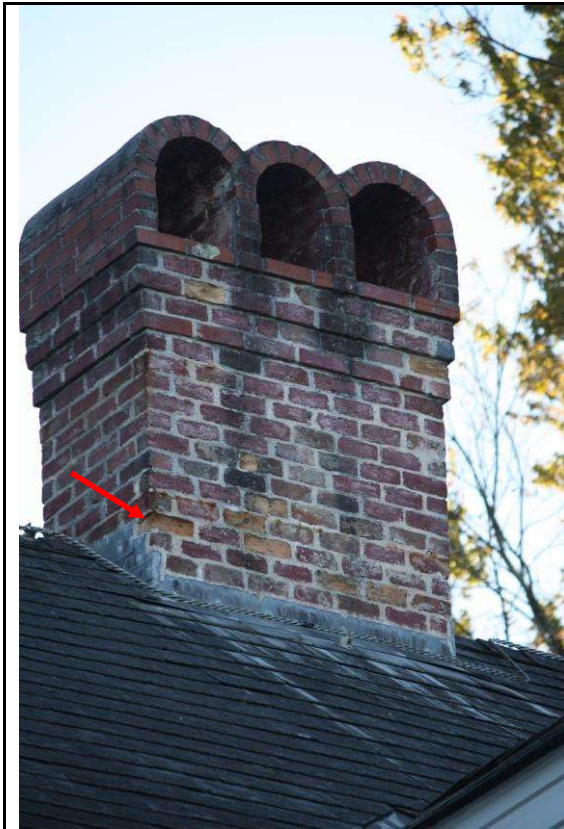
Weathered and spalling brick. N
face of ridge chimney.

Material & Amount	Unit Cost	Cost
Rake out deteriorated joints; Repoint chimneys with historically appropriate mortar; repair brick	\$45/sf	\$11,250.00
Engineer consult	Per job	\$1,500.00
TOTAL		\$12,750.00

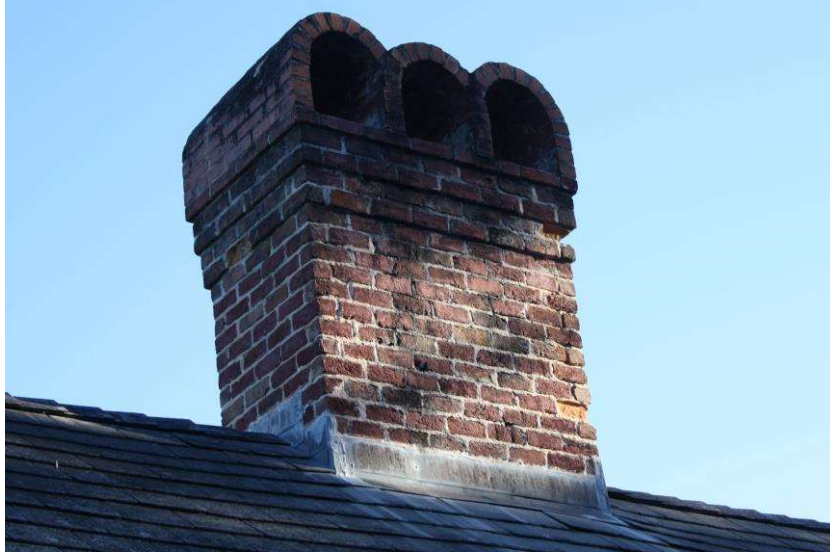
S face of ridge chimney – Brick weathered and spalling

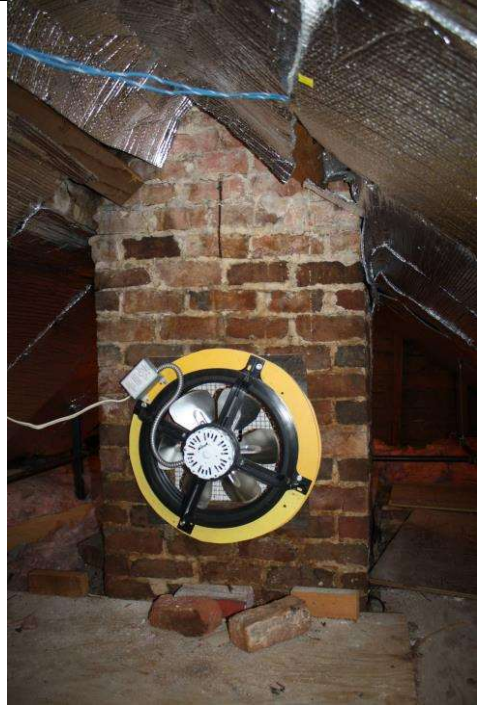
Interior view of center ridge chimney; Top part of flue was removed and to install the fan.

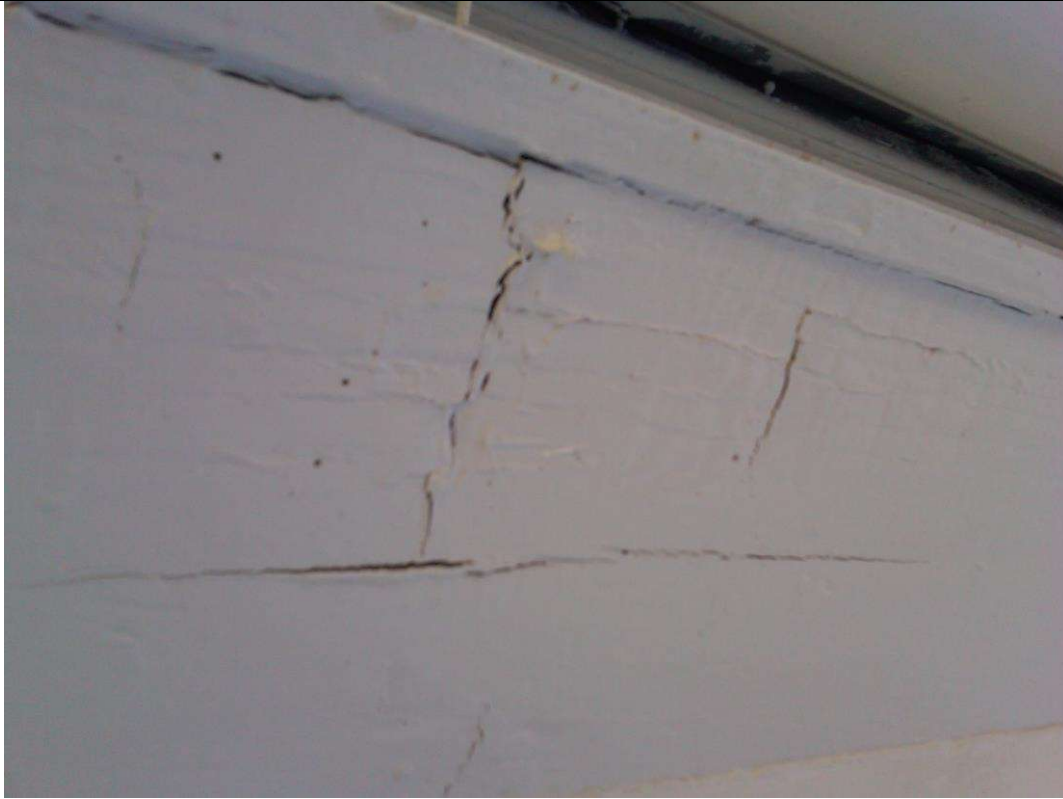
Deteriorated portion of west bay soffit board.

Material & Amount	Unit Cost	Cost
Repair/Replace deteriorated cornice boards – 10 lf	\$45/lf	\$1450.00
TOTAL		\$1450.00

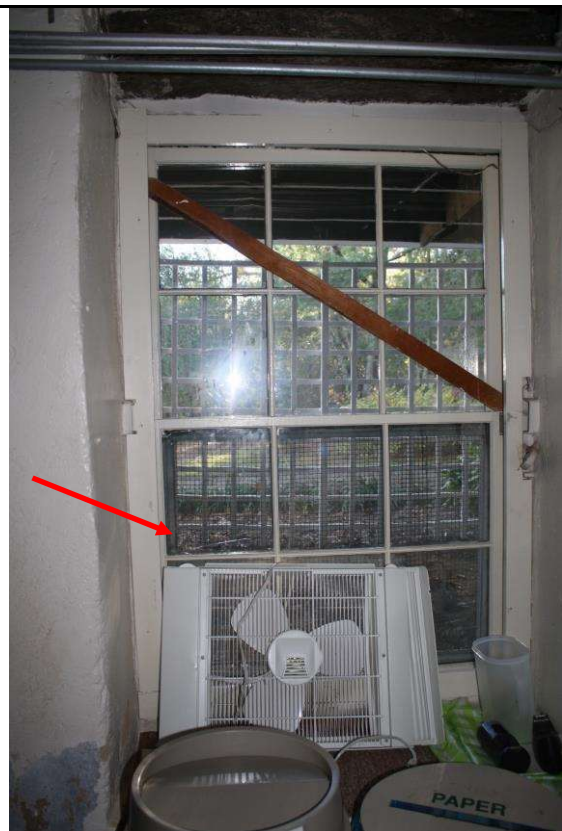
Interior view of 6/6 window; W013 has broken light and missing putty bar on exterior.

Material & Amount	Unit Cost	Cost
Remove, abate, repair, reglaze, paint and reinstall all window sash	\$3000/window	\$39,000
TOTAL		\$39,000

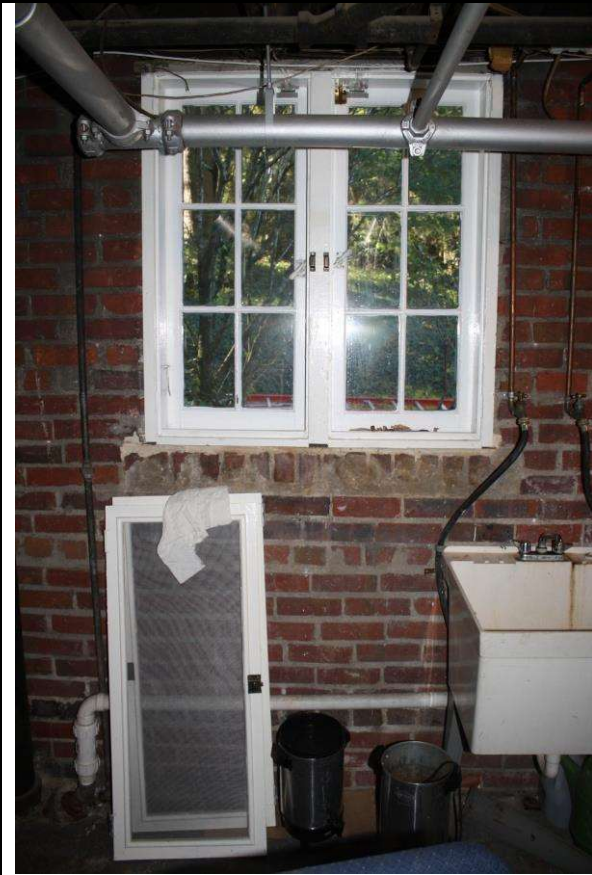
Interior view of addition 6-by-6 casement.
All have interior screens but many not
installed.

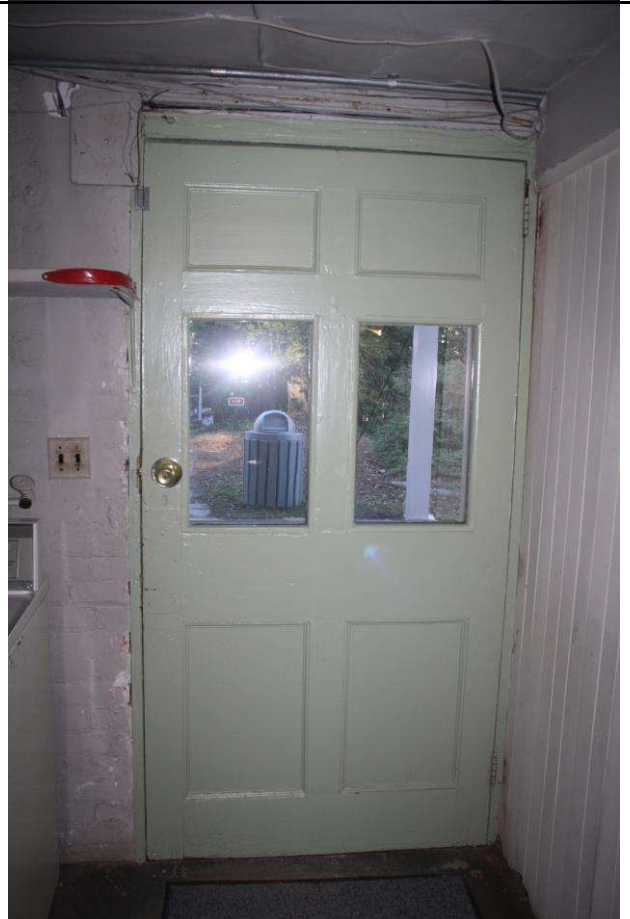
Kitchen entry; Missing hardware

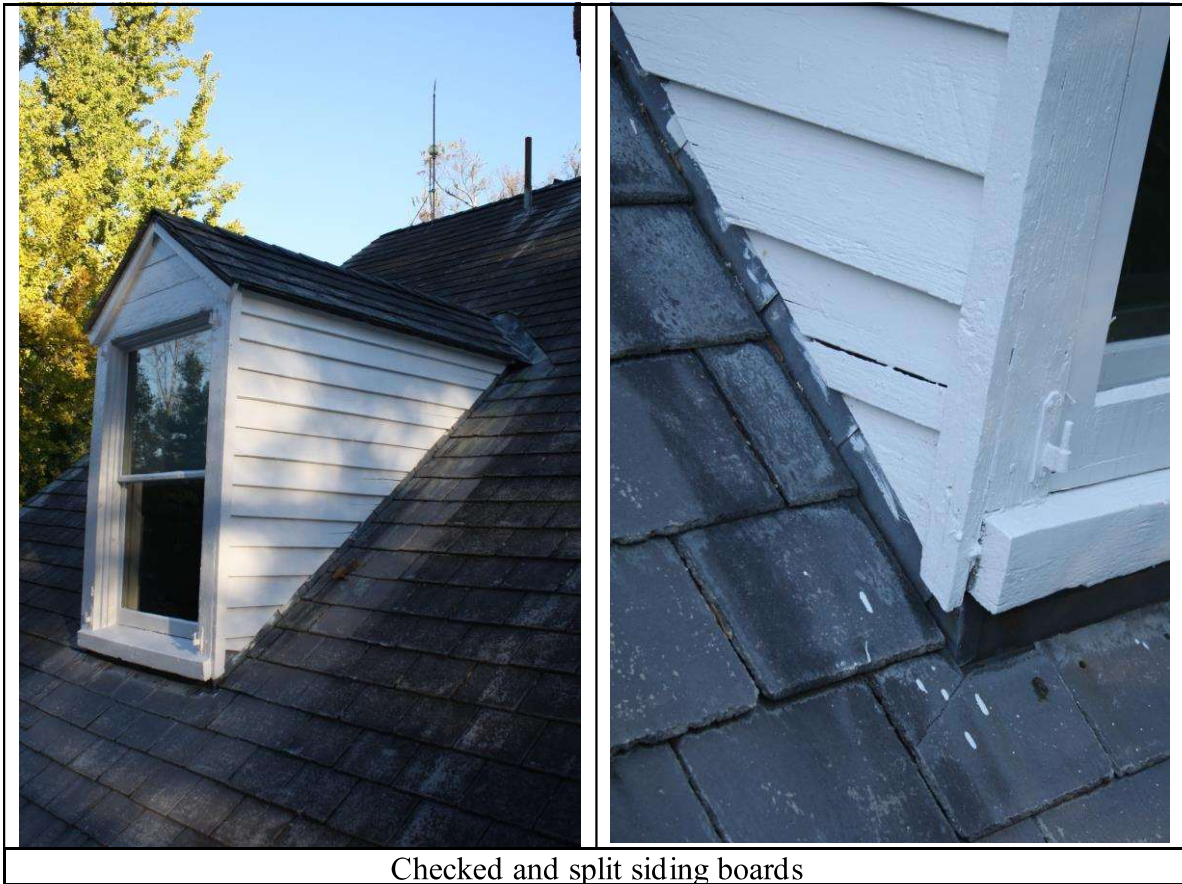
Checked and split siding boards

Material & Amount	Unit Cost	Cost
Repair/Replace deteriorated siding boards - 5 dormers	\$360/unit	\$1,800.00
TOTAL		\$1,800.00

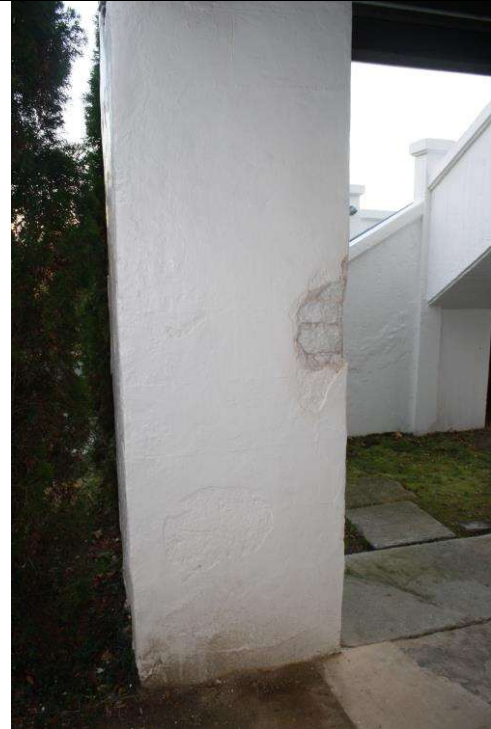
Stucco failed on column

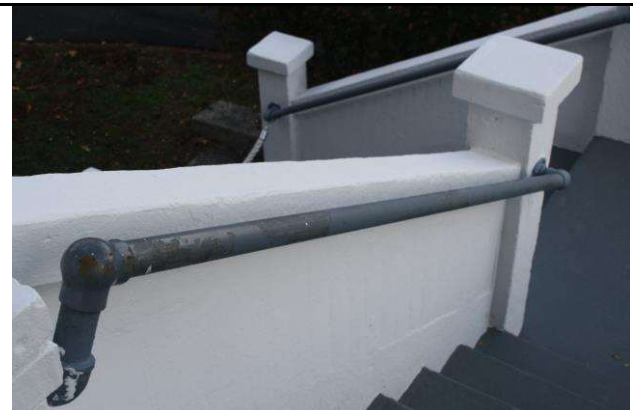
Paint failing on handrail

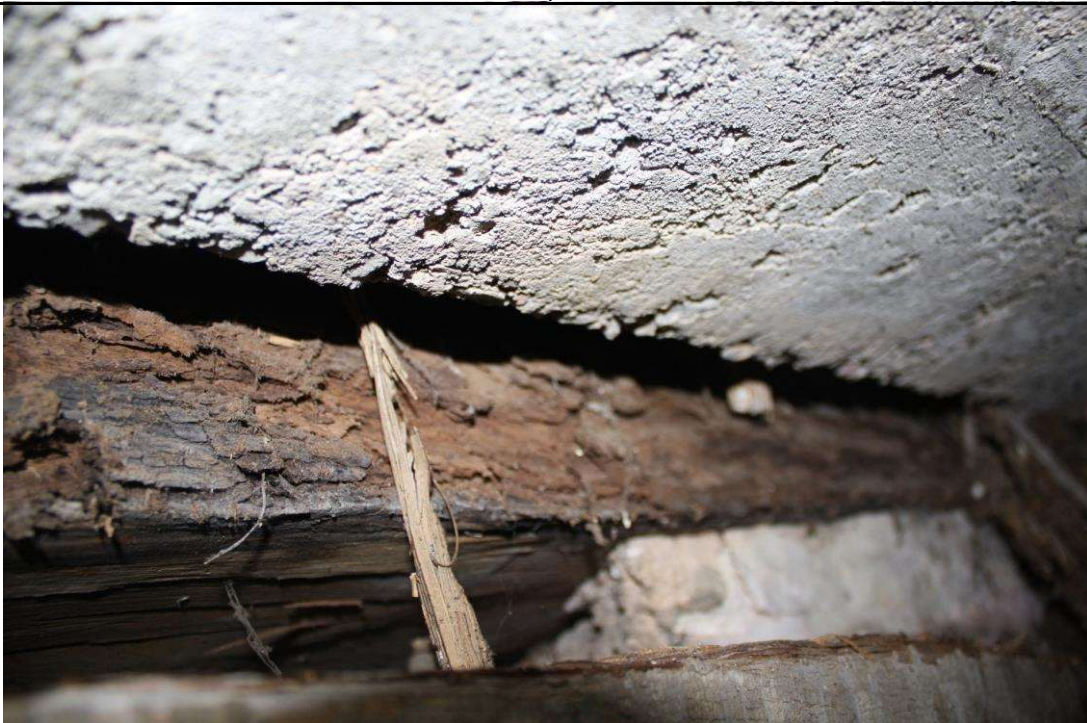
View of west sill plate – termite damage

Material & Amount	Unit Cost	Cost
Termite inspection	Per job	\$100.00
TOTAL		\$100.00

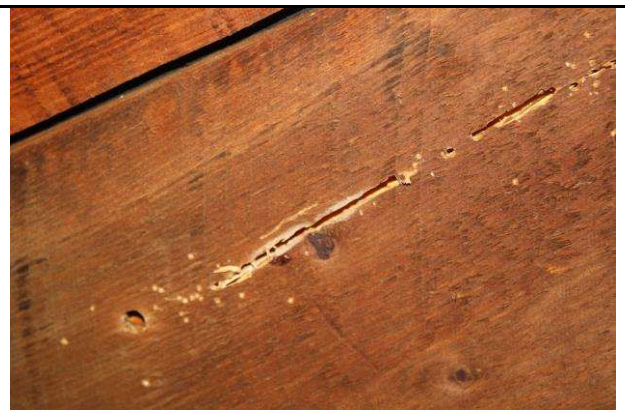
Carpenter bee damage to floor joists

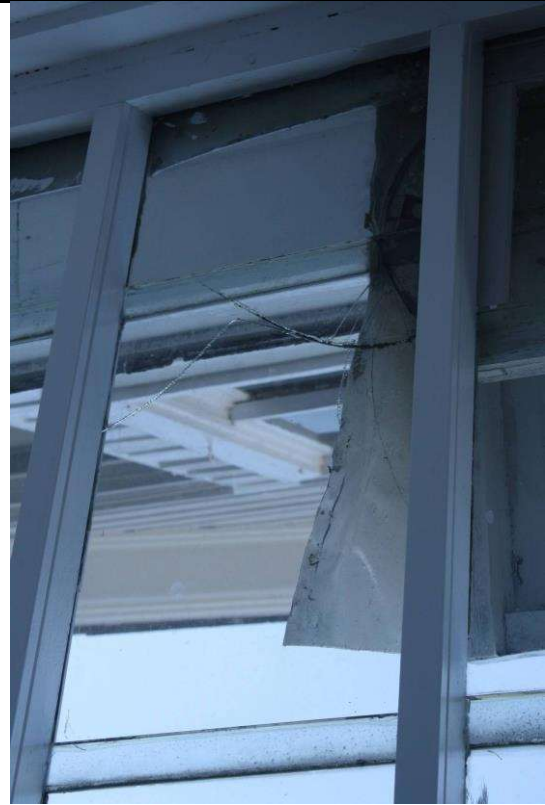
Broken glass

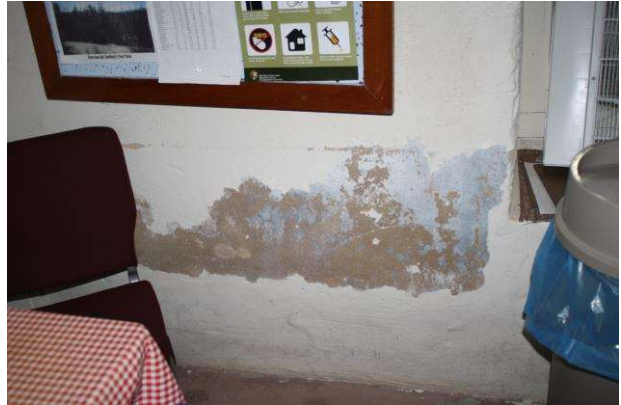
Peeling paint

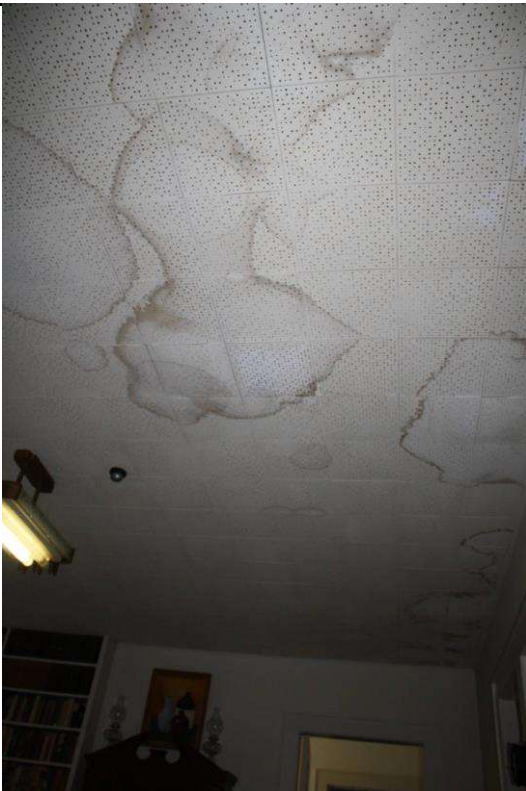
Dining room ceiling tiles

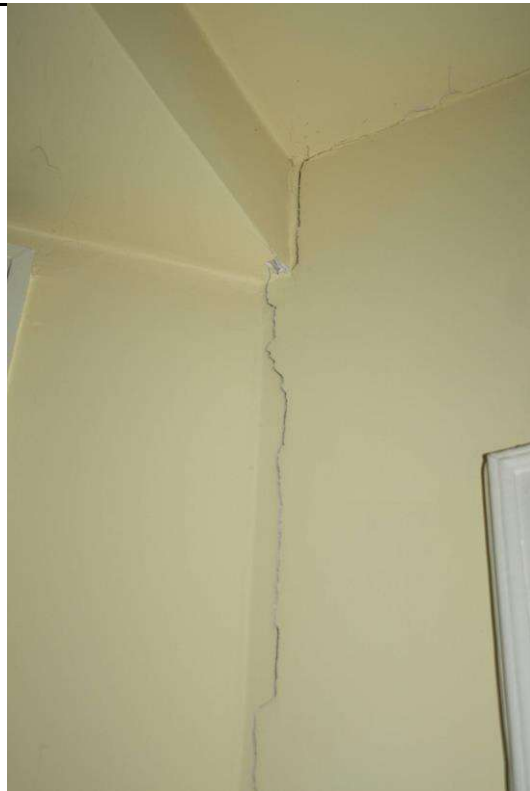
Large crack in conservator's office (Rm.108)
(could be caused by differential settlement)

Material & Amount	Unit Cost	Cost
Repair deteriorated plaster (50sf)	\$45/sf	\$2,250.00
Paint kitchen	Per job	\$1,010.00
Replace deteriorated ceiling tiles	Per job	\$500.00
TOTAL		\$3,760.00

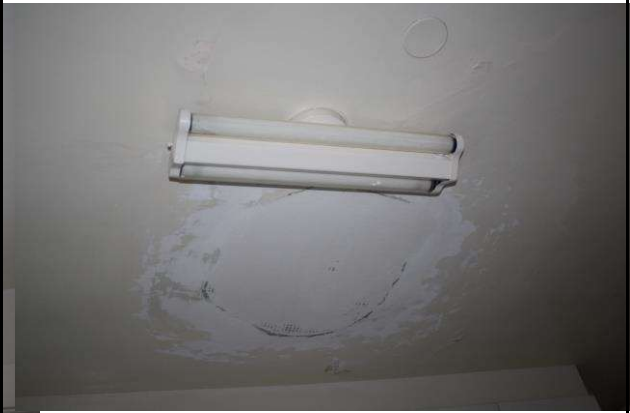
Patch in kitchen ceiling

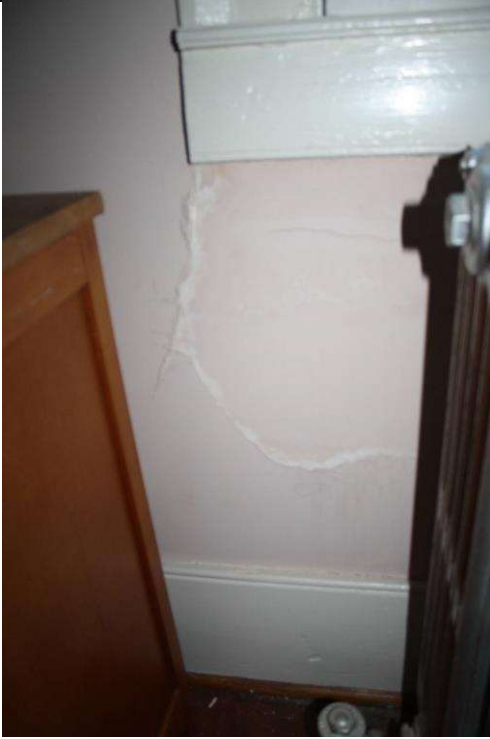
Crack under window

Material & Amount	Unit Cost	Cost
Repair deteriorated plaster – 75 sf	\$45/sf	\$3,375.00
TOTAL		\$3,375.00

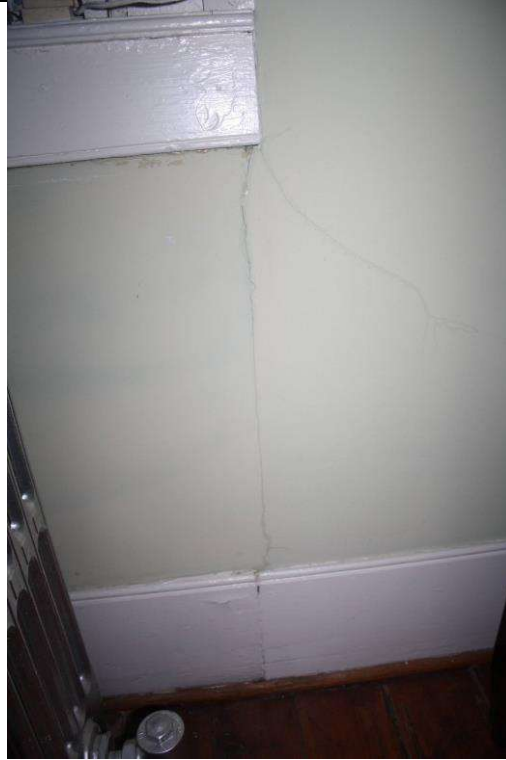
Crack radiating from window

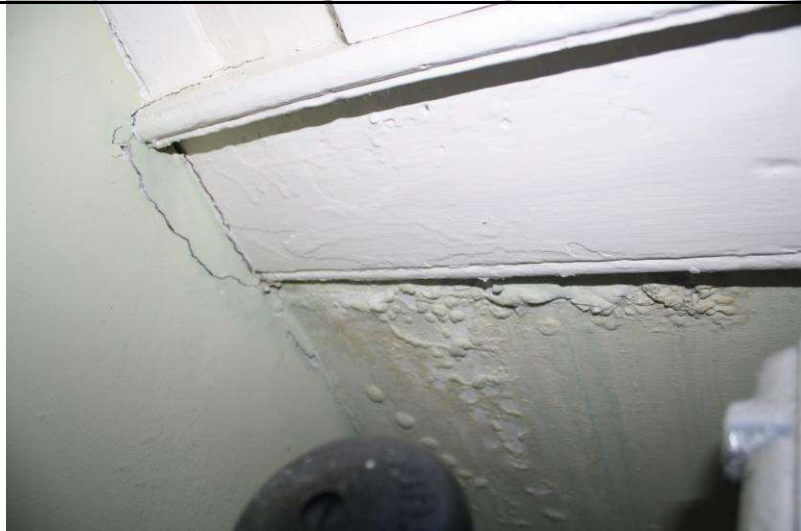
Moisture damage in east wall

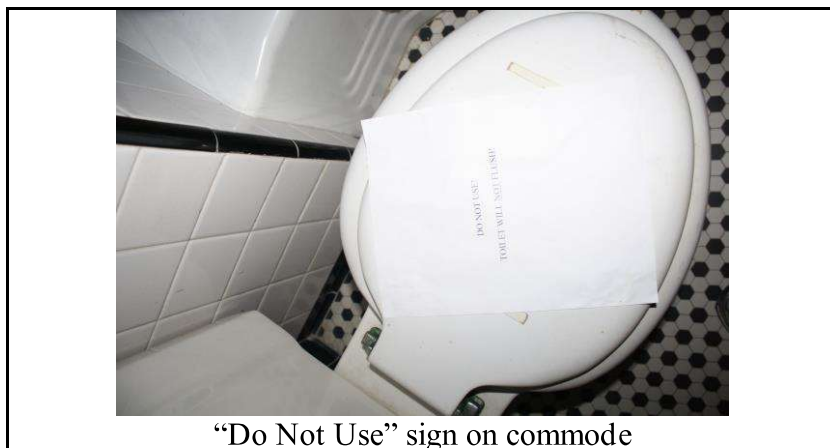
“Do Not Use” sign on commode
