Buck House
Carl Sandburg Home National Historic Site
Historic Structure Report
Phase 1

December 2014

Cultural Resources Division
Southeast Region, National Park Service

JOSEPH K. OPPERMAN – ARCHITECT, P.A.

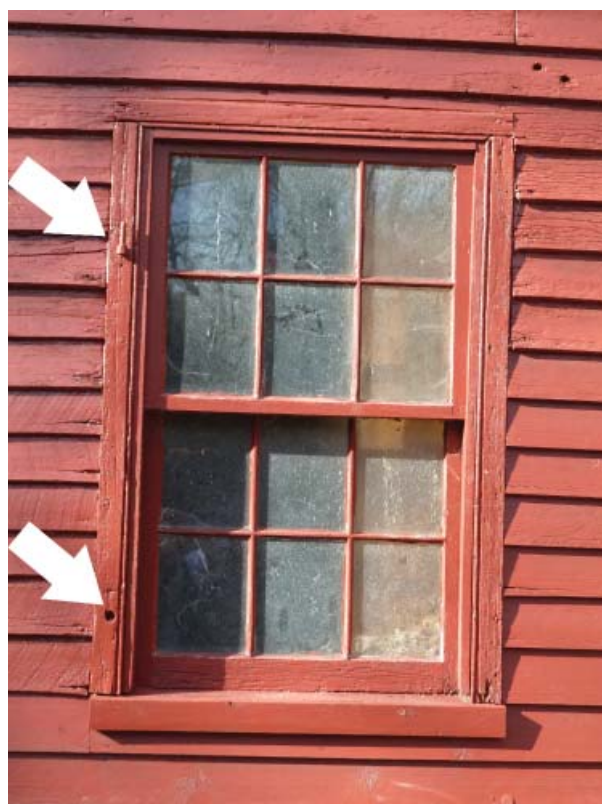
Figure 9. South elevation window with driven pintel for single-leaf shutter. Hole marks the location of lower missing pintel.

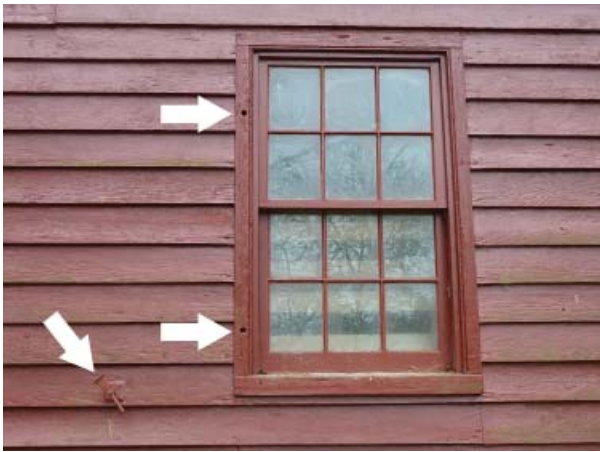
Figure 10. North elevation window with two pintel holes in east casing. Shutter dog attached to weatherboard siding.

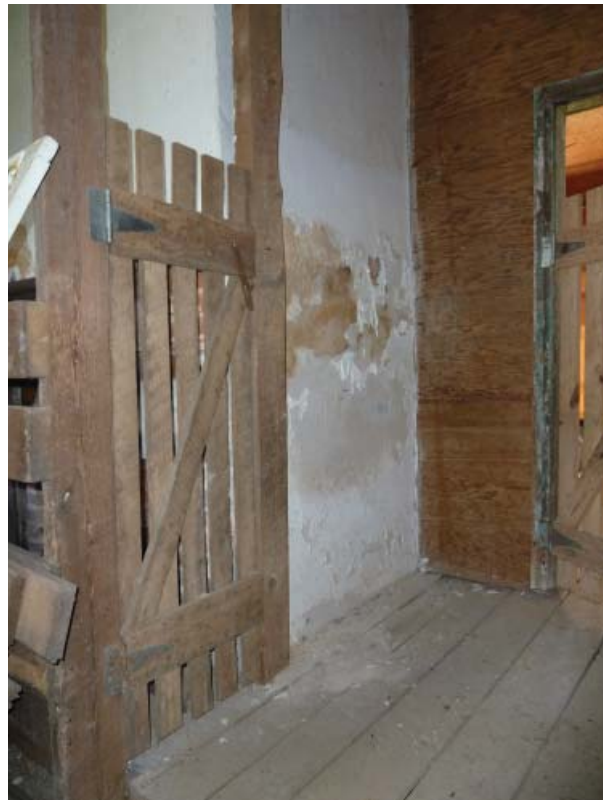
Figure 11. Slat gate installed by Sandburg. Note moisture-damaged plaster on chimney.

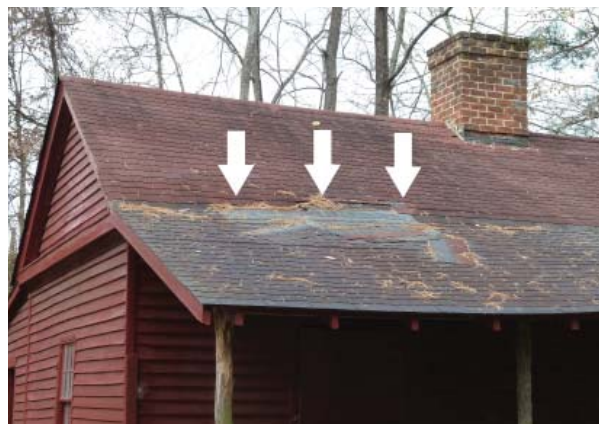
- A roof leak is present along the southern end of the east front shed roof, directly damaging

Figure 15. Damaged shingles of front shed roof.

- Repair roof leak.
- Close off access by burrowing animals.
- Repair deteriorated elements of the building envelope such as roofs, flashing, windows, doors, and siding.
- Replace inferior materials, such as defective siding, which are prone to fail.
- Cap the chimney.
- Install wire mesh in north elevation vent.
- Consider installing gutters and downspouts.
- Establish positive drainage around the exterior perimeter of the house to drain water away from the house.
- Seasonally remove plants, fallen leaves, and other organic materials to prevent build up on and around the building.

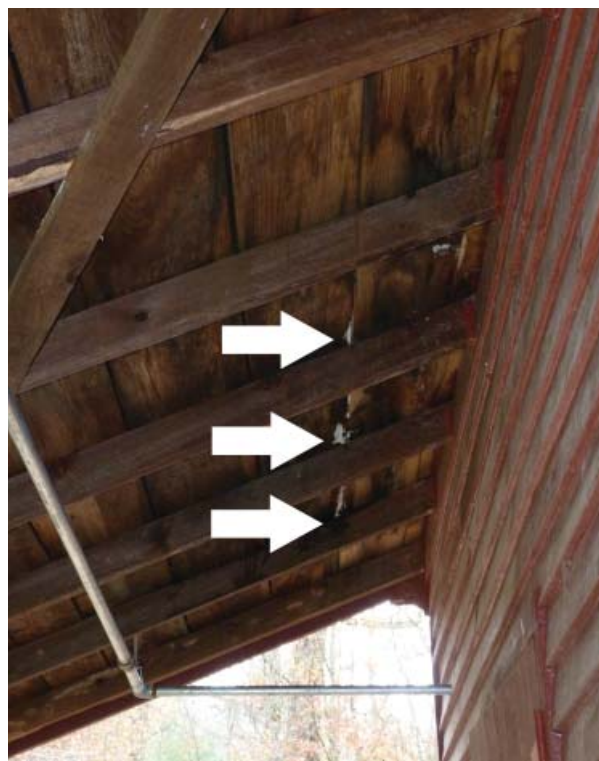
Figure 16. Rot in roof deck below damaged shingles of front shed roof.

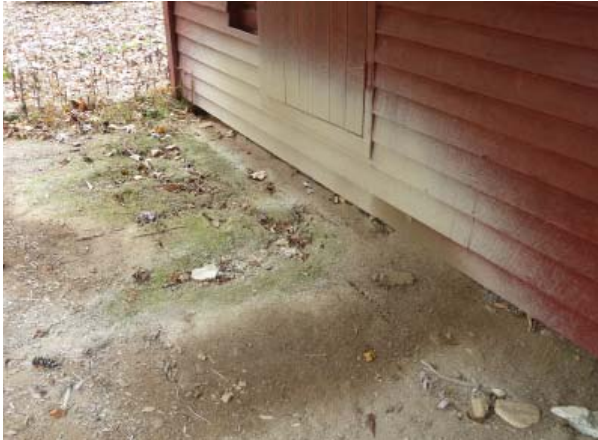
Figure 17. Splash from roof leak is damaging the protective finishes on low level architectural features.

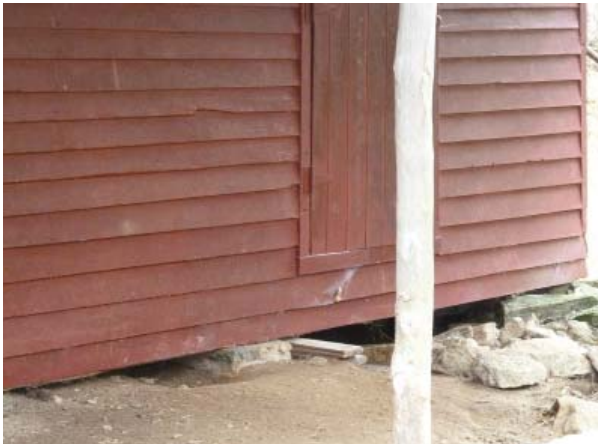
- Animals are burrowing under the house. The chimney has settled, forming cracks in the chimney stack both at first-floor level and attic level.

Figure 18. Animal entry burrows on front (east) elevation.

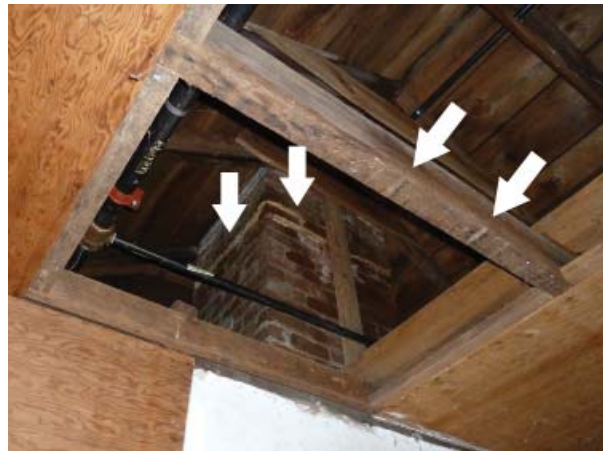
Figure 20. Chimney has settled. Patched joints have continued to open. Note lime stains on bottom of ceiling joists, indicating a previous plaster ceiling.

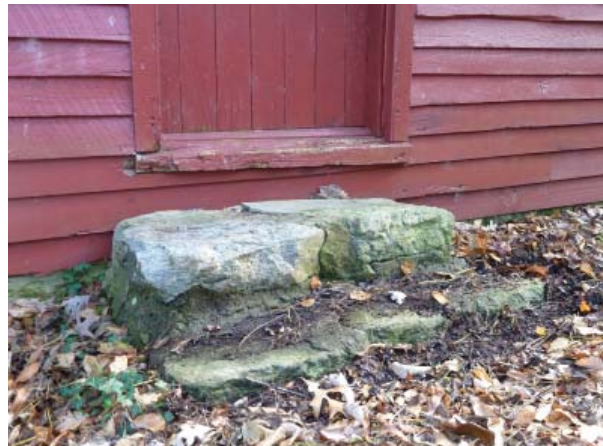
Figure 21. Water pools at building perimeter. Decaying organic material keeps the ground wet. Low wood elements are susceptible to rot.

- Negative slope of ground around the perimeter of the house causes water to drain towards the house and to pool, keeping the ground wet. The inevitable buildup of organic material in the Fall adds to the moisture retention.
- Both windows of the original house have rot in the wooden elements.
- The sill of the west doorway has rot.
- The damaged screen in the north gable vent allows entry by insects and small animals.
- The open chimney allows rain, insects, and small animals to enter.
- Carpenter bees are damaging exterior wood elements.
- The modern exterior wood siding has extensive knots, splitting, and checking.
- The exterior paint exhibits failure between paint layers, an indication of poor preparation before repainting.

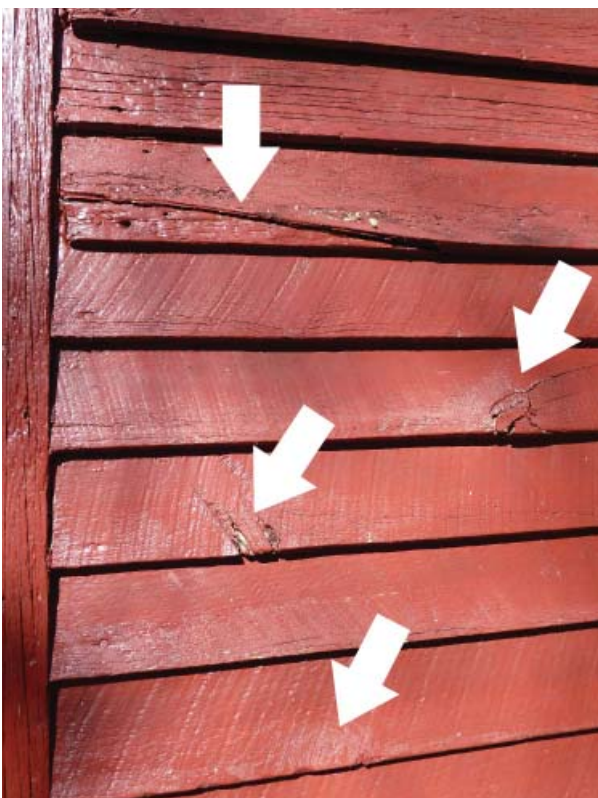
Figure 22. Recent siding has numerous knots and abundant checking, splitting, and cupping.

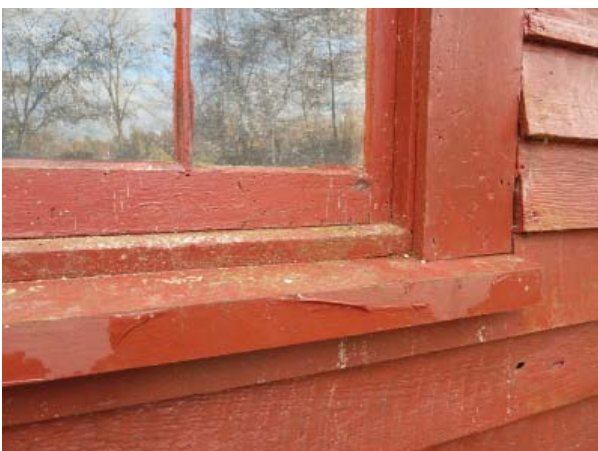
Figure 23. Failure between paint layers.

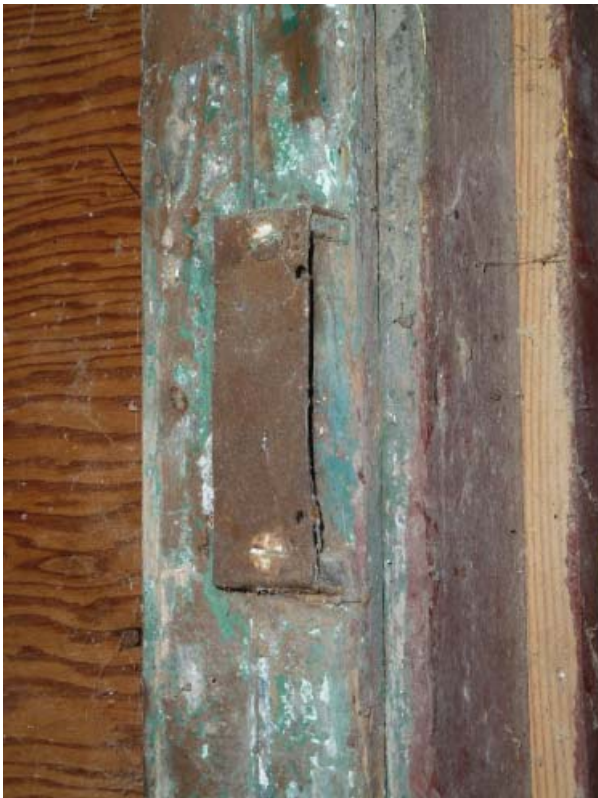
Figure 24. Early sheet metal keeper for a missing door's rim lock.

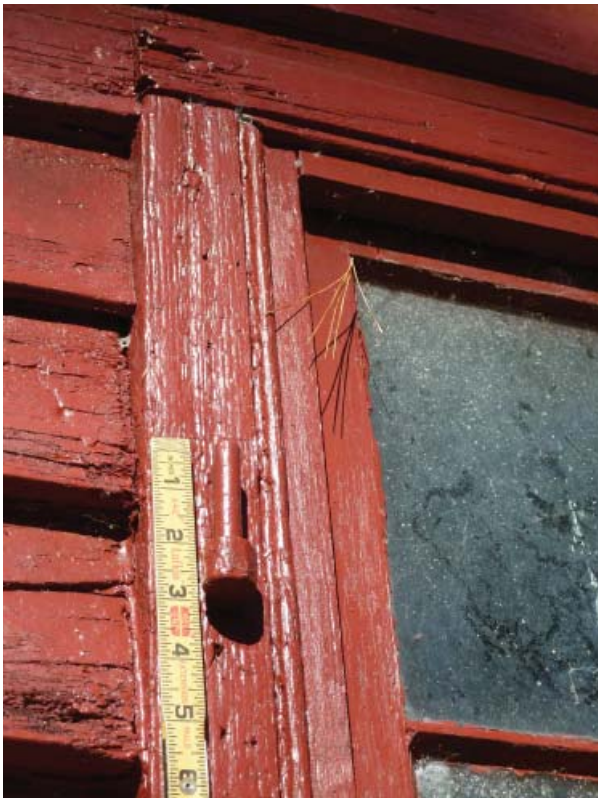
Figure 25. Driven pintel for a strap hinge remains; single-leaf shutter is missing.

- Be vigilant: the early board-and-batten doors and window shutters of the front section are missing and may be reused or stored elsewhere. The two window shutters measure 2'-4" wide by 3'-10" tall. The two front doors measure 3'-0" wide by 6'-6" tall. The two rear doors measure 2'-2" wide by about 6'-4" tall.
