Carl Sandburg Home National Historic Site

Chicken House/Wash House

Historic Structure Report

September 2007

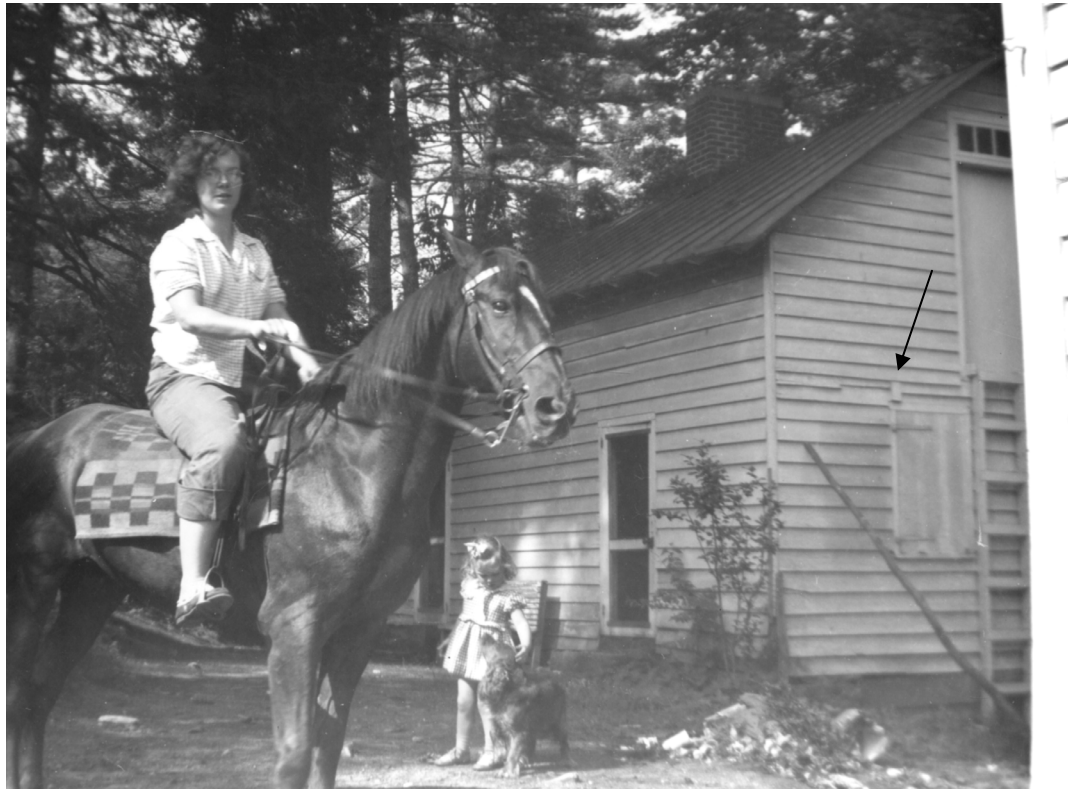
Figure B-2 Helga Sandburg on horse, with daughter Paula outside Chicken House, c. 1946. Note framing protruding from siding at arrow and lack of goat entrances on north elevation, and ladder aligned with eastern window. (CARL3000/08/25P)

Photographic documentation from the early Sandburg occupancy shows that there once were two framing members protruding from the weatherboard siding on the north elevation, on either side of the door to the second level, approximately at floor level. One of these is still existing, and measures 4 ½" by 3 ½". It is plausible that these are remnants of early landing framing that survives behind the siding. Selective removal of building elements to expose framing and archaeology would likely

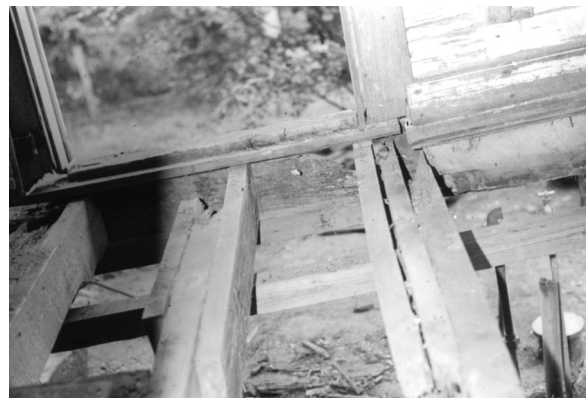
Figure B-10 Flooring removed in Kid room to facilitate joist repairs, Haynes, 1977 (CARL4007/35/09P)

Photographic documentation of the repair work begins in late 1977 and continues into the following summer. It shows that flooring was removed to facilitate repairs to framing. Dutchman repairs were made to the sills and studs, and many floor joists were sistered.

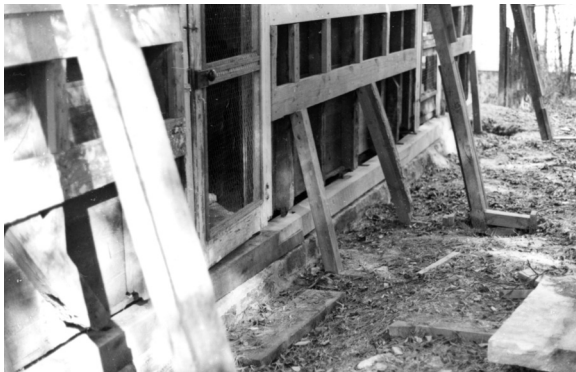
*Figure B-12 Sill repairs on east elevation,
summer 1978 (CARL4008/05/59P)*

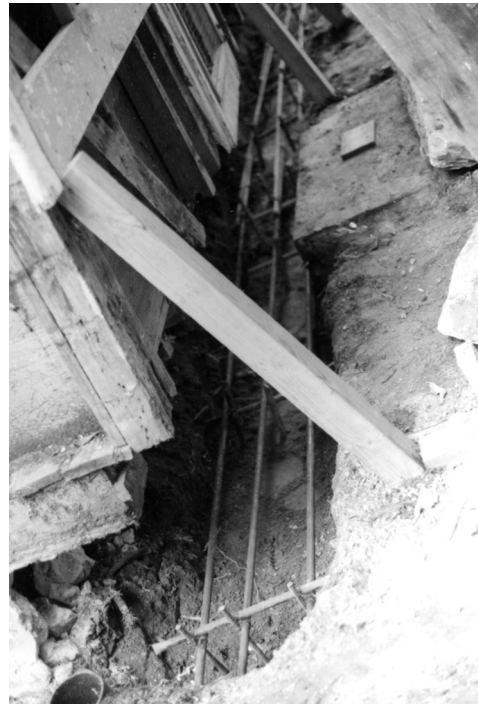
Figure B-13 New reinforced concrete footings, November 10, 1977 (CARL4008/05/35P)

Some siding was removed as well, and it is not known whether any of the removed siding was reinstalled or if new siding was used in its place. The building was shored up and the stone foundation completely removed. A reinforced concrete spread footing was poured, and the foundation rebuilt. It is not known if the original foundation stones were re-used, but it seems likely.

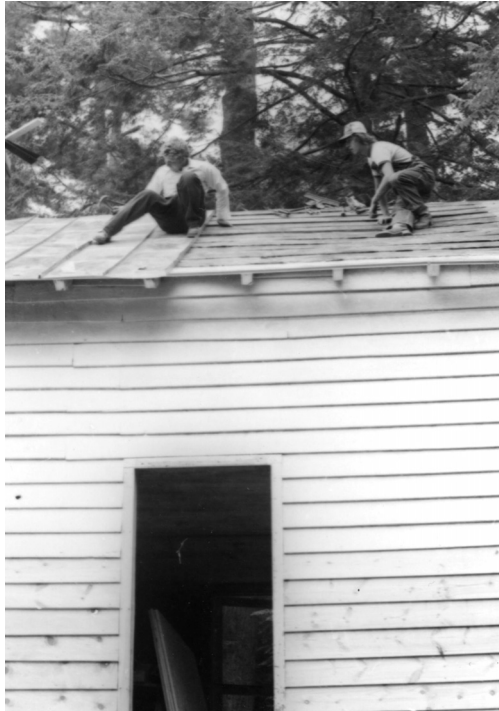
Figure B-15 Roof repairs in progress, May 1978
(CARL4008/05/46P)

A purchase order for roof replacement dated September 23, 1977, indicates that McCall Sheet Metal & Roofing, Inc., was awarded a contract for \$965 for installation of a new standing-seam tin-coated metal roof and flashing of the chimney. An amendment to the contract for roofing metal, dated May 26, 1978, added \$207.90 to McCall's contract. CARL records state that the building was painted by John Tulen in 1978.

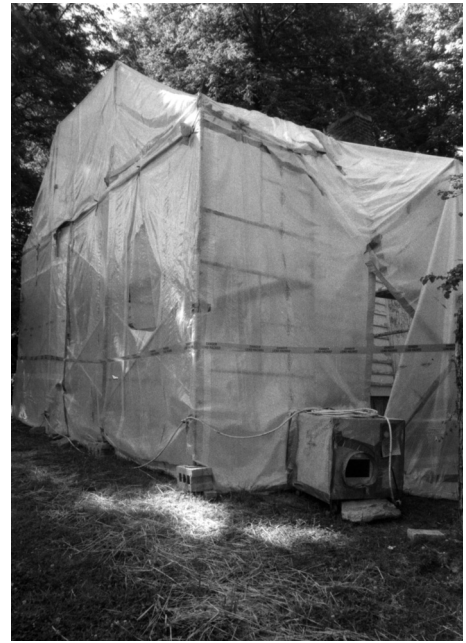
Figure B-19 Northwest oblique, showing tent for lead abatement, 2001 (CARL4018/2-116P)

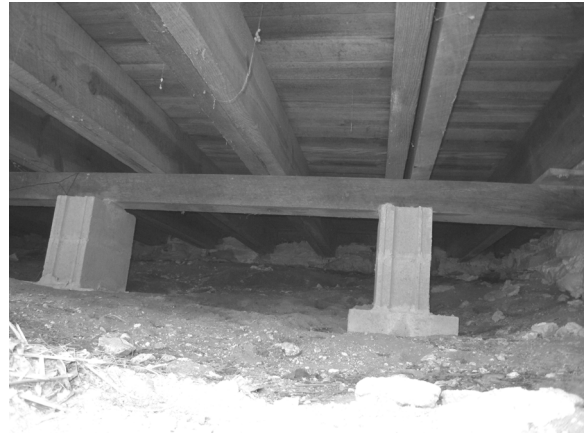
Figure C-6 Floor framing with modern sistered joists and CMU supports

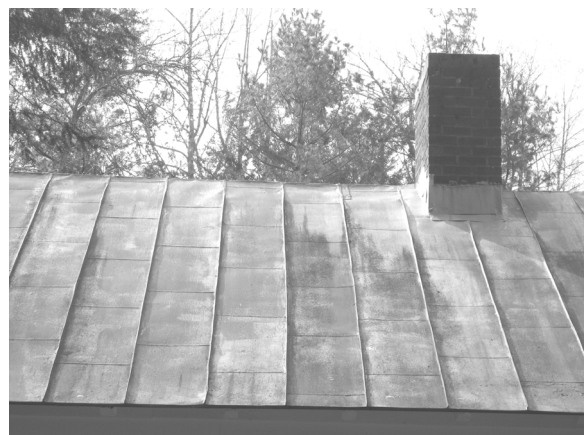
Roof and Rainwater Collection/Dispersal: The roofing material consists of standing-seam terne-coated metal roofing, installed in 1978. It replaced a previous metal roof seen in the earliest clear photo of the building, dated c. 1946 in the early years of

Figure C-8. Terne-coated metal roofing and stepped chimney flashing.

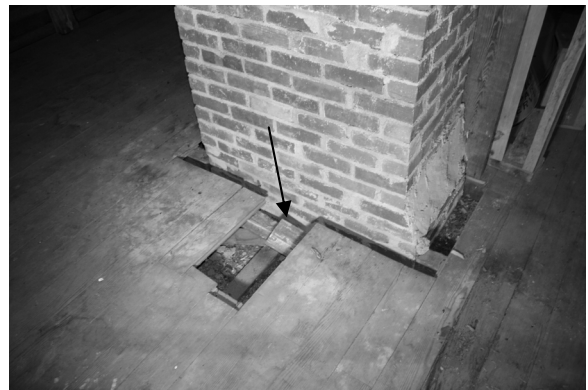
Figure C-63 Painted sections of baseboard discarded in floor cavity
