# historic structure report

## CRATER LAKE CRATER LAKE LODGE

HISTORIC STRUCTURE REPORT

CRATER LAKE LODGE  
CRATER LAKE NATIONAL PARK  
CRATER LAKE, OREGON

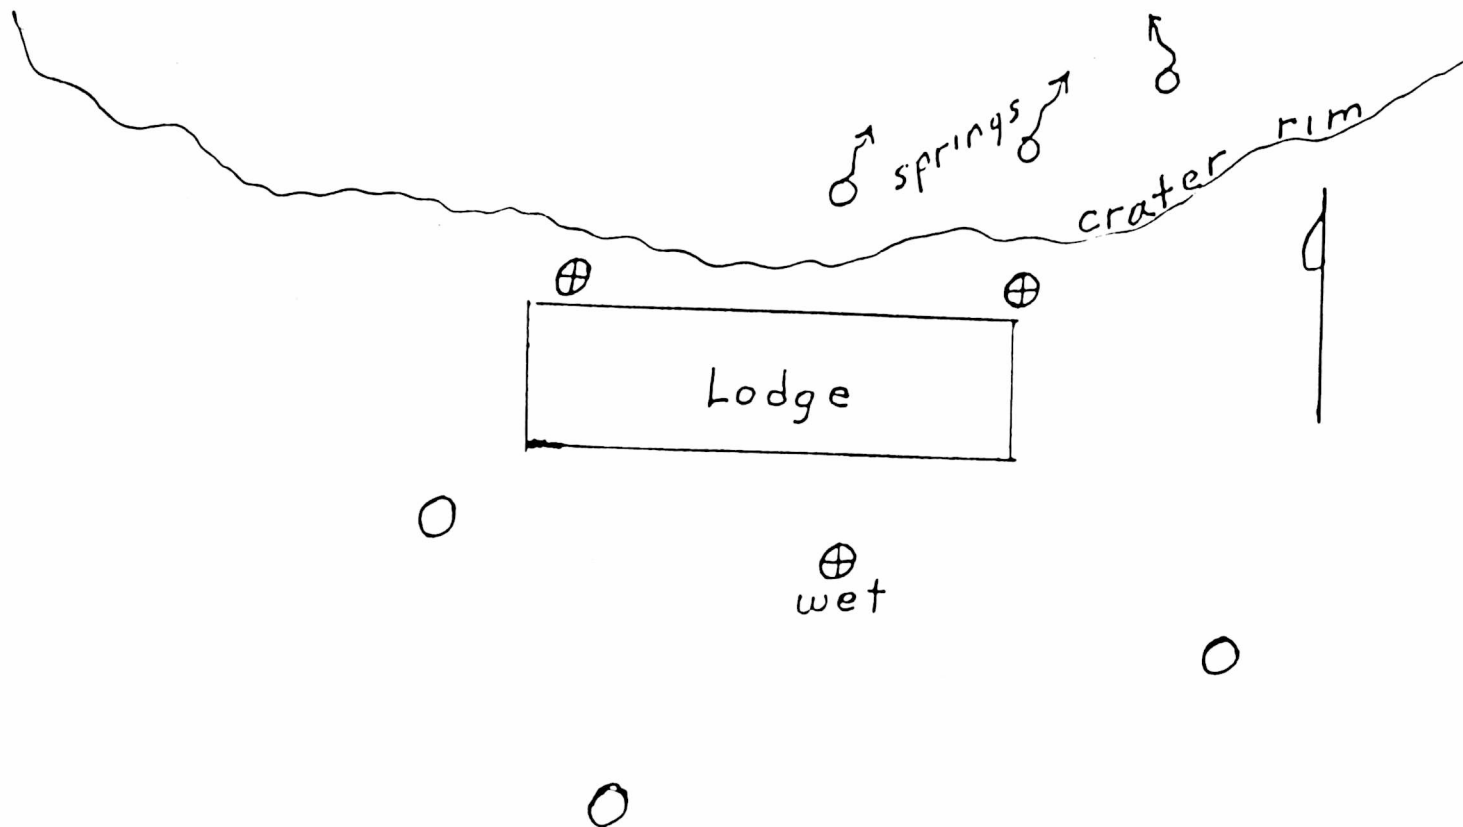
The drilling conditions were very difficult but the boring data has disclosed that the Lodge is, in fact, resting on loose, angular rubble which reaches depths of over one hundred feet. Any stress or deformation which takes place in this foundation zone because of over-steepening of the crater face will undoubtedly be reflected in the inclinometer tubes in the late spring thaw period.

⊕ = inclinometer,

○ = water bore

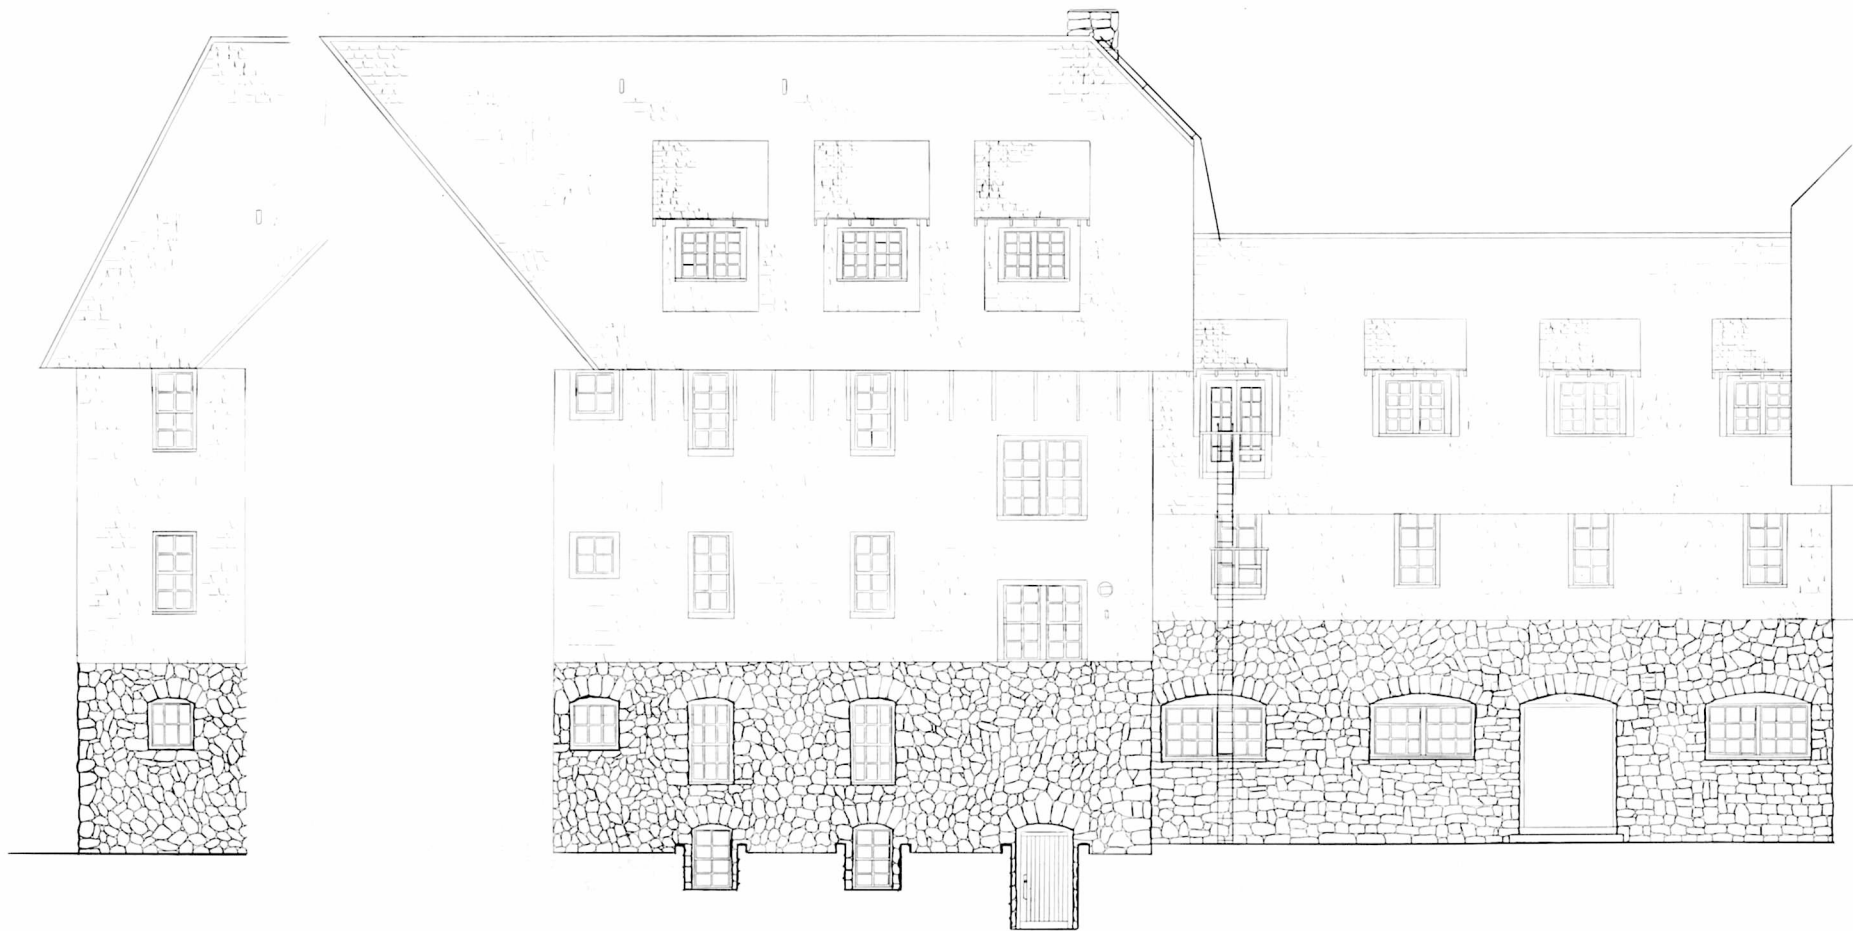
EAST ELEVATION  
SCALE 1/8"=1'-0"

| EXISTING CONDITIONS | | | | | | | | | | | RECOMMENDATIONS | | | | | | |
|---|---|---|---|---|---|---|---|---|---|---|---|---|---|---|---|---|---|
| Roof | Shingles<br>Sheathing<br>Rafters<br>Ladder<br>Flashing<br>Dormers (4)<br>Vent pipe | | | | x | | | | x | | To annex roof | | x | x | | x | Install additional framing |

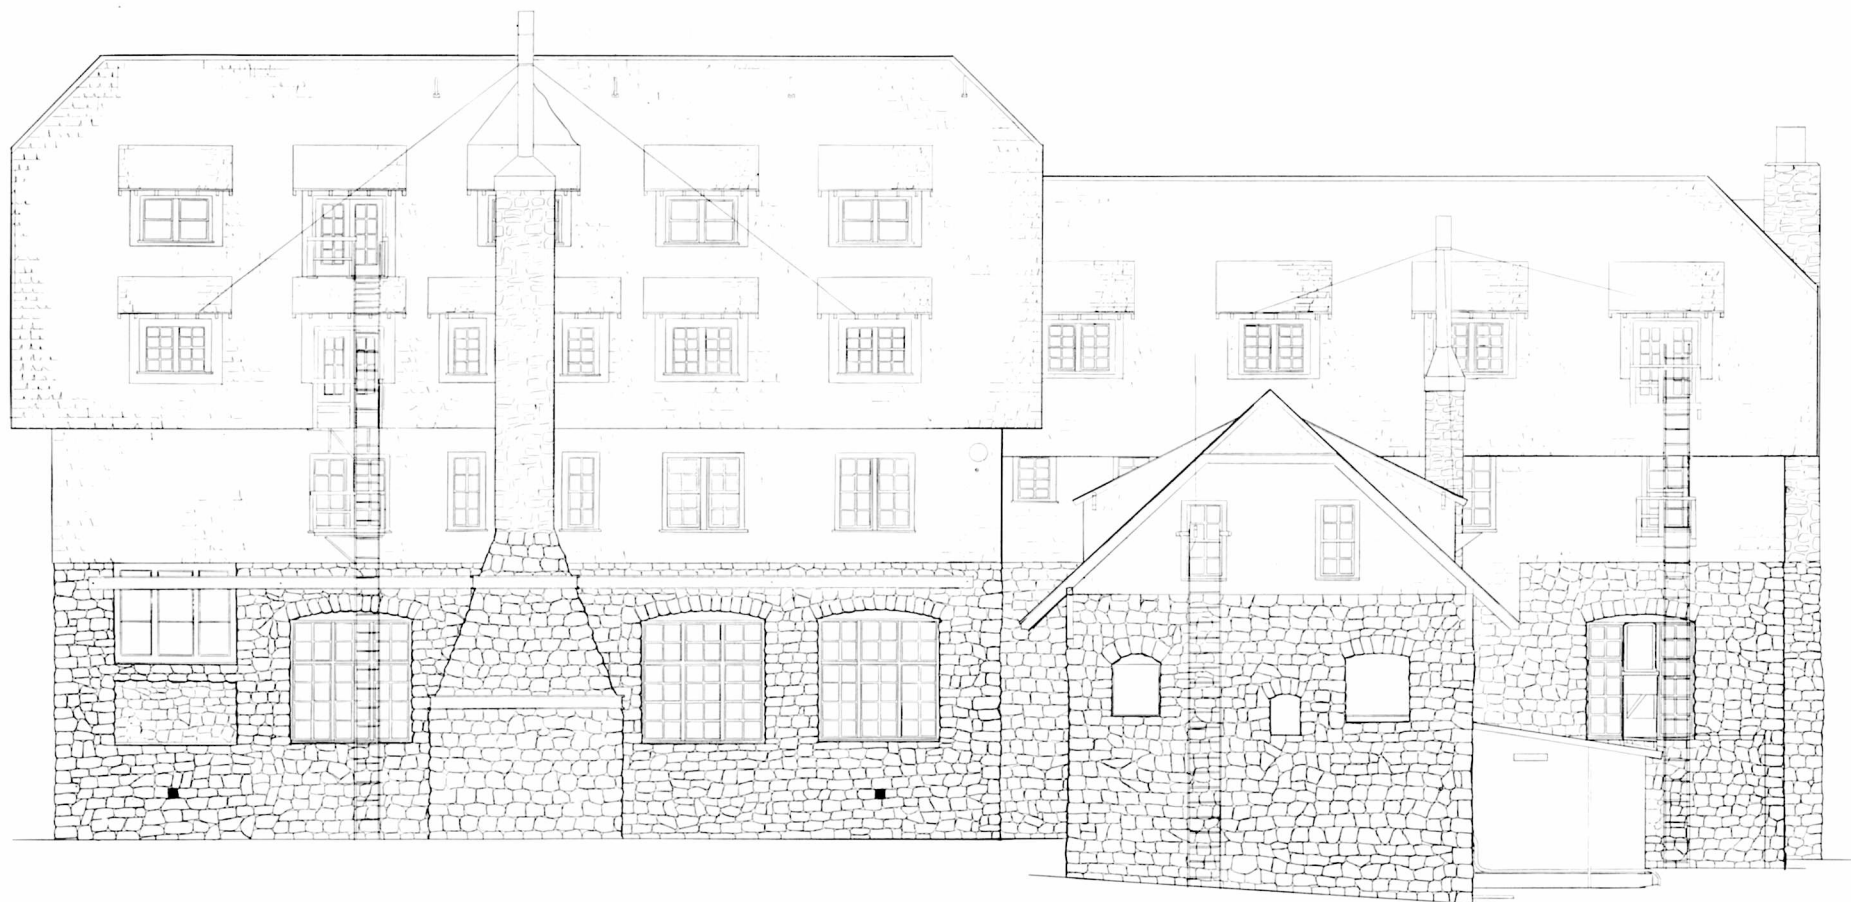
SOUTH ELEVATION  
 SCALE  $\frac{1}{4}'' = 1'-0''$   
 0 1 2 3 4 5 10 FEET  
 0 1 2 3 METERS

| EXISTING CONDITIONS | | | | | | | | | | RECOMMENDATIONS | | | | | | | |
|---|---|---|---|---|---|---|---|---|---|---|--|---|---|---|---|---|---|
| | Vent pipe | | | x | | | x | | | | | | | x | | | Additional framing as required |

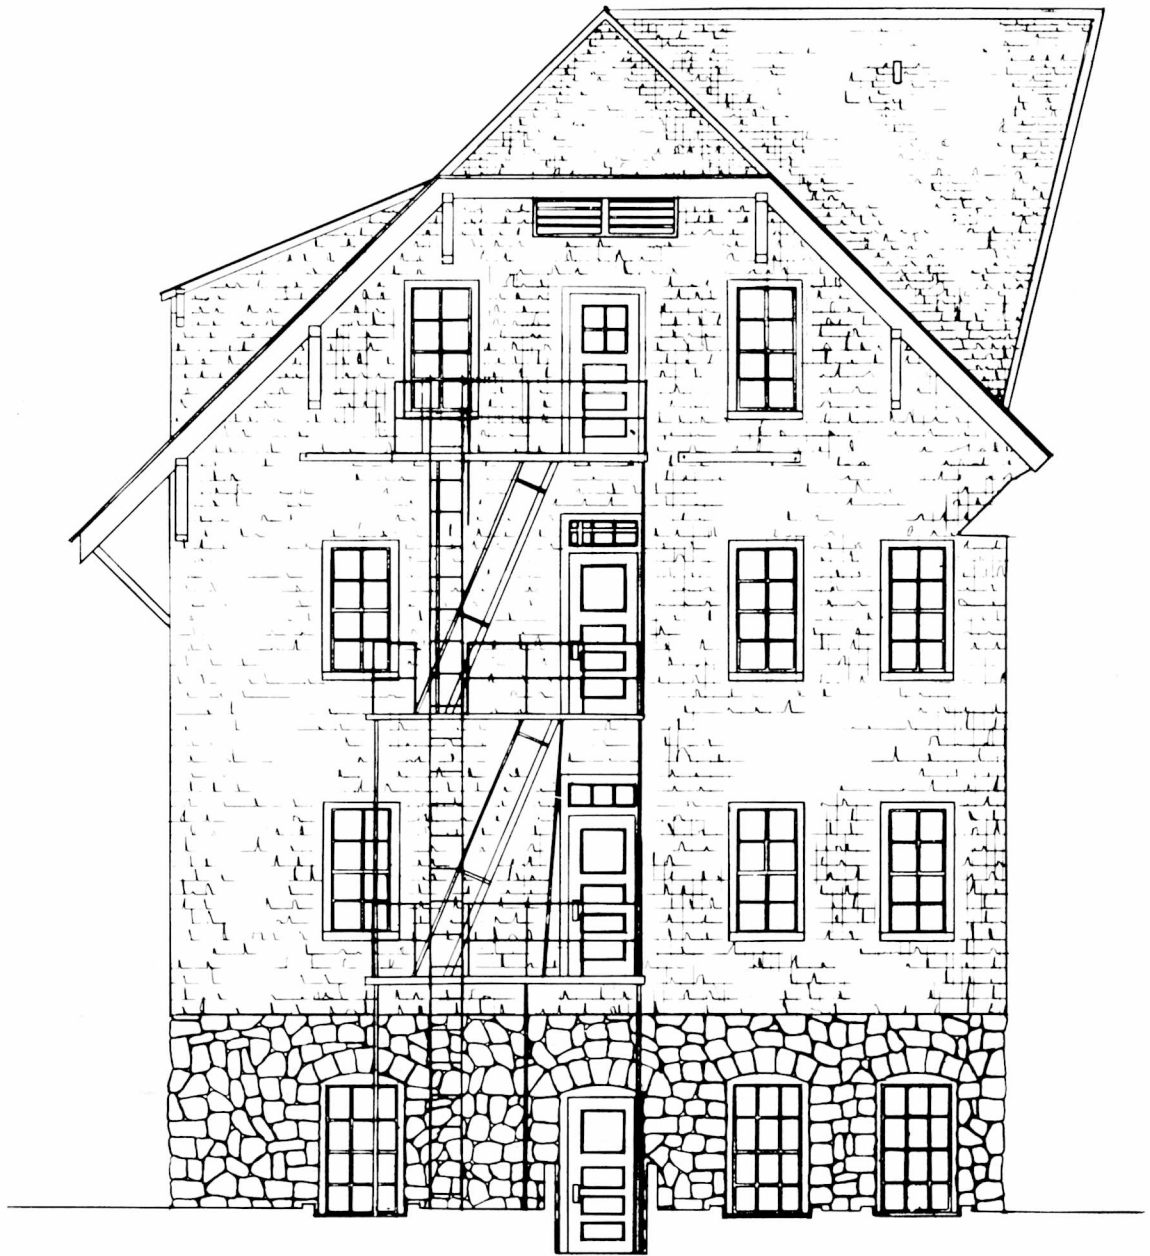
WEST ELEVATION - ANNEX  
SCALE  $\frac{1}{4}" = 1'-0"$

| EXISTING CONDITIONS | | | | | | | | RECOMMENDATIONS | | | | | | |
|---|---|---|---|---|---|---|---|---|---|---|---|---|---|---|
| Roofs (3) | Shingles<br>Sheathing<br>Rafters<br>Flashing<br>Dormers (4)<br>Vent pipes(4)<br>Eaves braces | | x | | x | | x | Northeast dormer poor<br>One near ridge of connecting roof | | | x | | | x Additional framing as required<br><br>Reconstruct northeast dormer |
