historic structure report
architectural data section
building hb-21

december 1981

FORT DAVIS

HISTORIC STRUCTURE REPORT
ARCHITECTURAL DATA SECTION
BUILDING HB-21
INTERIOR RESTORATION OF 1ST SERGEANT'S QUARTERS ROOM
AND NORTH SQUAD ROOM
FORT DAVIS NATIONAL HISTORIC SITE
FORT DAVIS, TEXAS

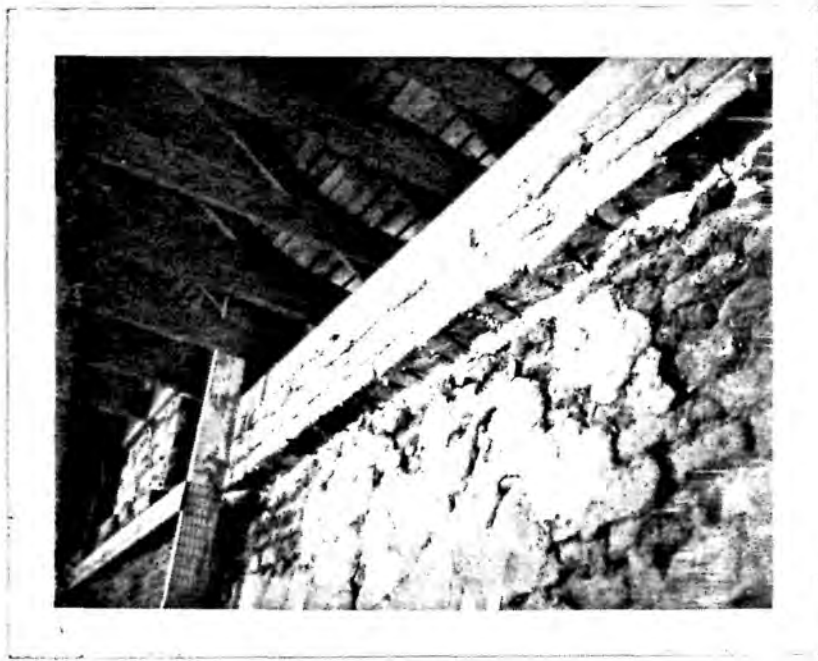
There is a concrete bond beam at the top of the east adobe wall about 6 inches in depth with two rebars supported by three horizontal rows of adobe blocks (see illustration 1). The bond beam extends 4 inches or more from the eroded interior adobe wall. The two openings found here are windows. The north window has been blocked up to 12 inches thick with adobe. A badly eroded fireplace is located near the center of the wall. There is a dirt floor, no interior trim, and an open ceiling (see illustration 2).

Illustration 1. Top section of east wall, north squad room

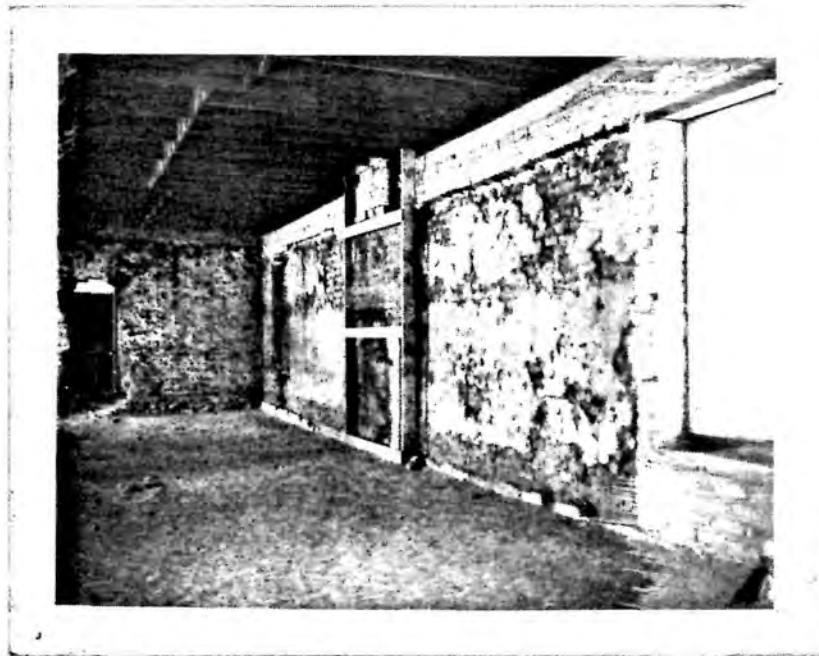
Illustration 2. Interior of east wall, north squad room

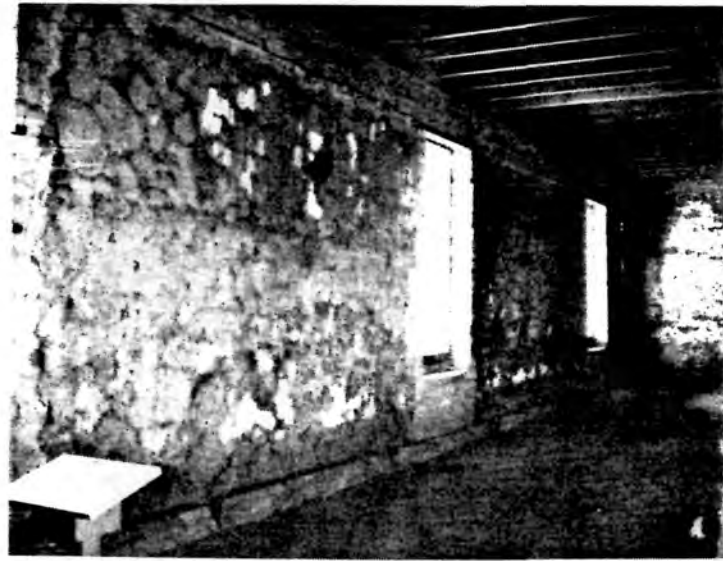
The same type of bond beam, placed in the same manner as exists on the east wall, is also located on the west wall. Three windows are on the west wall. This wall shows erosion with pockmarks, bits of plaster, and marks showing the location of the former hook strip and baseboard (see illustration 3).

Illustration 3. Interior west wall, north squad room

The 4-inch adobe veneer is in this particular case justifiable. The veneer will work flush with the existing bond beam above, which is permanent and necessary to the structure's stability, and it will also be flush with the top of the stone foundation below. If the present wall were to be repaired only on the interior, it would be 4 inches back of the 12-inch-thick bond beam that cannot be removed and this would be a horrible situation--the three rows of adobe blocks at just below the bond beam are flush with the bond beam. Below the third horizontal row, the existing wall is 4 inches back down to the stone foundations (see illustrations 3 and 4).

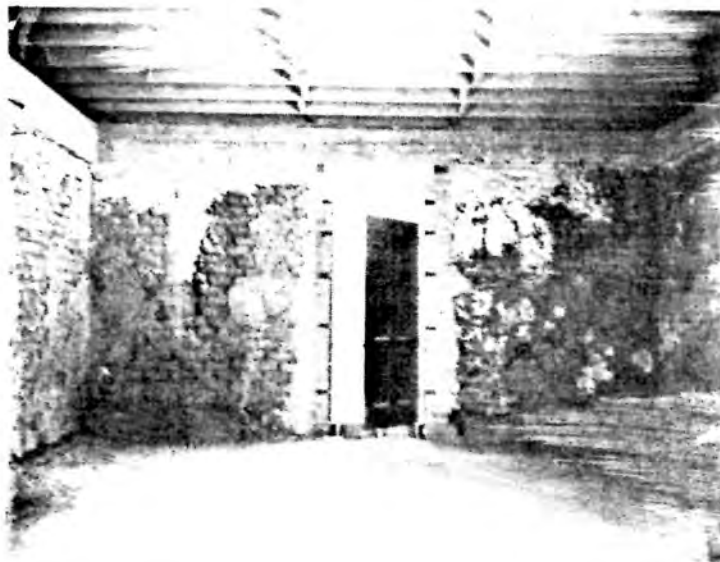
The south wall also has a bond beam that is supported by three horizontal rows of adobe block flush with the bond beam. A door in the center of the wall opens to the exterior cross corridor (see illustration 4). The wall has erosion, pockmarks, and vestiges of plaster. It too shows hook strip and baseboard marks.

Illustration 4. Interior south wall, north squad room

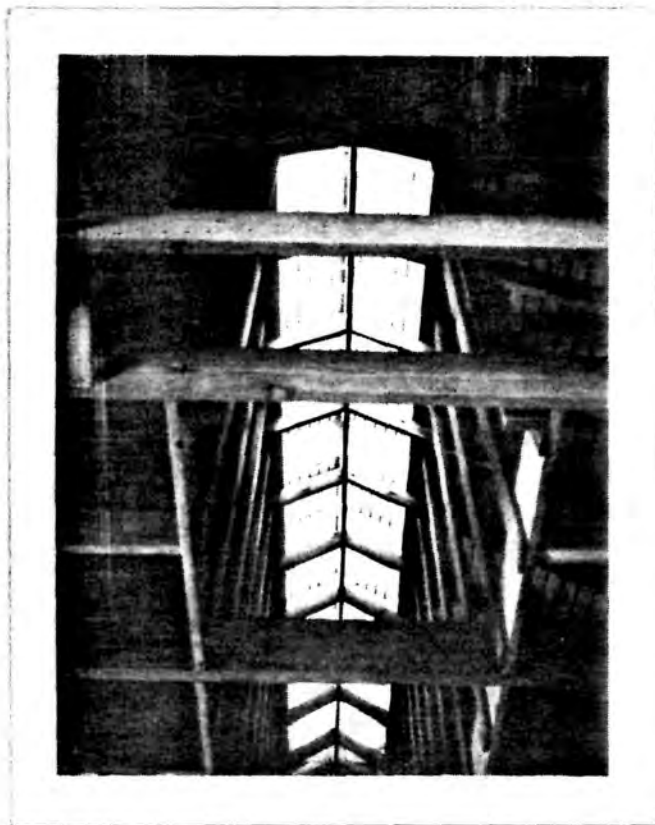
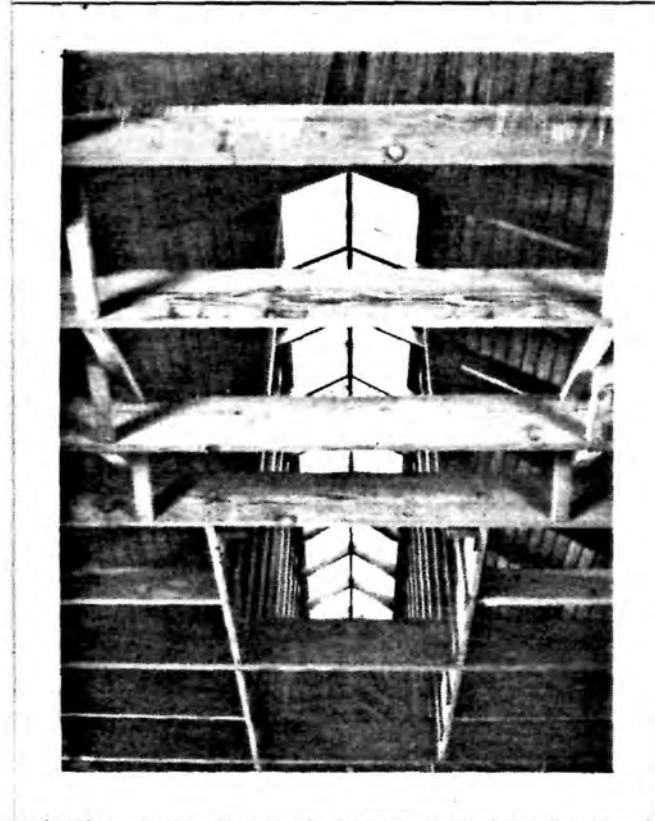
Illustrations 7, 8. Two views looking up at existing vents, north squad room

Ventilators were observed leaking onto the floor. The cause of this situation is either faulty flashing or rain passing through the louvers. This problem will have to be checked with great care, and a solution found to prevent leaking or condensation.

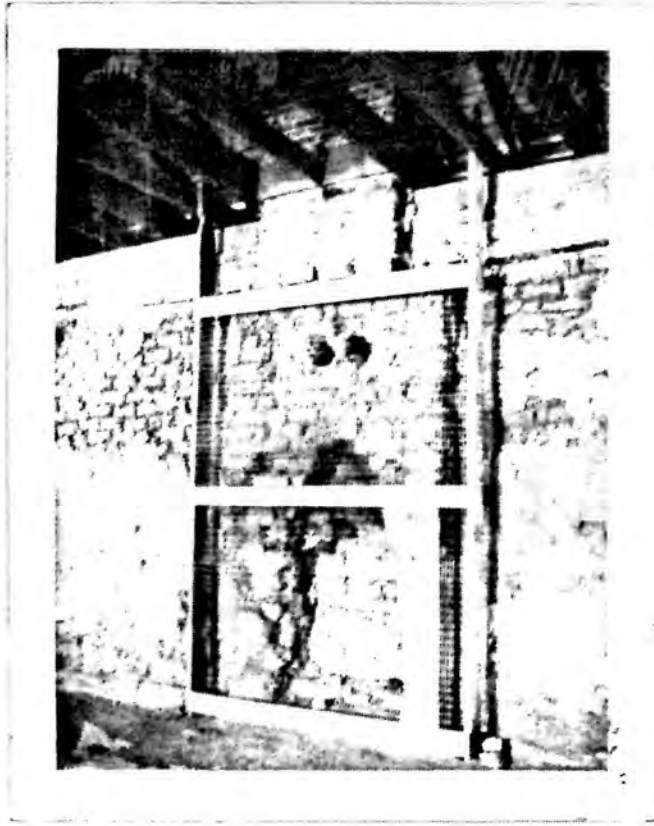
Illustration 10. Fireplace

The fireplace has been reconstructed only on the exterior (see drawing, sheet 4). A concrete bond beam supports the brick work above the roof. Below this bond beam on the interior, the fireplace has been left in a deteriorated condition (see illustration 10). The external wall is somewhat stabilized by a veneer of soil cement fastened to the existing adobe wall. The part of this exterior wall facing the interior fireplace will need considerable repairs. The front wall, fireplace opening, sides, and hearth will have to be reconstructed. New stone work to match existing adobe, steel damper, and two stove floor thimbles (7 inches in diameter) will be installed as shown by historic drawings. It will be difficult to do this work because the existing area above the concrete bond beam, as well as the bond beam itself, will have to be shored, or supported, while the area beneath is removed and reconstructed.

The fireplace measured in HB-20 by Lewis Koue gave an idea of what the more disintegrated fireplace in HB-21 was like and made it possible to put in the missing parts in the proposed restoration.

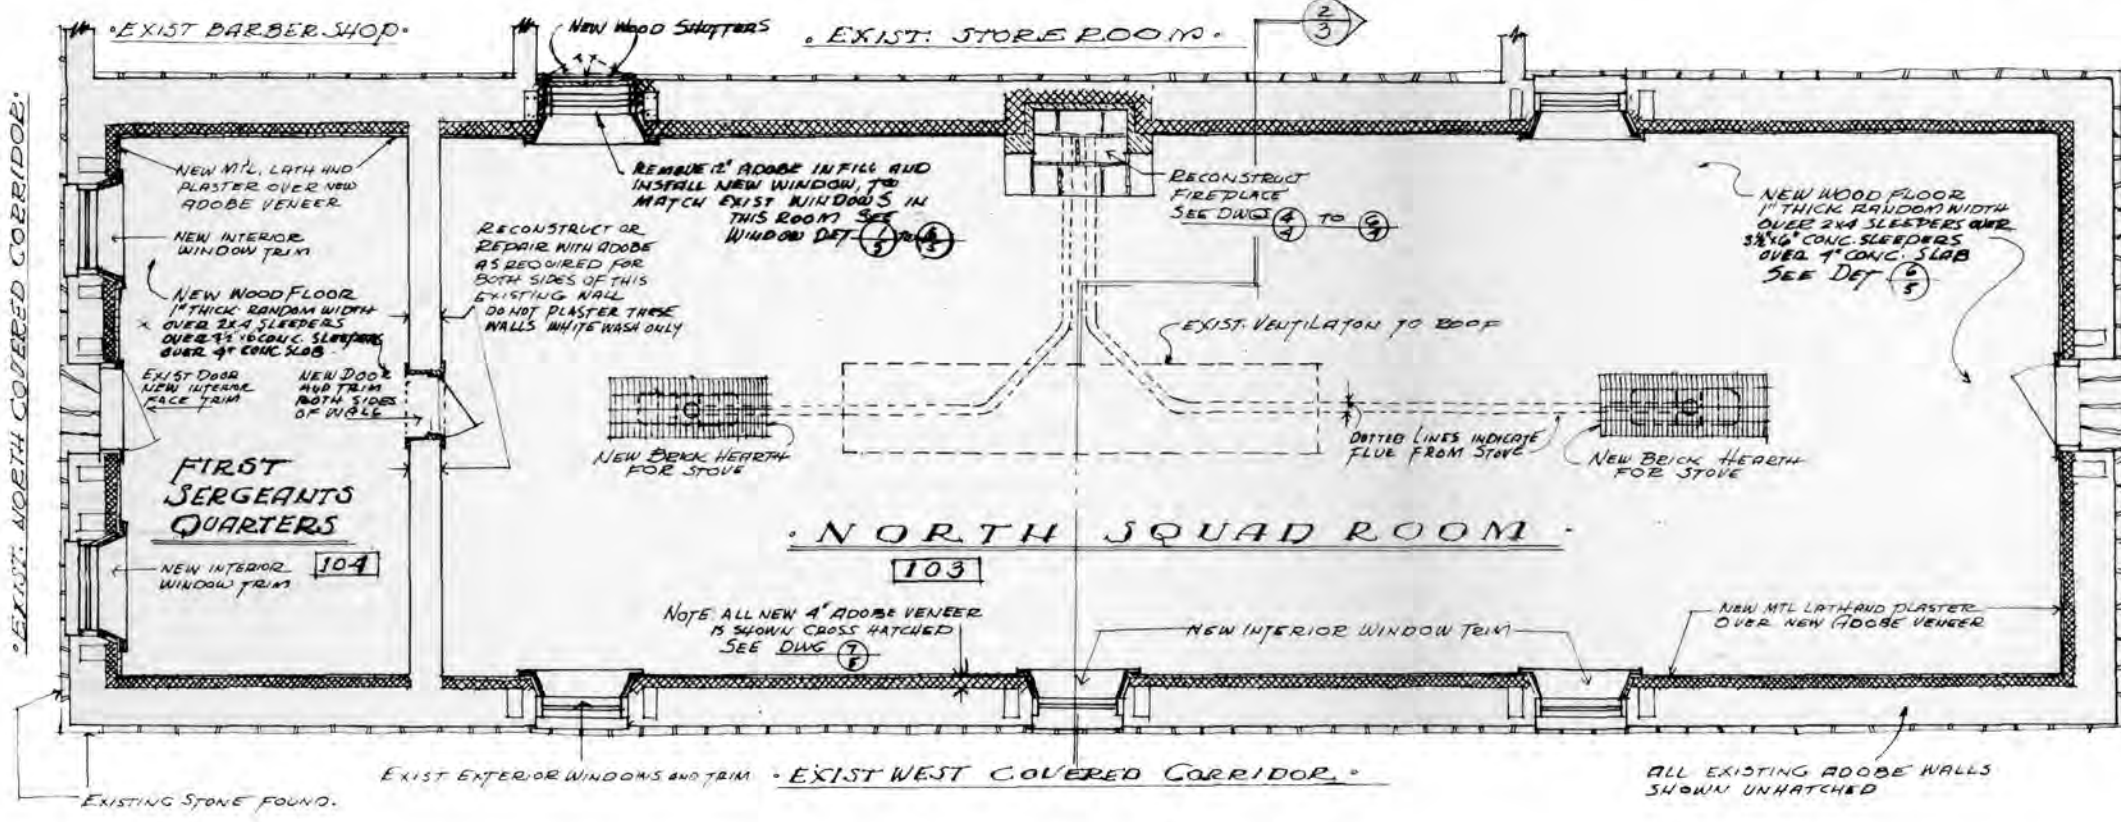
FIRST FLOOR PLAN
 NORTH SQUAD ROOM BLDG HB-21
 SCALE 1/4" = 1'-0"

The north, east, and west walls of the 1st sergeant's quarters room are eroded (see drawing, sheets 3, 4, and 5). Three horizontal rows of 4-inch adobe blocks form a supporting base for the concrete bond beam that extends approximately 4 inches from the face of the eroded interior walls. The south wall is badly eroded at the door opening, especially at the head.

Two brick hearths will be constructed in the north squad room as a platform for the stoves and as a place to store the fuel (see drawing, sheet 3). They will be approximately 2 feet 8 inches by 6 feet 8 inches in size. The brick will be on edge and have mortar joints.
