HISTORIC STRUCTURE REPORT
1874 CAVALRY BARRACKS
ARCHITECTURAL DATA
FORT LARAMIE NATIONAL HISTORIC SITE
WYOMING

by
Frank Gerner

DENVER SERVICE CENTER
HISTORIC PRESERVATION TEAM
NATIONAL PARK SERVICE
UNITED STATES DEPARTMENT OF THE INTERIOR
DENVER, COLORADO

June 1975

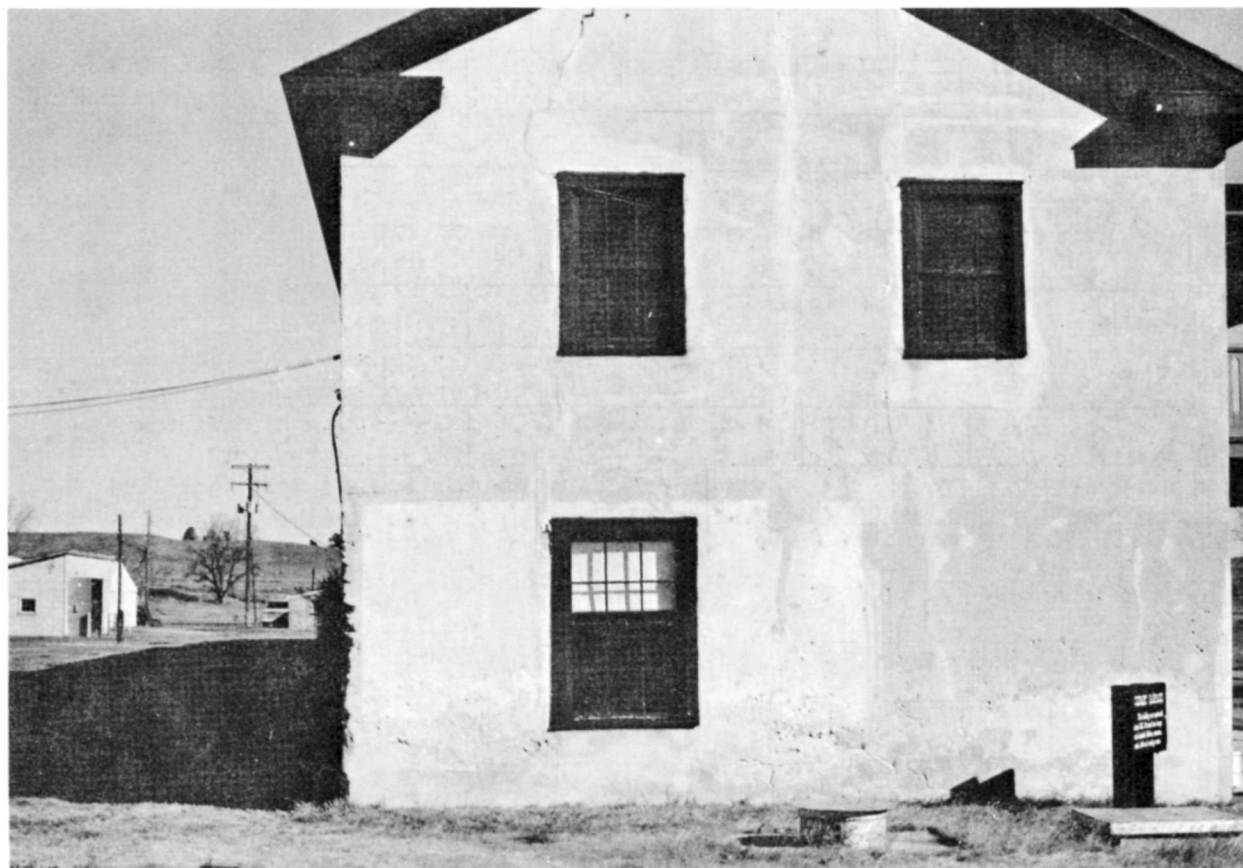
Illustration 3.

This 270-foot-long wall has over 29 cracks along its length. However, only two are of a serious nature. They are located adjacent to each of the end walls and will require extensive repairs to prevent further deterioration.

Southwest corner of the 1874 barracks, showing cracks at gable window area. Both end gables will require special care to prevent any eventual separation of gable walls at both ends from end walls.

The very deep and long cracks that occur on the south end wall and on the north end wall and the cracks on the west wall that are very close to both the north and south gable walls should be repaired as soon as possible.

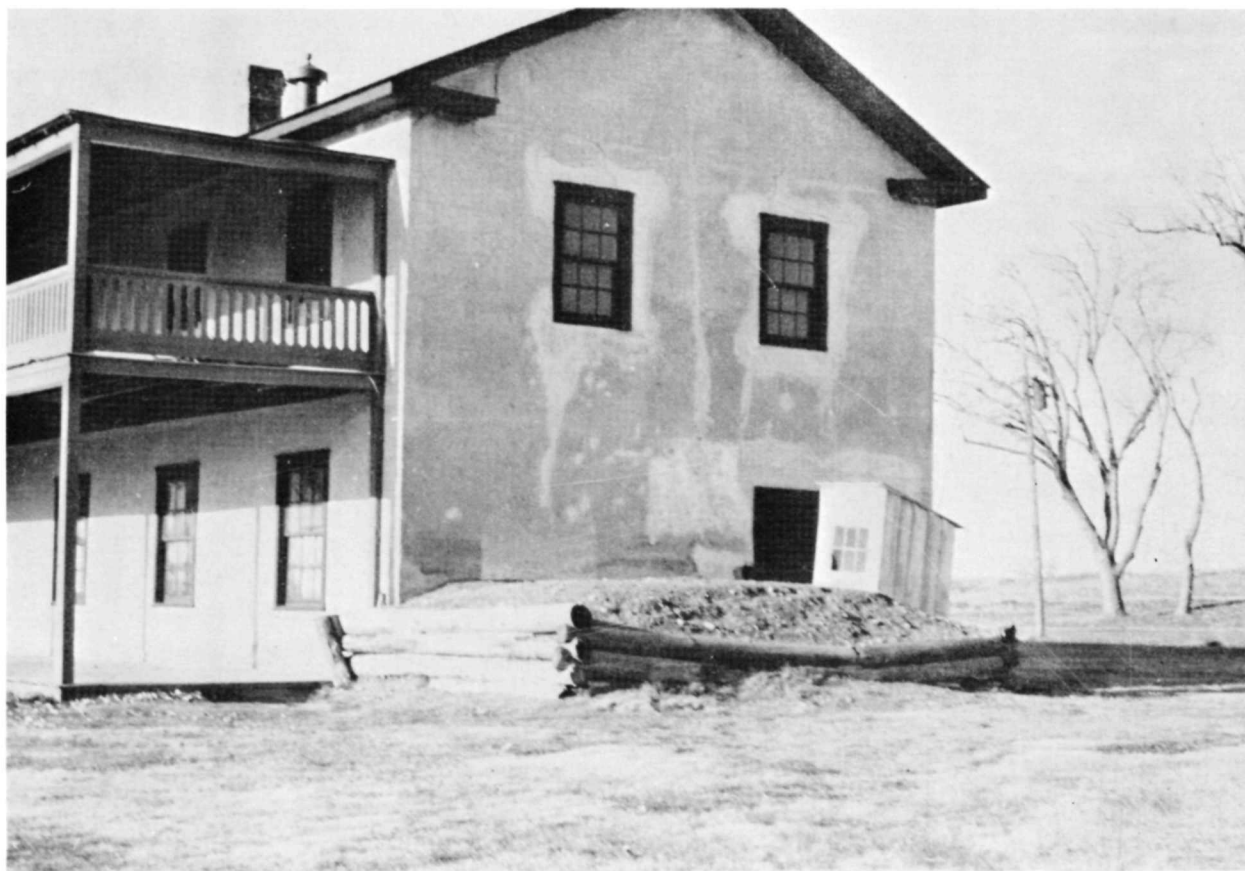
Illustration 4.

Northeast corner of the 1874 barracks. Close-up showing earth cellar adjacent to the north end of building. Also shows some cracks and patching at window areas. The earth cellar log retaining wall and wood shack to cellar will be removed.

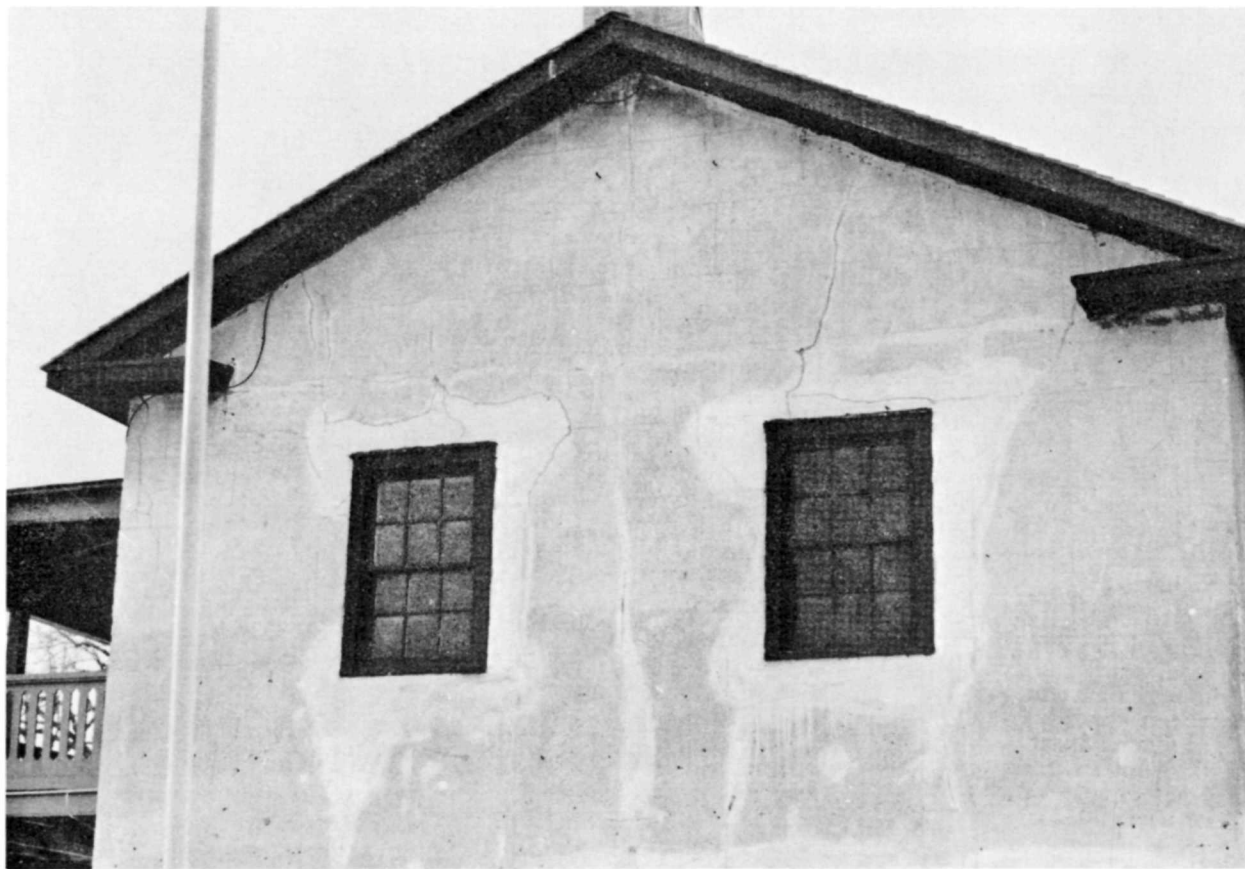
Illustration 5.

There are five large cracks on this wall. The largest starts at a peak of the gable and runs to within 1 foot of the ground. Another occurs at the top of the upper right window. Another crack that should be mentioned starts at the first-floor door head and extends to the cornice.

Close-up of north gable view of the 1874 barracks,
showing cracks at windows and gable.

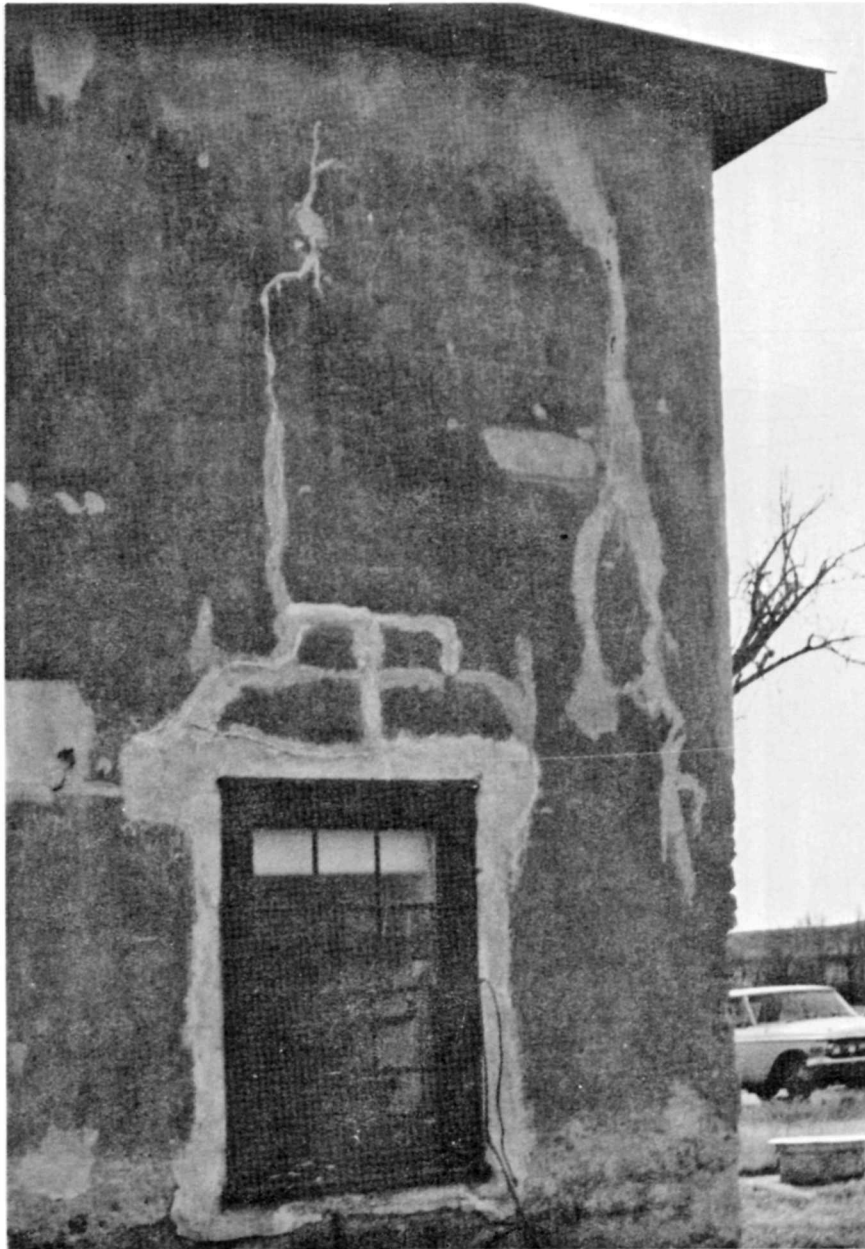
Illustration 6.

Some cracks penetrate the south walls, and there are two particularly bad ones in the west wall about 4 feet and 8 feet respectively from the south wall junction. All other walls show some cracks, but they do not appear as serious as these.

Close-up of window, west side, near south end of building. Photo shows cracks at southwest corner towards the gable end and at window. These cracks have been patched over at various times, but some still open up occasionally.

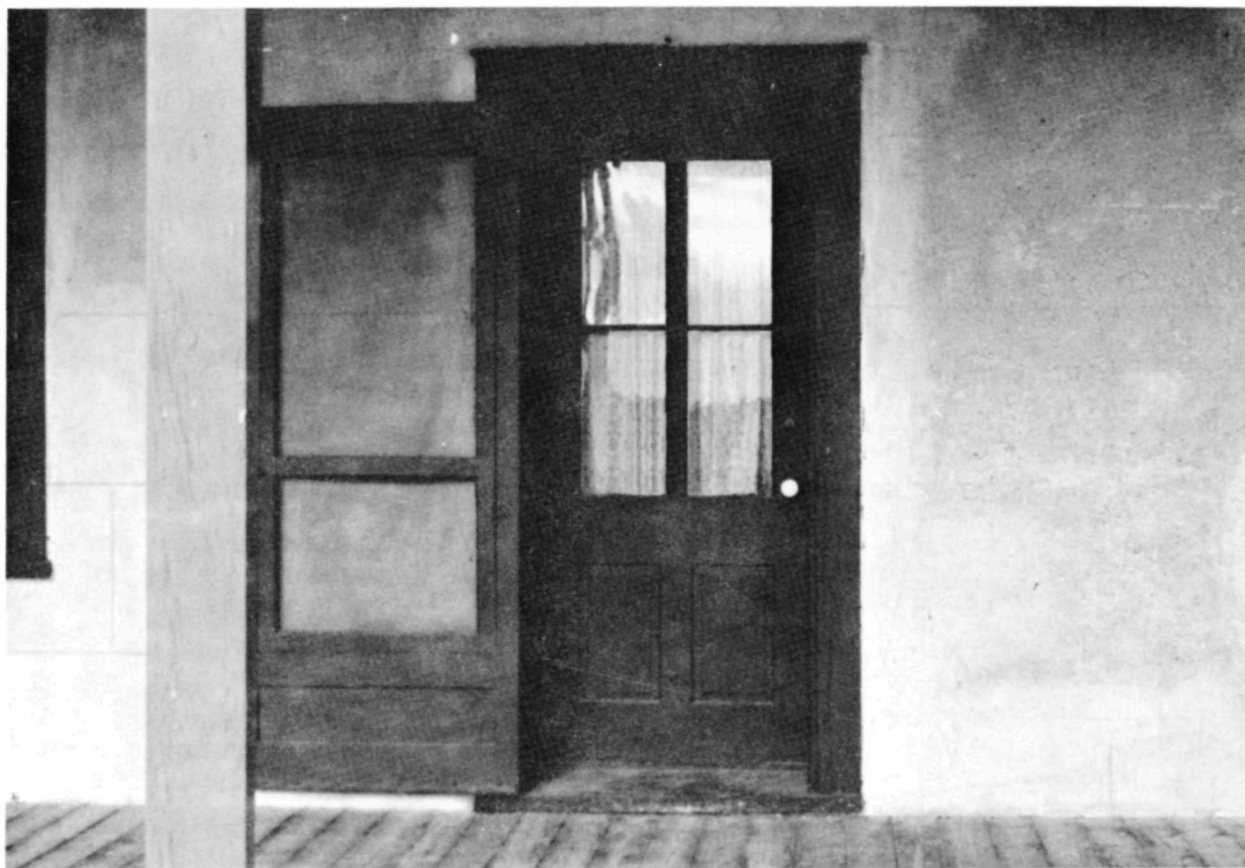
Illustration 7.

Close-up of original army door on veranda, east elevation. (Screen door is not original.) This will be the type used when restoring all exterior doors. Screens will not be used on any doors in the barracks.

The trim, head, jamb, and sills are for the most part in fair condition. As previously mentioned, only two doors are original. These will be the model for all the exterior doors that will be replaced or removed to new locations as shown on the drawings. There will be 15 new exterior doors replacing the adapted and later nonarmy doors on both the north and south barracks. These doors are 1-3/8 inches thick, about 2 feet 10 inches wide, and about 6 feet 7 inches high. They have two lower wooden panels that are raised and four glass panes above. The hardware on these will be 1864 patented locks, two authentic examples of which are in use in the building. The hinges will be selected from the building, because there are historic army hinges still in use on some existing doors. Two of these hinges and two of these locks are shown on sheet 7 of the drawings.

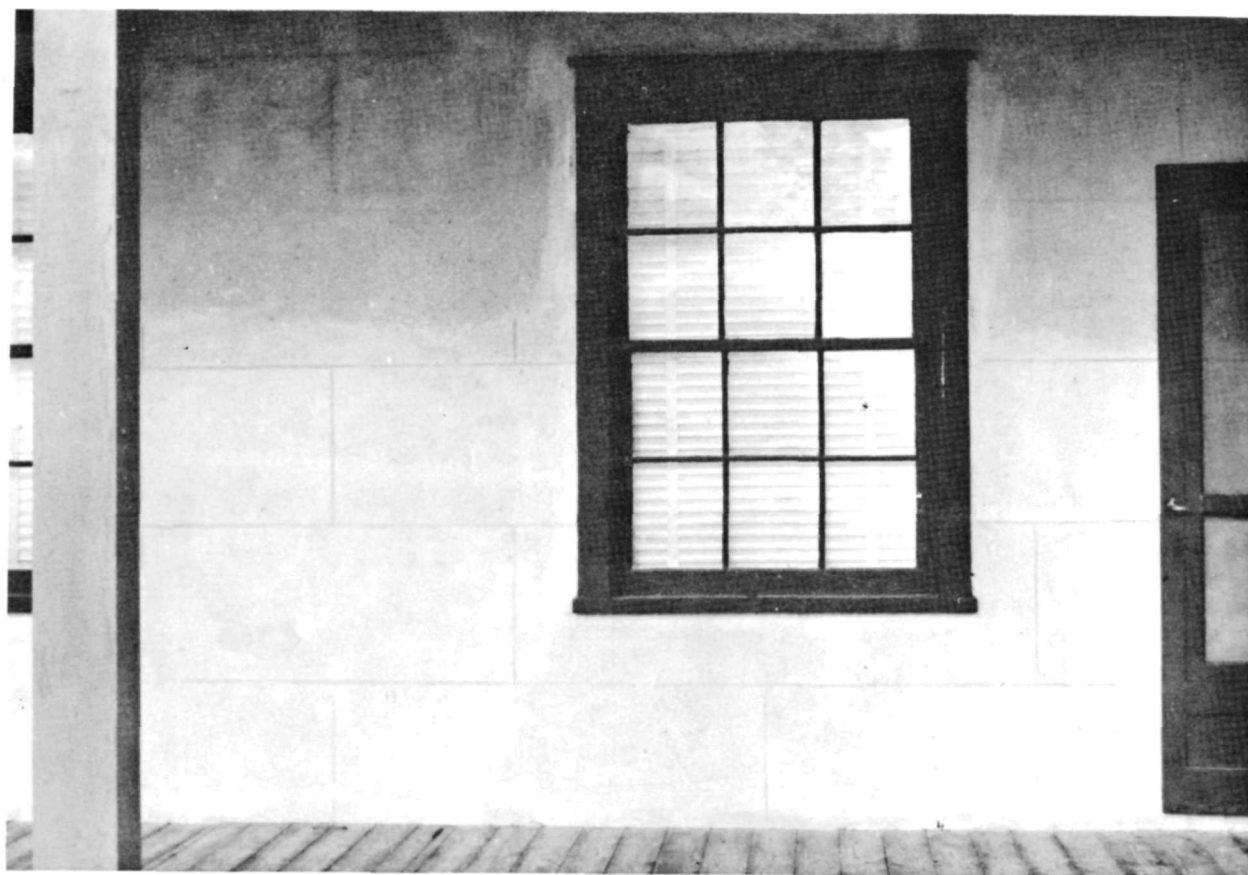
Illustration 8.

Close-up of lower-story, typical, army window.
This is an original army window and trim.
Picture shows part of wood flooring and wood
column of the veranda.

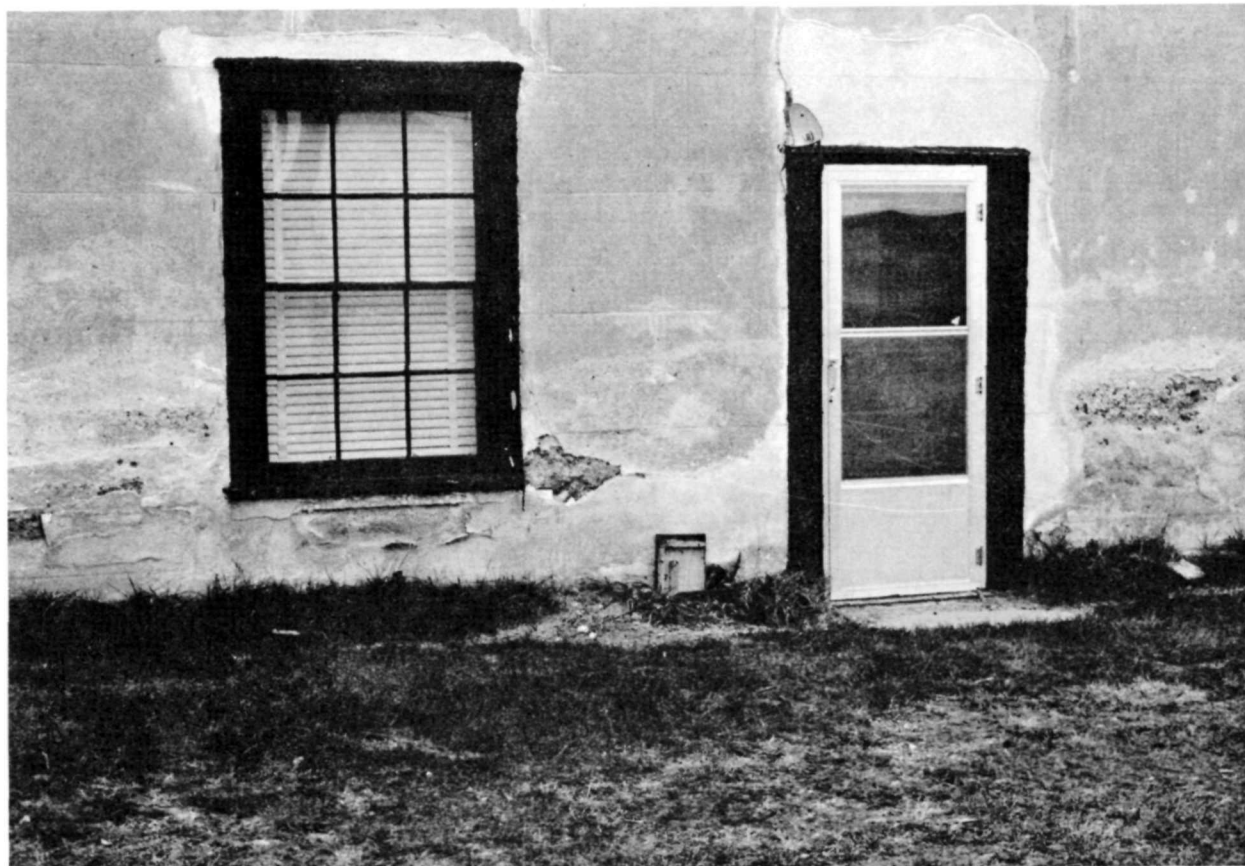
Illustration 9.

Close-up of window and door, west side.
Shows spalling below window near ground and
also at side of door.

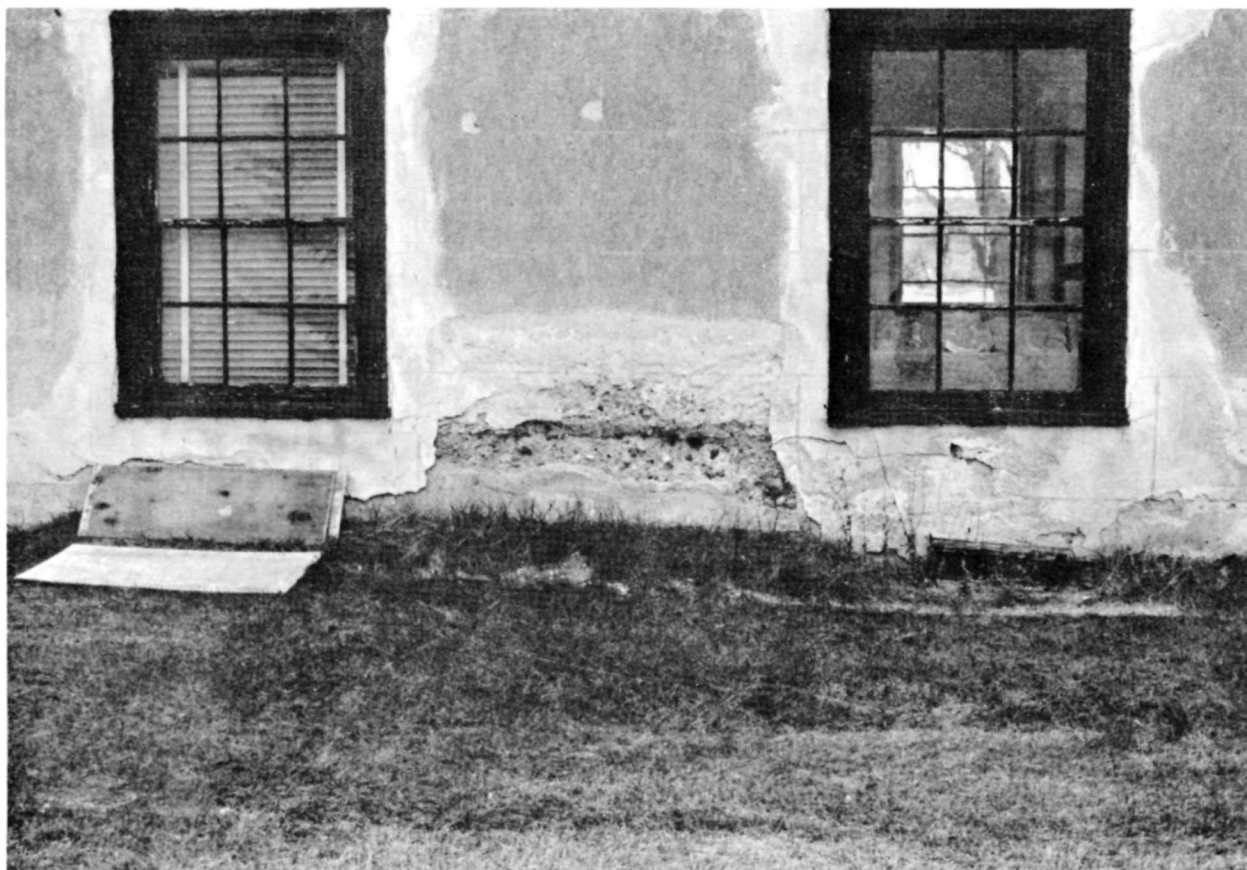
Illustration 10.

Close-up of windows, west elevation. Shows spalling near ground. Some plaster has been patched, while some has fallen off near the ground and spalling has developed.

The minor cracks can be filled with lime concrete grout and covered with scored plaster to conform to the existing pattern on the exterior walls.

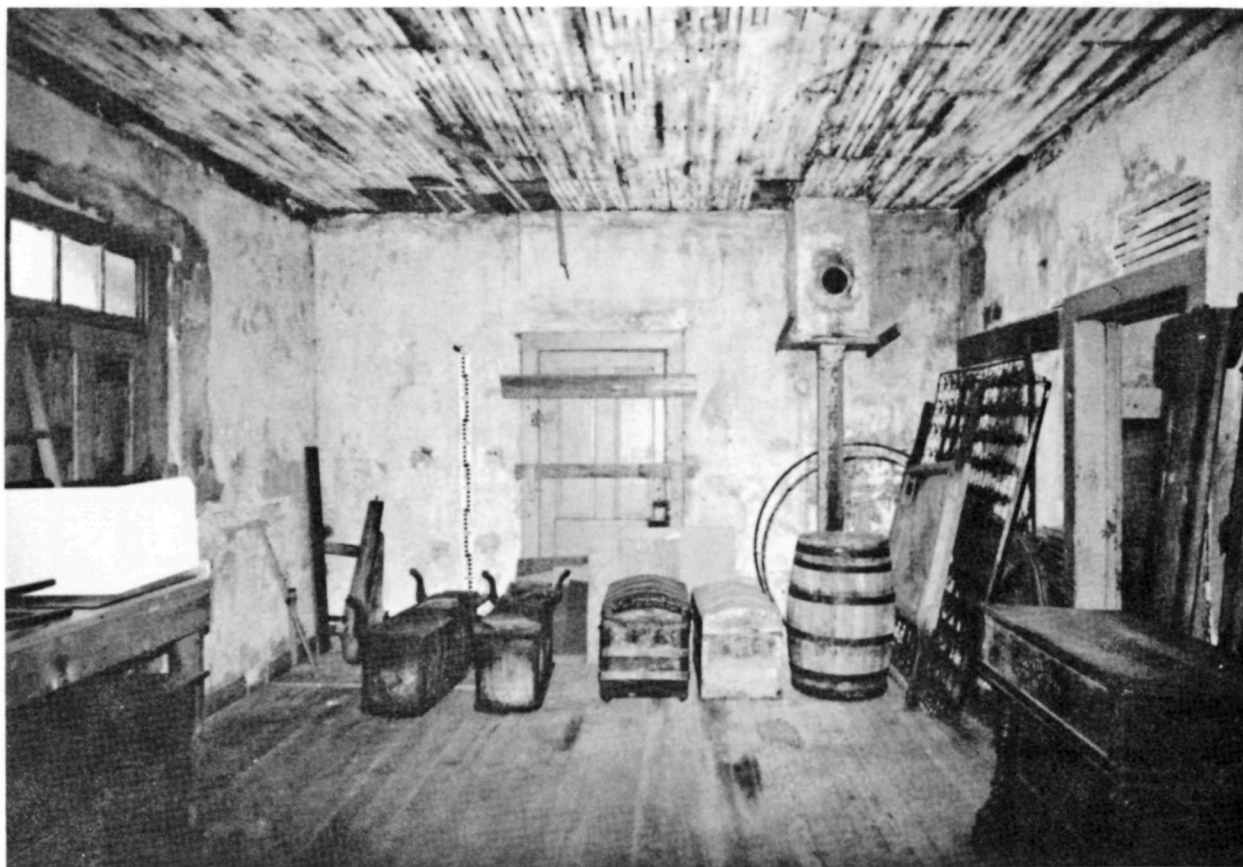
Illustration 11.

Interior of kitchen, north barracks. Note condition of interior plaster and flooring (decayed on bottom side). Shows old army door trim and kitchen chimney. The south kitchen is in similar condition. Note how plaster has come off the laths on the ceilings and on the stud walls.

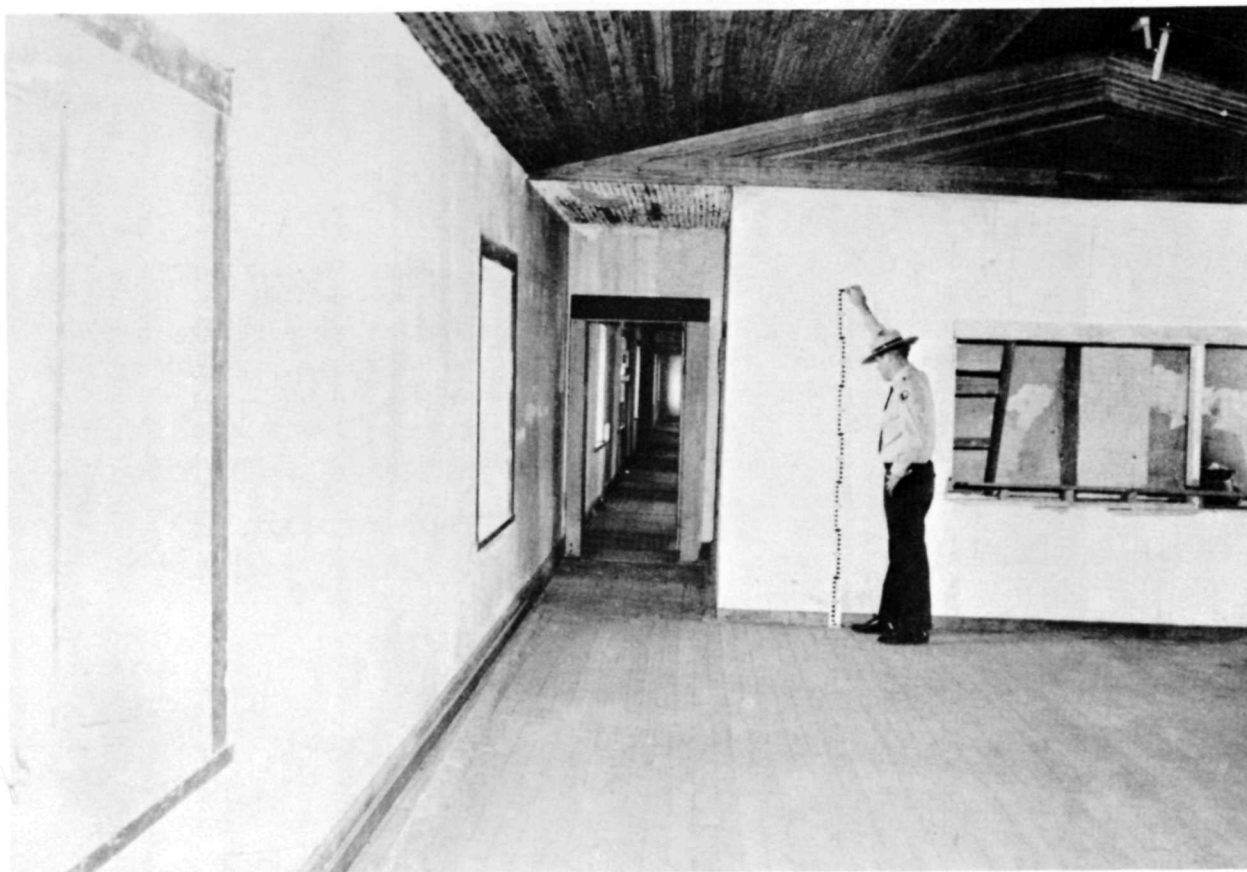
Illustration 12.

Interior of former south squad room, upstairs,
(dance hall and bar of the Joe Wilde era). Shows
change in ceiling from scissors trussed rafters
to the historic trussed rafters.

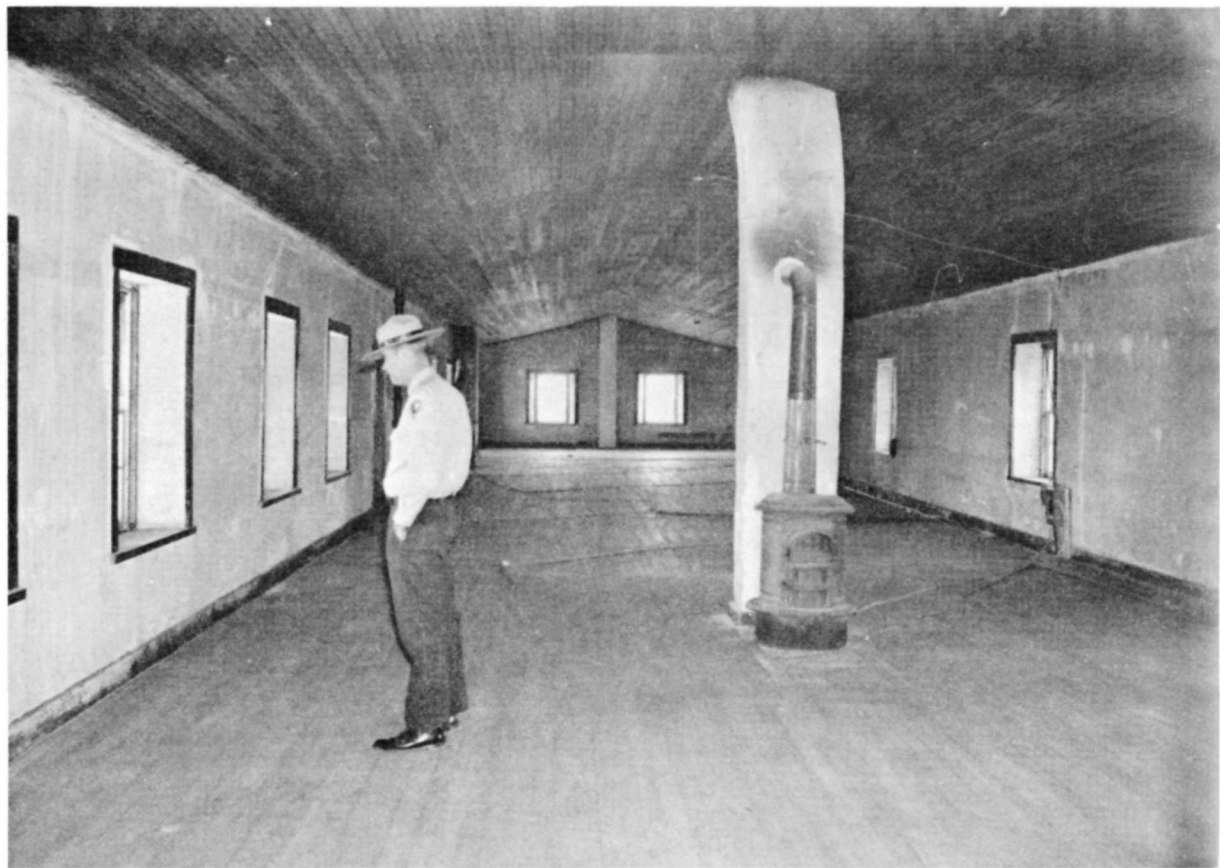
Illustration 14.

Almost this whole area has been converted to a dance floor. A bar forms an 8-foot strip across the north end of this former squad room. An oak floor, 1 inch thick on sleepers, was laid over the old existing wood pine floor. Examination of the old army floor underneath reveals a worn surface but a floor in fairly good condition. The original flooring is made up of boards 1-3/8 inches thick by 5 inches wide T & G. The stairs serving this area have been removed and the stairwell floored over.

Interior of Joe Wilde's dance hall (south squad room, second floor), looking west. Ceiling follows bottom chords of the scissors trussed rafters. Ceiling will be removed and trussed rafters connected to the historic rafters.

The existing hardwood floor in the dance hall should be removed, and the exposed army pine floor should be repaired where required. Two coats of hydrozo or of an approved preservative should be applied over the floor. The floor joists on the second floor are in good condition.

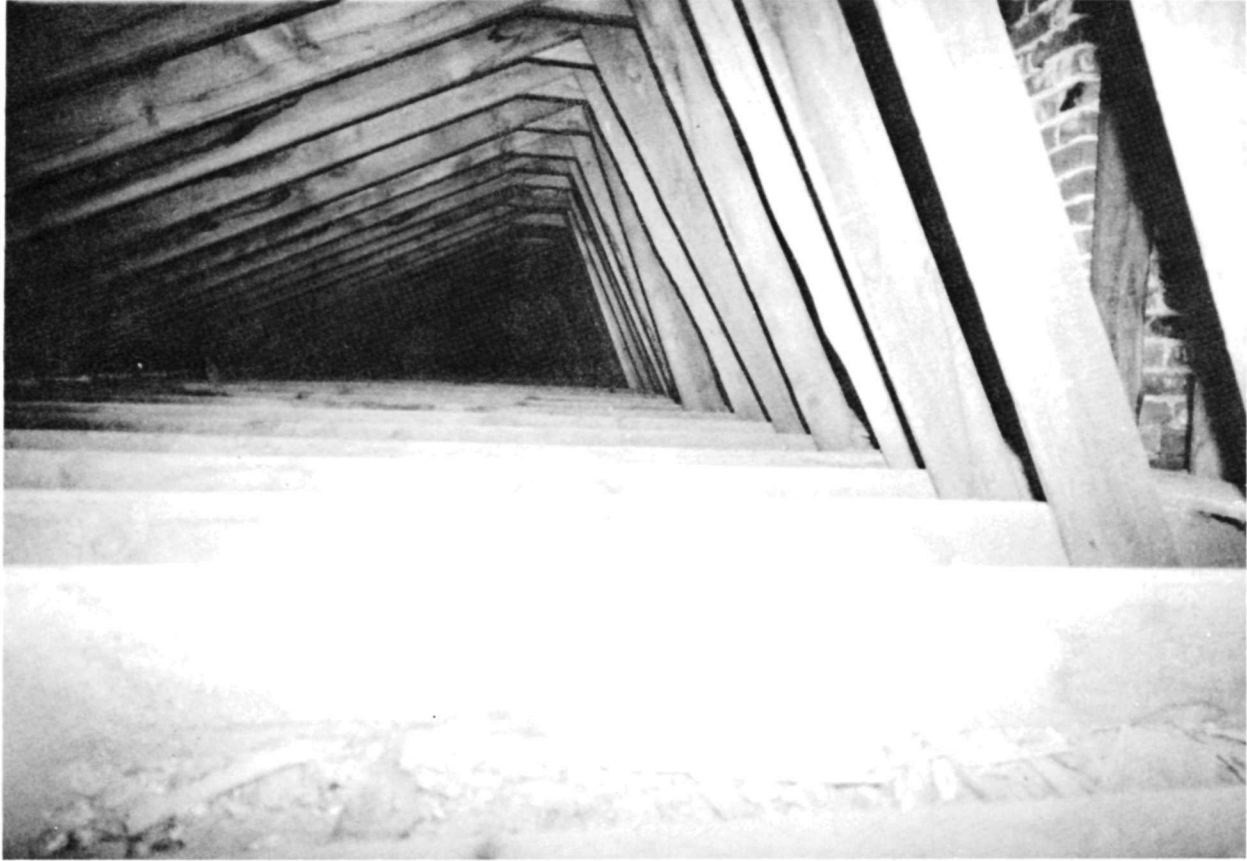
Illustration 15.

Trussed rafters, attic of north squad room. This is the way the scissors trusses of the south barracks will be restored.
