HISTORIC STRUCTURE REPORT

FORT POINT LIGHT

[ FORT POINT NATIONAL HISTORIC SITE

May, 1972

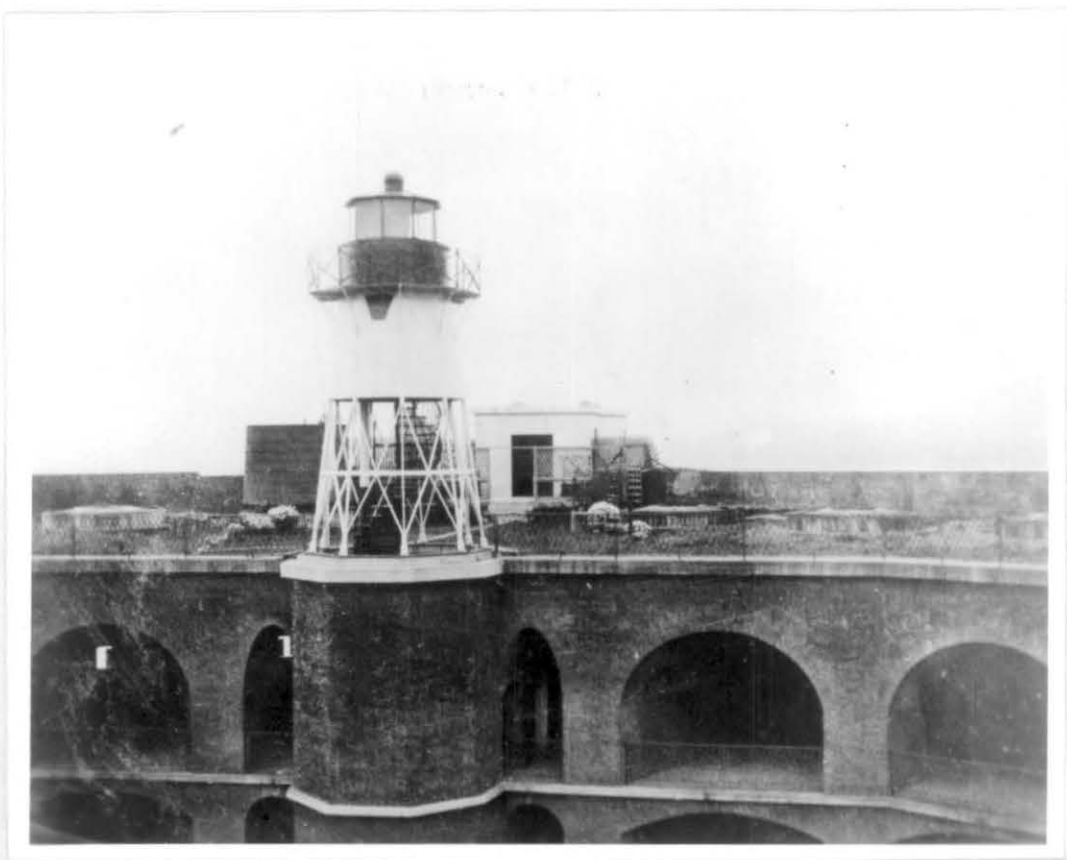
ILLUSTRATION NO. 2

View of Fort Point Light during historic period. Note the painting scheme, the light shield on the landward side of the lantern, and the dome over the roof vent. Also, note the large pipe extending from level "B" through level "A", and other structures over the westerly bastion.

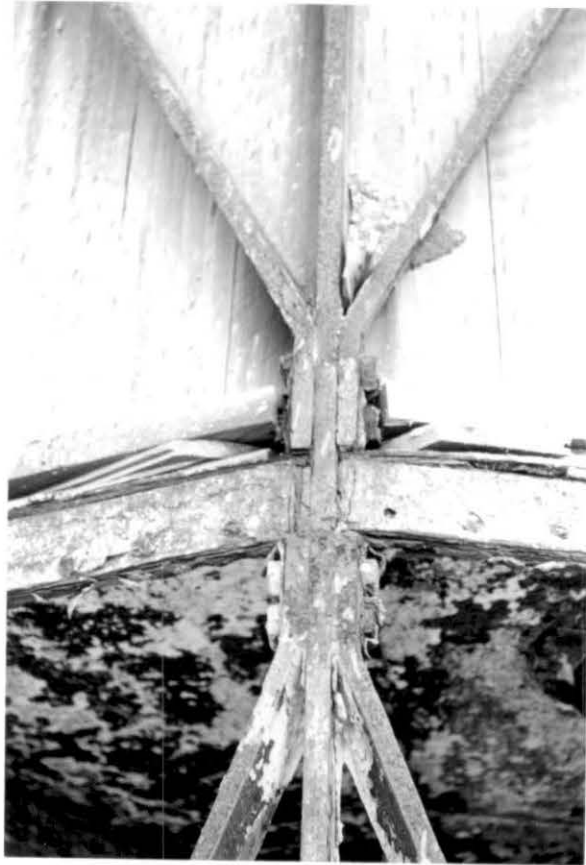
ILLUSTRATION NO. 5

Detail of framing at level "B". Note T&G decking and wall lining at level "B". Also, note that the iron forming the structural frame is in sound condition.

14. Repair interior T&G wall lining and decking and construct new hinged trap door at level "B".
15. Repair T&G decking at level "C".
16. Enclosed spaces shall be made weather-tight.

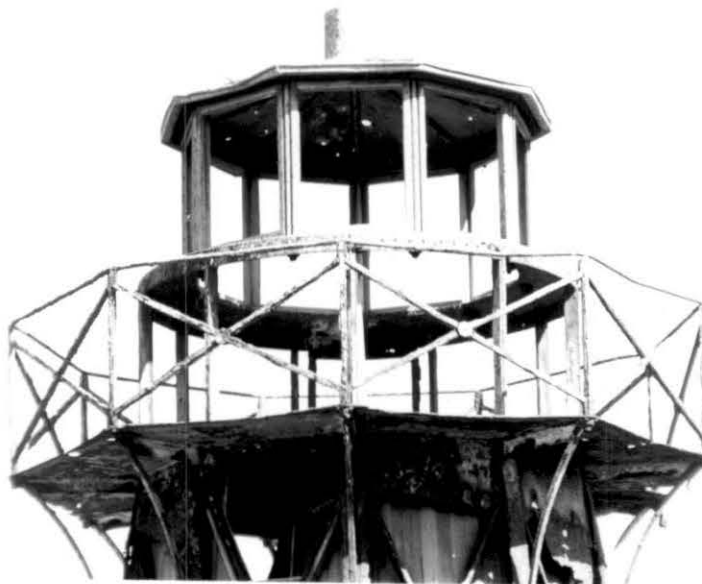
ILLUSTRATION NO. 6

Detail of lantern and gallery.

9. Replace spiral iron stairway and railing at level "A" and ladder at level "B" with new to match original.
10. Replace gallery including railing and exterior brackets that support it with like material.

11. Repair copper roof at level "D".
12. Install new dome cap over vent stack at roof at level "D".
13. Remove wood sash at lantern and install 1/2" thick laminated safety glass or plastic such as Lexan with neoprene gaskets or recommended sealant and bronze stops.

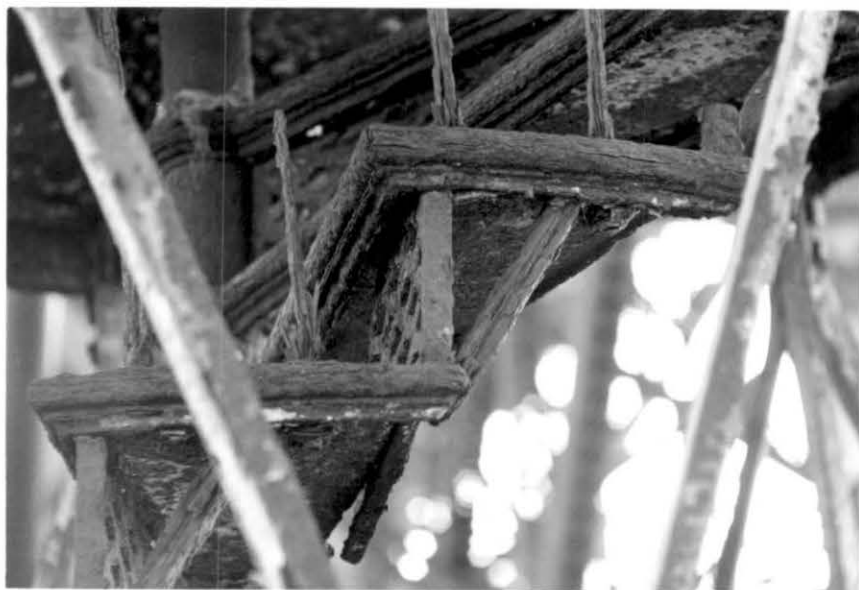
ILLUSTRATION NO. 7

Detail of cast iron spiral stairs. Note deterioration of iron beyond salvaging.

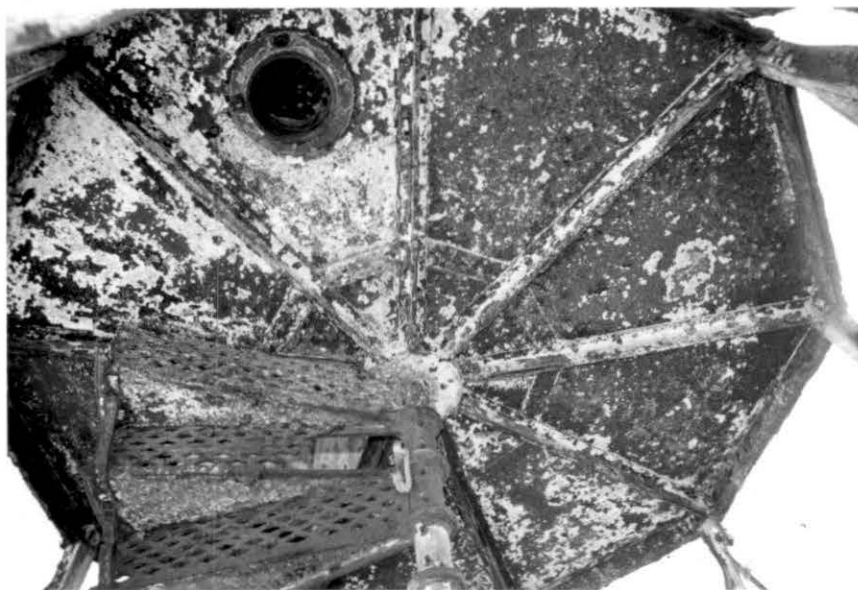
ILLUSTRATION NO. 8

Detail of underside of deck at level "B" and at gallery.

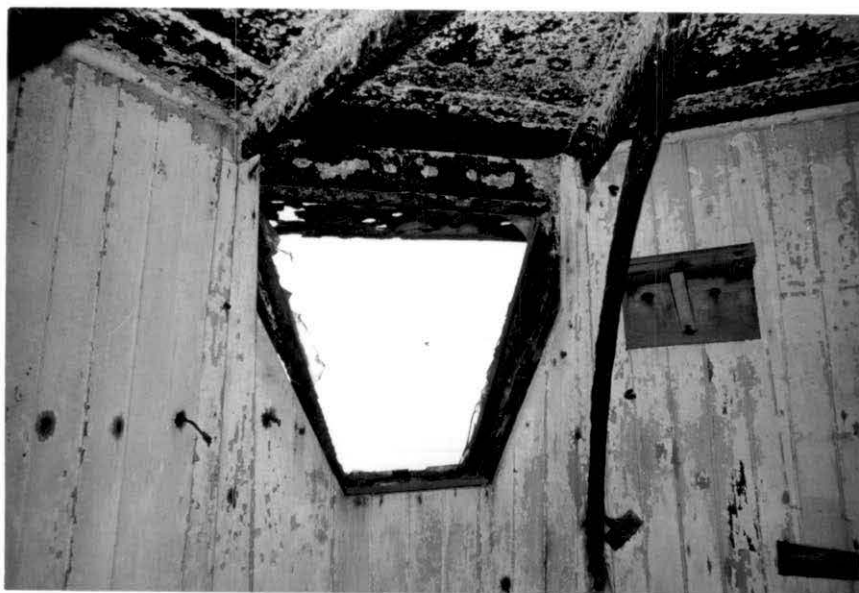
ILLUSTRATION NO. 10

At approximately 12 feet above the base an iron plate, over which is constructed a T&G wood floor, is supported by 4" T bars framed into a central ring. The space above to the gallery level, about 8 feet, is enclosed with iron plate on the exterior; and the interior is lined with beaded 1" x 4" T&G. This enclosed space was the Watch Room, and was reached by a spiral cast iron stairway and a trap door. Trapezoidal windows, of iron frame and 5/16" thick plate glass, fit between the "X" bracing in three panels below the gallery. The windows are rusted beyond salvage.

Detail of windows and interior T&G wall lining at level "B".  
Note iron knee bracing.

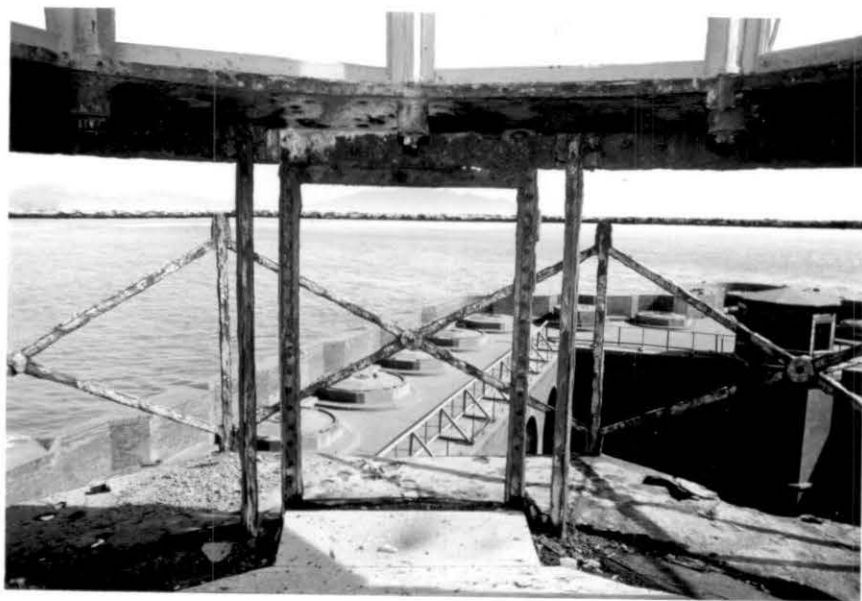
ILLUSTRATION NO. 12

Detail of framing and assemblage of access door at parapet, level "C".
