Fort Sumter
Fort Sumter National Monument
Historic Structure Report

Volume II
APPENDICES A-F

2015

JOSEPH K. OPPERMANN – ARCHITECT, P.A.

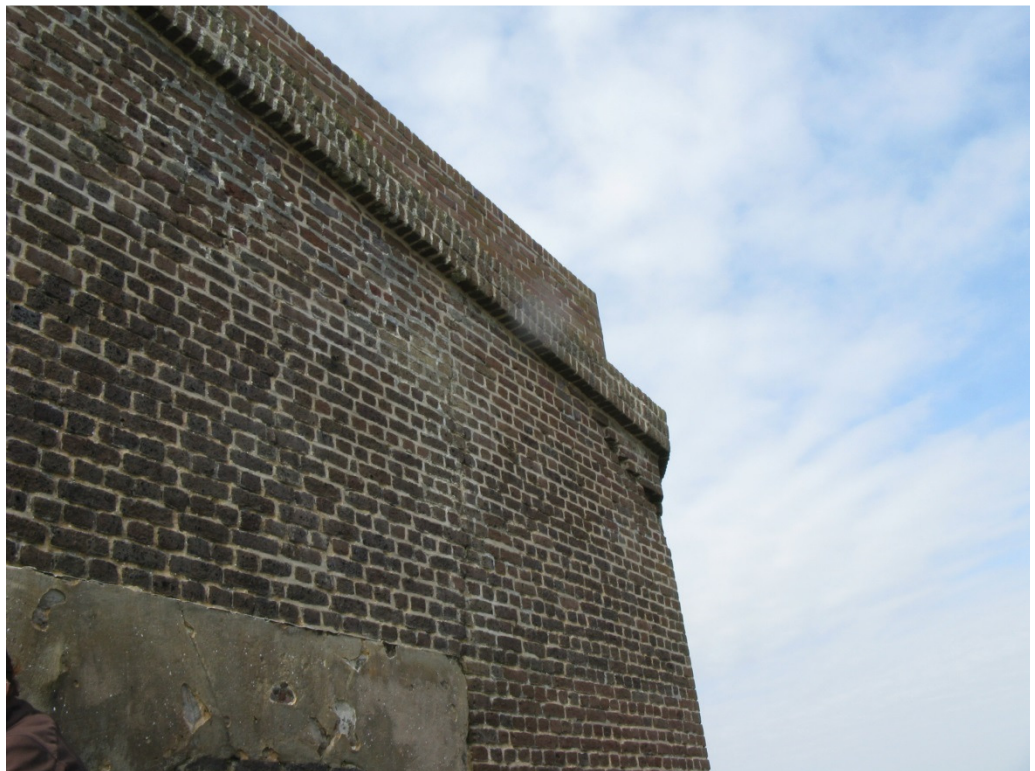
Several masonry cracks were found along the exterior of the fort. The cracks are located towards the ends of the long walls and on the shoulders (Figures 14 through 19). Several of these cracks extend from the top of the wall to below the revetment. Others start at the top of the wall and stop at a corner before reaching the base of the wall. The right face and right flank contain the majority of the cracks noted on this site visit.

Figure 14: Masonry cracks, Right Face at Salient, March 2009

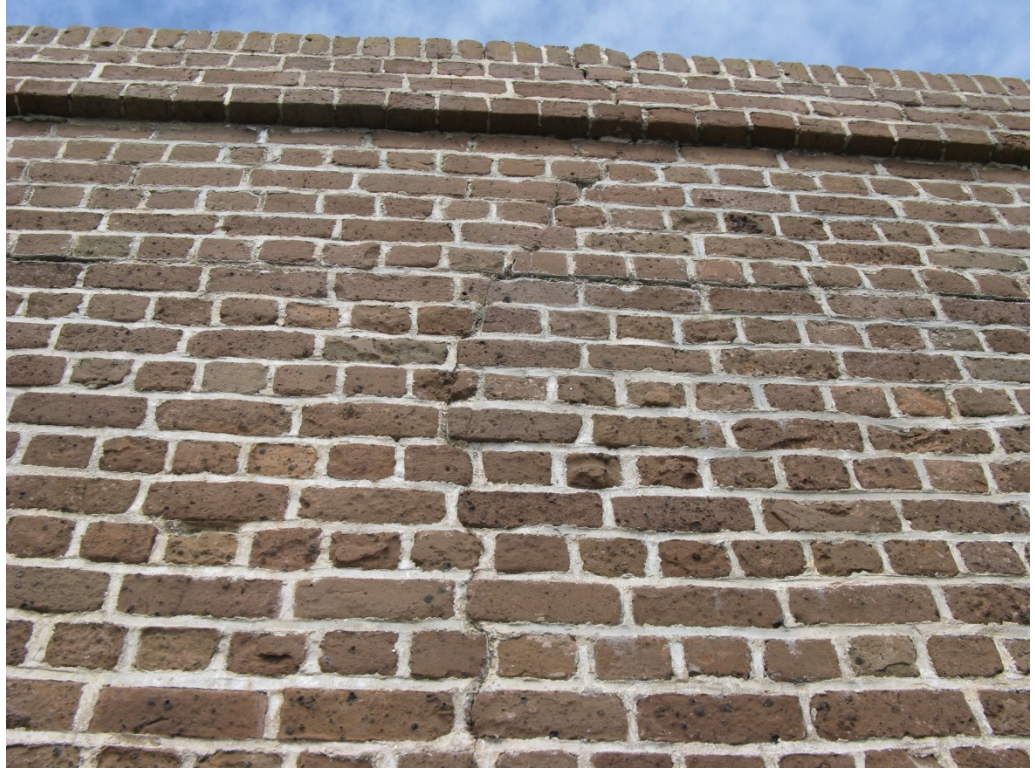
Figure 15: Masonry crack, Right Flank, March 2009

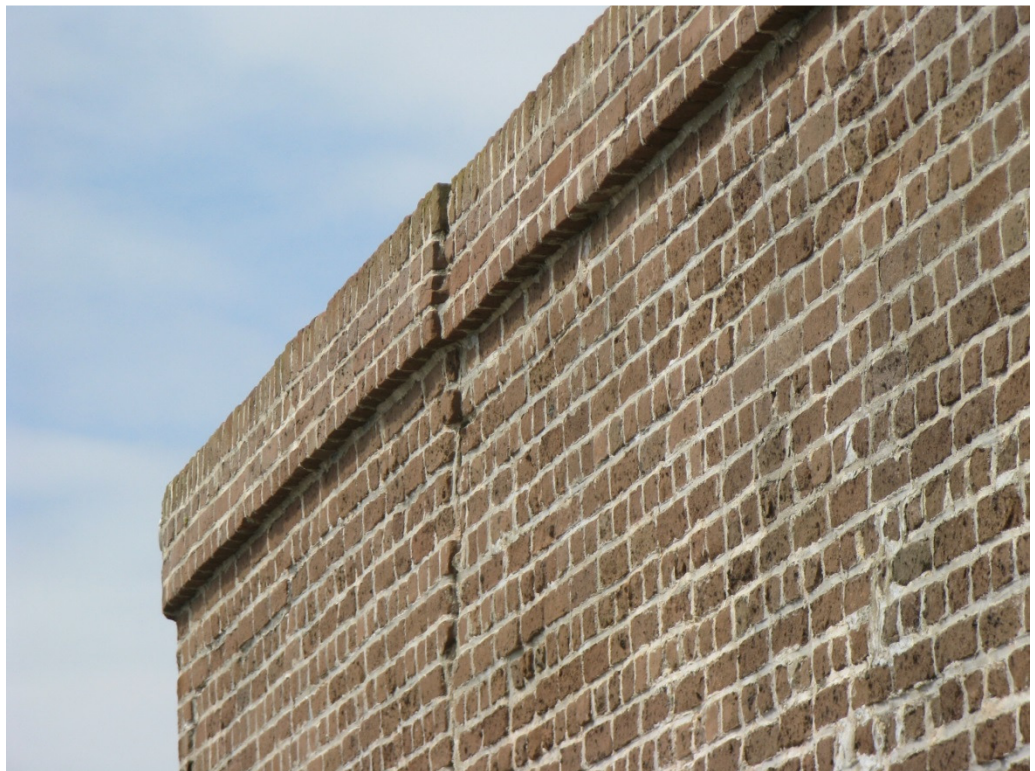
Figure 16: Masonry crack, Right Flank at Right Gorge, March 2009

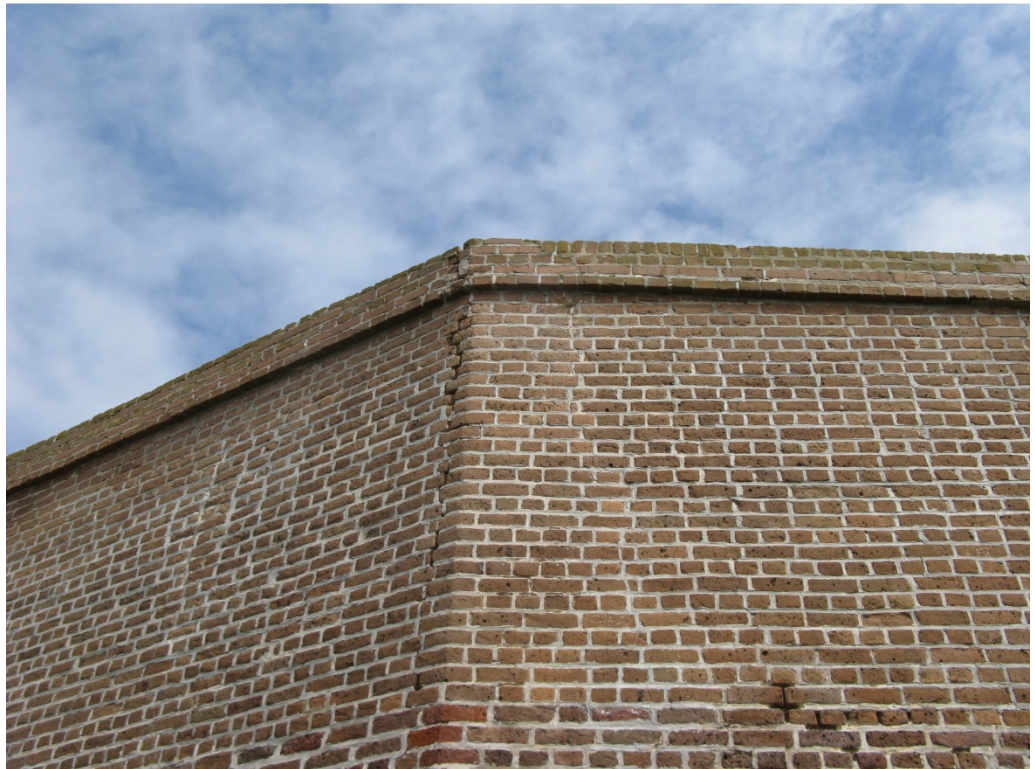
Figure 18: Masonry crack, Gorge Wall and Right Gorge, March 2009

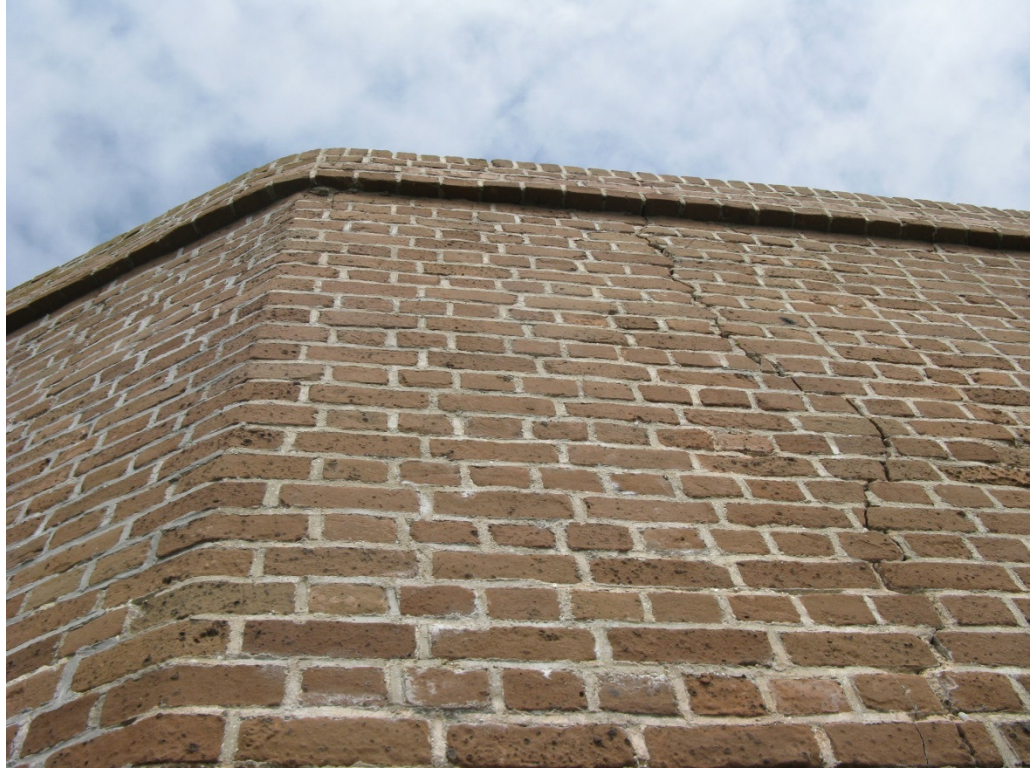
Figure 19: Masonry crack, Right Gorge and Right Face, March 2009

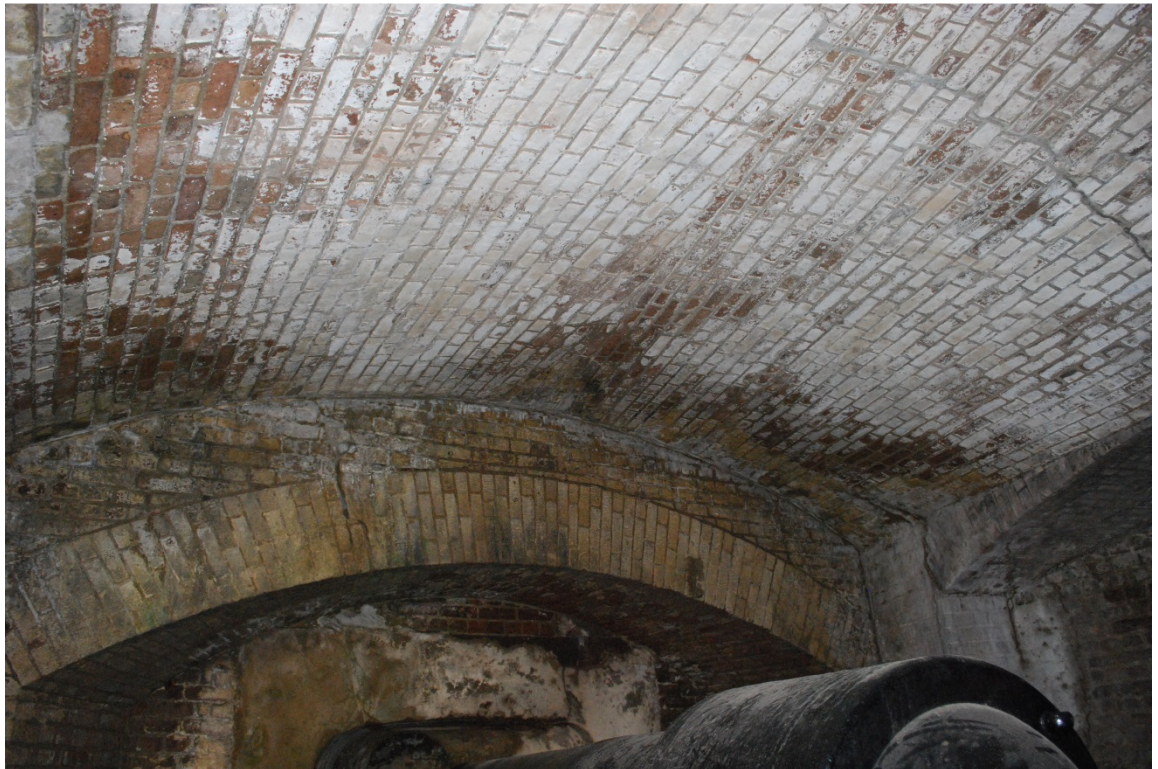
Inside the fort, much of the visible damage consists of cracked arches and vaults. A number of vaults in the arcades are cracked, especially at the ends of each arcade (Figures 20 and 21). Many of vault-supporting arches are also cracked; both vertical and horizontal cracks were found in a significant number of these arches (Figures 22 and 23). Some of the thrust resisting abutments also show signs of movement (Figure 24).

Cracks observed on the interior supporting arches are due to their supporting elements (piers, abutments, and perimeter walls) not adequately resisting the thrust of the arches and vaults. Many of these cracks can be found near the end of arcades or where an arcade has been broken by demolition. One good example of this phenomenon is illustrated by Figure 24. This arch is broken in two locations. In this particular case, the structure once giving additional stiffness to the interior abutment has been destroyed, weakening the system. The exterior abutment is located at the salient wall and at the end of an arcade, where resisting forces are weakest. Furthermore, a large horizontal crack through the upper abutment on the exterior side illustrates the force of the outward thrust of the arch. While this example of vault support movement is extreme, similar damage was observed throughout the fort.

Figure 20: Cracks through arch, Right Face arcade, March 2009

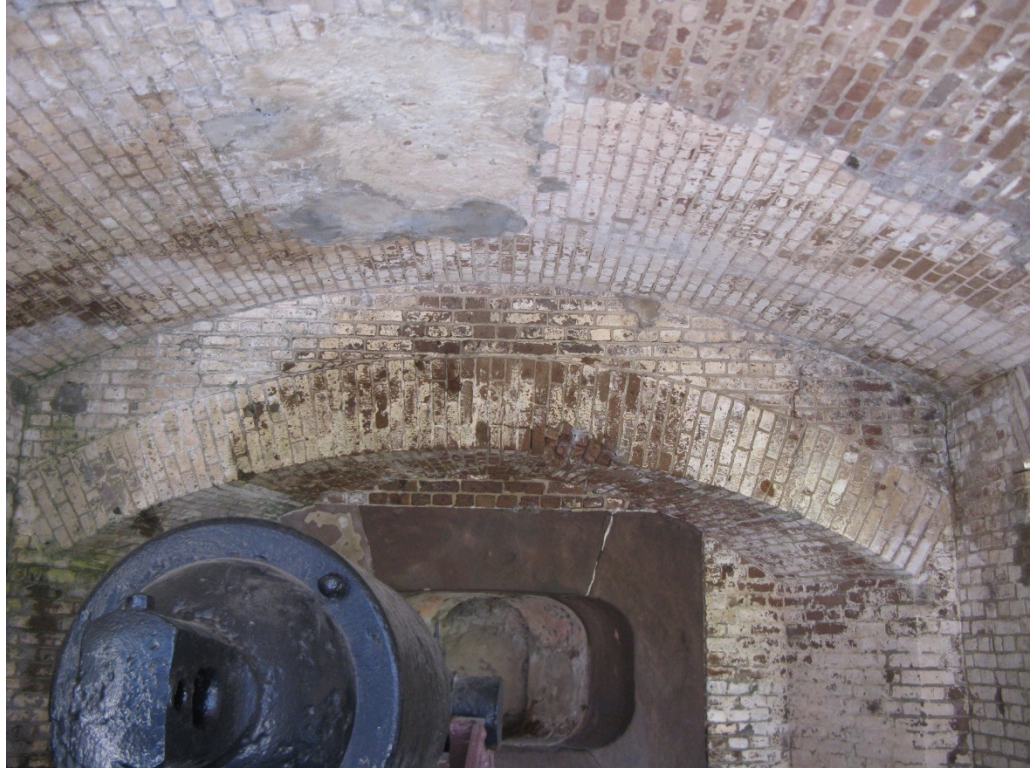
Figure 21: Cracks through arch, Right Face arcade, March 2009

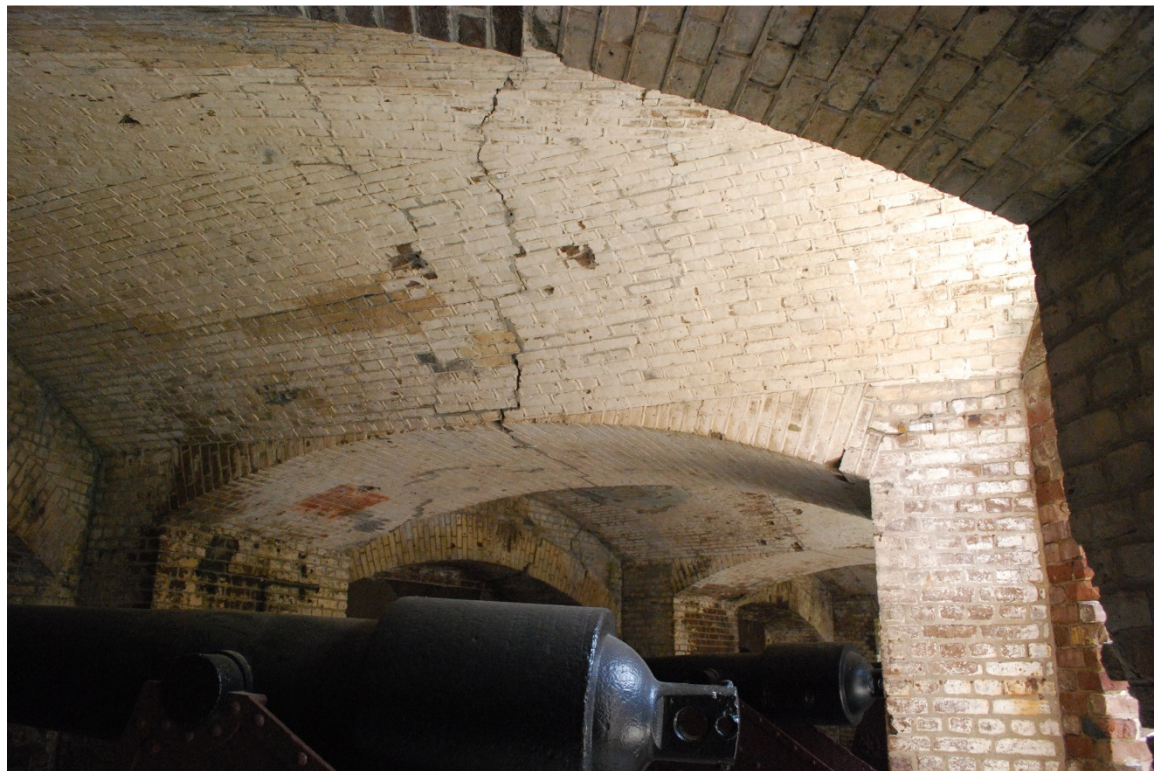
Each of the casement vaults that were examined as a part of this site visit has a crack running perpendicular to its axis (Figures 22 and 23, 25 and 26). The cracks are of varying sizes, and vary in location slightly, but tend to be close to the middle of the vault. In one vault along the right face, cracks run in both directions, and one section of the vault is dropping below the rest (Figure 27). Many of the cracks in the vaults have been filled with epoxy, mortar or grout (Figures 25 and 26). In some locations, the filled crack has reopened or a new crack has formed adjacent to the repair (Figure 26).

The cracks noted in the vaults generally result from the movement of the vault supports, causing the vaults to try to act as flexural members spanning between the inner and outer arcades rather than acting as compression-only elements, as originally intended.

Figure 22: Crack running through vault and supporting arch, Right Face, March 2009

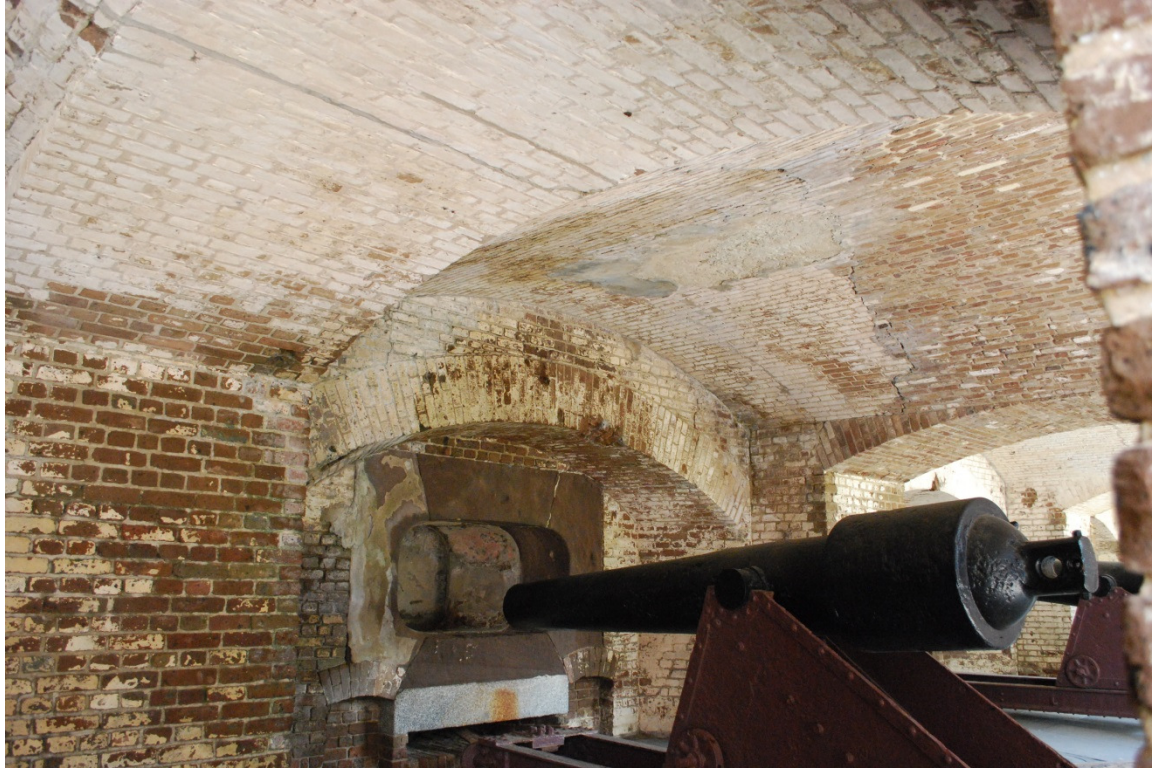
Figure 23: Crack extending through vaults and supporting arches, Right Face, March 2009

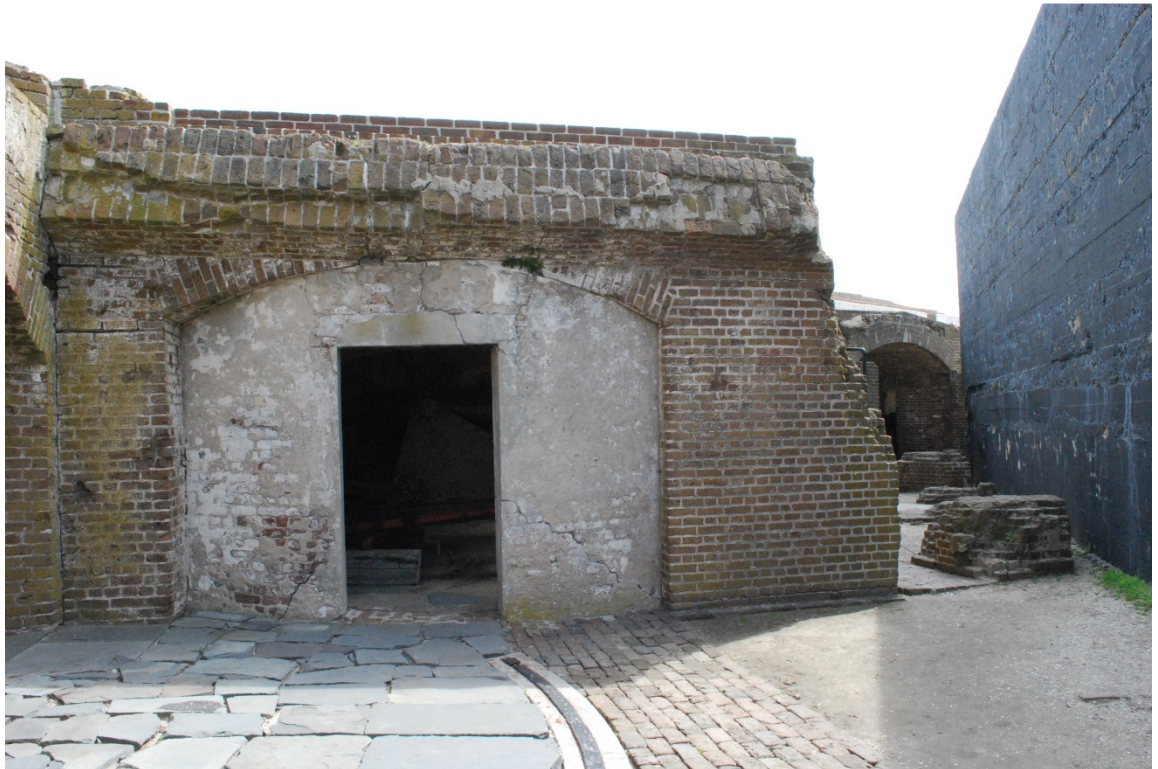
Figure 24: Several cracks are visible on this supporting arch at the Salient, March 2009

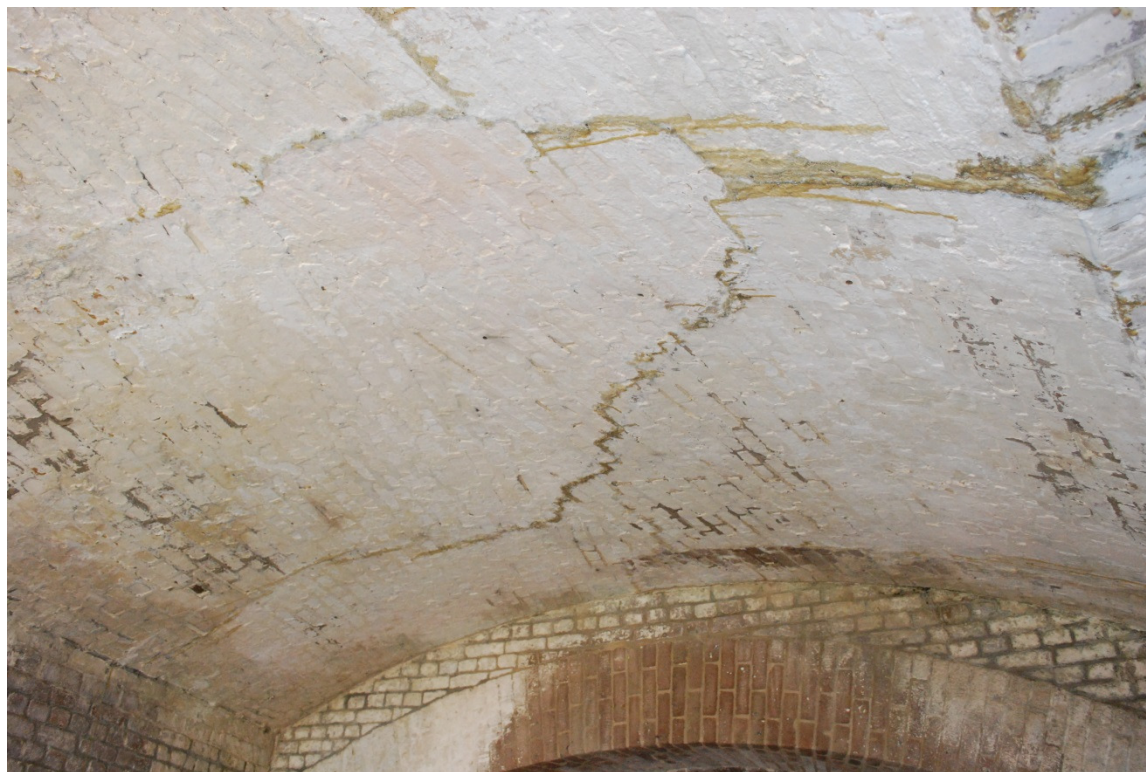
Figure 25: The crack in this vault has been repaired with epoxy, Left Flank, March 2009

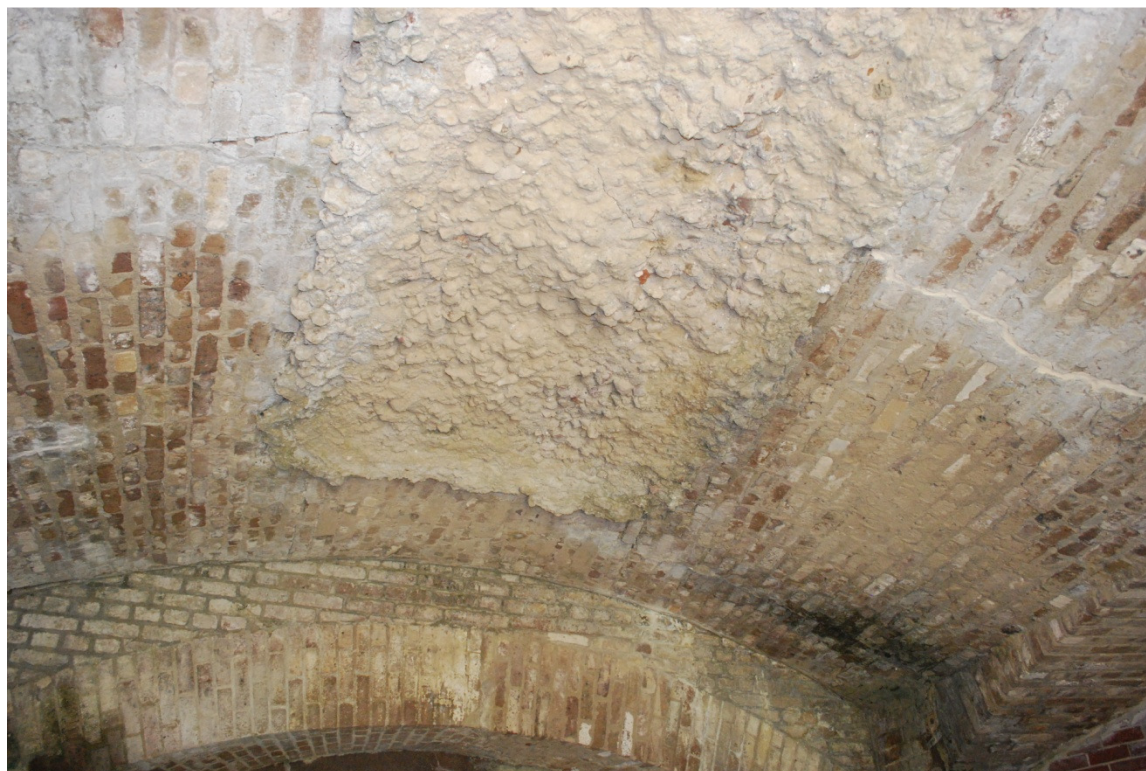
Figure 26: The crack in this vault has been covered with concrete, but that patch has also cracked, Left Shoulder, March 2009

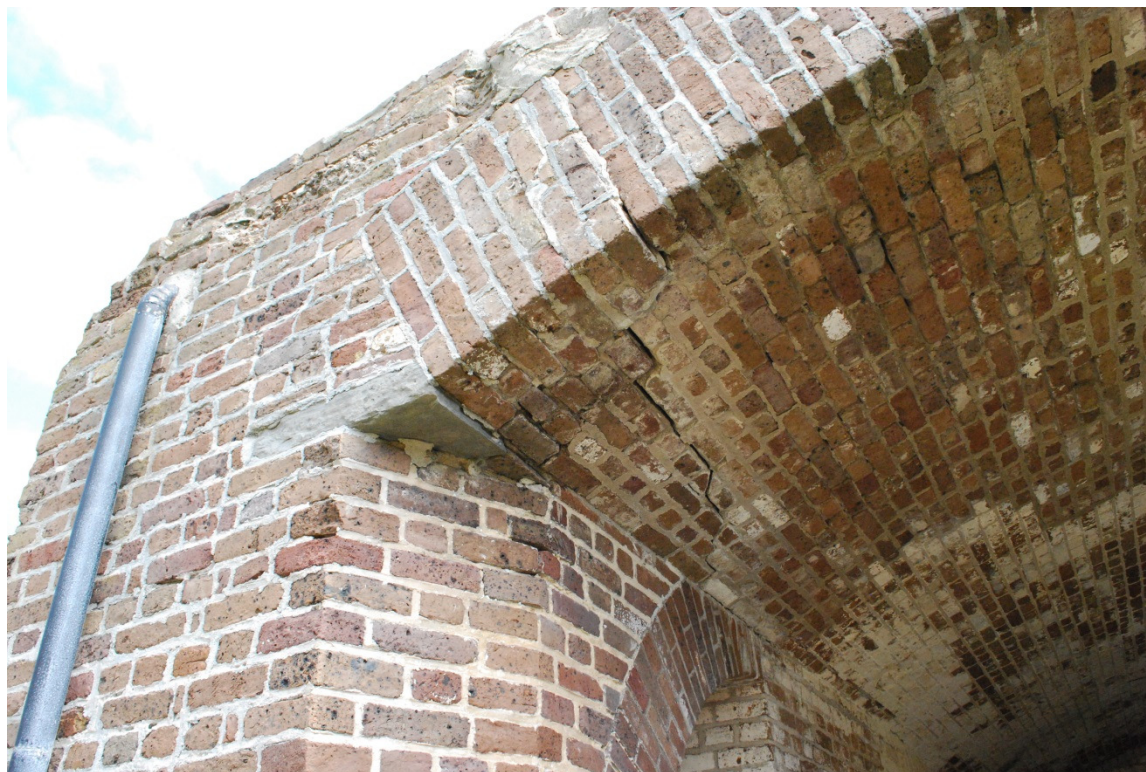
Other masonry cracks can be found throughout the fort (Figures 28 and 29). These will require evaluation individually to determine their cause and to determine whether the damage represents a common cause of structural distress.

Figure 29: Crack through corner of arch, Right Face, March 2009

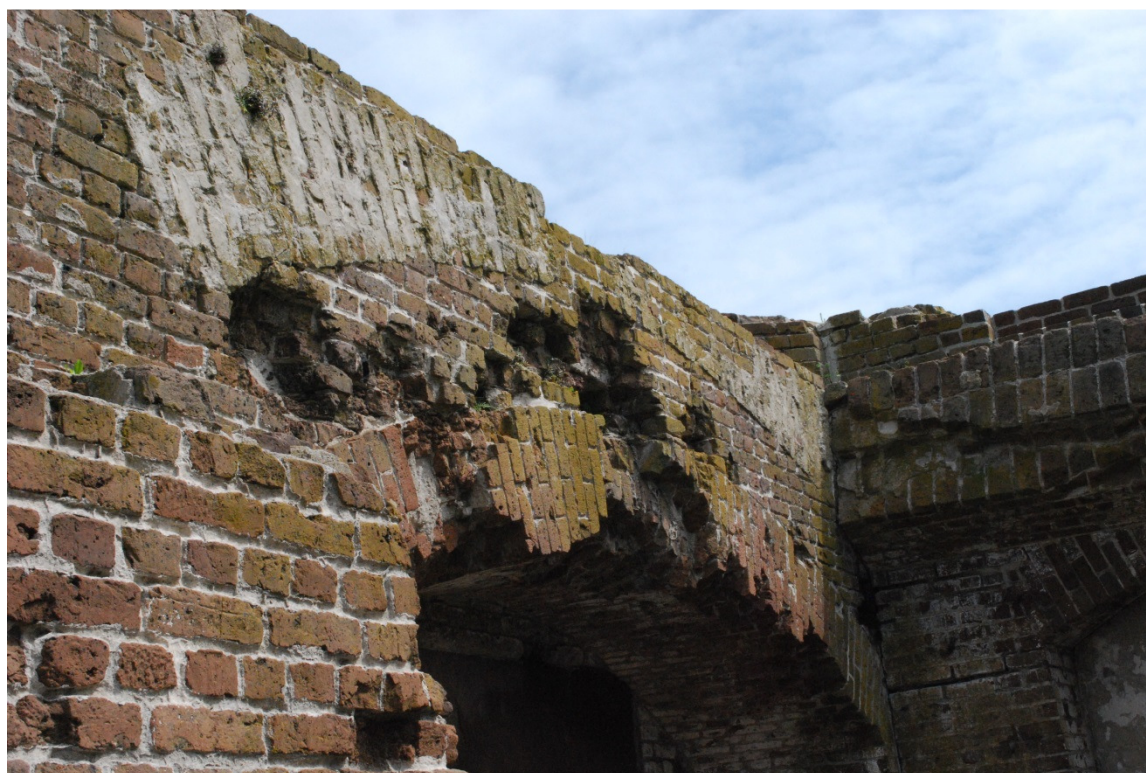
First, loose bricks along the edges of broken vaults, arches, and the cornice could fall, injuring a visitor or employee (Figures 9 and 30). Secondly, pieces of concrete broken by corrosion jacking of the embedded steel in the Endicott battery pose a similar threat. (Figures 42 through 47) Finally, cracks in the granite over the cistern near the Left Face indicate that there is the possibility of localized catastrophic failure (Figure 31). On our most recent site visits, visitors are allowed to walk over and stand on this cistern, but should not be. These three issues are addressed in particular in the "Recommendations" section of this report.

Loose bricks in several locations throughout the fort present a threat to life safety. The broken vaults along the left face are prime locations for this problem. The cornice also shows signs of distress in many locations. Though visitors are not allowed on the revetment, employees and workers hired to repair damage on the wall will be subjected to the danger from falling bricks. Finally, the cistern tops show signs of failure and potential collapse.

Figure 30: Loose bricks inside fort, Left Face, March 2009

Of utmost concern are any elements that compromise life safety at the fort. We recommend that all bricks that are held in place only by tension or shear stress in the mortar be regularly checked for a tight bond to the substrate, that all loose bricks be carefully removed and stored for use in future repair work, and that any cracks through the cornice or around single or small groups of bricks must be monitored for loosening. We also recommend that all cisterns with fractured granite tops be blocked off so that visitors cannot stand on them until they have been strengthened.

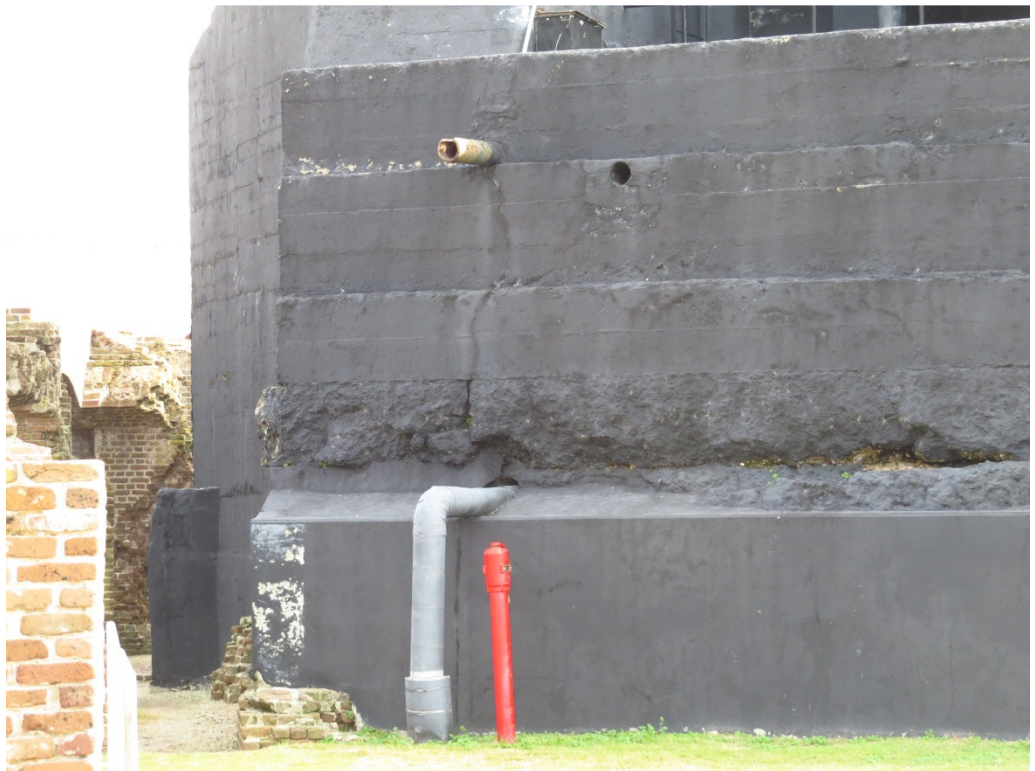
The fracture of the unreinforced concrete is most easily seen in the west wall of Battery Huger near ground level (Figures 34 through 41). Here one sees vertical fractures indicative of vertical movement of the middle portion of the walls relative to the north and south ends. Unfortunately, the 2006 Settlement Survey, comparing 1992 and 2006 settlements, was not able to confirm this behavior

Figure 36: Structural fractures in West wall of Battery Huger, December 2013

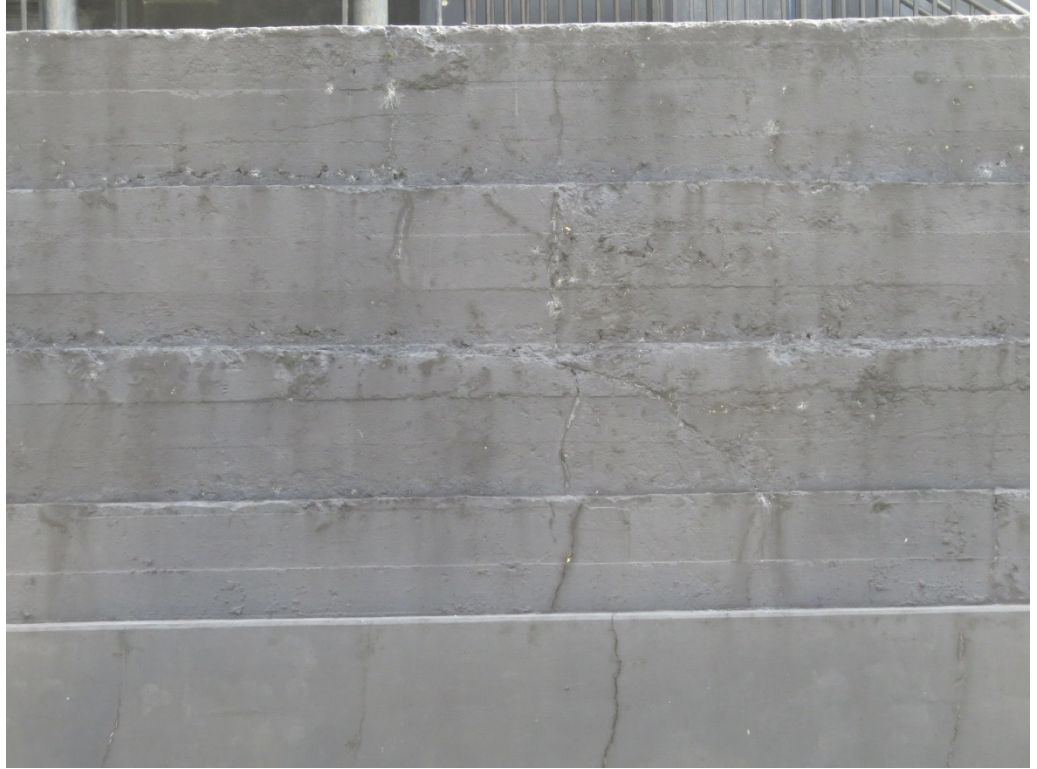
Figure 37: Structural fractures in West wall of Battery Huger, December 2013

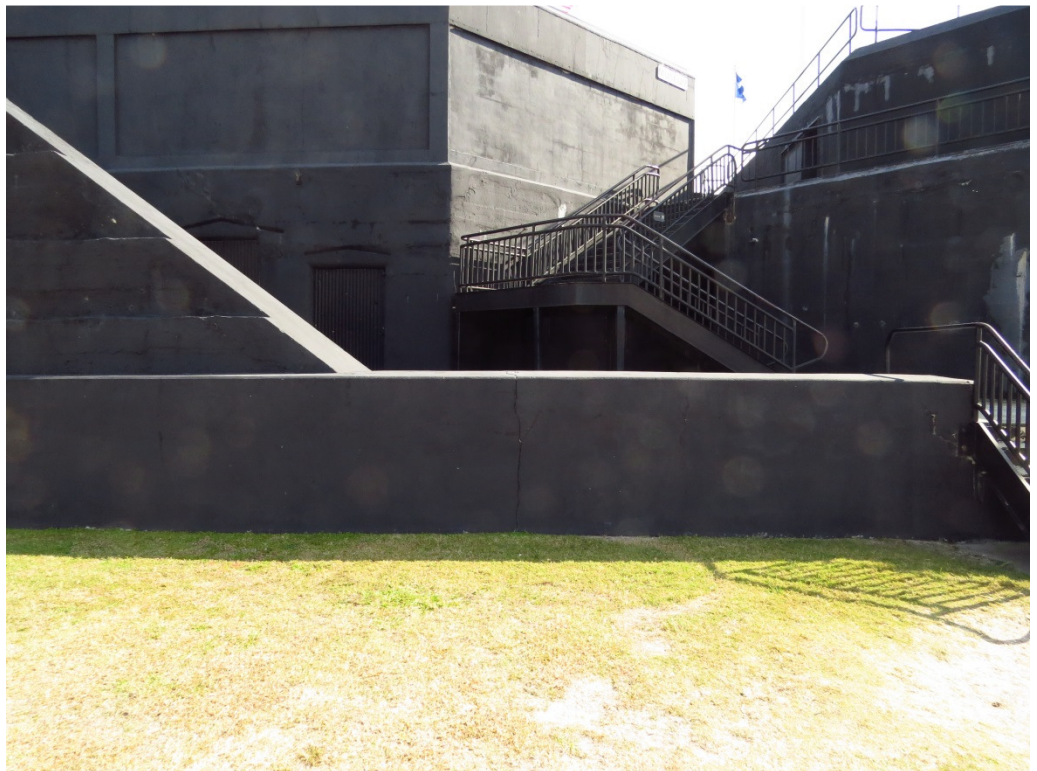
Figure 38: Structural fractures in West wall of Battery Huger, December 2013

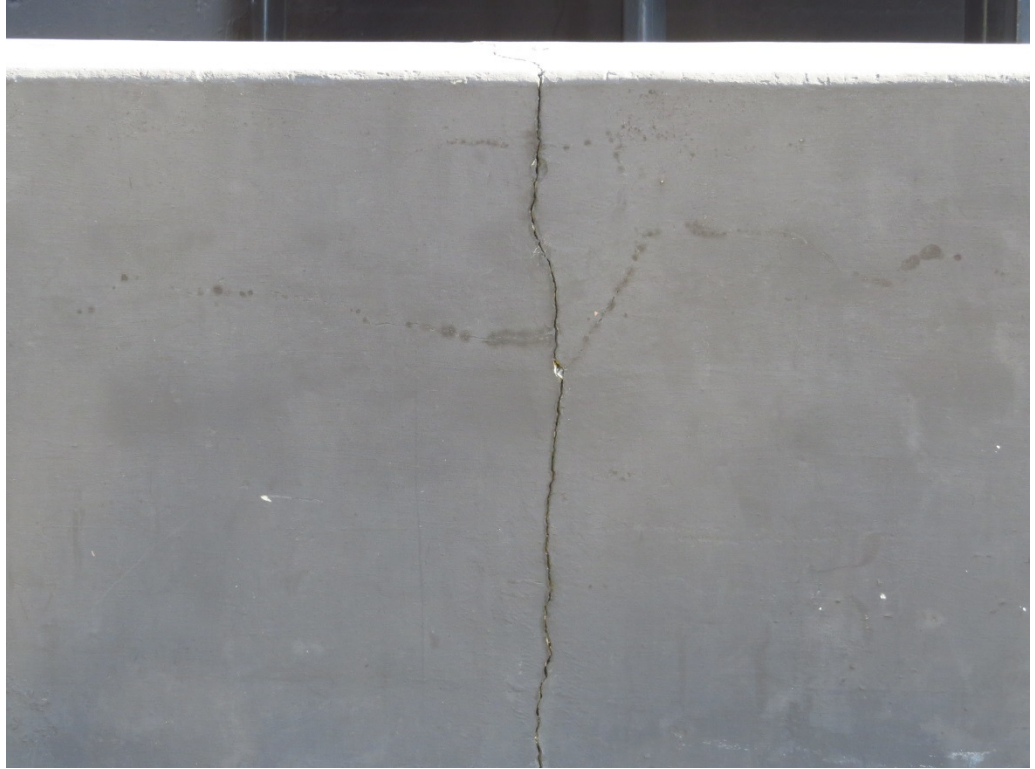
Figure 39: Structural fractures in West wall of Battery Huger, December 2013

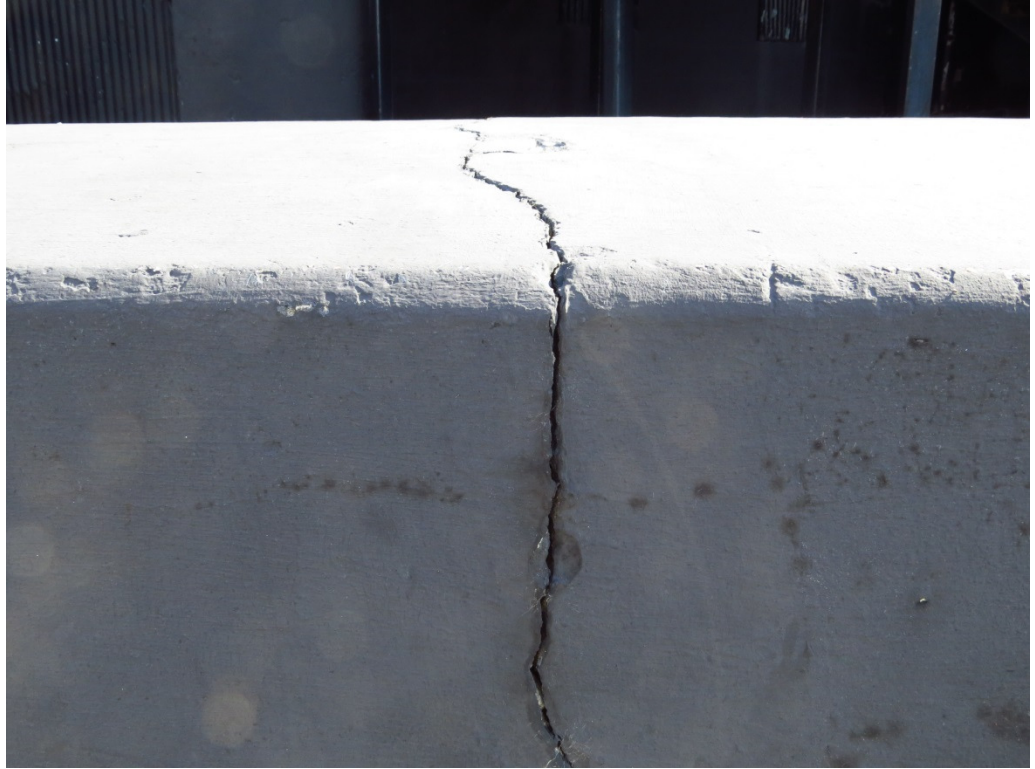
Figure 41: Structural fractures in West wall of Battery Huger, December 2013

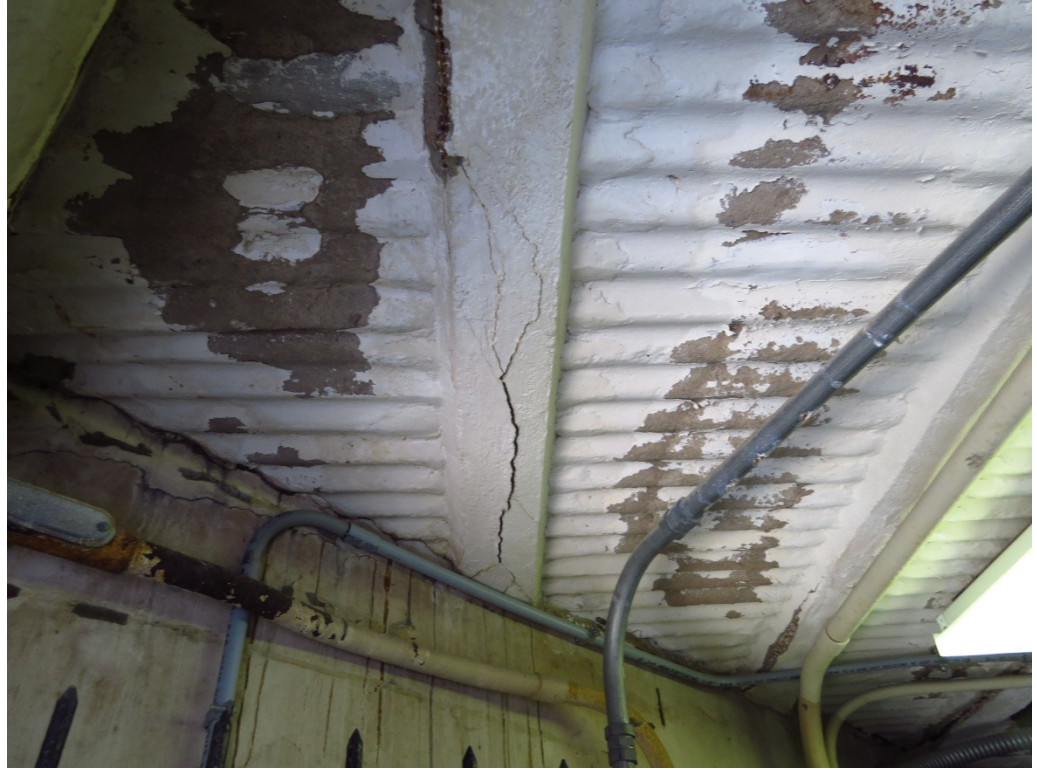
Corrosion of the supporting steel in Battery Huger is pervasive and, unfortunately, largely inaccessible. The columns generally are at least partially embedded in concrete and the girders and joists have significant portions embedded. Corrosion of the embedded portions is, in some areas, causing major damage to the concrete through corrosion jacking (Figures 42 through 47). It additionally suffers significant loss of section in the more exposed areas (Figures 50 through 52).

Figure 43: Corroding steel in joist system, December 2013

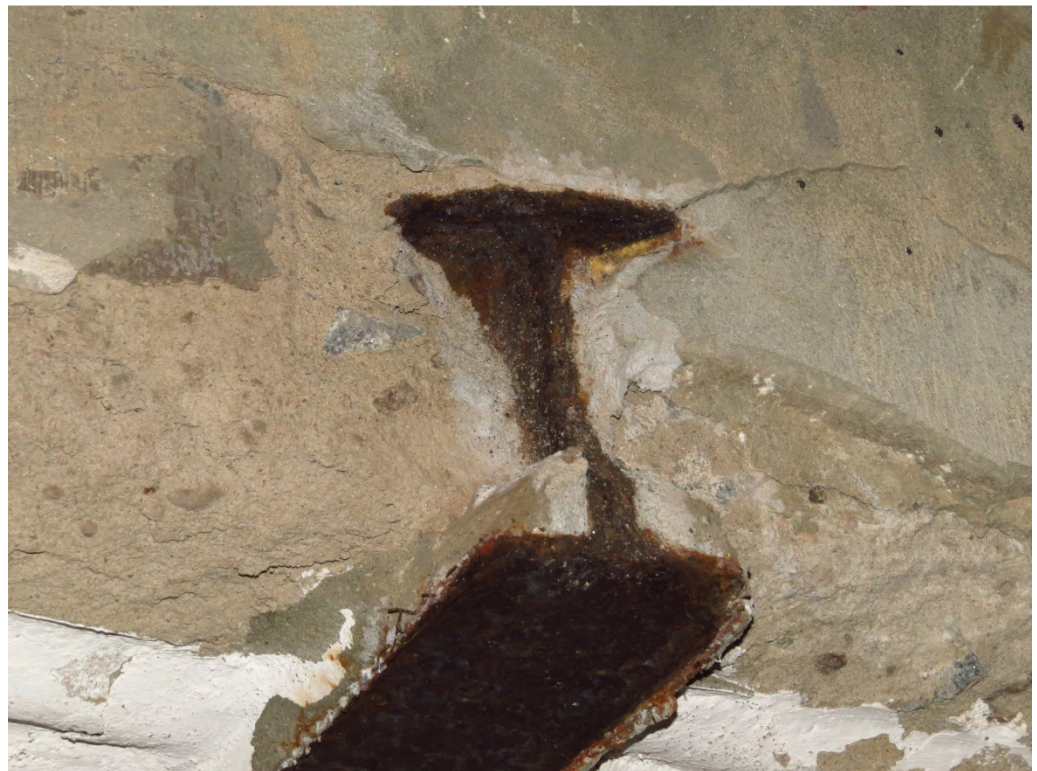
Figure 44: Corroding steel in joist system, December 2013

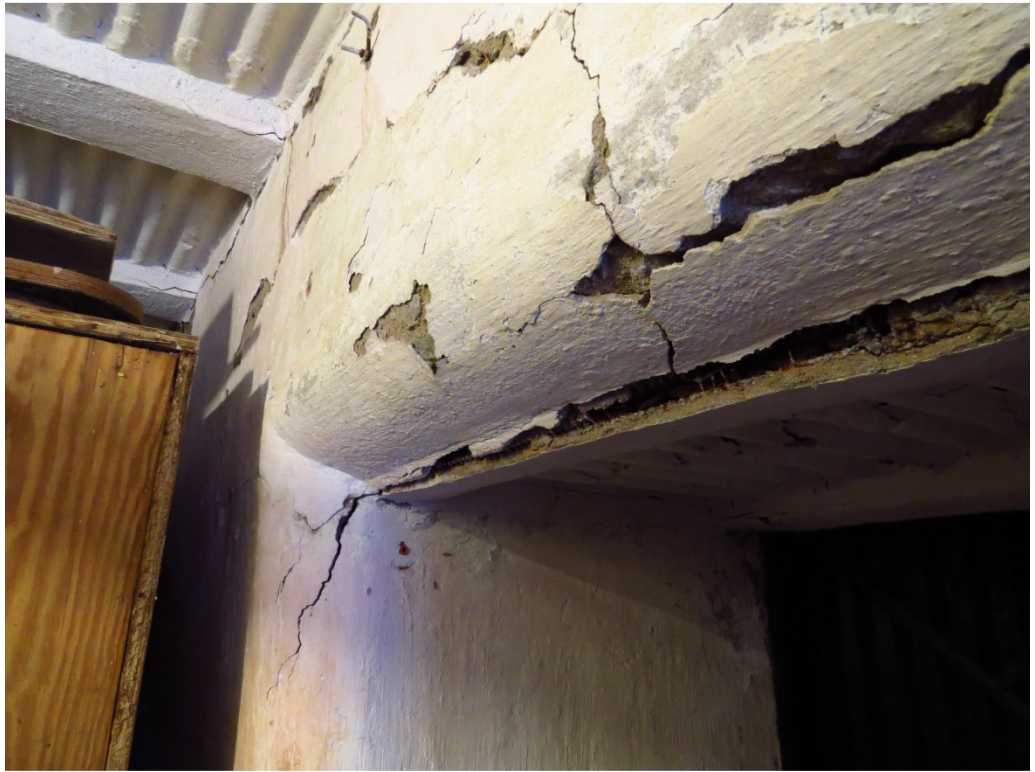
Figure 47: Corroding steel and jacking of concrete, December 2013

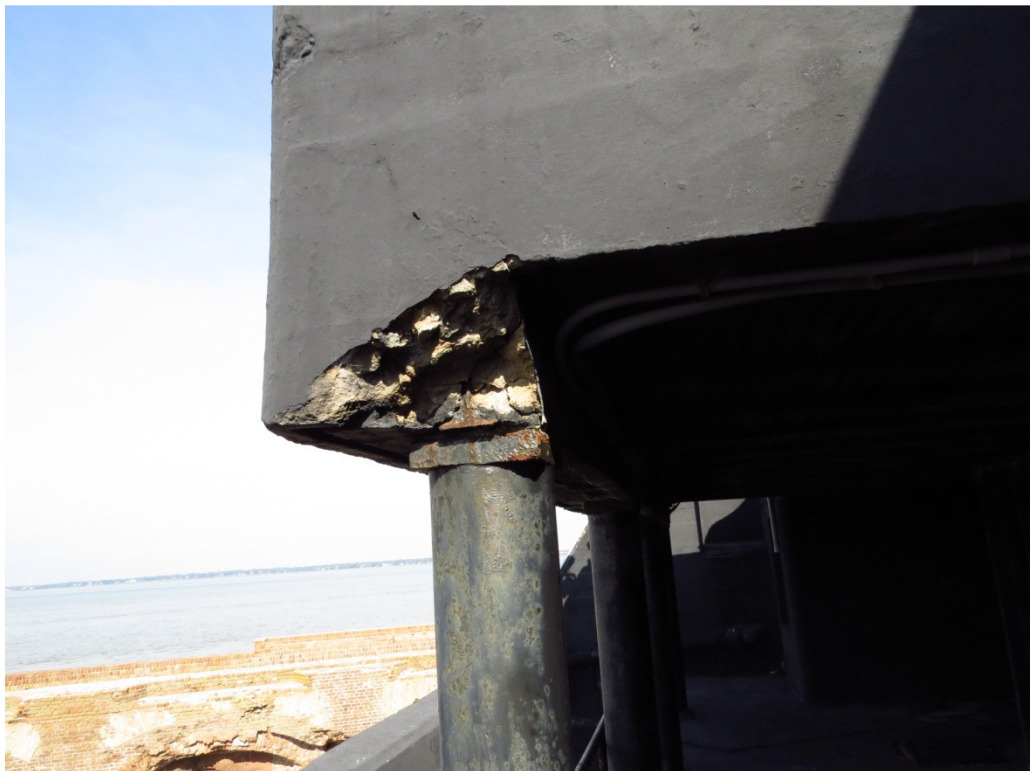
Figure 48: Corroding steel, December 2013

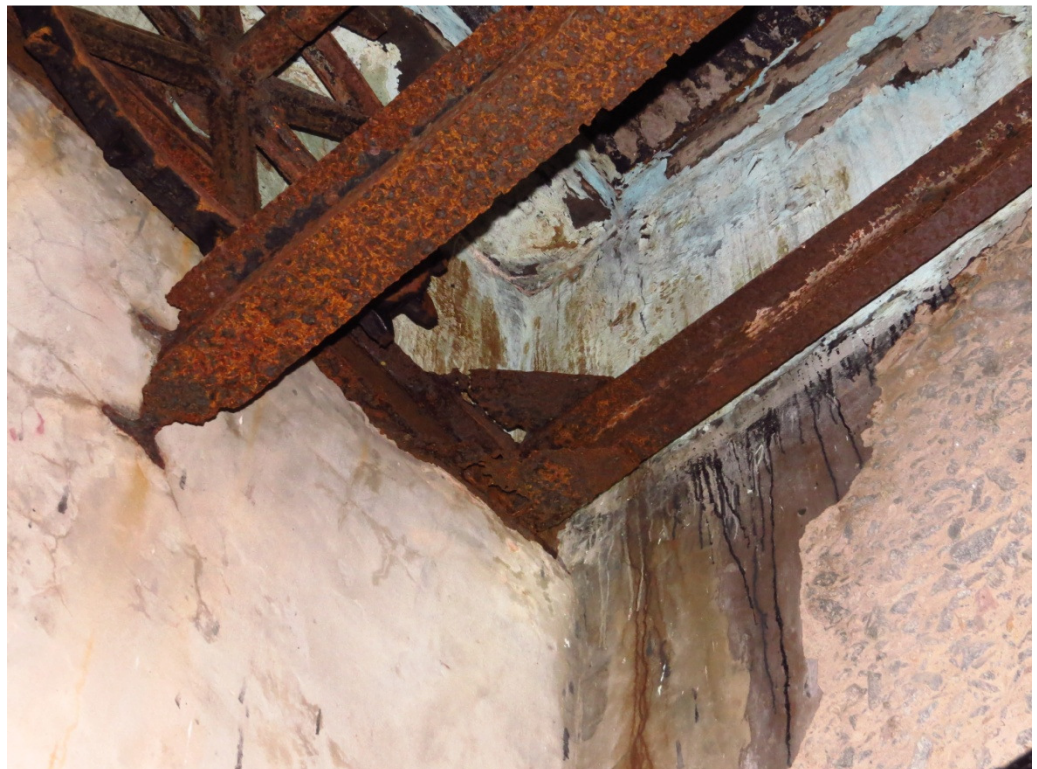
Figure 50: Corroding steel and jacking of concrete, December 2013

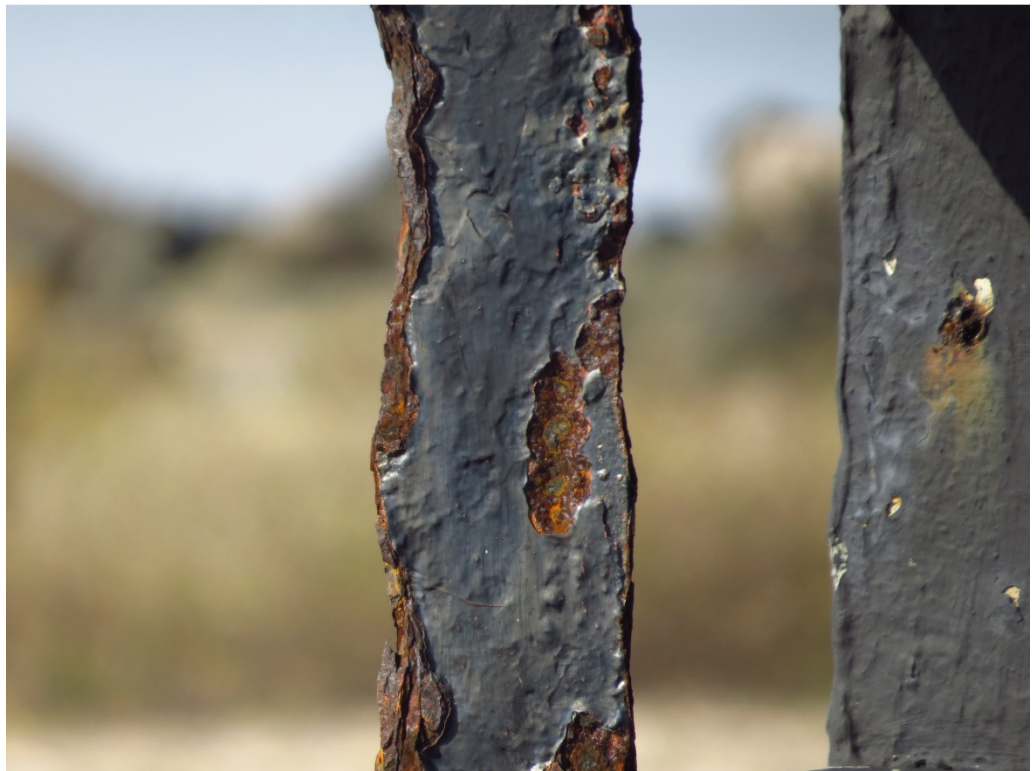
Figure 52: Corrosion of the steel at the Observation Post, December 2013
