Fort Sumter
Fort Sumter National Monument
Historic Structure Report

Volume II
APPENDICES A-F

2015

JOSEPH K. OPPERMANN – ARCHITECT, P.A.

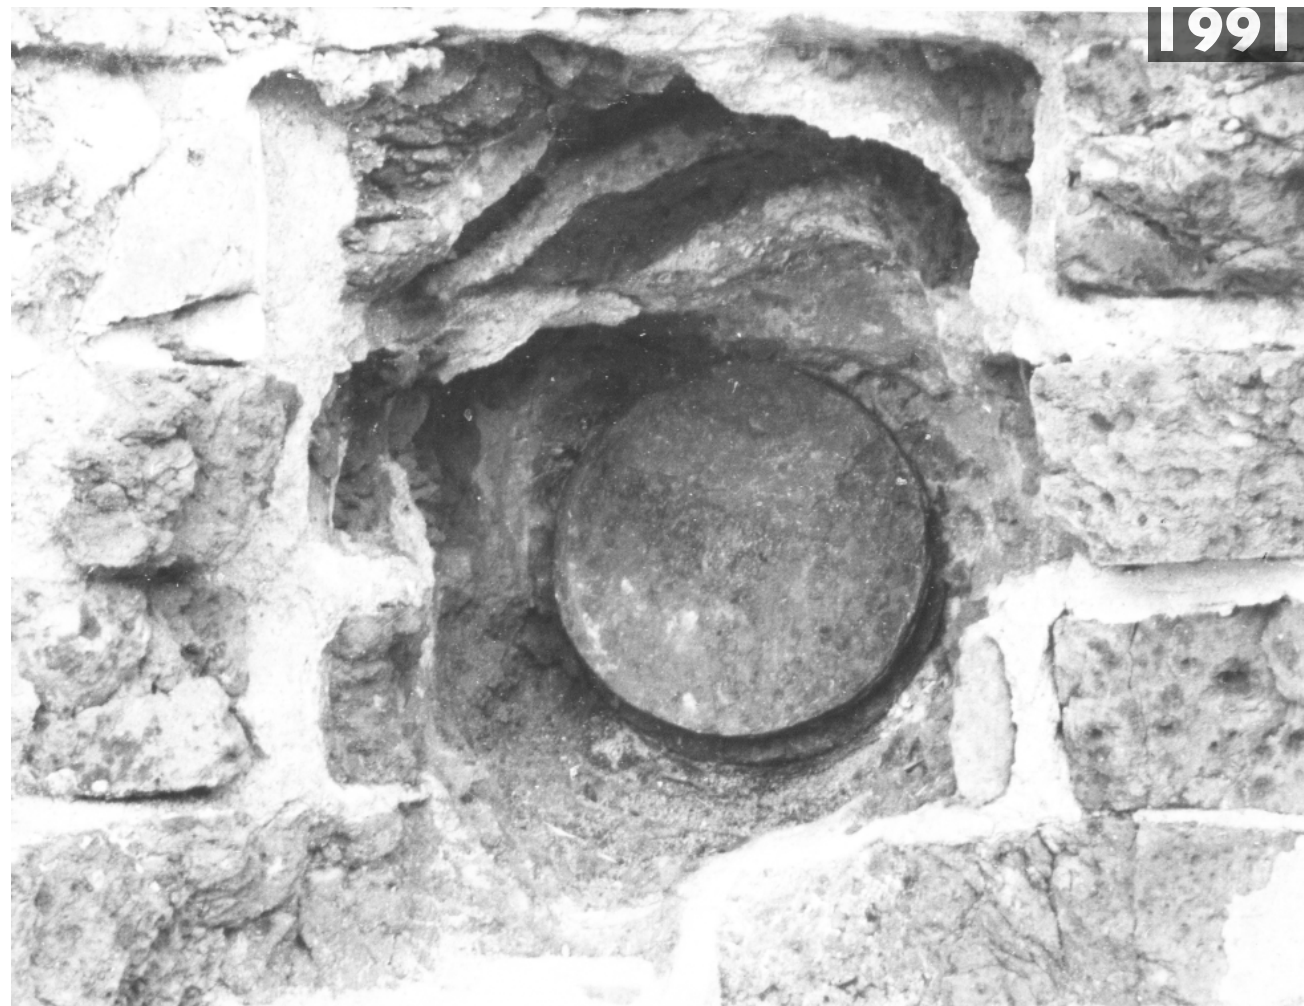
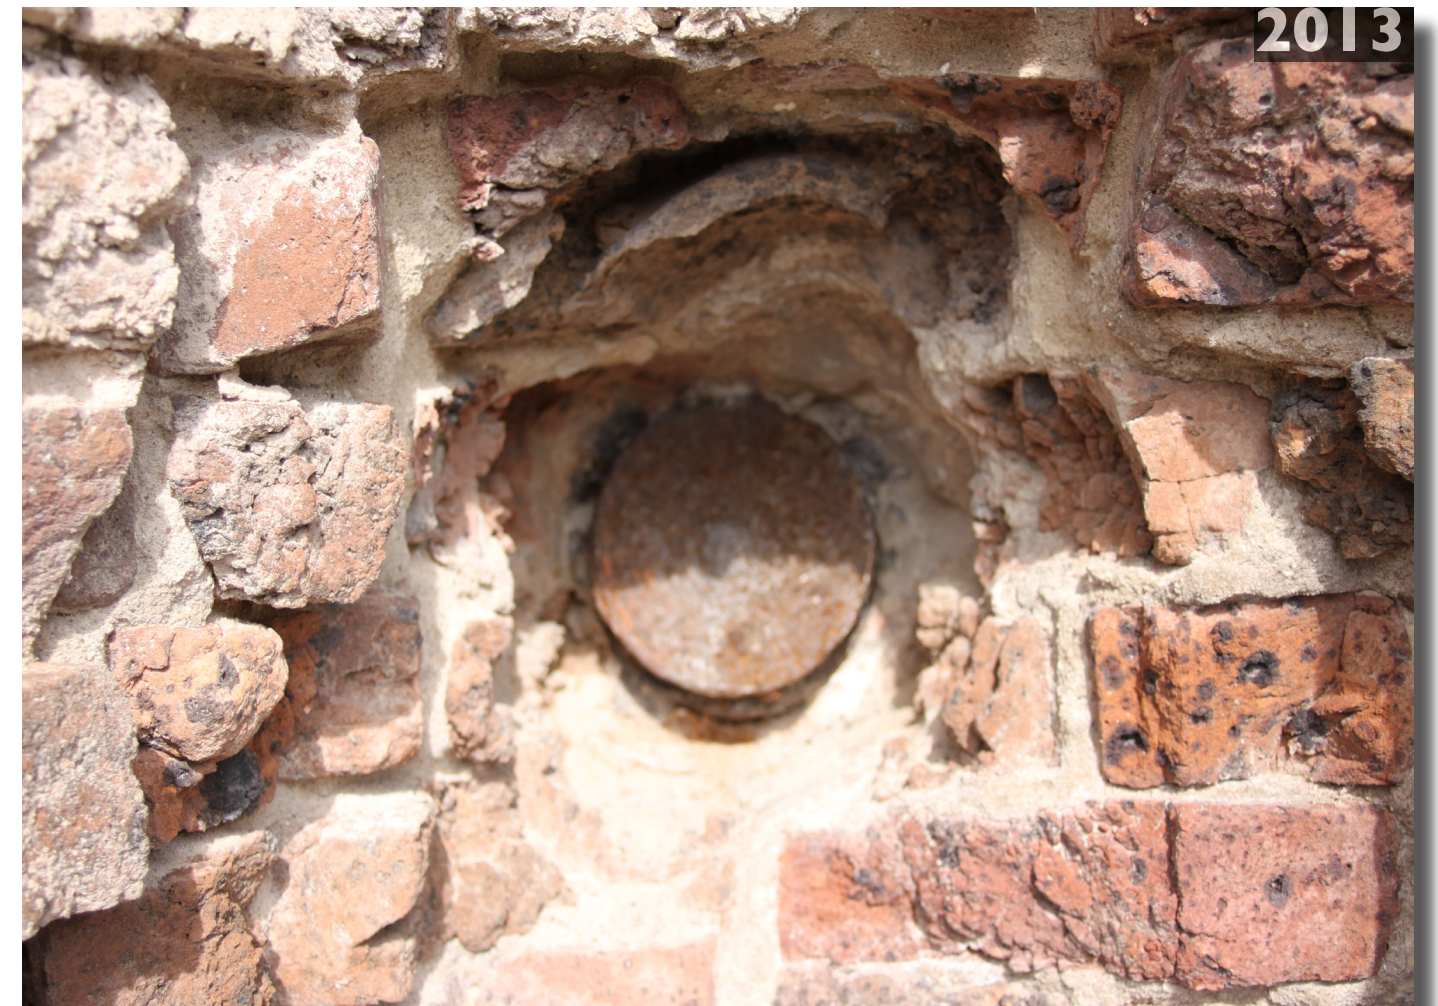
- The metal artifact appears to have further evidence of corrosion on its surface between 1991 and 2013.
