# PRESERVING the Many Glacier Hotel

By Ian Glaser, P.E., and Christine Britton, P.E.

The National Park Service initiated a comprehensive, phased rehabilitation around 2000. The first phases focused on the most immediate needs of the building's exterior. In 2004, JVA, Inc. was engaged as the structural engineer in partnership with the architect, Anderson Hallas Architects, P.C. The team worked on the rehabilitation for 13 years until its completion in 2017. Swank Enterprises was the general contractor for all the construction phases, which totaled approximately \$42 million.

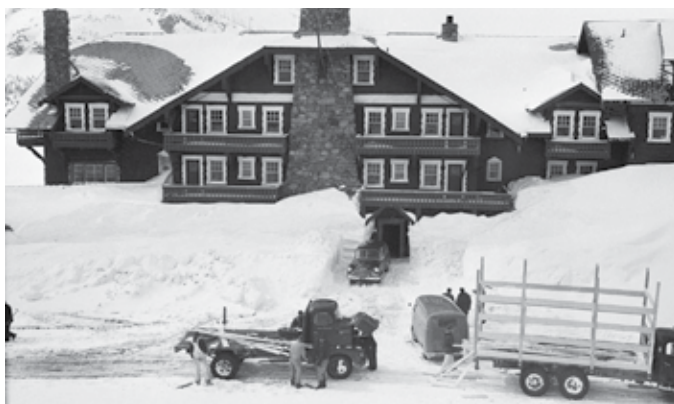
The Many Glacier Hotel in April 1956. Snow has reached the second floor of the lobby. Chimney at left was removed at an unknown date before the recent rehabilitation work. Courtesy of Glacier National Park Archives.

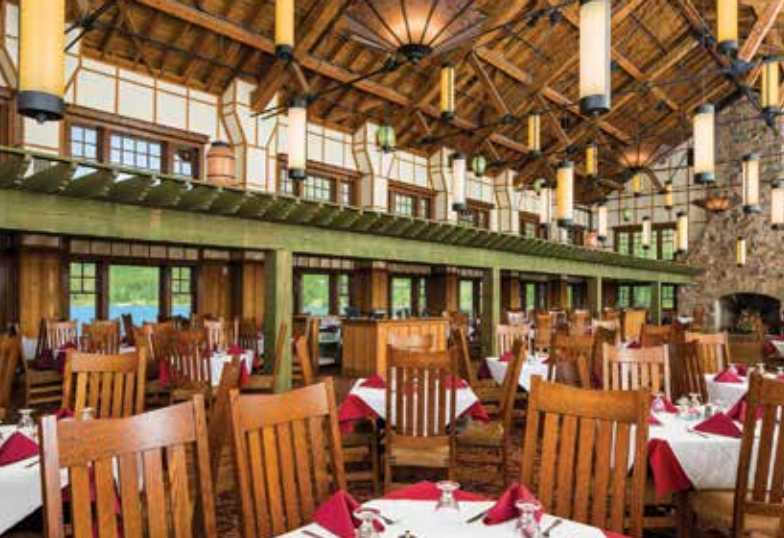
The roof framing over the dining room had been concealed by a dropped ceiling installed in the 1930s. After selective strengthening of the purlins using lumber that matched the original lumber in appearance, the dropped ceiling was removed. The timber and steel-rod trusses were re-exposed, paying homage to the railroad engineers that designed and built them.

Interior of the dining room featuring the chimney and the original roof trusses. Courtesy of Mark Bryant Photographics.

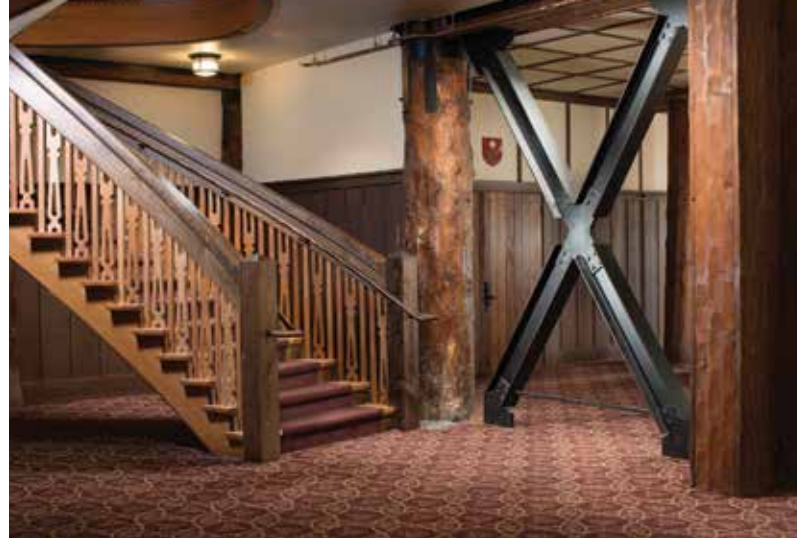
Braced frame in the basement level of the lobby. Courtesy of Mark Bryant Photographics.

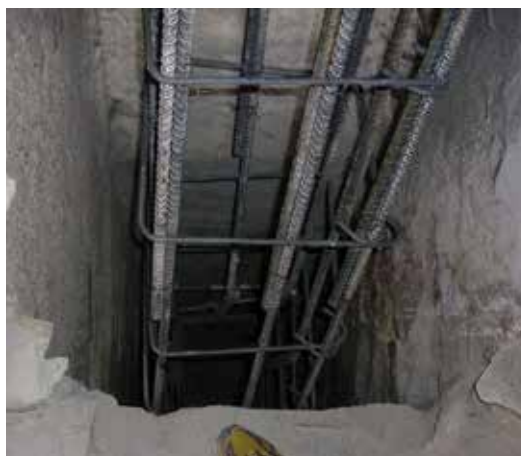
Reinforcing cage inserted into the full-height flue of the dining room chimney. Courtesy of Dan Cooke, JVA, Inc.

The dining room chimney has two flues. The flue that originally served the boiler in the basement was cleaned, reinforced, and grouted. The chimney's shoulder on the opposing side was removed, a reinforced concrete chord installed, and the shoulder was refaced with the original stones in their original positions. The dining room flue, which follows the reinforced shoulder, remains operational.
