# Up FROM THE Ashes

## Rebuilding the Sperry Chalet: Part I

By Ian Glaser, P.E., Jeffrey Schalk, P.E., S.E., and Laine McLaughlin, AIA, LEED AP

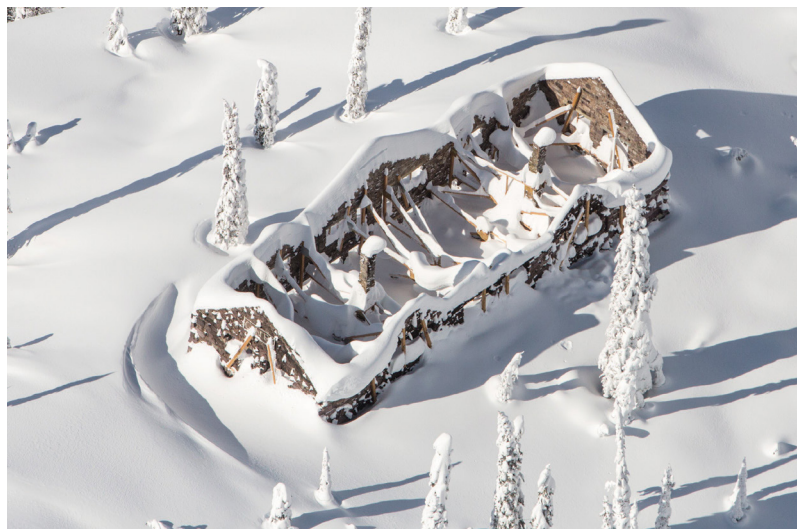
In October, National Park Service (NPS) crews raced to temporarily stabilize the free-standing walls with interior timber bracing before the snows began. The character-defining exterior masonry walls were at risk of collapse from snowdrifts and wind gusts over the upcoming winter season (*Figure 1*). This emergency stabilization effort was spearheaded by the NPS and the Glacier National Park Conservancy, the park's non-profit funding partner.

*Figure 1. The chalet survives the first winter after the fire, thanks to emergency bracing. Courtesy of GravityShots.com.*

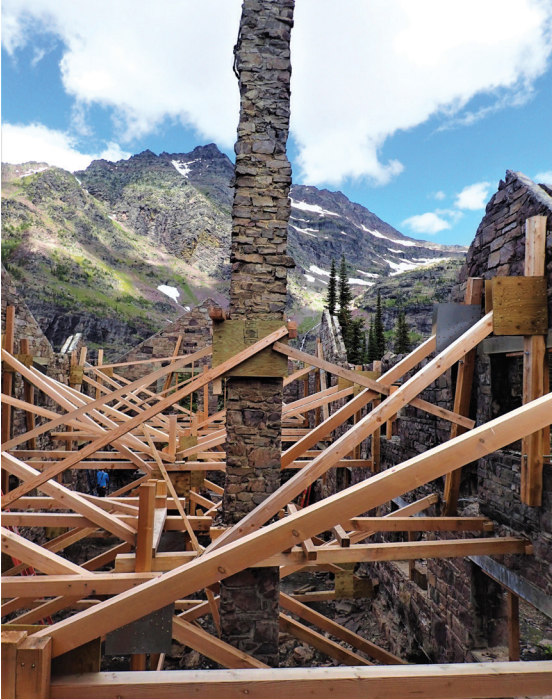
Figure 2. Designers assess the structure in July 2018 amongst the forest of braces.

Two days after the general contractor arrived on site, the design team trekked the 6.7-mile trail to reach the structure perched on the cliffside 3,300 feet above the trailhead at Lake MacDonald. Provisions and hand tools were carried by mule-train, and testing equipment was delivered by helicopter. The purpose of the visit was to validate the construction drawings and begin assessing the fire-damaged stone masonry (Figure 2). While the contractor mobilized and the design team investigated, they collaborated.

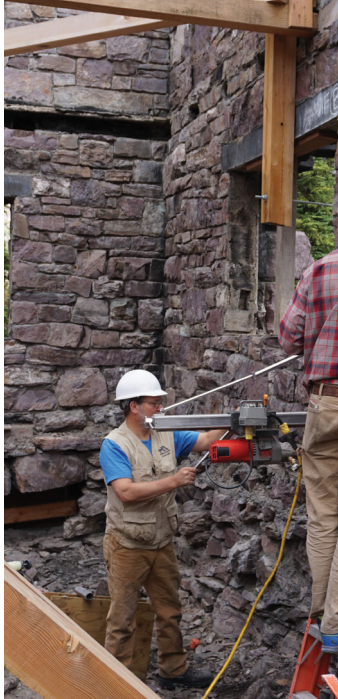
Figure 3. Engineers core-drill the masonry wall.

Bedrock in the crawlspace was cored for laboratory analysis that ultimately confirmed that the geotechnical criteria assumed for the design were appropriate. Surface penetrating radar was implemented to profile the historic masonry walls' layout, and scans were substantiated in strategic locations with video-scoped cores (Figure 3). Several anchors were installed into the masonry walls on the first reconnaissance day. They were load-tested at the end of the trip to verify anchor shear and tension capacities used for the seismic calculations.

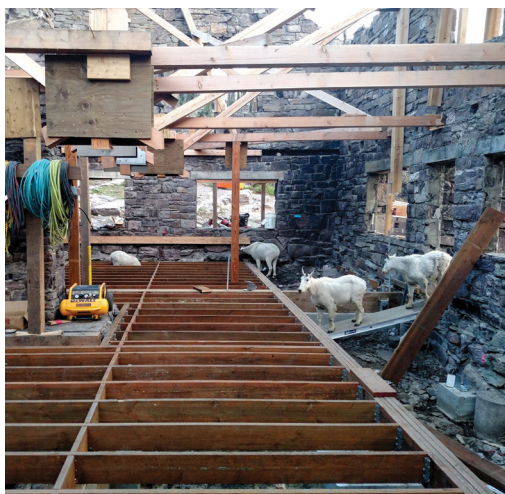
Figure 4. The first floor is framed as interior bracing is progressively removed.

The other early pivotal design decision was to phase construction by framing the building in the first summer and repairing the masonry walls in the next summer. The drawings specified a new exterior raker bracing scheme that supplemented the interior timber bracing. The design stipulated progressive removal of the interior bracing as the floor levels were installed from the bottom up. Temporary stud sister walls, located just inboard of the exterior masonry walls, were designed to support the new structure's weight

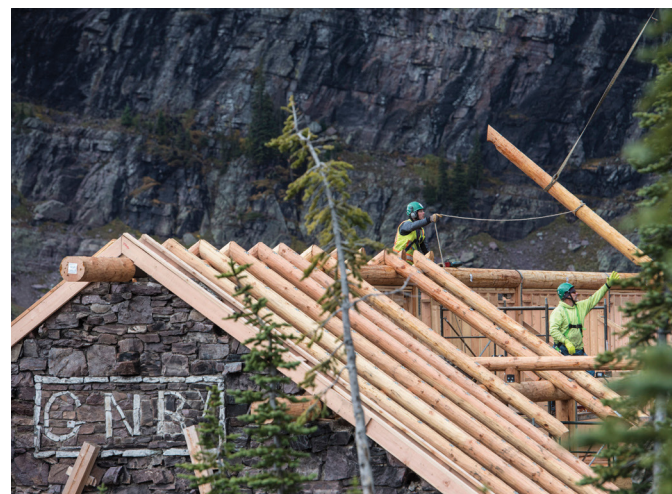
With two alternating crews working seven days a week, the Chalet was enclosed (Figure 5) and the damaged

Figure 5. Timber framers set the log rafters via helicopter assist. Courtesy of A Boring Photo.
