# **Lagoon Island Cabin**

## **Glacier Bay National Park & Preserve**

### **Historic Structure Report | 2025**

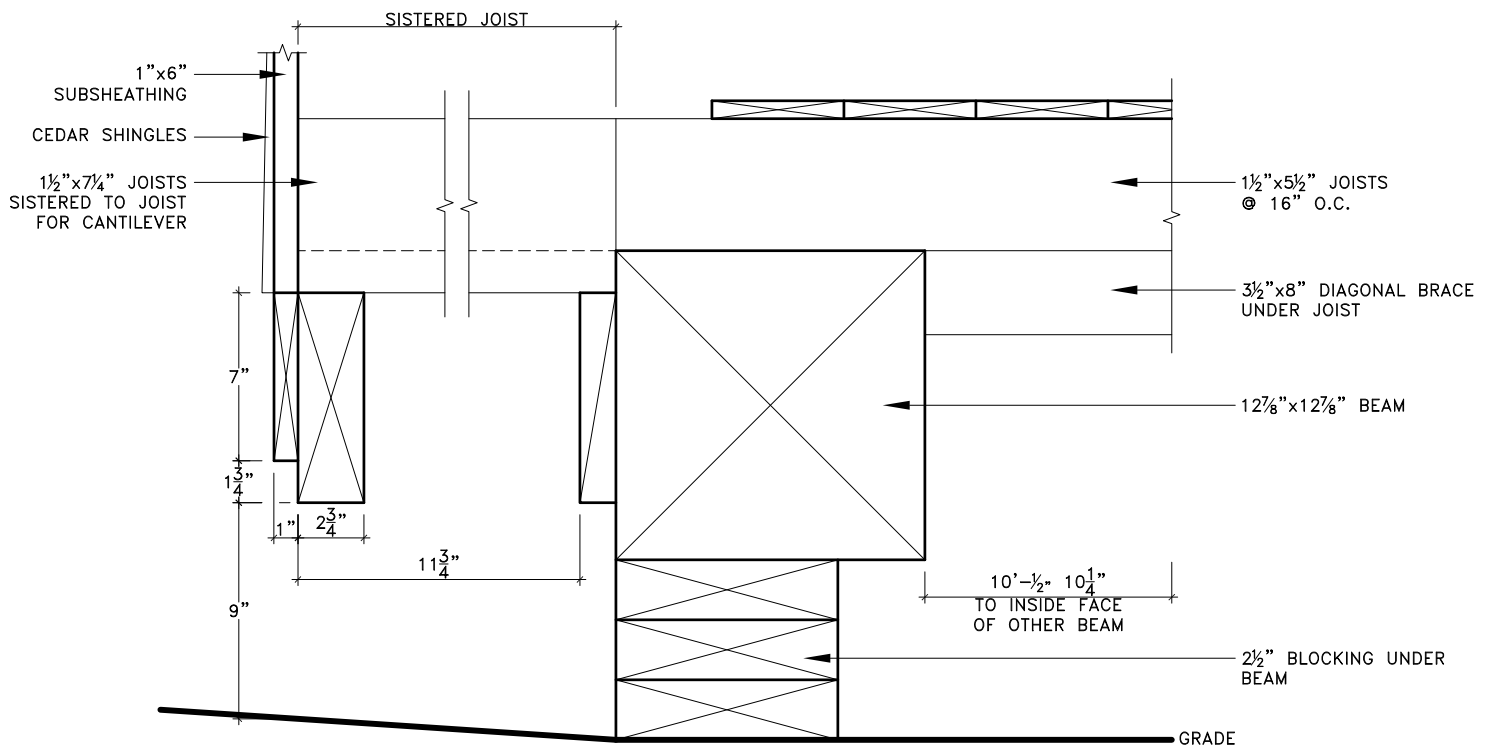
**Figure 5.3:** Detail of the northeast corner of the Lagoon Island Cabin's existing foundation which is comprised of untreated post and pad configuration. The 1 1/2" x 5 1/2" floor joists are oriented east-west, perpendicular to the roof ridge, and cantilever 2'-0" beyond the primary 12 7/8" square foundation beams. The reason is unknown but may be attributed to the relocation effort. Grant Crosby NPS AKRO 2018.

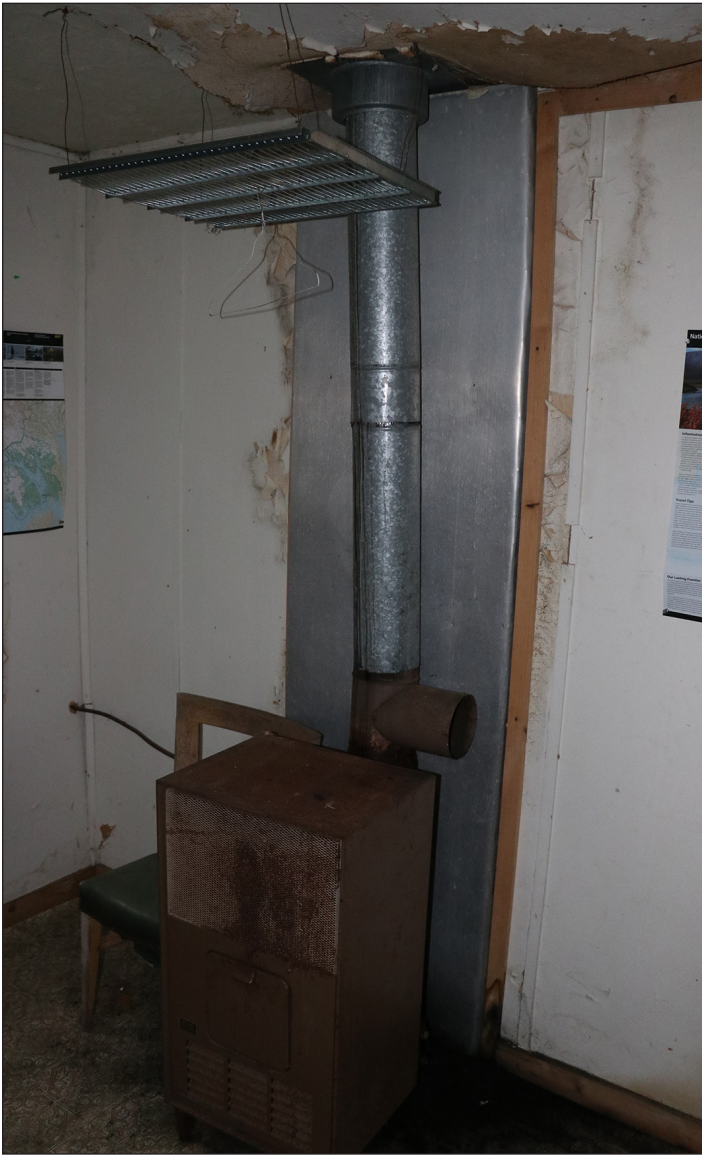
**Figure 5.32:** The primary heat source for the Lagoon Island Cabin was an oil-fired heater located in Room 2 which no longer functions. Oil leaks have damaged and stained the floor and water leaks from the vertical exhaust pipe has damaged the ceiling and walls.

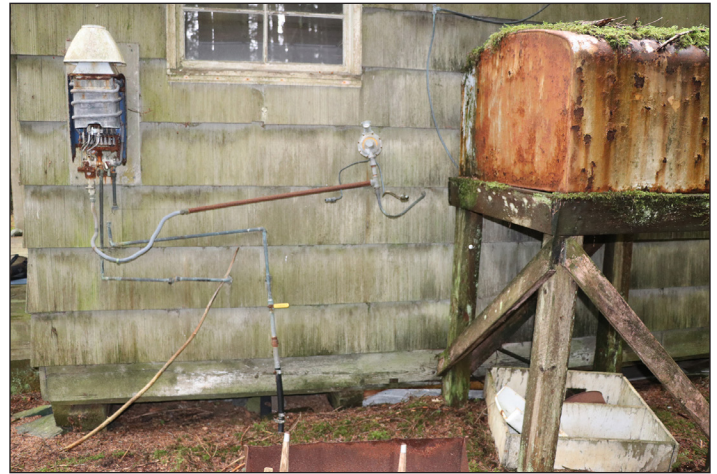
**Figure 5.33:** The south elevation of the cabin includes the mechanical systems including an oil fired hot water heater, 100-gallon fuel tank supported by an untreated timber frame and regulators with copper tubing for appliances at the interior. All the equipment has exceeded its useful life and will require replacement.

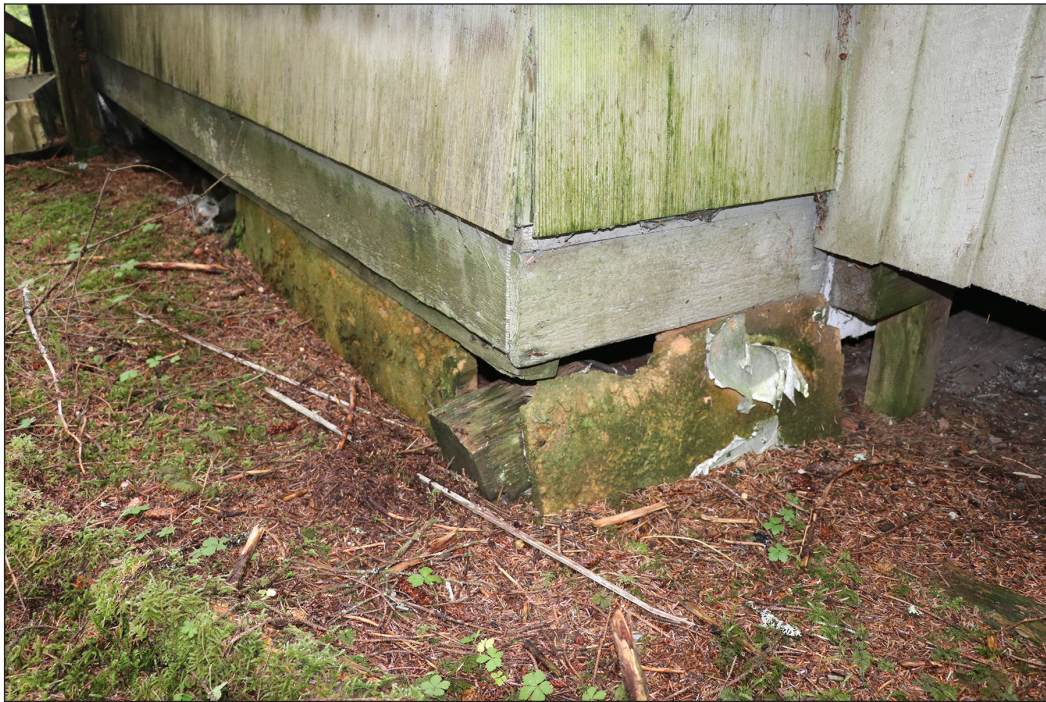
**Figure 8.1:** Detail of the northeast corner of the Lagoon Island Cabin's foundation which is comprised of untreated post and pad configuration. The 1 ½" x 5 ½" floor joists are oriented east-west, perpendicular to the roof ridge, and cantilever 2'-0" beyond the primary 12 7/8" square foundation beams. The reason is unknown but may be attributed to the relocation effort.

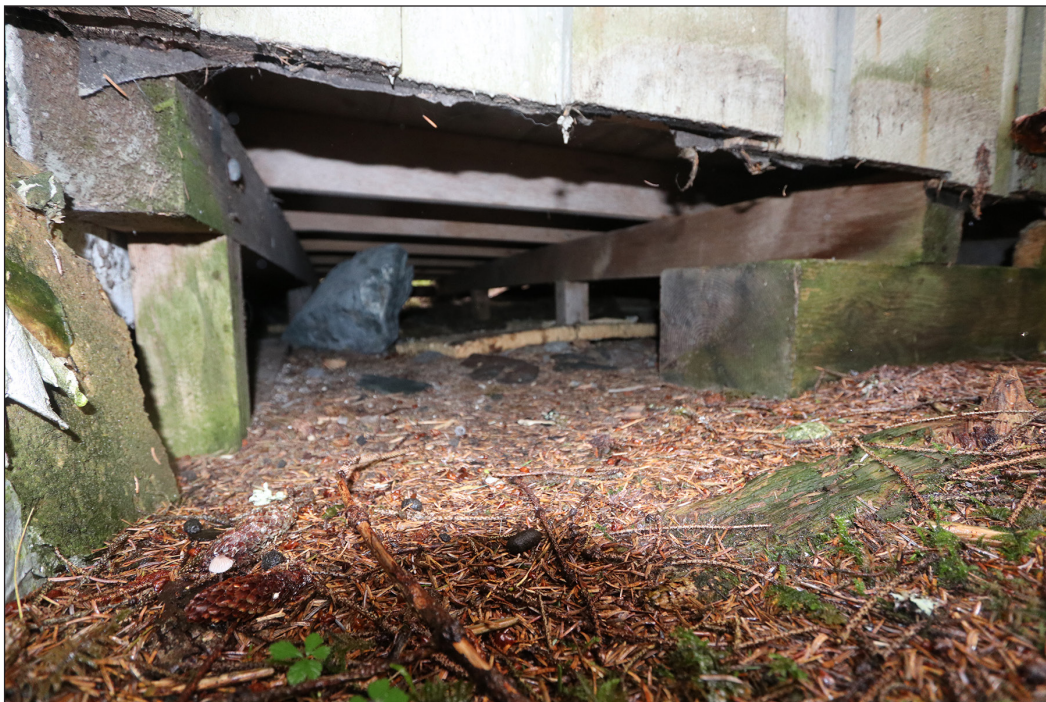
**Figure 8.2:** Detail photo of the shed addition foundation from the south elevation.

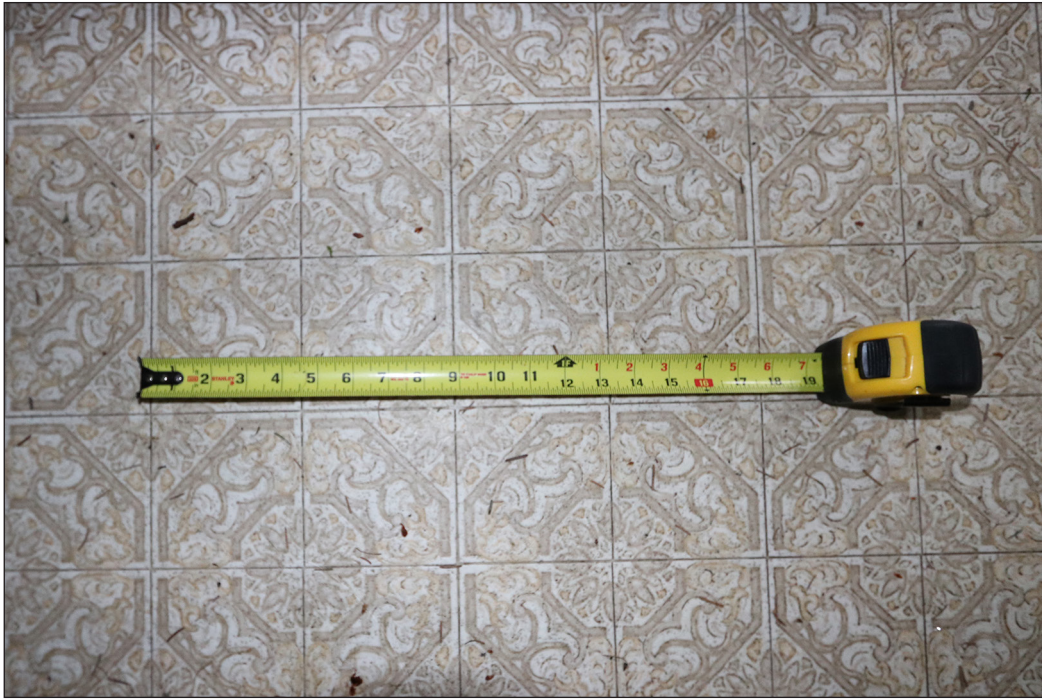
**Figure 8.3:** The flooring in Rooms One and Two is comprised of a sheet linoleum which is in fair condition.

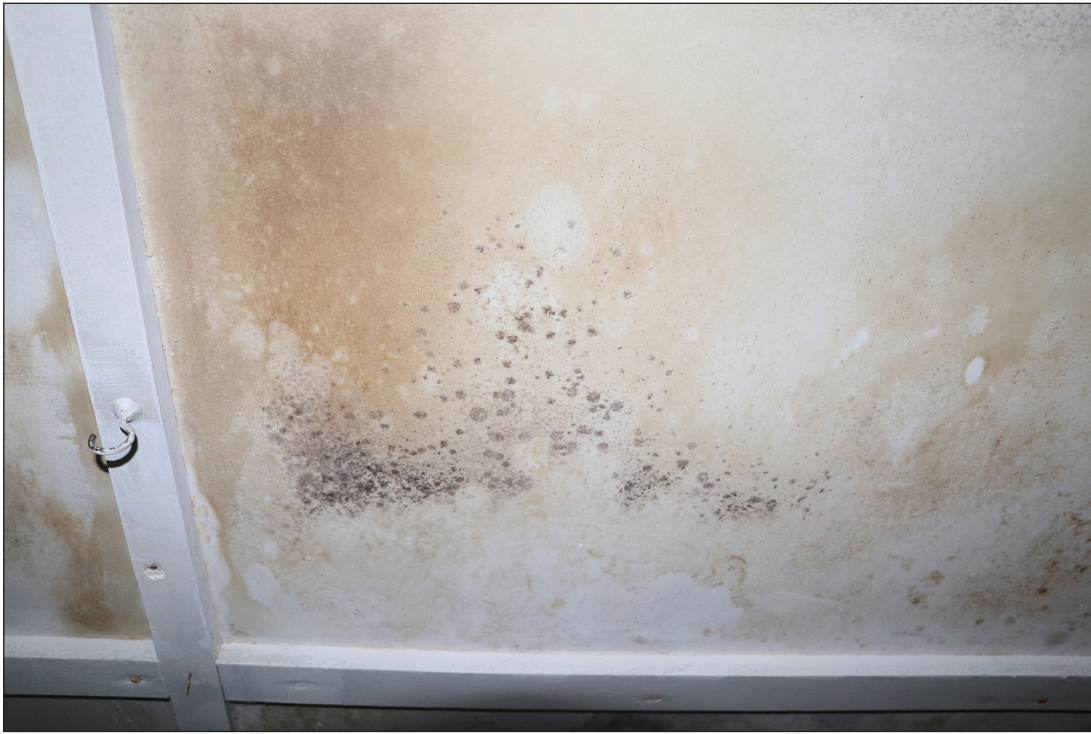
**Figure 8.4:** The ceiling and a few locations on the walls are stained and have mold growth.

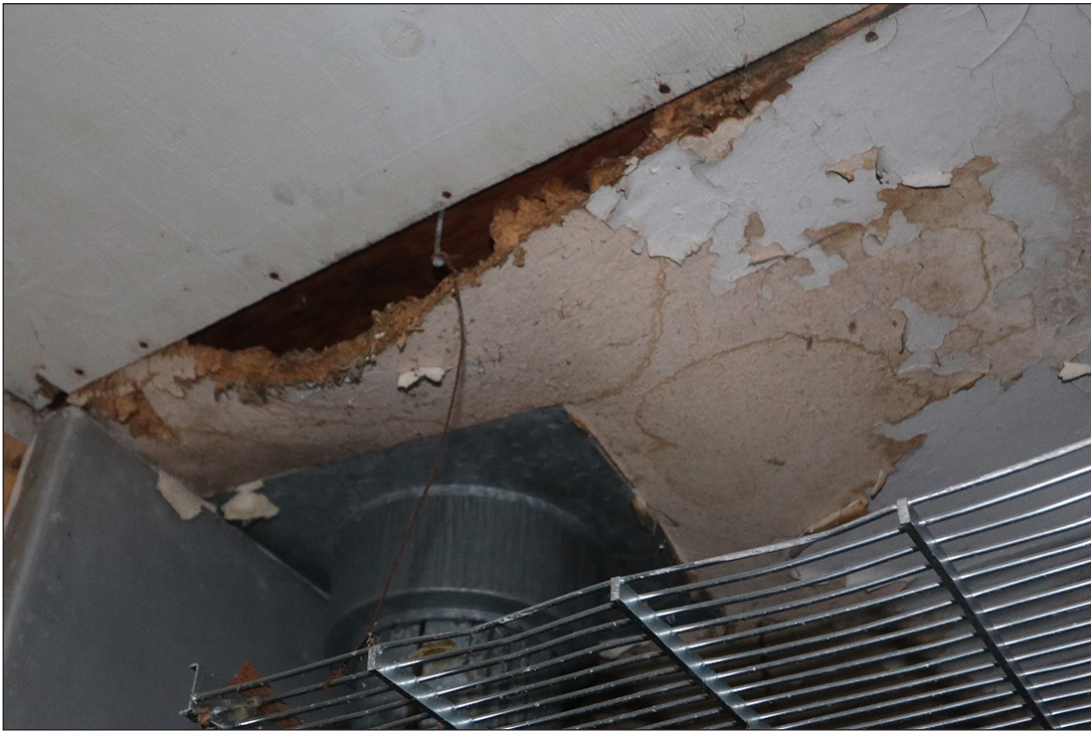
**Figure 8.5:** The ceiling around the gas stove has deteriorated beyond repair. The attic appeared dry during the 2018 inspection.

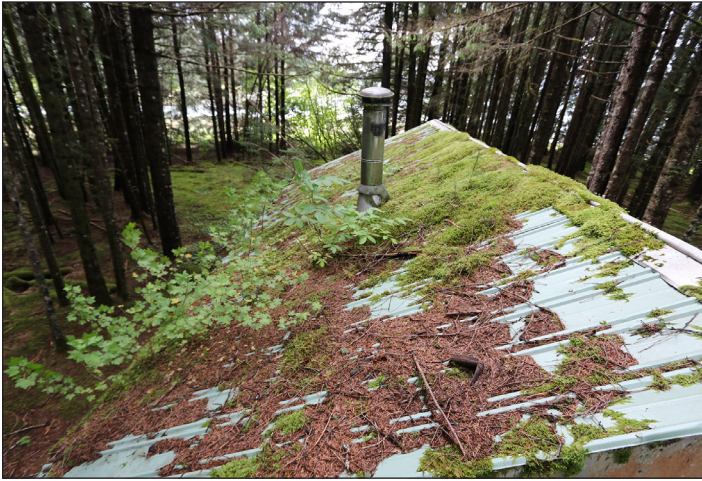
**Figure 8.6:** The roof was covered with duff, moss and vegetation during the 2018 site visit. Park staff cleared the debris shortly after the site visit. The aluminum roof is programmed for replacement in 2025.

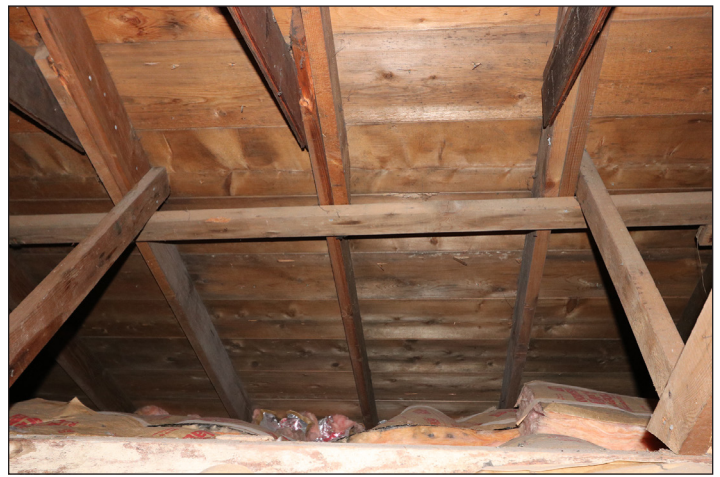
**Figure 8.7:** View of the roof framing from the attic access hatch in Room One. The ceiling is insulated with fiberglass batt. The attic is dry with no rot concerns.

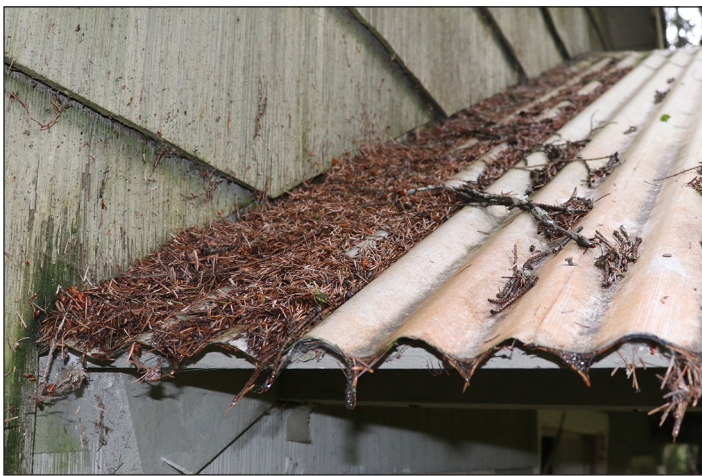
**Figure 8.8:** The forested environment deposits considerable duff throughout the year as seen here at the junction of the porch roof west gable wall of the cabin.

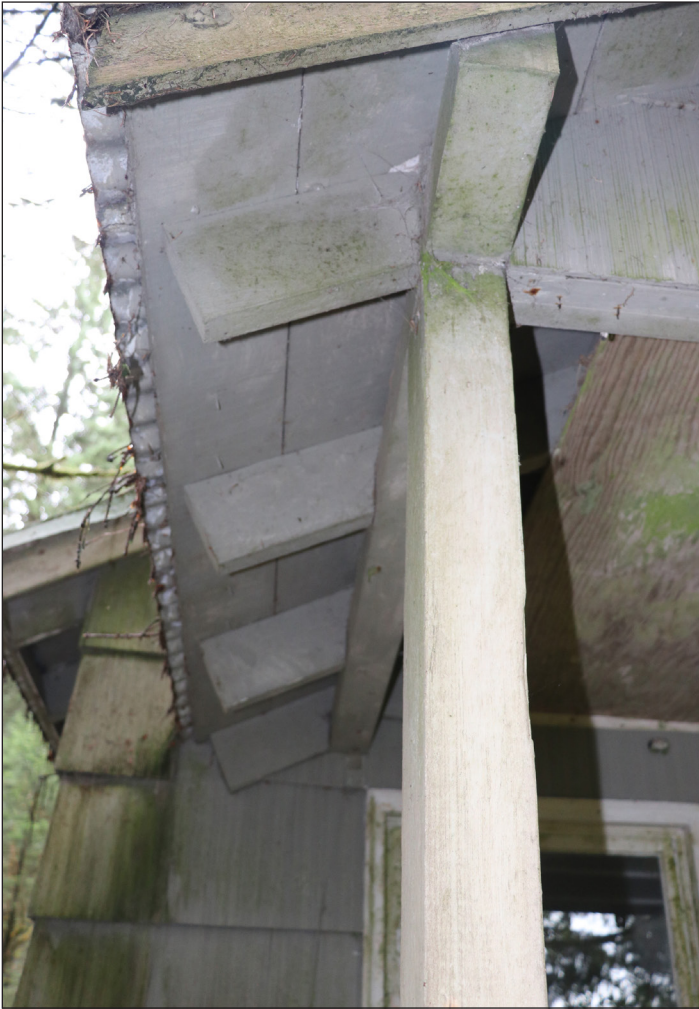
**Figure 8.10:** View of the porch roof north eave assembly which remains in sound condition despite some moss growth which can be mitigated with simple cleaning and repainting.

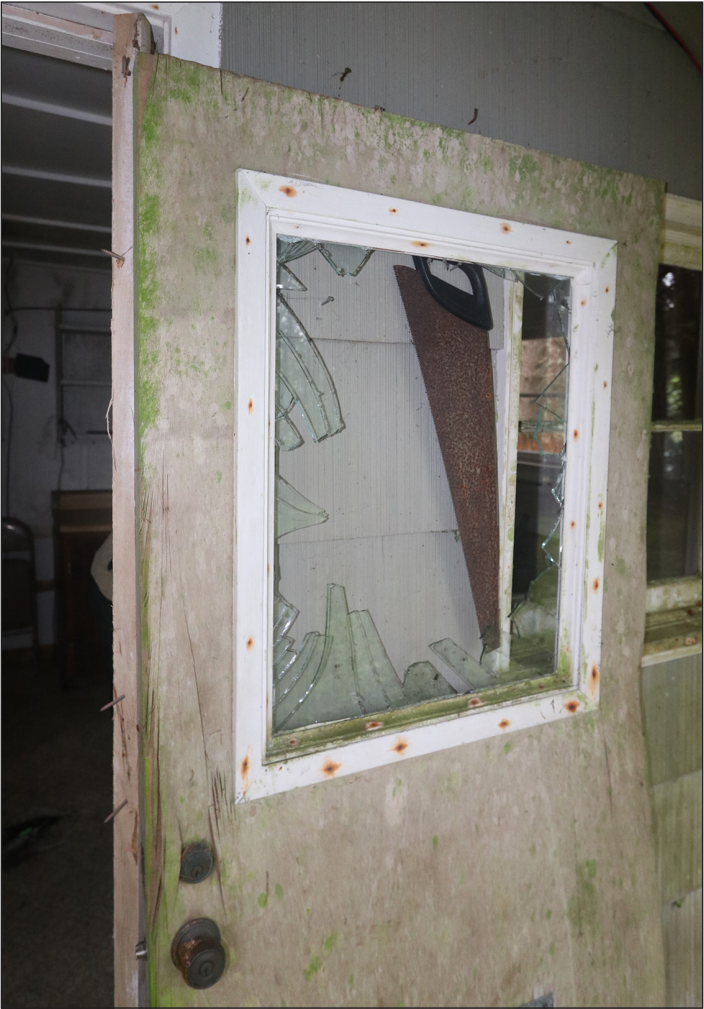
**Figure 8.11:** The door serving the primary entry to the cabin on the south elevation was vandalized in 2018. The door was severely damaged and is no longer serviceable. Following the 2018 site visit for this HSR, park facilities staff installed plywood over this entrance as a stabilization measure. Plywood remains in place and a period appropriate door will be specified when the project proceeds.

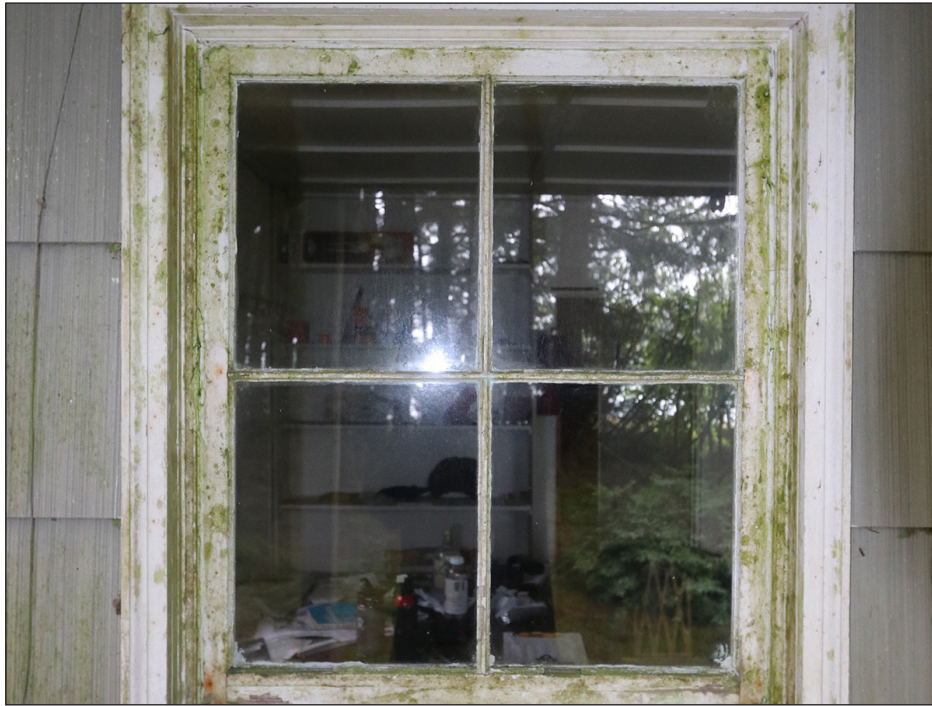
**Figure 8.12:** Typical fixed, wood sash 4-lite window located on the east elevation to the north of the primary door. The windows remain in sound condition despite the moss growth.

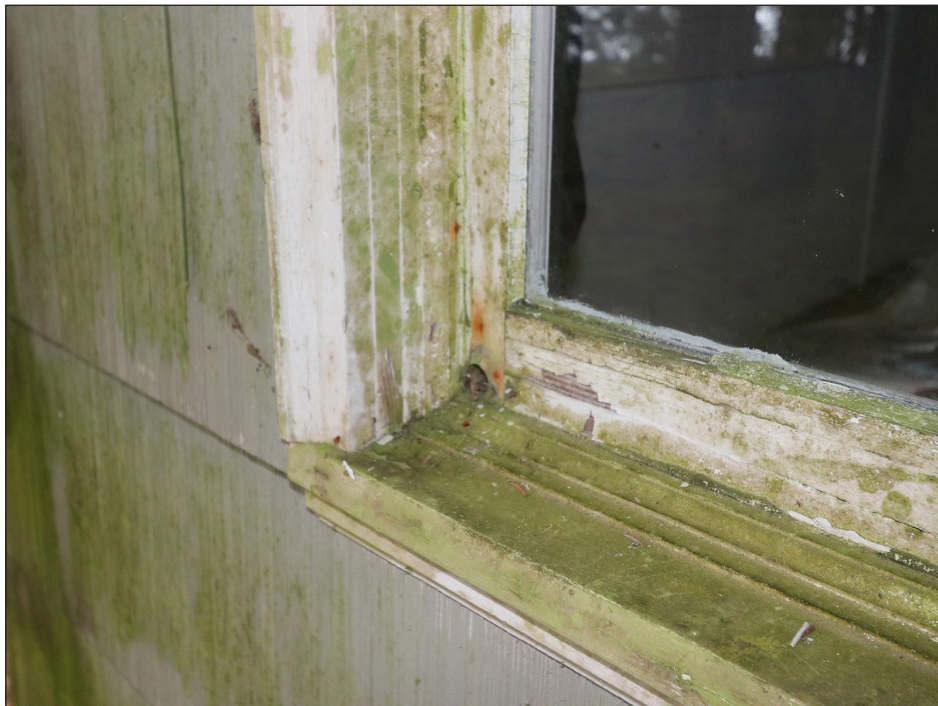
**Figure 8.13:** Detail view of the window sill pictured above illustrating the moss growth on the wood sill and sash.

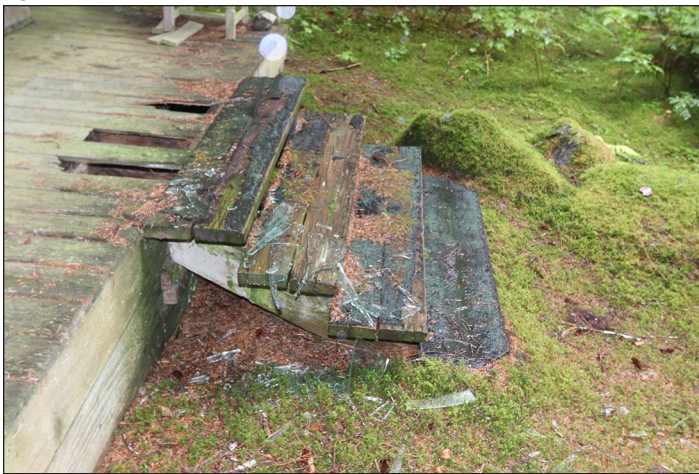
**Figure 8.15:** View of the deteriorated stairs at the cabin's primary entrance.

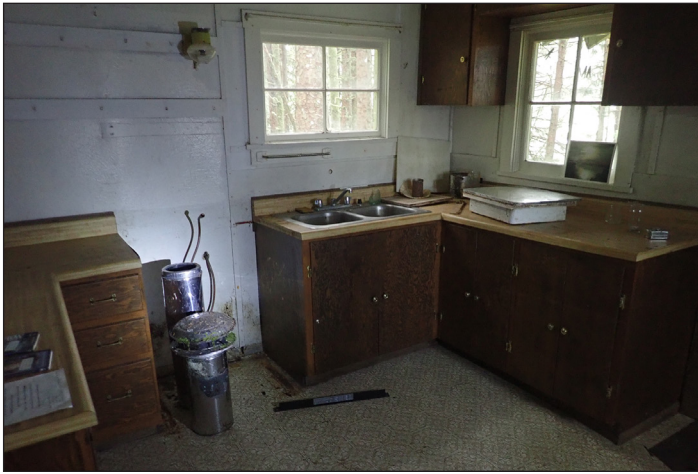
**Figure 8.17:** The kitchen casework may not be original to the cabin but is in serviceable condition.

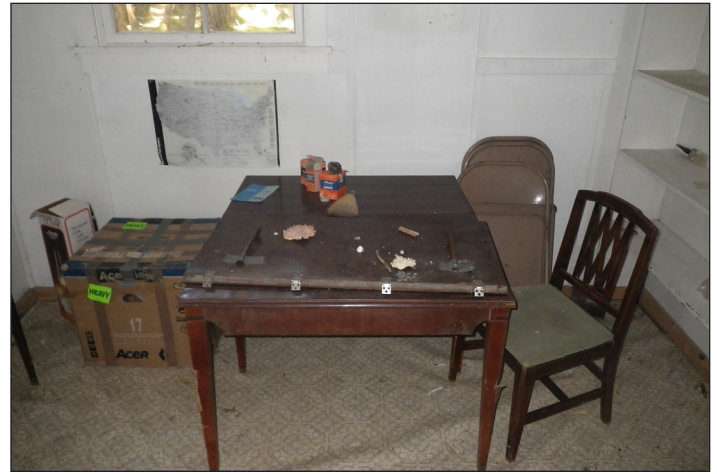
**Figure 8.18:** The kitchen table may not be original to the cabin but remains in good condition.

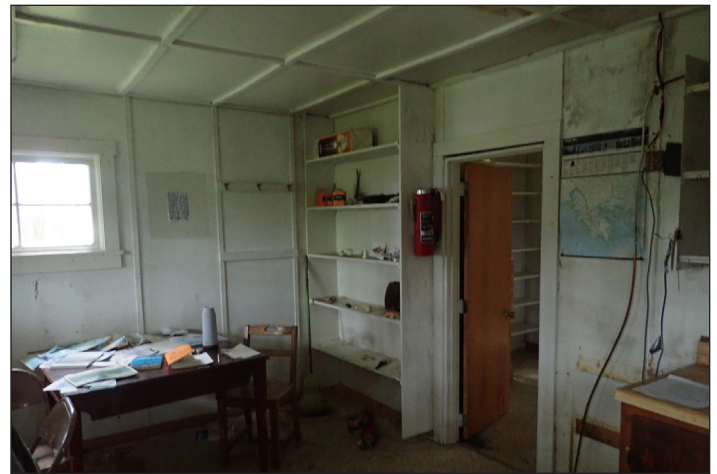
**Figure 8.20:** The kitchen casework may not be original to the cabin but is in serviceable condition.

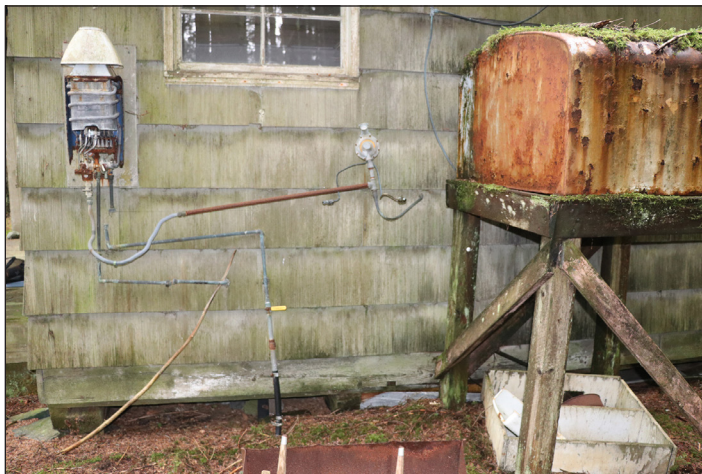
**Figure 8.22:** The North Elevation of the Lagoon Island includes the mechanical systems including an oil fired hot water heater, 100-gallon fuel tank supported by an untreated timber frame and regulators with copper tubing for appliances at the interior. All of the equipment has exceeded its useful life and will require replacement.

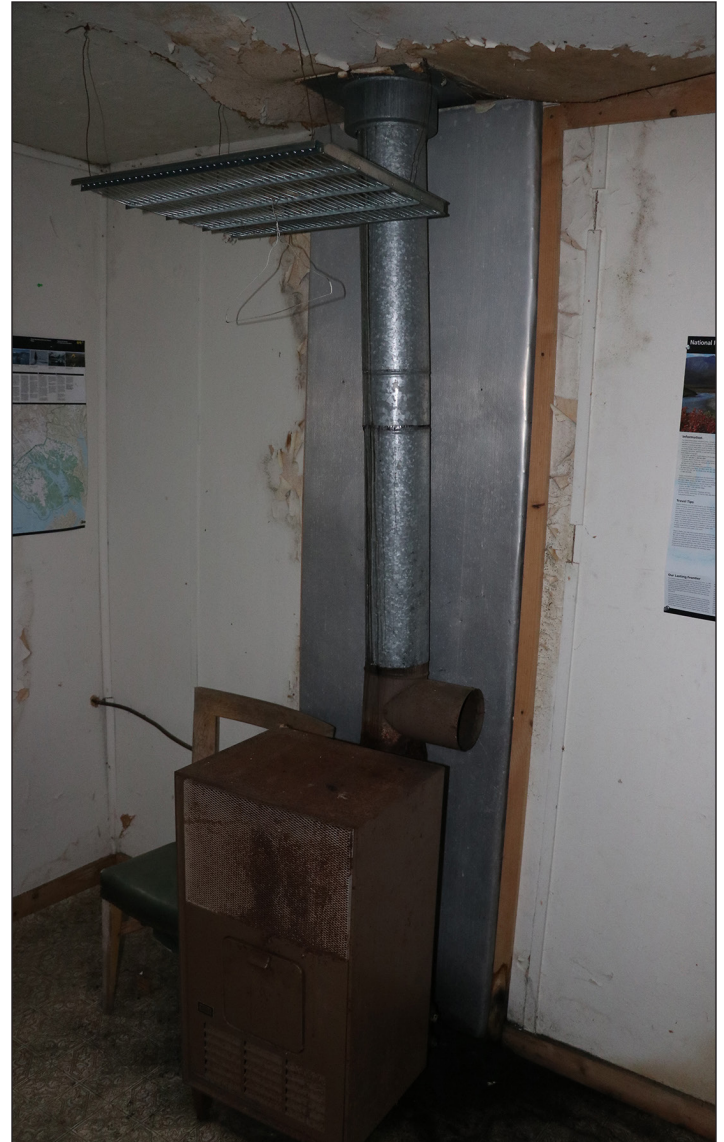
**Figure 8.23:** The primary heat source for the Lagoon Island Cabin was an oil-fired heater located in Room Two which no longer functions. Oil leaks have damaged and stained the floor and water leaks from the vertical exhaust vent has damaged the ceiling and walls.

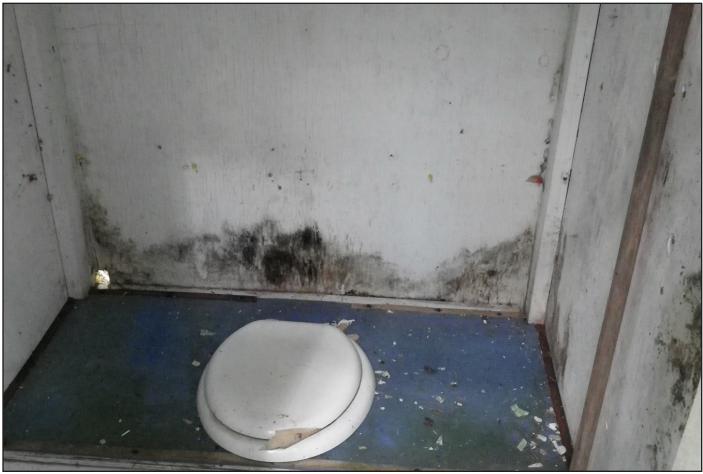
**Figure 8.25:** Interior view of the existing outhouse with mold growth at the interior.

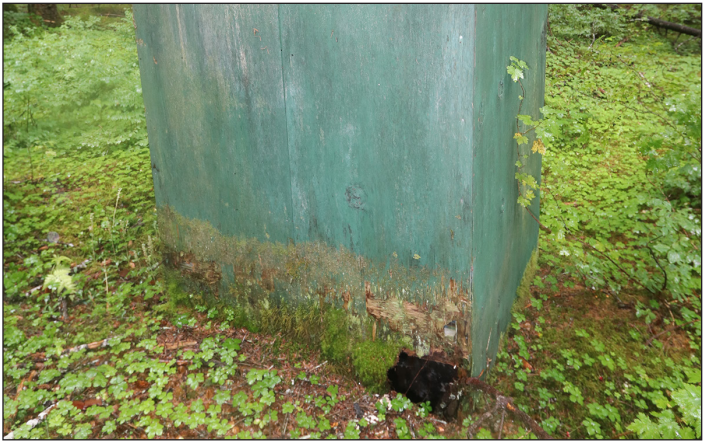
**Figure 8.26:** The North elevation has deteriorated at the corner. A new outhouse will be required for the cabin site.
