Cain Cabin
Elkmont Historic District
Great Smoky Mountains National Park
Historic Structure Report

September 2014

Historic Structure Report

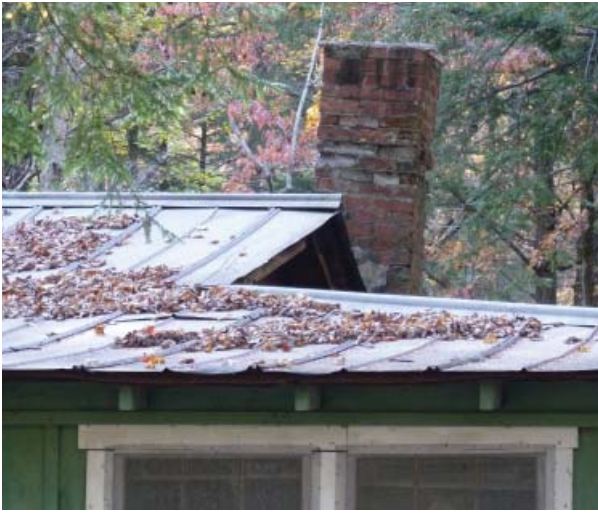
Associated with the roof leaks are leaks at the chimney. Problems are evident at the flashing at the base of the chimney and in the repointing that holds the bricks of the chimney together. The flashing has failed and the chimney mortar is in desperate need of repointing. Water is pouring in and onto the wood shelf at first-floor level that holds the chimney stack; the wood shelf is failing and will eventually lead to collapse of the chimney.

Figure 46. Brick chimney that is leaning to the north.

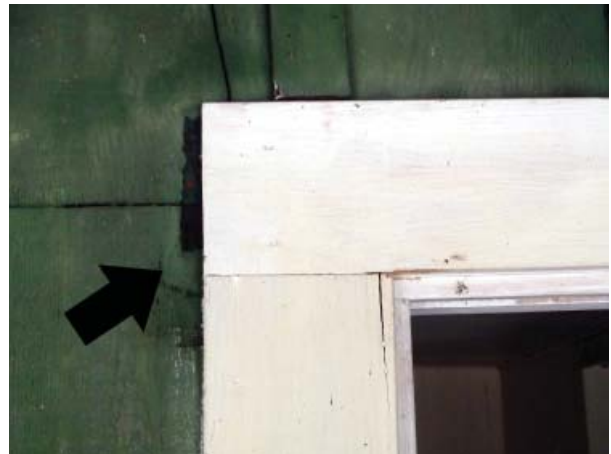
Figure 48. Exterior door casing of front door with paint remnants indicating size of earlier trim board.

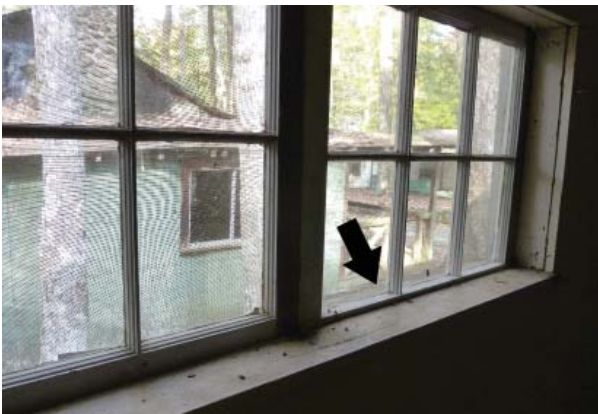
Figure 53. Recently repaired window of the north elevation that is lacking the Type A profile.

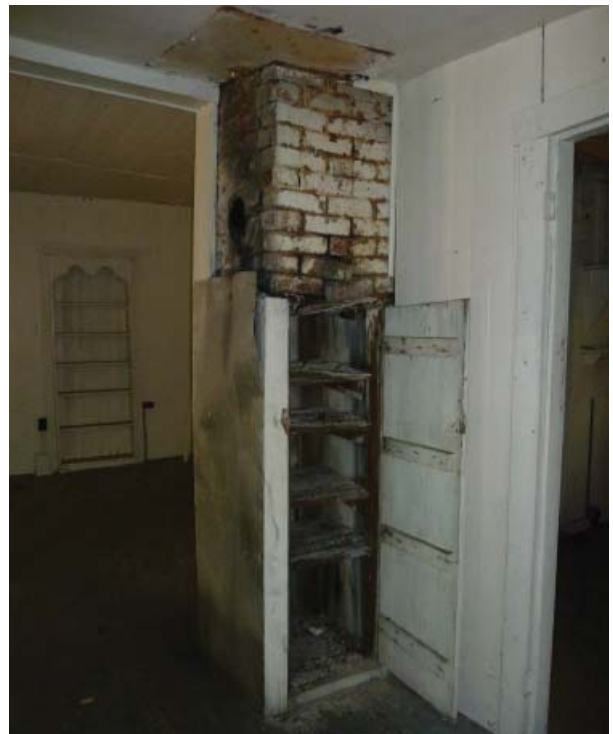
Figure 76. Chimney supported by built-in wooden cabinet in the southwest corner of Room 104.

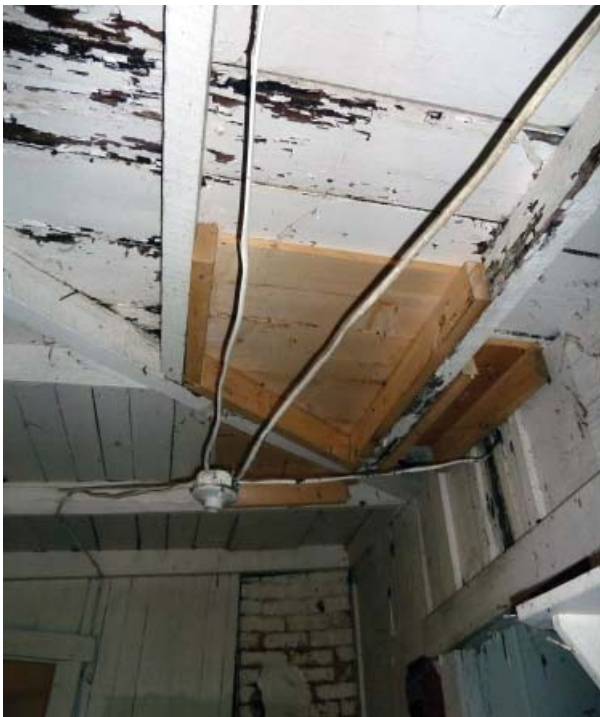
Figure 81. Exposed roof rafters and various areas of ceiling repair in Room 105.

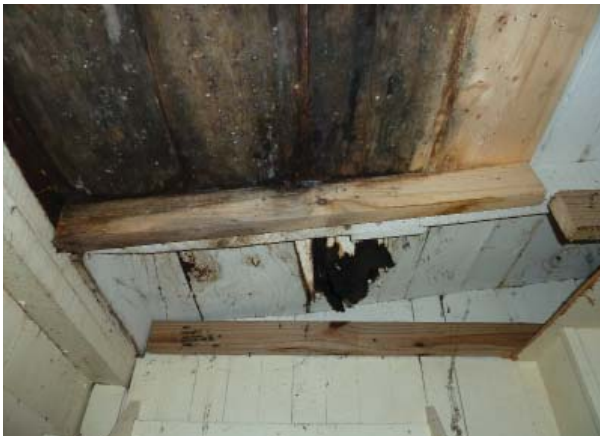
Figure 95. Exposed roof rafters and decking with various repairs in Room 108.
