National Park Service
U.S. Department of the Interior

Harry S Truman National Historic Site
Missouri

Truman Home

Cultural Landscapes Inventory

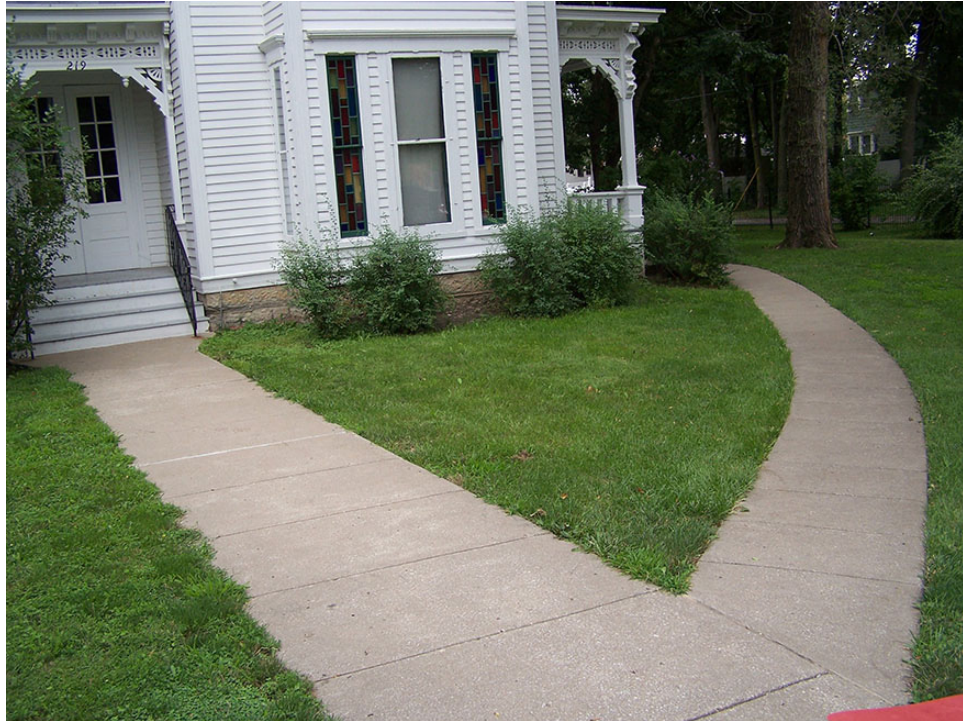
Truman Home Walkways looking Southeast (LCS 2013)

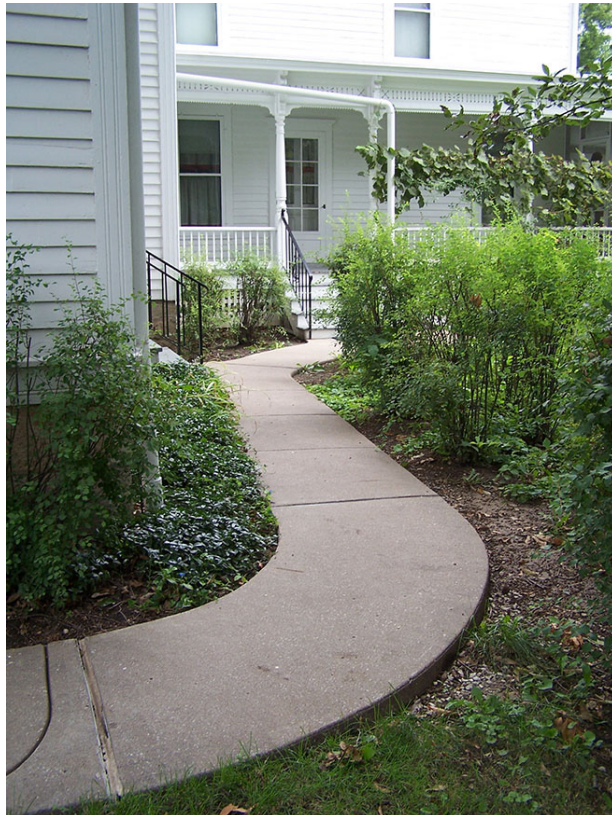
Truman Home Walkways looking North
(LCS 2013)

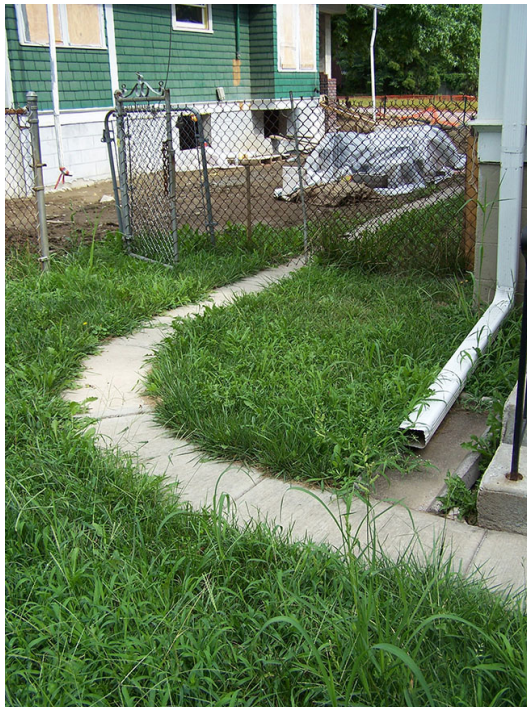
Frank & Natalie Wallace home: There is a long, straight concrete walkway that leads from Truman Road south to the front porch. There are several concrete stepping stones that lead across the lawn in front of the front porch from the front sidewalk to the gravel driveway on the east of the property. The walkway continues south around to the back door at the southwest corner of the house. The walkways, built in 1915, are in fair condition.

Frank Wallace Walkway looking Northwest
(LCS 2013)

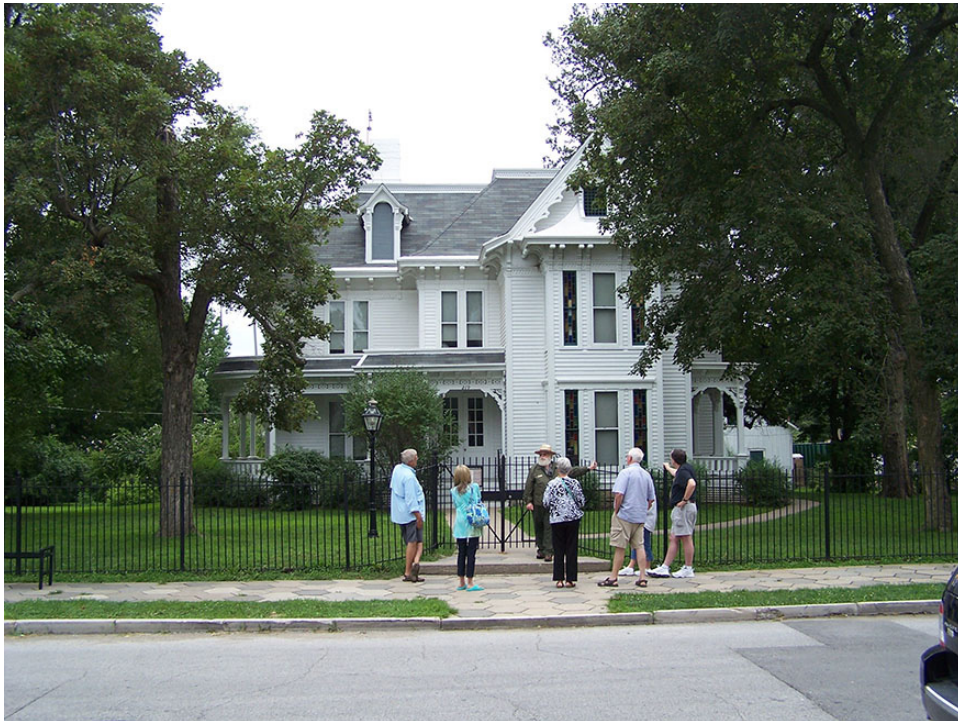
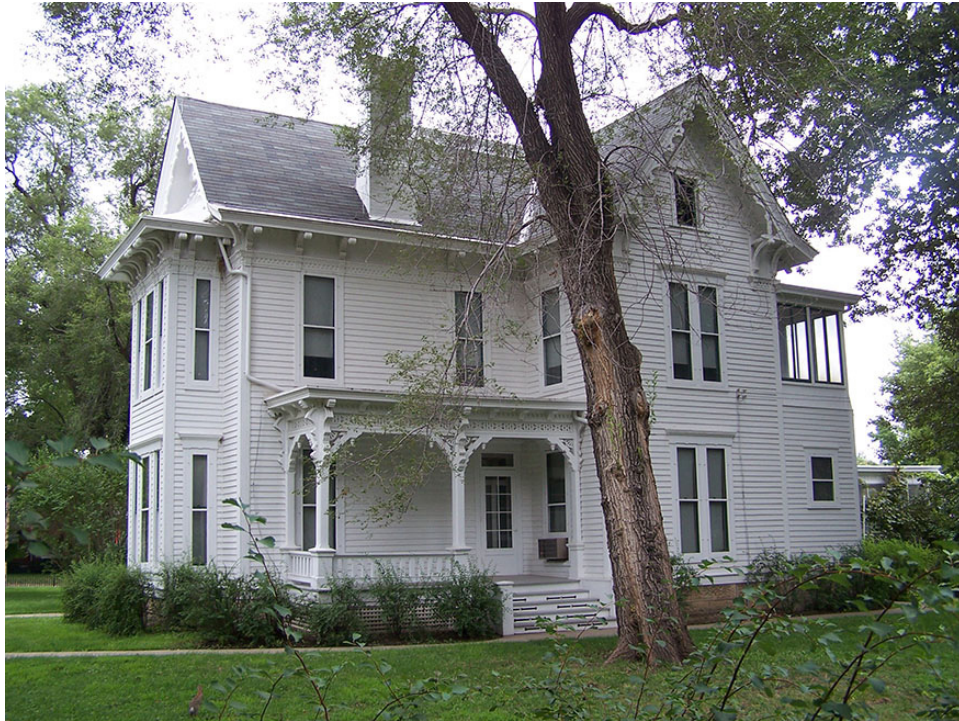
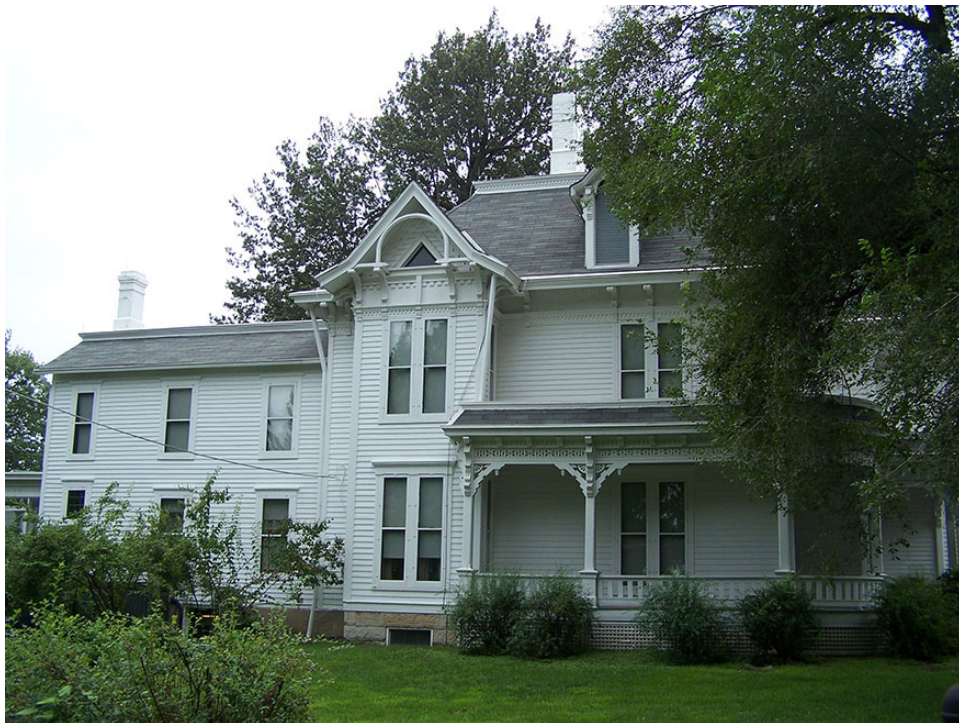
Current structural problems include ceiling and wall failures in the second floor master bedroom, living room, music room, and other rooms in the home. The lath and plaster separation from the ceiling joists and wall studs is currently being repaired and additional assessments are underway. Work is also underway to correct the damage to the ceiling and wall paper (park information, 2004).

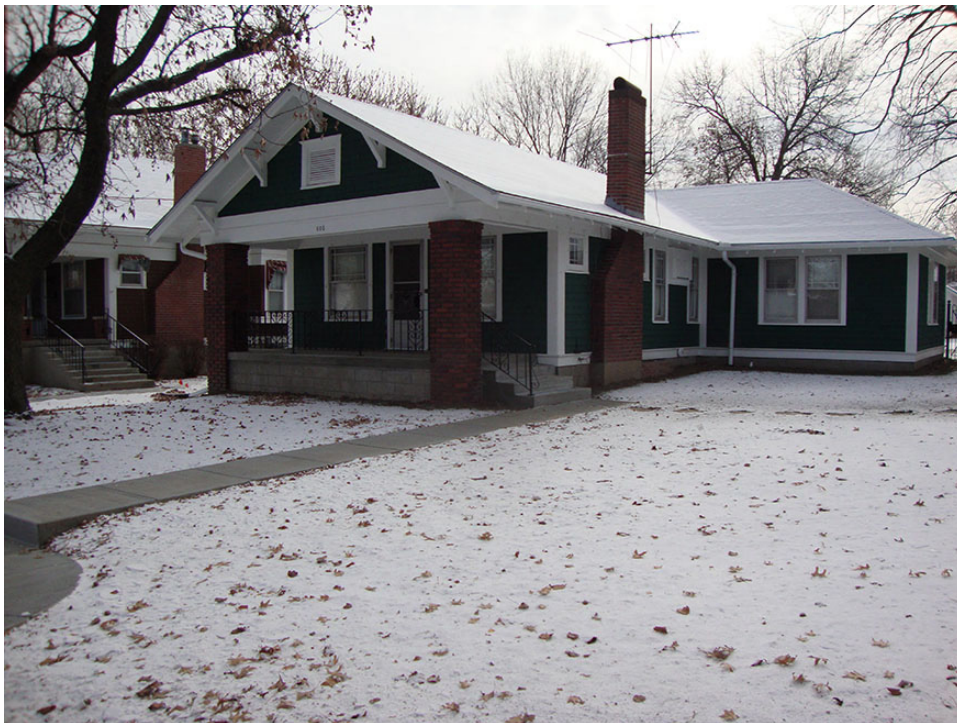
The interior consists of five major rooms: a living room, dining room, kitchen, and two bedrooms. There are also two bathrooms accessed from the bedrooms. Floors are wood, as are the wide baseboards. There is a brick fireplace, built-in bookcases, and decorative wood ceiling beams in the living. Some original hardware remains on the doors and windows. The basement is accessed via a door in the kitchen (LCS records, 2004). The house, in poor condition, is currently used as government offices.

George Wallace House, looking southeast (LCS 2013)

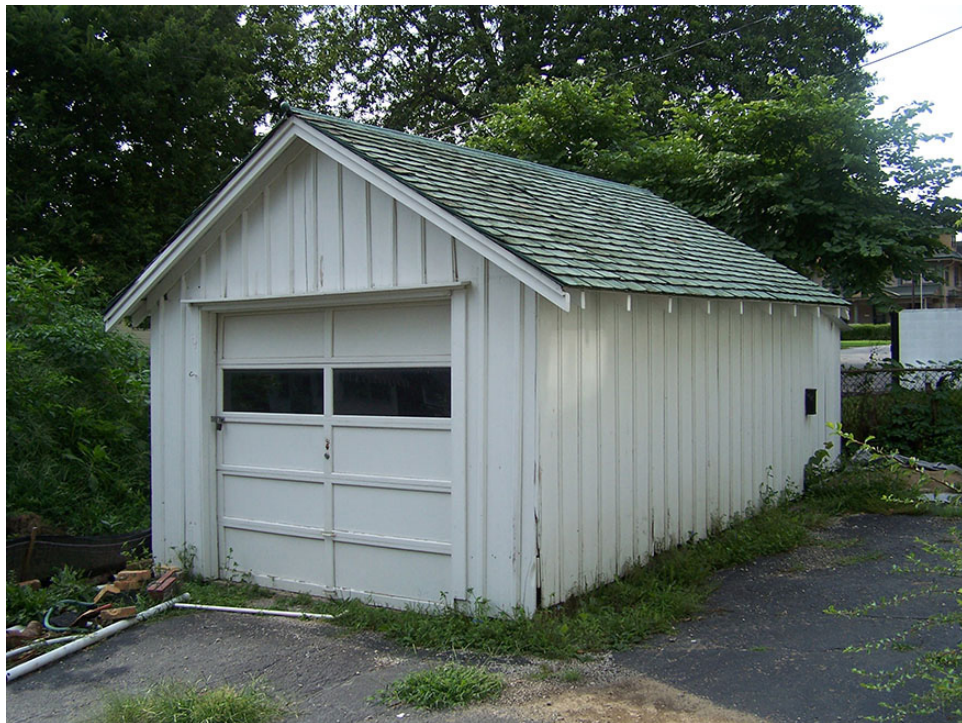
Garage: The garage, built in 1922 for May's car, is located at the back of the George Wallace home, and just east of the Truman carriage house. The one story garage is 12 feet by 21 feet, with board and batten siding. It has a gable roof with exposed rafter tails. There is a rear shed addition. The wooden garage door has eight panels with two small windows near the top. The garage is in poor condition with extensive termite damage. Additionally, the log sills forming the foundation have rotted away, and the walls are rotting from the ground up (LCS records, 2004).

George Wallace Garage, looking southeast (LCS 2013)

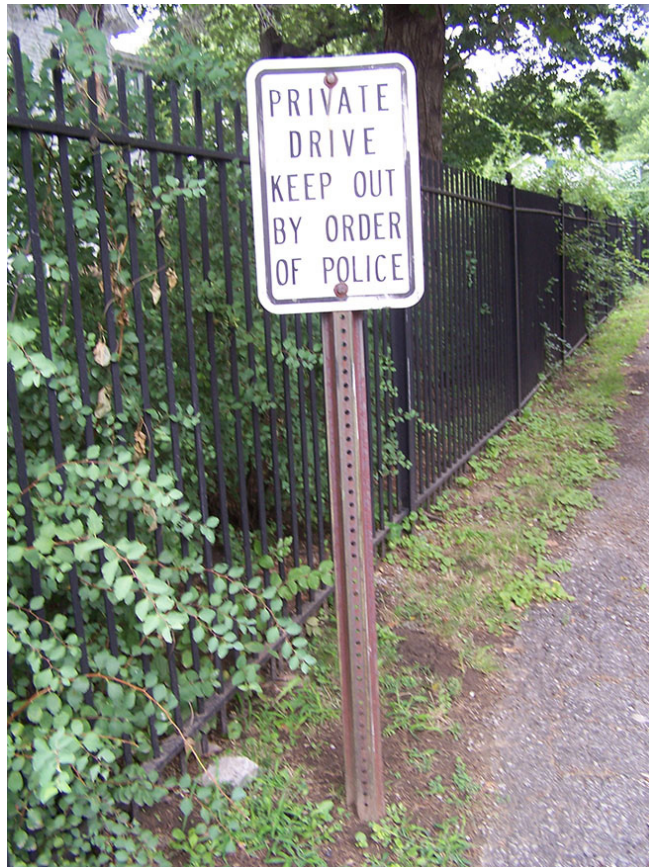
'Private Drive' sign: The sign, installed in 1945, was placed at the alley entrance by the Independence police department after Mr. Truman was elected president. Placed to aid in security, it reads: "private drive, keep out by order of police". It is attached to a steel post five feet high at the entrance of a drive from Delaware Street along the south side of the Truman home. There are some rust stains from the bolts. It is in good condition (LCS records, 2004).

Truman Home Private Drive Sign, looking East
(LCS 2013)

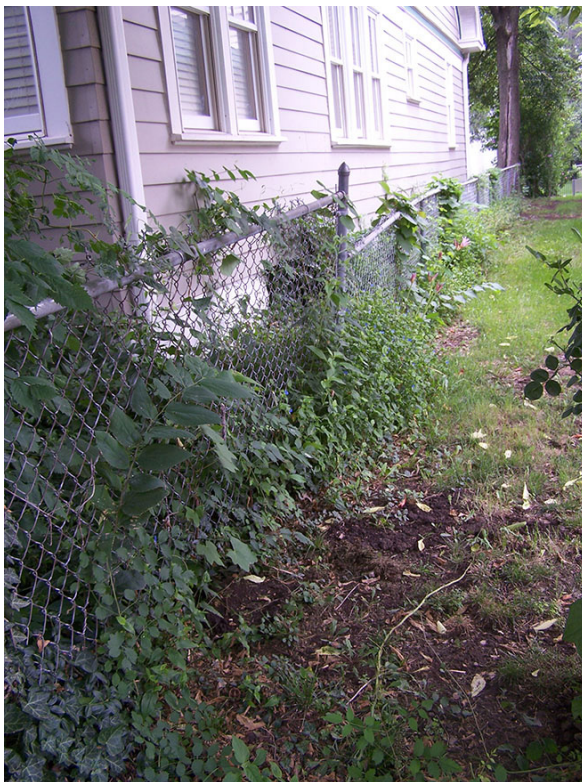
Link Fence: The fence, built in the 1950s or 1960s, delineates the Noland property line. It is three feet seven inches high, around the north, south, and west sides of the property. Portions of it are covered with vines and honeysuckle. It is sagging in places. It is in fair condition (LCS records, 2004).

Noland link fence, looking east (LCS 2013)
