KALAUPAPA BUILDING INVENTORY

KALAUPAPA - HAWAII

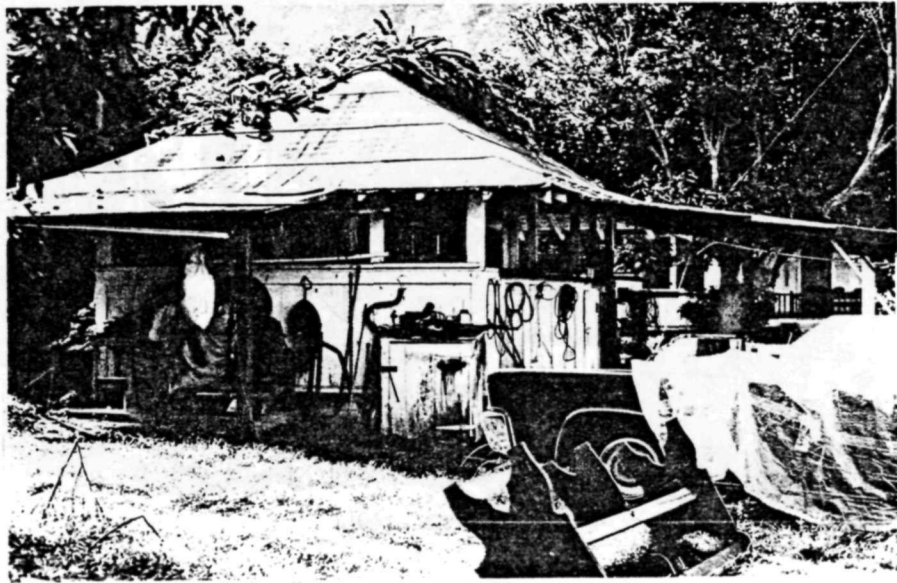
STRUCTURE: Building 18

DESCRIPTION: The structure is a single story building of single wall construction. The hip roof is finished with rolled composition roofing. Vegetation is growing out of the roof. The foundation is a concrete slab. The building was originally a laundry house for the patients living in the McVeigh Home. The structure is now considered private (it is no longer on the list of buildings owned by the State). No maintenance is recommended. Removal of this structure, after it is no longer needed, would be an asset to the McVeigh Home.

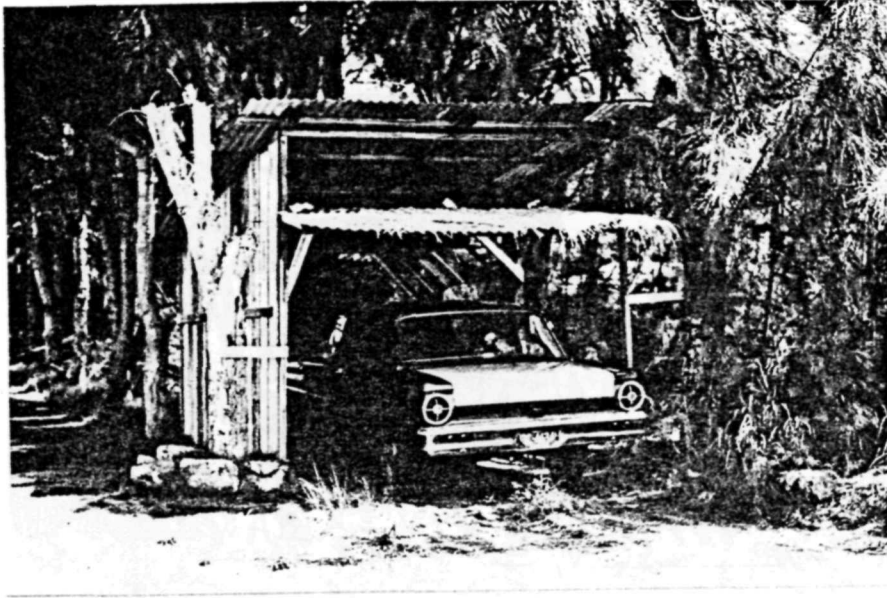
STRUCTURE: Building 510

DESCRIPTION: The structure is a frame garage, with two shed roofs (one over-
hanging the other). The building has no foundation. Two sides are open.
The other two sides are finished with vertical siding, complete with girt.

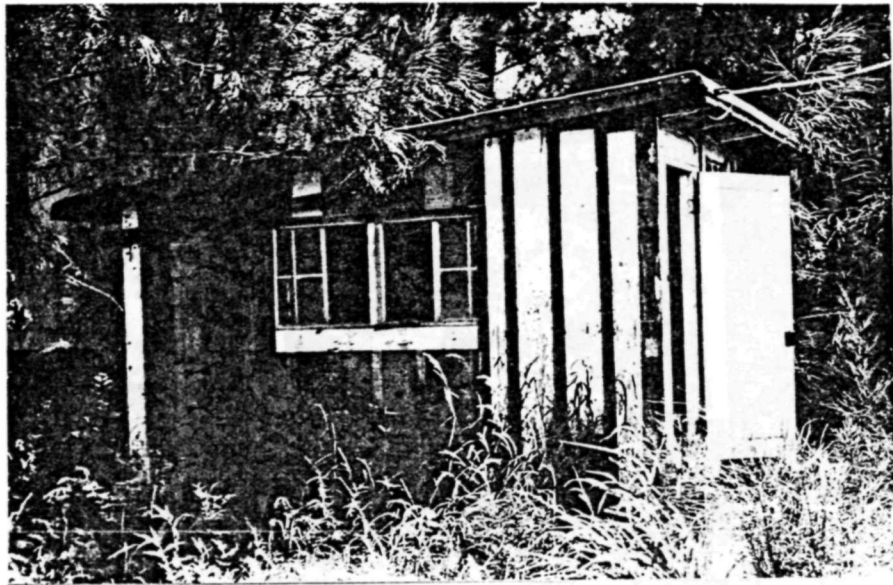
STRUCTURE: Building 506

DESCRIPTION: The structure is a single story building of single wall construction (board and batten). The shed roof is finished with red rolled composition roofing. The foundation is obscured by vegetation. The structure seems to have been made of recycled materials.

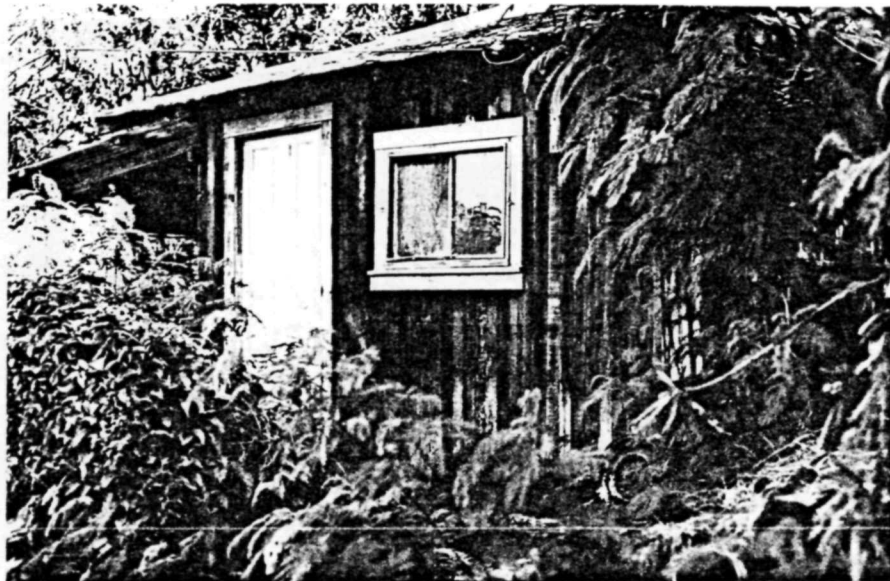
STRUCTURE: Building 503

DESCRIPTION: The structure is a one story building of single wall construction (board and batten). The foundation is not visible, due to vegetation. The hip roof is finished with rolled composition roofing. An addition with a shed roof extends to the right. The structure could have been left from a poultry farm located in the immediate area.

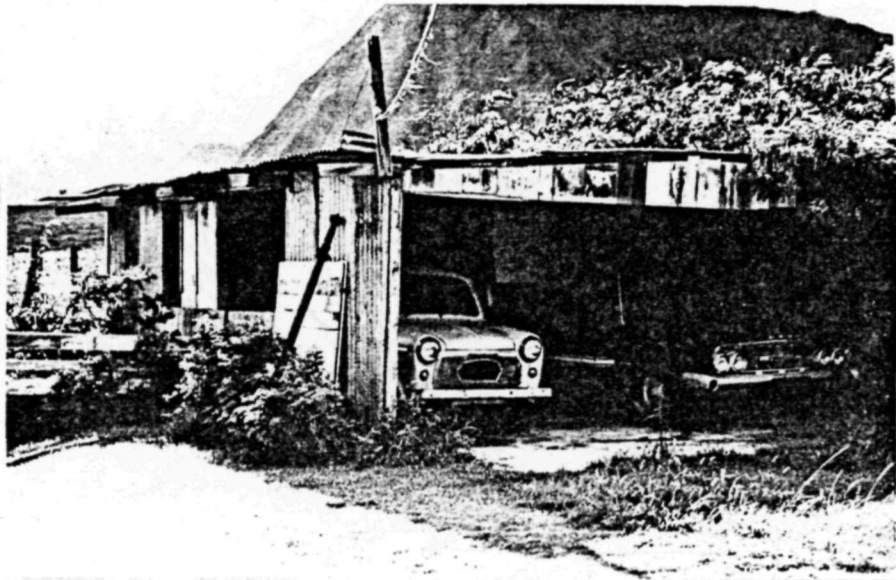
STRUCTURE: Building 500

DESCRIPTION: The structure is a wood frame, one story garage, with corrugated metal siding. The gently sloping gable roof is also finished with corrugated metal. The structure seems to have been made of recycled materials, and is adequate for its purpose. No evaluation of the condition of this private structure was made.

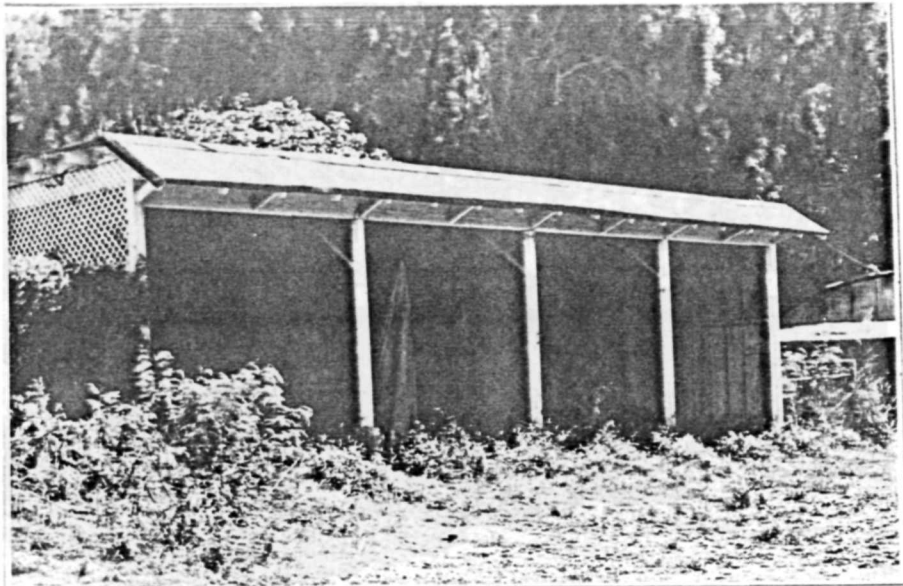
STRUCTURE: Building 4

DESCRIPTION: The structure is a one story four-car garage, of single wall construction. The foundation is stone, the floor is dirt. The shed roof is finished with rolled composition roofing. The building is in poor condition (termites, rot, etc.), but should be maintained until it is no longer needed or until it becomes a hazard, at which time it should be removed.

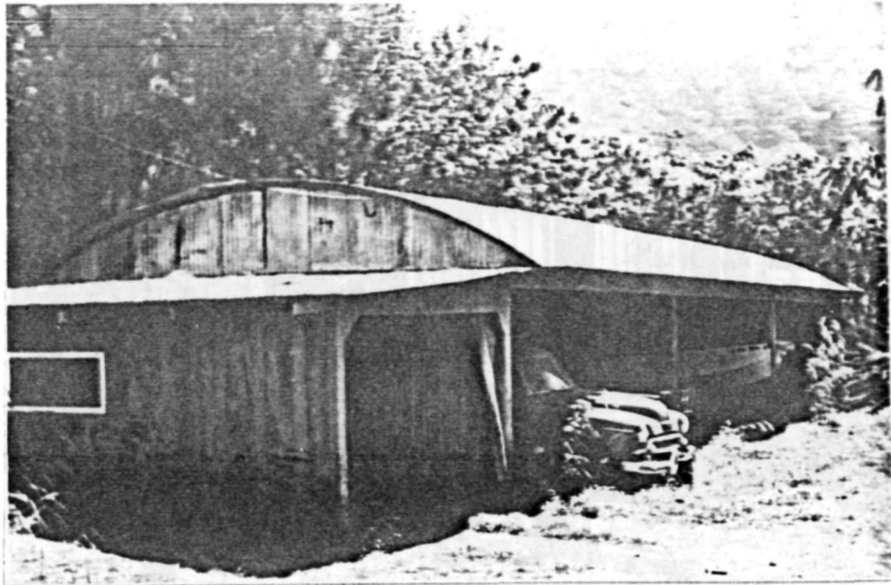
STRUCTURE: Building 4-A

DESCRIPTION: The structure is a six-car garage of metal and wood frame construction. The quonset roof, with metal framing members is finished with corrugated metal, as are the walls of the structure. A wood frame addition, with a corrugated metal shed roof was constructed as the north end of the structure. The building is in fair condition, and should be maintained until it is no longer needed, or until it becomes a hazard, at which time it should be removed.

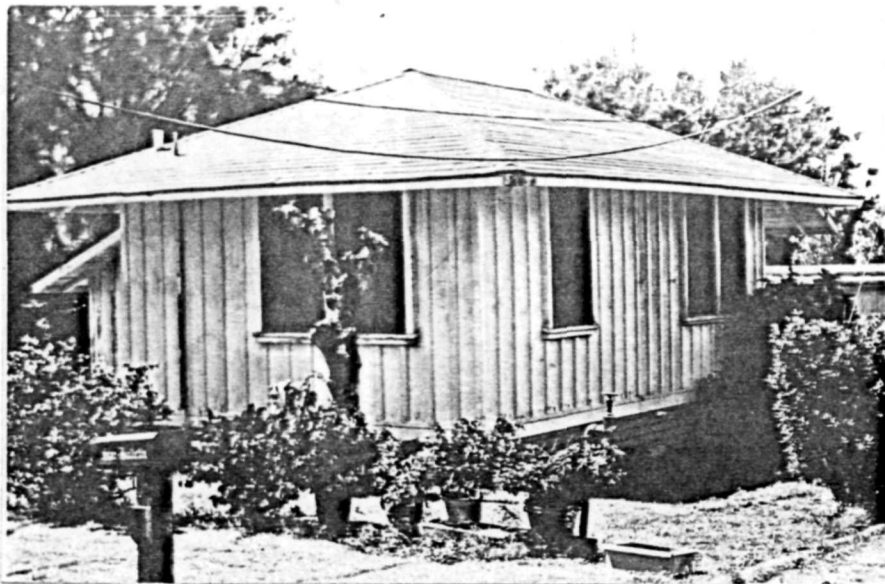
STRUCTURE: Residence 5

DESCRIPTION: The structure is a one-story building of single wall construction (board and batten), with a concrete pad and post foundation. The hip roof is finished with red composition shingles. A small wooden porch with a shed roof is located at the west of the structure. The wood window frames of the 12-light double-hung windows project several inches from the exterior wall. A washroom, constructed on a concrete slab and with a shed roof, is located at the rear of the T-shaped structure. The structure is occupied and in fair condition. The building should be fumigated, boards deteriorated by termites should be replaced (particularly in the eaves), and the structure should be painted.

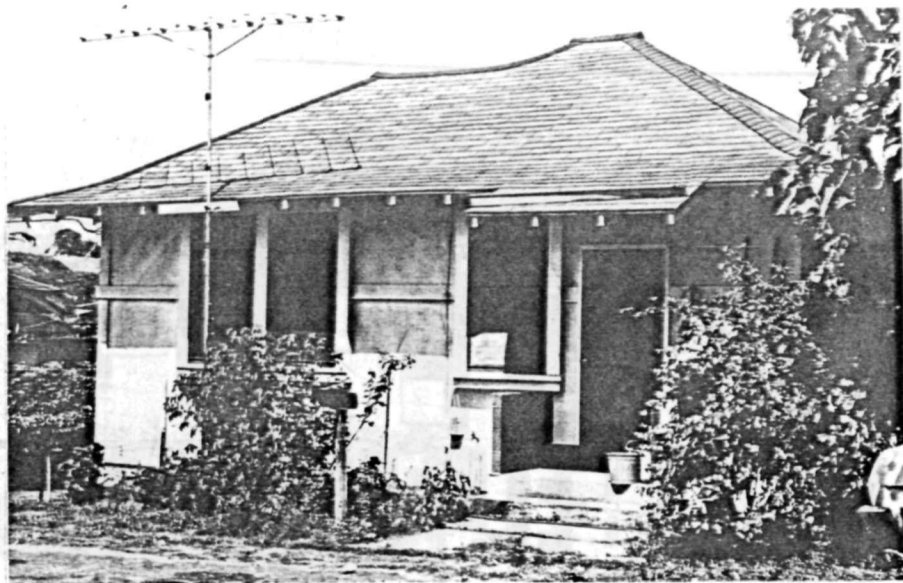
STRUCTURE: Building 8

DESCRIPTION: The structure is a one-story building of single wall construction, with a concrete pad and post foundation. The hip roof (irregularly shaped, and with a broken pitch) is finished with red composition shingles. A small concrete entrance porch at the south side of the structure is edged by hollow tile railings. The wood frames of the 12-light double hung windows project several inches from the exterior wall. A broken girt surrounds the exterior wall and the corners of the structure are finished with cornerboards. A highly compatible addition was completed recently on the southeast corner of the structure. A partially enclosed exterior washroom constructed on a concrete slab and with a shed roof, is located at the rear of the T-shaped structure. The building is occupied, and is in fair to good condition, although in need of fumigation and painting.

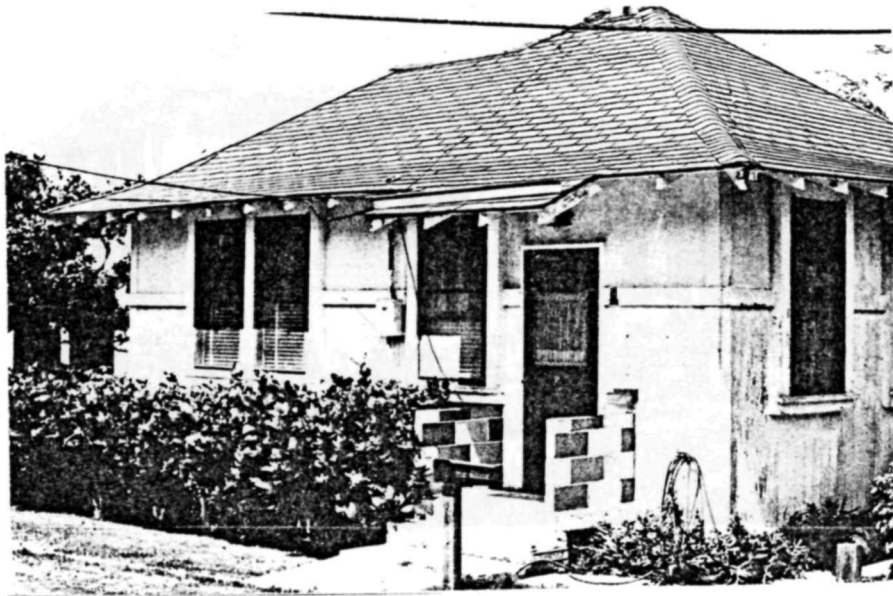
STRUCTURE: Building 9

DESCRIPTION: The structure is a one-story building of single wall construction, with a concrete pad and post foundation. The irregularly shaped hip roof has broken pitch, and is finished with red composition shingles. A small concrete entrance porch is edged by hollow tile solid railings. The wood frames of the 12-light double-hung windows projects several inches from the exterior wall. A broken girt surrounds the exterior of the building. The corners of the structure are finished with cornerboards. A partially enclosed exterior washroom, constructed on a concrete slab and with a shed roof, is located at the rear of the L-shaped structure. The building is occupied, and is in fair condition. The structure is in need of some board replacement, fumigation, and painting.

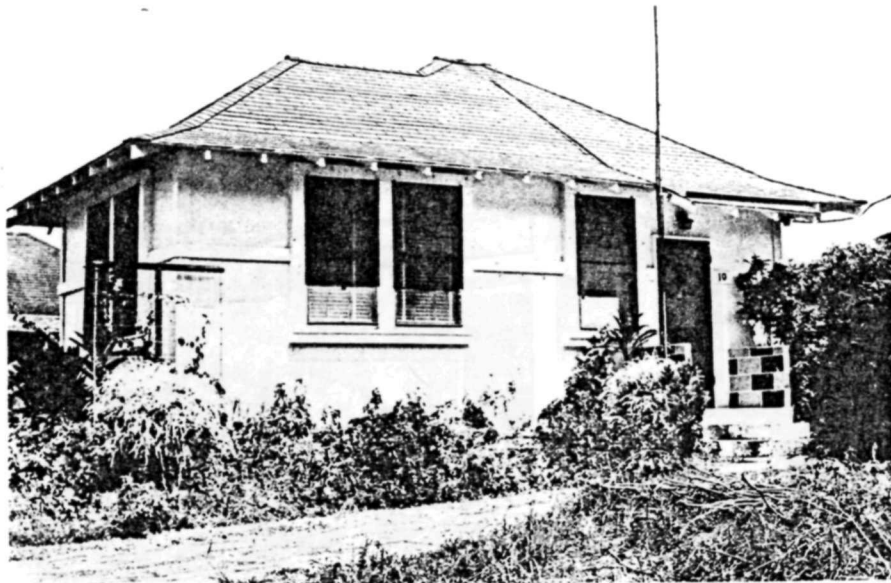
STRUCTURE: Building 10

DESCRIPTION: The structure is a one-story building of single wall construction, with a concrete pad and post foundation. The irregularly shaped hip roof has a broken pitch, and is finished with red composition shingles. A small concrete entrance porch at the southeast corner of the structure is edged by hollow tile solid railings. The wood frames of the 12-light double hung windows project several inches from the exterior wall. A broken girt encircles the exterior. The corners of the structure are articulated by cornerboards. An exterior washroom, constructed on a concrete slab and with a shed roof, is located at the rear of the L-shaped structure. The building is occupied, and is in good condition. The structure is in need of some minor board replacement, fumigation and painting.

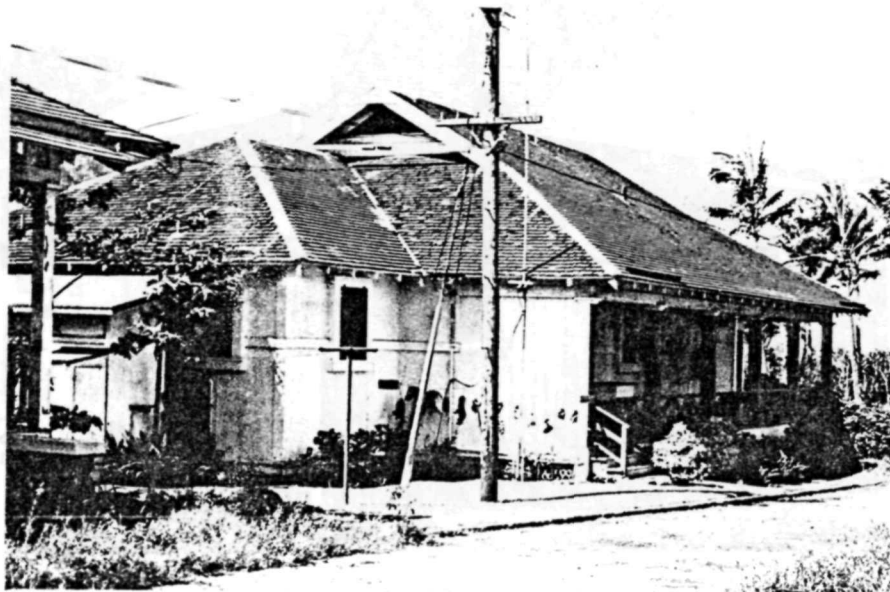
STRUCTURE: Building 12

DESCRIPTION: The structure is a one-story building of single wall construction, with a concrete pad and post foundation. The main hip roof (with gablet) is flanked by hip roofs of the wings at the east and west ends of the structure. The roofs are finished with wood shingles. A railing with a traditional vernacular pattern encloses the recessed veranda, incorporated under the main roof. Corners of the structure are finished with cornerboards. The wood frames of the 12-light windows project several inches from the exterior wall. A broken girt encircles the exterior. The structure is divided into 4 1-bedroom apartments, and is occupied. The building is in fair to poor condition. Vegetation should be cleared from the base, the shingle roof should be patched (with the original material), rotted and termite-eaten wood should be removed and replaced. The structure should be fumigated and painted.

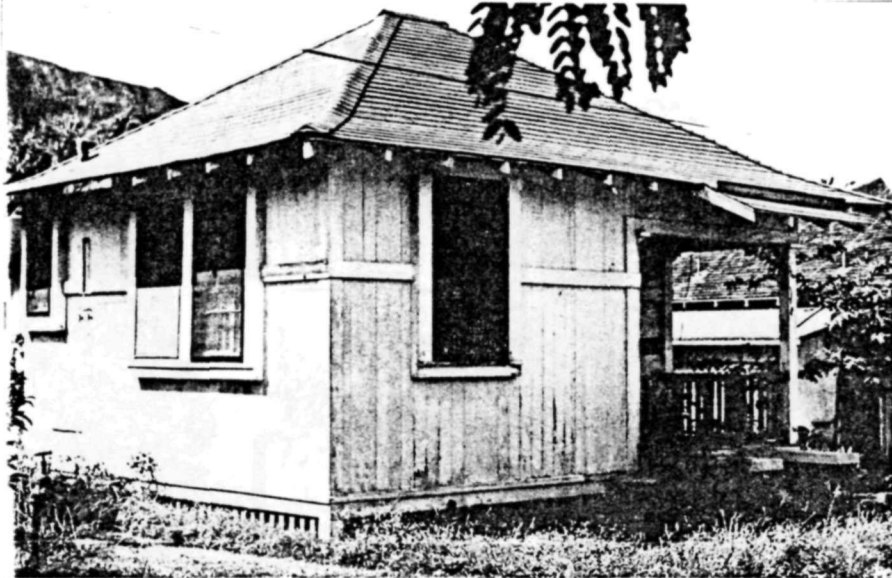
STRUCTURE: Building 13

DESCRIPTION: The structure is a one-story building of single wall construction, with a pad and post foundation. The broken-pitch hip roof is finished with green composition shingles. Concrete and stone steps provide access to the recessed corner porch which is incorporated under the hip roof. A post and two pilasters articulate the edges of the porch. Other corners of the structure are finished with cornerboards. The wood frames of the 12-light double-hung windows project several inches from the exterior wall. A broken girt encircles the exterior. A partially enclosed exterior washroom, constructed on a concrete slab and with a shed roof, is located at the rear of the rectangular structure. The structure is in poor condition. Vegetation and earth should be cleared away from the base of the structure. Much of the wood in the structure, including some in the settling foundations should be replaced. The building should be fumigated, and painted.

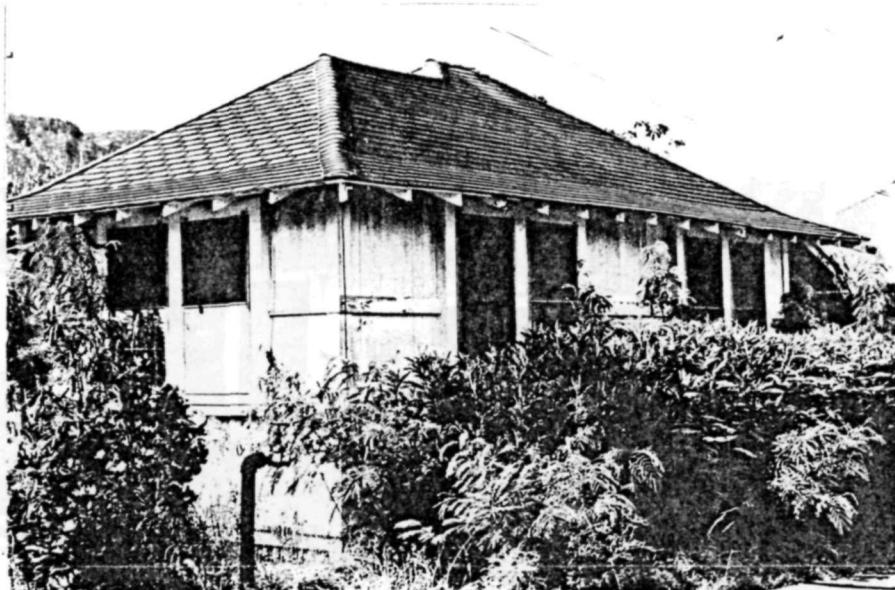
STRUCTURE: Building 14

DESCRIPTION: The structure is a one-story building of single wall construction, with a concrete pad and post foundation. The irregularly-shaped hip roof has a broken pitch, and is finished with green composition shingles. A wooden porch with a shed roof is located at the west side (main entrance) of the structure. The wood frames of the 12-light double-hung windows project several inches from the exterior wall. A broken girt encircles the exterior. The corners of the structure are finished with cornerboards. The rectangular structure is unoccupied, and in fair condition. Vegetation should be cleared from the base of the structure, and the tree leaning against the west side of the roof should be trimmed or removed. The building is in need of some board replacement and roof work; it should also be fumigated and painted.

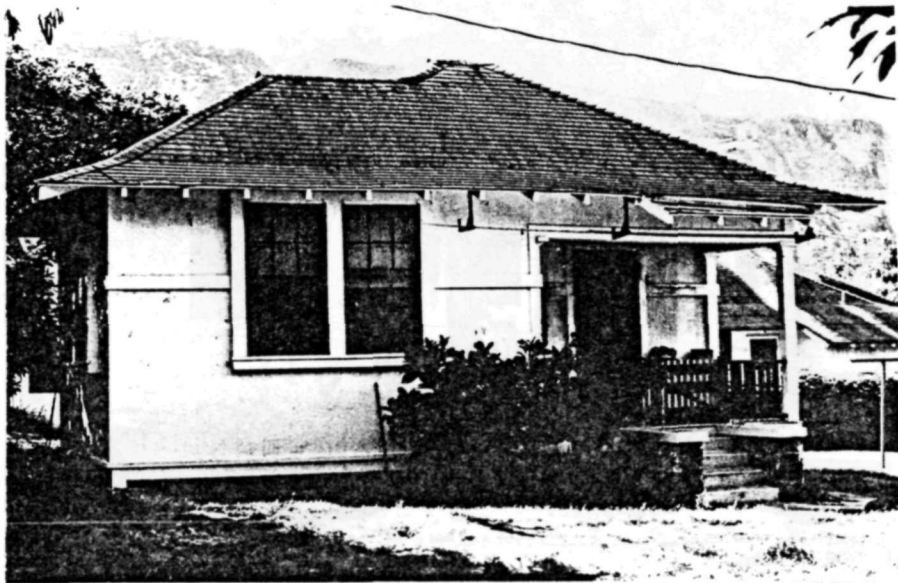
STRUCTURE: Building 16

DESCRIPTION: The structure is a one-story building of single wall construction, with a concrete pad and post foundation. The irregularly shaped hip roof has a broken pitch, and is finished with green composition shingles. Concrete steps with solid stone rails provide access to the recessed corner porch which is incorporated under the hip roof. A post and two pilasters articulate the edges of the porch. Other corners of the structure are finished with cornerboards. A broken girt encircles the exterior. The wood frames of the 12-light double hung windows project several inches from the exterior wall. A partially enclosed porch, constructed on a concrete slab and with a shed roof, is located at the rear of the rectangular structure. The building is occupied, and in good condition, although in need of minor board replacement and painting, and fumigation.

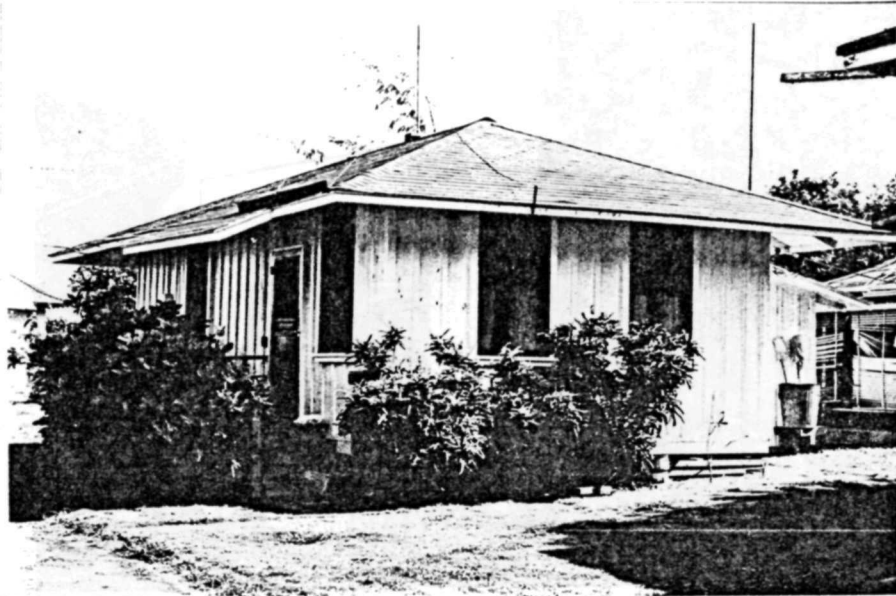
STRUCTURE: Building 20

DESCRIPTION: The structure is a one-story building of single wall construction (board and batten), with a concrete pad and post foundation. The hip roof is finished with red composition shingles. The wood frames of the 12-light double-hung windows project several inches from the exterior wall. A partially enclosed washroom, on a concrete slab and with a shed roof, is located at the rear of the structure. The building is occupied, and in good condition. The structure should be fumigated.

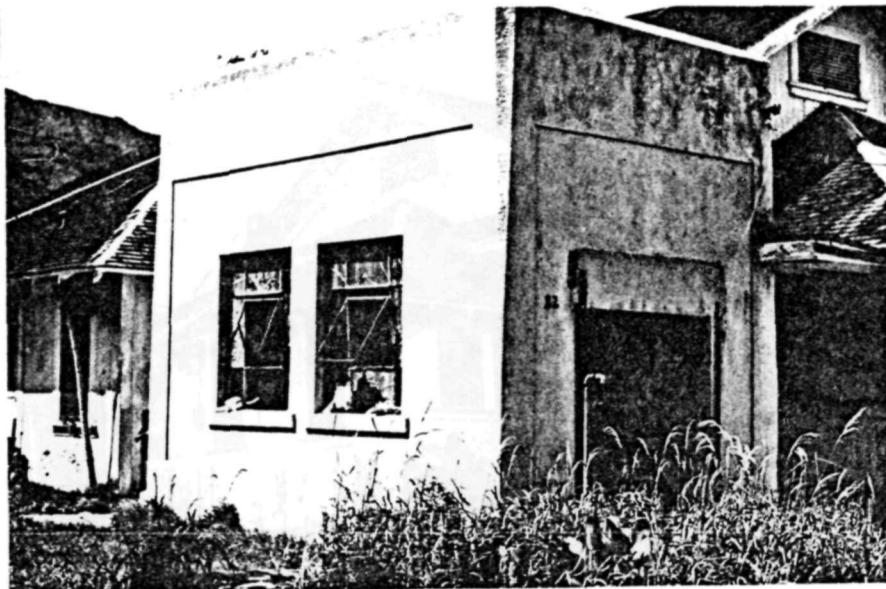
STRUCTURE: Building 22

DESCRIPTION: The structure is a reinforced concrete building with a cement stucco exterior finish. The metal frame industrial windows have fixed and hinged sash. The foundation and floor are concrete. The building is in poor condition, and should be demolished.

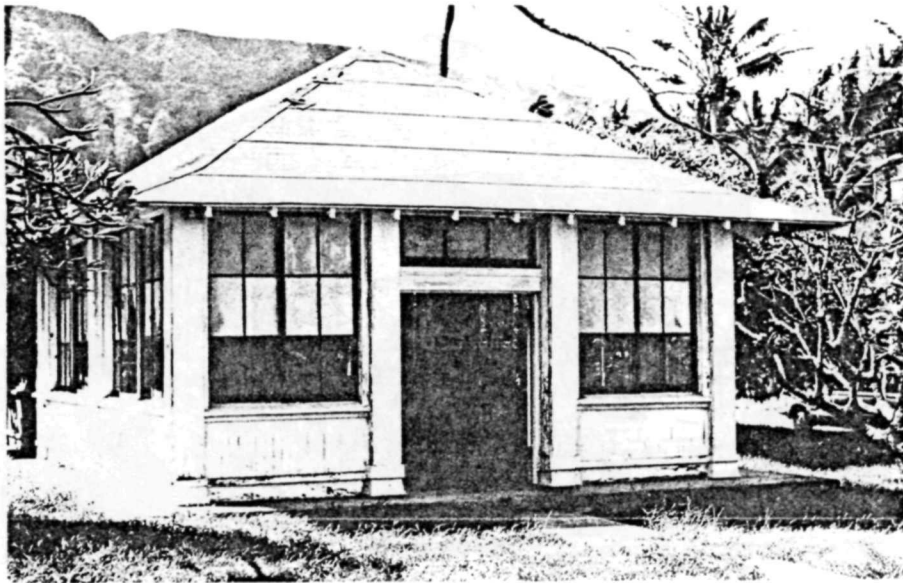
STRUCTURE: Building 24

DESCRIPTION: The structure is a one-story symmetrical building of single wall construction, built on a concrete slab. The hip roof is finished with rolled composition roofing paper and composition shingles. Windows comprise the greatest amount of wall section. Many of these windows, which are built on tracks to slide open for ventilation, are broken and in need of replacement. The building is finely detailed, with two pilasters on each side, and one on each corner articulating the structure and the building edges. The building is in fair condition, although in need of painting, lumber replacement, re-roofing, and fumigation.

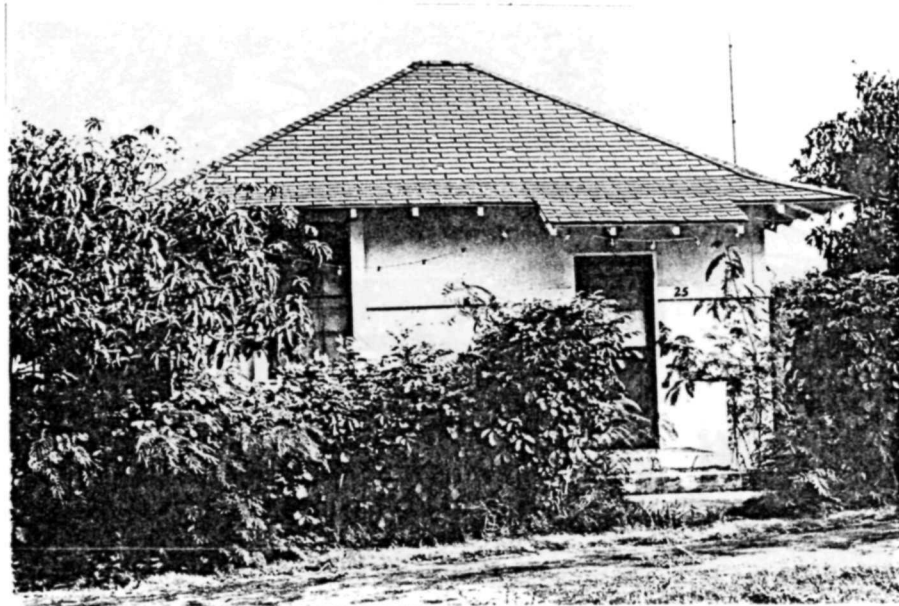
STRUCTURE: Building 25

DESCRIPTION: The structure is a one-story building of single wall construction, with a pad and post foundation. The hip roof has a broken pitch, and is finished with green composition shingles. A small concrete entrance porch is located at the southeast corner of the structure. The wood frames of the 12-light double-hung windows project several inches from the exterior wall. A broken girt surrounds the exterior of the building. The building is occupied, and is in fair condition. Vegetation should be cleared from the base of the structure, some of the wood should be replaced, and the structure should be painted and fumigated.

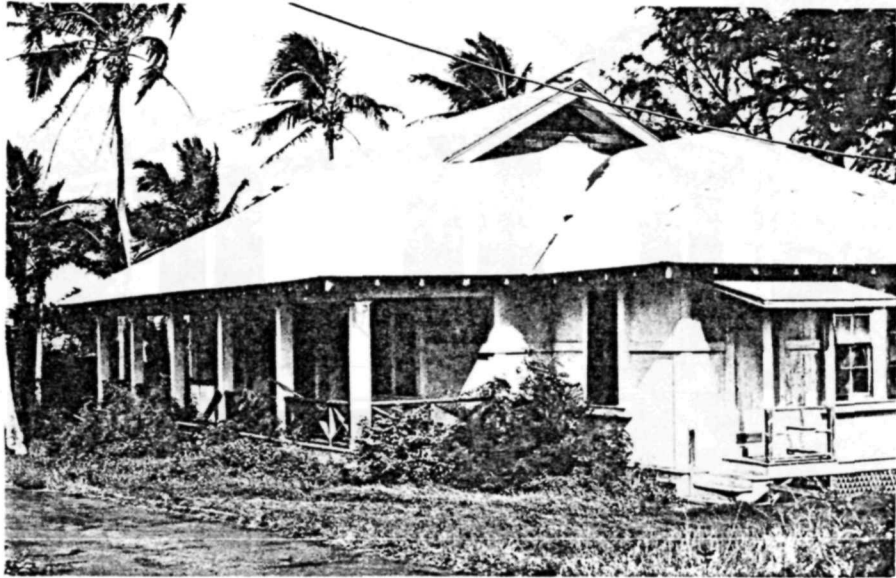
STRUCTURE: Building 28

DESCRIPTION: The structure is a one-story building of single wall construction, with a concrete pad and post foundation. The main hip roof (with gablet) is flanked by hip roofs of the wings at the east and west ends of the structure. The roof complex is finished with grey composition shingles. A railing with a traditional vernacular pattern encloses the recessed veranda which runs the length of the main wing. Corners of the structure are finished with cornerboards. The wood frames of the 12-light double hung windows project several inches from the exterior wall. A broken girt encircles the exterior. The structure was originally divided into 12 bedrooms. The building is unoccupied and in poor condition. Vegetation should be cleared from the base of the structure. Much of the lumber needs replacement. The interior and exterior should be cleaned and painted. The structure is infested with termites and should be fumigated.

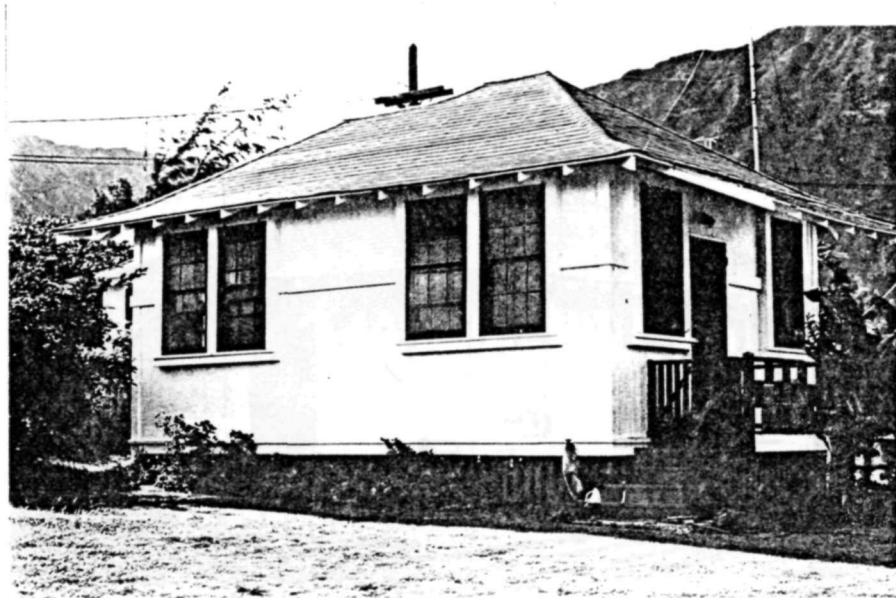
STRUCTURE: Building 30

DESCRIPTION: The structure is a one-story building of single wall construction, with a concrete pad and post foundation. The irregularly shaped hip roof has a broken pitch, and is finished with red composition shingles. A wooden porch with a shed roof is located at the west side (main entrance) of the structure. The wood frames of the 12-light double-hung windows project several inches from the exterior wall. A broken girt encircles the exterior. The corners of the structure are finished with corner boards. The rectangular structure is occupied, and in good condition. The building is in need of minor wood replacement, eave scraping and repainting, and fumigation.

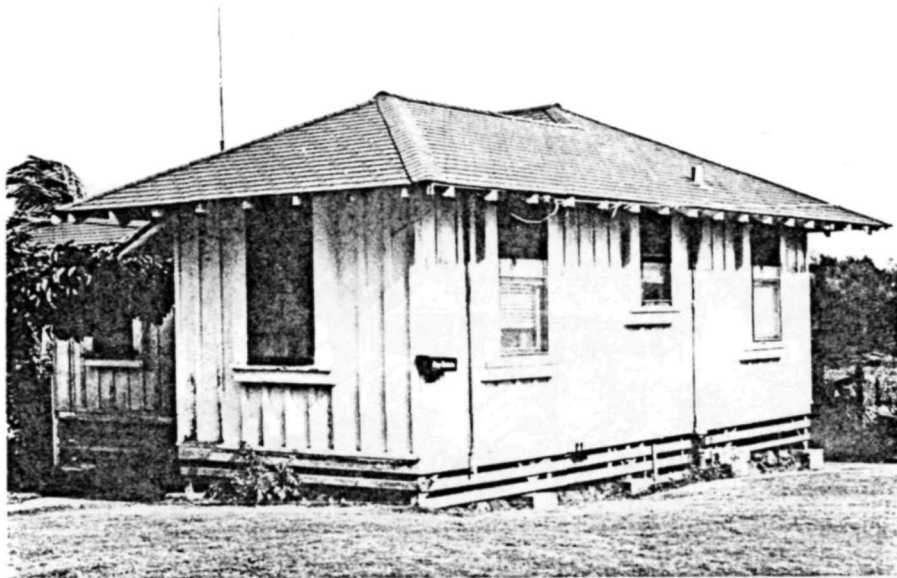
STRUCTURE: Building 32

DESCRIPTION: The structure is a one story building of single wall construction, with a concrete pad and post foundation. The hip roof of the L-shaped building is finished with red composition shingles. The wood frames of the six-light double-hung windows project several inches from the exterior wall. The exterior finish is board and batten. A partially enclosed washroom, constructed on a concrete foundation and with a shed roof, is located at the rear of the structure. The building should be scraped, painted, and fumigated. Some lumber, particularly the rafter ends, needs replacement. The deteriorated drainage plumbing, which is exposed to the elements, should be checked and replaced if necessary. The structure is occupied and in fair condition.

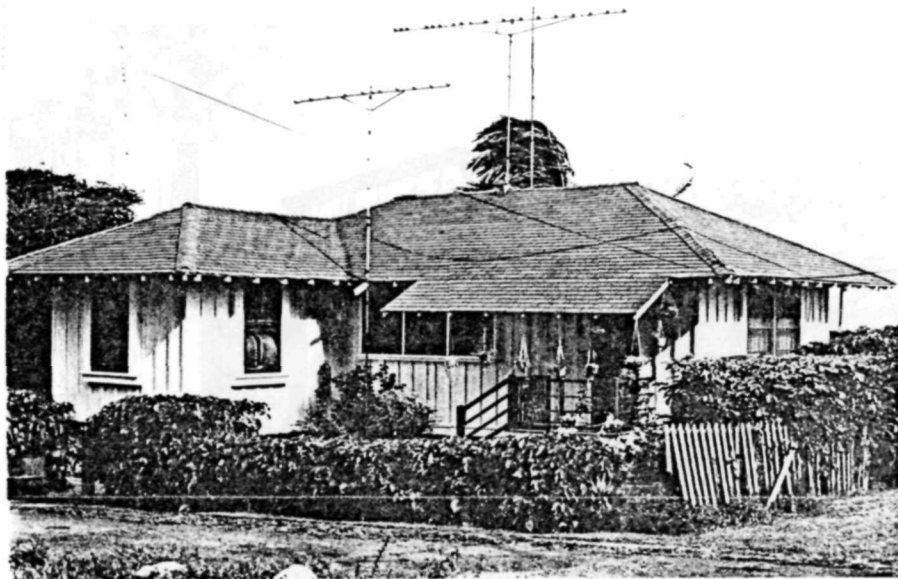
STRUCTURE: Building 33

DESCRIPTION: The structure is a one-story building of single wall construction, with a concrete pad and post foundation. The hip roof of the L-shaped building is finished with red composition shingles. The wood frames of the 12-light double hung windows project several inches from the exterior wall. The exterior finish is board and batten. A wooden porch, covered with a shed roof, provides access to the main entrance on the south side of the structure. The building is occupied. The structure has been recently painted, and seems to be in very good condition. Fumigation is recommended.

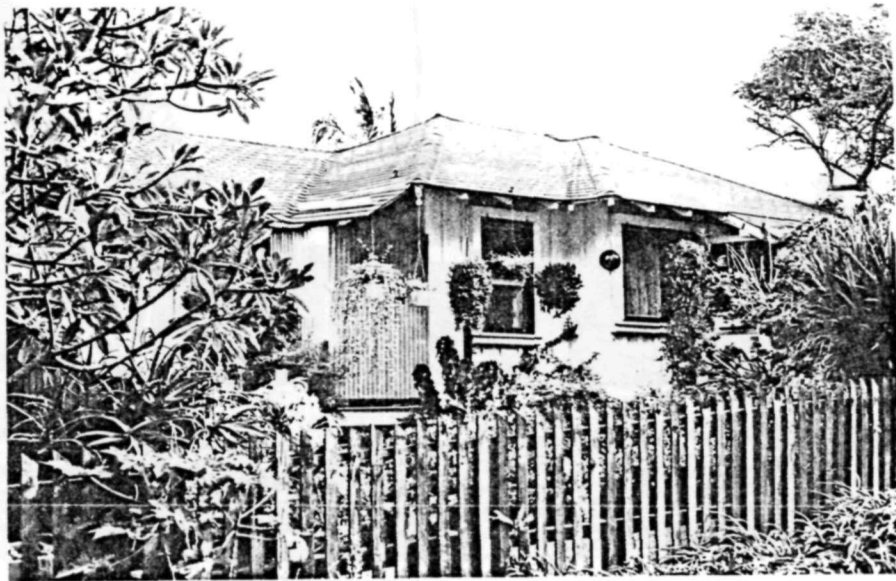
STRUCTURE: Building 34

DESCRIPTION: The structure is a one story building of single wall construction, with a concrete pad and post foundation. The generally hip roof of the irregularly shaped structure is finished with generally green composition shingles. The wood frames of the 12-light double-hung windows project several inches from the exterior wall. The exterior finish is board and batten. At the rear of the structure is an addition with a shed roof finished with rolled composition roofing. The structure is occupied and in good condition. The roof eaves should be scraped and painted. A tree at the southeast corner of the structure should be trimmed or removed to prevent damage to the roof. The structure should be fumigated. Grade on all sides of the building should be clear of earth and vegetation, to help prevent rot and termite damage.

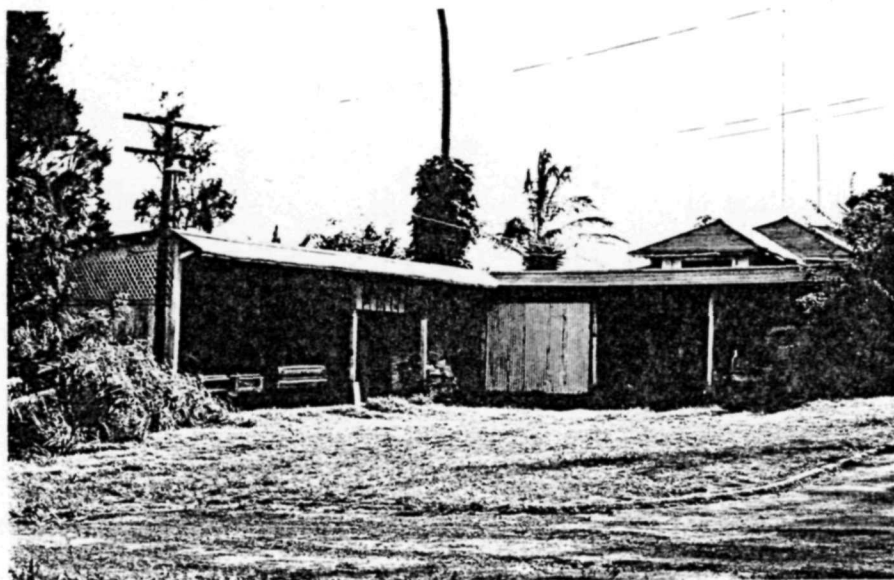
STRUCTURE: Building 35

DESCRIPTION: The structure is a one story garage, of single wall construction. The shed roof of the L-shaped structure is finished with green rolled composition roofing. The rectangular portion at the vertex of the "L" is a storeroom constructed on a concrete slab. The structure is in fair condition, although infested with termites and rot. The building, which is still in use, should be maintained until it is no longer needed, or until it becomes a hazard, at which time it should be removed.

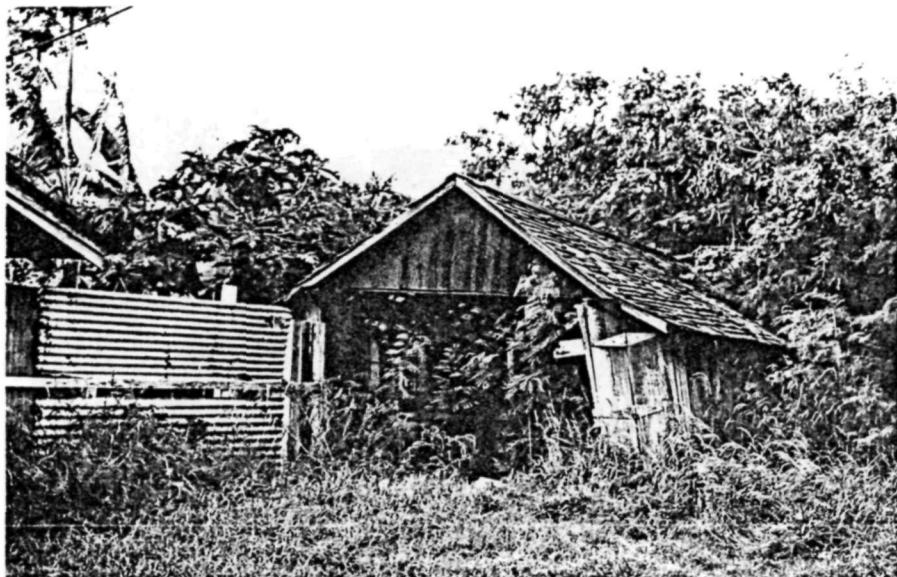
STRUCTURE: Building 514
LOCATION: Bay View area
USE: Abandoned garage
SIZE: Approx. 15 x 15 OWNERSHIP: Private
DATE OF STRUCTURE: Unknown
DESCRIPTION: The structure is a frame building of single wall construction. The walls are board and batten and vertical plank siding. The gable roof is covered with wood shingles. The structure is sagging badly, and about to collapse.
