KALAUPAPA BUILDING INVENTORY

KALAUPAPA - HAWAII

RESIDENTIAL AREA - PRIVATE OWNED STRUCTURES

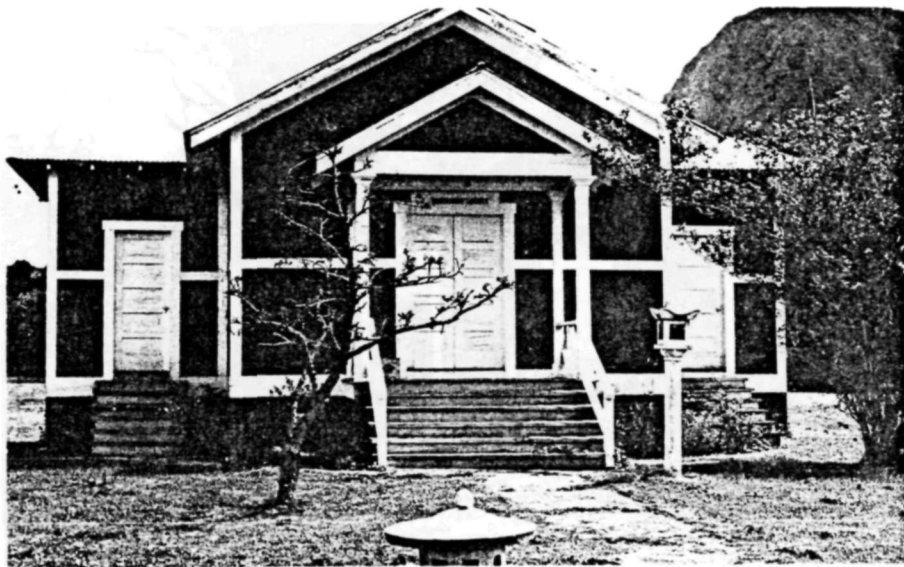
STRUCTURE: Building 308

DESCRIPTION: The structure is a one-story building of single wall construction, with a stone pad and post foundation. The symmetrical structure has a cruciform shape. The main gable roof is intersected by the hip roofs of the wings which are approximately one foot lower than the top of the gable. A possible addition, with a shed roof is located at the rear. A projecting portico, with a gable roof is the main entrance to the structure. The corners of the portico are articulated by two chamfered posts and two chamfered pilasters. All roofs are finished with corrugated metal. Most of the foundation is camouflaged by latticework skirting. The wood frame windows are double hung (twelve-light). The front entrance has a five-panel double door. Five panel doors also are located at the wing entrances on either side. A broken girt encircles the exterior of the structure, except for the rear wing, which is simply the vertical plank siding. The corners of the structure are finished with cornerboards. The lower portion of the building is finished with a wide water table. All trim is painted white, which contrasts with the pea-green of the plank siding. The structure is in deteriorated condition, and is in need of approximately 50 percent board-by-board reconstruction, fumigation and painting. The building is used for storage, and intermittently for social gatherings. A mill stone of fine-grained stone is located at the rear of the building. The origins and specific use of the stone are unknown.

SIGNIFICANCE: The structure is well-proportioned and finely put together. The history warrants further research. The structure is not a Monument of Hawaiian Architecture, but a symmetrical and formal building interpreted with the simplicity, rudeness and charm of Hawaiian vernacular architecture.

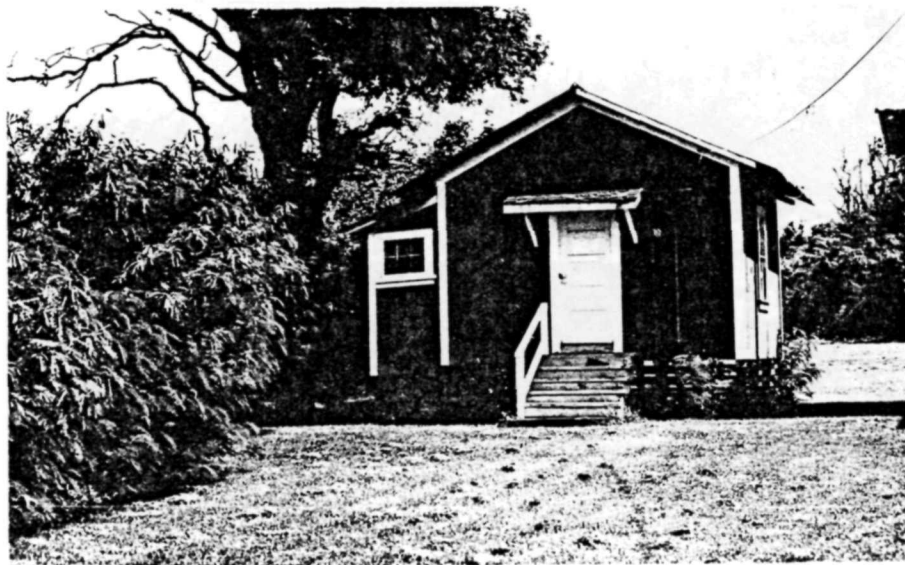
STRUCTURE: Building 309

DESCRIPTION: The structure is a one-story building of single wall construction, with a stone pad and post foundation. The structure has a gable roof, finished with corrugated metal. An extension (addition?) on the north side of the structure is sheltered by a shed roof. Another shed roof, finished with wood shingles, covers the front entrance way. The corners of the structure are finished with cornerboards. The structure is in poor condition, and preservation is of questionable value.

SIGNIFICANCE: Not of architectural significance, and in more deteriorated condition than the main structure. Historical significance is also doubtful, but should be research before demolition is approved.

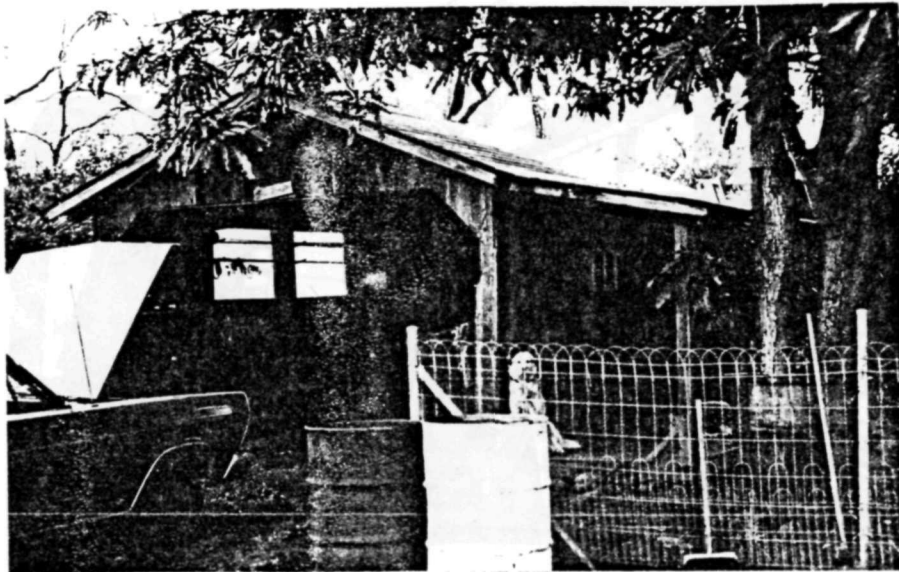
STRUCTURE: Building 562

DESCRIPTION: The structure is a frame building of single wall construction with a concrete foundation. The gable roof and shed extension are finished with composition shingles. The structure has vertical plank siding. The building is in fair condition, and is still in use.

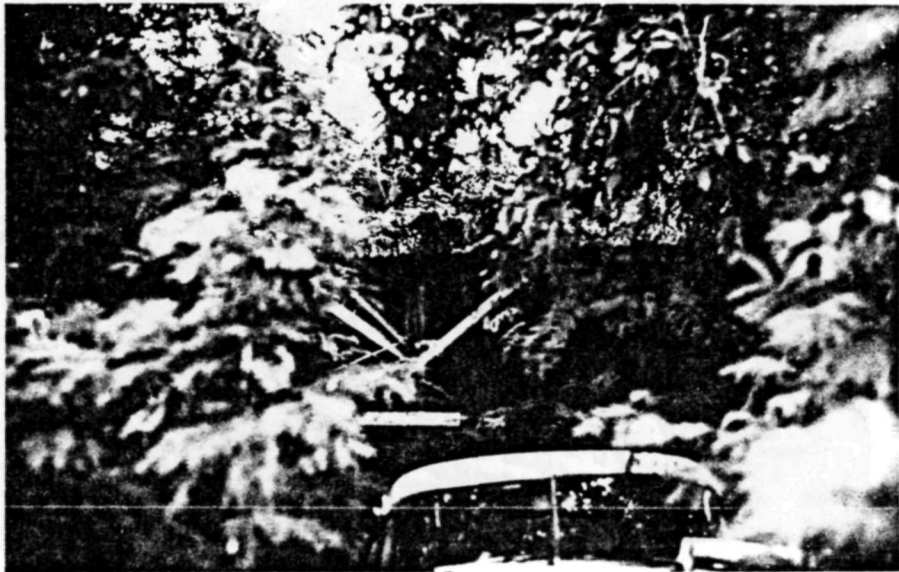
STRUCTURE: Building 566

DESCRIPTION: The structure is a frame building of single wall construction, with a shed roof. The roof is finished with corrugated metal. The structure is so overgrown, that it is hardly visible, and very inaccessible. Presumed to be in deteriorated condition.

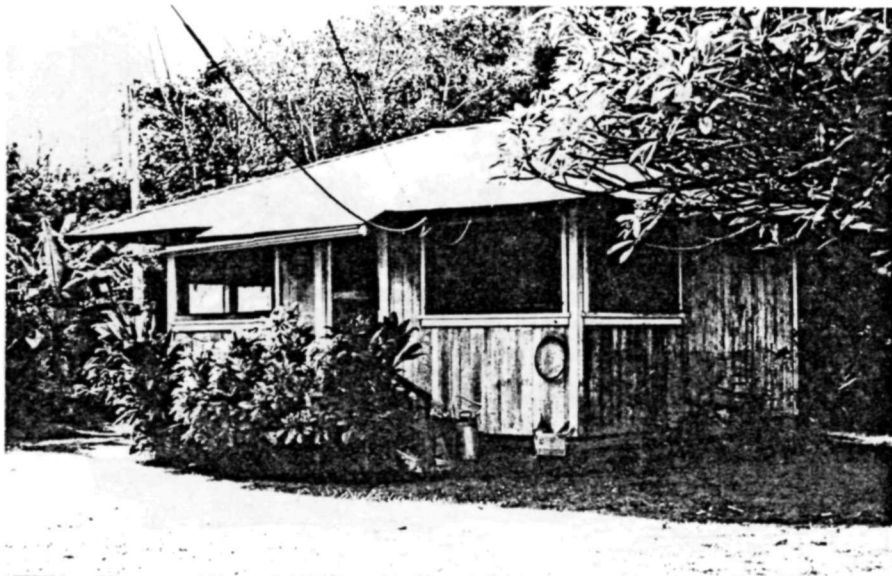
STRUCTURE: Building 569

The structure shows signs of rot and termites, and is in fair to poor
condition.

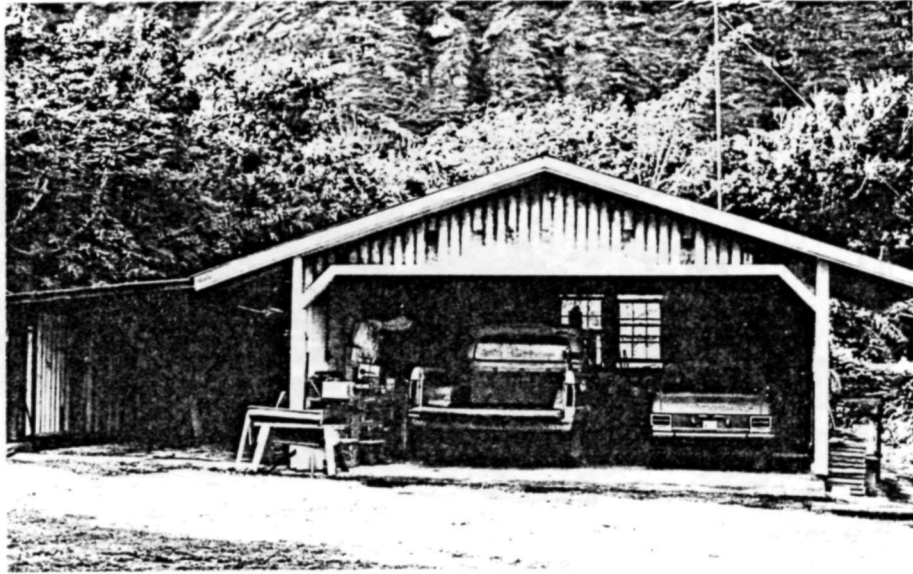
STRUCTURE: Building 571

DESCRIPTION: The structure is a frame building of single wall construction. The gable and shed roof are covered with corrugated metal. The structure has a concrete foundation. The exterior is vertical plank siding. The structure is in use, and seems to be in fair condition.

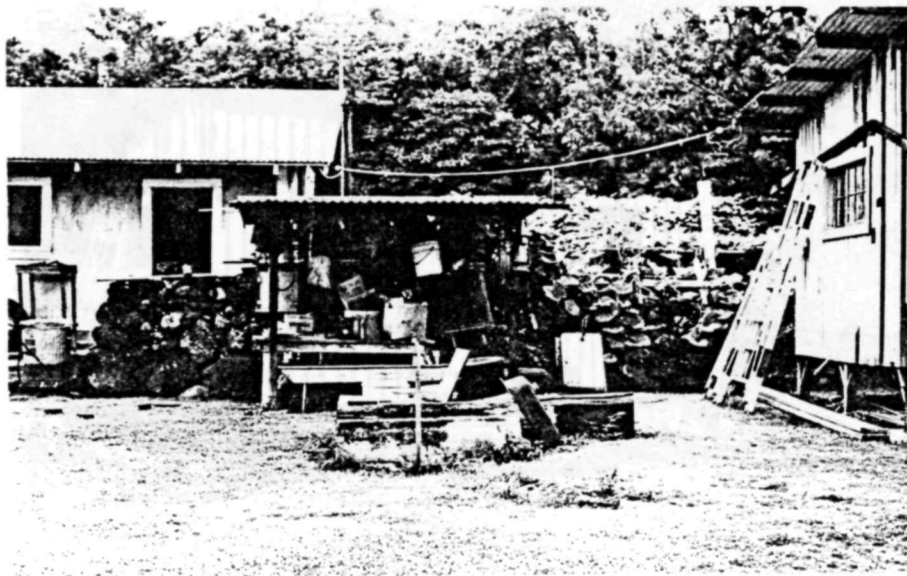
STRUCTURE: Building 572
LOCATION: Kaiulani Street
USE: Storage shed
SIZE: Approx. 8 x 10 OWNERSHIP: Private
DATE OF STRUCTURE: Unknown
DESCRIPTION: The structure is a wood frame which rests on concrete footings.
The shed roof is covered with corrugated metal. The structure is in use,
and seems to be in fair condition.

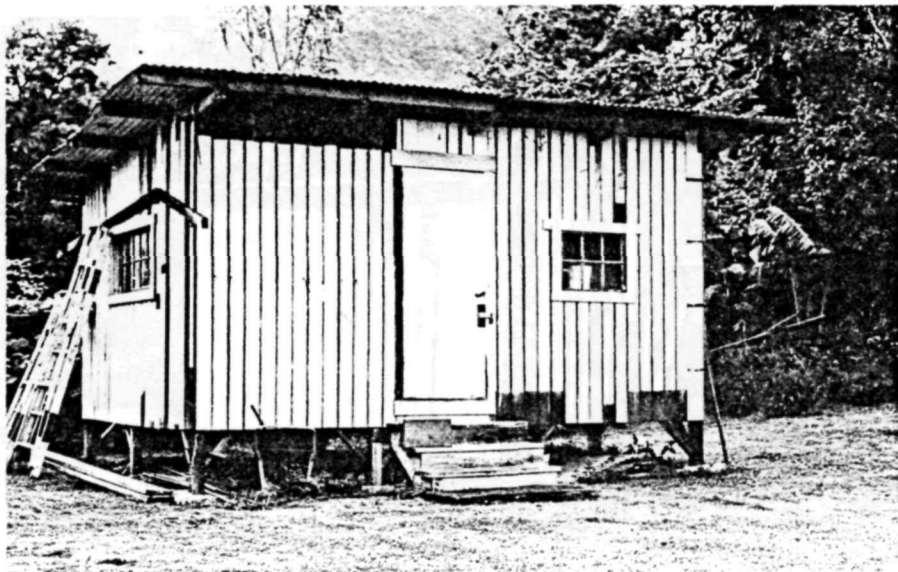
STRUCTURE: Building 573

DESCRIPTION: The structure is a frame building of single wall construction,
with a concrete pad and post foundation. The walls are covered with vertical
plank siding, which seems to have been recycled from another structure. The
shed roof is covered with corrugated metal. The structure seems to be in
fair condition.

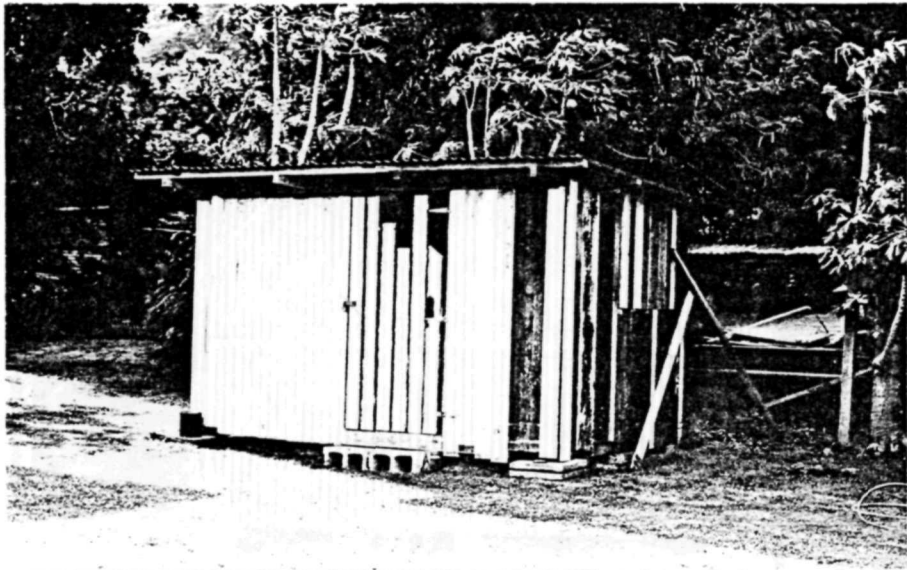
STRUCTURE: Building 574

DESCRIPTION: The structure is a frame building of single wall construction, with a concrete pad and post foundation. The walls are covered with vertical plank siding. The shed roof is covered with corrugated metal. The structure seems to be in fair condition.

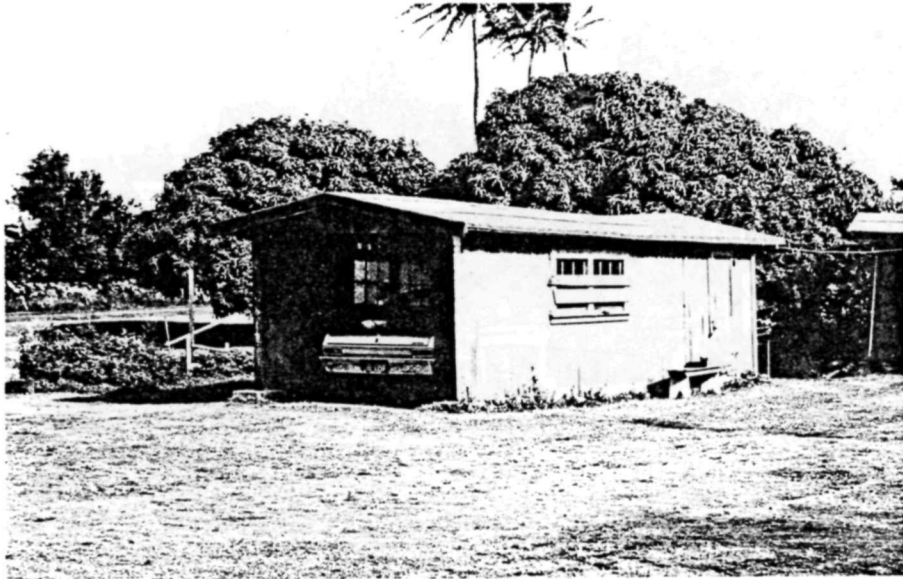
STRUCTURE: Building 581

DESCRIPTION: The structure is a frame building of single wall construction, built on a concrete foundation. The sagging gable roof is finished with rolled composition roofing material. The walls are vertical plank siding. The structure has termites and rot, and seems to be in poor condition.

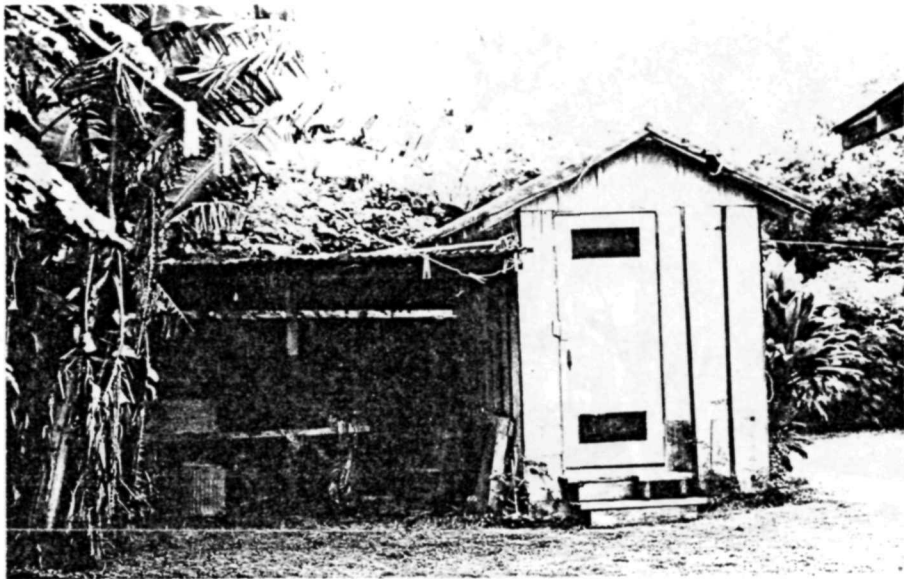
STRUCTURE: Building 583

DESCRIPTION: The structure is a frame building of single wall construction, with a board and batten exterior. The foundation consists of concrete blocks. A partially enclosed shed is located on one side of the structure. The gable roof is finished with rolled composition roofing, and the shed roof is covered with corrugated metal. The structure is in poor condition, and shows signs of rot and termite damage.

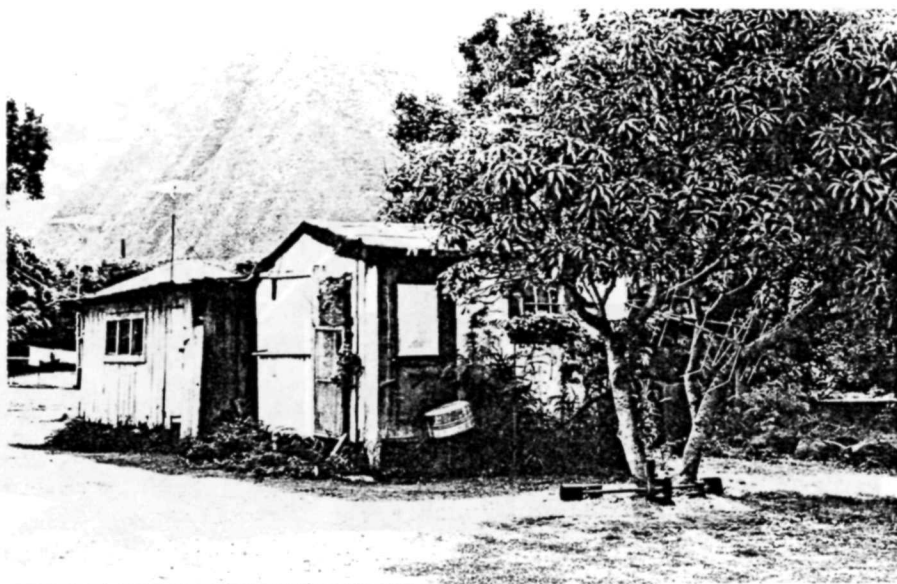
STRUCTURE: Building 584

DESCRIPTION: The structure is a frame building of single wall construction. The shed and gable roofs are finished with rolled composition roofing material and corrugated metal. The structure has had many additions, and seems to have been constructed of recycled material. The building is in poor condition.

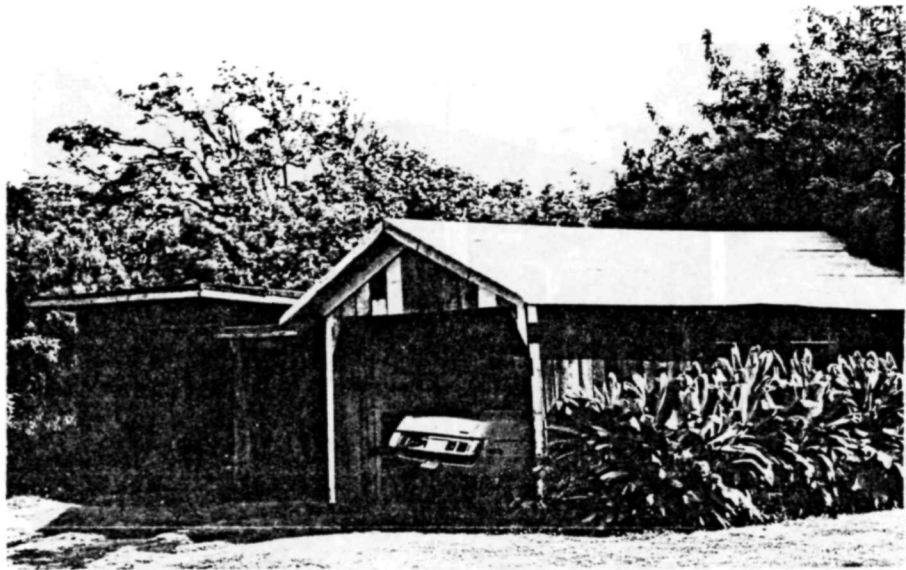
STRUCTURE: Building 585

DESCRIPTION: The structure consists of three buildings joined together. All are of frame construction, with vertical plank or board and batten siding. The one gable and two shed roofs are finished with rolled composition roofing material. The structure shows signs of rot and deterioration. The structure is in use, and in fair condition.

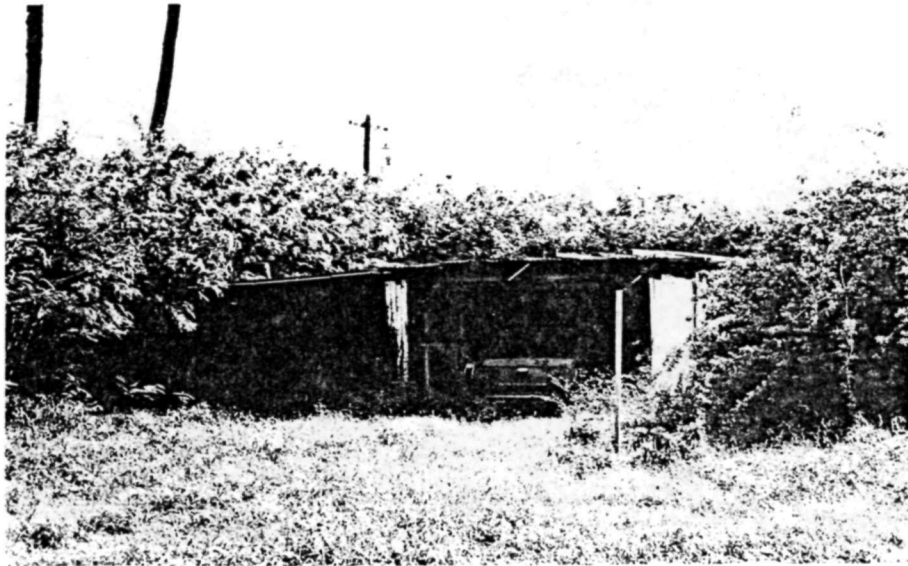
STRUCTURE: Building 589

DESCRIPTION: The structure is a frame building of single wall construction.
The shed roof is covered with corrugated metal. The building is divided
into stalls for two vehicles. The structure is used (vehicle storage),
but is in poor condition.

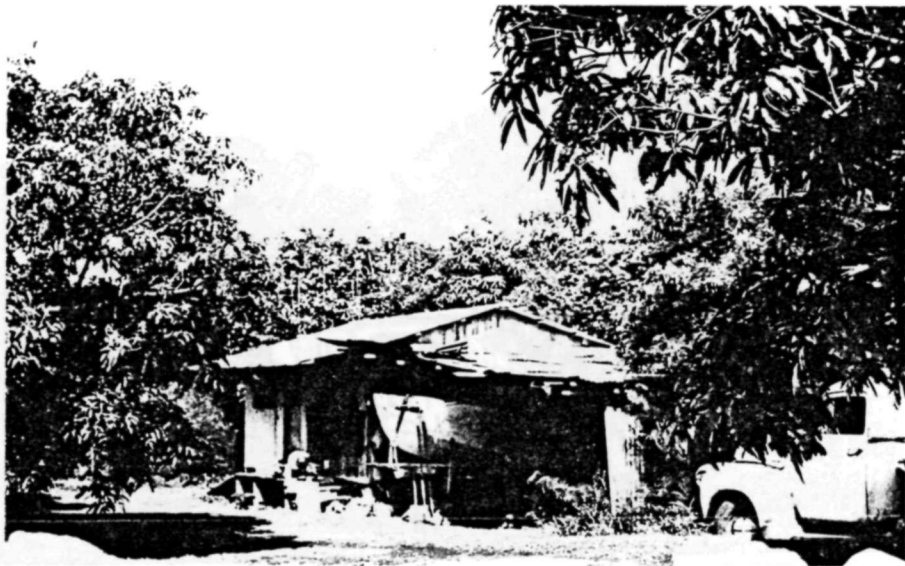
STRUCTURE: Building 590

The gable roof covered the main section of the structure. A shed has been attached to one side of the building. Both roofs are finished with corrugated metal. The structure is in use, and is in deteriorated condition.

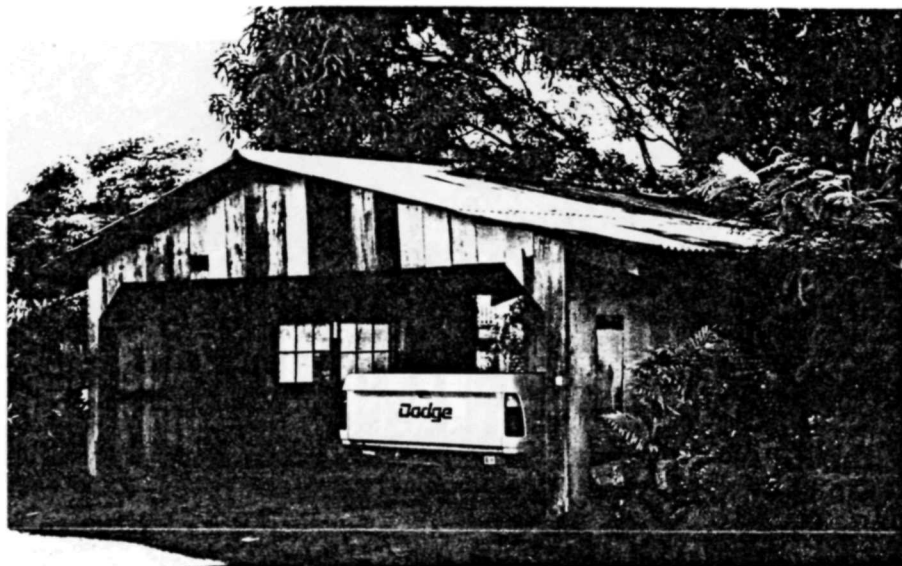
STRUCTURE: Building 592

DESCRIPTION: The structure is a frame building of single wall construction, with a concrete foundation. The gable roof is covered with vertical plank siding. The building is used to shelter two vehicles. The structure is in fair condition.

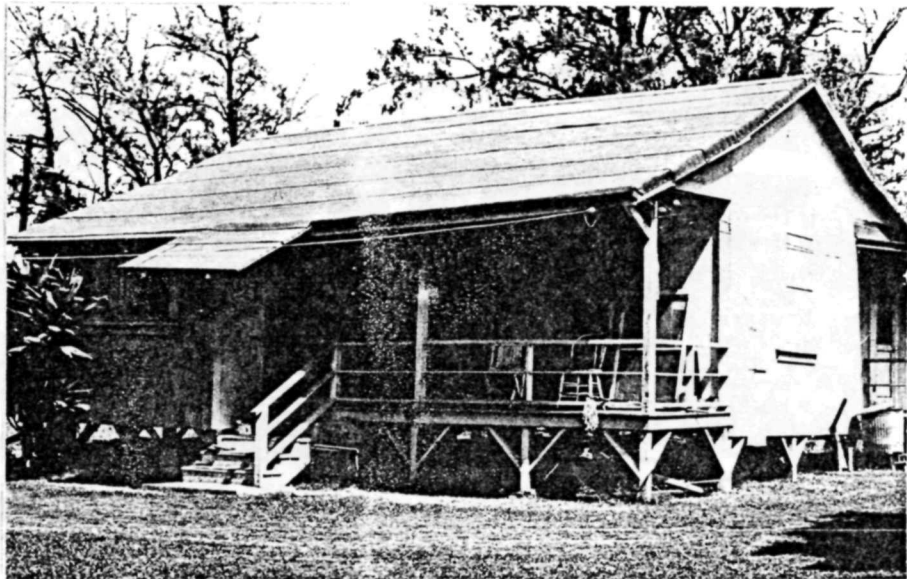
STRUCTURE: Building 115
LOCATION: Goodhue Street
USE: Residence
SIZE: Approx. 1000 sq. ft. OWNERSHIP: State
DATE OF STRUCTURE: 1931
DESCRIPTION: The structure is a one-story building of single wall construction. The exterior finish is board and batten and verticle plank siding, with corner boards at the corness. The gable roof is finished with green rolled composition roofing material. The wood frame windows are double hung (twelve light). A recessed porch is incorporated under the roof is sagging. The structure is occupied and in fair to poor condition. The building should be painted. Termite damage should be replaced. The structure should be re-roofed with the original roofing material (shingles?). The building should be fumigated.

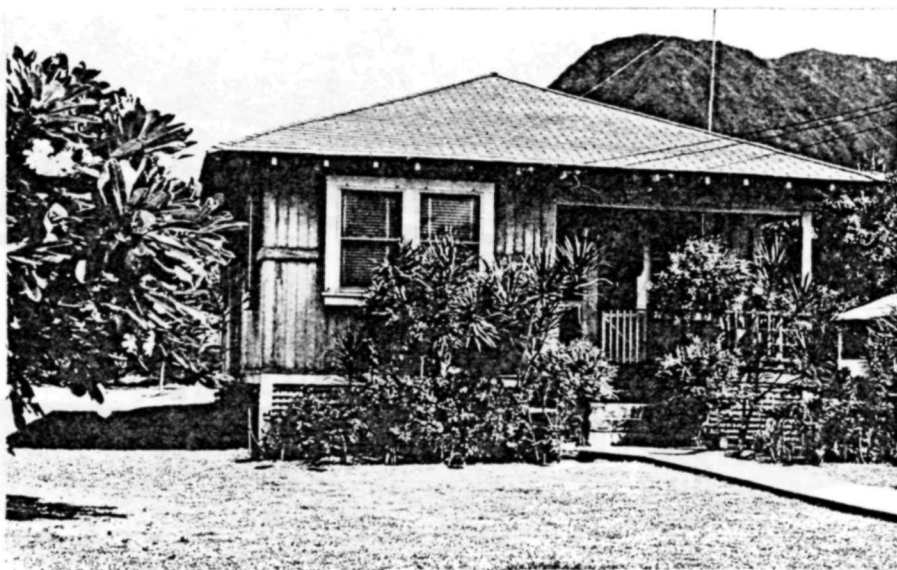
DESCRIPTION: The structure is a one-story building of single wall construction, with a pad and post foundation. Stone and concrete steps provide access to the recessed corner porch which is incorporated under the hip roof. One chamfered post and two chamfered pilasters articulate the edges of the porch. The corners of the building are finished with corner boards. A girt encircles the structure and is broken by the wood frames of the double-hung windows which project several inches from the exterior of the vertical plank wall. The hip roof is finished with composition shingles. A wood porch is located at the rear of the structure. The building is occupied and in good condition. The structure was recently painted. Fumigation is recommended. Termite damage should be repaired. The masonry of the front steps is in need of minor repointing.

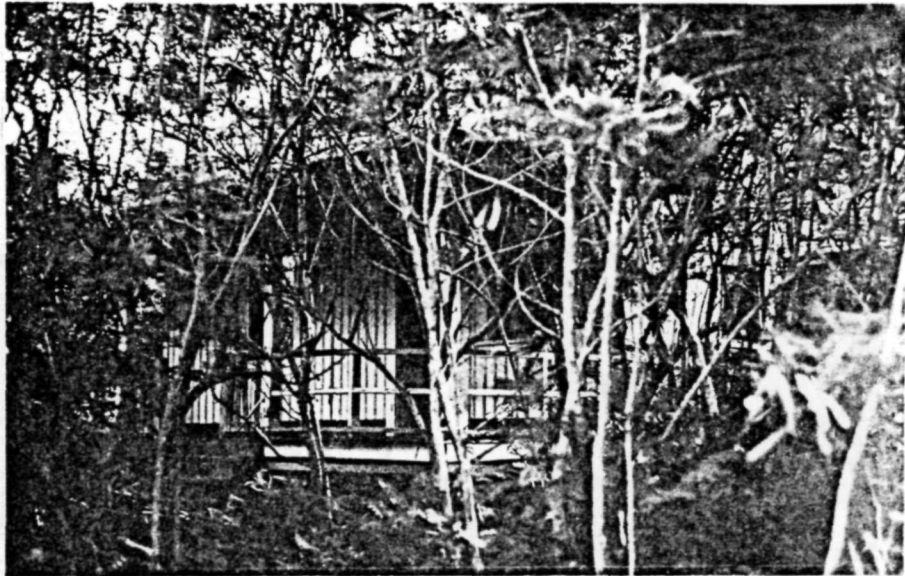
STRUCTURE: Building 188
LOCATION: Kaiulani Street
USE: Abandoned Residence
SIZE: Approx. 900 sq. ft. OWNERSHIP: State
DATE OF STRUCTURE: Unknown (1931?)
DESCRIPTION: The structure is a one-story building of single wall construction with a pad and post foundation. The board and batten exterior finish is the same as that of the dining hall (Building 5, Staff Row). The gable roof of the structure is finished with wood shingles, covered in some sections with rolled composition roofing material. The structure has not been occupied for a long period of time and is very overgrown. The building is riddled with rot and termites. Removal is recommended because of its deteriorated condition.
