# KALAUPAPA BUILDING INVENTORY

## KALAUPAPA - HAWAII

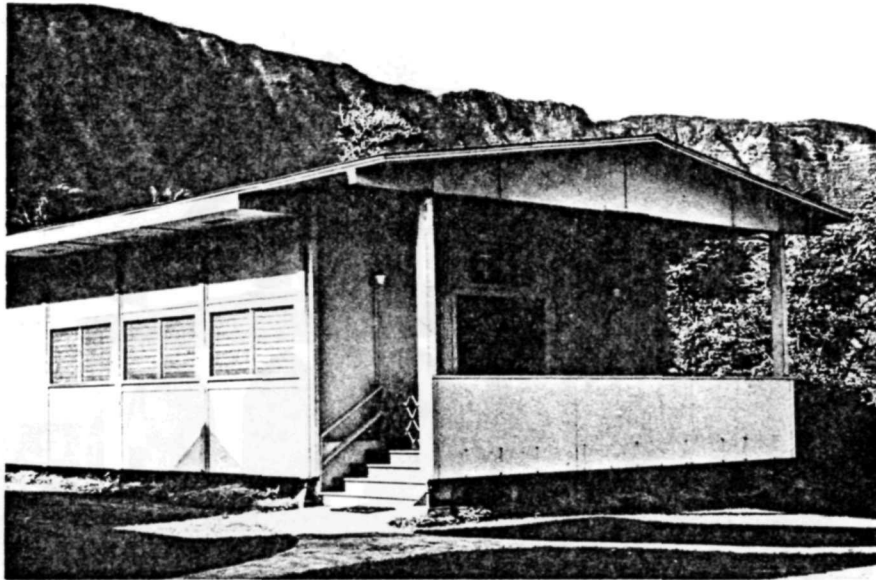
STRUCTURE: Building 287

DESCRIPTION: The structure is a frame building, with a plywood exterior. The foundation consists of concrete pads and metal posts. The gable roof is finished with composition shingles. A veranda, sheltered by the gable roof, stretches across the north end of the structure. The building is frequently used, and seems to be in fair to good condition.

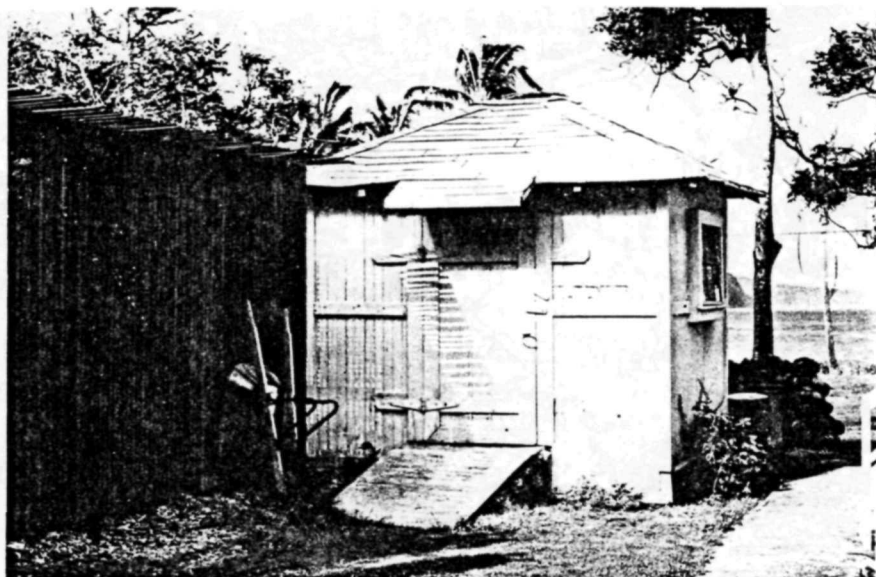
STRUCTURE: Building 637

DESCRIPTION: The structure is a frame building of single wall construction, with a stone pad and post foundation. The hip roof is covered with grey composition shingles. A concrete ramp leads up to the front door of the building. The structure is used, and seems to be in fair condition, although it is infested with termites.

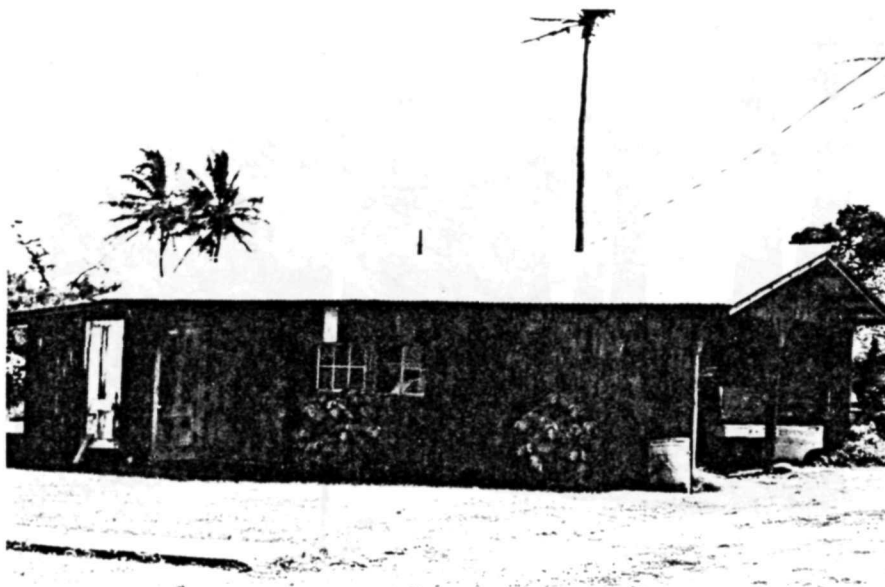
STRUCTURE: Building 643

The walls consist of vertical plank and board and batten siding. The  
gable roof is covered with corrugated metal. The building is divided into  
sections for two cars. A wood frame shed has been attached to the rear  
of the building. The structure is used, and is in poor condition.

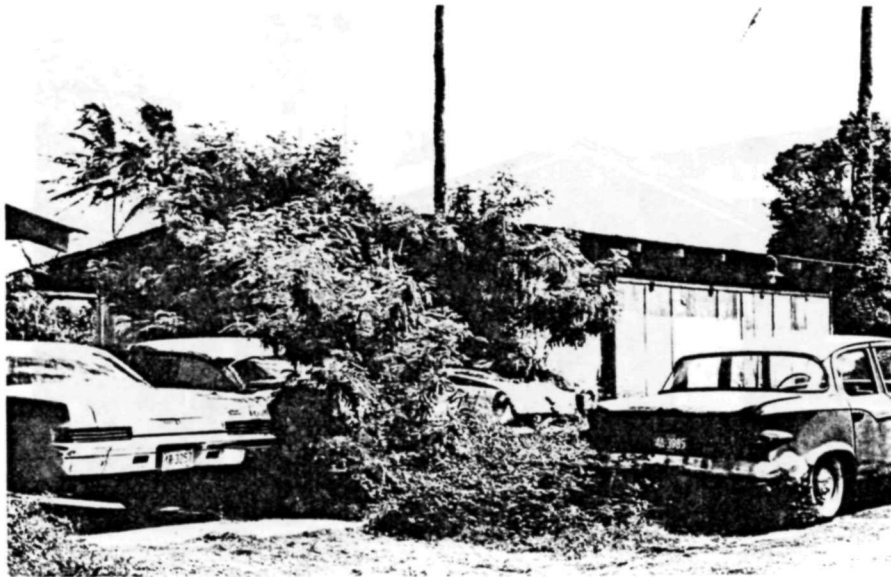
STRUCTURE: Building 646

DESCRIPTION: The structure is a frame building of single wall construction. The walls consist of board and batten siding, and corrugated metal sliding doors. The gable roof is covered with corrugated metal. The structure is becoming overgrown with koa. The building seems to be abandoned, and is in poor condition.

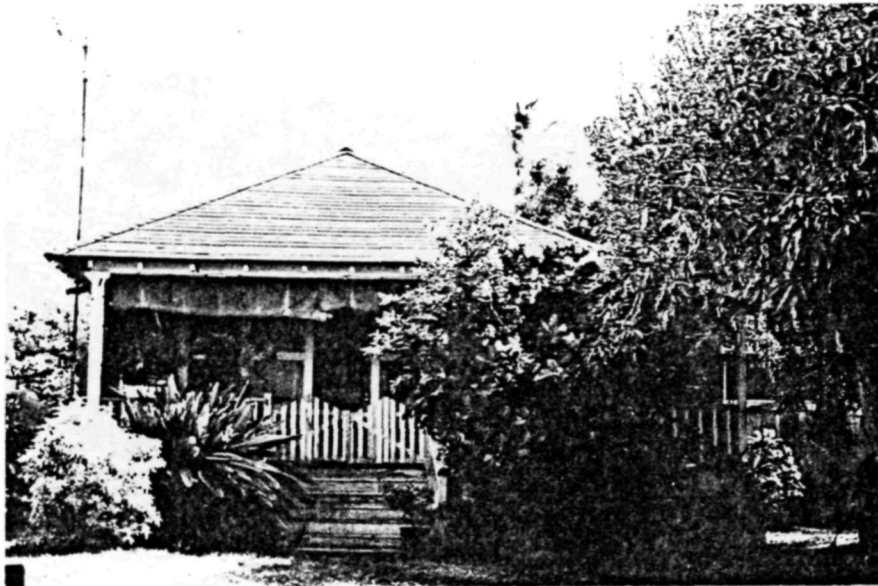
STRUCTURE: Building 30

DESCRIPTION: The structure is a one-story frame building of single wall construction, with a stone pad and wood post foundation. Wood steps provide access to the recessed corner porch which is incorporated under the hip roof. One chamfered post and two chamfered pilasters articulate the edges of the porch. The corners of the building are finished with cornerboards. A girt encircles the structure, and is broken by the wood frames of the double hung windows which project several inches from the exterior of the vertical plank wall. The hip roof is finished with composition shingles. An addition with a gable roof has been attached to the rear of the structure. The building is occupied and in fair condition. Termite damage should be repaired (eaves, particularly), and the structure should be fumigated.

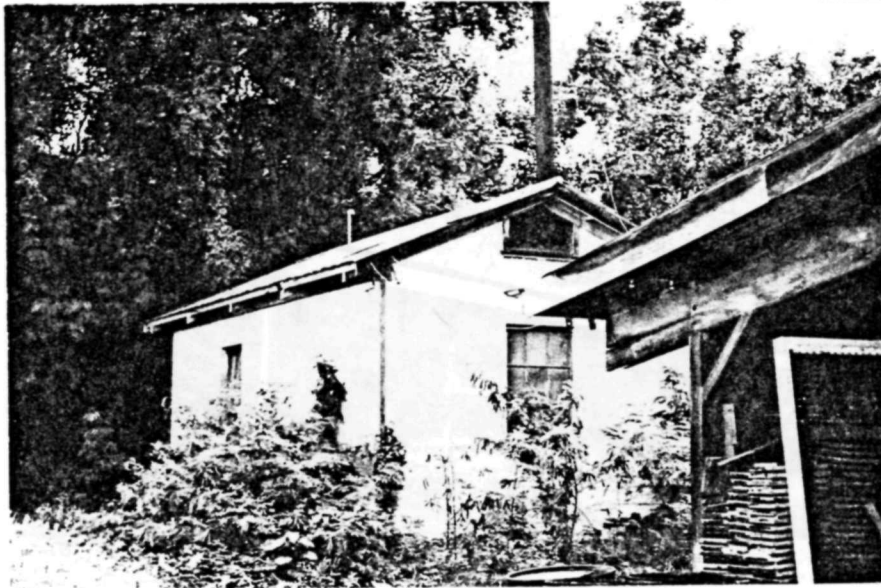
STRUCTURE: Building 262

DESCRIPTION: The structure is a hollow tile building with a gable roof covered with corrugated metal. The building has nine-light metal industrial windows (fixed and hinged sash). The structure is in poor condition, and is being overgrown with koa. It is assumed that the building is no longer used. Removal is recommended.

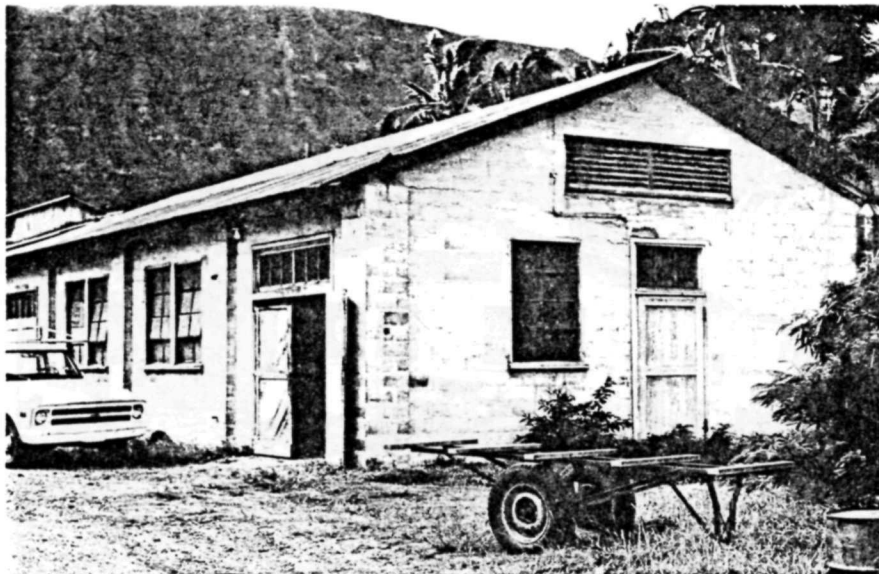
STRUCTURE: Building 264

DESCRIPTION: The structure is a hollow tile building, with a gable roof covered with corrugated metal. The foundation consists of a concrete slab. Single and double wood doors are located at the north and south ends of the building. Most of the windows are eight-light industrial windows (hinged and fixed metal sash). Ventilation louvers are located at the north and south gable ends. The building is in poor condition. Most of the metal throughout the structure is rusting out, including the roof structure. The building receives much use. Replacement of the structure is recommended if a facility of this type is needed over a long period of time. In the mean time, vegetation should be cleared from the base of the building. If the building is to be kept, walls and windows should be repaired, and the roof should be rebuilt.

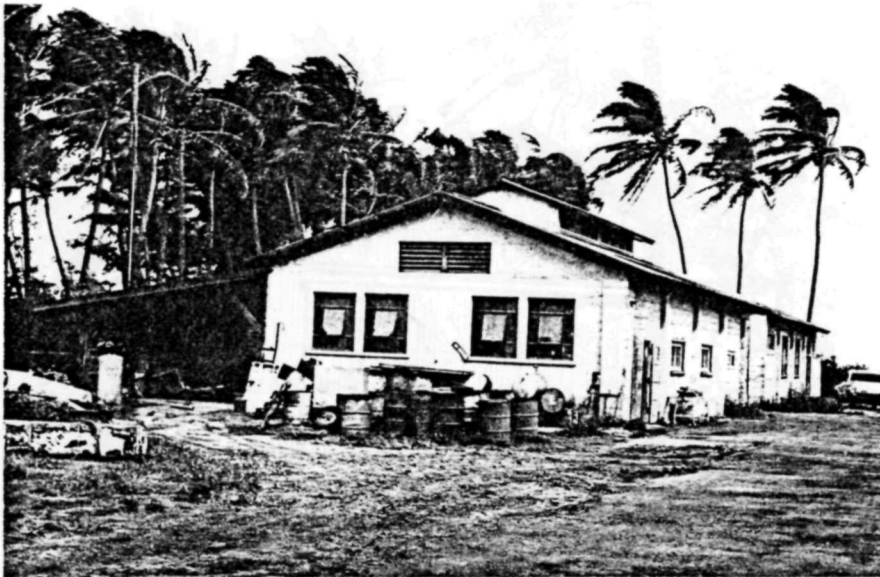
STRUCTURE: Building 265

DESCRIPTION: The structure is a hollow tile building, with a gable roof covered with corrugated metal. A ventilating monitor covers approximately half of the gable. The foundation is concrete. Single and double wood doors are located at the north and south ends of the building. Most windows are eight light industrial (metal sash, hinged and fixed). Ventilation louvers are located at the north and south gable ends. A large wood frame shed, with a corrugated metal shed roof, is located at the rear of the structure. The building is in poor condition. Most of the metal throughout the structure is rusting, including the roof structure. Replacement of the structure is recommended if a facility of this type is needed over a long period of time (very likely). In the mean time, vegetation should be cleared from the base of the building. If the building is to be kept, the walls and windows should be repaired, and the roof should be rebuilt.

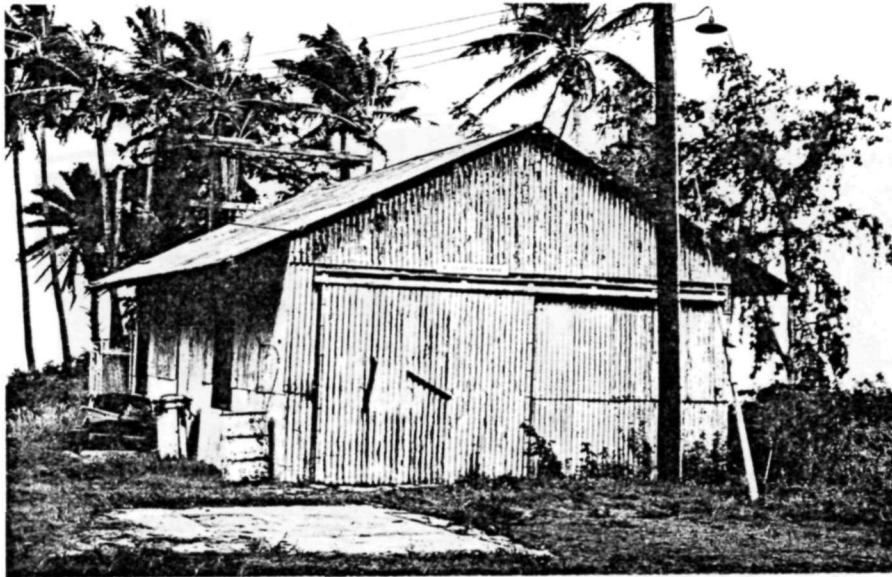
STRUCTURE: Building 266

DESCRIPTION: The structure is a frame building, with corrugated metal walls and roof. The foundation is concrete. The building is in poor condition. A cyclone fence with power transformer is located at the rear of the building. Replacement of the structure would be less expensive than rehabilitation.

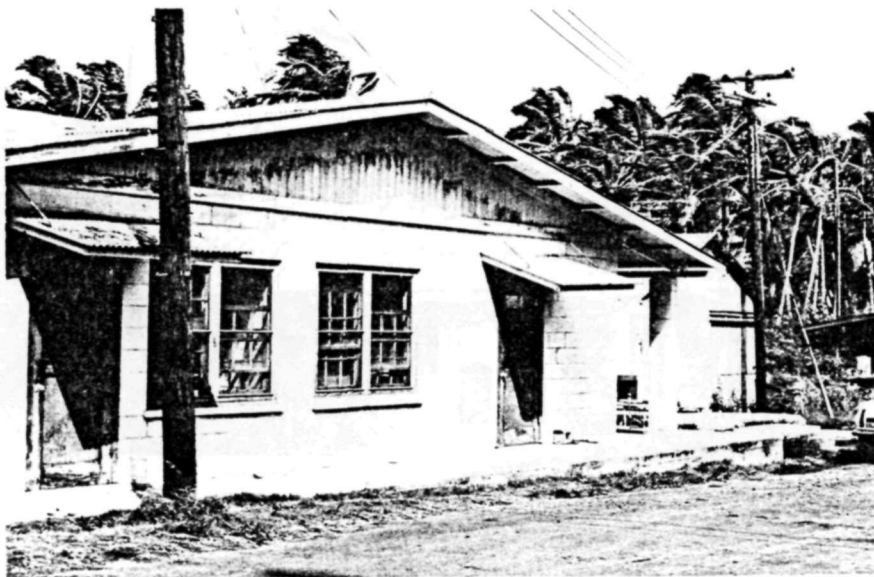
STRUCTURE: Building 267-268

DESCRIPTION: The structure (two buildings with several additions) is built of hollow tile and frame construction. The multiple roofs (gable, shed) are covered with corrugated metal. Most windows are wood frame double hung (twelve light). Gable ends and some wall sections are covered with corrugated asbestos. A loading dock is located on the north side of the structure. An open shed is located on the west side. The structure is in deteriorated condition. Superficial work of fumigating, patching the roof, and painting the exterior will keep the structure usable for several more years. Eventual replacement will be necessary.

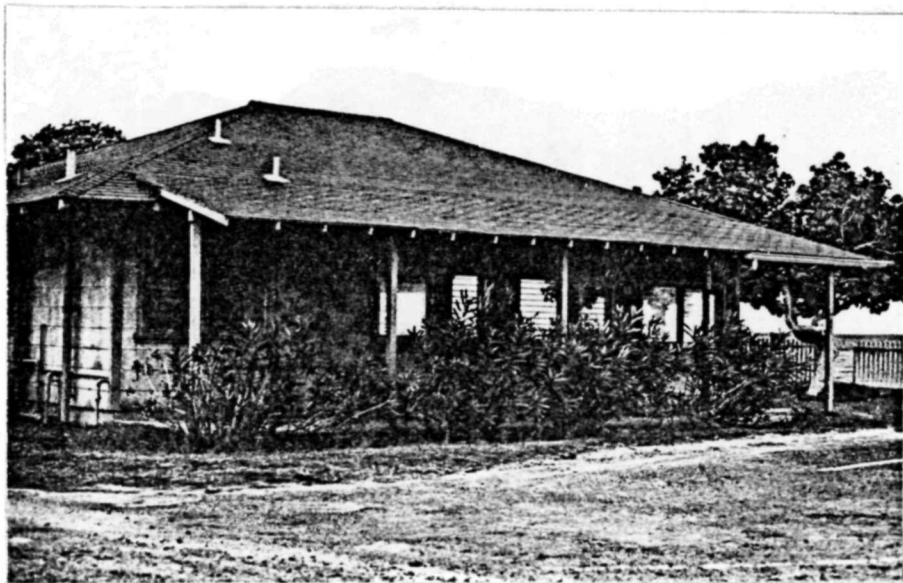
STRUCTURE:	Building 703		
LOCATION:	Airport		
USE:	Airport Terminal		
SIZE:	Approx. 1200 sq. ft.	OWNERSHIP:	Department of Transportation
DATE OF STRUCTURE:	Unknown

DESCRIPTION: The structure is a frame building of single wall construction, with a concrete slab foundation. The hip roof is finished with green composition shingles, and is extended over verandas on sides of the structure. The exterior wall finish is asbestos siding. The wood frame jalousie windows are paired. Most of the north side of the building is open. The structure houses a waiting area for leaving and arriving passengers and restrooms for visitors. The building receives daily use and seems to be in good condition, although it should be fumigated and have small areas painted.
