Kalaupapa and Kalawao Settlements Cultural Landscape Report

VOLUME II OF II
APPENDIX A - INVENTORY TABLE AND MAPS
APPENDIX B - CEMETERY MANAGEMENT PLAN
JUNE 2020

Appendix A: Inventory Tables and Maps

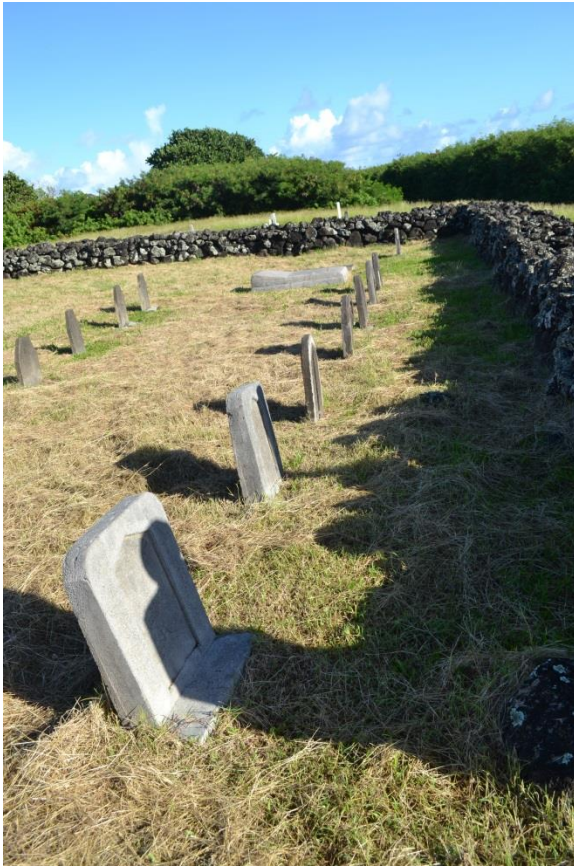
Figure B-67. Example of a leaning grave marker within Cemetery L.

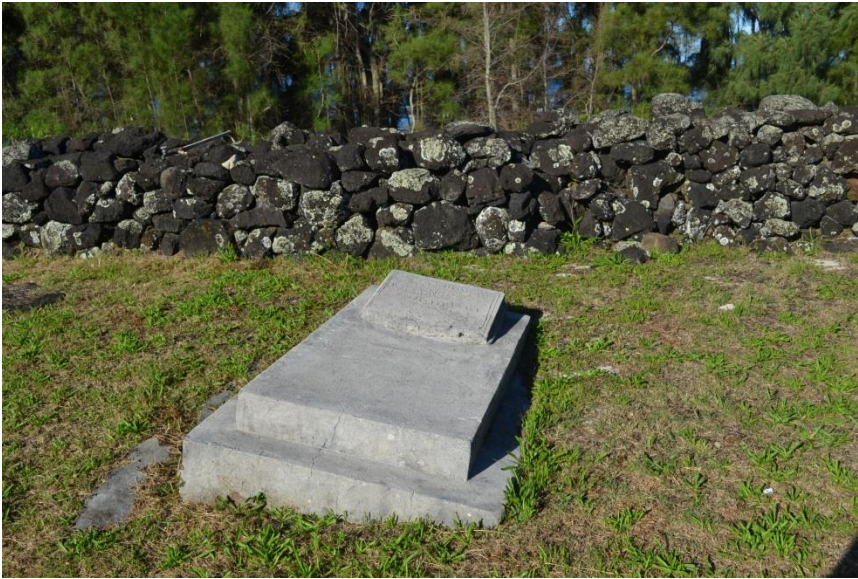
Figure B-68. Example of a grave marker subject to differential settlement in Cemetery L.

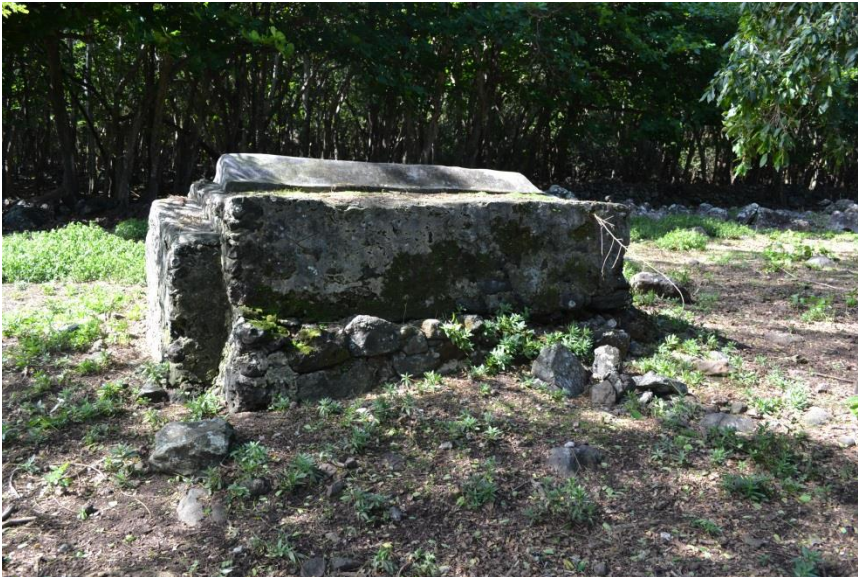
Figure B-69. Example of grave marker with lichen growth in Cemetery P.

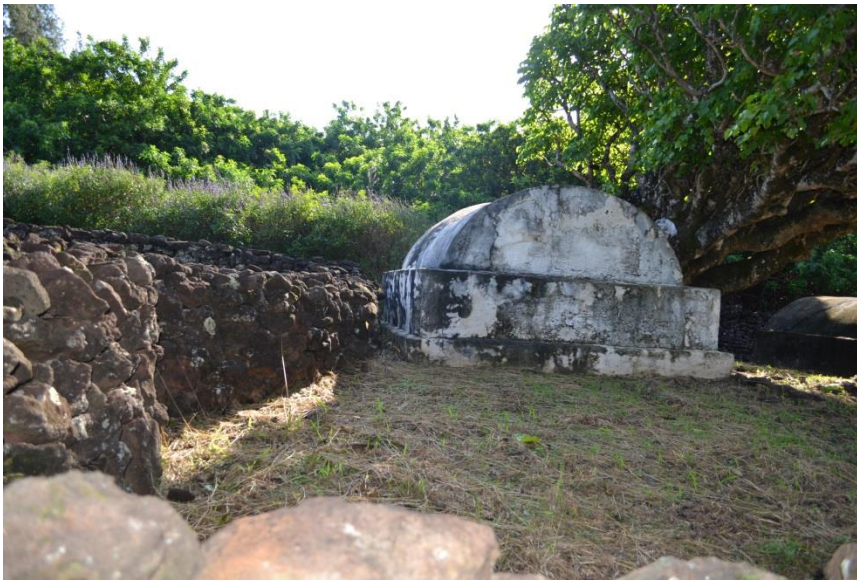
Figure B-70. Example of biological soiling on markers and tombs in Cemetery N.

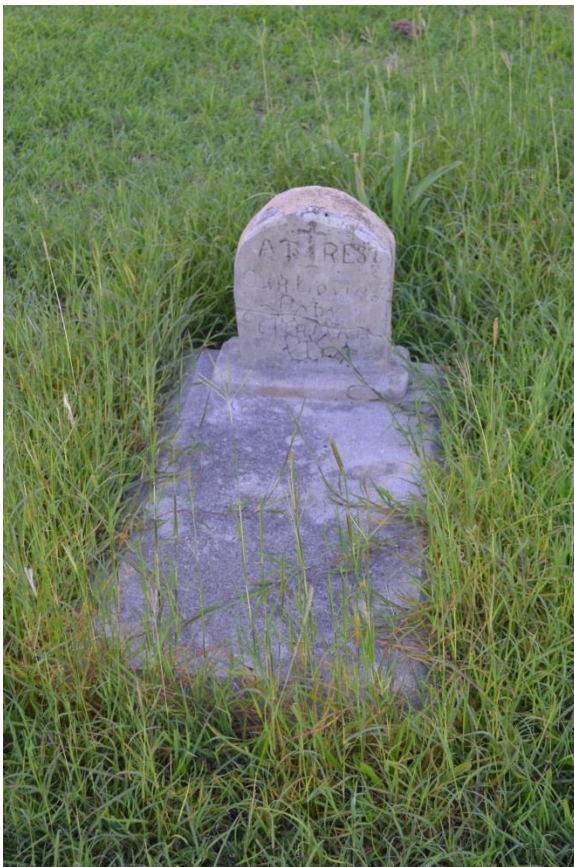
Figure B-71. Example of grave marker inscription at risk of being lost in Cemetery H.

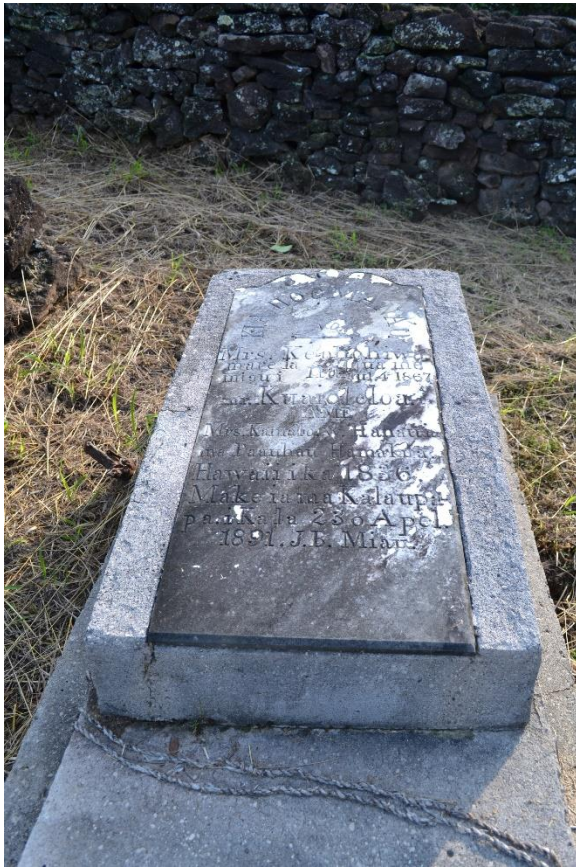
Figure B-72. Example of erosion and surface wear on a horizontal grave marker in Cemetery N.

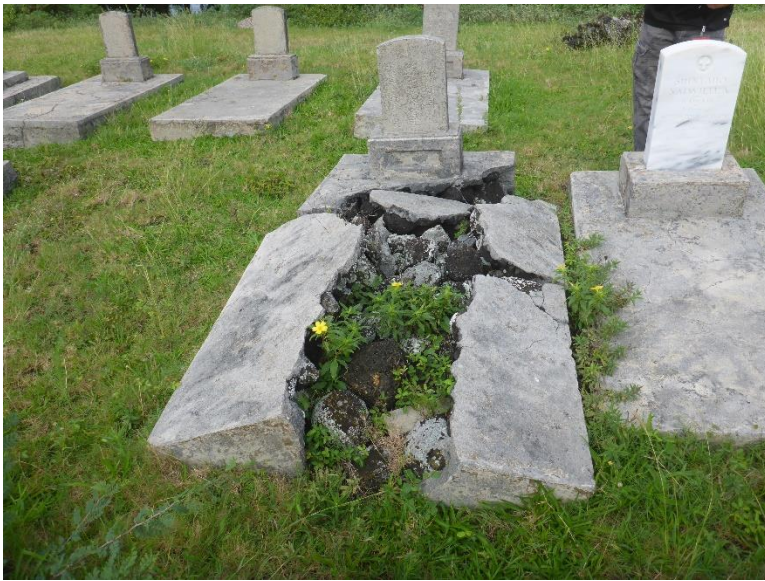
Figure B-73. Example of deteriorated lime-based mortar exposing lava rock below at a grave marker in Cemetery K. (Source: Garcia and Associates, 2018).

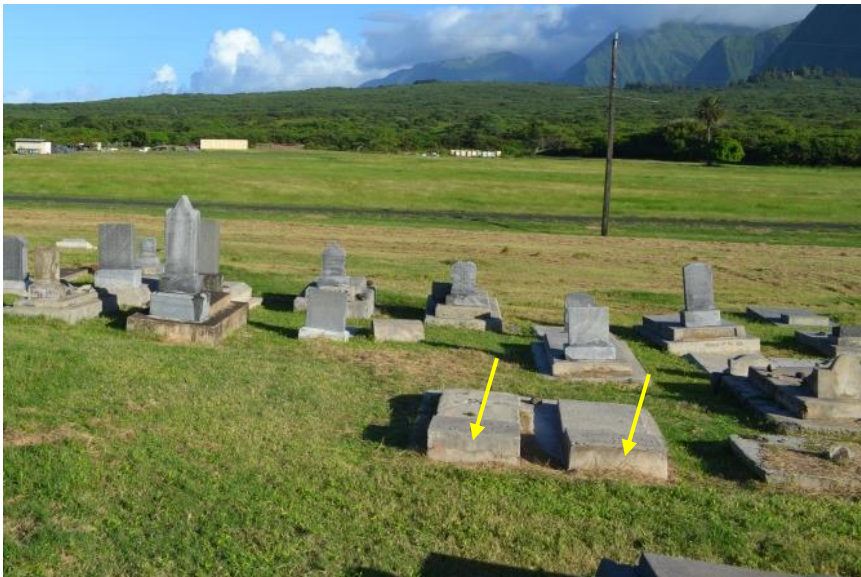
Figure B-74. Example of grave markers with signs of rising damp in Cemetery B.

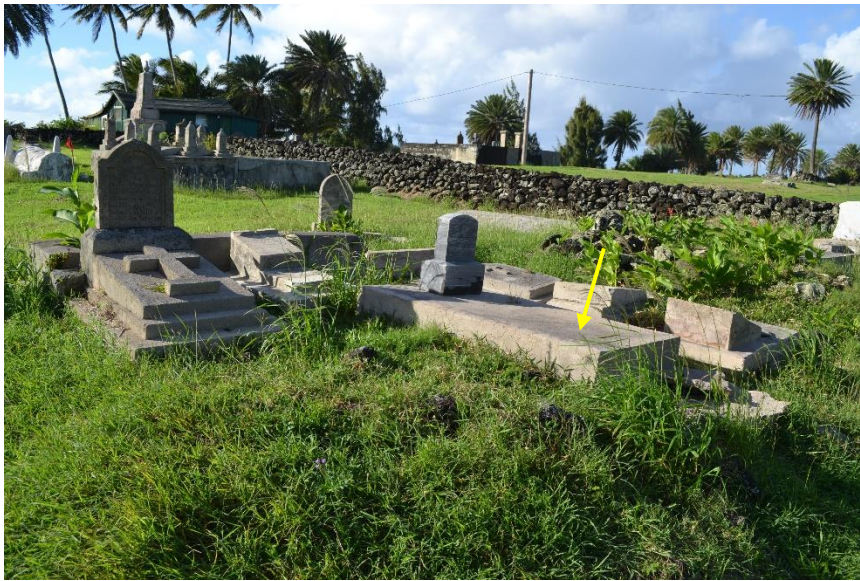
Figure B-75. Evidence of ponding at a flat surface within Cemetery G.

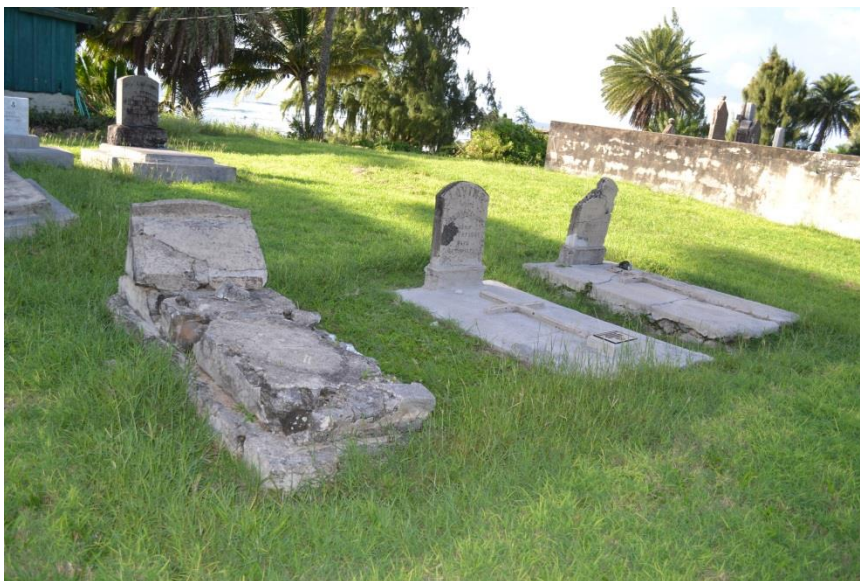
Figure B-76. Example of grave marker with severely cracked and chipped concrete within Cemetery G.

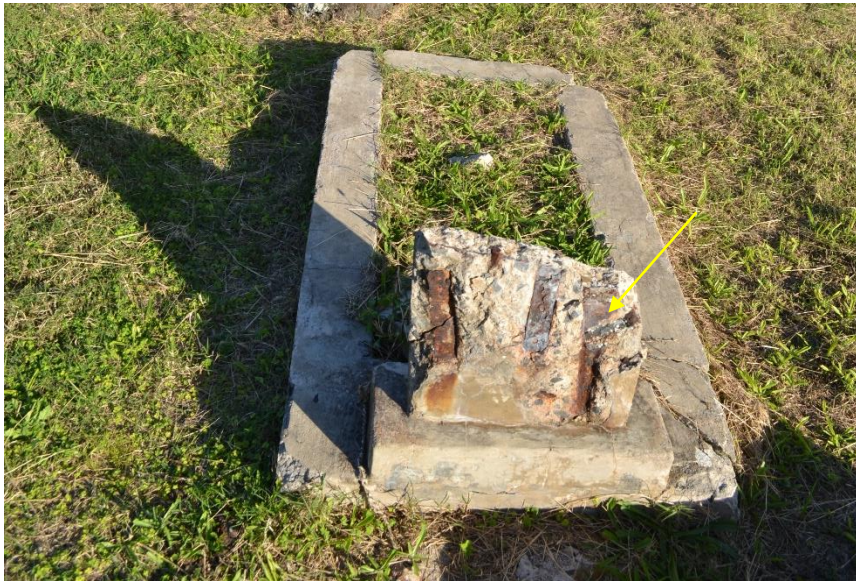
Figure B-77. Example of spalls resulting from corrosion of embedded ferrous metal within Cemetery C.

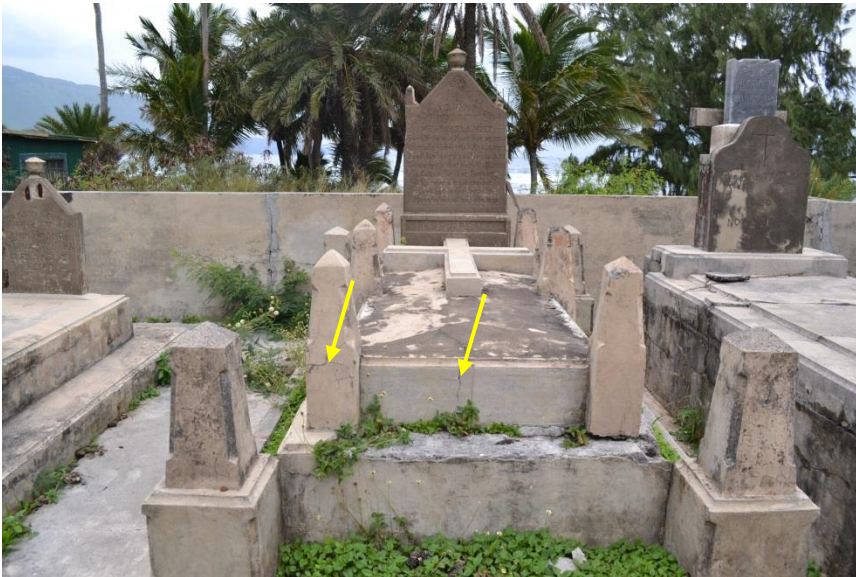
Figure B-78. Example of grave markers with cracking that may be due to corrosion of reinforcing steel within Cemetery G.

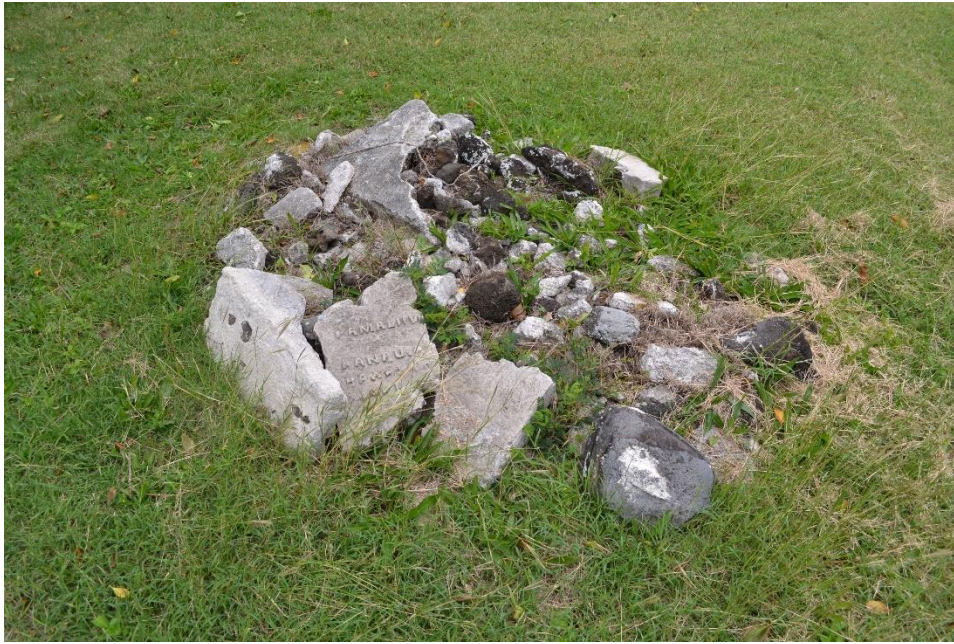
Figure B-79. Example of a broken grave marker within Cemetery H.

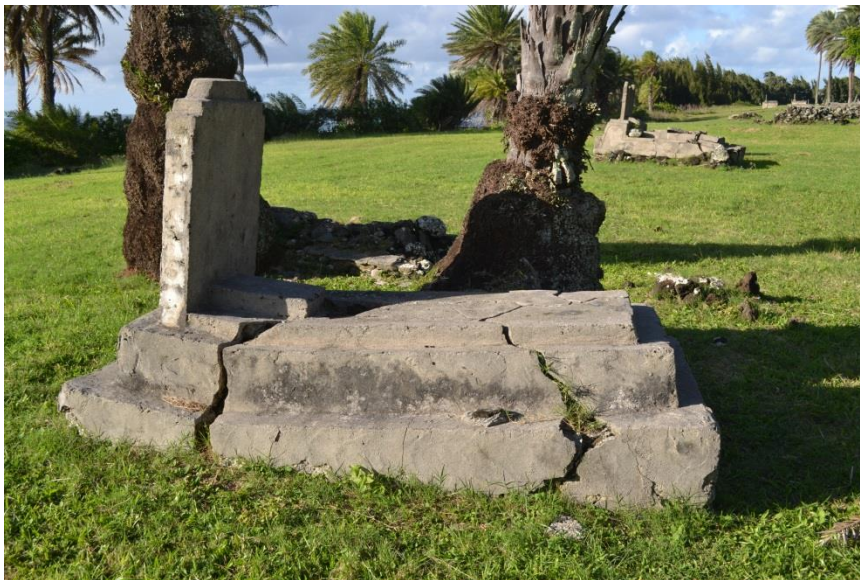
Figure B-80. Example of a collapsed vault within Cemetery G.

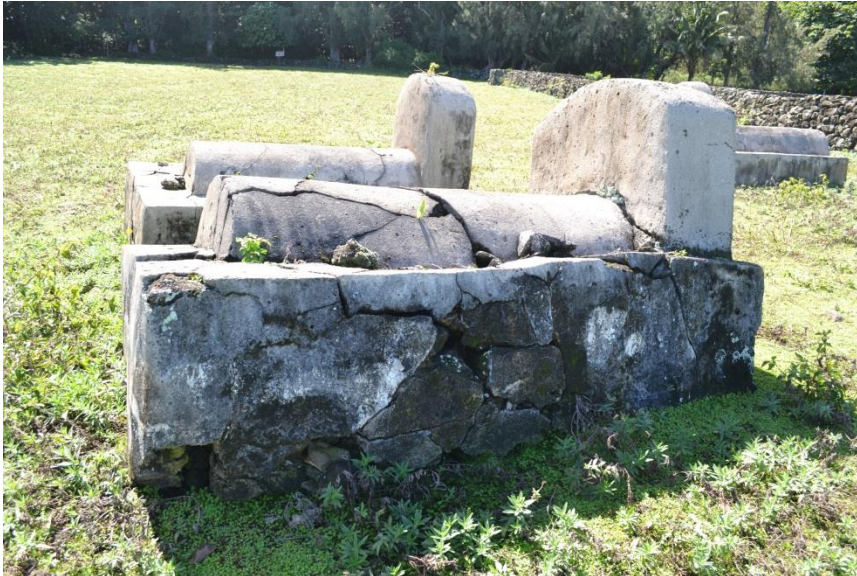
Figure B-81. Example of cracked and broken lime render and limewash coating within Cemetery R.

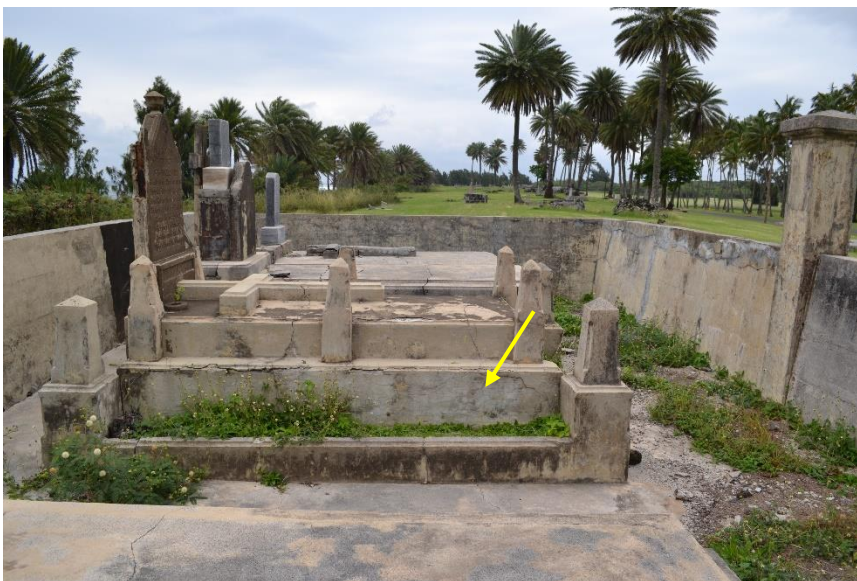
Figure B-82. Example of deterioration from previous incompatible repairs within Cemetery G.

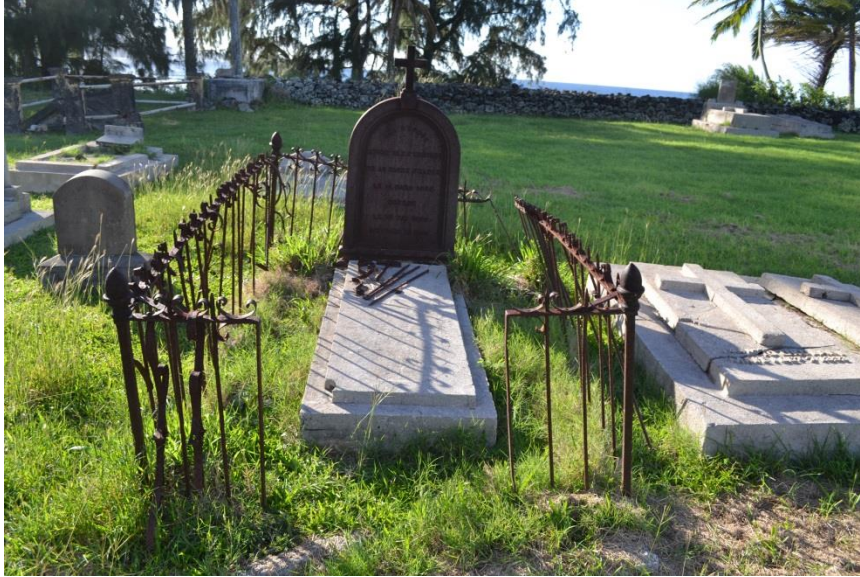
Figure B-83. Example of iron plot surrounds with corrosion and pitting within Cemetery H.

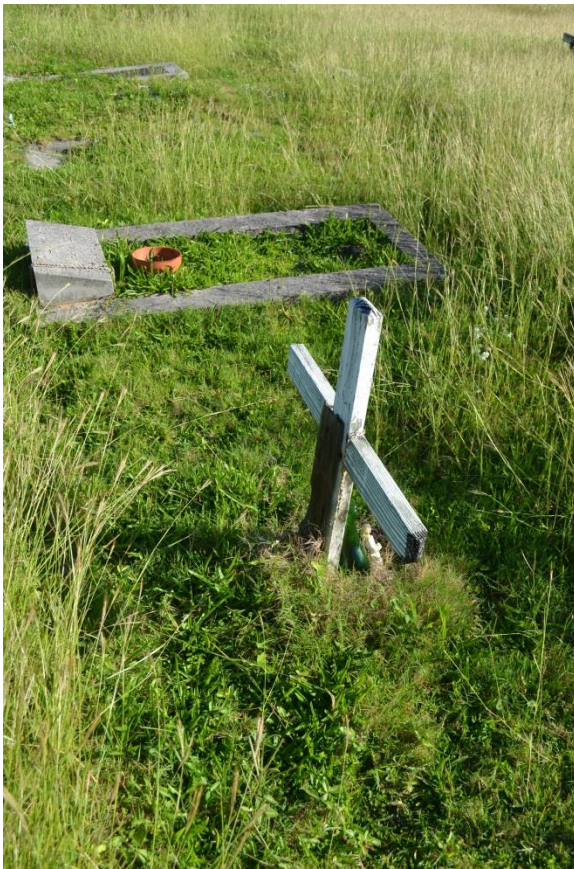
Figure B-84. Example of deteriorating wooden cross within Cemetery J.

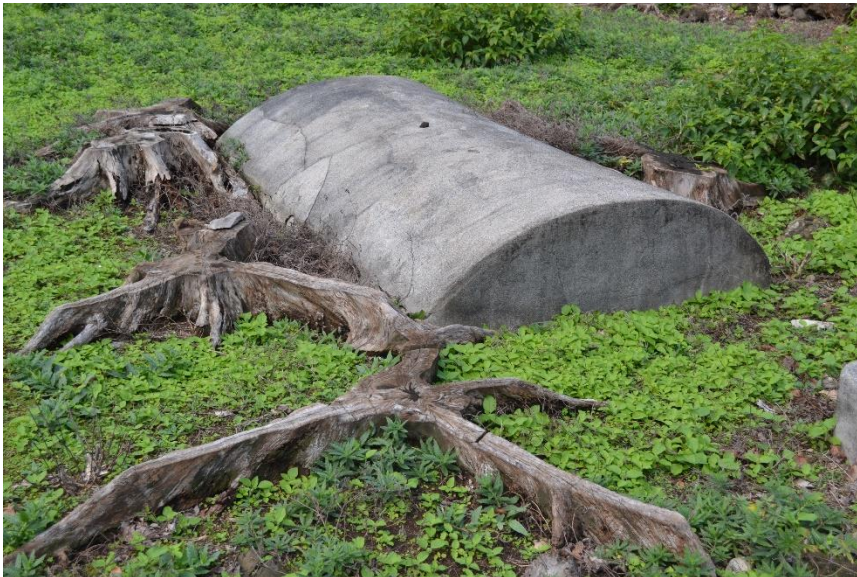
Figure B-85. Example of damaging effects of tree trunks damaging adjacent tomb within Cemetery O.

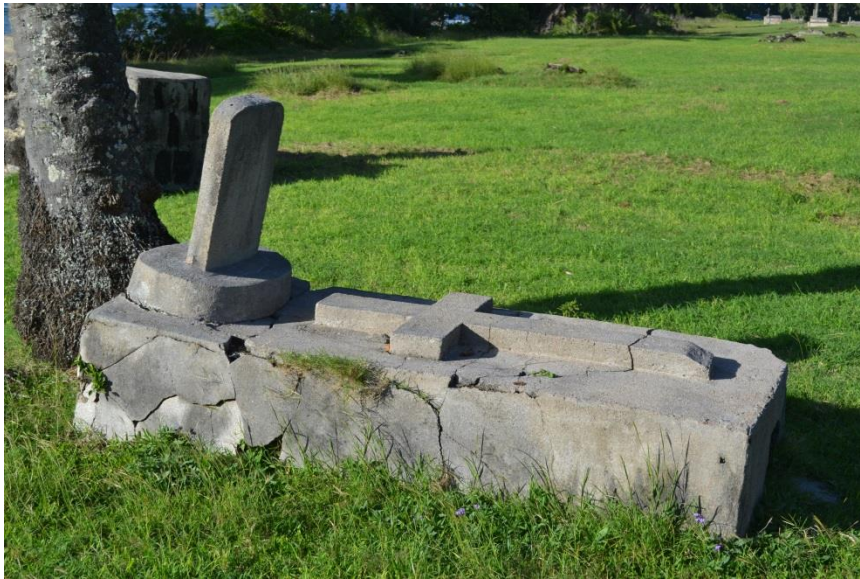
Figure B-86. Example of grave marker impacted by root and trunk damage within Cemetery G.
