HISTORIC STRUCTURE REPORT

ST. PHILOMENA CATHOLIC CHURCH

KALAUPAPA NATIONAL HISTORICAL PARK  
Molokai, Hawaii

January 1985

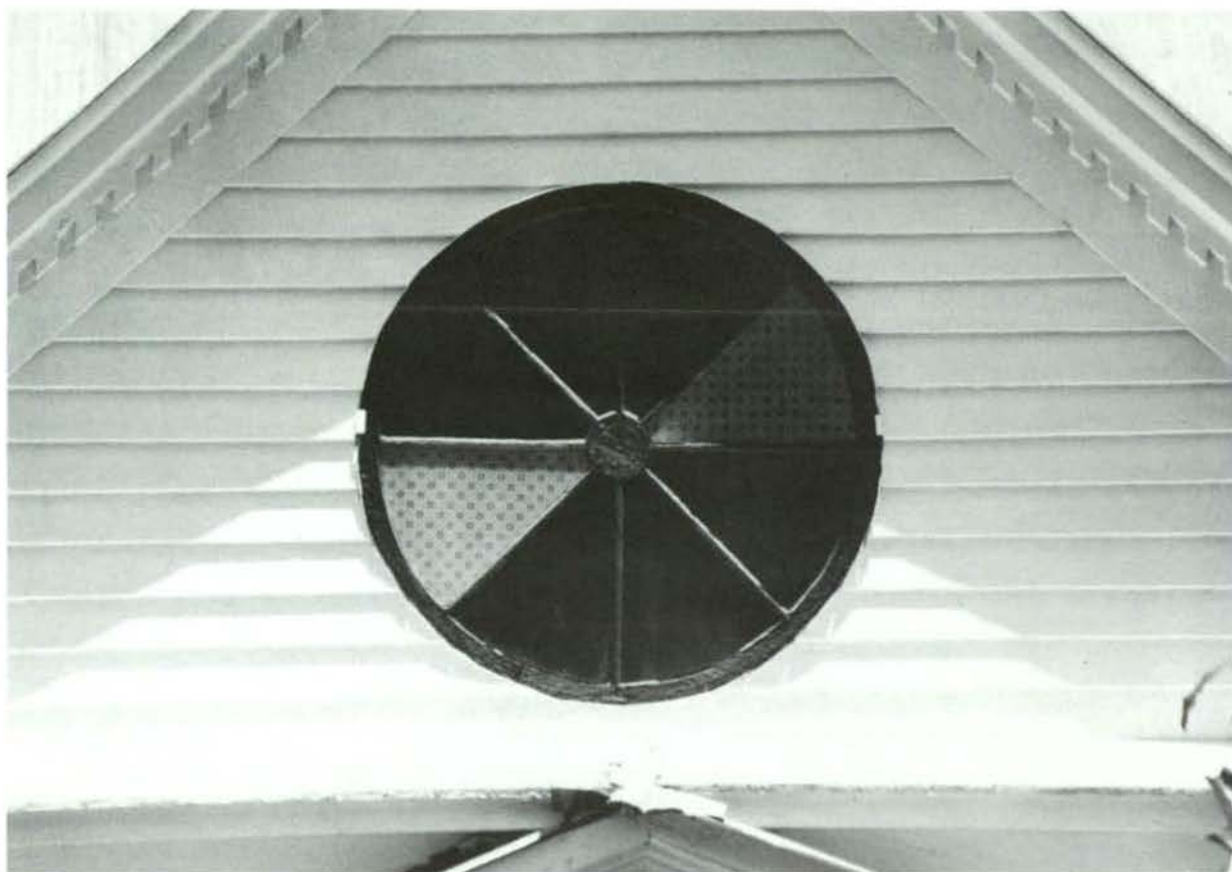
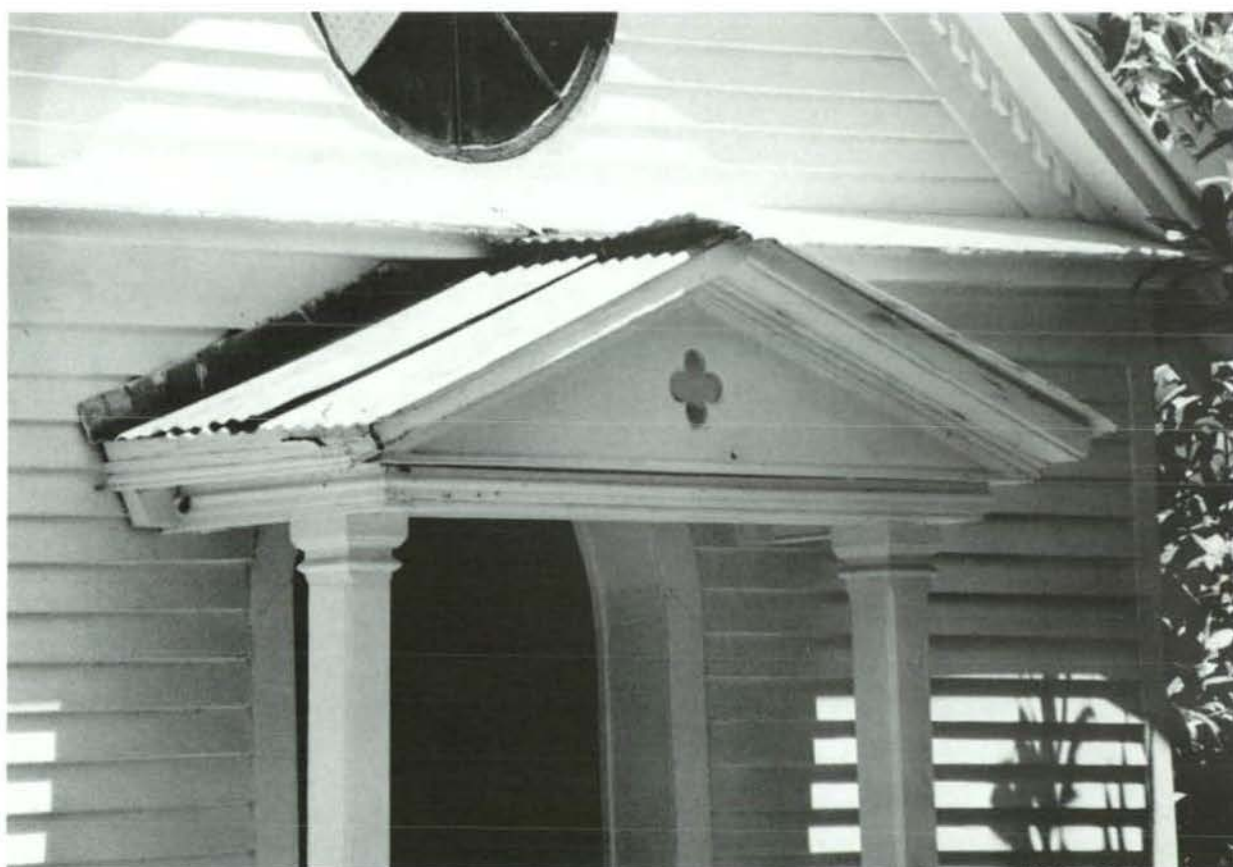
Illustration A14.

Detail of portico roof at 'west' entry of 1876 nave. Deterioration of the framing and sheathing no longer will hold the roofing nails. 6/84. R.L.C.

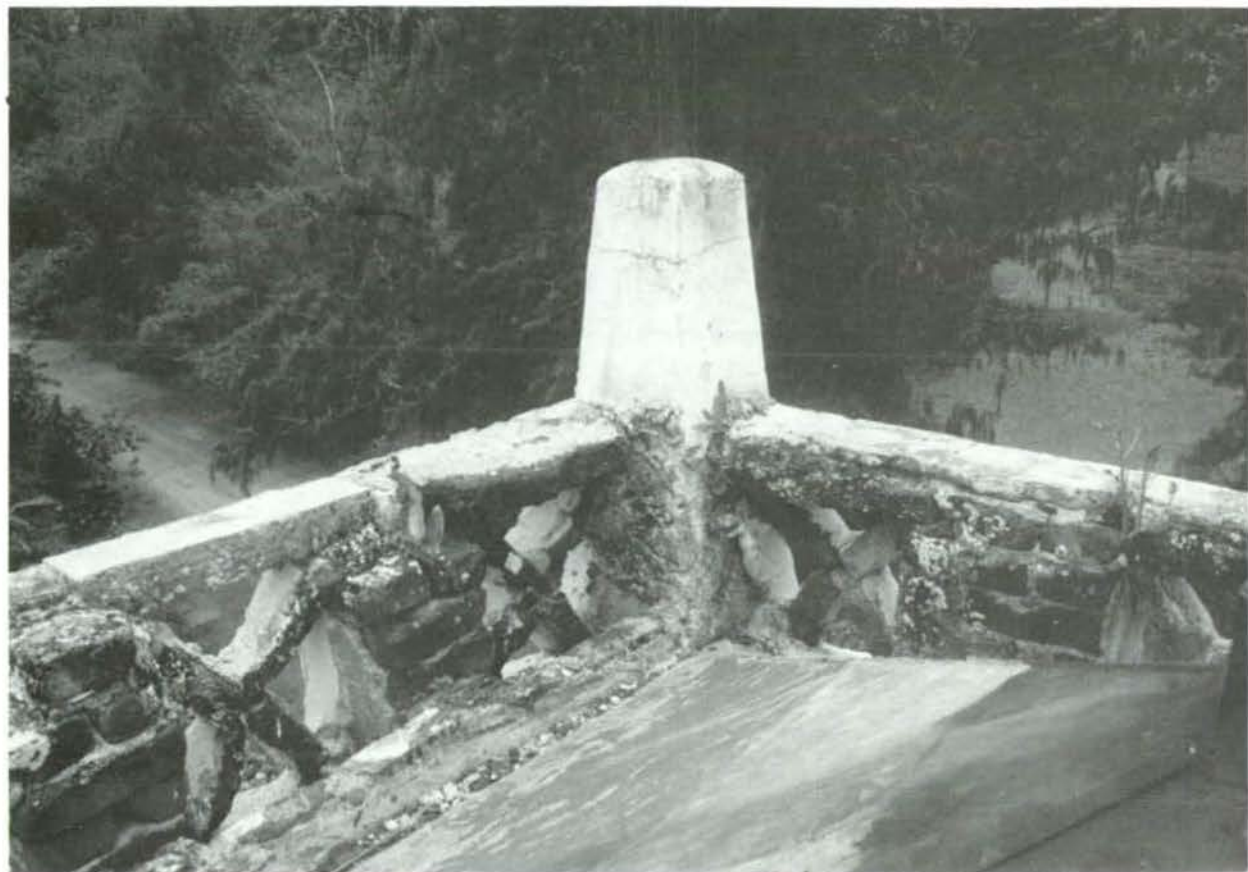
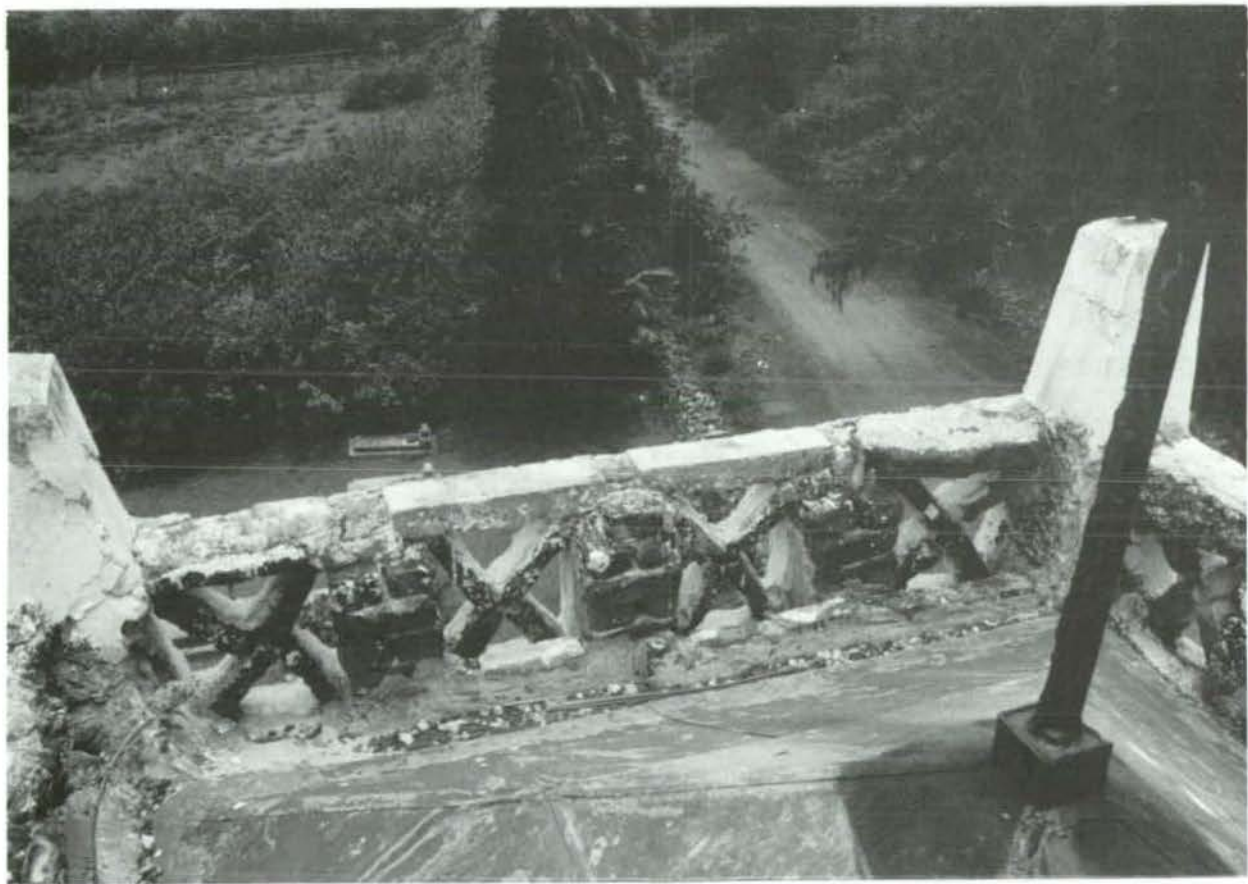
'East' parapet. Note concrete masonry units used for repairs. The copper roofing is in reasonably good condition but the drainage gutter around the base of this square pyramidal roof does not drain well and the base plate of the roof framing is rotted. All crosses are rusted and exfoliated. 5/84. H.G.L.

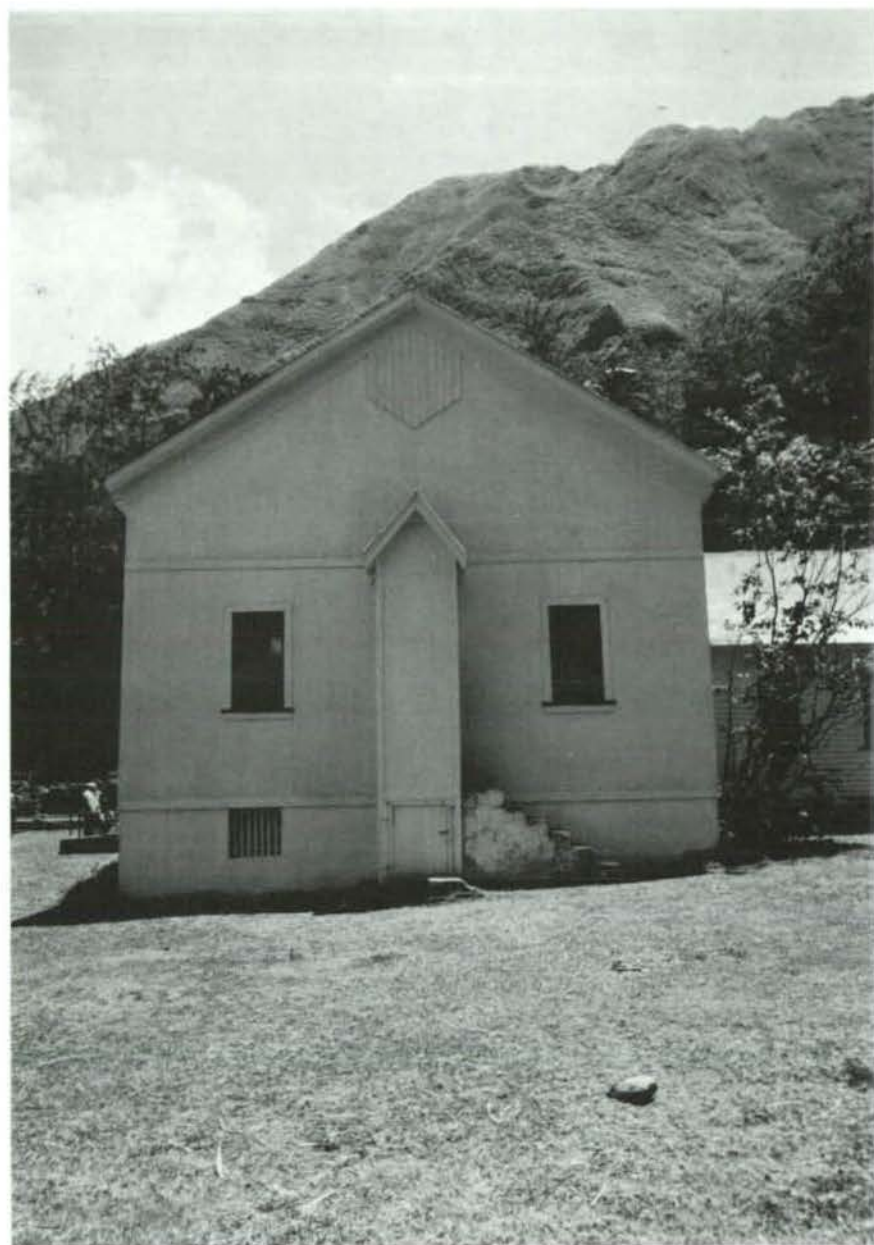
Illustration A33.

Rear ('north') elevation of 1888-89 portion of building. This wall was replaced after collapse during a storm. The sand density in the paint on this wall does not match that of the other siding of the building. 6/84. R.L.C.

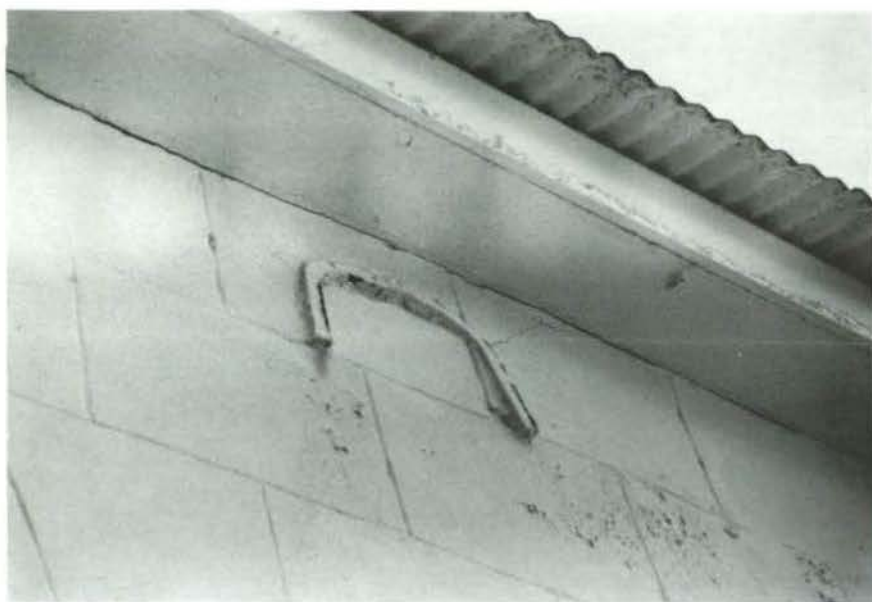
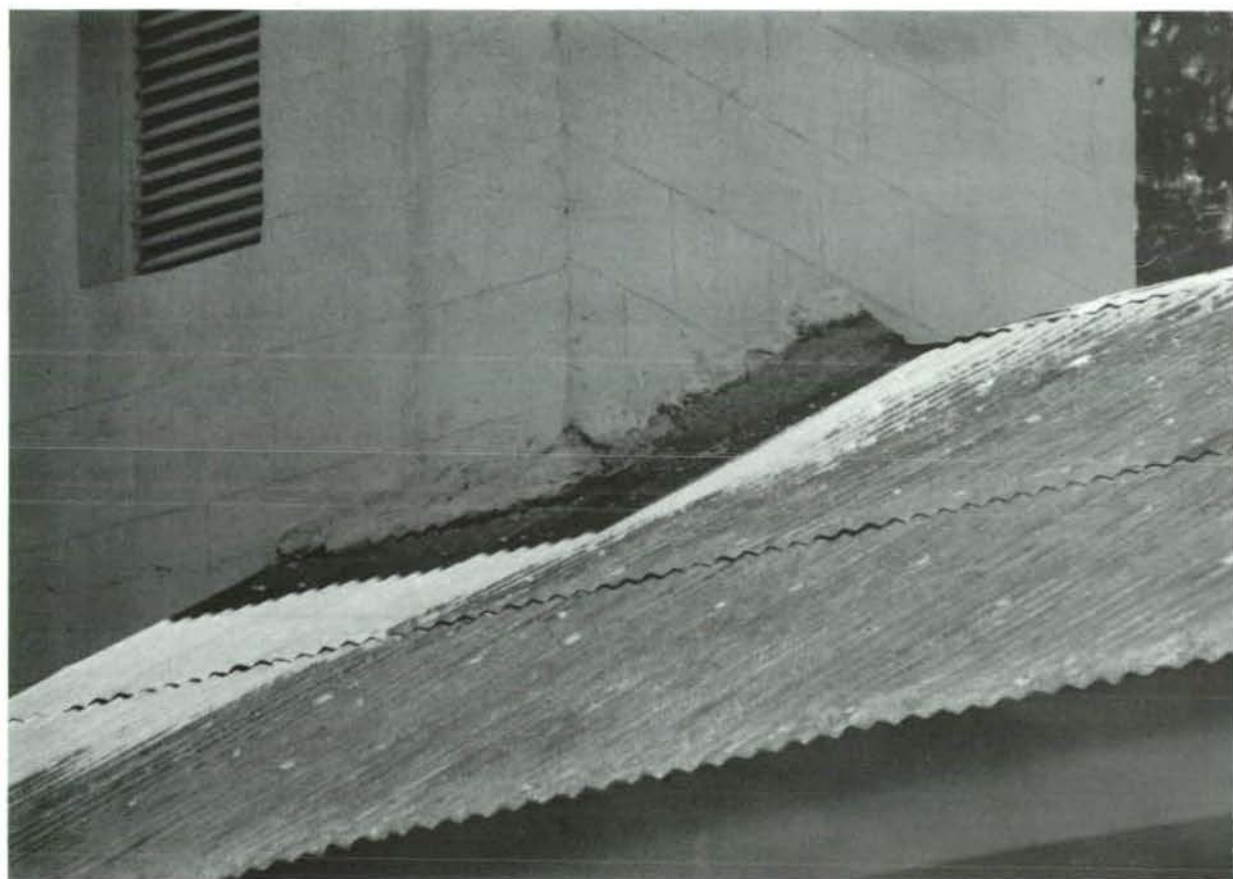
Illustrations A39 and A40.

Detail at juncture of main roof and bell tower. Numerous attempts to seal this joint are evident. Leakage here is the cause of damage to the stations of the cross. 6/84. R.L.C.

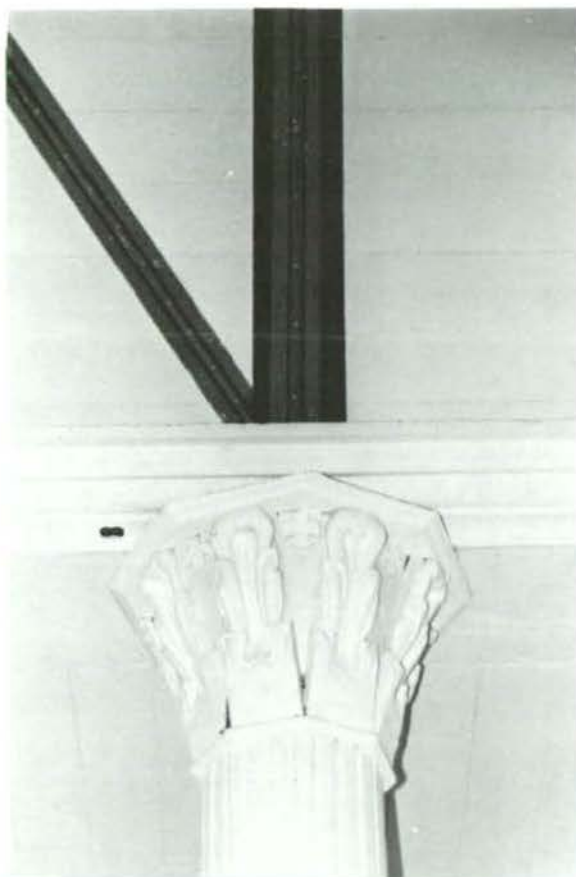
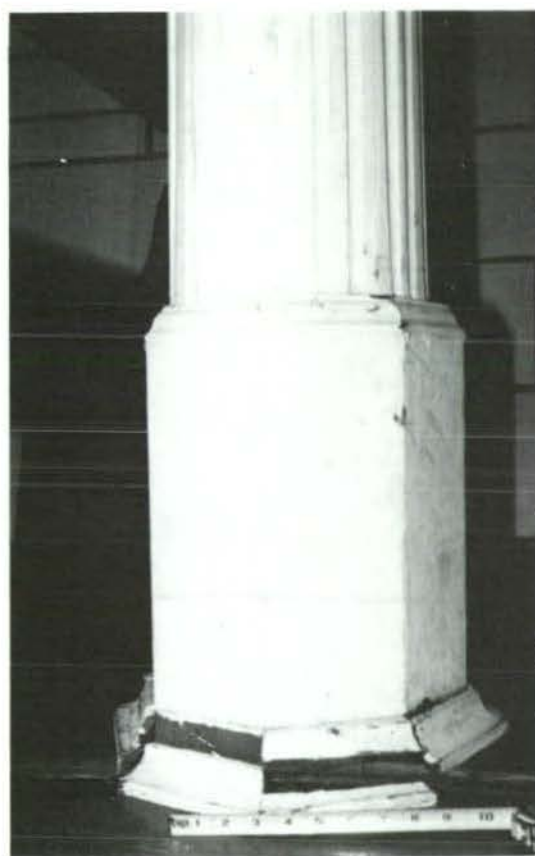
Illustrations A50 and A51.

Base of 'southeast' column of 1888 nave showing subsidence of floor structure, which damaged base trim. 8/84. P.C.C.

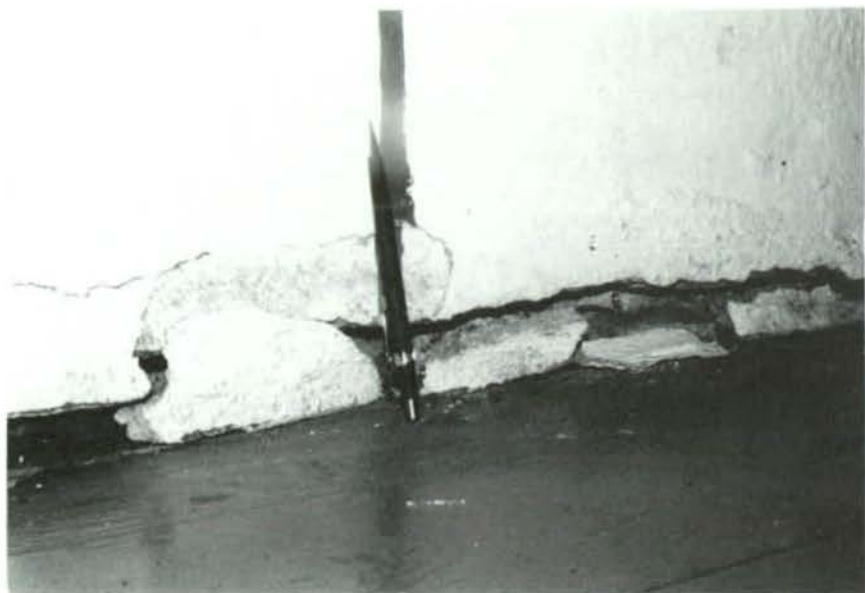
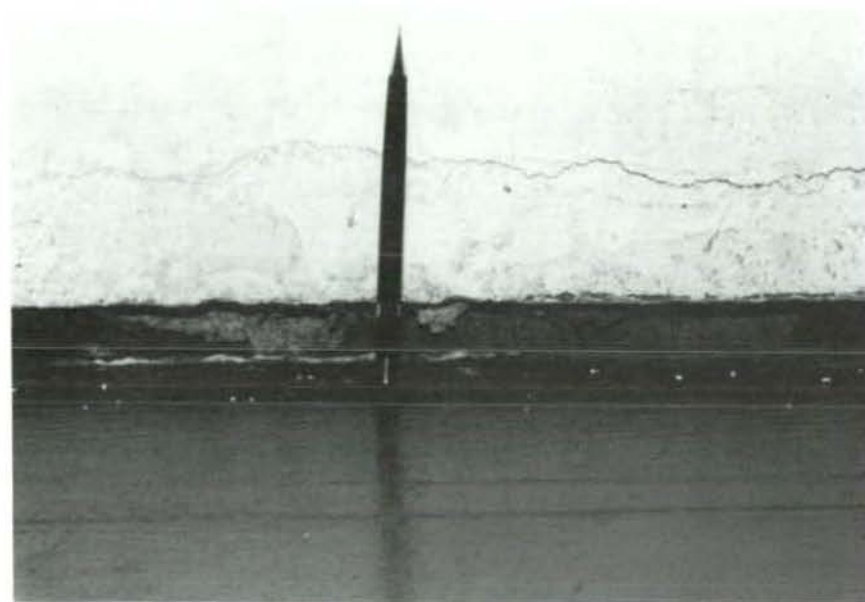
Details showing subsidence of floor of 1888 nave. The greatest settlement occurred in the area of the two 'southern-most' columns. Repairs to the wall plaster have failed as the cement plaster mix did not bond to the earlier lime plaster. 8/84. P.C.C.

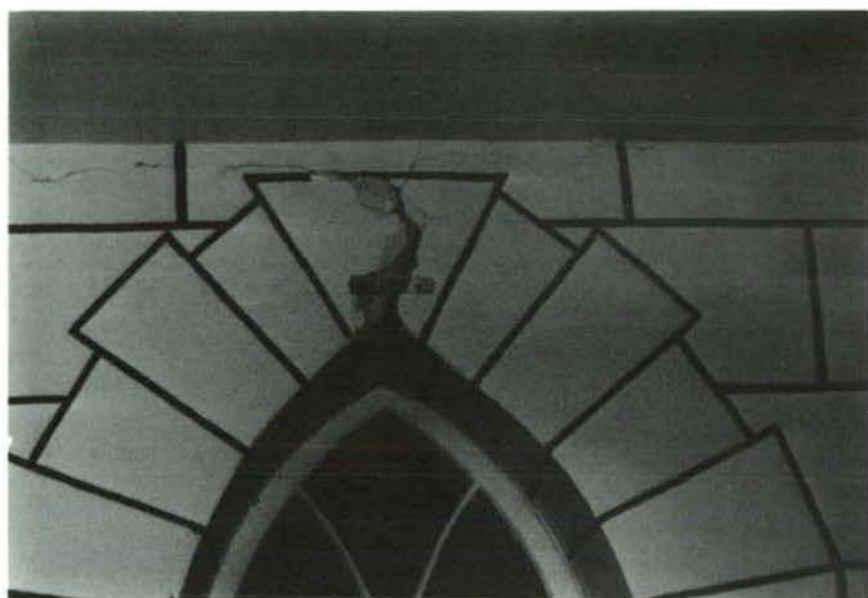
Illustration A53.

Illustration A52. Earthquake damage at 'south' window of 1888 nave, west wall. Similar damage occurred at the window on the opposite side of the building. There has been no movement recorded since the tell-tale was installed. 8/84. P.C.C.

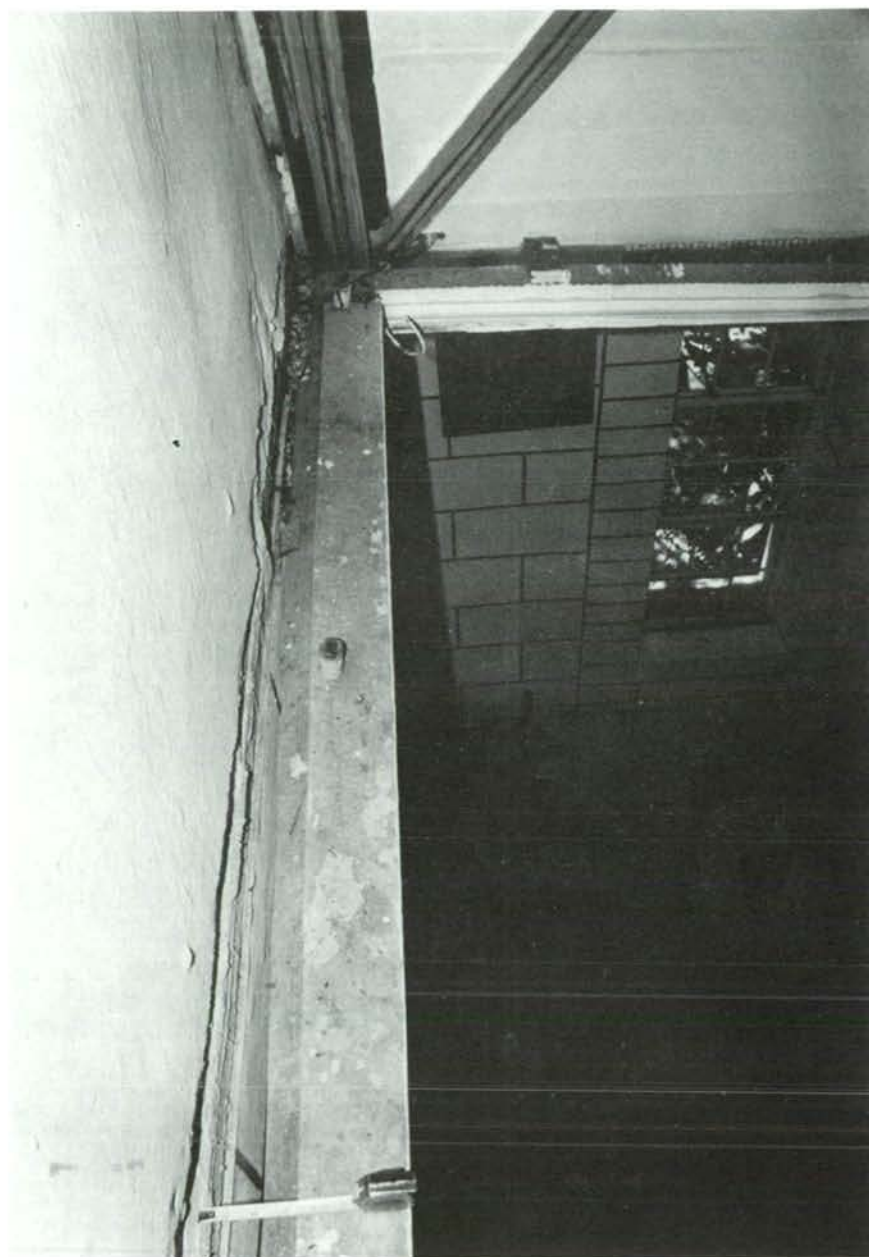
Top of cornice at 'south' wall of 1888 nave. The nails which formerly secured it to the wood nailer set in the masonry wall are completely rusted away, and it is held in place only by the ends of the cornice members at the base of the vault. 8/84. P.C.C.

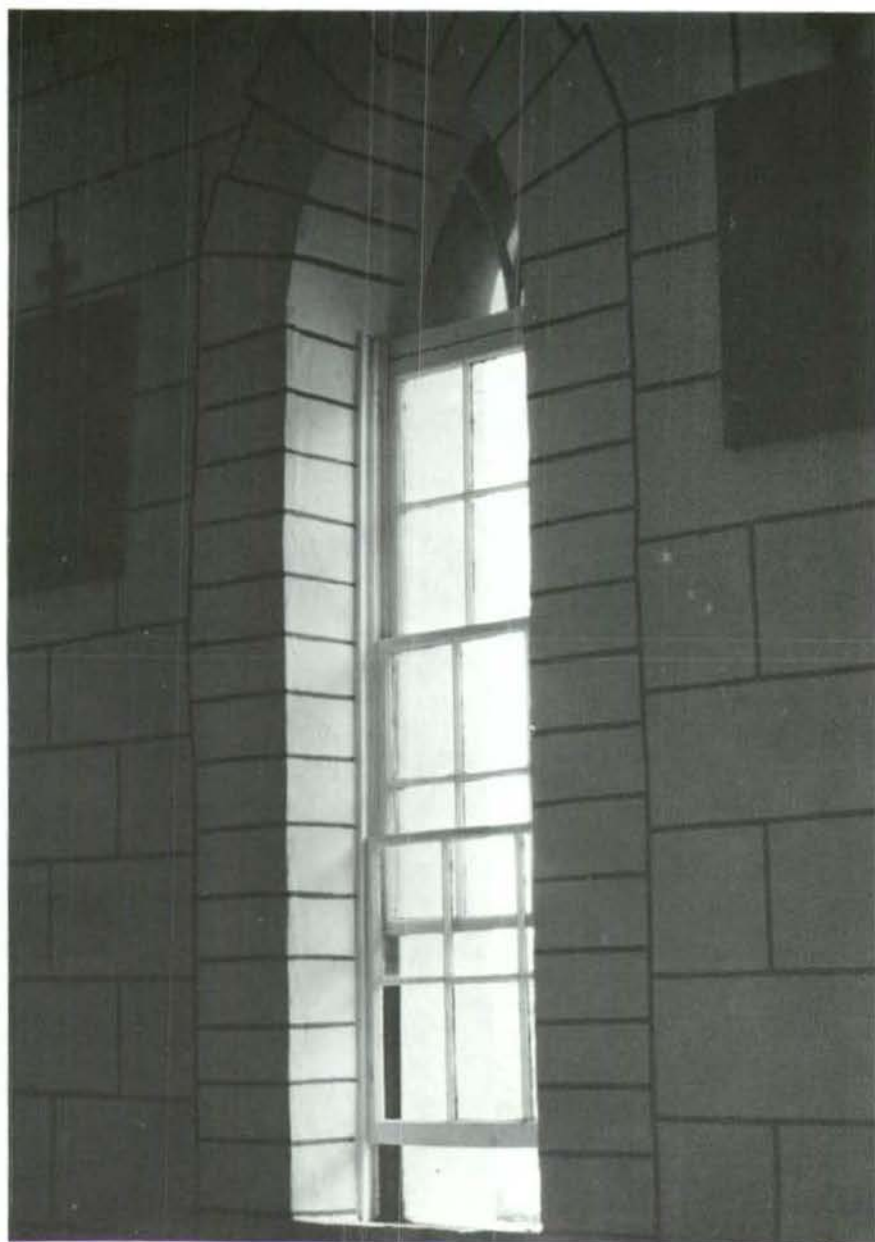
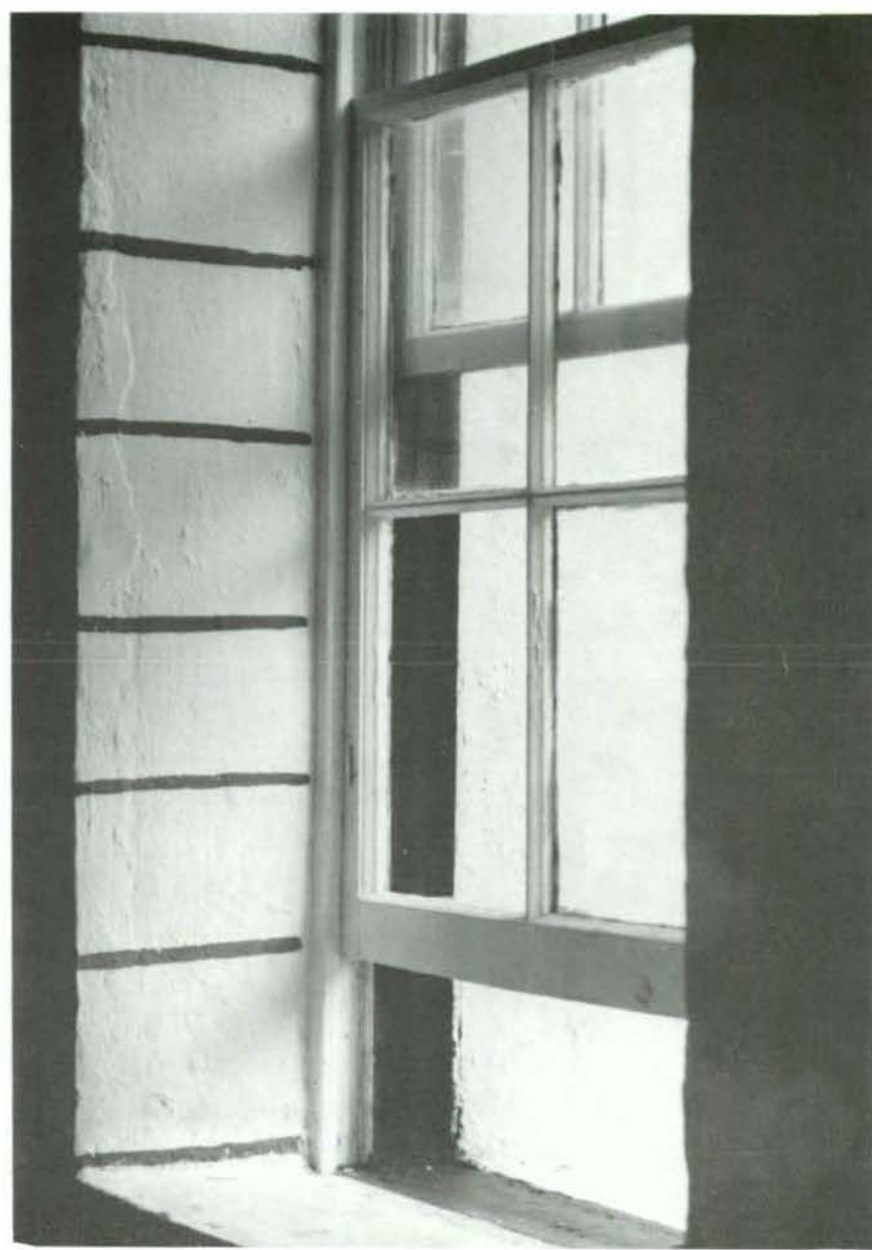
Illustration A56.

Window details, 1888 nave. Only the lower sash units of these windows are operable. There is no hardware, nor does it appear that there ever was, so they must be propped open. Some glazing is missing, as illustrated here, or broken. Sash, sash guides, wood jambs and sills need refurbishing, and in some cases, elements need replacement. 6/84. R.L.C.

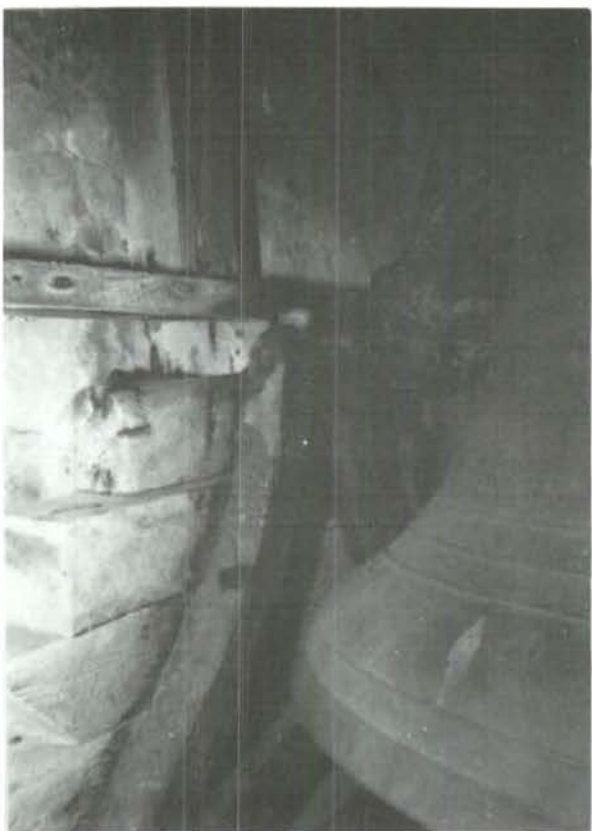
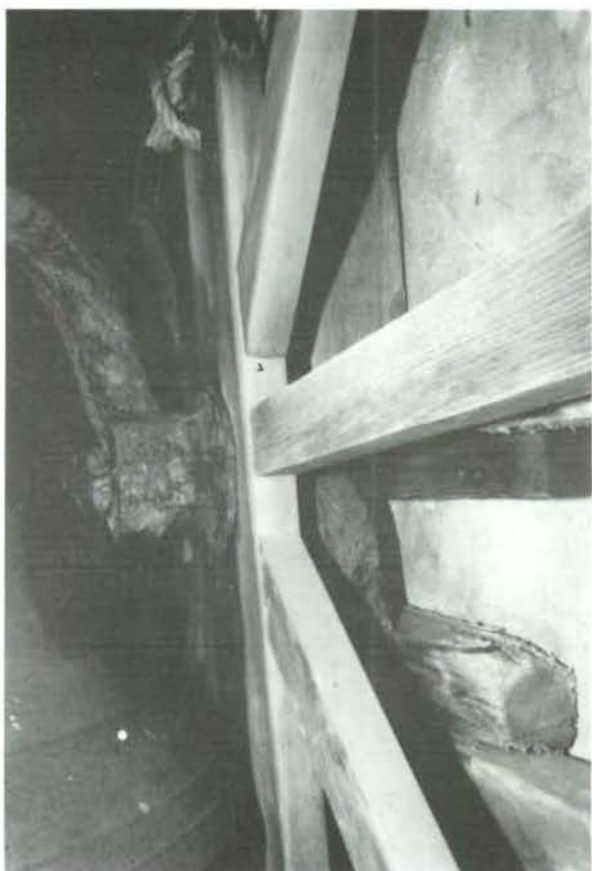
Illustration A72.

Details of the deteriorated bell yoke. The bell is frozen because of the rust and exfoliation of the iron. 6/84. R.L.C.

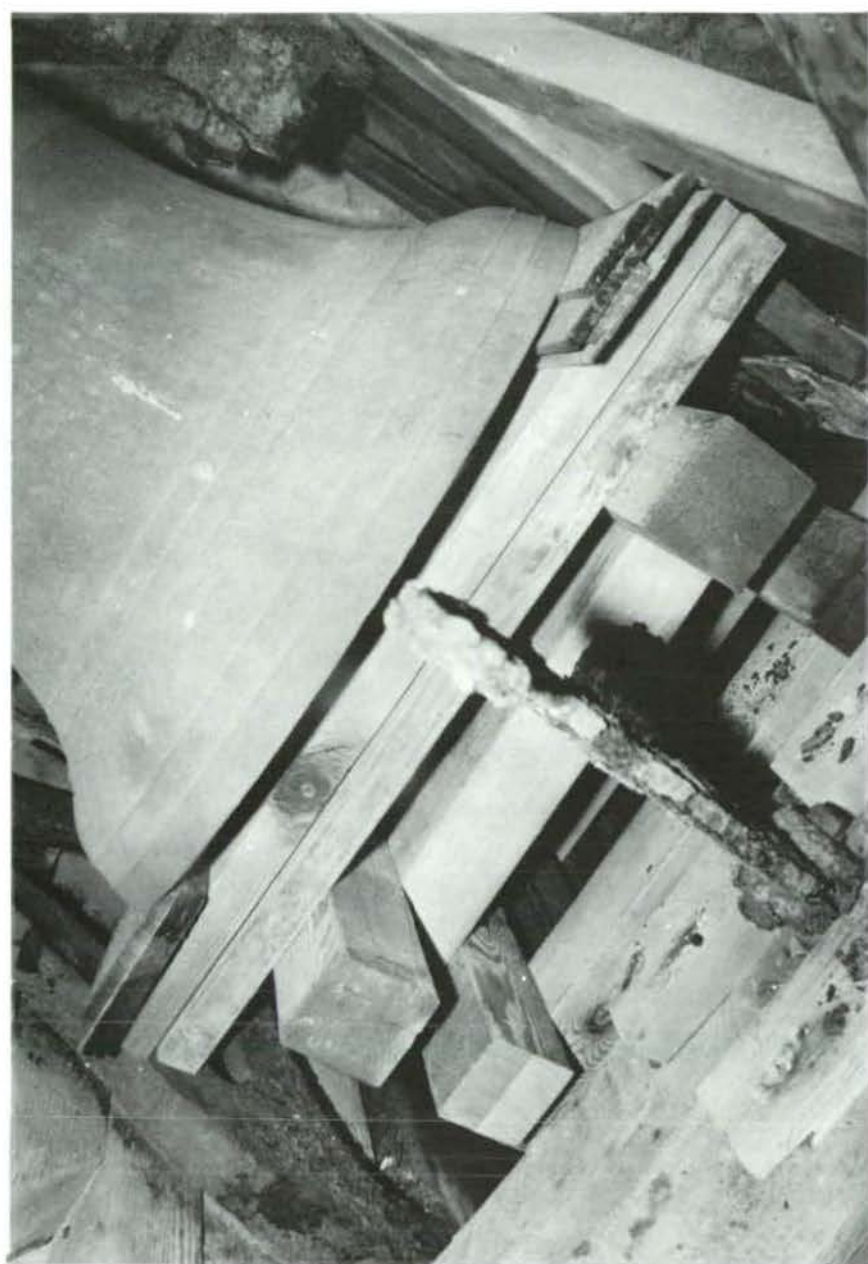
Illustration A73.

Detail showing cribbing installed in August, 1984 as a safeguard against failure of the deteriorated shafts and connections of the bell yoke. 8/84. P.C.C.

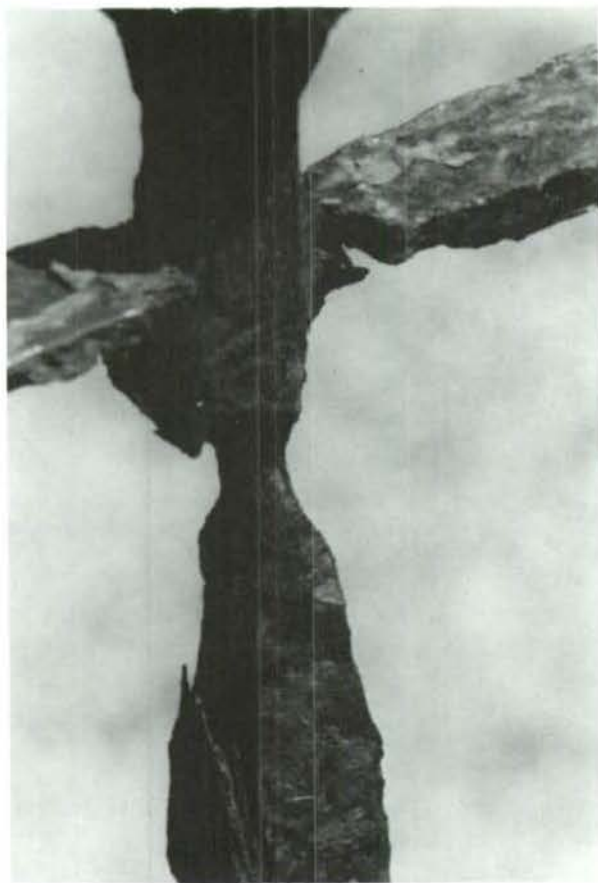
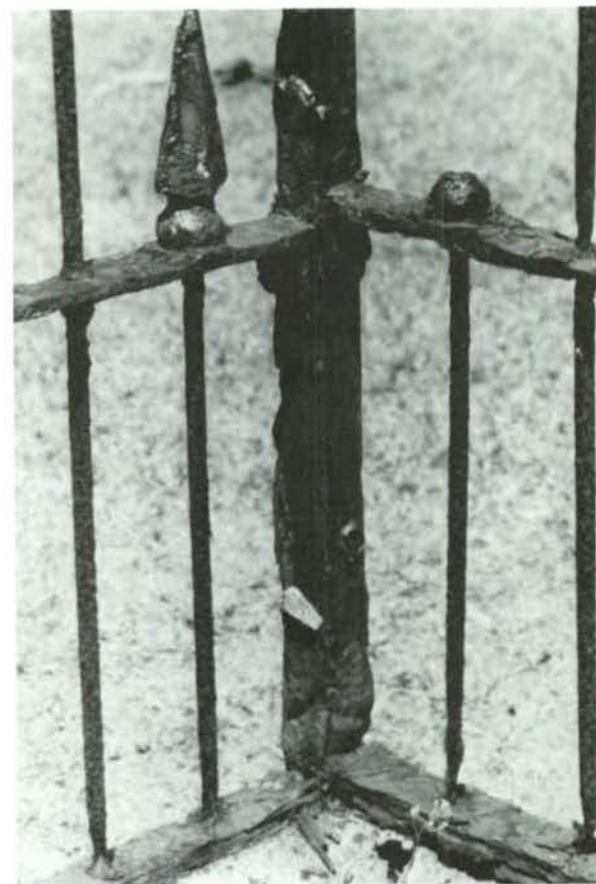
Illustrations A117 and A118.

Details of railing, Fr. Damien's grave, showing deterioration of metal. 6/84. R.L.C.

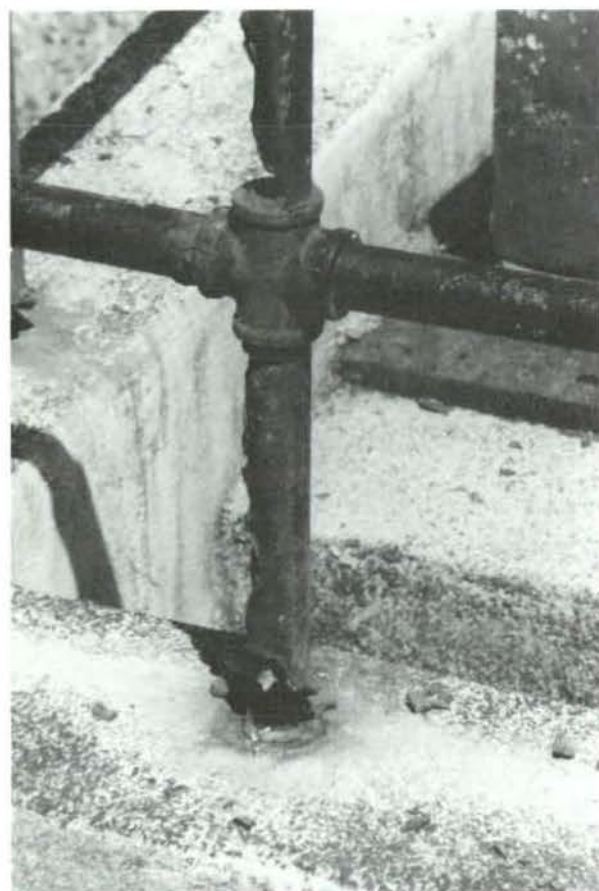
Illustration A124.

Detail of deteriorated pipe railing of Br. Dutton's grave. 6/84. R.L.C.
